**TECHNICAL MEMORANDUM
BROWNFIELDS SUSTAINABILITY PILOT
ALLEN-MORRISON SITE, LYNCHBURG, VIRGINIA**

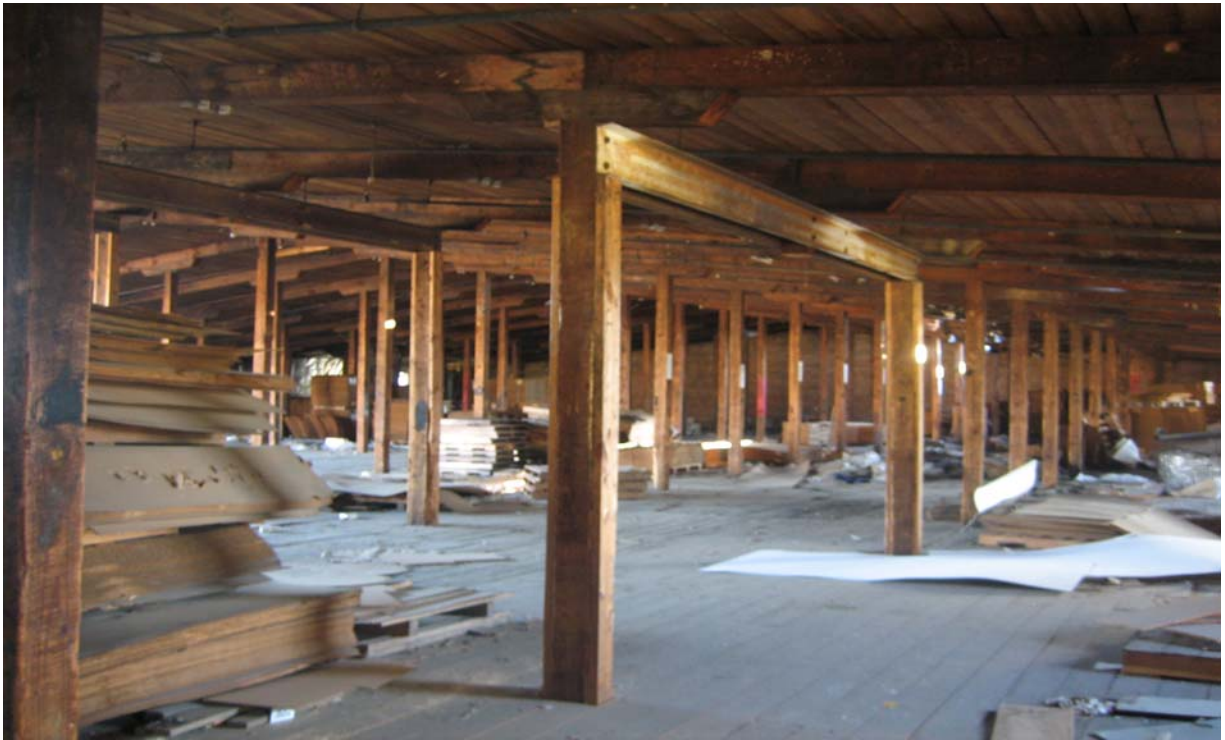
Photograph No. 1: Thornhill 7A (upstairs)—view of 6”x 6” timber column structure

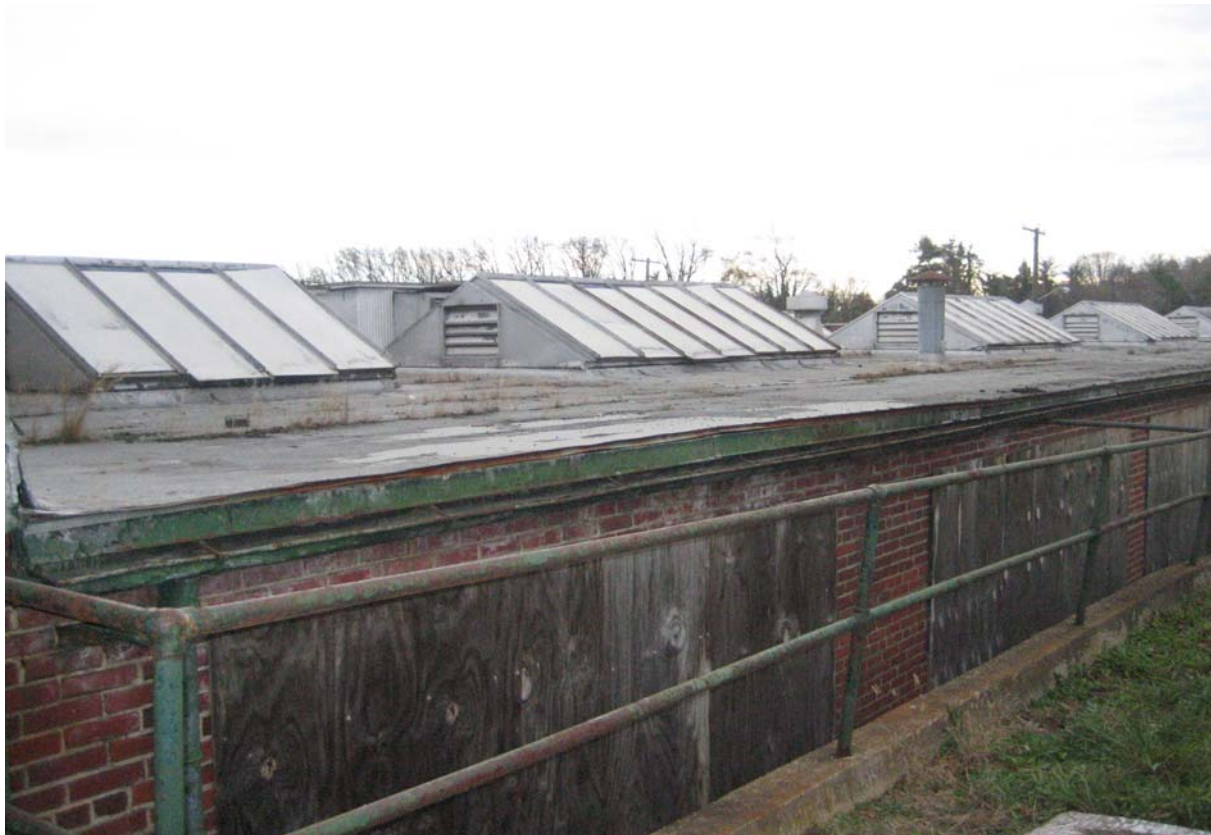
- Skylights: About 12 approximately 8- by 12-ft, glass, peaked skylights are located on the roof of the Allen-Morrison facility (see Photograph No. 5). If these features can be carefully removed despite the roof damage in these buildings, they could be reused in the development to highlight the architectural and industrial heritage of the site, or possibly as part of greenhouse structures for *Lynchburg Grows*.

Photograph No. 5: Skylights on top of Allen-Morrison facility

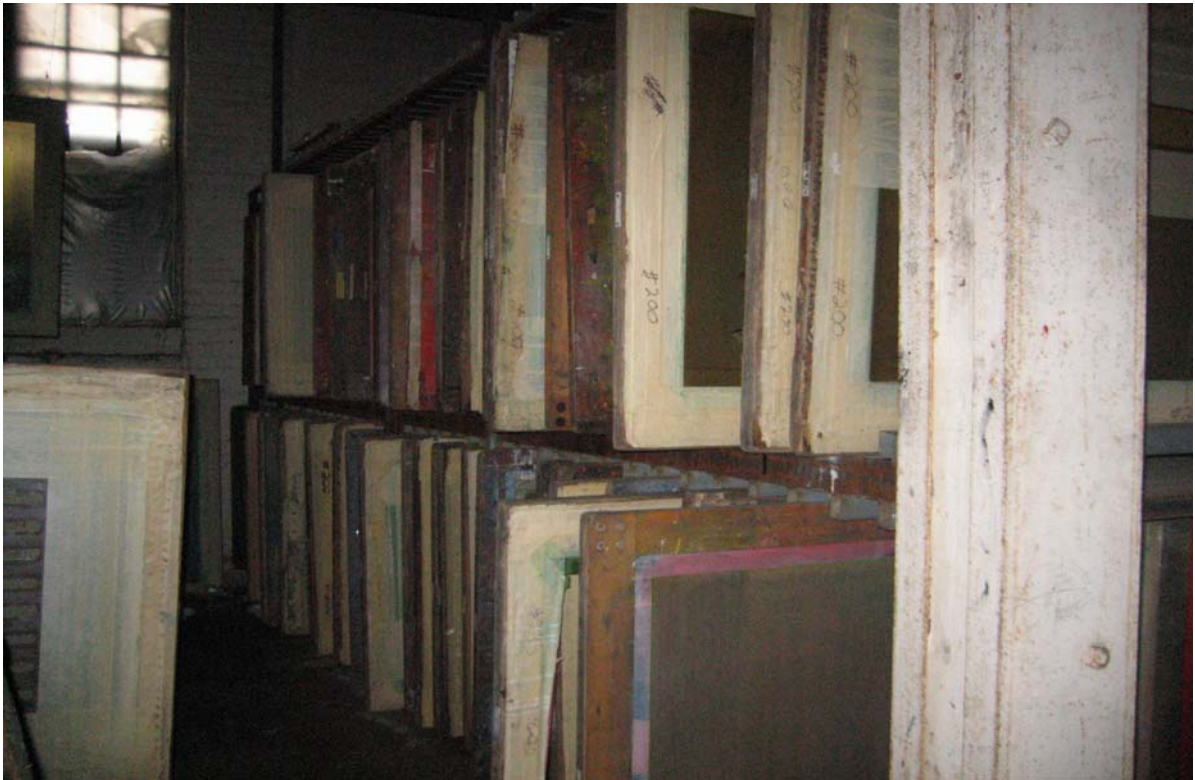
and incorporated as artwork or other uses to highlight the industrial heritage of the site. The wooden frames could also be restored by local artists for their use. Insect- or water-damaged wooden frames that cannot be restored could be shredded for mulch.

Photograph No. 7: Silk screens and frames in Thornhill 7D

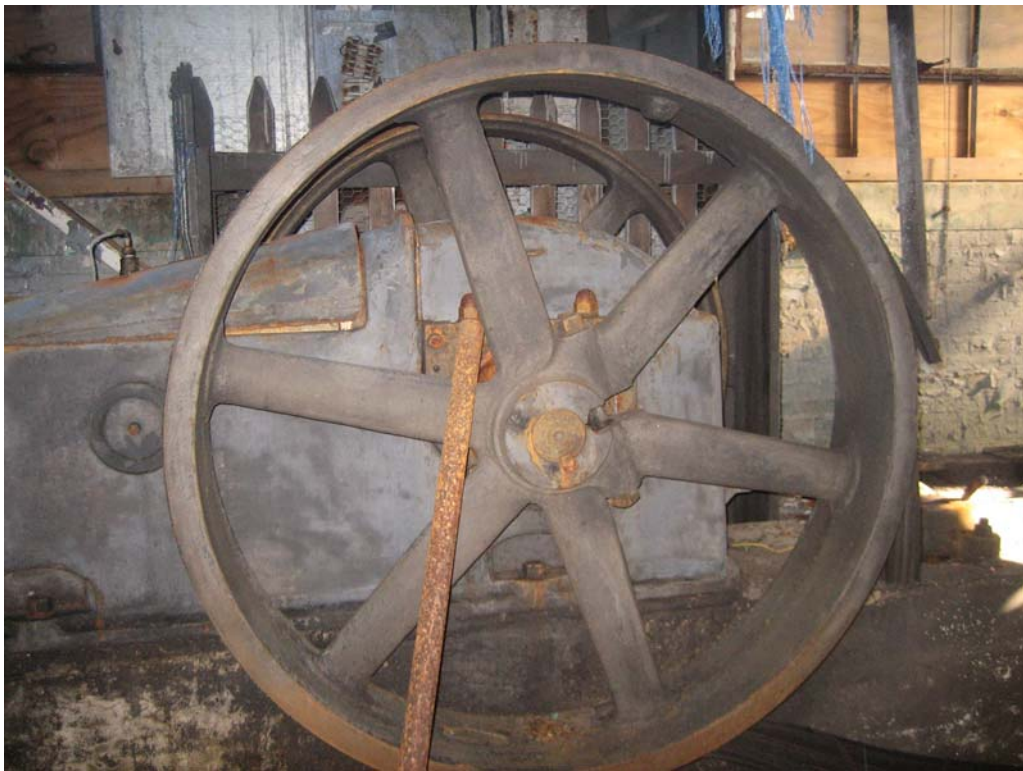
- Wheeled Hoist System and Equipment: An interesting wheeled hoist system and piece of wheeled equipment were located on the second floor of Thornhill Building 7A and in Allen-Morrison Building 1A, respectively (see Photograph No. 12). This hoist system could be repaired for reuse, or this system and the wheeled equipment refurbished as vintage pieces of equipment for display to highlight the industrial heritage of the site.

Photograph No. 12: Wheeled equipment in Allen-Morrison 1A
