**TECHNICAL MEMORANDUM
BROWNFIELDS SUSTAINABILITY PILOT
LANGDALE MILL, VALLEY, ALABAMA**

**ATTACHMENT C
PHOTOGRAPHIC LOG**

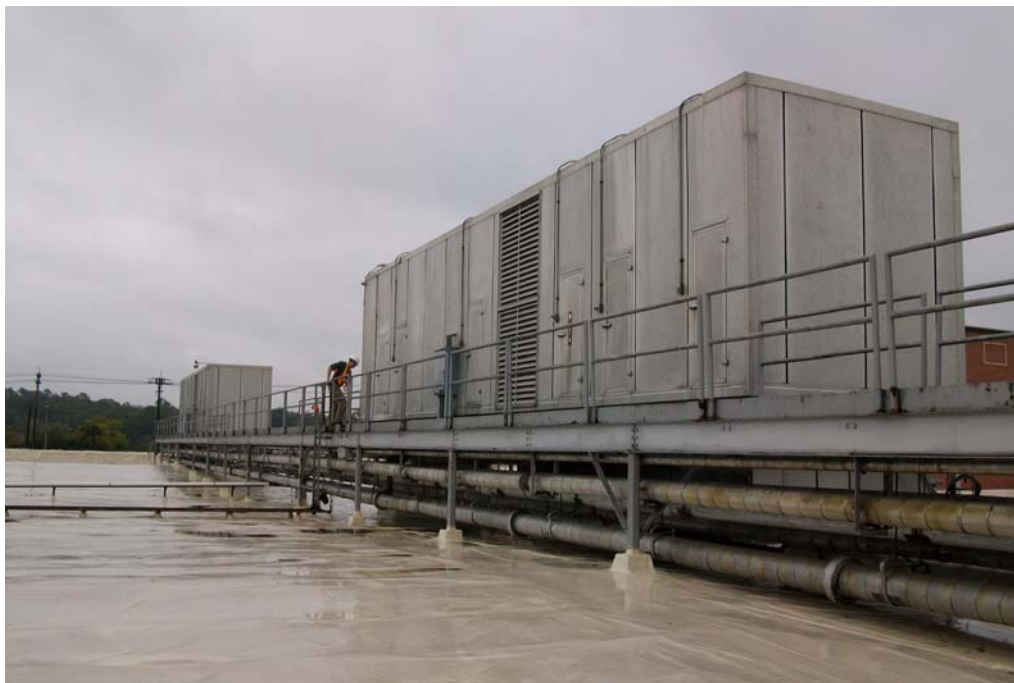
Photograph No. 1: Rooftop air handling units and associated steel support structure above Weave Room No. 2.

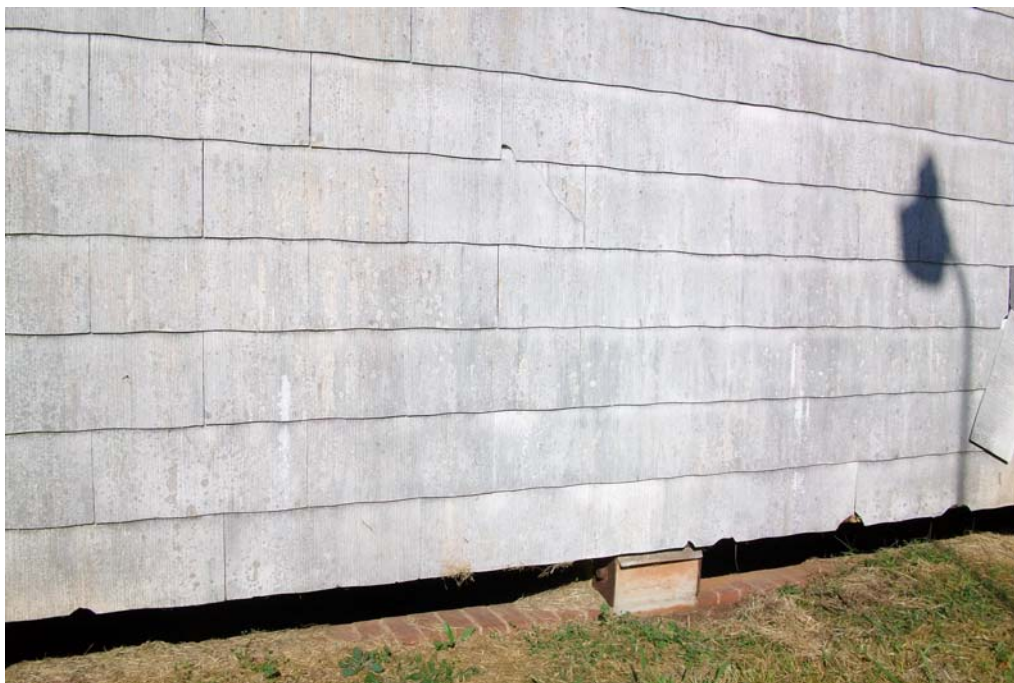
- **Asbestos and Hazardous Materials:** According to field measurements, approximately 4,200 sf of exterior siding that appeared to be asbestos-containing material (ACM) is present on Warehouses No. 1 and 2 (see Photo No. 2); ACM may also be present in the roof coating materials. ACM material should be properly tested and managed accordingly; associated ACM management and disposal costs should be added to the cost of deconstruction. In addition, more than 400 fluorescent light fixtures were also present; light fixtures may be salvaged for scrap metal value, but the associated fluorescent lamps should be removed and disposed of as “universal waste” according to the applicable regulations found in Alabama Department of Environmental management (ADEM) Administrative Code Chapter 335-14-11.

Photograph No. 2: Possible asbestos containing material (ACM) shingles on exterior of Warehouse No. 1.

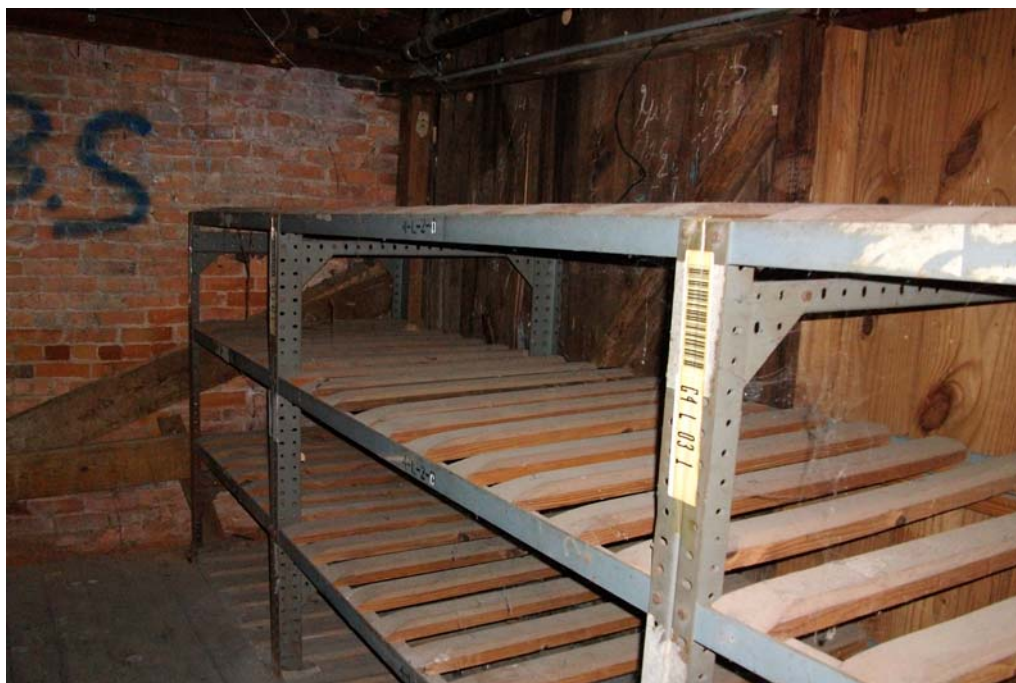
Photograph No. 3: Typical metal shelving unit in Warehouse No. 4.

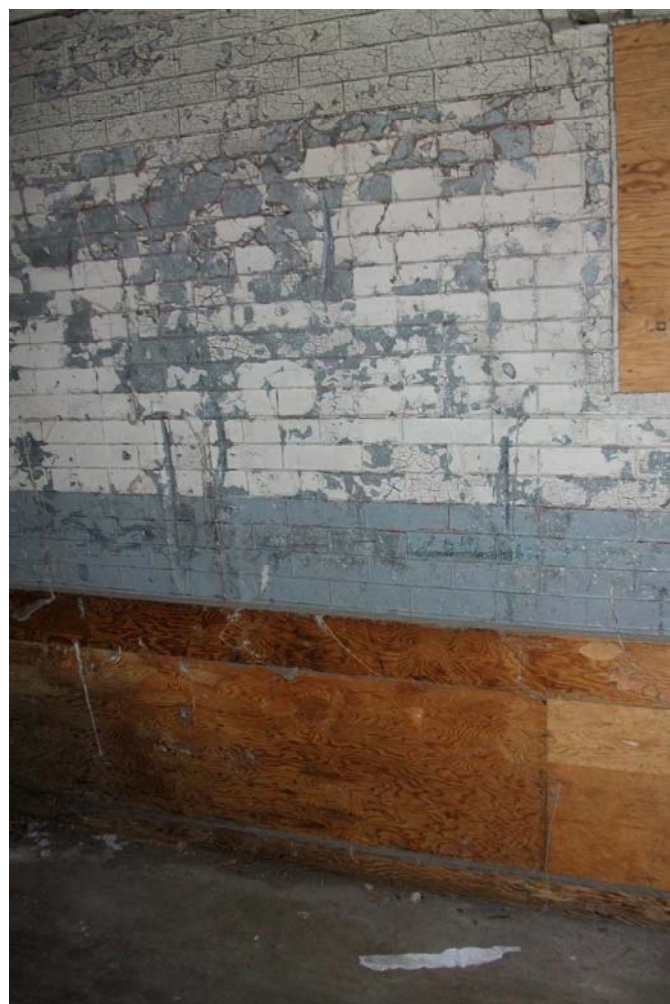
Photograph No. 4: Pressed metal, faux brick fascia on wall of Warehouse No. 4.

- Pressed Metal Fascia: Approximately 2,700 sf of pressed metal (likely tin), faux brick fascia was noted on site (see Photograph 4). This material could be refinished and reused on walls or ceilings of the redevelopment to highlight the historical architecture of the mill and promote the sustainability aspects of the project.

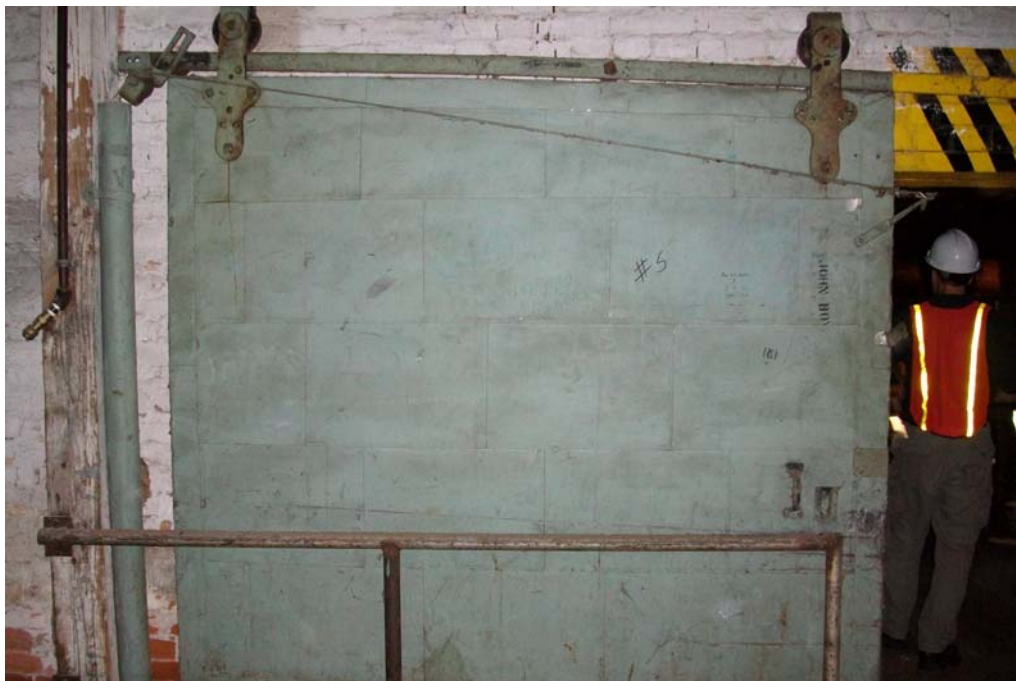
Photograph No. 5: Typical sliding track, wooden doors with pressed metal finish in Warehouse No. 5.

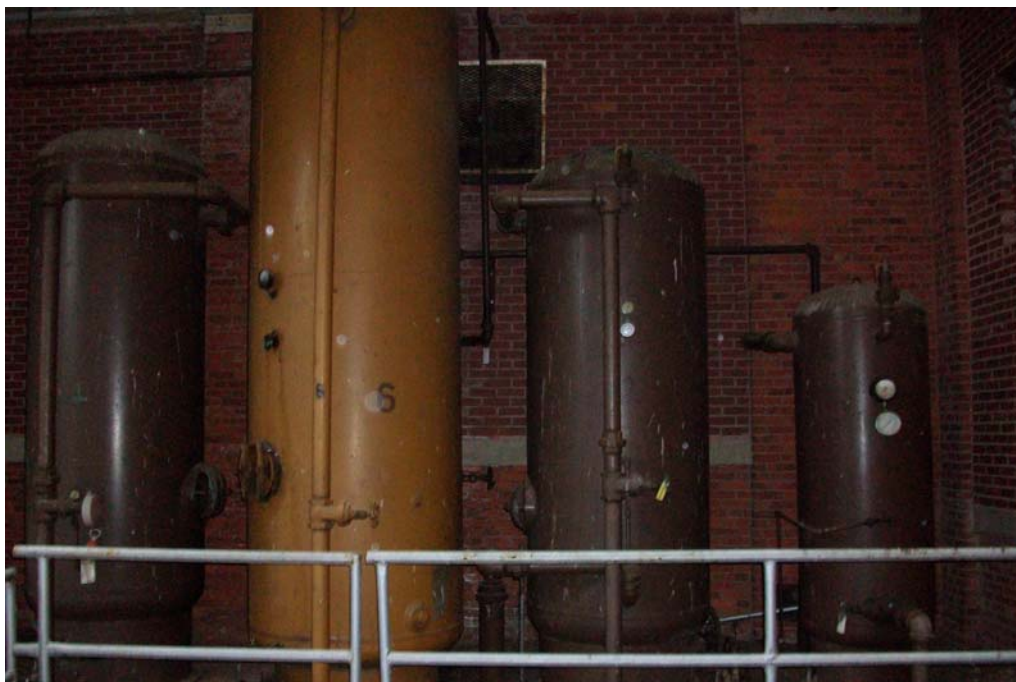
Photograph No. 6: Compressor tanks.

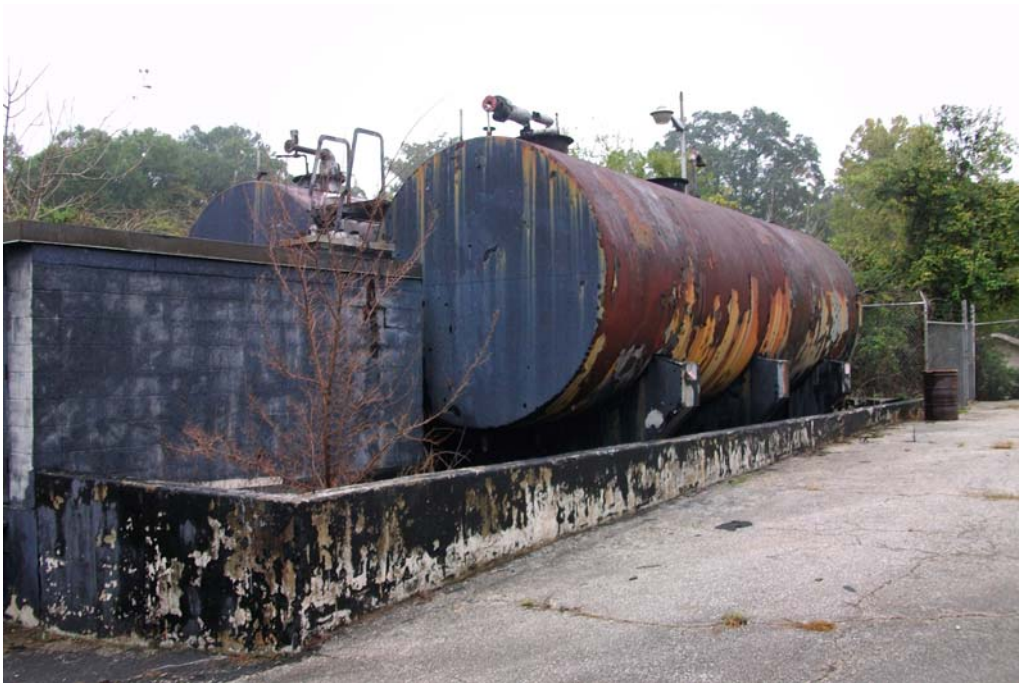
Photograph No. 7: Fuel oil storage tanks.

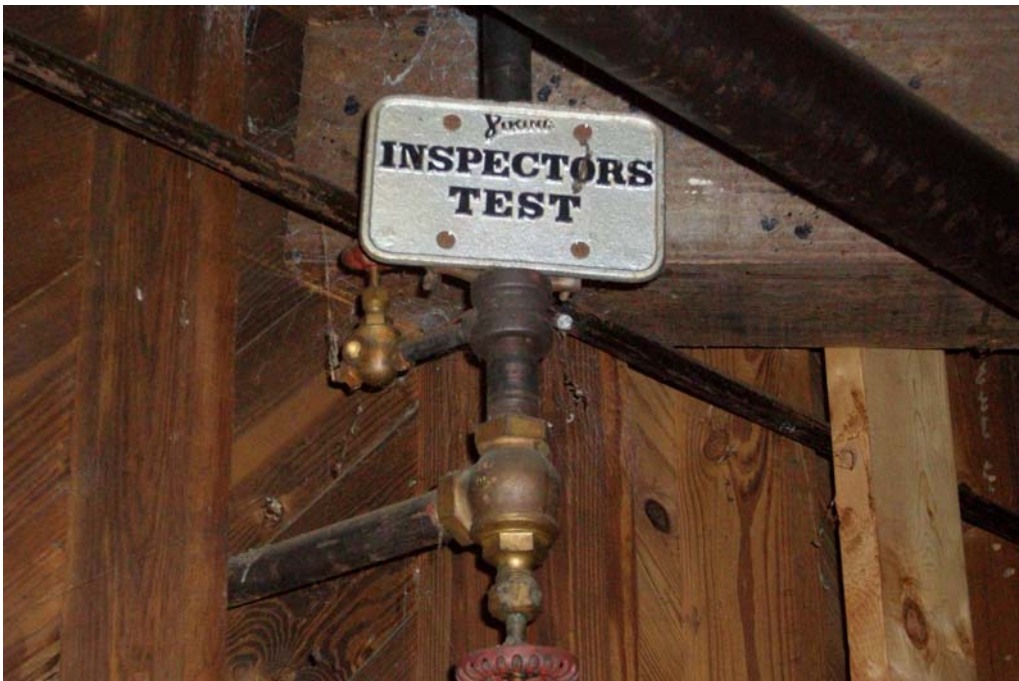
Photograph No. 8: Sprinkler system inspector test plate.

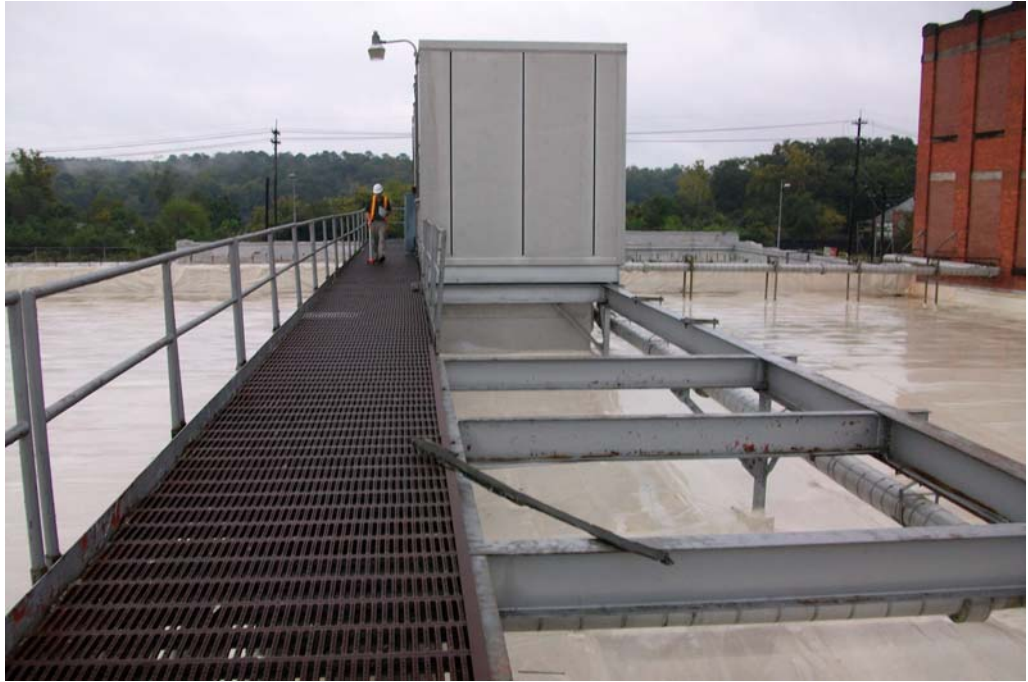
Photograph No. 9: Metal walkway grating and associated handrails of the rooftop air handling unit above Weave Room No. 2.

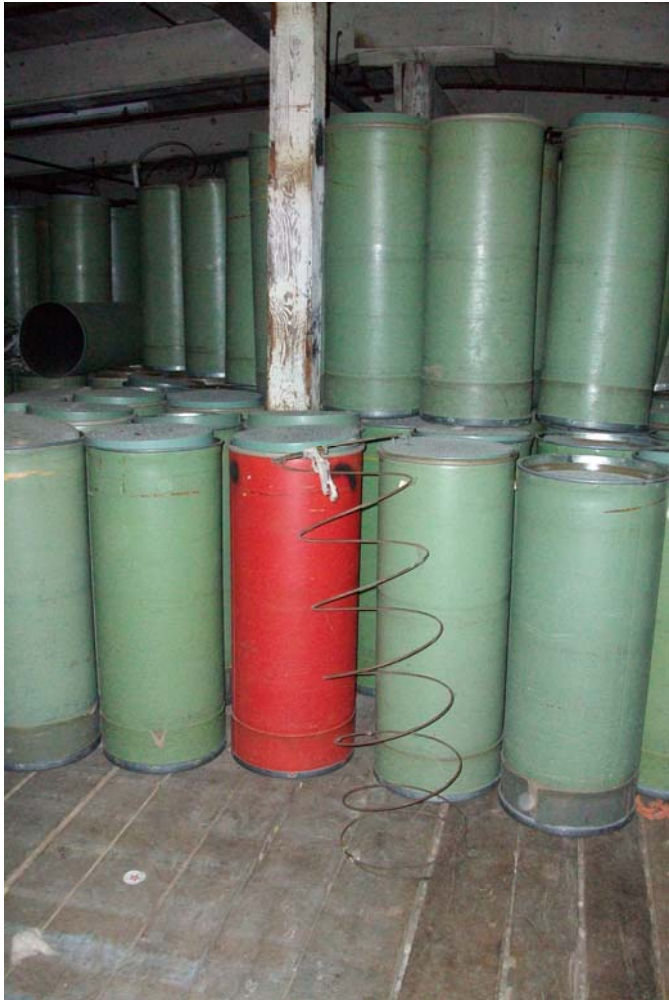
- Storage Containers: Approximately 2,900, 16-inch-diameter by 36-inch tall fiberglass/fiberboard storage containers with metal coils to spring-load the bottoms were observed in Warehouses No. 2 and 5 (see Photograph No. 10). These containers could be sold for reuse or recycled. The approximately 7,400 pounds of steel coils could also be salvaged as scrap metal for an approximate value of \$370.

Photograph No. 10: Fiberglass/fiberboard storage containers with metal coils in Warehouse No. 5.
