**The Rio dos Padres case study – Working in a dangerous area and minimizing the impact of clean-up activities on the environment.**

**Fernando Henrique Falkiewicz, Process Senior Engineer, Petrobras, President**

**Getúlio Vargas Refinery, Parana State, Brazil.**

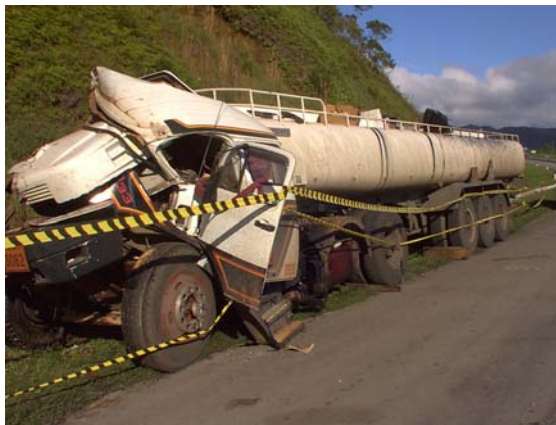
In April 2001, a tank truck carrying fuel oil collided with a soy bran truck, the oil tank ruptured and all its 30,000 liter of fuel was discharged. The oil contaminated the road and run to the rainwater sewer. The sewer discharged the oil to the roadside, into the rainforest and then to a pristine river in this forest.

Fig 1 – The tanker truck in this casualty.

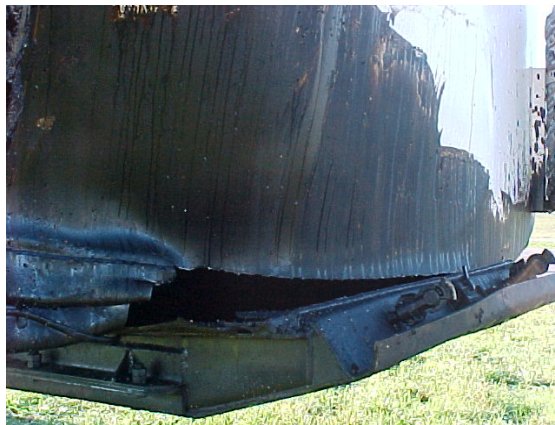
Fig 2 – Tank rupture detail.

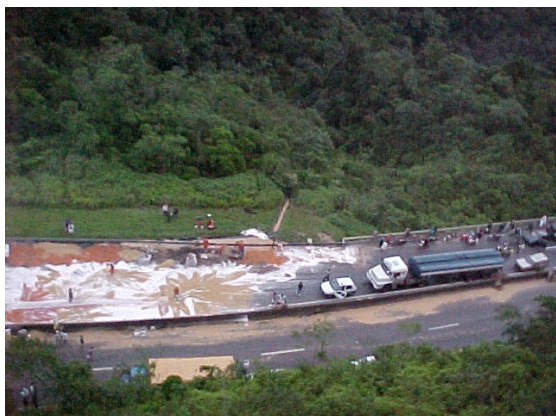
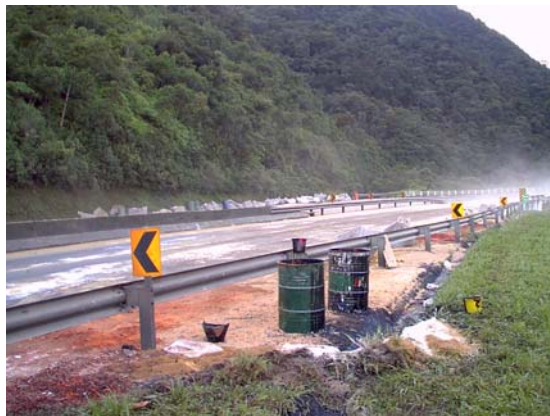
Fig. 5 – Road cleaning and decontamination.

Fig. 6 – Road cleaning and decontamination.

The first job was to finish the road cleaning. The oil on the road was absorbed with the second trucks' soy bran, sawdust, lime and peat powder, all material was removed from the road surface with shovels and hoes. Contaminated material was conditioned in plastic bags and sent to a petroleum refinery for treatment.

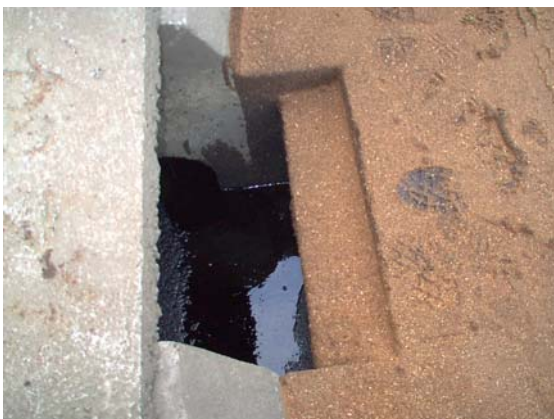
Fig. 7 – Rainwater sewer inlet.

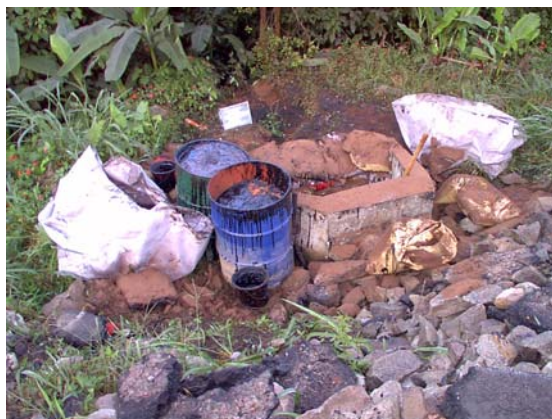
Fig. 8 – Sewer discharge to the forest.

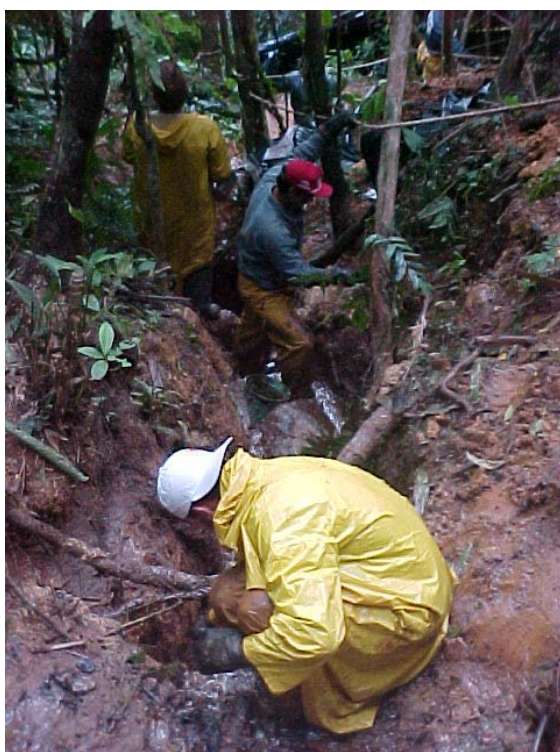
Fig. 17 – Workers cleaning one of the “tracks”.

In the “tracks”, the oil was absorbed with sawdust and/or peat powder, packed in plastic bags, and then carried manually up hill; most of the way with rows of men and passing the bags hand to hand up hill, once walking up the hill was very exhaustive. Some residue bags

were too fluid; these bags were packed into buckets to protect against rupture by impact on trees or rocks. At the first working base, at the roadside, the bags were packed in containers and removed for treatment and final disposal at a petroleum refinery. The equipment utilized in this site included shovels, backhoes, plastic bags, buckets, ropes and wood sticks as anchor points. Where possible, in the tracks, small dikes were built to contain the oil. All the hardware and material had to be small and light enough to be carried into the forest without damage to the environment. Although slow and difficult, these techniques were effective and had very good results, technically leaving no oil in this portion of the forest. The cleaning of this section finished in one week.

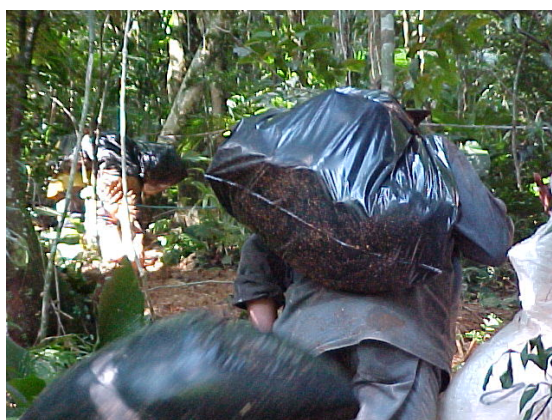
Fig. 18 – Worker carrying bag with oil recovering material up hill.

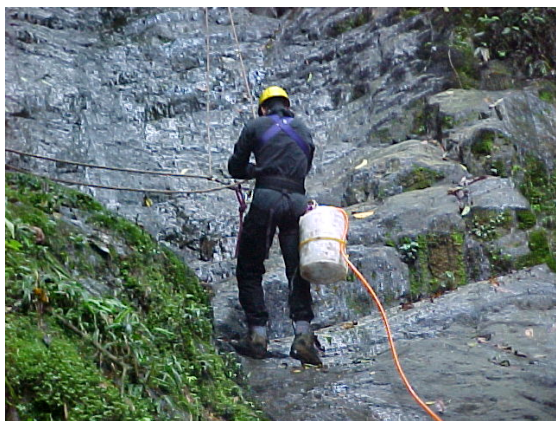
Fig. 19 – Ready to climb the rock wall.

The tracks finished at a vertical rock wall, around a hundred feet high. The wall was soaked with oil and workers were rock climbing to clean it using high-pressure water jets. At the bottom of this wall, the team built a pool to contain the wash water and recover the oil. The pool was made of sand bags, coated with plastic sheet and drained at the bottom. The oil could then be recovered from the surface of this pool with cans and absorbent material as booms and pads. The oil was conditioned in sealed light drums and carried up hill to the roadside base.

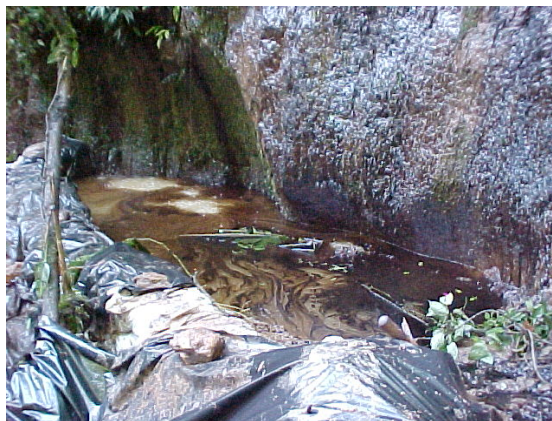
Fig. 20 – Pool for containment of the wall wash water.

No chemical product was used to wash the rock wall, since it could contaminate the river. The pool water was drained at the bottom into portable oil-water separators and from them to the river.

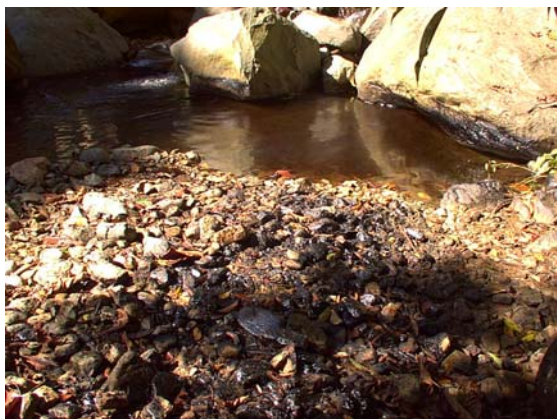
Fig. 21 – Oil stained portion of Rio dos Padres.

The river rocks still had oil stains, the best solution to clean them was to rub each one with absorbent pads and synthetic cotton. The rocks were all hand cleaned one by one on the river and put back on their original place. This job took a month to finish. The cleaning cloths were sent to burn on a co-processing plant.

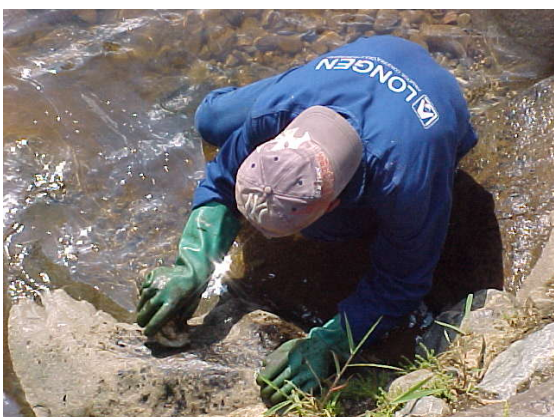
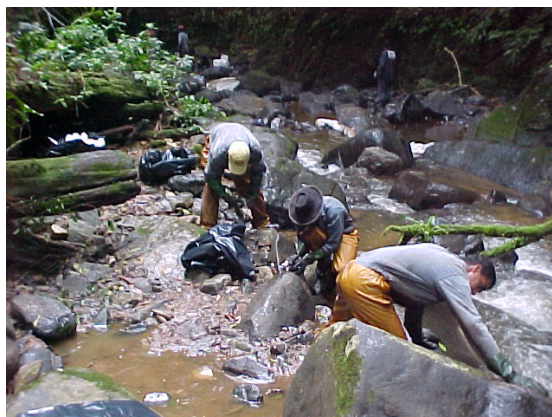
Fig 25. – Manual cleaning of river rocks.

Fig. 26. – Manual cleaning of river rocks.
