## Inland Oil Spill – Well Blowout, 2004

### Abstract

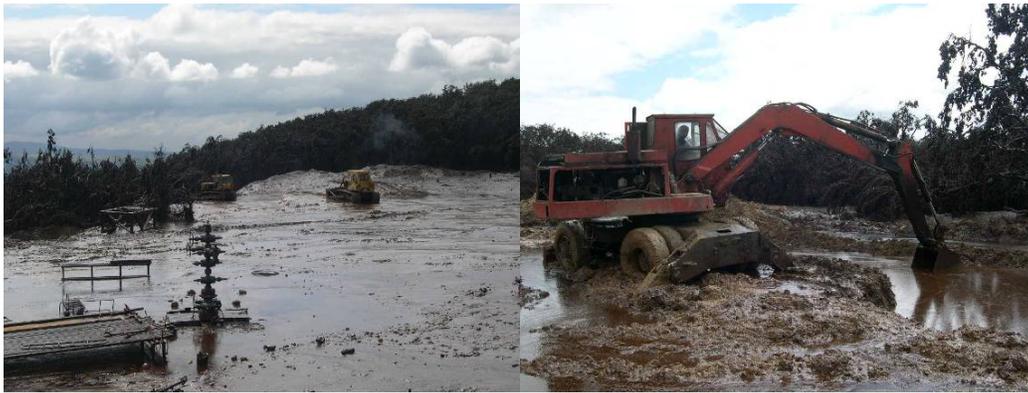
The initial assessment revealed the extent of the damage caused in the four days before the well was capped. In addition to the effects of the spill itself, the actions taken in the four days until OSRL's arrival had exacerbated the impact. Large earth moving equipment was used to create earthen bunds and collection pits in an attempt to prevent the bulk of the oil migrating down the hillside (Fig. 1). Unfortunately this had limited success; the oil was mixed into the clay substrate and the pits were

inundated by the volume of oil. A large volume of oil migrated down the hillside, following a natural ravine to the village, 2km away.

Figure 1. Showing wellhead operations prior to OSRL's arrival to the spill site.

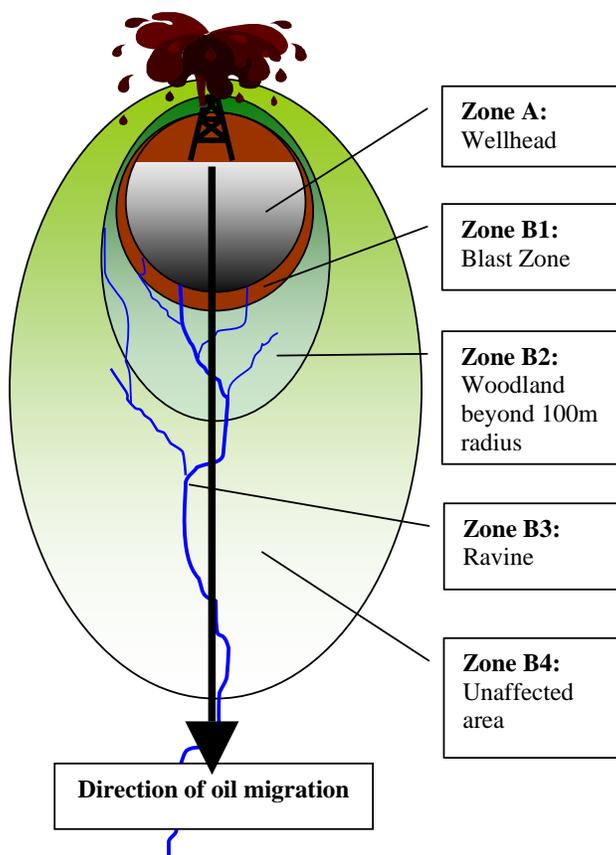
Trees at the edge of the wellhead clearing suffered the most direct damage, with leaves and branches being stripped from some. To the south of the well the topography slopes steeply toward the village. Both airborne and surface flowing oil migrated in this direction, funnelled and concentrated into the ravine. Here oil coverage was almost complete, from tree-top to leaf-litter layer. This highly polluted area extended south for about 100m from the tree line.

At approximately 100m from the tree-line the intensity of the pollution began to lessen, with trees and the leaf-litter layer suffering a less intense coverage. Coverage of the leaf litter layer was shallow, with only the top layer being affected.

The ravine cuts through the hillside in a southerly direction down to the village. Free flowing oil was present along the entire length of the ravine. The ravine's clay substrate, acted to prevent infiltration of oil. At the time of the survey a small flow of water was present which mobilised the stranded oil.

Figure 2. Showing the subdivision of Zone B.

The felling of trees was considered a viable option in Zone B1 due to the number of trees condemned during the survey. Removal of these trees would reduce the threat of secondary contamination and chronic oiling from the remobilisation of oil and improved access to areas where bulk surface oil removal was required. The trees identified to be felled were clearly marked prior to felling, thus avoiding unnecessary removal and ultimately more waste.

Coppicing was recommended for trees within Zone B2 that were partly oiled and so presented a higher chance of recovery. This option resisted the removal of the entire tree, maintaining soil stability through root binding and allowing the ingress of opportunistic species through increased light fill. Following the coppicing, any remaining bulk oil was removed, followed by manual clean-up of residual oil on trees.

Due to the inaccessibility of this area it was recommended that low pressure / high volume flushing be used to drive the mobile oil down the ravine. This mobilised oil was captured in pits constructed on the outskirts of the village. It was deemed preferable to conduct this in a controlled fashion using recycled water from the flushing of the wellhead than wait until the rains of fall or the snowmelt of spring.

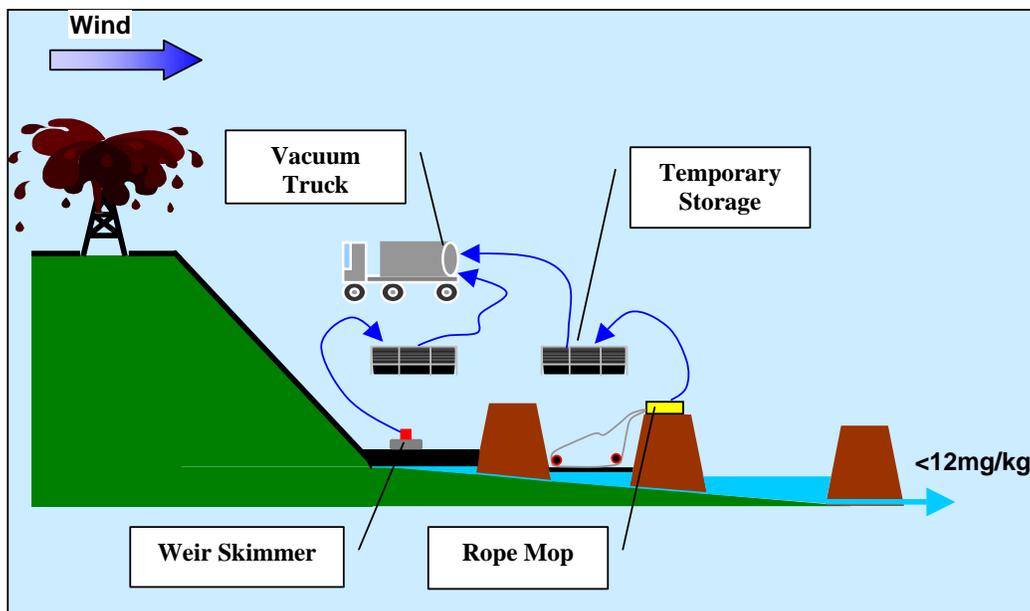
In an attempt to reinstate the stream's flow, the pre-existing pit was split into three to produce a crude oil/water separation facility (Fig.3). The top pit was used to collect and concentrate oil mobilised from the ravine, while allowing the separation of water and oil. The bottom water level was then allowed to decant at a controlled rate to the next pit, which was again allowed to settle and allowed any oil to accumulate on the surface for removal. Again the water was decanted into the third and final pit where sorbants were used to remove any trace of sheen ready for release downstream once hydrocarbon levels of 12mg/l or lower were reached. This level was given as the acceptable limit after consultation with the Ministry of Environment and levels were monitored by an independent agency.

Figure 3. Diagrammatic representation of the oil / water separation pits.

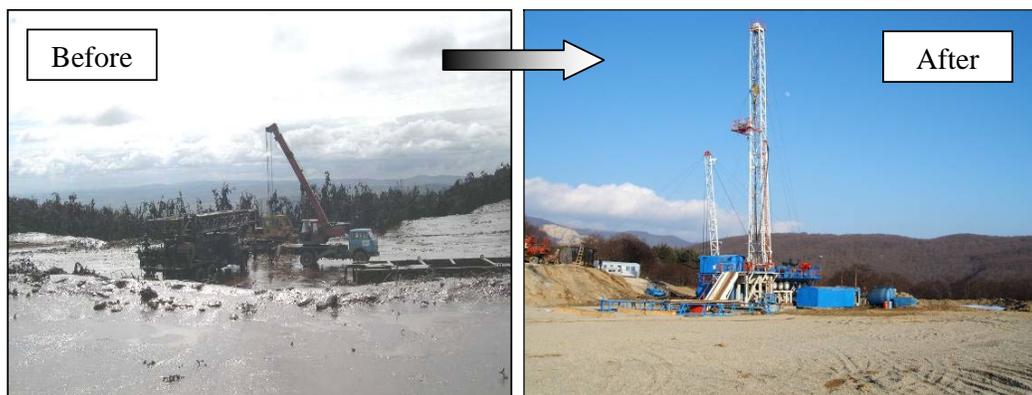
Figure 3. Showing the wellhead site immediately after the spill and four months after.

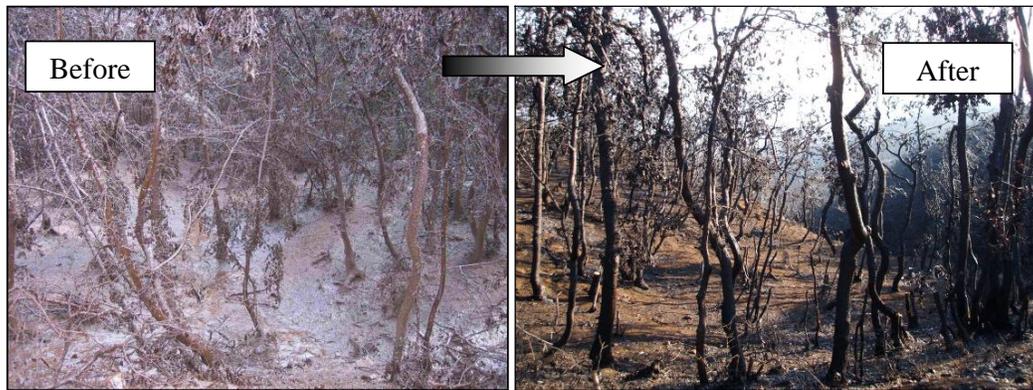
The environmental action plan written by OSRL had been closely followed. Selective felling and the removal of oiled leaf litter, fallen branches and badly damaged trees had been removed as prescribed in the action plan (Fig. 4). The remaining trees within this area still showed signs of surface oiling but the majority of oiled leaves had fallen and been removed, thereby reducing the risk of chronic re-oiling.

Figure 4. Showing the woodland site immediately after the spill and four months after.

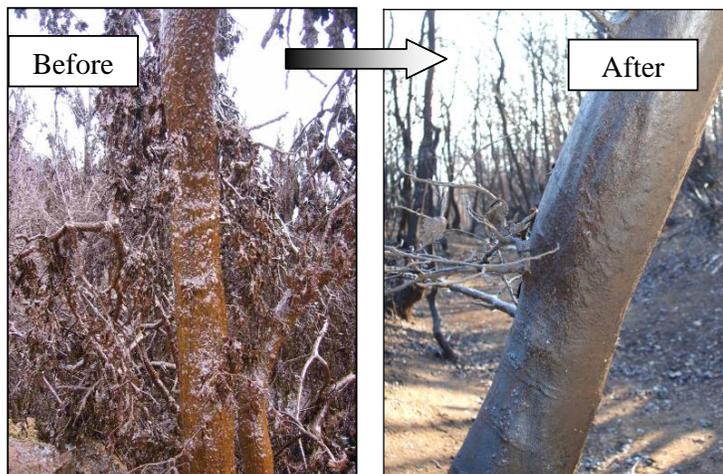
Figure 5. Showing the *in-situ* weathering of oil on a tree in the main fallout area.

Two deciduous trees that suffered the same exposure to the well blow out. A weathered surface deposit still remains on the bark, but it is thought that this will not have an effect on the survival chances of the tree. Of more concern is the infiltration of oil into the root system, which was limited by the thick leaf litter layer and clay substrate.

The weathering of any oil that was left *in-situ* was slowed due to the low temperatures experienced during the winter. It is thought that with the coming of summer the weathering process will accelerate and perhaps some remobilisation of oil will occur, for this reason the separation pits will remain as a permanent feature.

A bioremediation scheme was planned for the worst affected areas of the woodland which was due to start in the spring of 2004. It is hoped that this will accelerate the recovery of the woodland.

If following the spring the trees in the blast zone show no sign of recovery it is suggested that a replanting scheme be attempted. Trees characteristic of those species

lost should be planted in addition to fast growing endemic species to further stabilise the area.

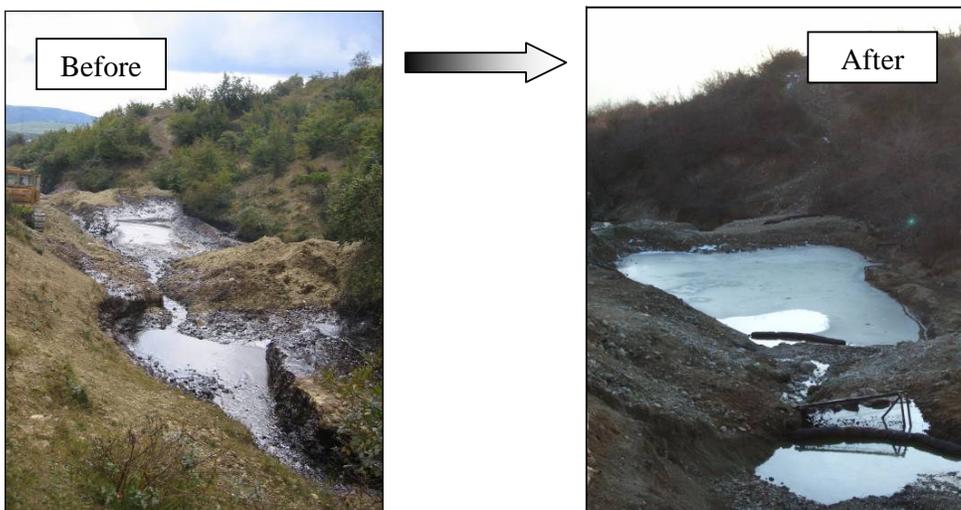
The pits remain in place and are manned in order to monitor the water flow and manually skim any sheen from the surface. The upper pits are still showing some surface sheen, though it is unclear whether this is as a result of oil mobilised from the ravine or chronic oiling from the pit itself. It is predicted that this sheen may increase during the wetter, warmer months as oil is remobilised and transported down the ravine.

Figure 4. Showing a separation pit during and after the response.

The client has also planned to landscape the pit area to create a permanent facility for the collection and separation of runoff for this watershed using concrete pits and larger sluice gates. An independent hydro-geologist has been consulted to design this facility in order to withstand a 1 in 100 year event.
