## **WHEN LOW TECHNOLOGY IS THE ANSWER: RESPONSE TO A REMOTE OIL SEEP:**

**Robert M. Mandel**

Federal On-Scene Coordinator  
United States Environmental Protection Agency  
75 Hawthorne St.  
San Francisco, CA 94105 USA

IOSC 2001-306 Mandel

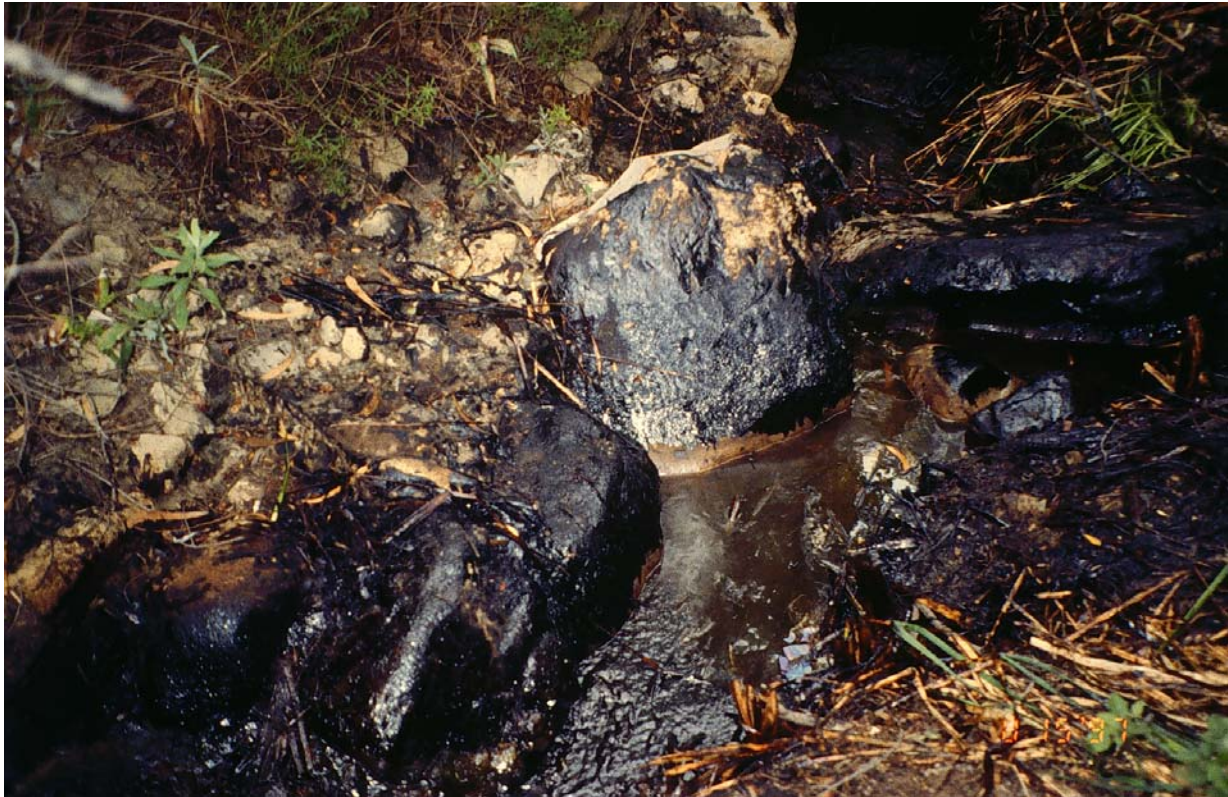
Protection Agency (EPA) responded at the request of DFG. Figure 1 shows a heavily oiled portion of Toro Creek on July 24, 1997. The EPA Federal On-Scene Coordinator (OSC) determined that a release of oil to Toro Creek was on-going, that Toro Creek was a water of the United States, and that other parties were unable to address the oil spill. This determination brought the oil spill under the authority of the Oil Pollution Act of 1990 (OPA), and allowed response funds to be authorized from the Oil Spill Liability Trust Fund.

- Fig 1: A heavily oiled portion of upper Toro Creek during July 1997.
- Fig 2: Workers set the 3-chambered OWS clarifier in position.
- Fig 3: The chemical hose holding the oil is enclosed within the PVC pipe to provide secondary containment.

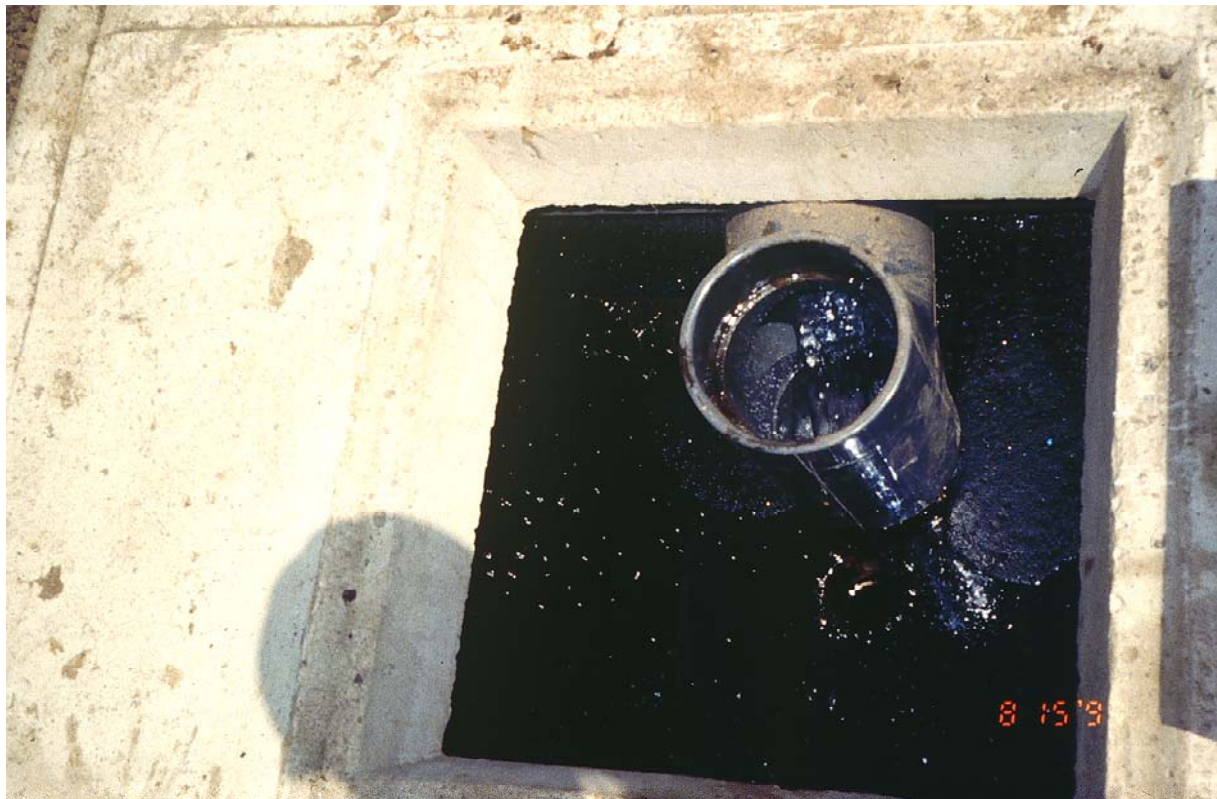
The seep water, after flowing through the two separation chambers, flows into a third chamber where it can be observed and sampled (if necessary) prior to its discharge to the headwaters of Toro Creek. Figure 6 shows the oil layer that accumulates in the first separation chamber of the OWS.

- Fig 4: Pipeline trench containing the secondary containment hose and electrical wiring for the high level alarm.
- Fig 5: The UST is installed.
- Fig 6: Here is the thick oil layer that accumulates in the primary separation chamber.

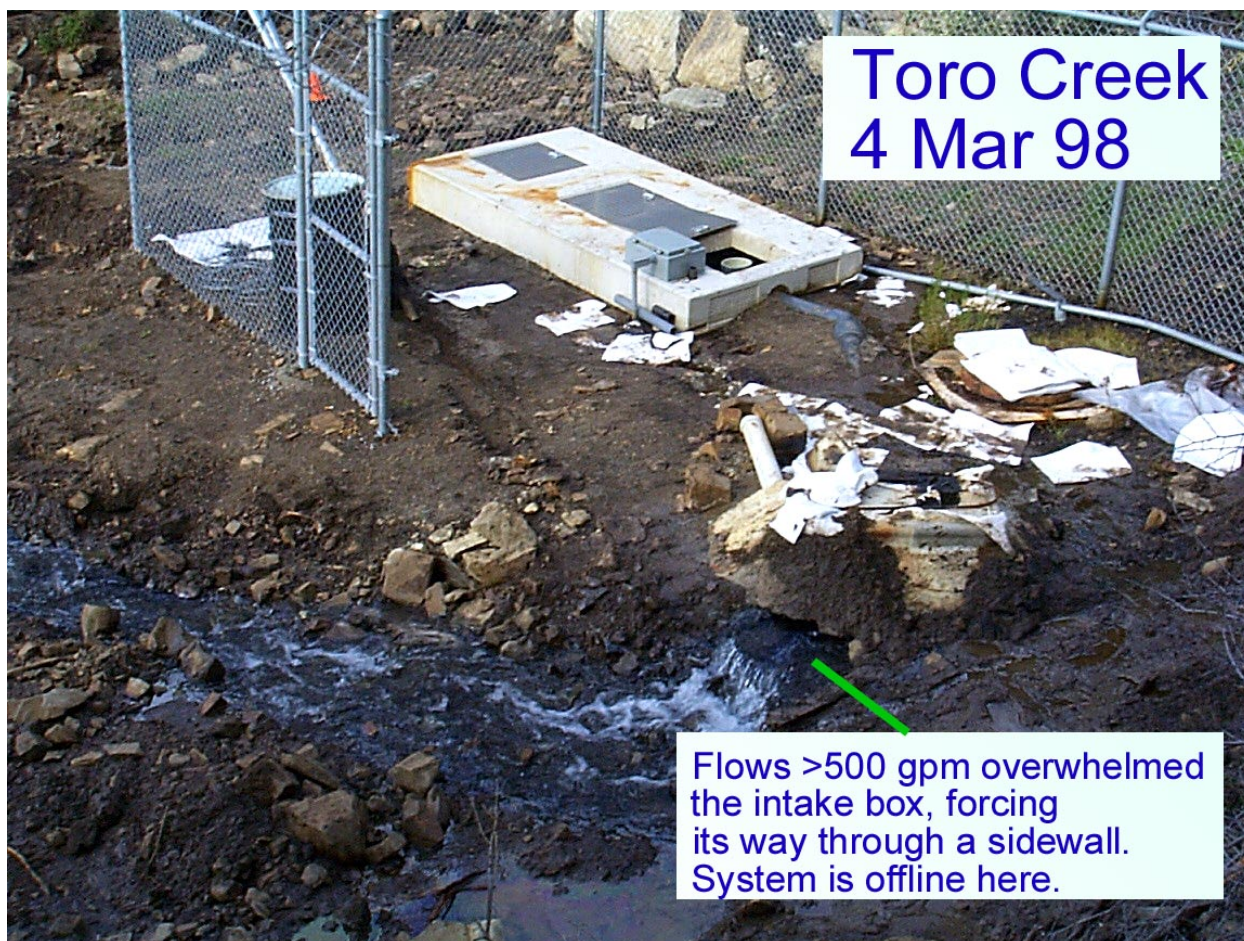
Although the collection system was sized for five times normal flow 125 gpm (473 LPM), it proved inadequate for heavy rains associated with the El Nino storms of February 1-3, 1998, when 9.48 inches (241 mm) of rain fell at Toro Creek. This deluge caused landslides, flash flooding, and greatly increased flows to the OWS estimated to be in excess of 800 gpm (3520 LPM). The enormous flow ruptured the concrete vault that conveyed seep fluids into the OWS. Figure 8 shows the blowout that occurred in the collector vault. High flows also overwhelmed the OWS in both separation chambers forcing water, instead of just oil, to flow down the pipeline to the UST. This situation quickly over-filled the UST with storm water. Fortunately, the UST was piped to function as an OWS when excessive water flowed into it. Slides and flooding eroded several sections of the buried secondary pipeline, exposing but not breaking it. Figure 9 shows this erosional damage. The alarm systems functioned as designed, alerting responders to

- Fig 7: Vacuum truck removes oil from the UST periodically.
- Fig 8: El Nino flows ruptured the concrete intake structure upstream of the OWS.
- Fig 9: An example of erosional damage resulting from the El Nino storms.

After inspecting the damage, we decided to increase the capacity of the OWS collection and treatment system to handle peak flows of 800 gpm (3520 LPM). An additional clarifier was added upstream of the existing OWS designed to handle increased flows when necessary, and act as pre-treatment for the existing OWS. The new OWS was fabricated as a bottom-less stainless steel box with underflow baffles for oil-water separation. Figure 10 shows the artesian seep just prior to the new OWS being placed on top of it. It was placed directly on top of the seep resulting in an upflow from the bottom into the new OWS. A stainless steel wire mesh coalescer was added to the bottom of the new OWS to agglomerate the finer oil particles and make them more amenable to separation.

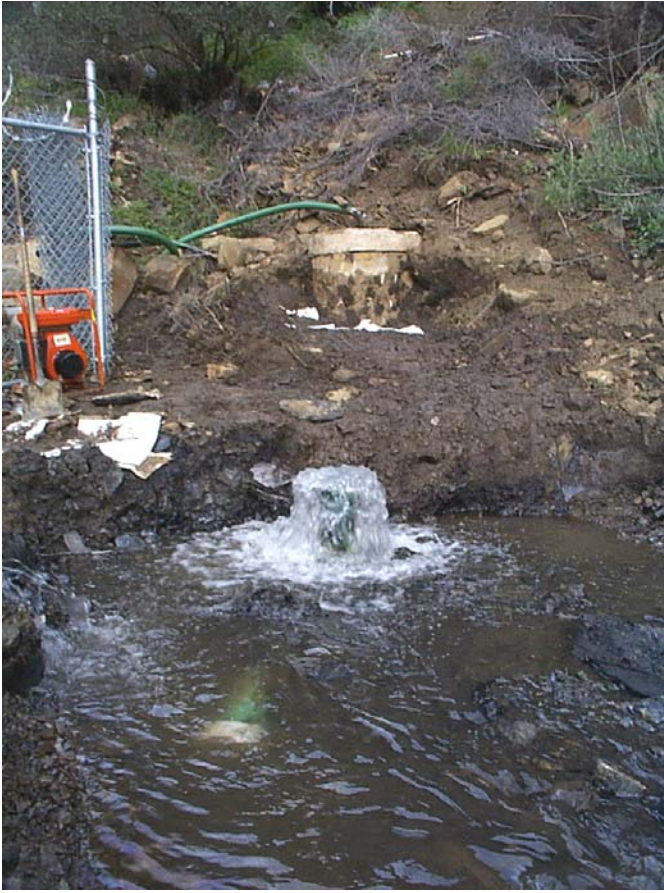
Figure 10

- Fig 10: The artesian flow of the seep at Toro Creek prior to the installation of the new primary OWS.
- Fig 11: Badly eroded pipeline trench required re-burial and the construction of surface diversion berms.

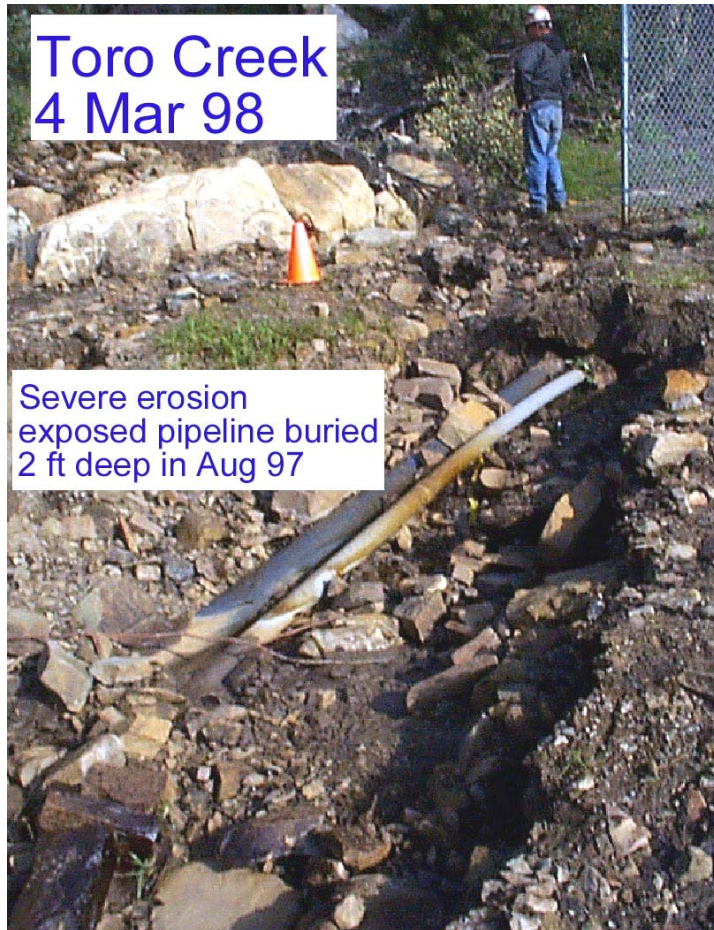
The exposed portions of the pipeline were re-buried and a large dirt and rock berm constructed to direct high surface water flows and debris flows away from sensitive areas. Figure 11 shows the serious erosion around the buried secondary containment pipeline resulting from the El Nino storms. Figures 12 and 13 show the new OWS being placed and the final configuration of the OWS system. Figure 14 shows a schematic of the OWS system as built at Toro Creek.

Toro Creek  
4 Mar 98

Severe erosion  
exposed pipeline buried  
2 ft deep in Aug 97
