Region 7  
Emergency Response and Removal Branch  
Kansas City, KS

# CHEMICAL ACCIDENT INVESTIGATION REPORT

## TERRA INDUSTRIES, INC. NITROGEN FERTILIZER FACILITY PORT NEAL, IOWA

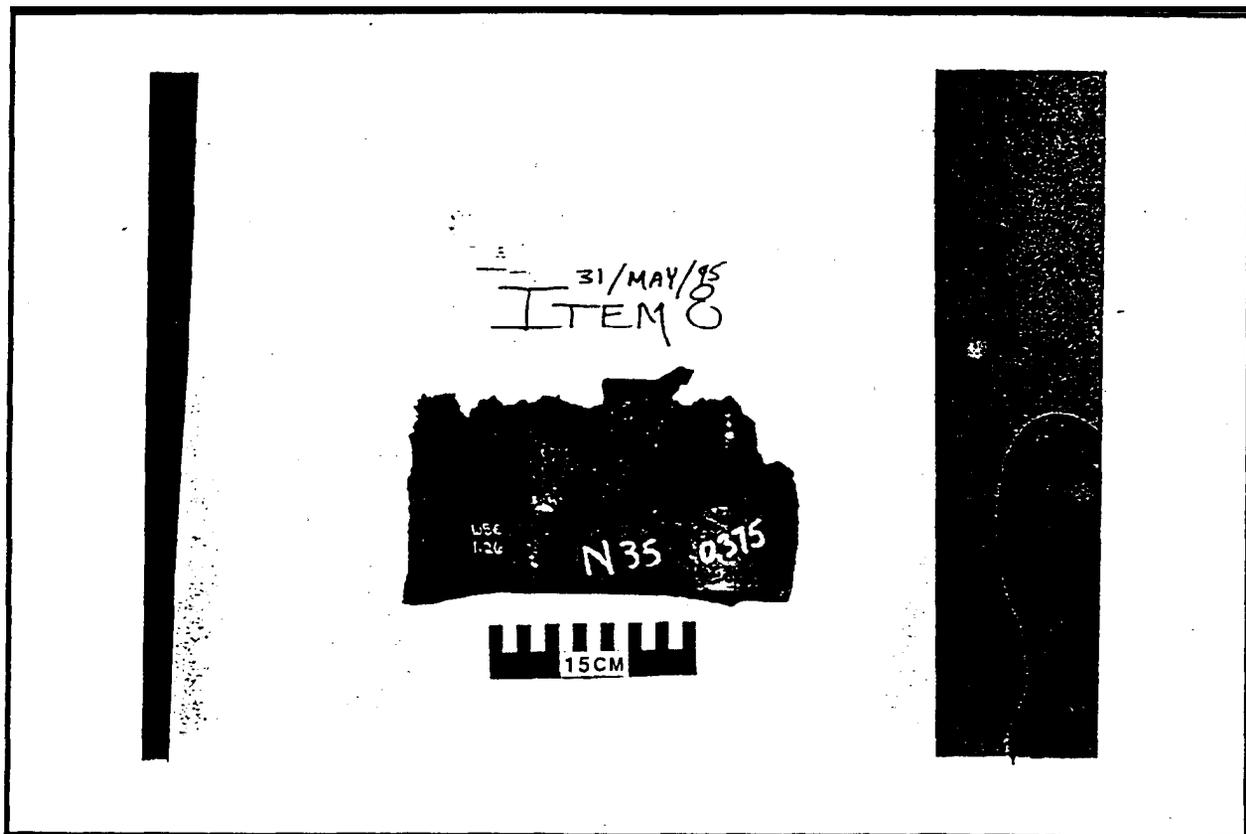
Photo 7 - 2  
Neutralizer Fragment

Metallurgical analytical results indicated that the fragment displayed a high-temperature discolored surface and severe erosion in one direction (*Photo 7-2*). The adjacent area showed little discoloration. The opposite surface exhibited severe tearing and fracturing with evidence of high-temperature discoloration (*Photo 7-3*). Unetched cross sections exhibited high-temperature oxidation on the inside diameter with severe surface tearing/seams or laps. The etched cross-sections displayed evidence of severe surface movement and cold working with a one-directional heavy force. Of the fragments analyzed, metalographic analysis suggests that the highest temperature, internal pressure and velocity was located in the area of Item #8. This sample exhibited the most severe surface distortion and high-temperature grain structure change.

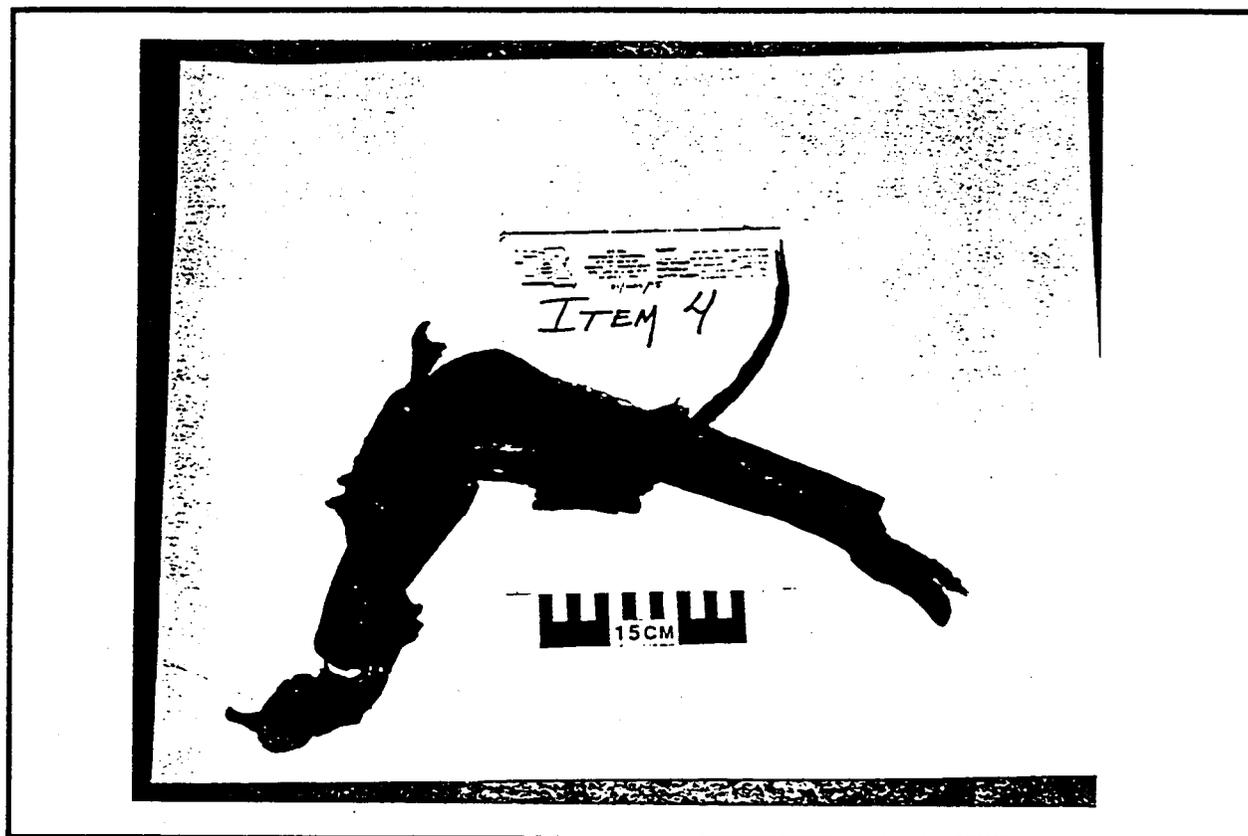
Photo 7 - 4  
Sparger Fragment

2. EPA Item #4. This fragment was described as originating from, the titanium sparger, and had been severely twisted (*Photo 7-4*). The titanium fragment exhibited a dark-colored surface with numerous areas indicating high-temperature oxidation. The interior and exterior surfaces displayed numerous mechanical damaged areas and no excessive thinning.
3. EPA Item #17. This fragment was described as originating from the titanium sparger, and displayed the same characteristics as all titanium fragments examined. The fragment was severely distorted and exhibited a dark interior and exterior surface.

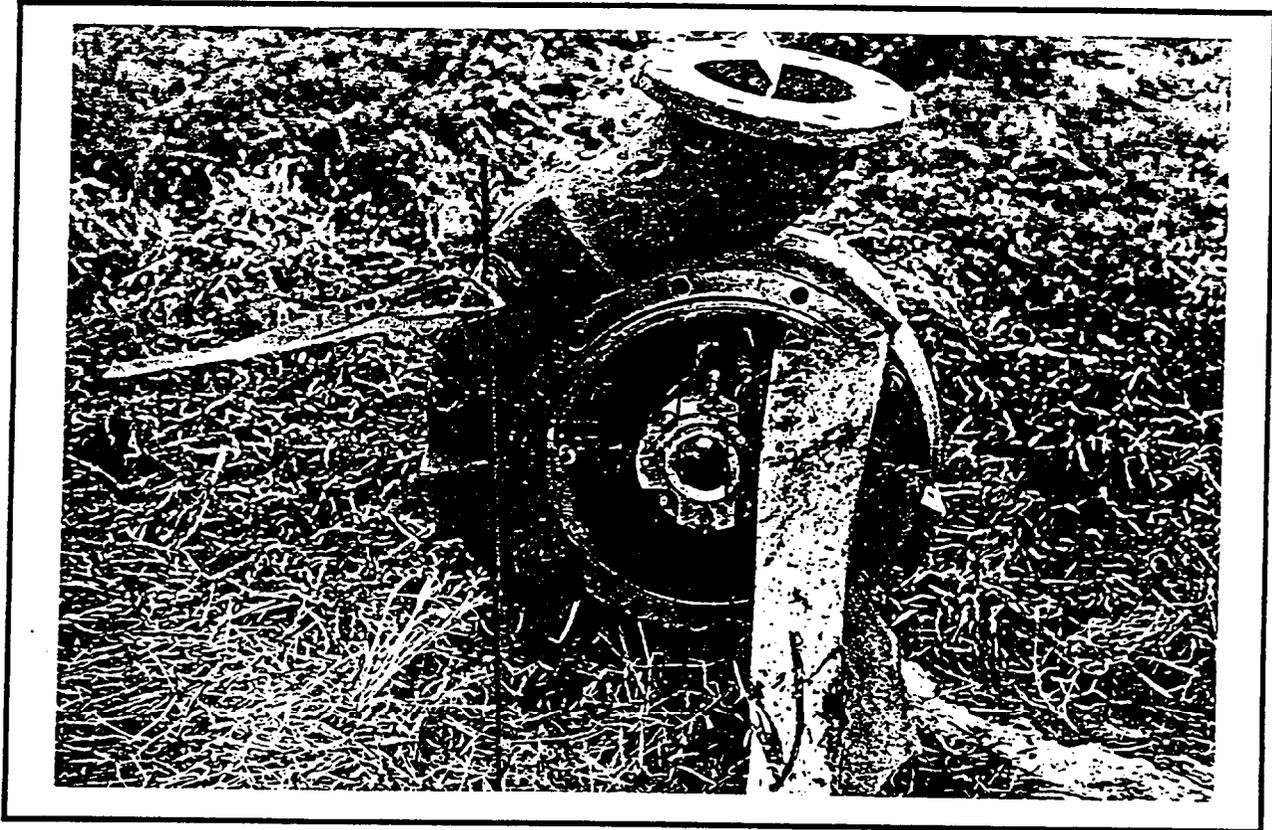
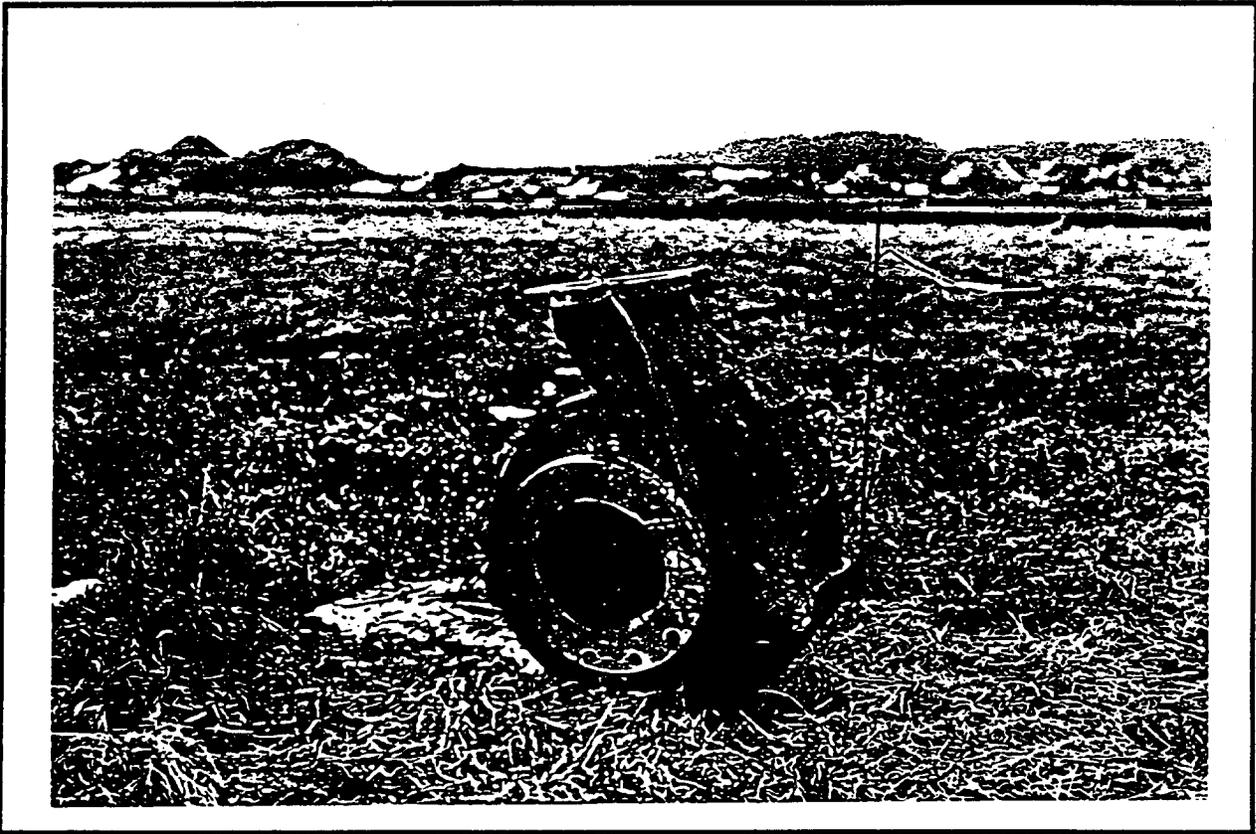
1. The pump casing was intact and located approximately 800 feet northwest of the AN plant as a result of the explosion (*Photos 8-4 A and 8-4B*).

**Photo 8 - 4A**  
**4165 Shaft View**

Photo 8 - 4B  
4165 Suction View

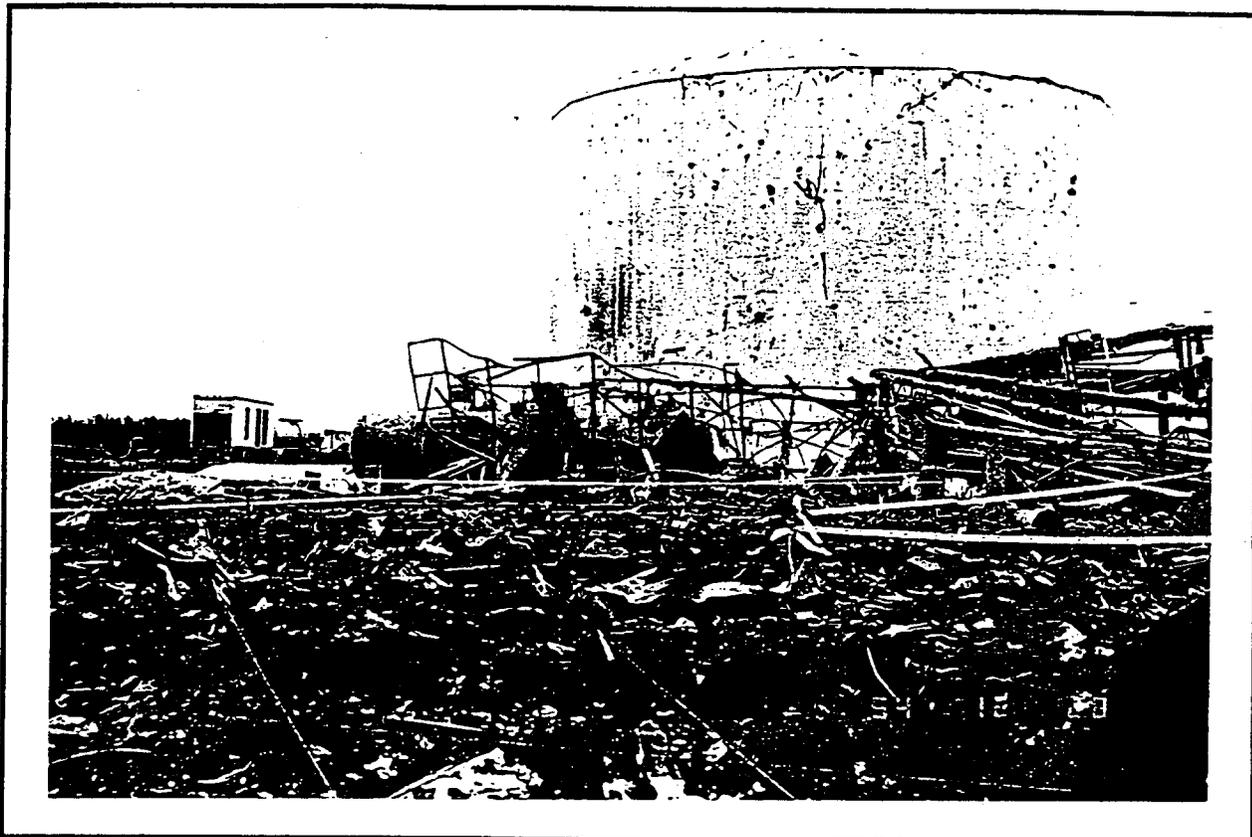
1. Reverse trajectory sighting of damage to a nearby water tank (*Photo 8-12*) and the ends of two pressure ammonia vessels (*Photo 8-13*) indicated that the neutralizer was the source of the penetrating fragments.
2. Reverse trajectory sighting of reinforcing bar angles, anchor bolt directions, and prill tower footing bolts and pads converged on the original neutralizer site.
3. Reverse trajectory sighting of a chemical stripper originally located near the AN plant indicated the explosion origin to be along a line that intersected with the original neutralizer site (*Photo 8-14*).
4. Reverse trajectory sighting of scrubber sections and the ammonia vaporizer indicated the explosion origin to be along a line that intersected the original neutralizer site.

Photo 8 - 12  
Water Tank Damage (Ammonia Tank Background)

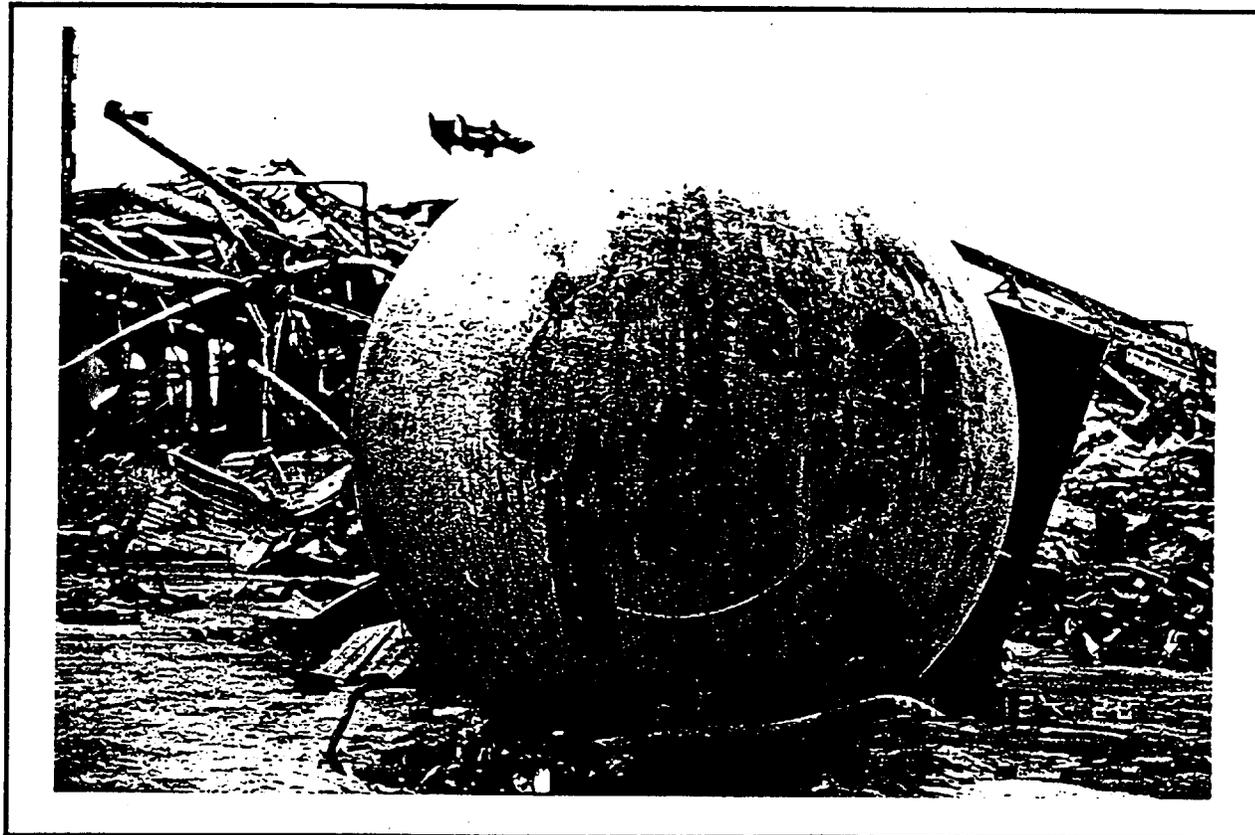
Photo 8 - 13  
Ammonia Bullet Tank Damage

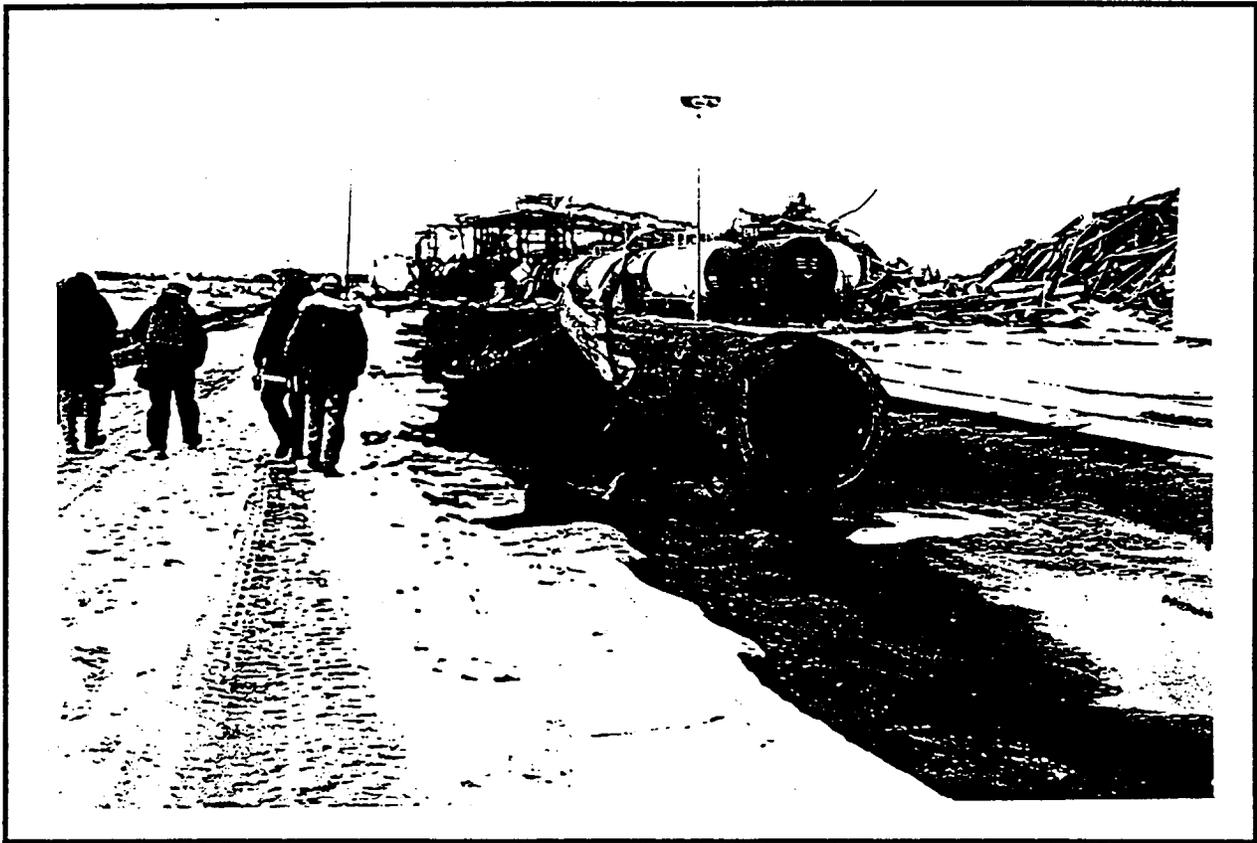
Photo 8 - 14  
Chemical Stripper Trajectory
