United States  
Environmental Protection  
Agency

## CHEMICAL ACCIDENT INVESTIGATION REPORT

### TERRA INDUSTRIES, INC. NITROGEN FERTILIZER FACILITY PORT NEAL, IOWA

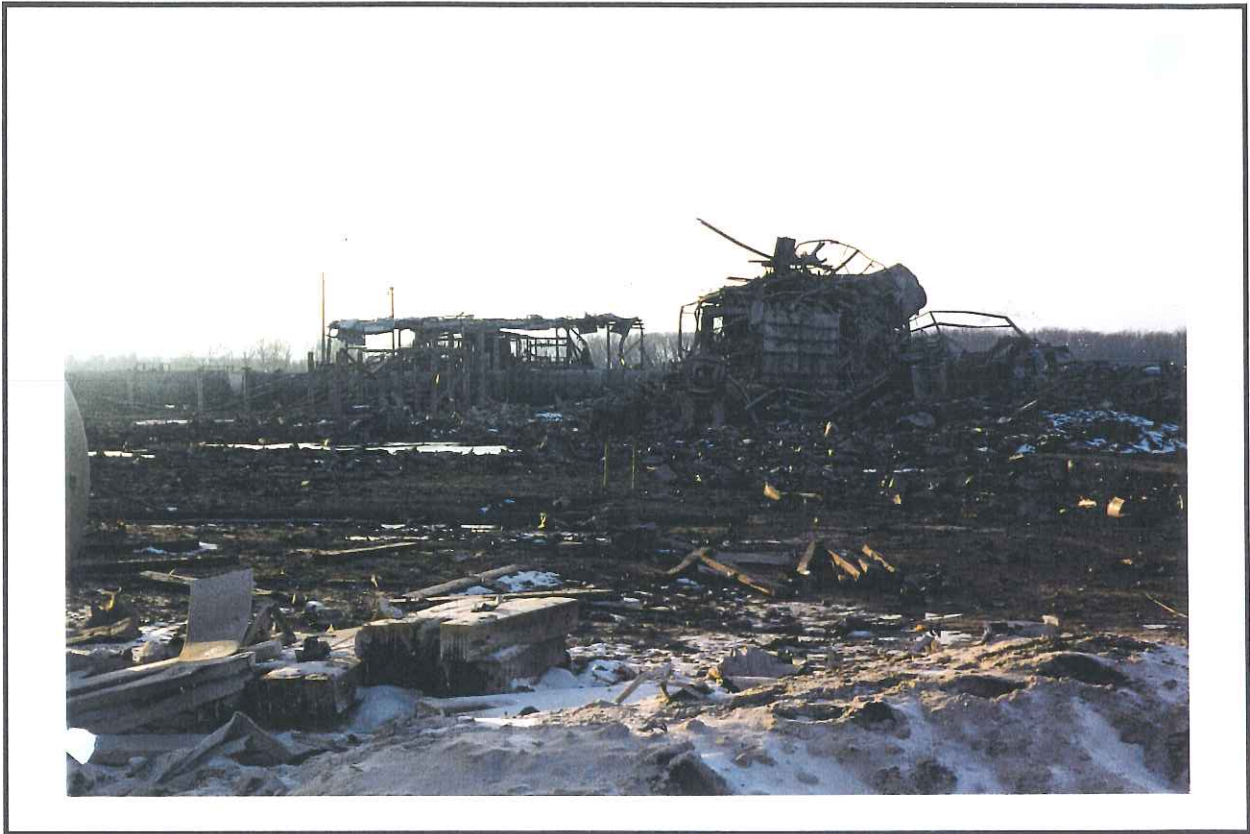
**Photo 3 - 1**  
**AN Plant Area After Explosion**

Initial site investigation included sketching and photographing the Terra facility to determine the location of the explosion(s) and photographing explosion debris and damage to facilities off site. Initial observations included sketching collateral damage patterns to determine the location of the explosion(s). The investigation team concluded that more than one explosion occurred in the area identified by Terra personnel as the AN plant. Craters in this area were located in the AN plant at

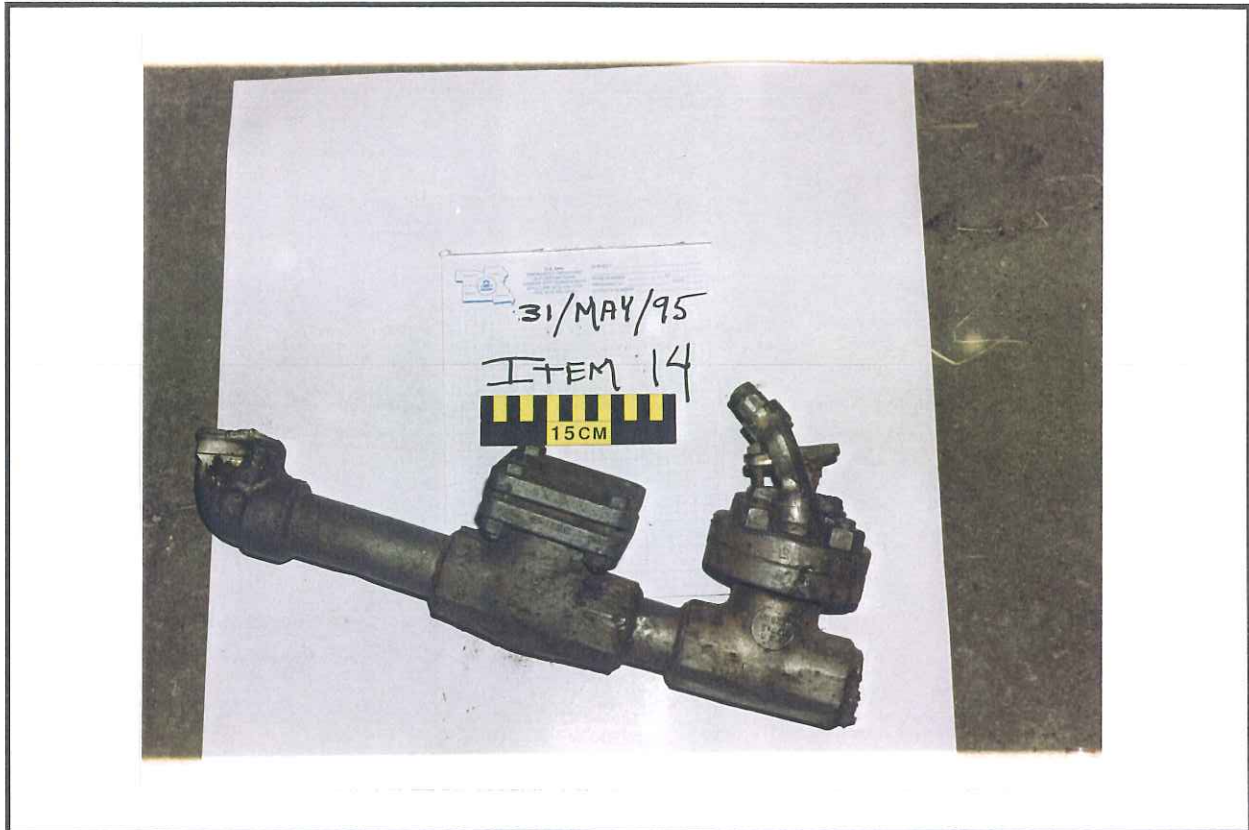
**Photo 7 - 1**  
**EPA Item # 14, Unknown Fragment**

Based on information available to the investigation team when the report was completed, hydrocarbon contamination could not be eliminated as a factor in the explosion.

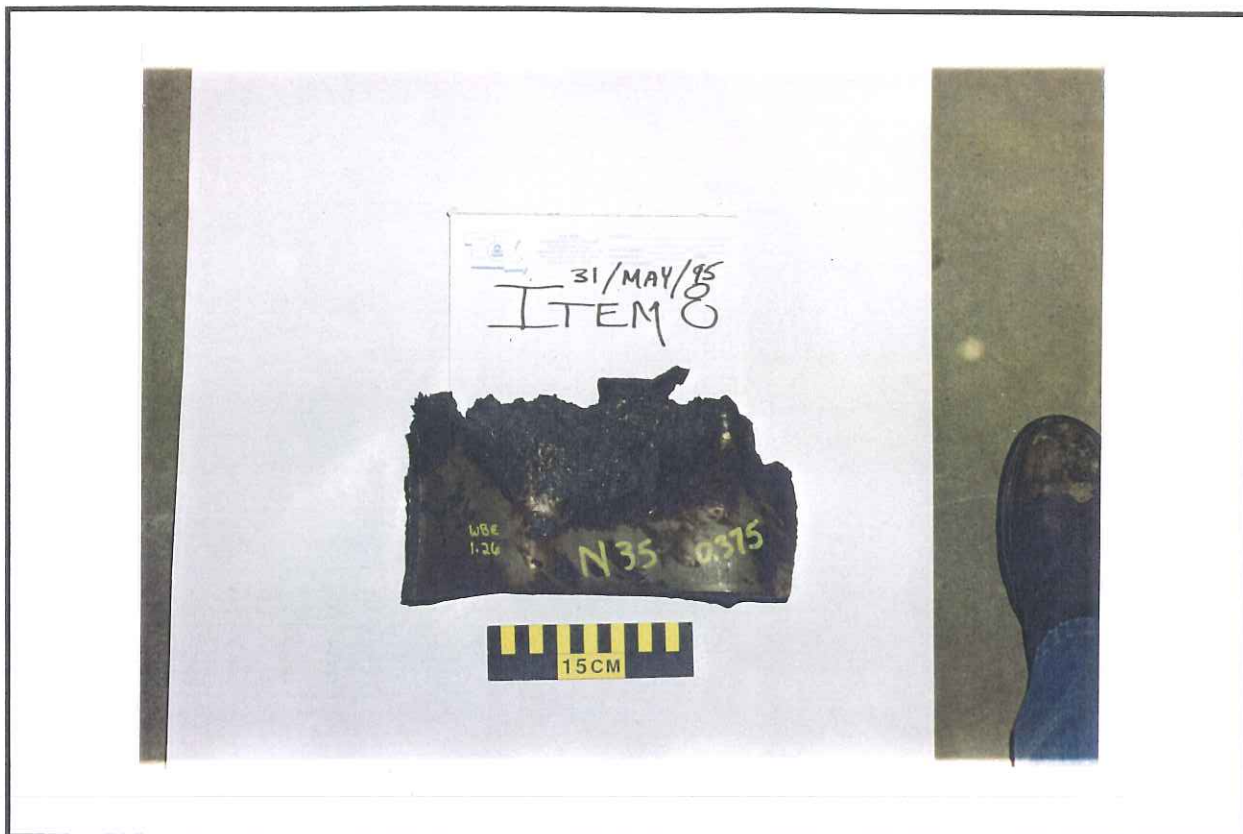
Photo 7 - 2  
Neutralizer Fragment

Metallurgical analytical results indicated that the fragment displayed a high-temperature discolored surface and severe erosion in one direction (*Photo 7-2*). The adjacent area showed little discoloration. The opposite surface exhibited severe tearing and fracturing with evidence of high-temperature discoloration (*Photo 7-3*). Unetched cross sections exhibited high-temperature oxidation on the inside diameter with severe surface tearing/seams or laps. The etched cross-sections displayed evidence of severe surface movement and cold working with a one-directional heavy force. Of the fragments analyzed, metalographic analysis suggests that the highest temperature, internal pressure and velocity was located in the area of Item #8. This sample exhibited the most severe surface distortion and high-temperature grain structure change.

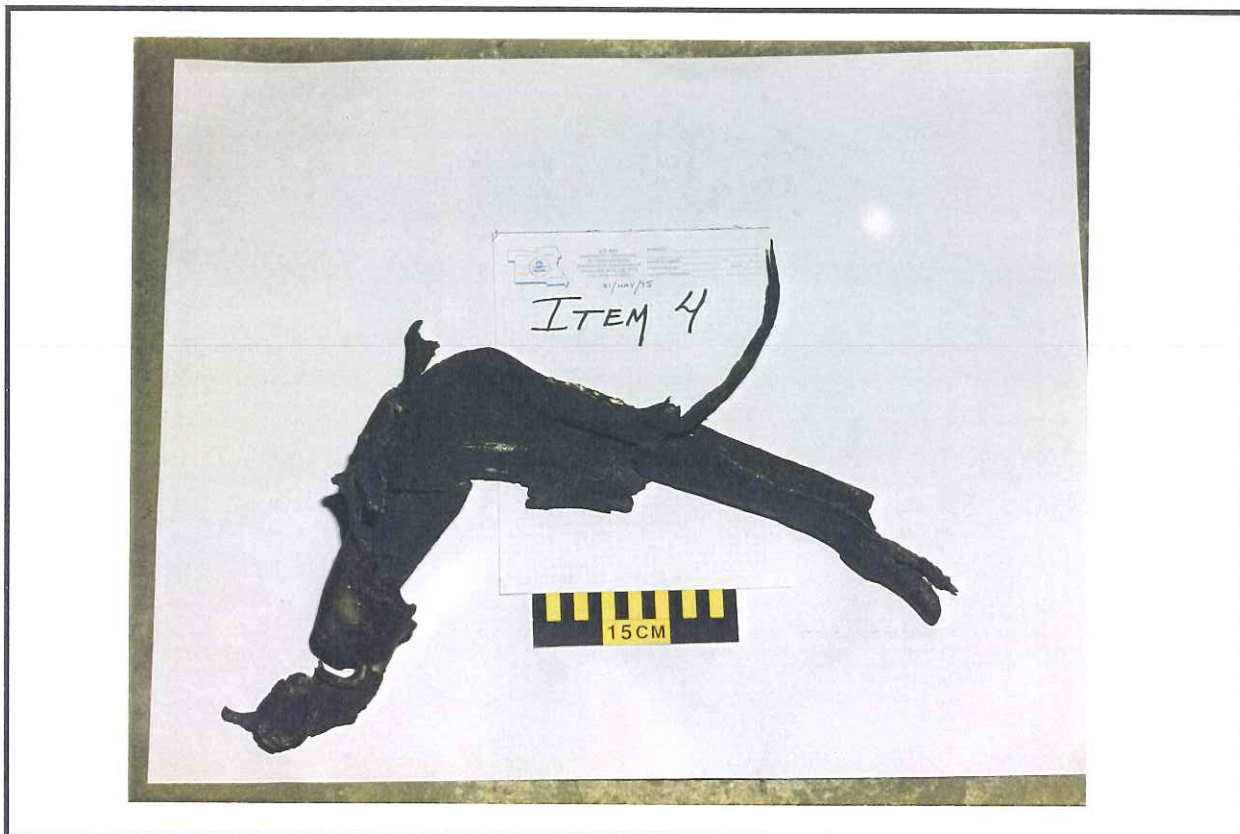
**Photo 7 - 4**  
**Sparger Fragment**

2. EPA Item #4. This fragment was described as originating from the titanium sparger, and had been severely twisted (*Photo 7-4*). The titanium fragment exhibited a dark-colored surface with numerous areas indicating high-temperature oxidation. The interior and exterior surfaces displayed numerous mechanical damaged areas and no excessive thinning.
3. EPA Item #17. This fragment was described as originating from the titanium sparger, and displayed the same characteristics as all titanium fragments examined. The fragment was severely distorted and exhibited a dark interior and exterior surface.

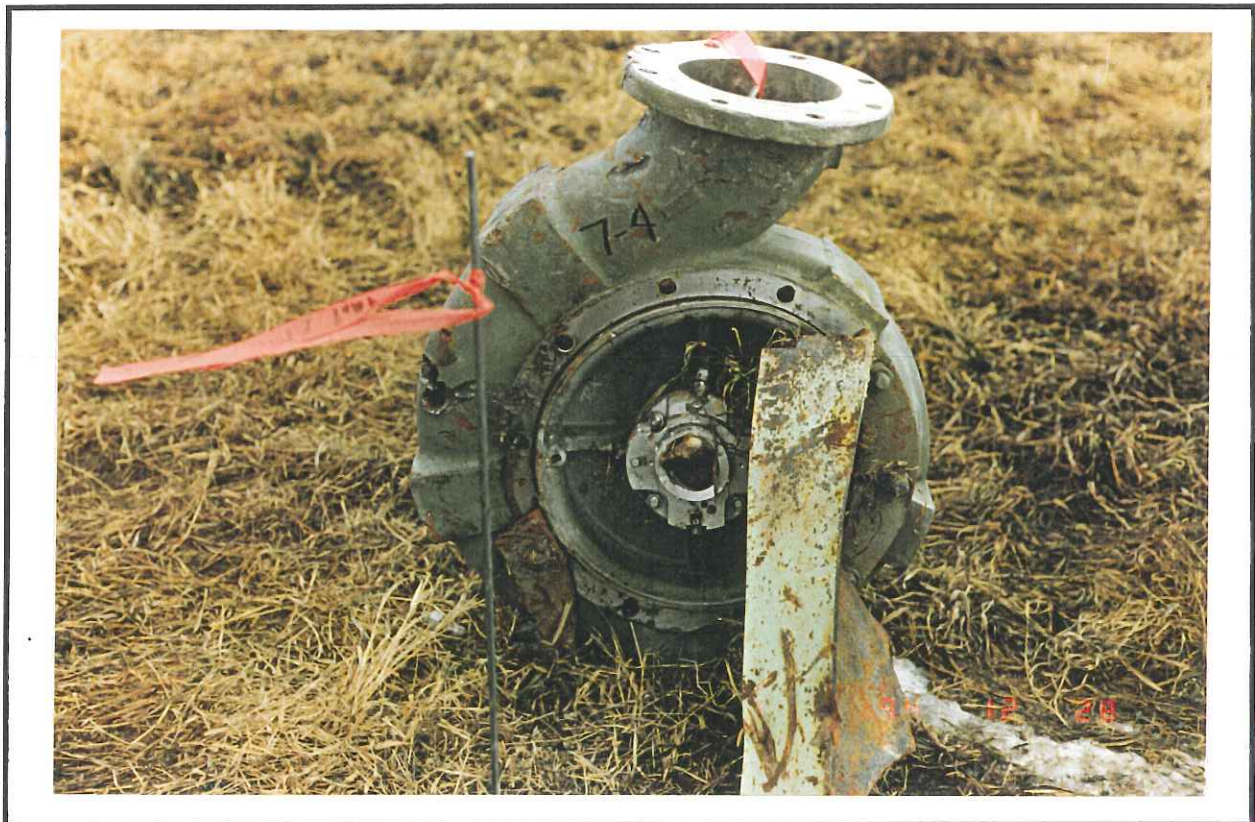
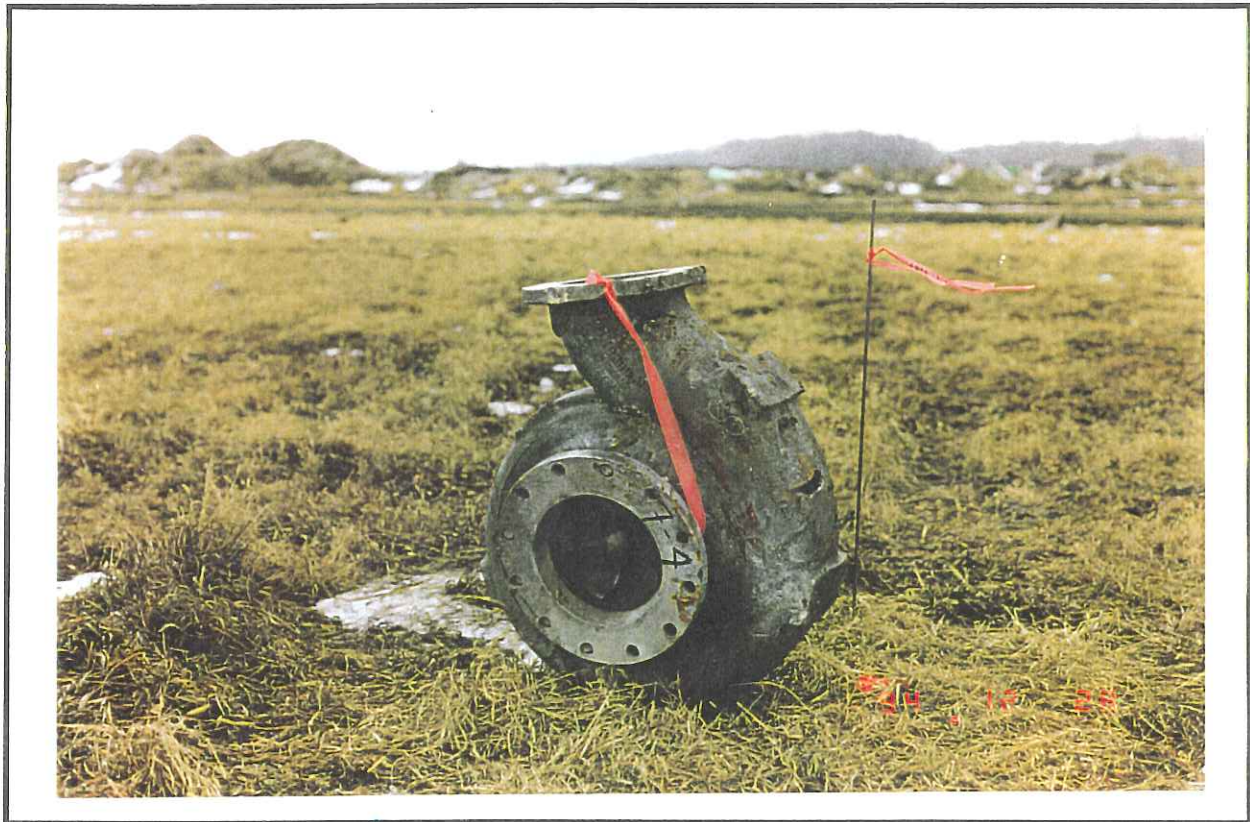
1. The pump casing was intact and located approximately 800 feet northwest of the AN plant as a result of the explosion (*Photos 8-4A and 8-4B*).

**Photo 8 - 4A**  
**416J Shaft View**

**Photo 8 - 4B**  
**416J Suction View**

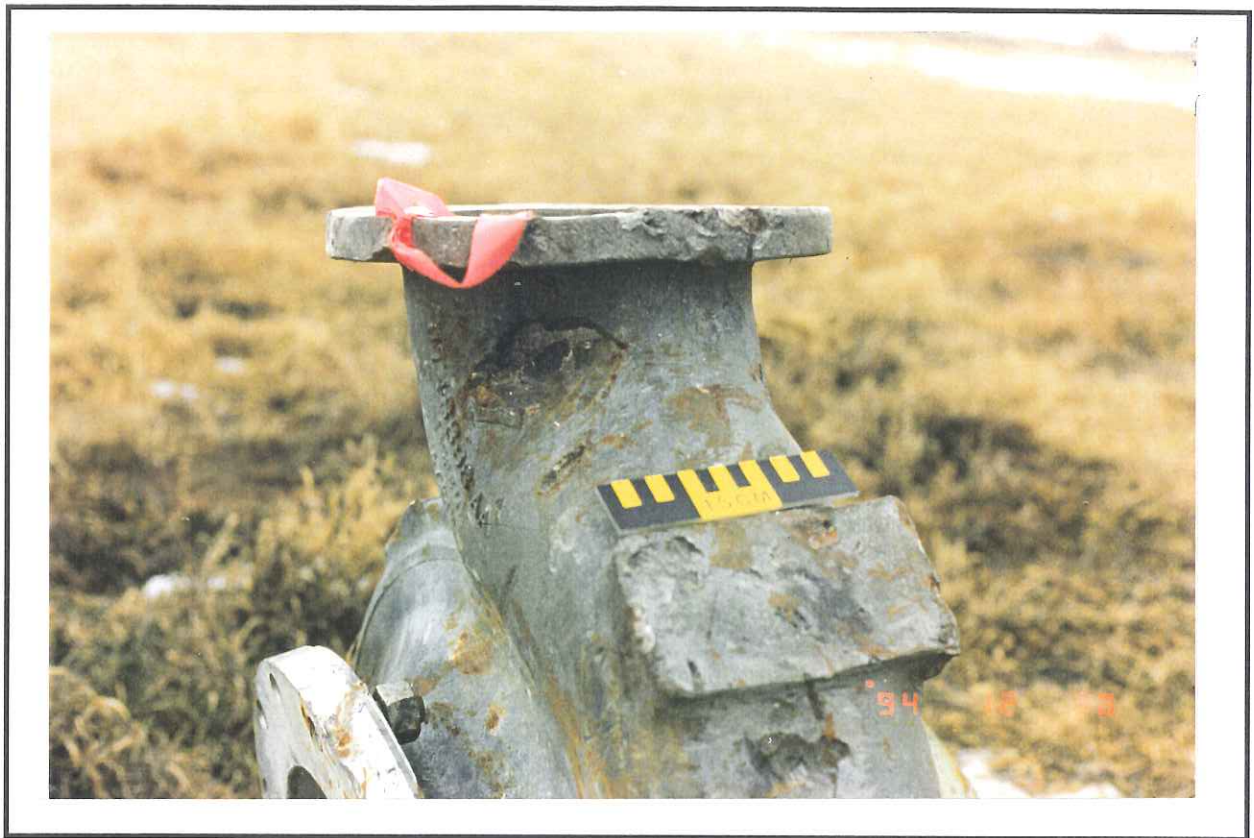
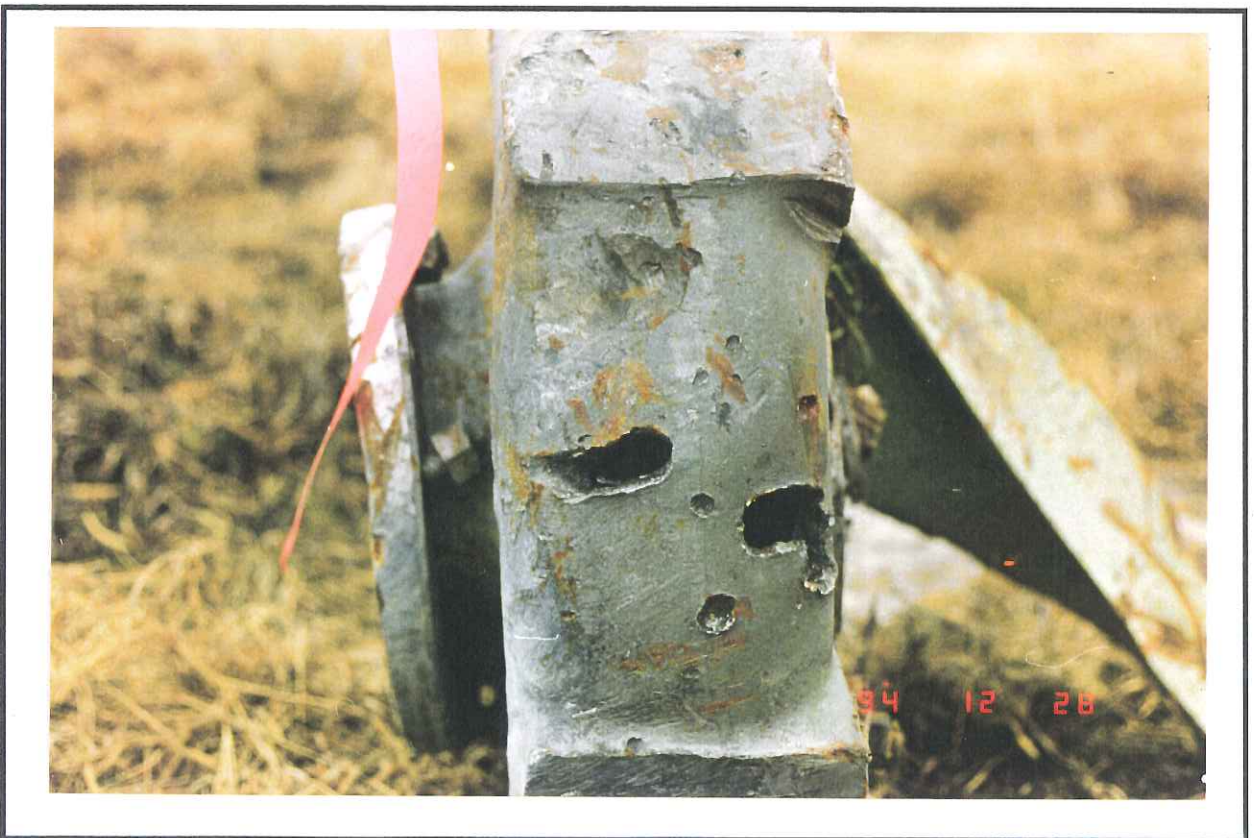
2. Damage to the pump casing included perforations caused by high-energy missiles from outside the pump from the direction of the neutralizer (*Photo 8-5 and 8-6*).
3. Damage to the pump impeller and impeller shaft were consistent with an external force from the direction of the neutralizer.
4. Metallurgist's inspection of the pump failed to reveal any evidence of heating or deformation from internal pressures (*Photo 8-7 and 8-8*).

**Photo 8 - 5**  
**416J External Damage**

**Photo 8 - 6**  
**416J External Damage**

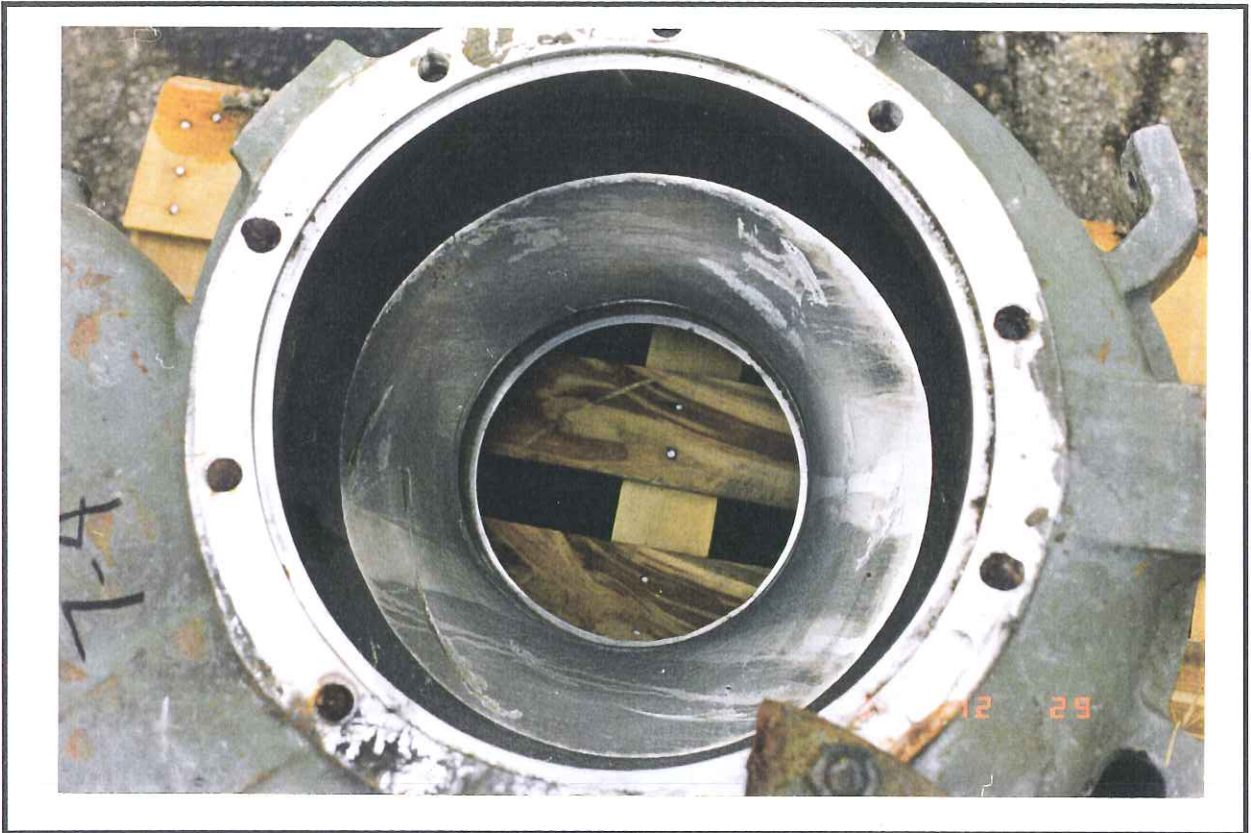
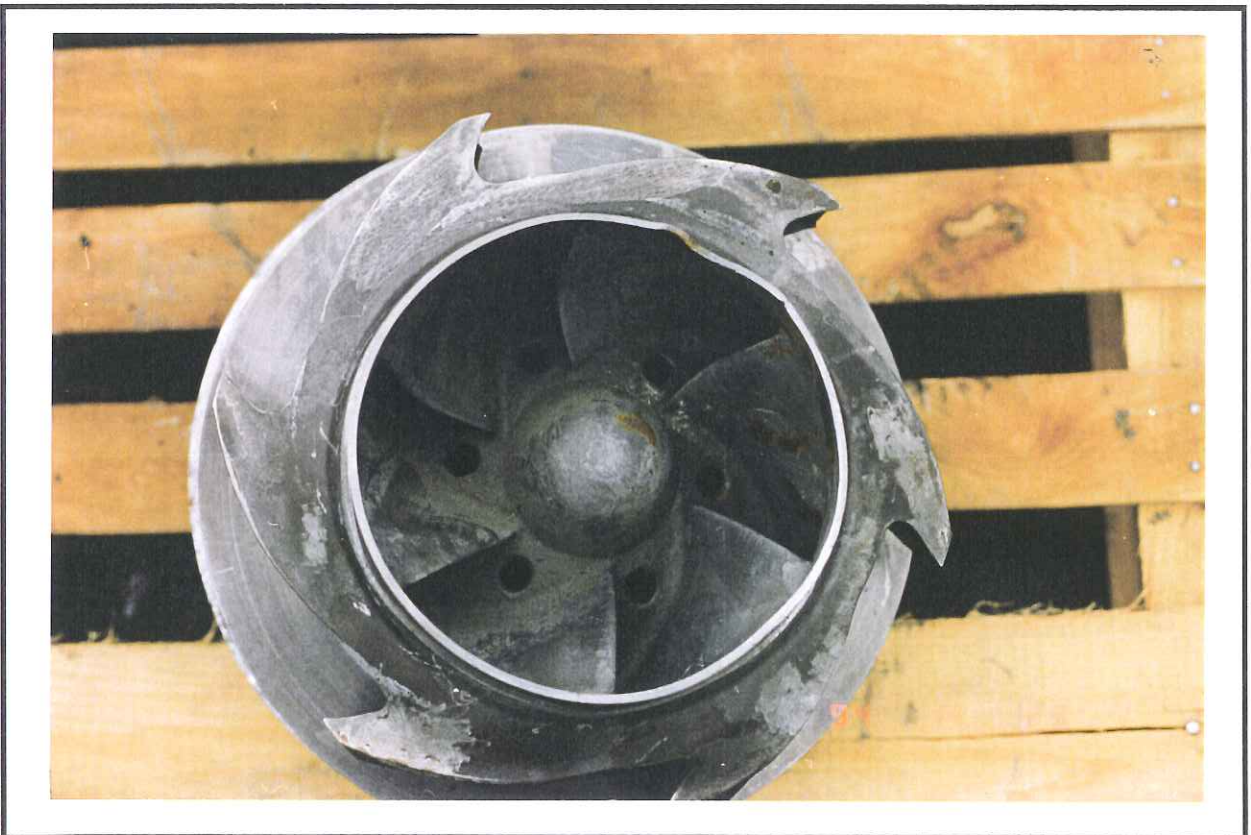
**Photo 8 - 7**  
**416J Casing**

**Photo 8 - 8**  
**416J Impeller**

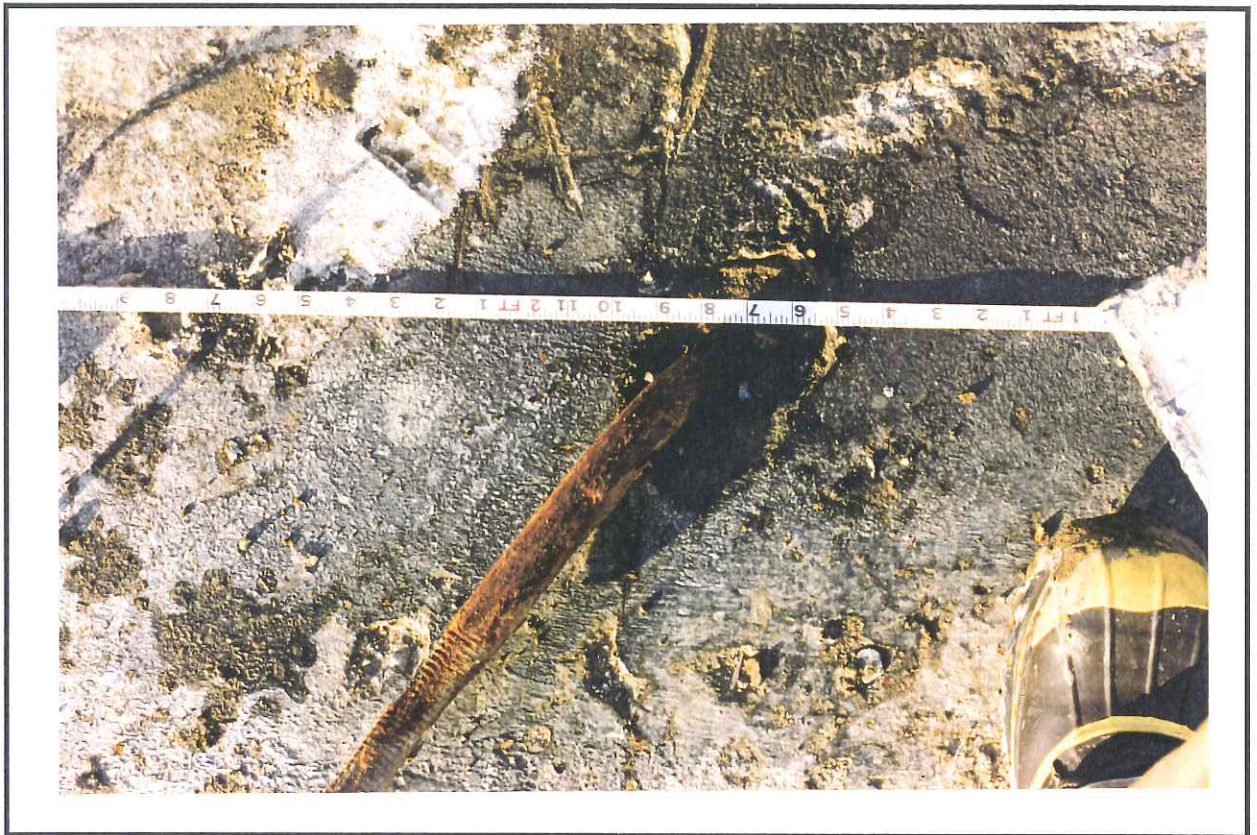
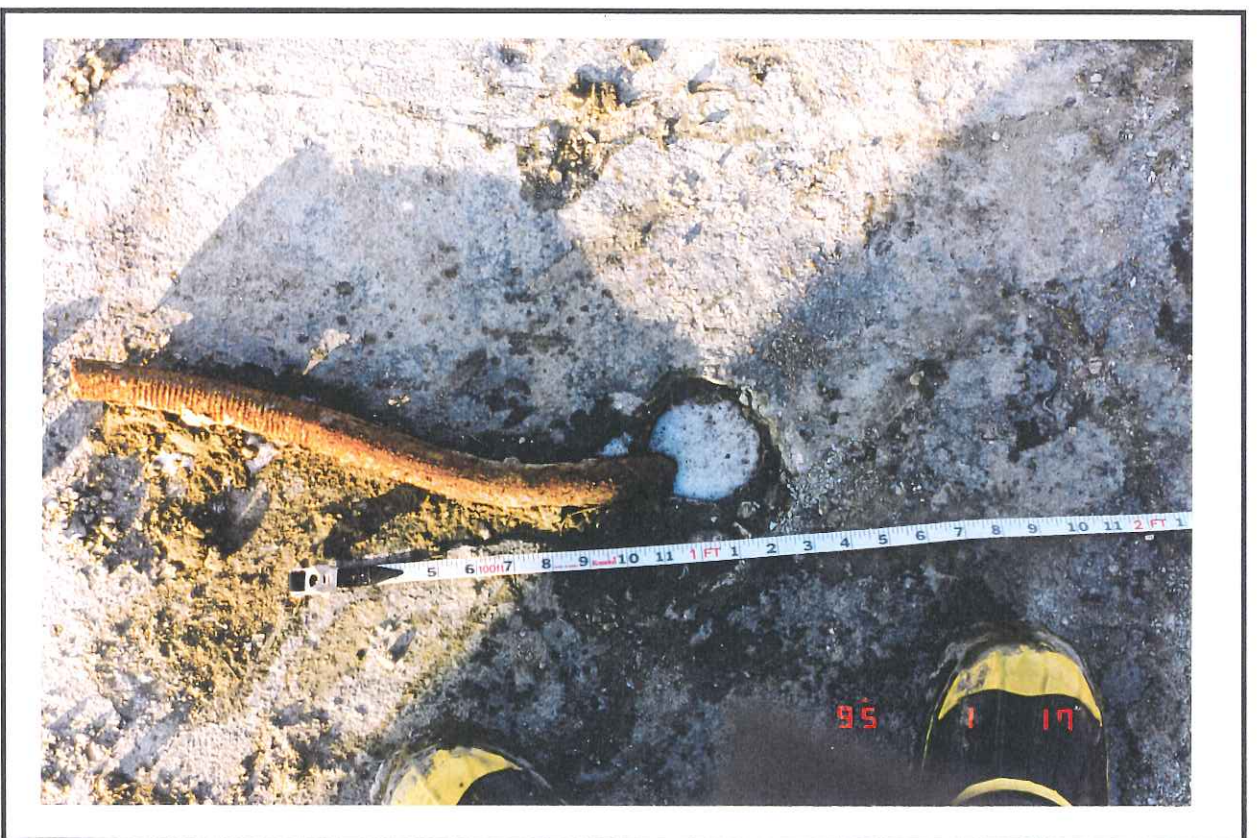
**Photo 8 - 10**  
**AN Scrubber Mounting Bolts**

**Photo 8 - 11**  
**AN Scrubber Mounting Bolts**

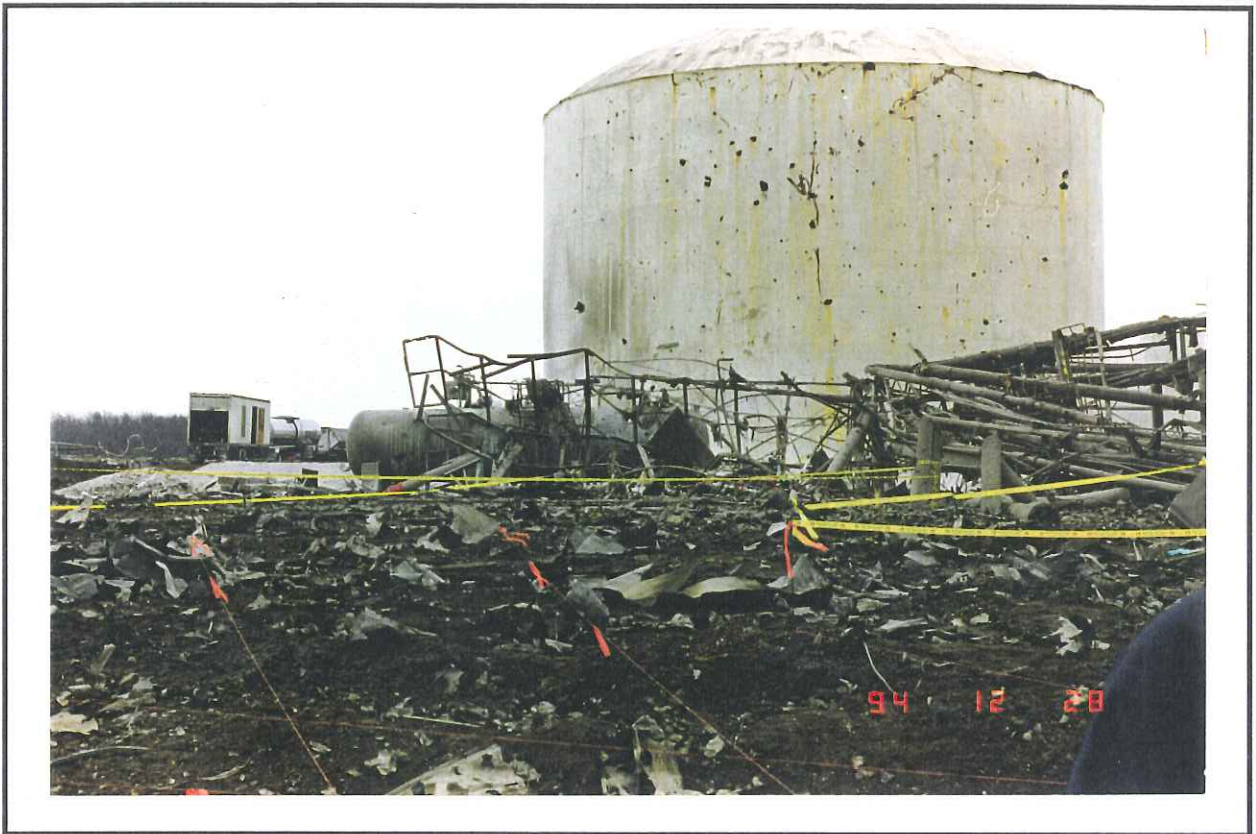
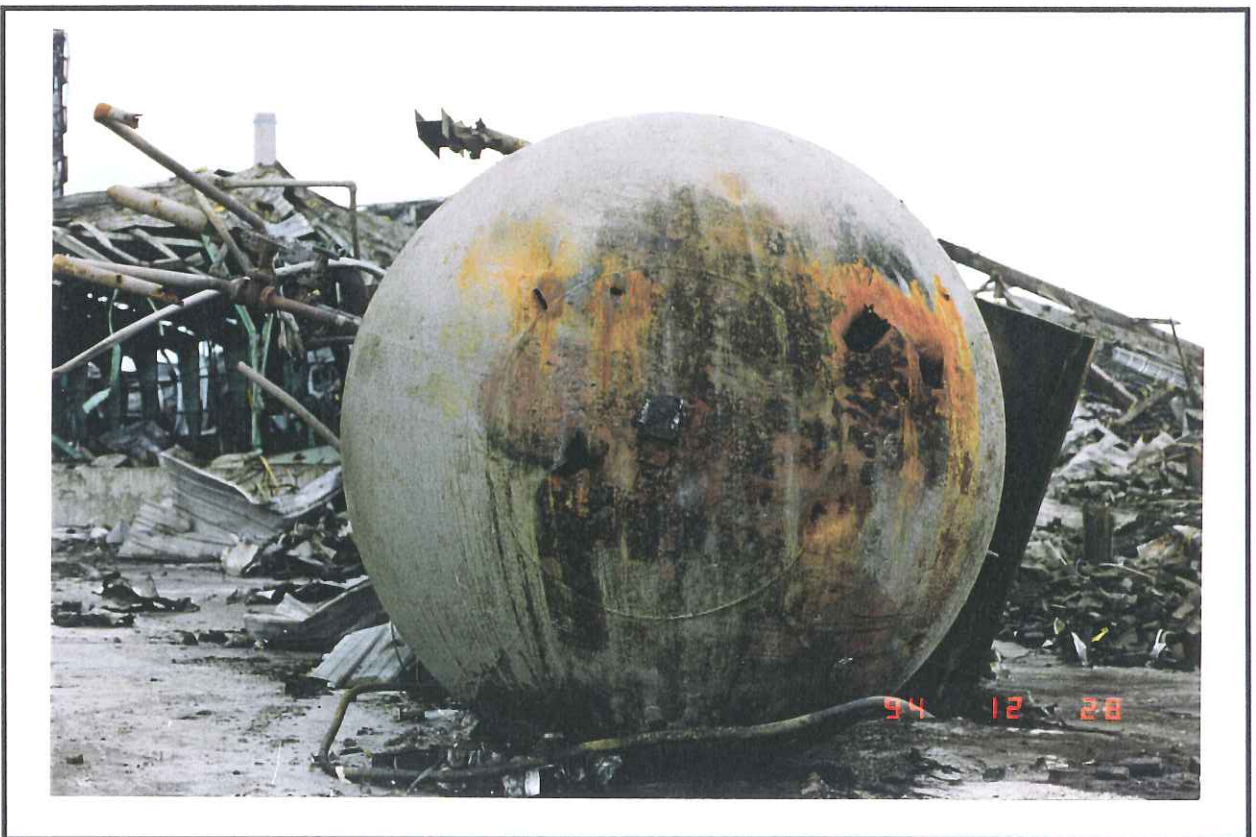
1. Reverse trajectory sighting of damage to a nearby water tank (*Photo 8-12*) and the ends of two pressure ammonia vessels (*Photo 8-13*) indicated that the neutralizer was the source of the penetrating fragments.
2. Reverse trajectory sighting of reinforcing bar angles, anchor bolt directions, and prill tower footing bolts and pads converged on the original neutralizer site.
3. Reverse trajectory sighting of a chemical stripper originally located near the AN plant indicated the explosion origin to be along a line that intersected with the original neutralizer site (*Photo 8-14*).
4. Reverse trajectory sighting of scrubber sections and the ammonia vaporizer indicated the explosion origin to be along a line that intersected the original neutralizer site.

**Photo 8 - 12**  
**Water Tank Damage (Ammonia Tank Background)**

**Photo 8 - 13**  
**Ammonia Bullet Tank Damage**

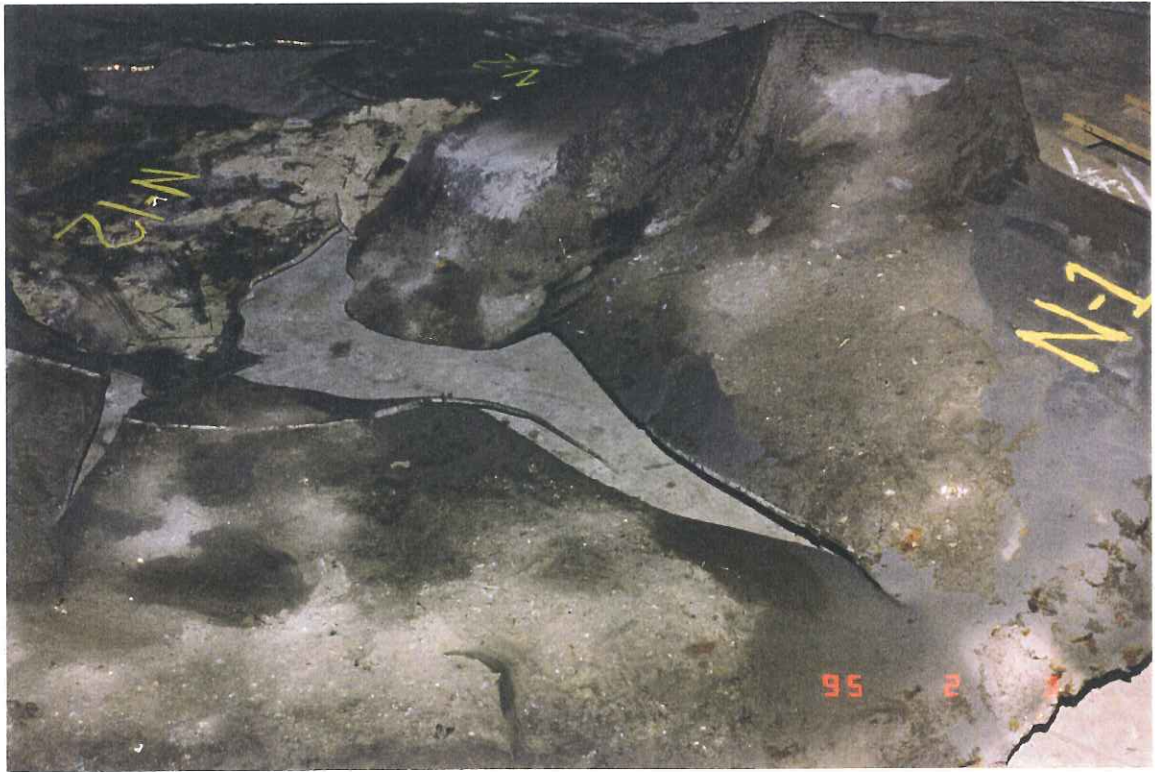
**Photo 8 - 15**  
**Neutralizer Base Fragments**

5. Visual analysis of recovered neutralizer pieces indicated that a deflagration had originated inside the vessel, and none of the pieces examined exhibited impacts from external missiles (*Photo 8-15*).

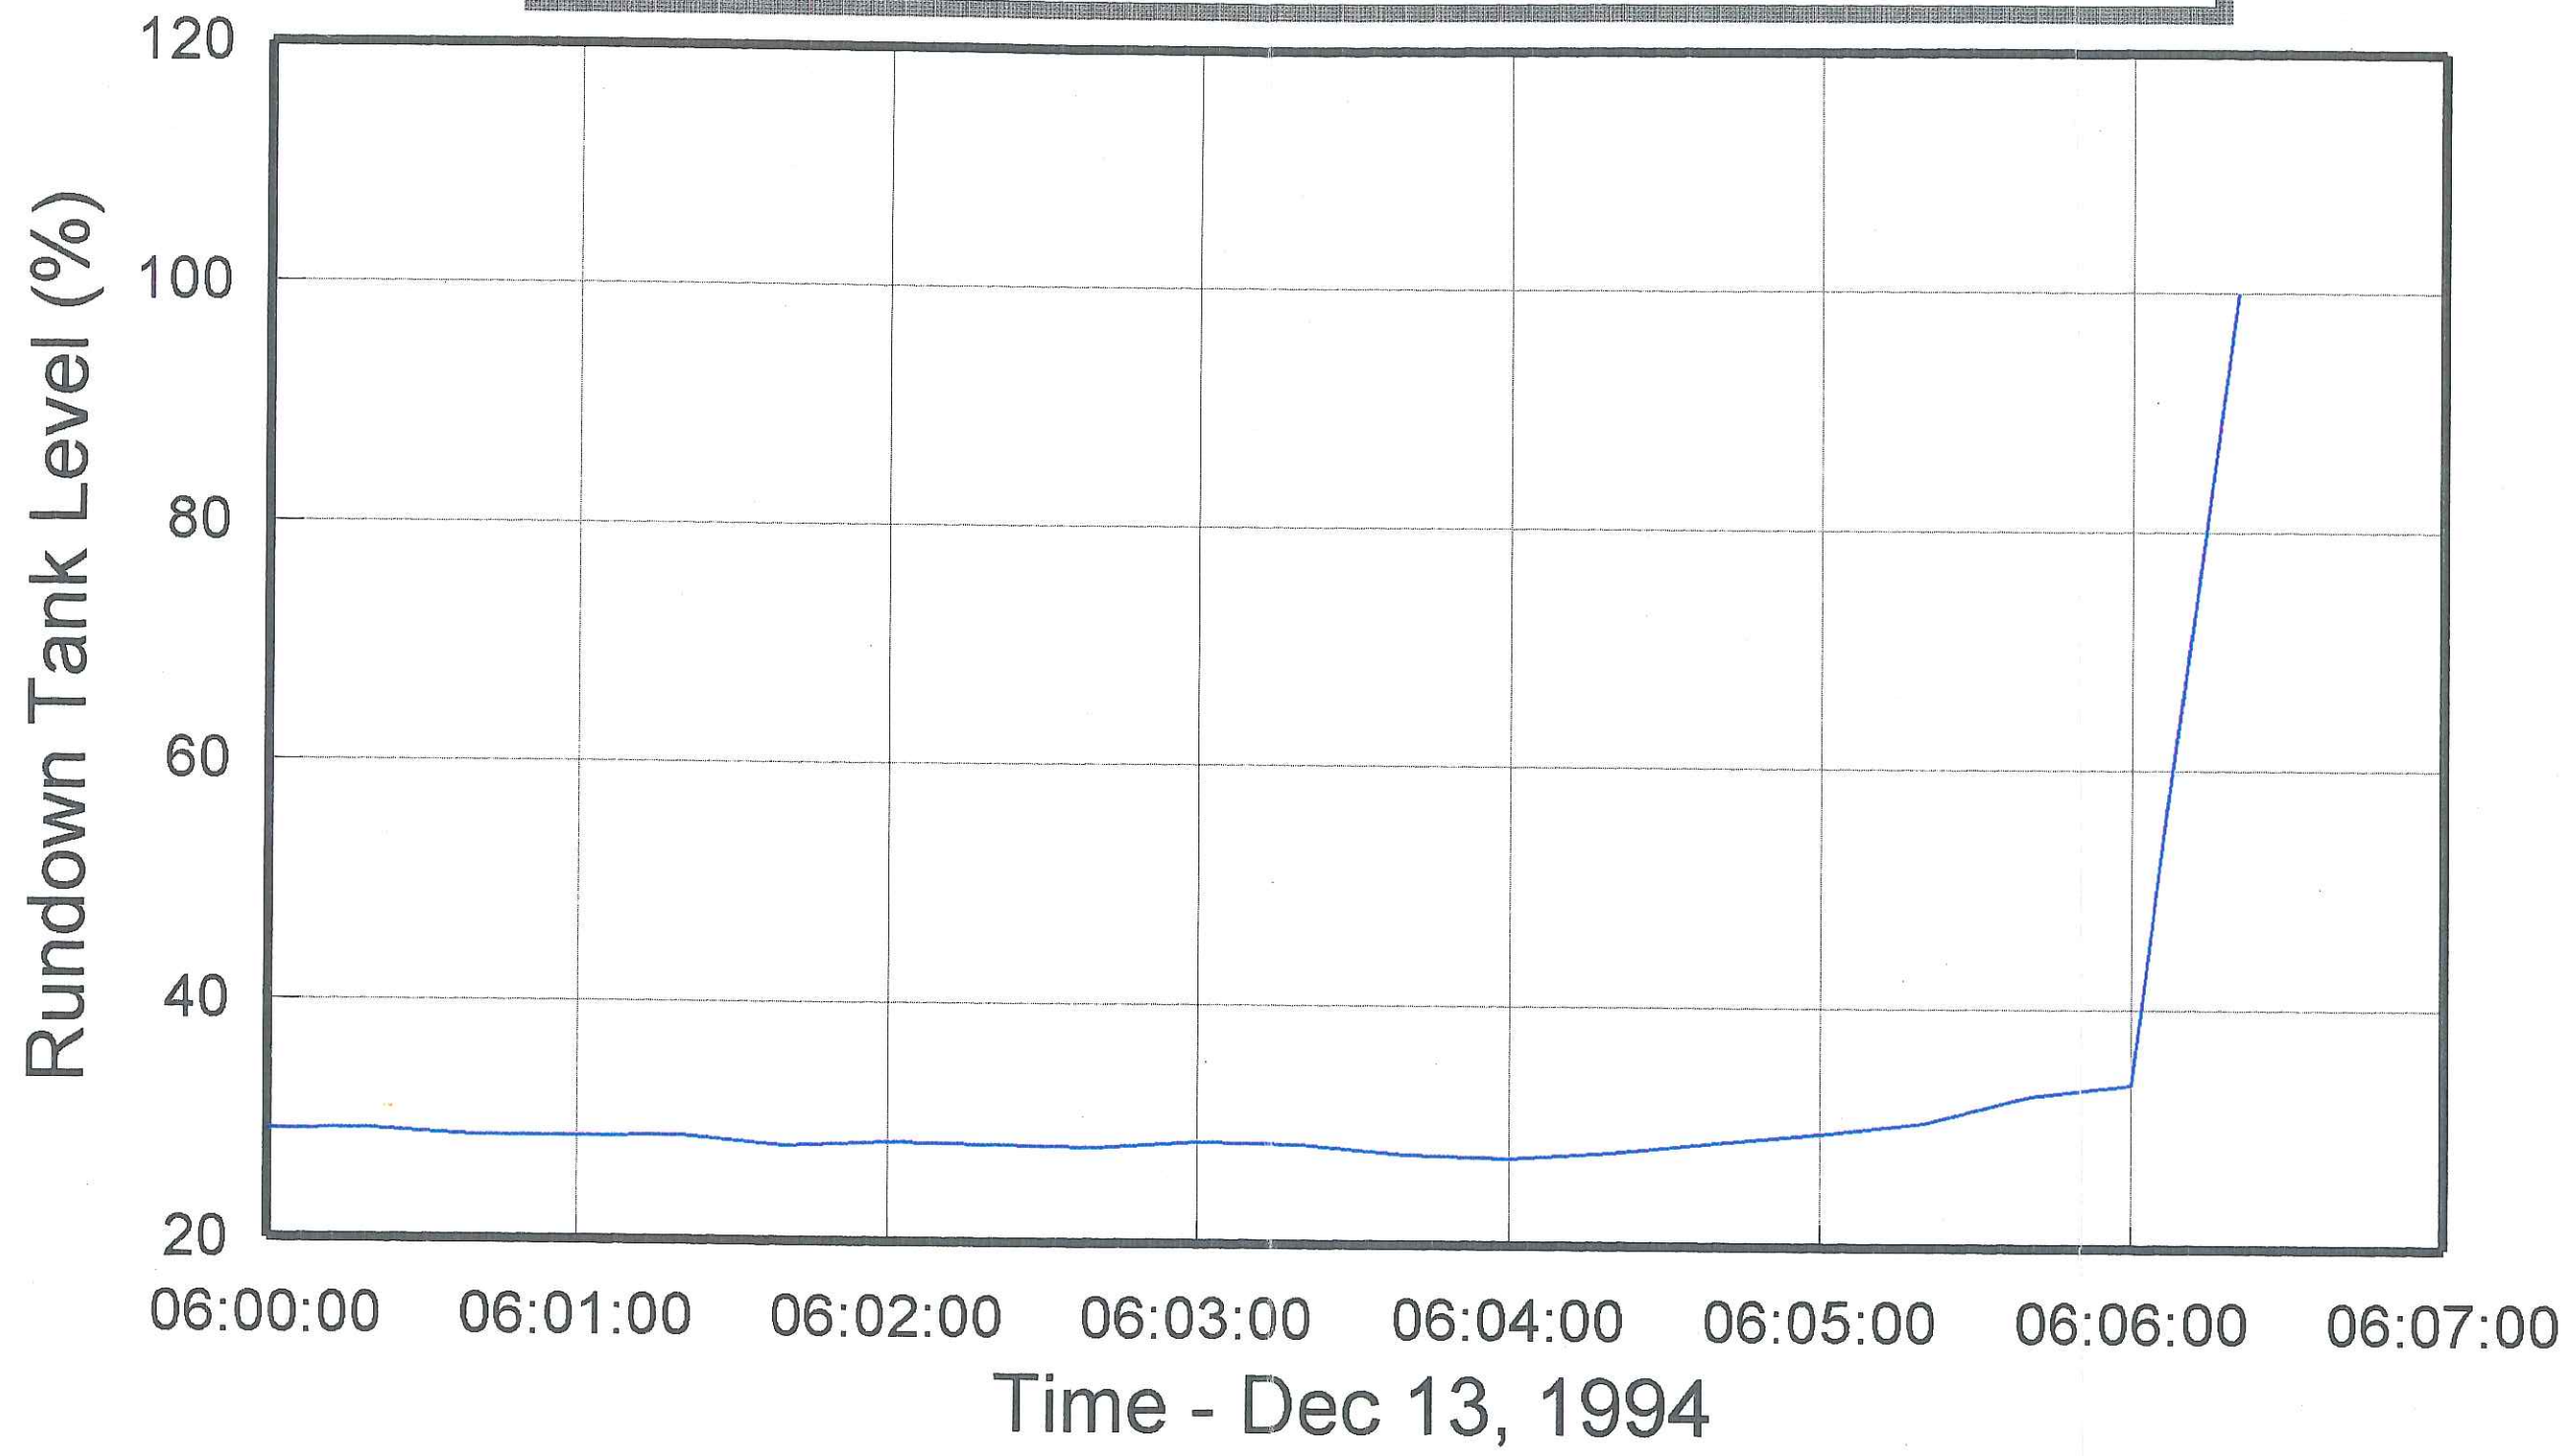
FIGURE 8 - 5

3. The rundown tank was equipped with steam coils that were attached to a steam header, but steam was not applied because of problems with the coils.
4. The pH of the rundown tank solution was determined to be approximately 1.0 and analytical data indicated the presence of chlorides.
5. Approximately 2 minutes before the explosion (DCS time), the level indication showed an exponential increase to an indicated level of 100% at the approximate time of the explosion (*Figure 8-5*).
