# EPA/OSHA JOINT CHEMICAL ACCIDENT INVESTIGATION REPORT

Napp Technologies, Inc.  
Lodi, New Jersey

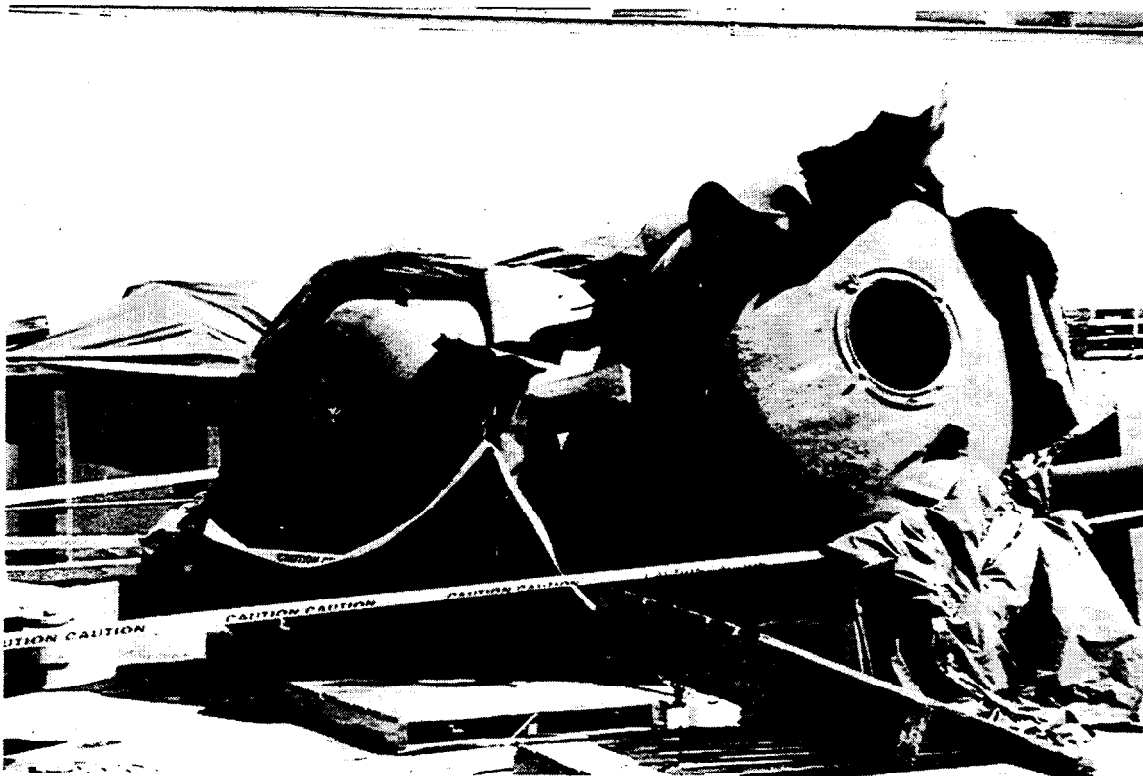
Figure 9: The general condition of the 125 cubic foot blender: a) the top access ports and damaged insulation jacket, and b) the flange to which the belt drive attaches.

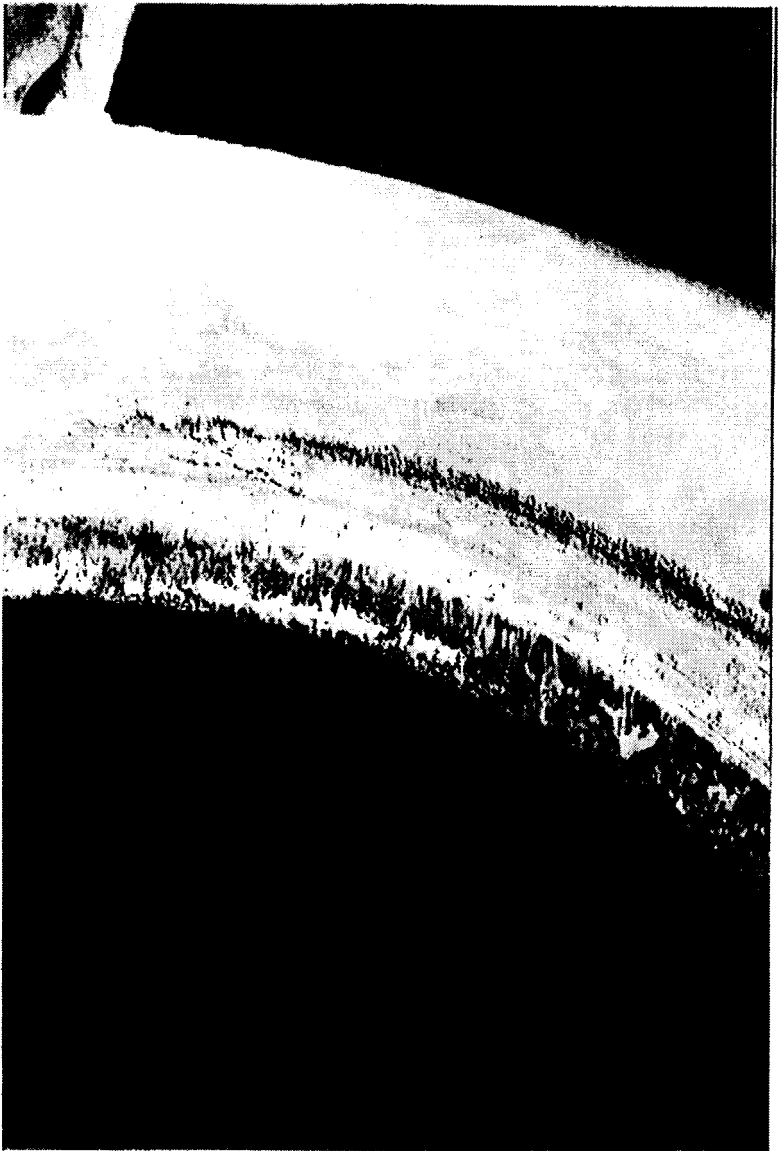
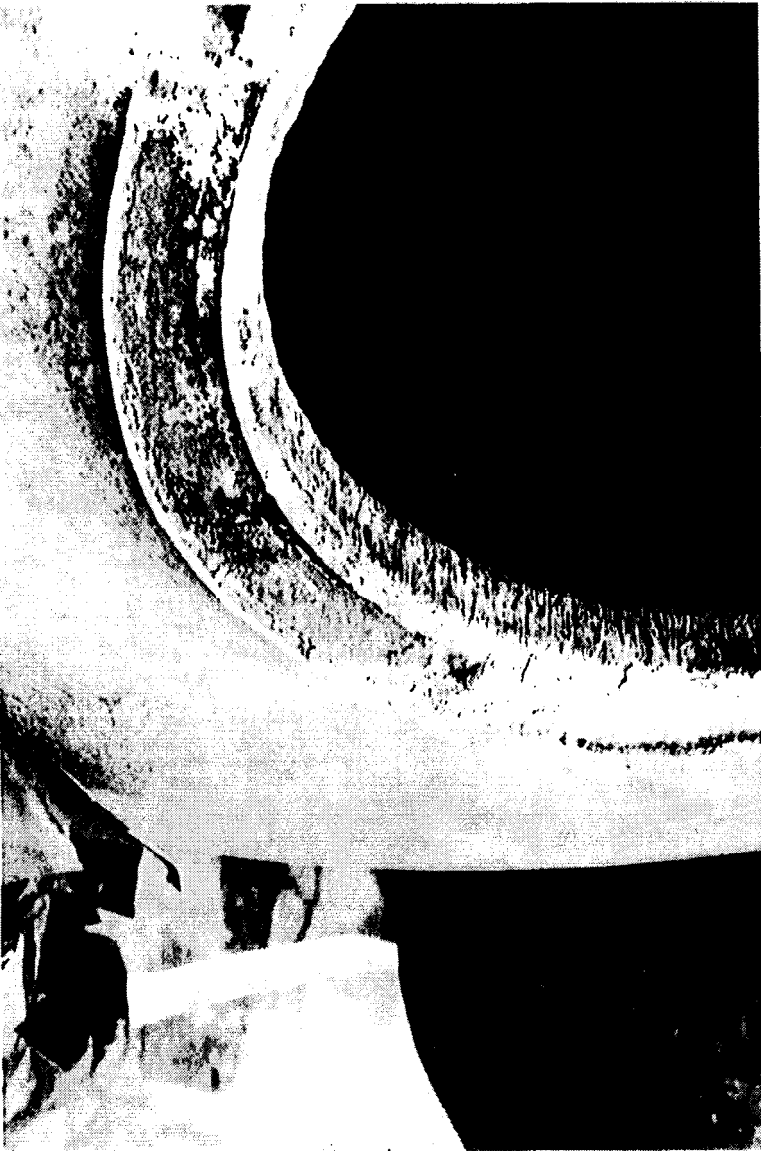
Figure 12: The striation markings on the top access ports.

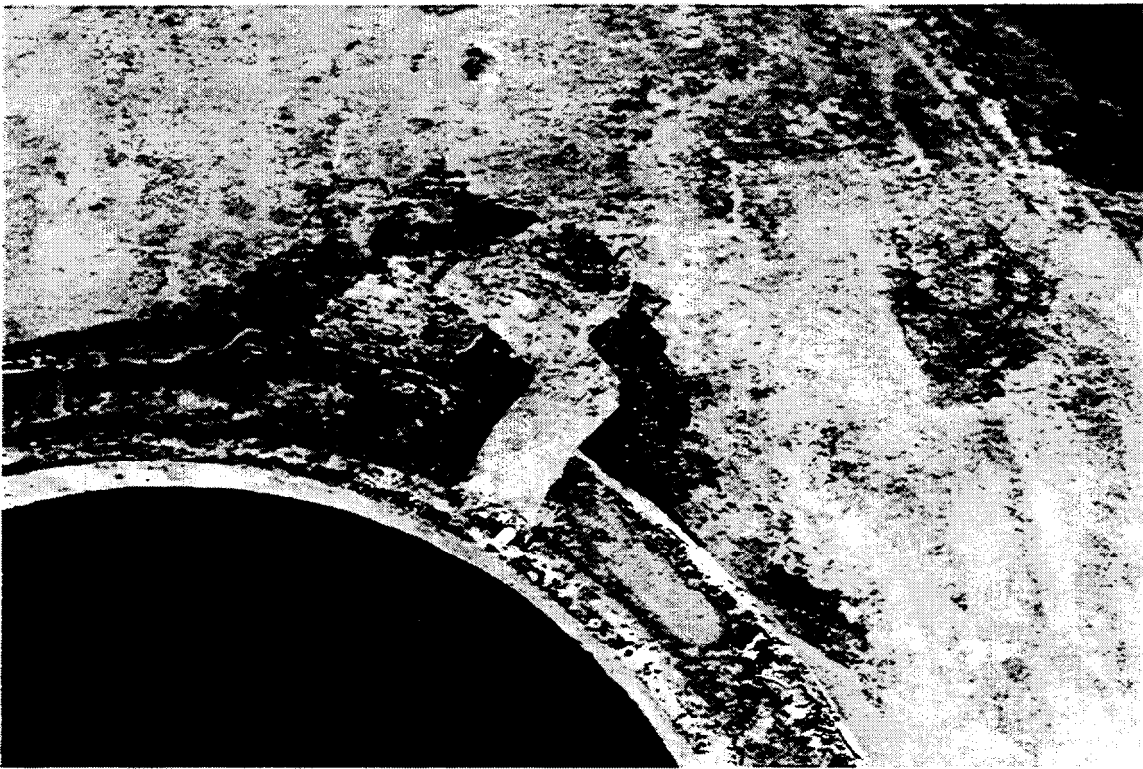
Figure 13: The tabs that held the to access port door are bent down against the stainless steel shell.

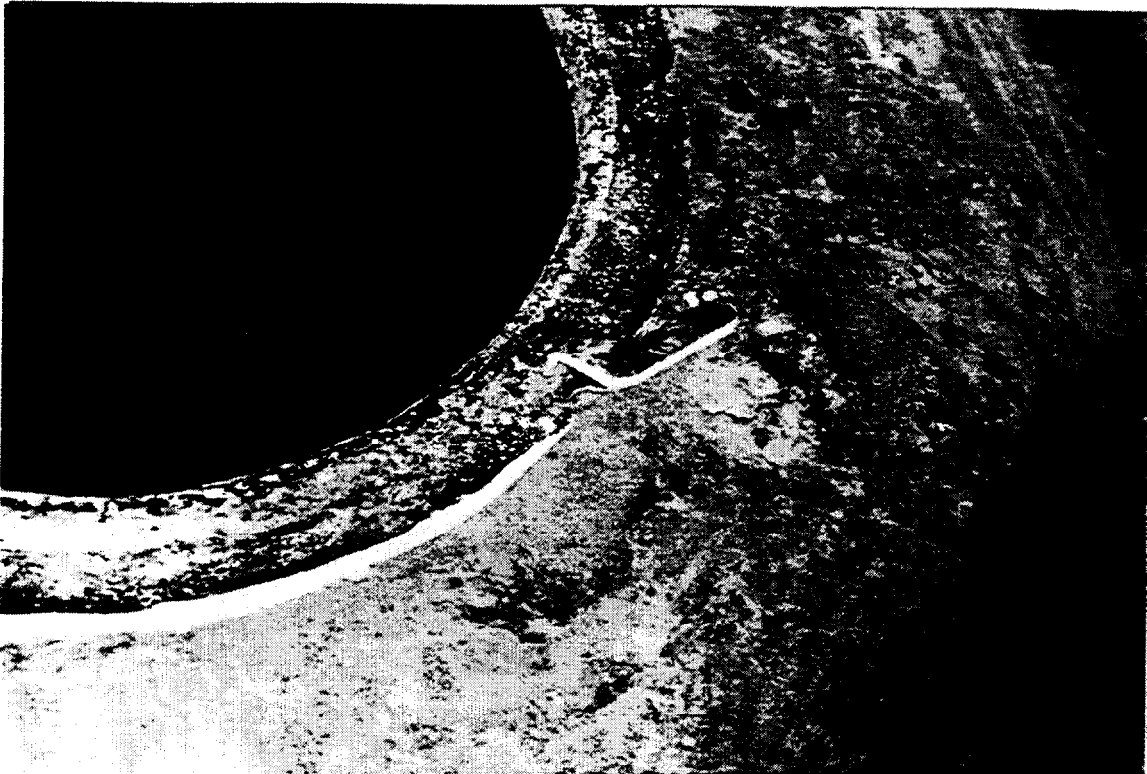
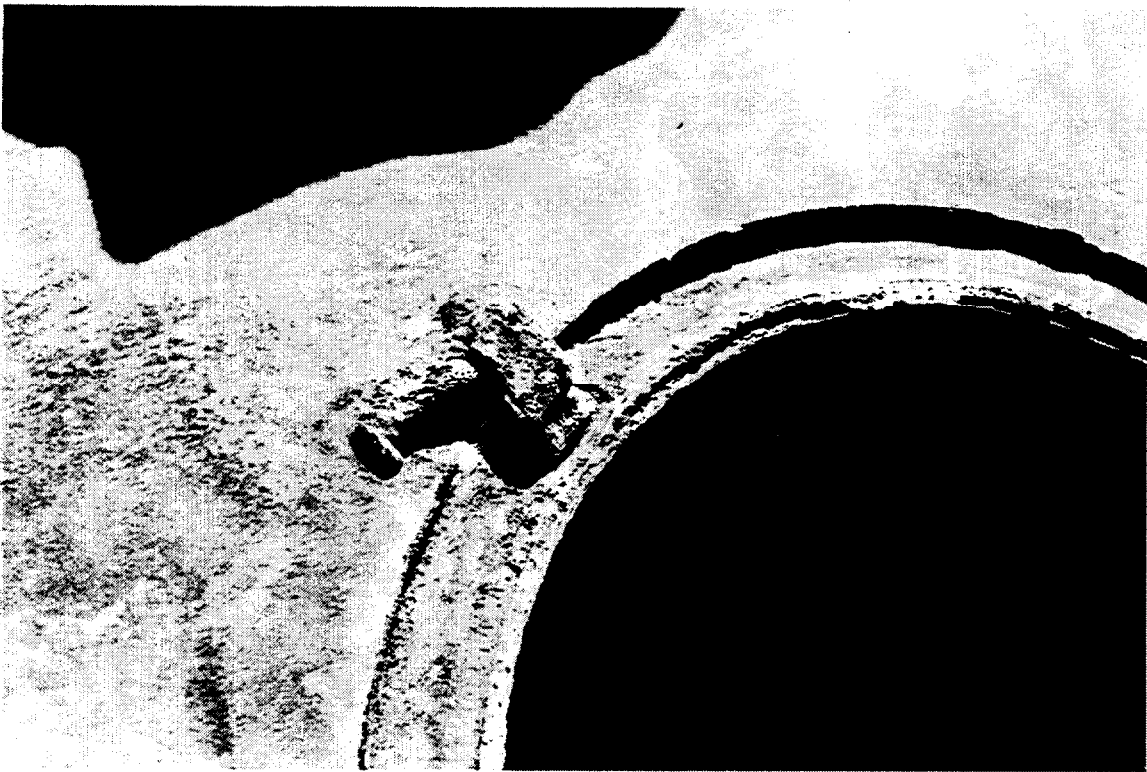
Figure 14: The insulation jacket has tom away from where it was attached to the stainless steel shell and the access door tabs are bent over against the shell.

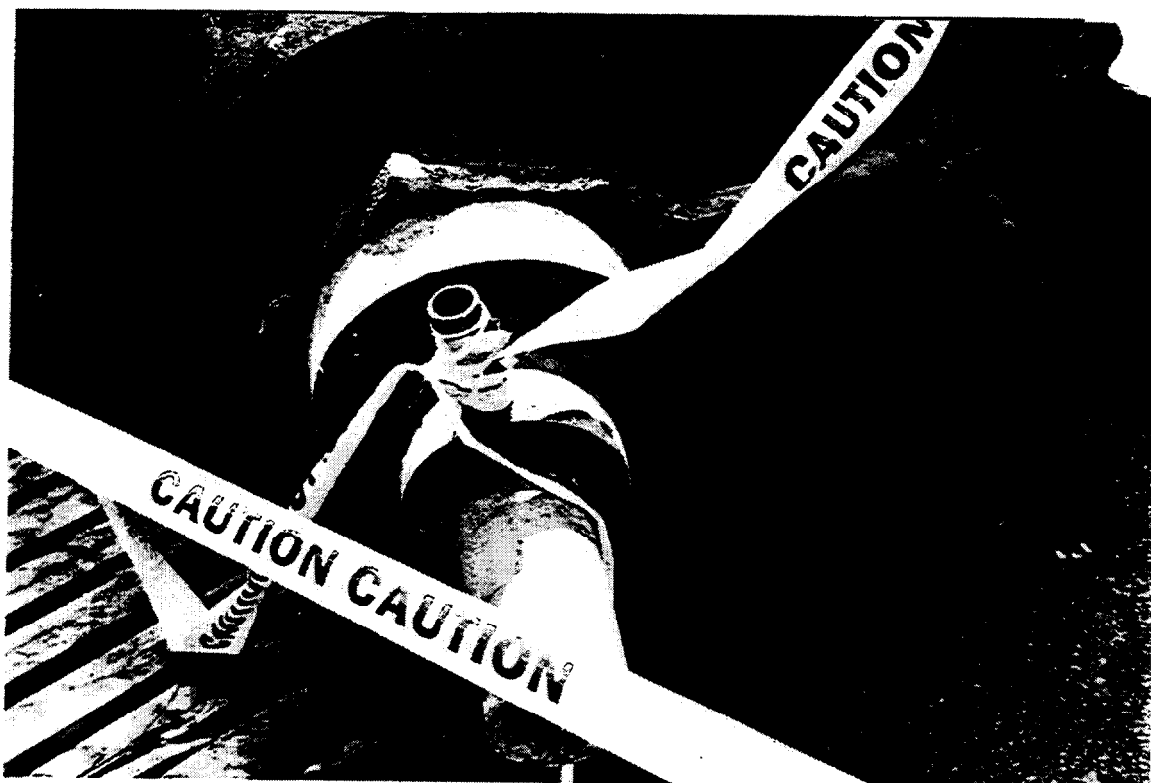
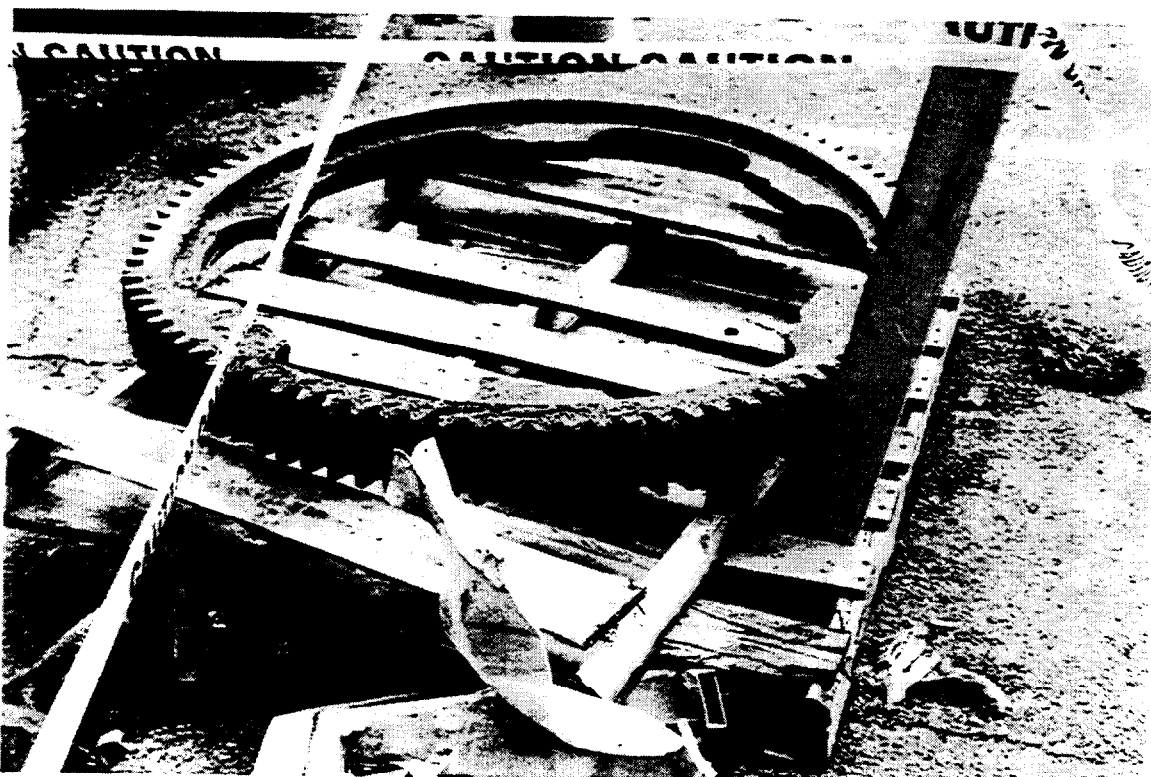
Figure 16: The gear drive side of the blender: a) the shaft (drive side) and b) the portion of the gear that fractured and separated from the blender in the accident.

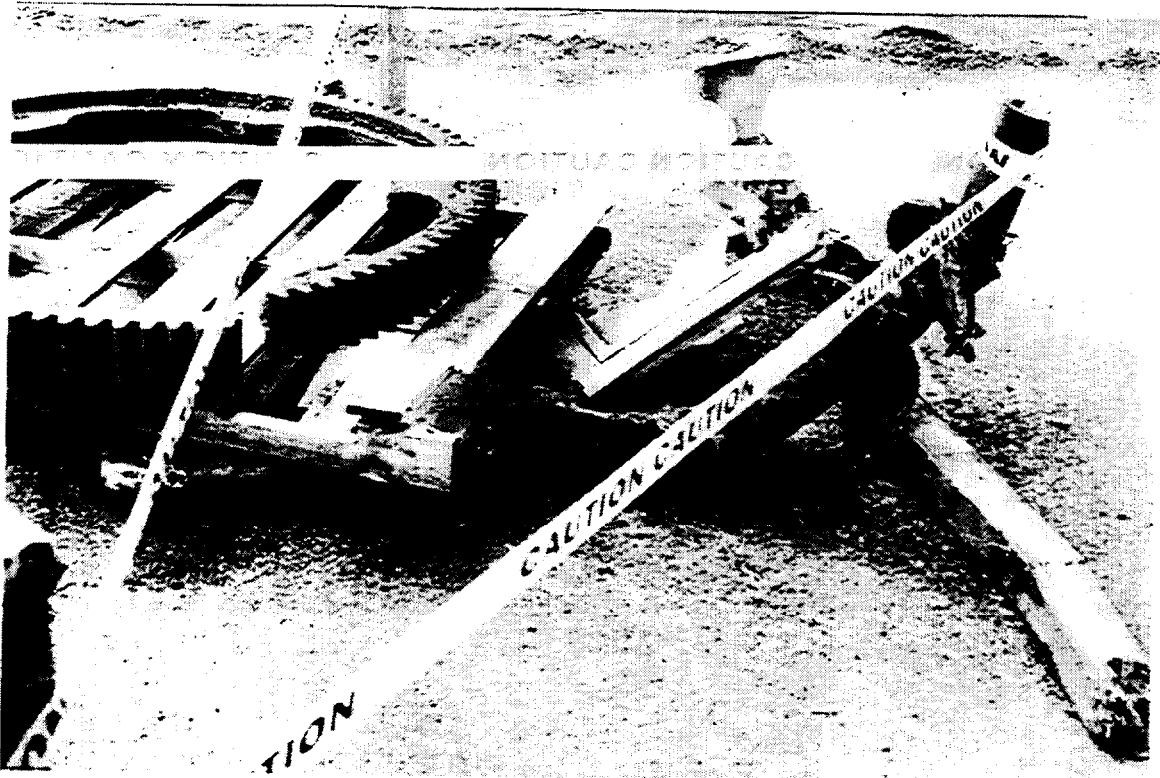
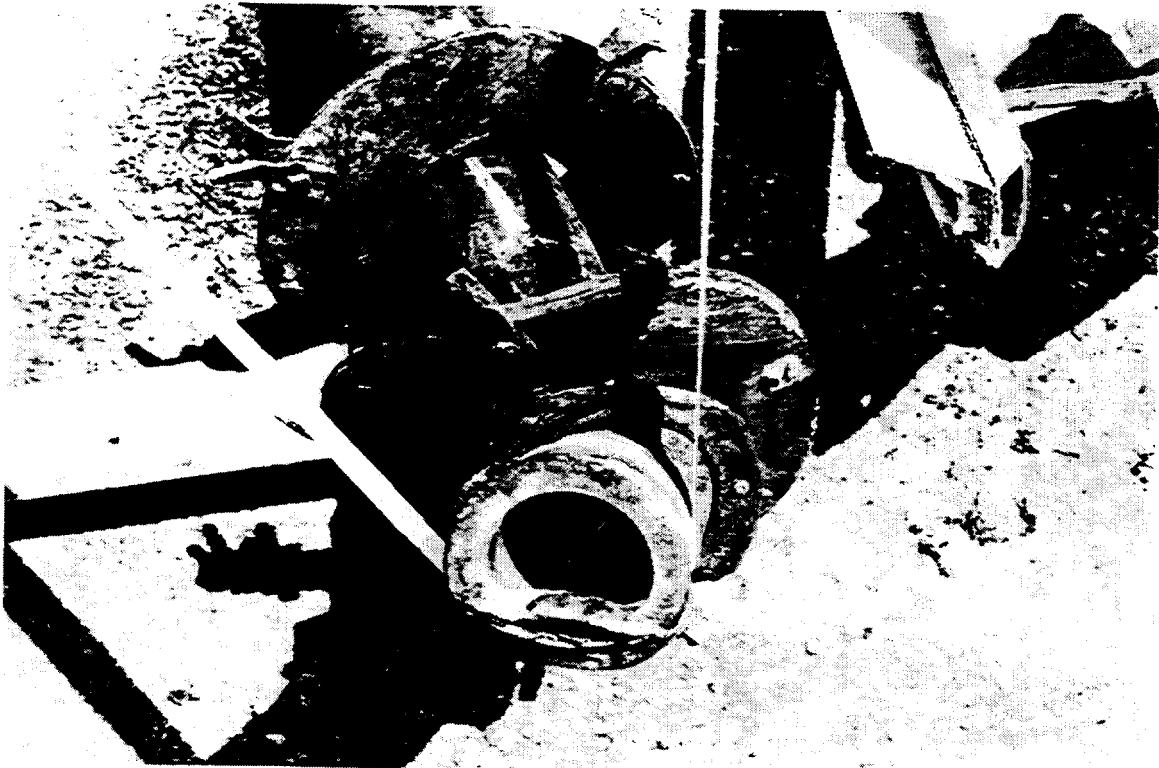
Figure 23: The intensifier bar: a) the shaft of the bar is severely deformed, b) two of the mixing plates are left, both are broken away from the shaft.

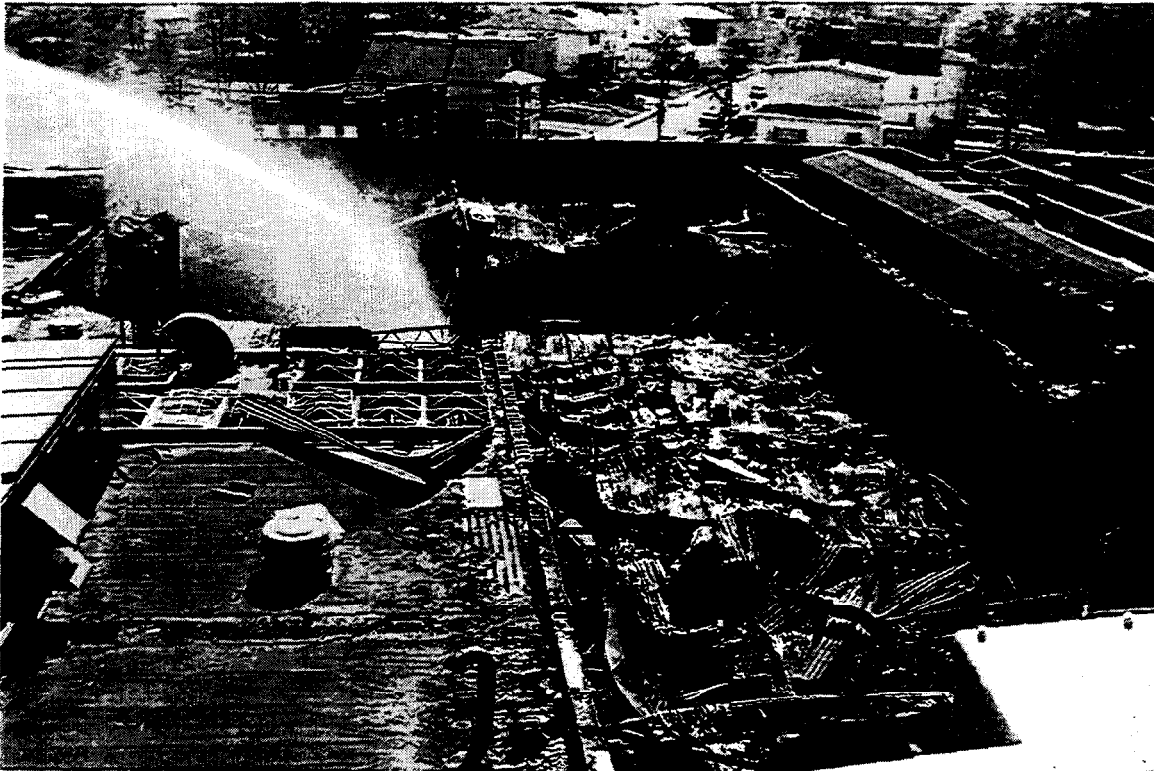
Figure 24: The Napp facility after the explosion and fire showing location in the plant where the processing took place and the location of the facility with respect to residential area in background.
