# **EPA CHEMICAL ACCIDENT INVESTIGATION REPORT**

**Powell Duffryn  
Terminals, Inc.  
Savannah, Georgia**

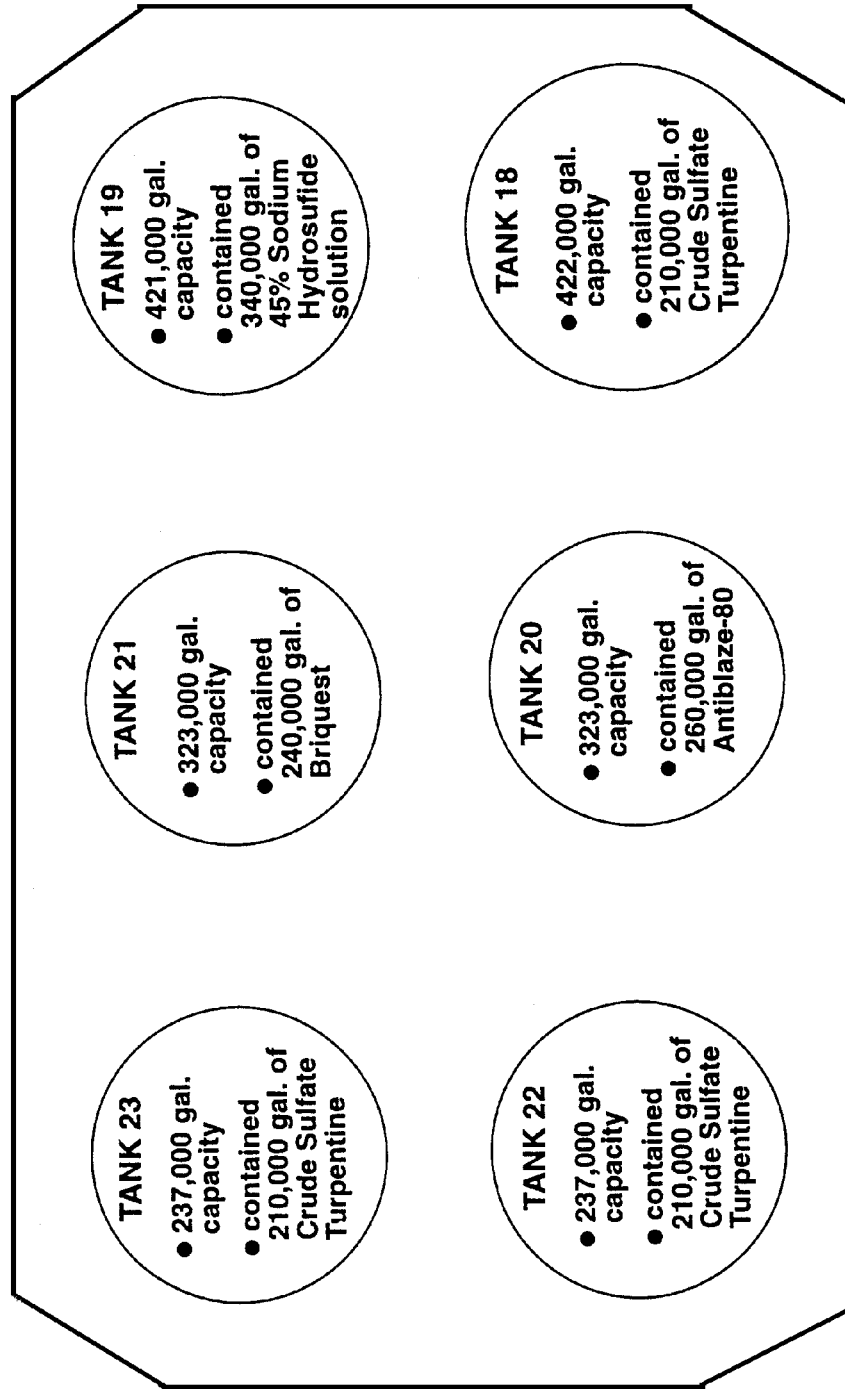
**Exhibit 2**  
**Six-Tank Enclosure, Site of Fire**  
**(100 x 200 feet, surrounded by 5-foot Concrete Berm)**

- Incompatible chemicals were stored in the same walled enclosure area. Sodium hydrosulfide solution was stored in the same enclosure area as acidic cleaning solution resulting in production of toxic hydrogen sulfide vapor when the tanks leaked. The toxic hydrogen sulfide release caused injuries, forced extended evacuations, and hampered response and cleanup.

- Facilities should examine process and storage areas and equipment to ensure that potentially incompatible substances are kept separated. Leaks or spills of incompatible substances from equipment should not go into the same containment or other areas as a result of fire or other incident.

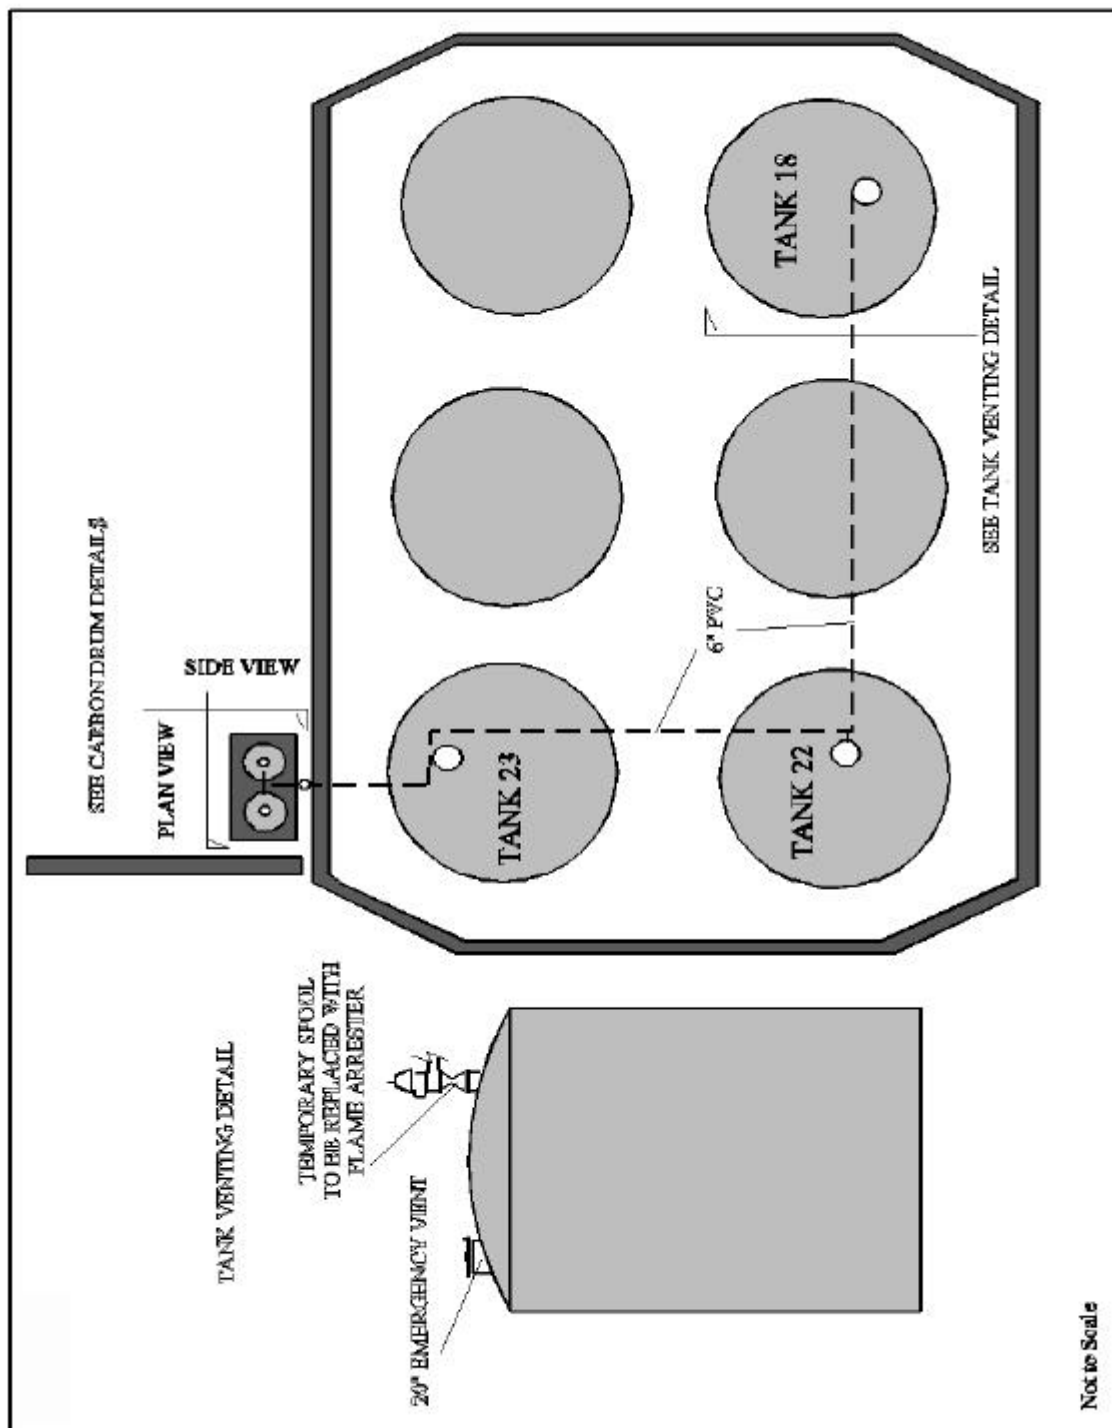
Exhibit 3. Vapor Control System

The system consisted of two metal drums (50-gallon size) containing activated carbon used for absorbing CST vapor, polyvinyl chloride (PVC) piping connecting the drums to the three flame arresters, and three pressure release vents located on the storage tanks.<sup>25</sup> It was intended that vapor from the tanks would travel through the flame arresters to the PVC piping that was mounted to existing cat walks and enter two drums of activated carbon located at ground level just outside of the enclosure area. Each tank was supposed to be equipped with a

flame arrester at its connection to the PVC pipe; however, at the time of the accident, the flame arresters were not installed. The VC system was in place, with the exception of the flame arresters, for more than a month before the accident. Piping "spools" (small fixed sections) were installed in place of the flame arresters. (However, the system was not completely closed to the atmosphere until the last foamer was installed and sealed at 2 p.m. on the afternoon of the accident - see below.)

The VC system was designed without electrical grounding for the drums containing activated carbon. The metal drums were connected to the storage tanks by non-conducting PVC pipes. This permitted possible development of differences in electric potential between the drums containing activated carbon and the CST storage tanks. A spark in the PVC pipe resulting from static discharge could possibly ignite the CST vapor and trigger a vapor explosion and fire. However, the weather conditions at the time of the fire, low wind speed and high humidity, make this an unlikely possibility.

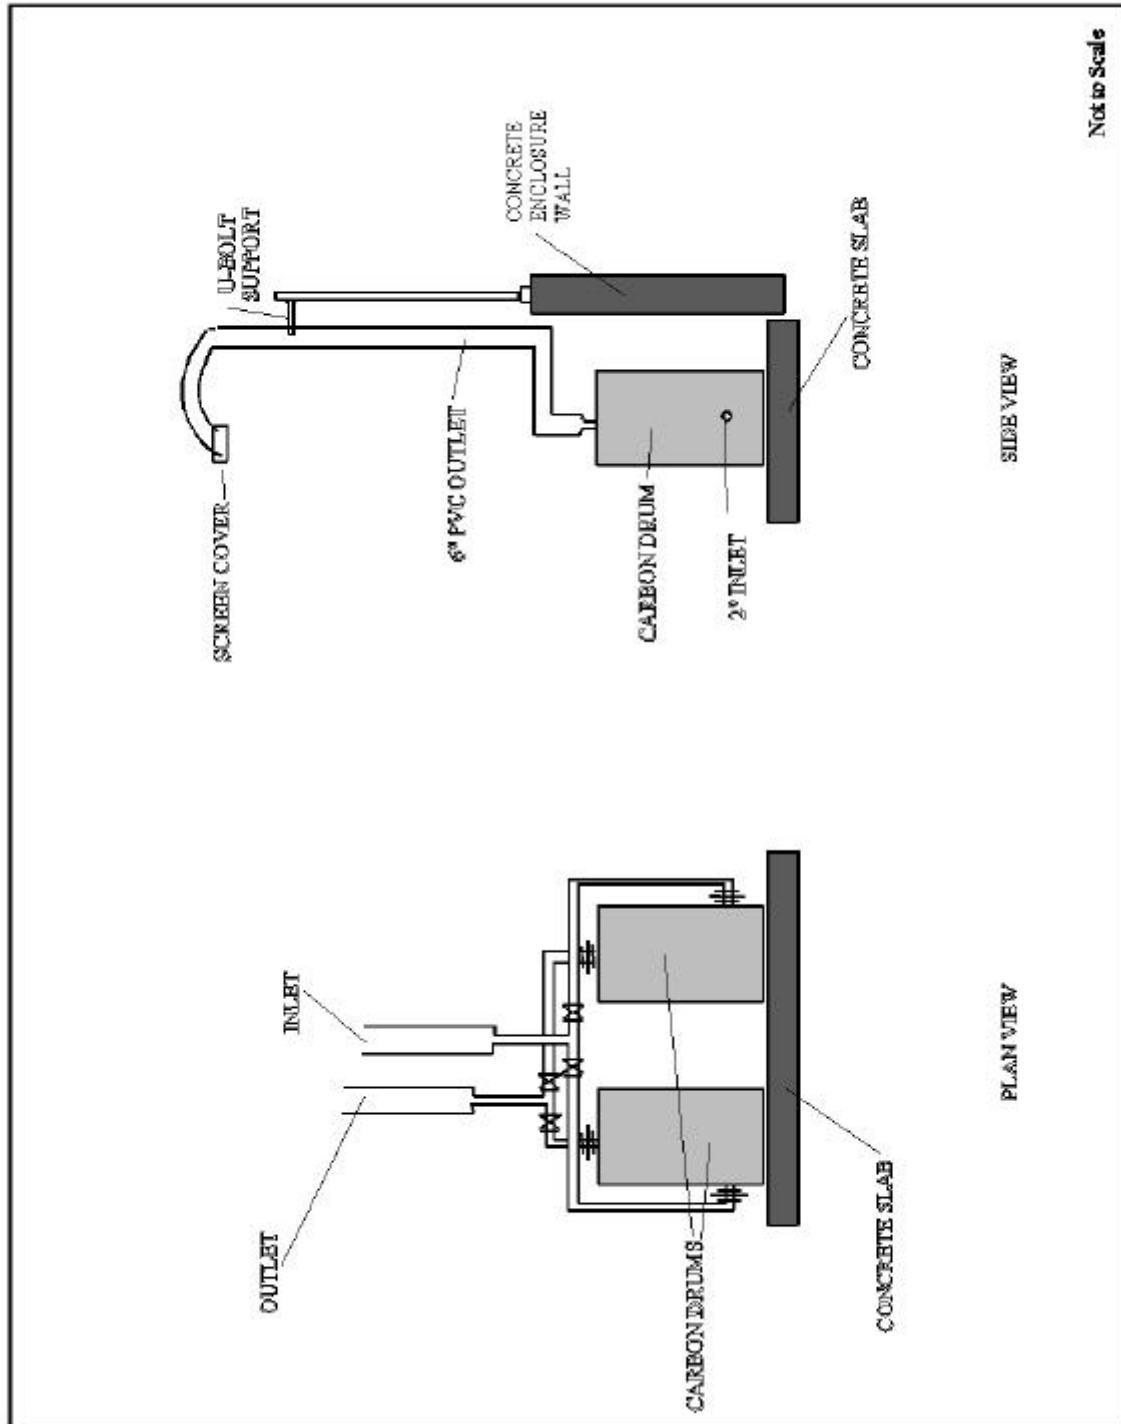
Exhibit 4. Carbon Drums

Product literature from Calgon, the manufacturer of the activated carbon, highlighted the hazards of exotherms (high temperatures) caused by adsorption of organic sulfur compounds, present in CST, onto activated carbon. Heat generated from the adsorption of CST vapor on the activated carbon can raise the temperature in the drums above the autoignition temperature of the CST vapor.

Although the temperature of the activated carbon may have become hot when CST vapor was vented from the storage tanks to the carbon drums, the low level of oxygen present in the drums probably averted a fire. However, the VC system did not have a bypass for preventing outside air from being drawn into the drums when cool outside temperatures caused vapor in the storage tanks to contract. The introduction of air provided the needed oxygen to trigger a fire.

Calgon Carbon Corporation, the manufacture of the activated carbon, recommended a procedure of wetting the carbon in the drums with water and of re-wetting it periodically thereafter. The evaporation of the water in the drums would prevent the activated carbon from becoming too hot. PDTI reportedly followed this procedure during initial installation. The VC system had been in place for over a month before the accident. However, it was not functioning as designed during this time, since part of the system was open to the atmosphere. During this time, the carbon in the drums could have dried out, even if it had been wetted initially. It is not known if the carbon was rewetted at anytime after initial installation.

- Facilities using activated carbon systems, in conjunction with vendors or recognized experts, should conduct tests to determine the potential for formation of hot spots, runaway reactions, or other consequences associated with adsorption of vapors on activated carbon and ensure that the hazards associated with the heat of adsorption are identified, well understood, and addressed through safeguards, procedures, or other controls. An evaluation of the potential for, and the consequences associated with, air being drawn into a carbon adsorption system (for example, associated with normal tank breathing) must also be addressed as necessary through safeguards or other controls.

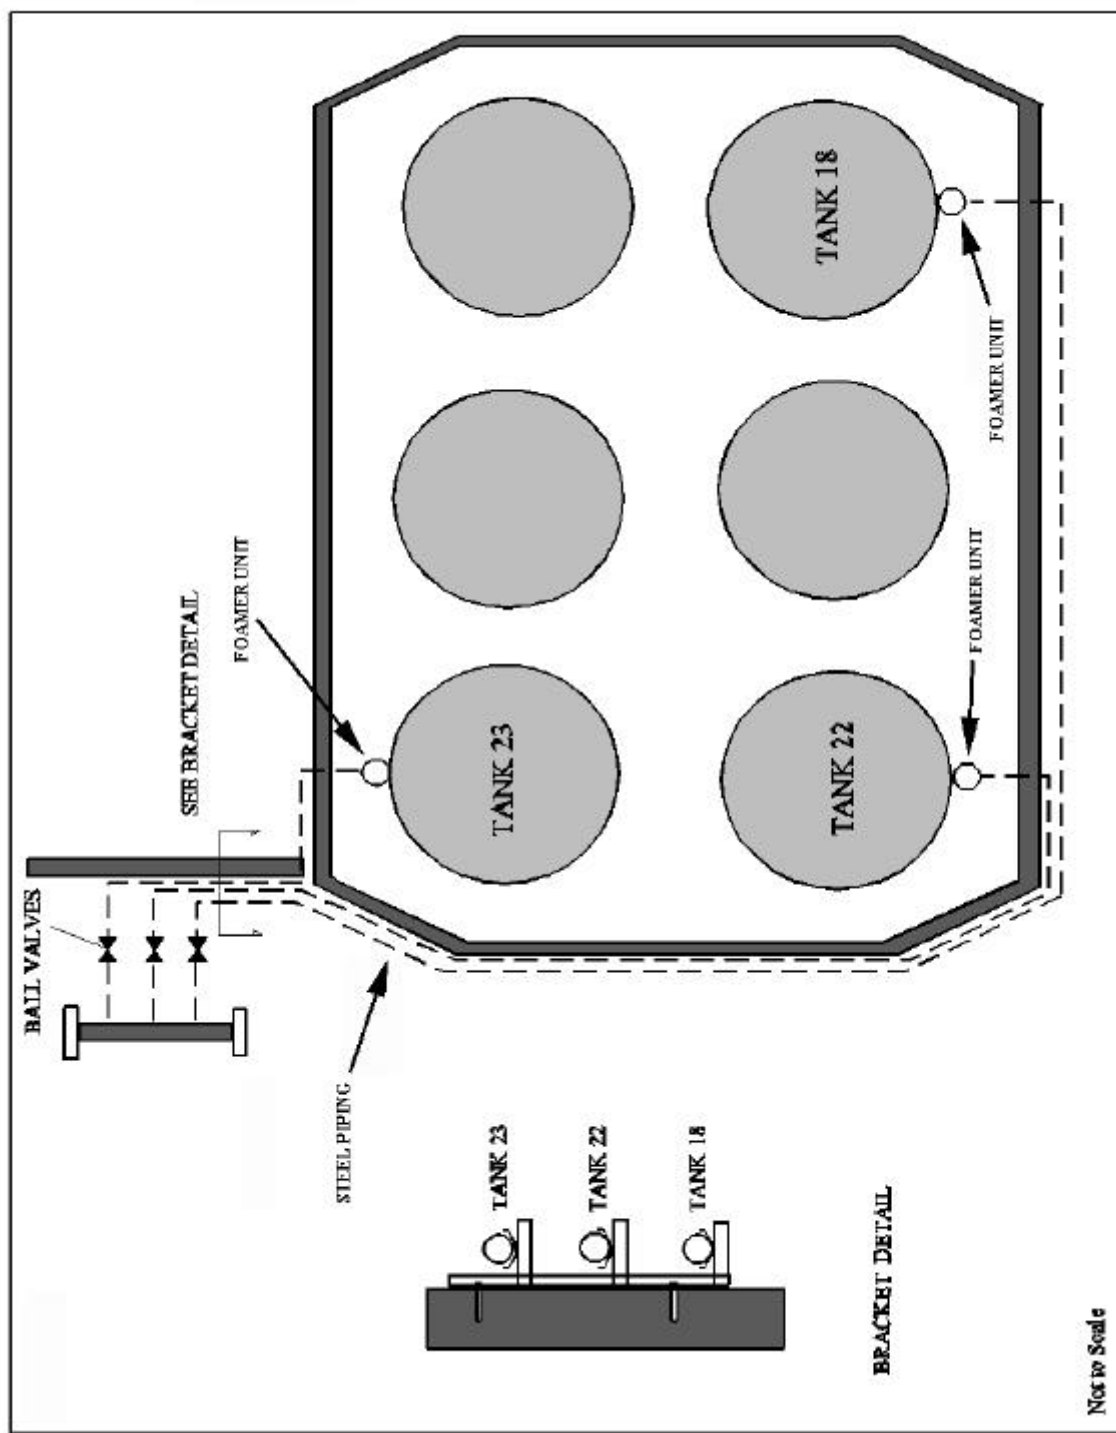
Exhibit 5. Fixed Piping Foam Fire Protection System

- The facility had been broken into and vandalized on two occasions -- two months prior to the fire and two weeks prior to the fire.<sup>4</sup>
- On March 3, 1995, PDTI's contractor began installing the foam fire protection system. The installation of the foam fire protection system had not been completed, and the system was not operational at the time of the fire.<sup>41, 44</sup>

- The foam fire suppression system was not completed on the tanks containing CST. Foam fire suppression system was included as part of changes to be made for storing flammables. CST storage had begun before modifications were completed. Fire fighters were not able to use the foam pumper connection outside the enclosure area. Fire fighters used water to fight the fire until a connection to the foam pumper could be rigged within the enclosure area. An operational foam fire suppression system could have reduced the amount of time required to suppress the fire and reduce the amount of heat damage to the adjacent storage tanks and limited the amount of runoff from fire water which contaminated sensitive wetland area along the Savannah River.

- Facilities must ensure that equipment for use in handling hazardous substances is equipped with the proper safety devices, and in compliance with national, state, and local fire and hazardous material safety codes and standards before hazardous materials are handled in such equipment. The safeguards, safety devices, or emergency systems designed to prevent or protect the equipment must be in place and fully operational as intended prior to startup of the equipment.

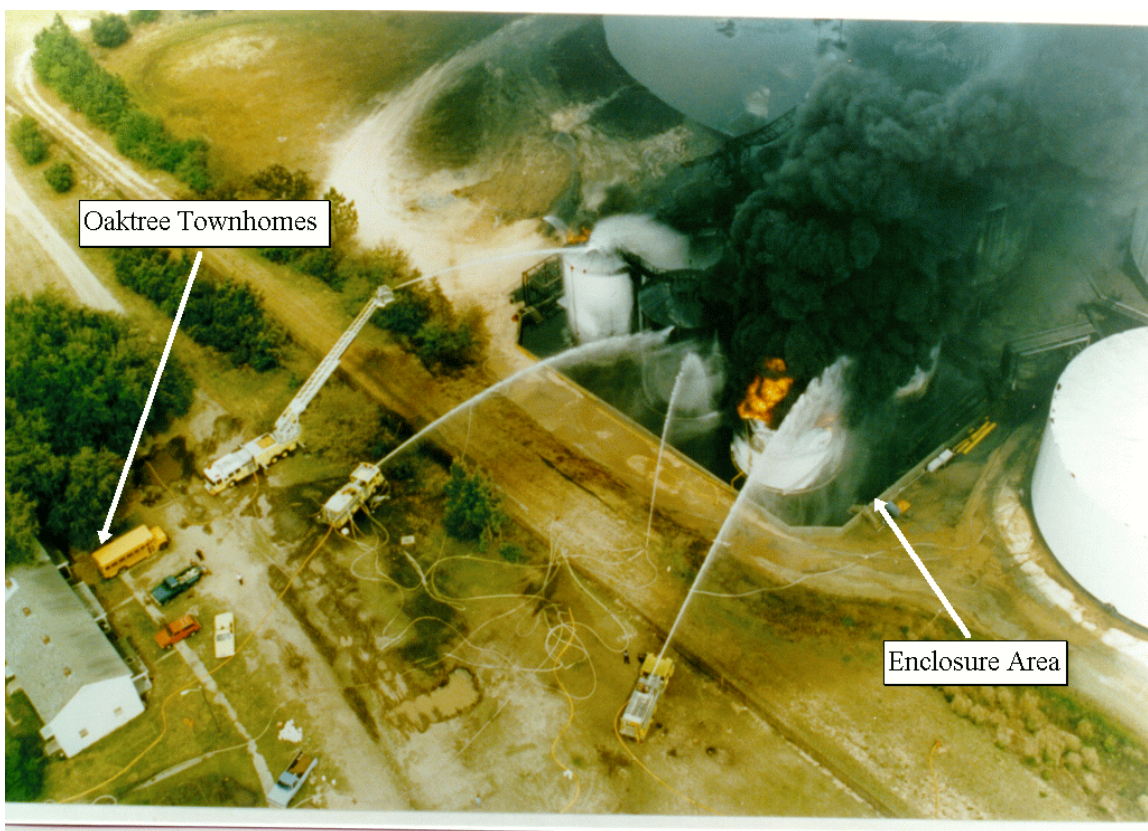
**Exhibit 6**  
Area of Fire and Firefighting Efforts <sup>29</sup>

Eventually, firefighters were able enter the enclosure area and connect the foam system to apply foam to the tanks. The fire appeared to be extinguished several times only to reignite because the CST tanks had become extremely hot as a result of the fire. Water was used to cool the CST tanks to prevent re-ignition and protect the adjacent tanks within the enclosure area. However, due to concerns over contamination of marshland and the Savannah River from the overflow of fire water, the use of cooling water had to be limited until the Coast Guard constructed a berm to prevent contaminated water from reaching the river. The Savannah

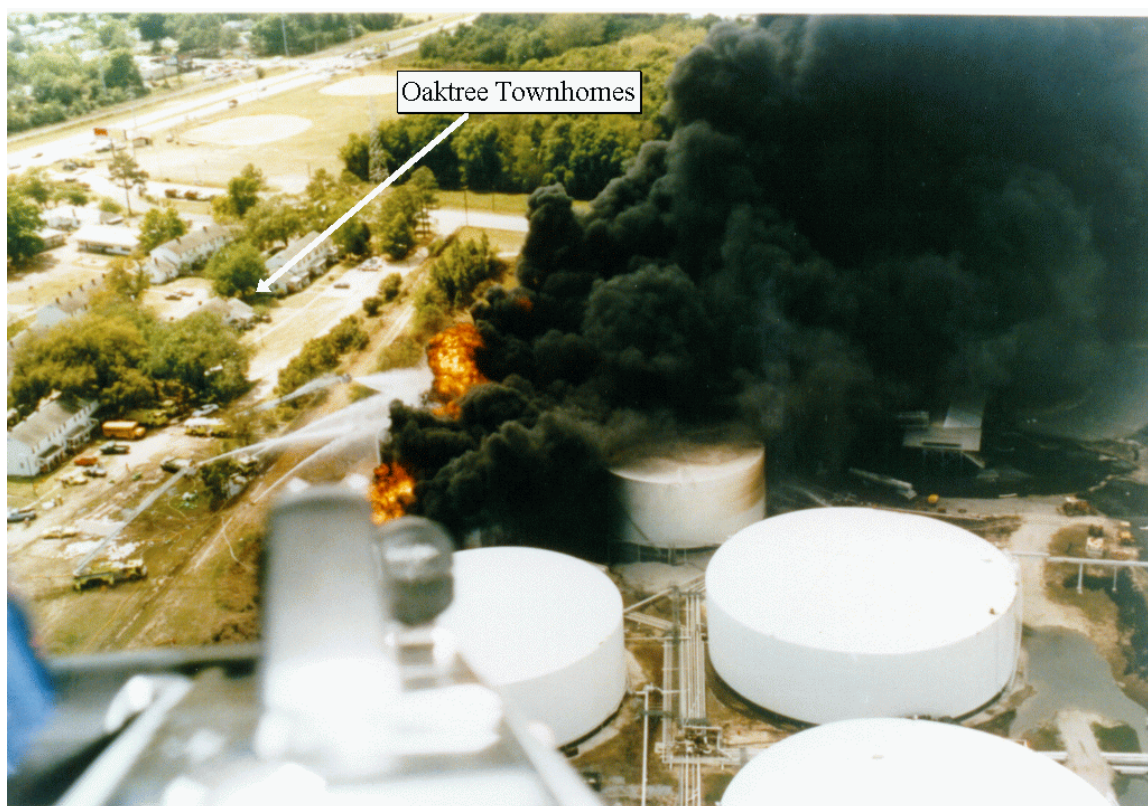
**Exhibit 7**  
Area of Fire and Oaktree Townhomes <sup>29</sup>

The intense fire forced the nearby residents of the Oaktree Townhomes complex to immediately evacuate. The fire was sufficiently intense to cause damage to some trees and buildings in the Oaktree complex. The location of the Oaktree Townhomes in relation to the fire can be seen in the photograph in Exhibit 6.<sup>3, 7, 30, 31</sup>
