# **EPA CHEMICAL ACCIDENT INVESTIGATION REPORT**

**Pennzoil Product  
Company Refinery  
Rouseville, Pennsylvania**

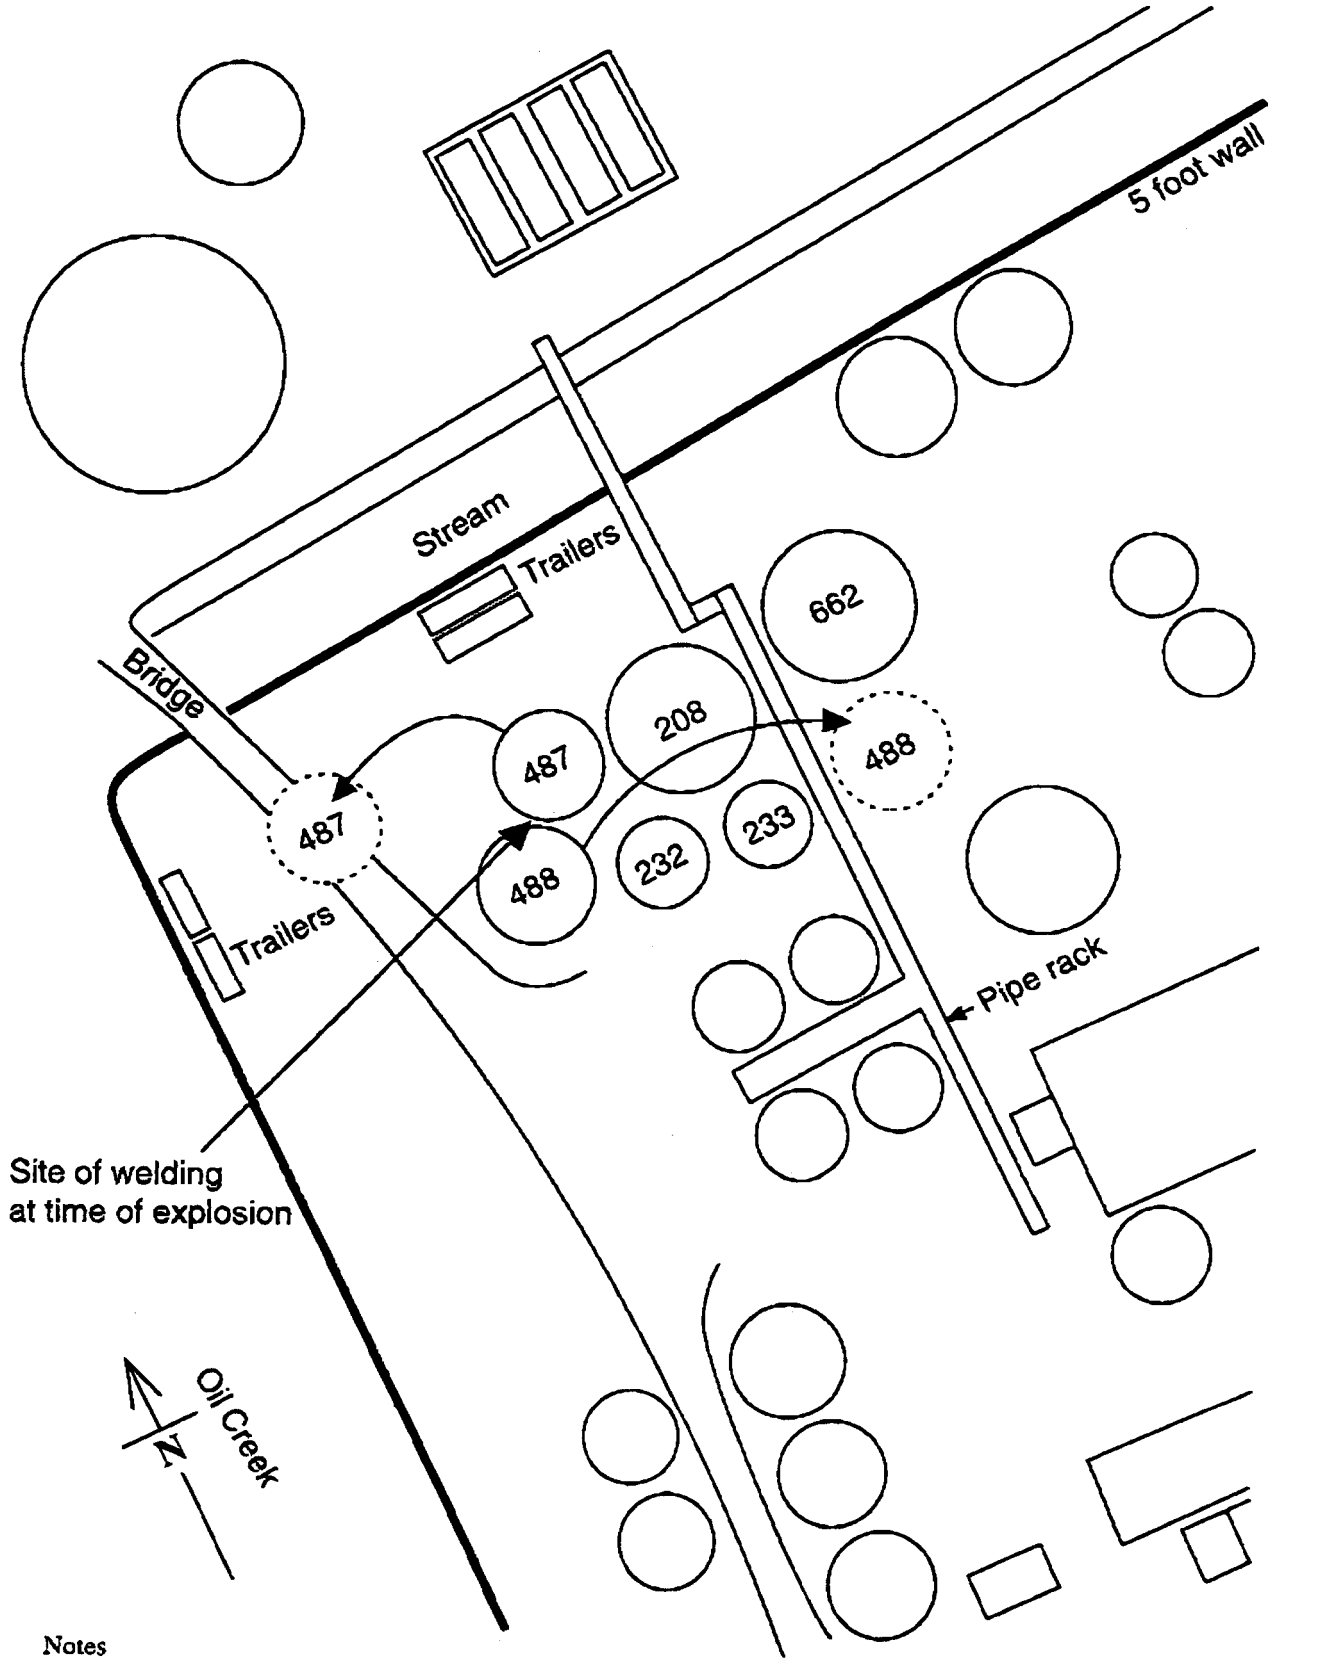
Exhibit 3  
Area of Explosion and Fire at Pennzoil Refinery

Curved lines indicate trajectory of tanks 487 and 488

Tank 208: Naptha; burned in place

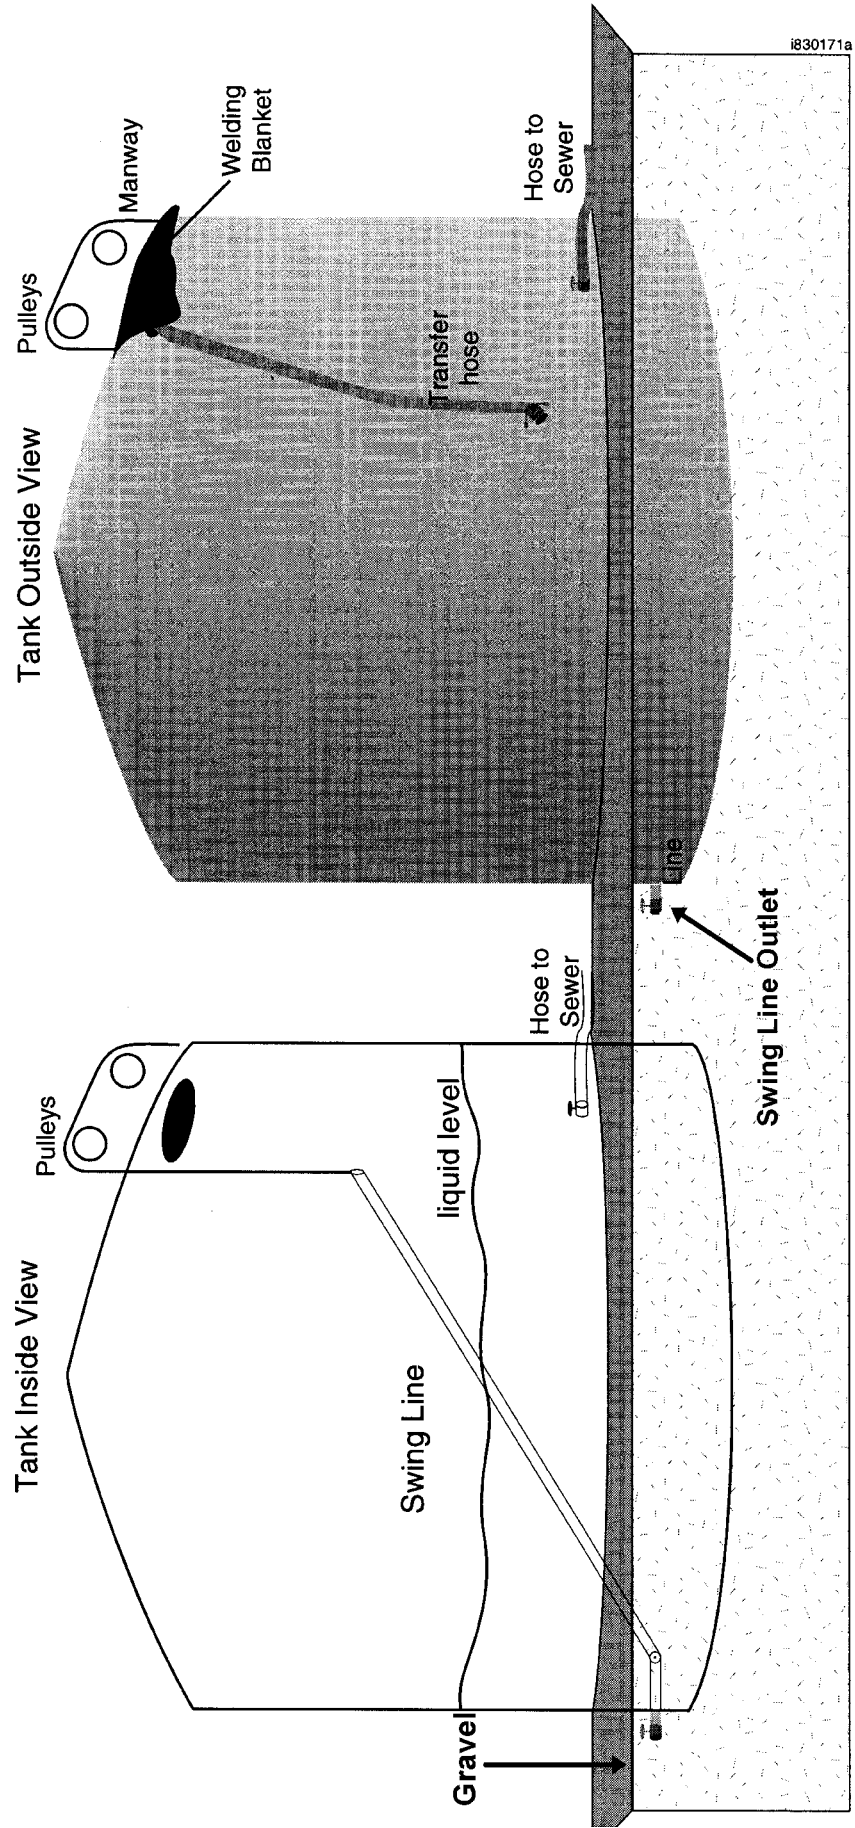
Exhibit 4  
Inside and Outside Views of Tank 487

Tanks 487 and 488, which were similar in size and design, were 30 feet in diameter with 25-foot high sidewalls and five-foot high domes. The tanks, built in 1937, were constructed of steel plates riveted together. The riveted "umbrella" domes were replaced in 1950. The tanks were about four feet apart and shared a common set of stairs leading to the top for employee activities such as gauging the volume of liquid in the tank or inspections. These tanks were not individually diked; i.e., they did not have a secondary containment wall around them. However, they were located in a general tank farm area that had walls and berms to prevent any spilled materials from reaching the Oil Creek.

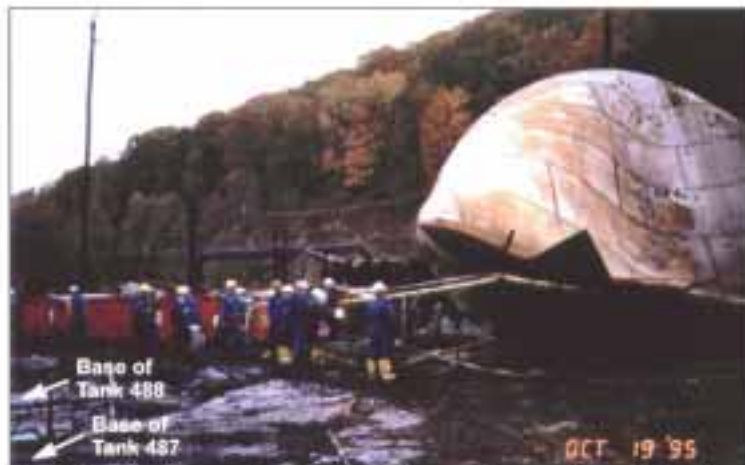
B. Dips in ground showing the original site of tanks 487 & 488. Tank 487 in background.

- The bottoms of the tanks at the shell wall seam may have been weakened through corrosion. The tanks generally contained water at the bottom. Gravel was also built up around the bottoms and sides of the tanks, which may have allowed moisture to collect on the outside, on the bottom and tank wall edge, leading to corrosion and weakening of the bottom seam at the shell wall. (Evidence of this gravel can be seen in Exhibit 5-B, which shows the indentations left in the ground by tanks 487 and 488.)

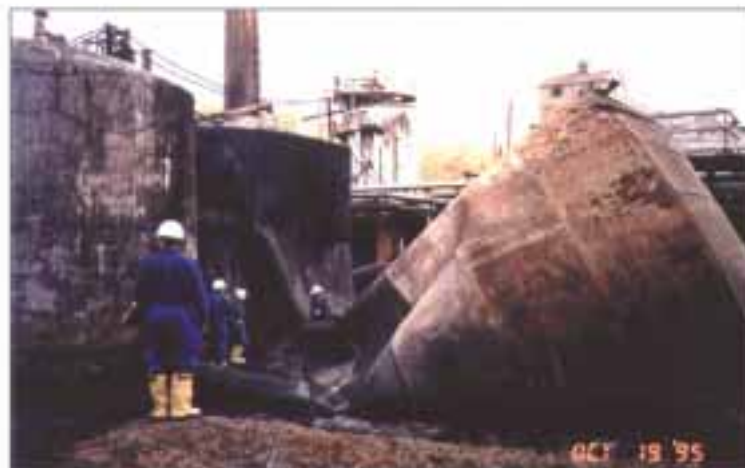
As a result of the explosions, each tank failed catastrophically at the bottom seam where the vertical sidewall of the tank was connected to the bottom horizontal floor plate, lifting the tanks up in opposite directions. Tank 487 lifted off its base and landed about 20 feet to the west. Tank 488 landed about 50 feet to the east after clearing a storage tank and a pipe rack. The burning contents of the tanks, released when the tanks failed, created a wave of burning hydrocarbon that engulfed the entire area.

C. Tank 488, after explosion.

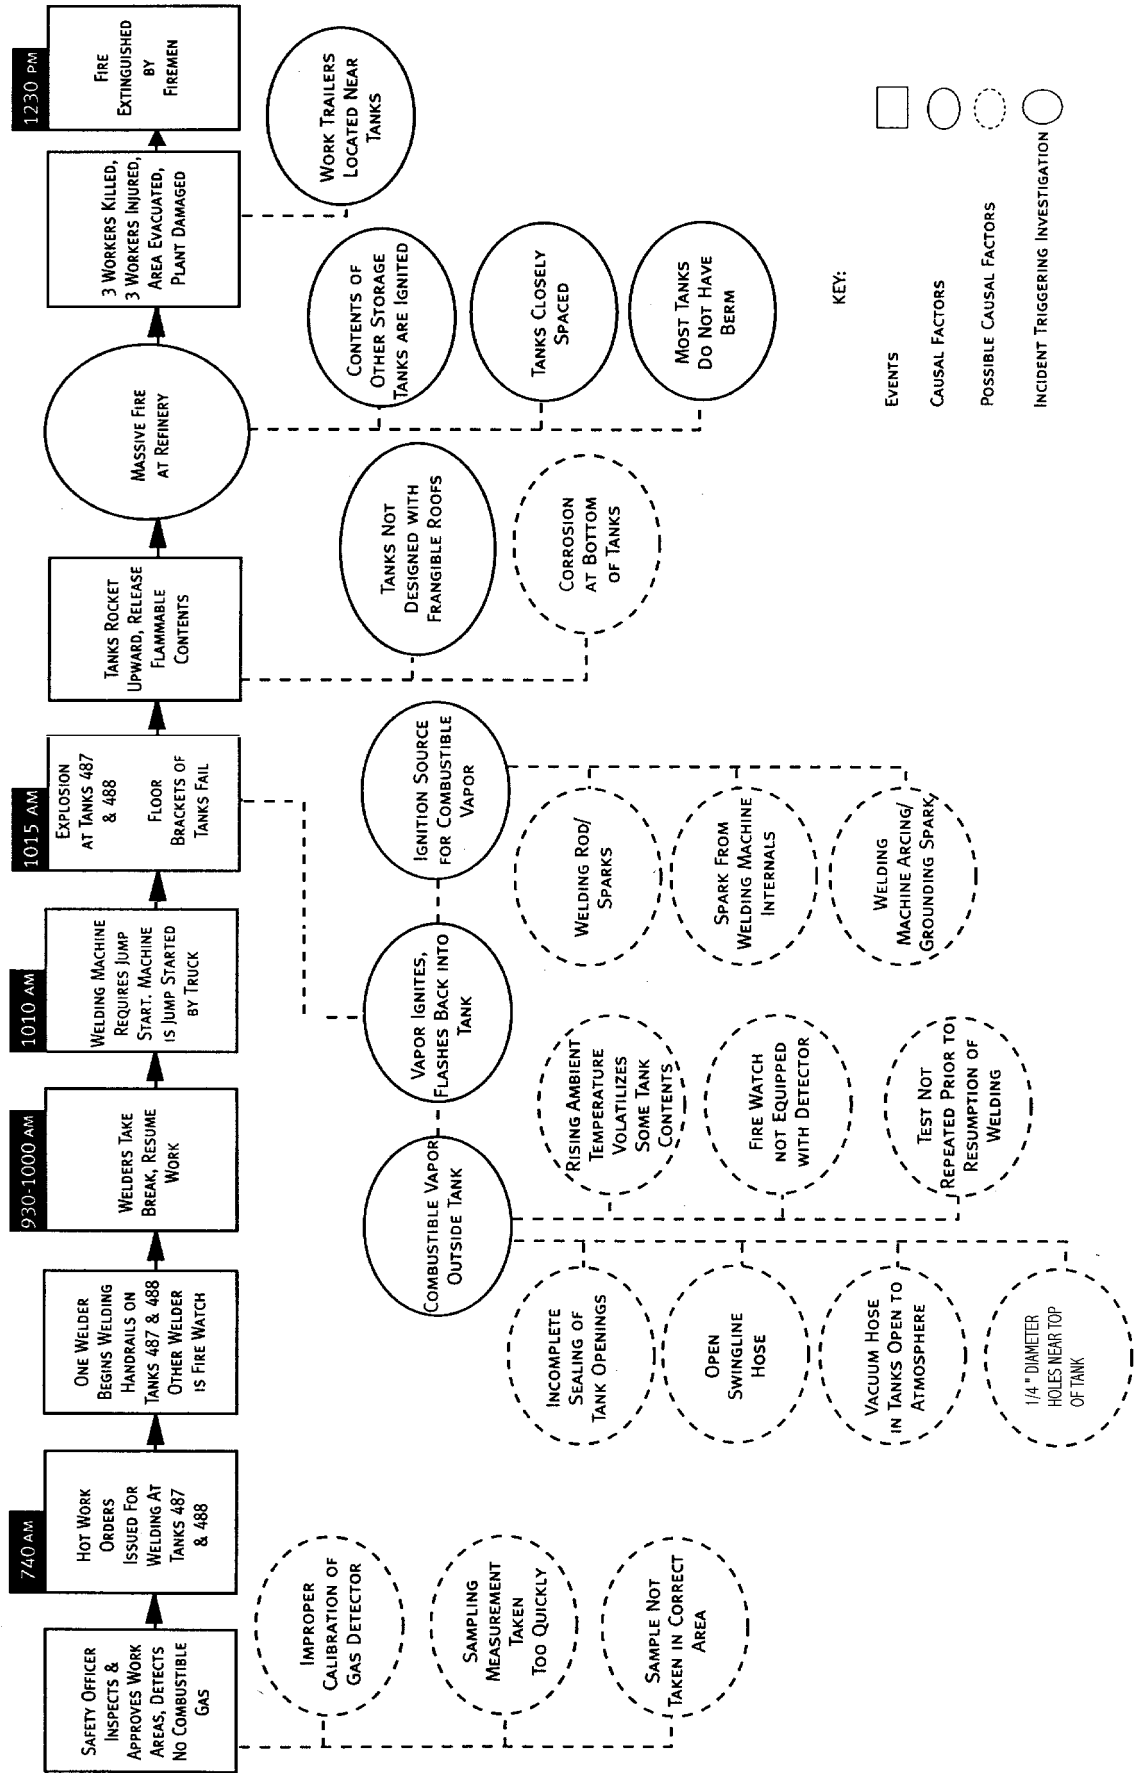
EXHIBIT 6  
 EVENT AND CAUSAL FACTORS DIAGRAM  
 OCTOBER 16, 1995 EXPLOSION OF TANKS 487 & 488 AT  
 PENNZOIL REFINERY - ROUSEVILLE, PA

The CAIT used the information collected to develop an Event and Causal Factors Chart (described below). The Event and Causal Factors Chart combined with the factual information collected in addition to professional and engineering judgement were used to determine the causes of this accident.

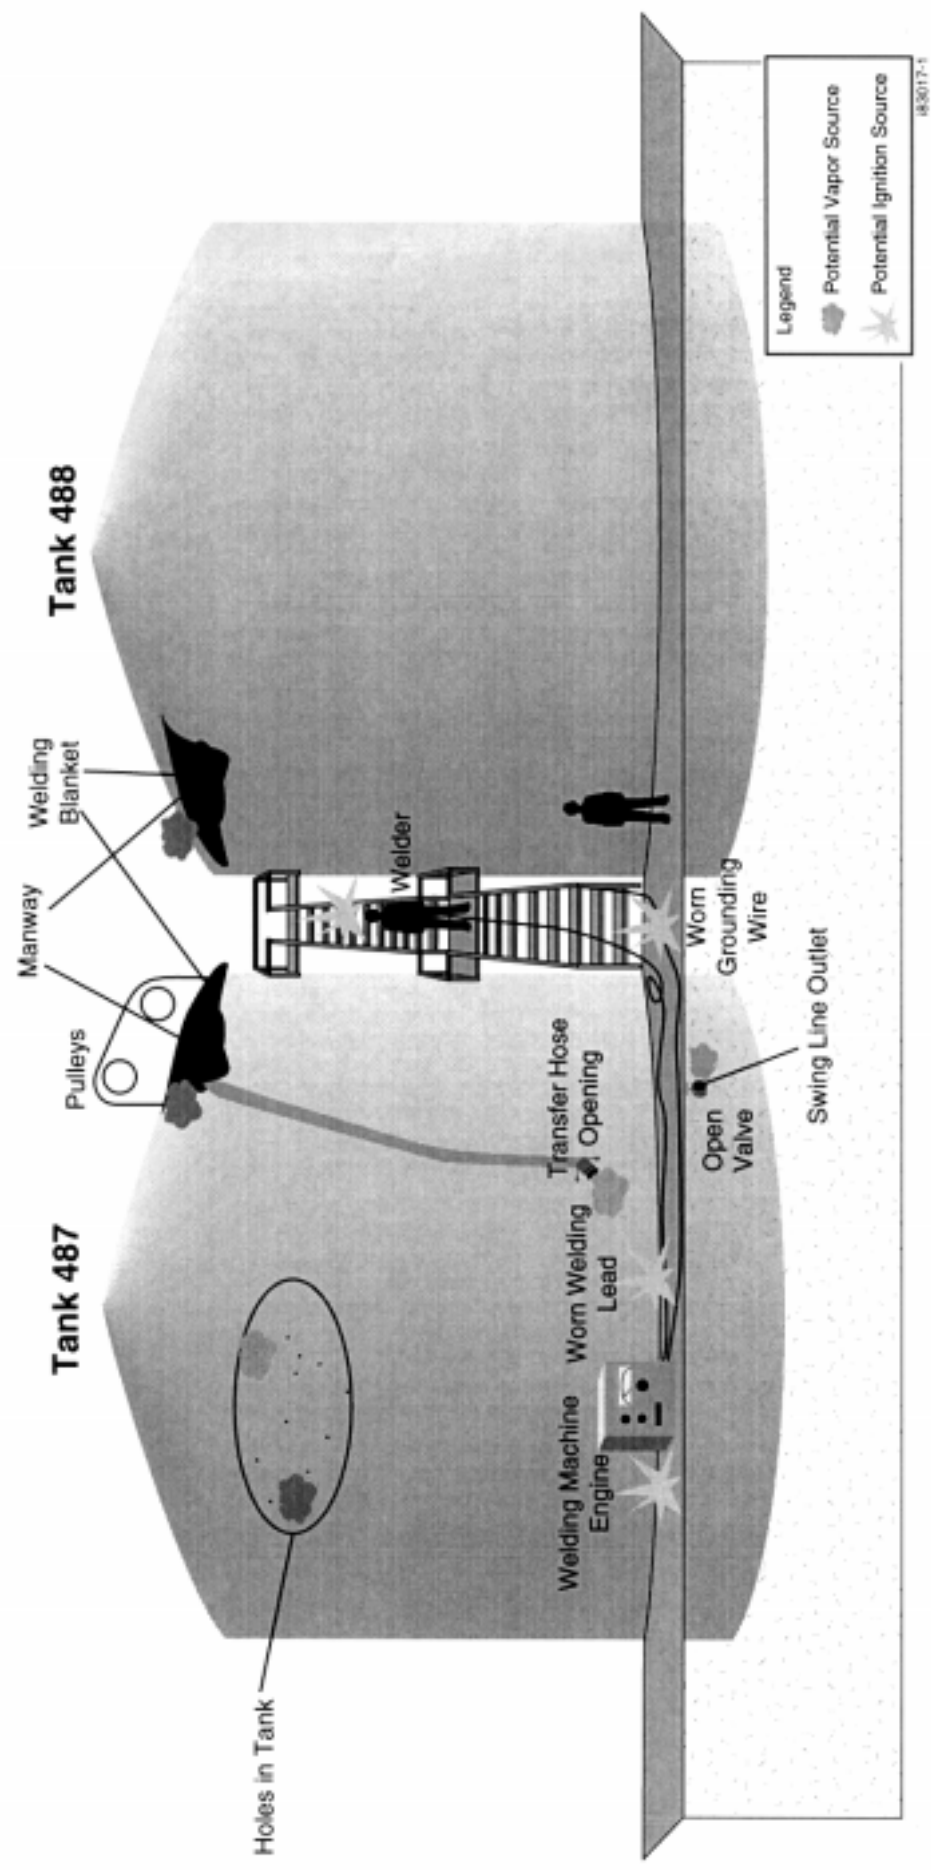
Exhibit 7  
Pennzoil Tank Explosion:  
Potential Vapor and Ignition Sources at Tanks 487 & 488

**Vapor Escaping from Swingline.** The swingline could have provided a route for vapor release (see Exhibit 7). The swingline portion inside the tank was raised above the liquid level in the tank vapor space. Investigators found after the accident that the outside valve near the base of the tank connected to the swingline inside the tank was open. As above, as the tank warmed, if sufficient driving force was present, undiluted heavier-than-air flammable vapors could have been pushed out through the swingline and open valve. If there was little or no wind, these dense vapors could have collected at grade level near ignition sources (see below). After ignition, the flame front could have flashed back through the swingline, igniting vapors in the tank. However, the end fitting on the swingline valve outside the tank was buried under the soil. Further, inspection of the inside of the swingline, after the accident, revealed no evidence of burn or scorch marks.

- The welding rod or sparks from hot slag or spatter possibly could have caused ignition of vapors present, if welding had been started (see Exhibit 7 for employee accounts of the position of the welder). During welding, flux coating the welding rod burns off. The welding rod being used by the welder was found after the accident and inspection revealed that flux on the tip was not burned off; however, there could have been an instantaneous arc, which could have caused ignition, but could have been of such short duration that the flux was not burned off. Or, the welding gun may have been dropped or kicked against the stairway causing an arc. However no evidence was discovered (e.g. arc marks) to support this scenario. Flammable and combustible materials are often ignited during hot work; generally, the material ignited is in the equipment being worked on. It is relatively rare for hot work to ignite a vapor cloud (Lees, 1996).
