EPA/OSHA JOINT CHEMICAL ACCIDENT INVESTIGATION REPORT

Shell Chemical Company Deer Park, Texas

Accident Investigation Report Shell Chemical Company, Deer Park, TX, June 22, 1997

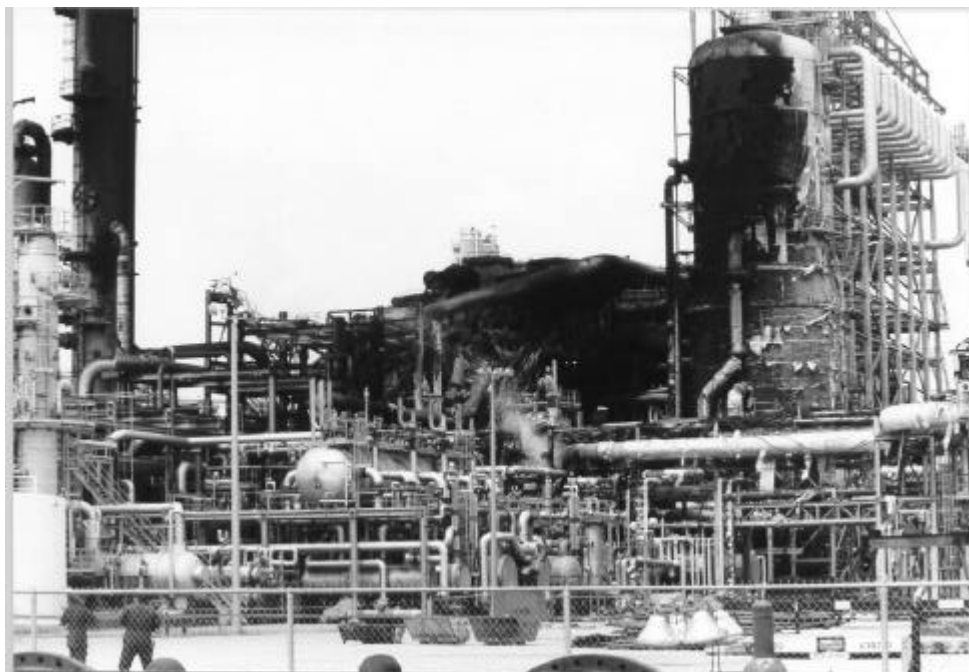
Figure E-1: Photograph of the damage resulting from the explosion and fire at Shell Olefins Plant Number 3 (view from west of blast area). Note the heavy structural damage in the rear center of the photograph.

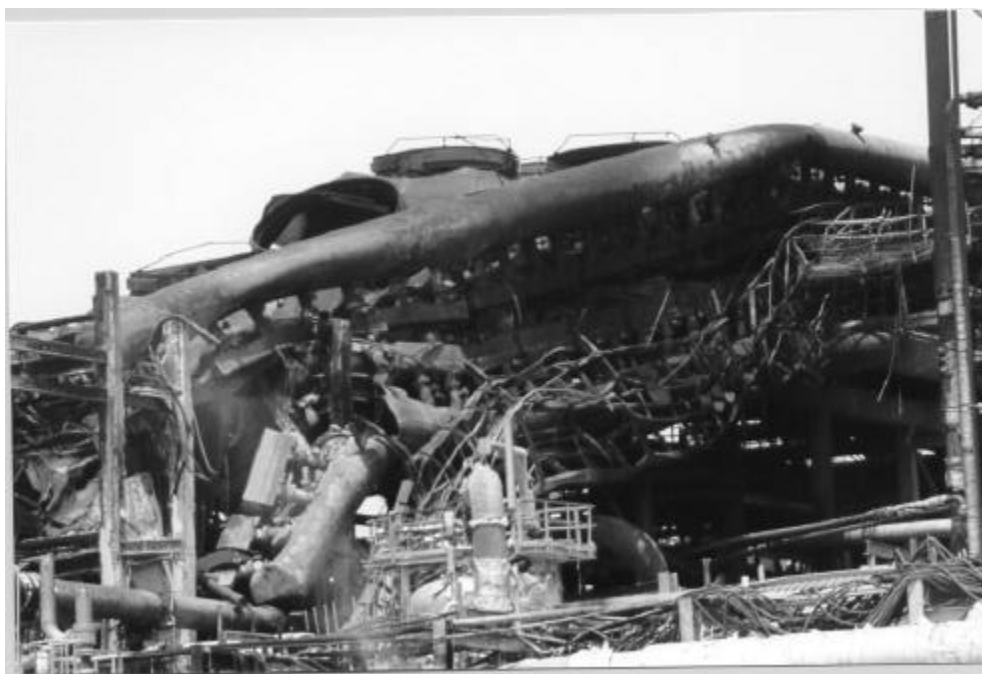
Figure E-2: Close-up of OP-III damage. The structure supporting the overhead cooling fans melted due to the intense heat of the fire and collapsed on top of the pipe rack.

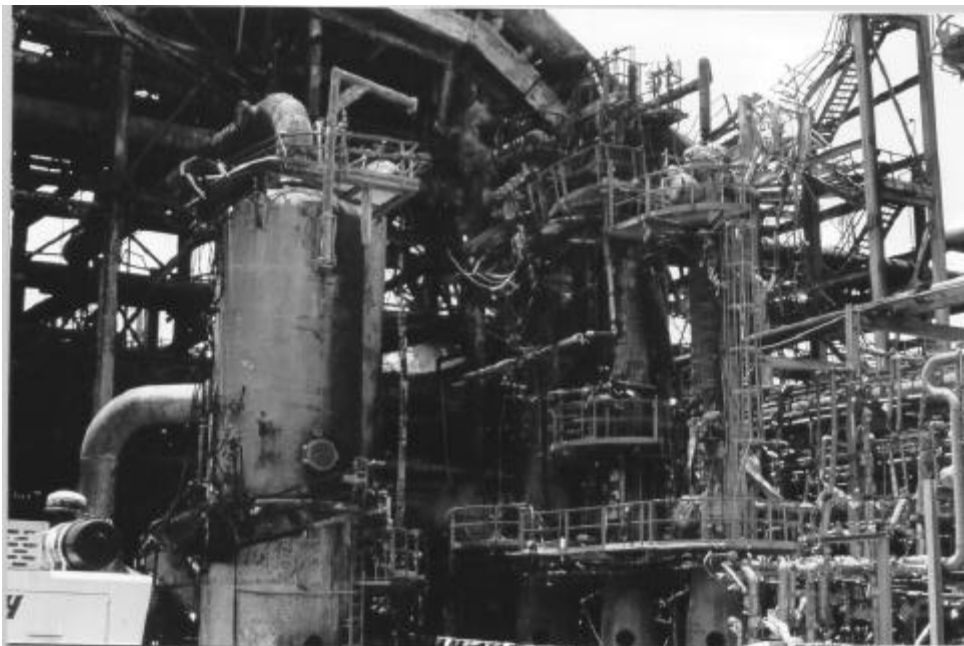
Figure E-3: Photograph of explosion and fire damage at OP-III as seen from the north side of the blast zone.

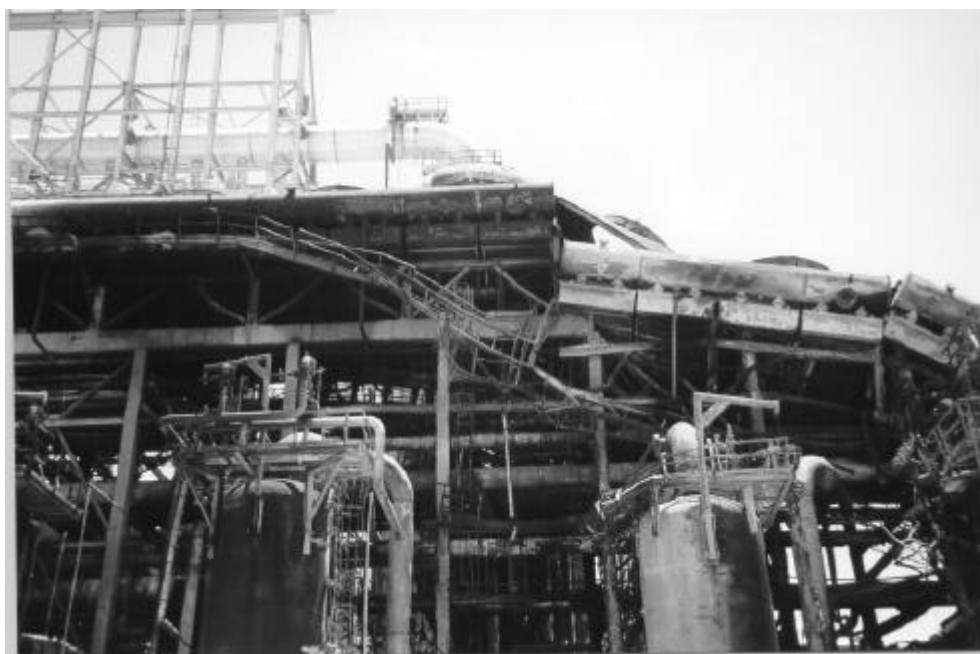
Figure E-4: Photograph of explosion and fire damage at OP-III as seen from north side of pipe rack, looking upward.

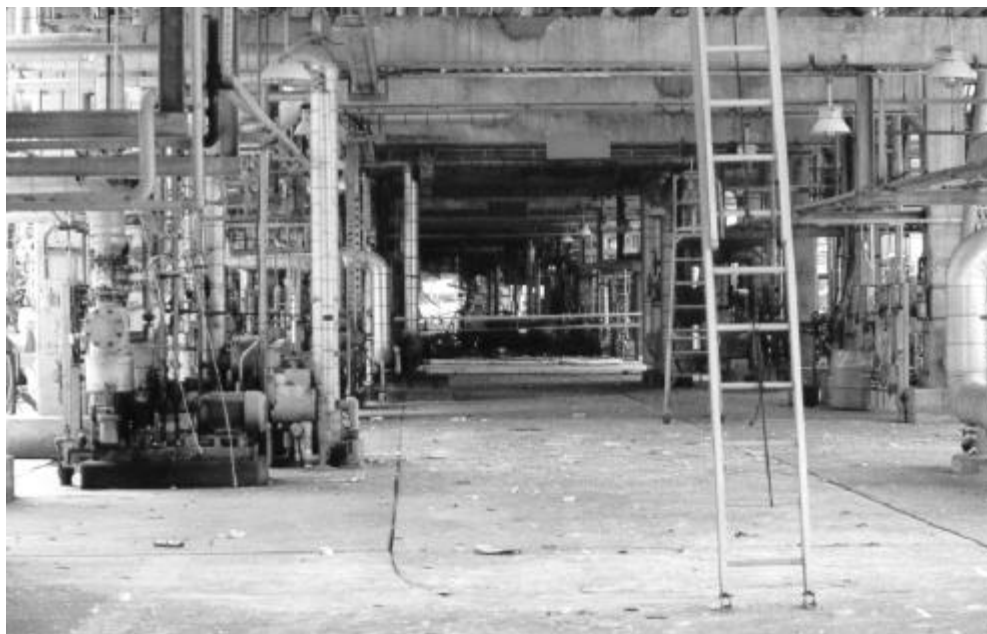
Figure E-5: Photograph looking down pipe alley (passable area underneath pipe rack) where explosion occurred.

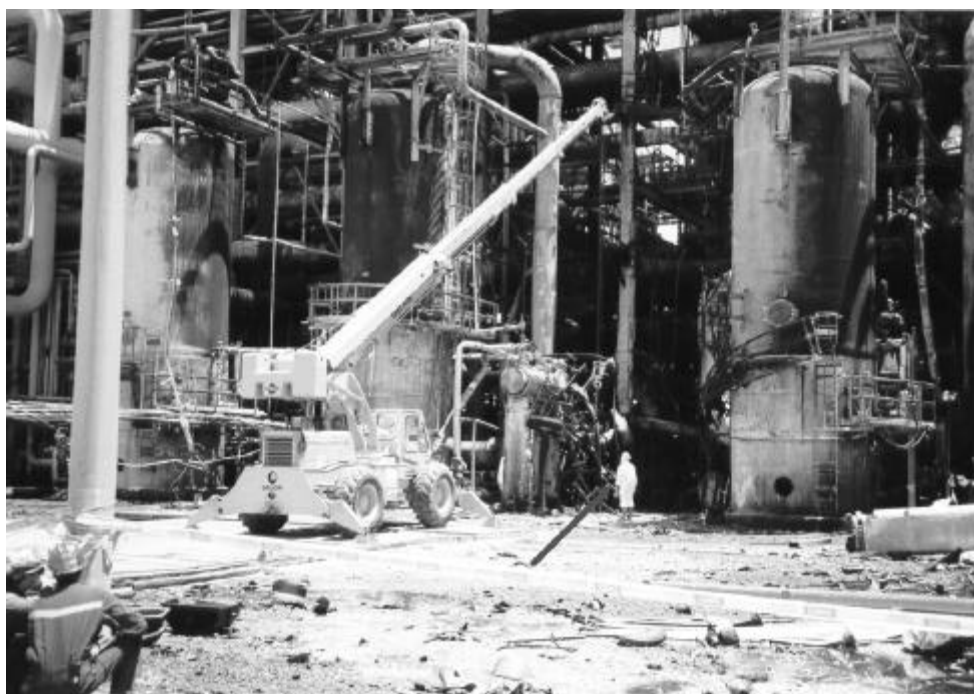
Figure E-6: Photograph of explosion and fire damage in the area of the PGC fifth stage suction and discharge drums (viewed from the north). The man in the lower center provides a reference to the scale of the surrounding structures. The failed check valve was located behind the drum to the man's right.

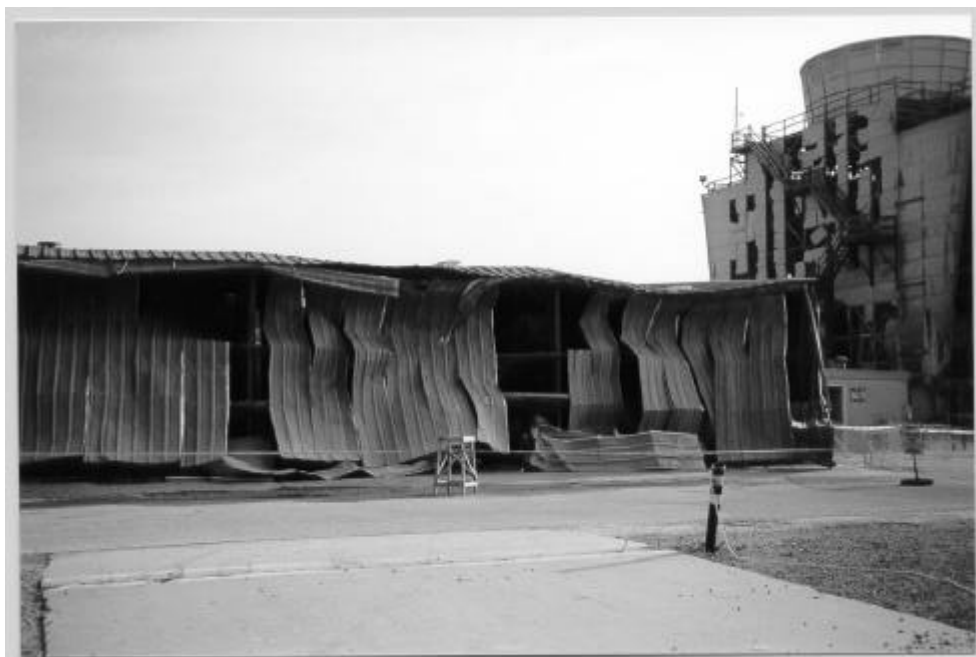
Figure E-7: Photograph of blast damage to buildings and structures in the vicinity of the explosion. Note the buckled metal walls of the storage building in the center and the panels missing from the cooling tower on the right. These buildings were located approximately 500 feet north of the blast center.

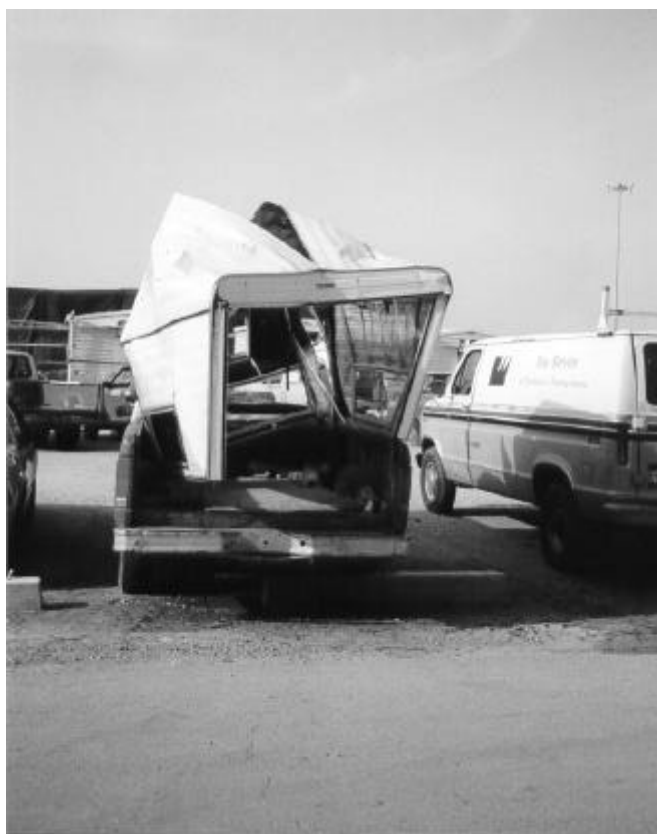
Figure E-8: Photograph of damage to a pickup truck parked near the blast site. Most automobiles parked in this company lot during the accident suffered damage.

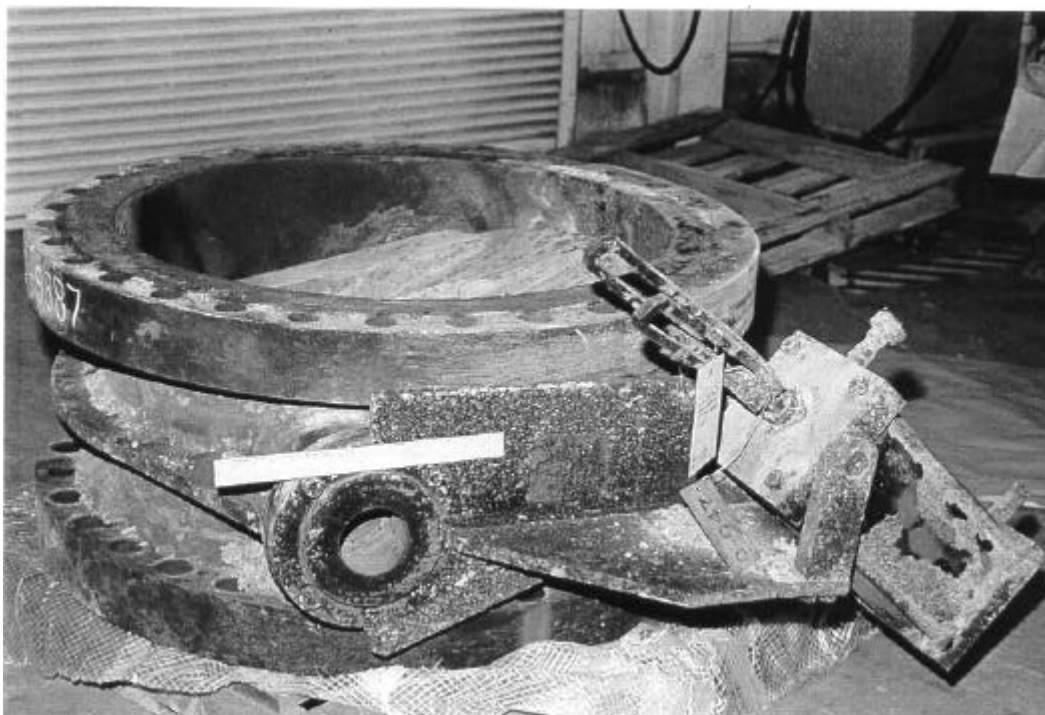
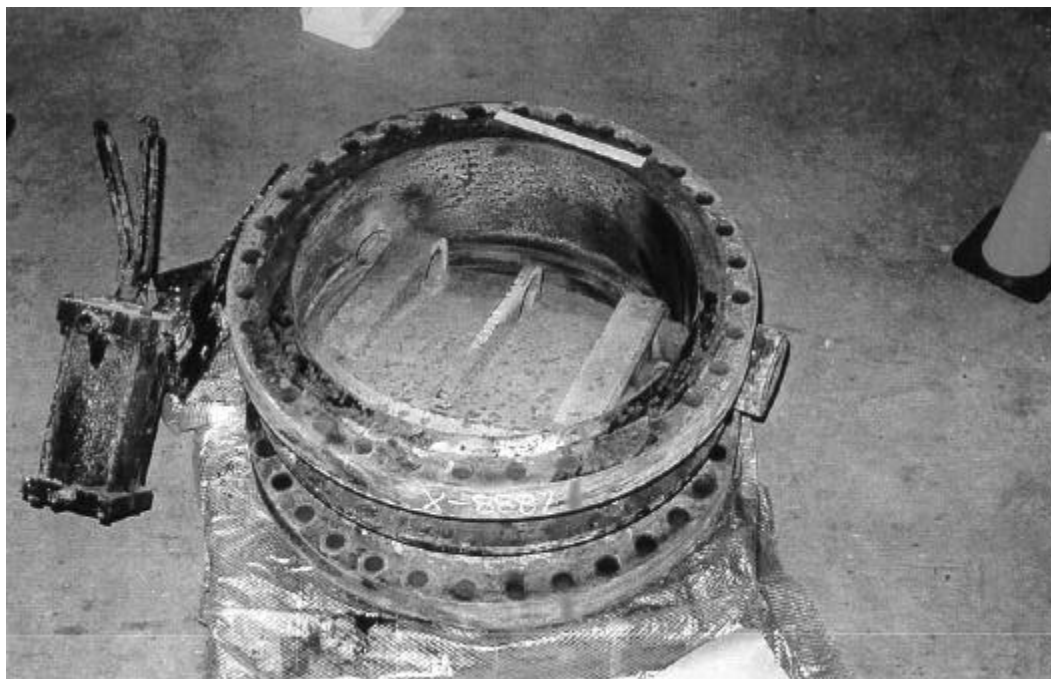
The JCAIT determined that the immediate cause of the accident was the internal structural failure and drive shaft blow-out of a 36-inch diameter pneumatically-assisted Clow Model GMZ check (non-return) valve. The valve was located on a high-pressure light hydrocarbon gas line installed in the process gas compression (PGC) system of Olefins Plant Number III (OP-III). The check valve's failure started a large flammable gas leak. The escaping gas formed a vapor cloud and eventually ignited, resulting in an unconfined vapor cloud explosion.

Figures E-9 and E-10: Photographs of two views of the disassembled subject 36" Clow check valve. The pneumatic actuator assembly can be seen in both views. In the lower photograph, the hole directly below the 12-inch ruler formerly contained the valve's drive shaft. This is where the shaft blow-out and flammable gas release occurred.

- Prior to restarting OP-III, Shell Chemical Company should replace all Clow Model GMZ check valves installed in the unit with valves not susceptible to shaft blow-out. Other Shell facilities and other companies as appropriate should review their process systems to determine if they have valves installed that may be subject to this hazard, and modify or replace those valves as necessary to prevent shaft blow-out. Companies should consult valve manufacturers or other appropriate design authorities to ensure any modifications made are safe. [Editor's note: Prior to this report being published, Shell Chemical Company replaced all Clow Model GMZ check valves installed in OP-III with valves not susceptible to shaft blow-out.]

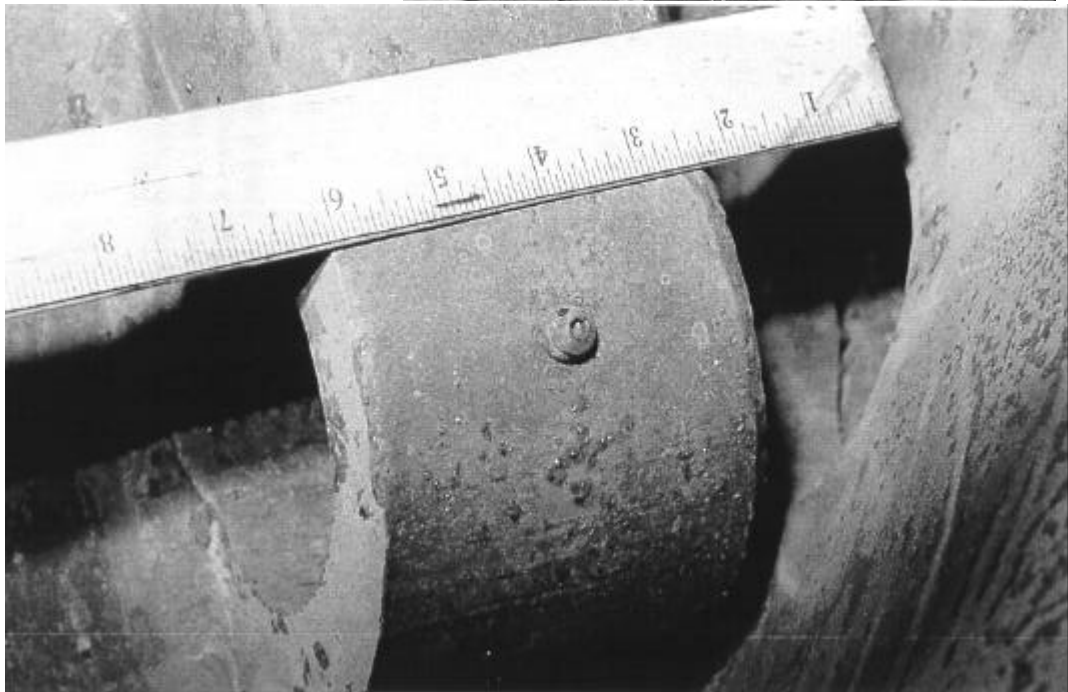
Figure E-12: Photograph shows the head of the machine screw protruding from the portion of the fractured pin. The pin is shown extended slightly out from the surface of the flange, or disk "ear", from which the valve shaft was ejected.

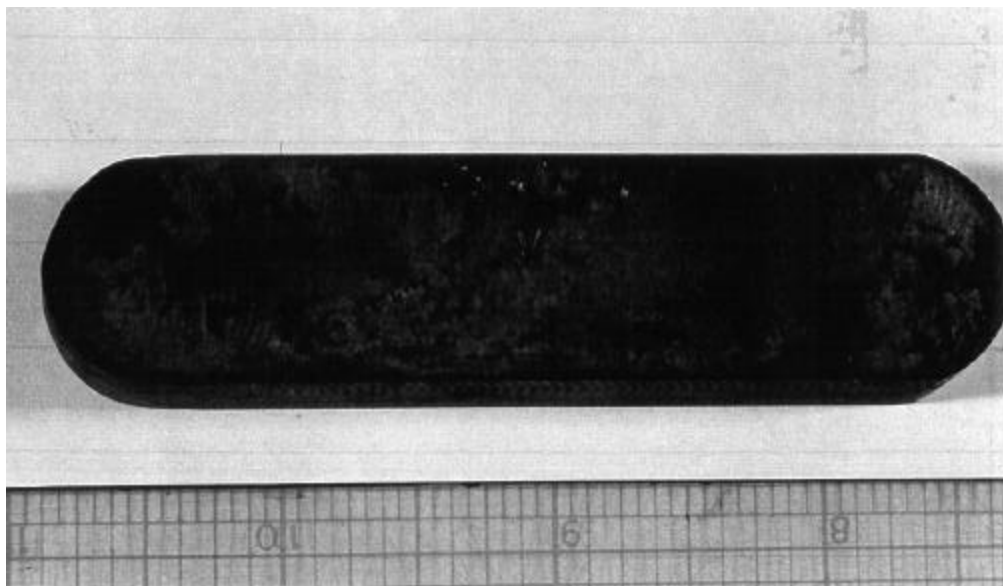
Figure E-13: Photograph shows the metal key intended to help mechanically connect the drive shaft to the valve disk.

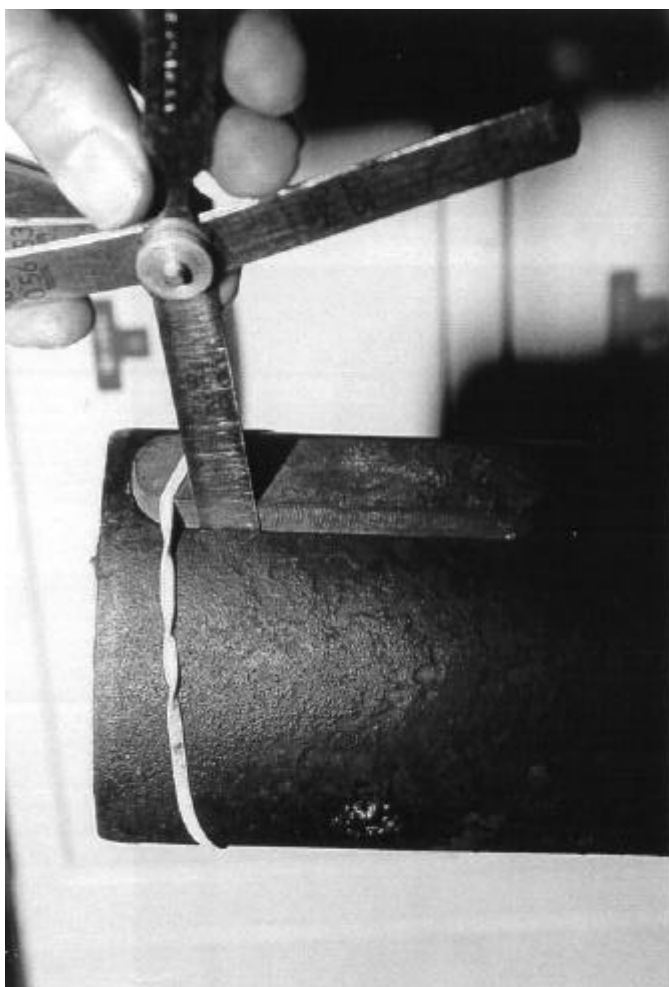
Figure E-14: Photograph depicts the measured looseness of the key within its machined slot, or keyway. The key was intended to transfer torque between the shaft and the valve disk, but the key's loose fit forced the much smaller dowel pin to transfer virtually all drive shaft torque. The key eventually fell out of its slot as the drive shaft moved outward after the dowel pin fractured.

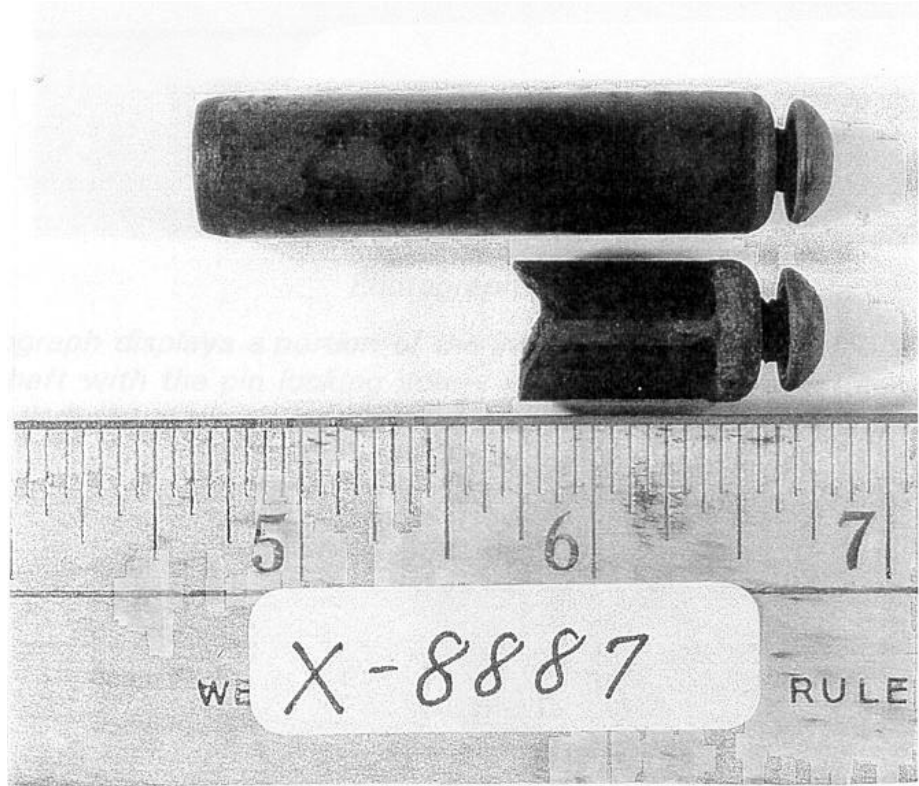
Figure E-15:
Photograph shows the general configuration of the intact dowel pin removed from the idler shaft, and a portion of the fractured pin. Both pins exhibit the threaded machine screws, which were placed in holes drilled in the center of each pin to allow later pin removal.

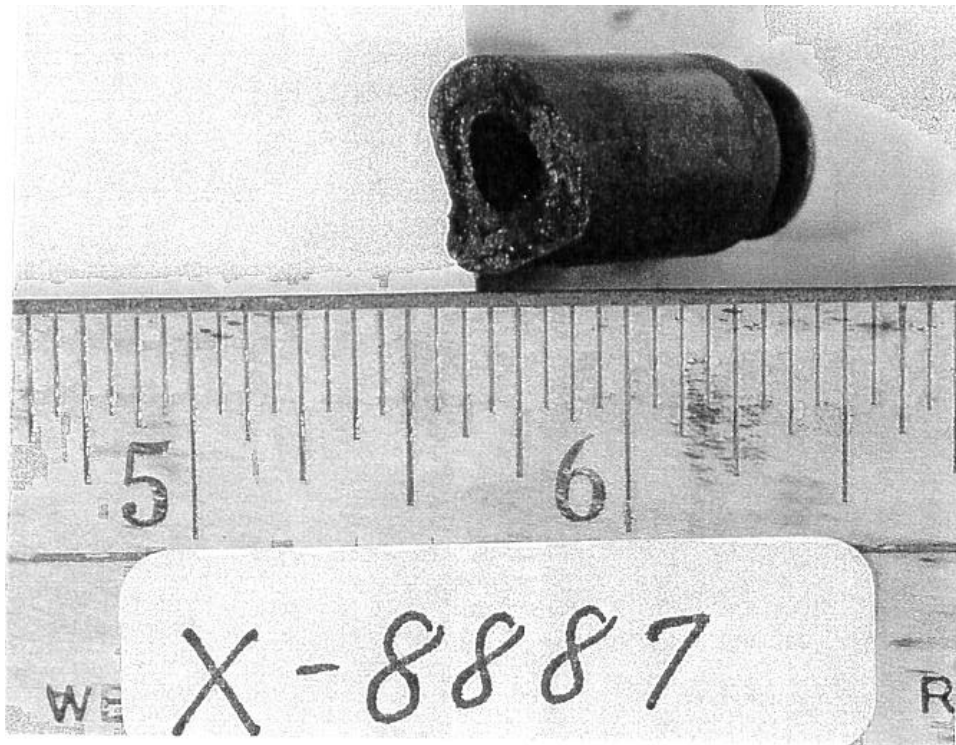
Figure E-16:
Perspective view of the fractured dowel pin showing the fracture face extending through the drilled hole within the center of the pin.

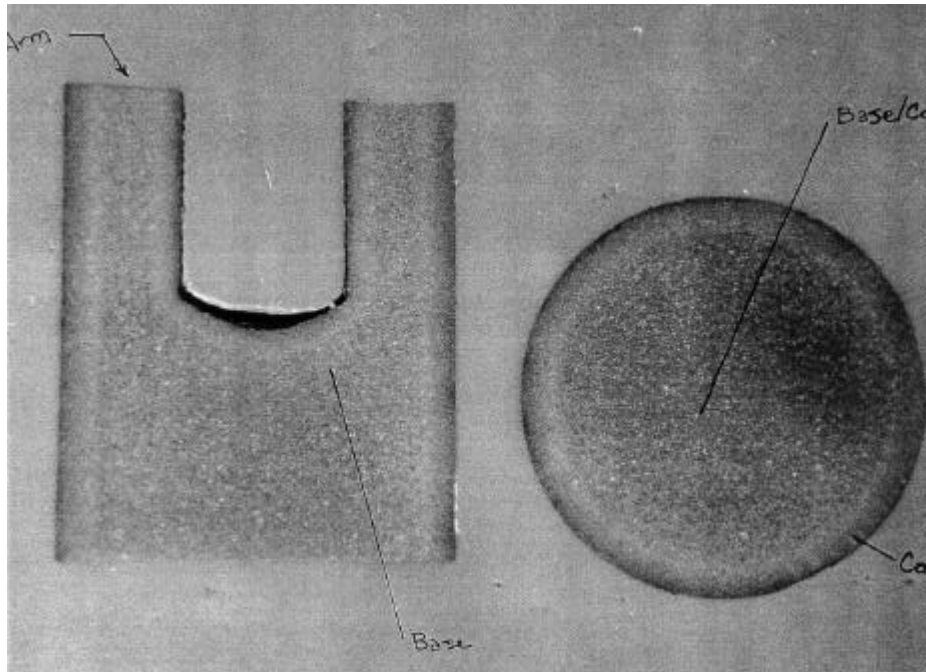
Figure E-17: Views of the longitudinal and transverse cross-sections taken through the intact dowel pin showing the carburized case at both the outside diameter of the pin and within the drilled hole.

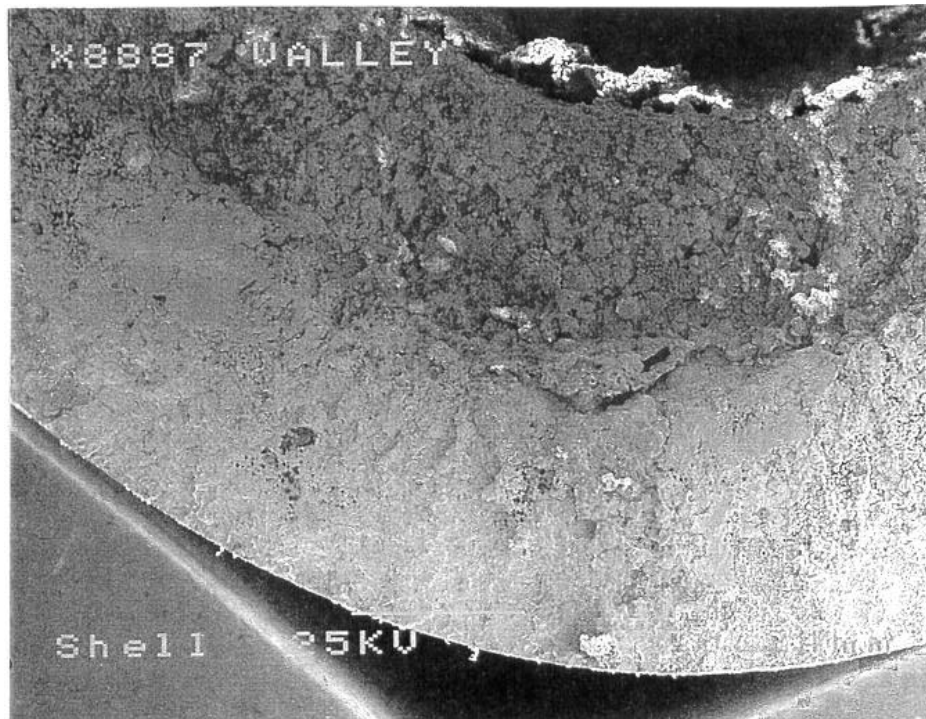
Figure E-18: 25X magnification fractograph displaying a portion of the fracture face of the dowel pin which broke in the service of the 36" Clow check valve.

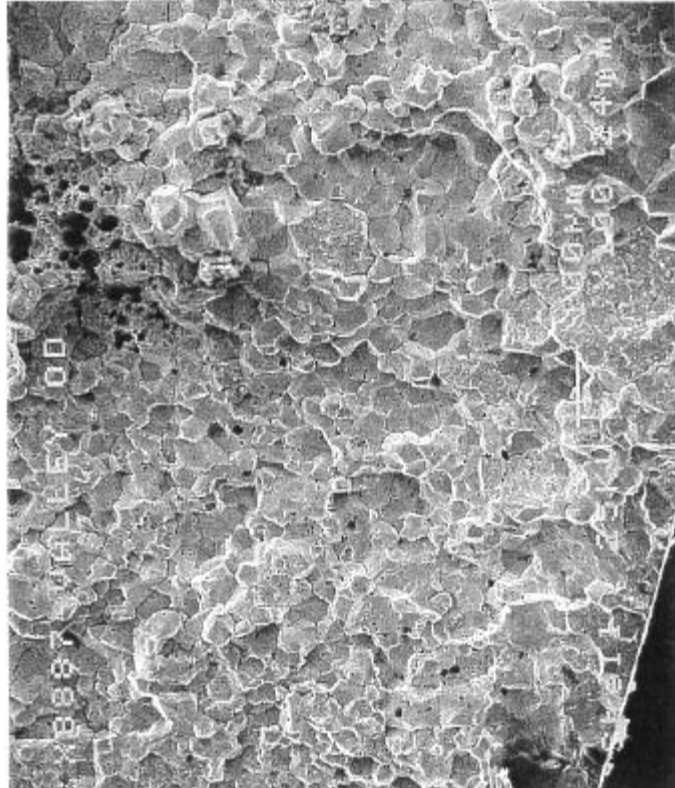
Figure E-19: 100X magnification scanning electron microscope (SEM) fractograph depicting the intergranular fracture at the carburized surface of the dowel pin.

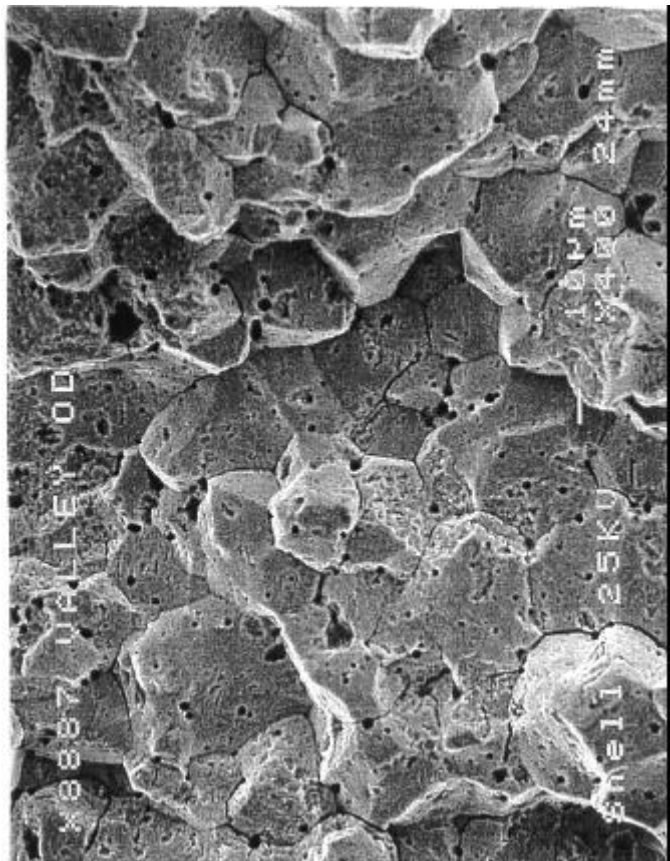
Figure E-20: 400X magnification SEM fractograph of the dowel pin shows details of the intergranular “rock candy” fracture surface at the outside diameter of the dowel pin, a characteristic of hydrogen embrittlement failure mode.

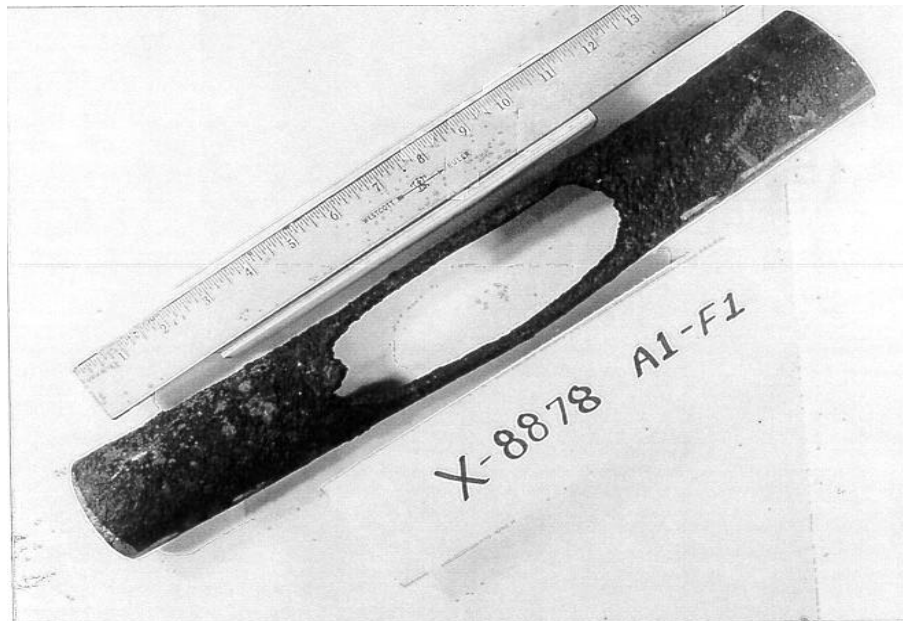
Figure E-21: A view of pipe section X-8878, one of four pipe sections removed from OP-III in addition to the Clow check valve for laboratory analysis as possible sources of the initial flammable gas leak.

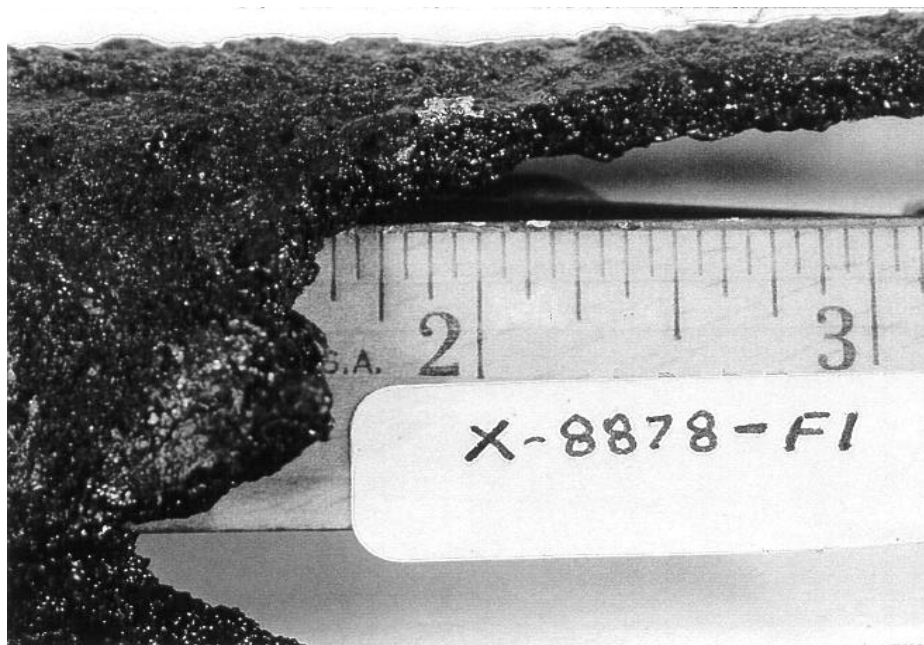
Figure E-22: At higher magnification, this macrograph shows the high temperature oxidation and fire damage around the opening in the pipe section. Laboratory analysis of this and each of the other three pipe sections revealed similar fire-induced failure modes, indicating that none were the likely source of the initial flammable gas leak.
