EPA/OSHA JOINT CHEMICAL ACCIDENT INVESTIGATION REPORT

**Surpass Chemical Co., Inc.
Albany, NY**

Accident Investigation Report
Surpass Chemical Company, Inc., Albany, New York, April 8, 1997

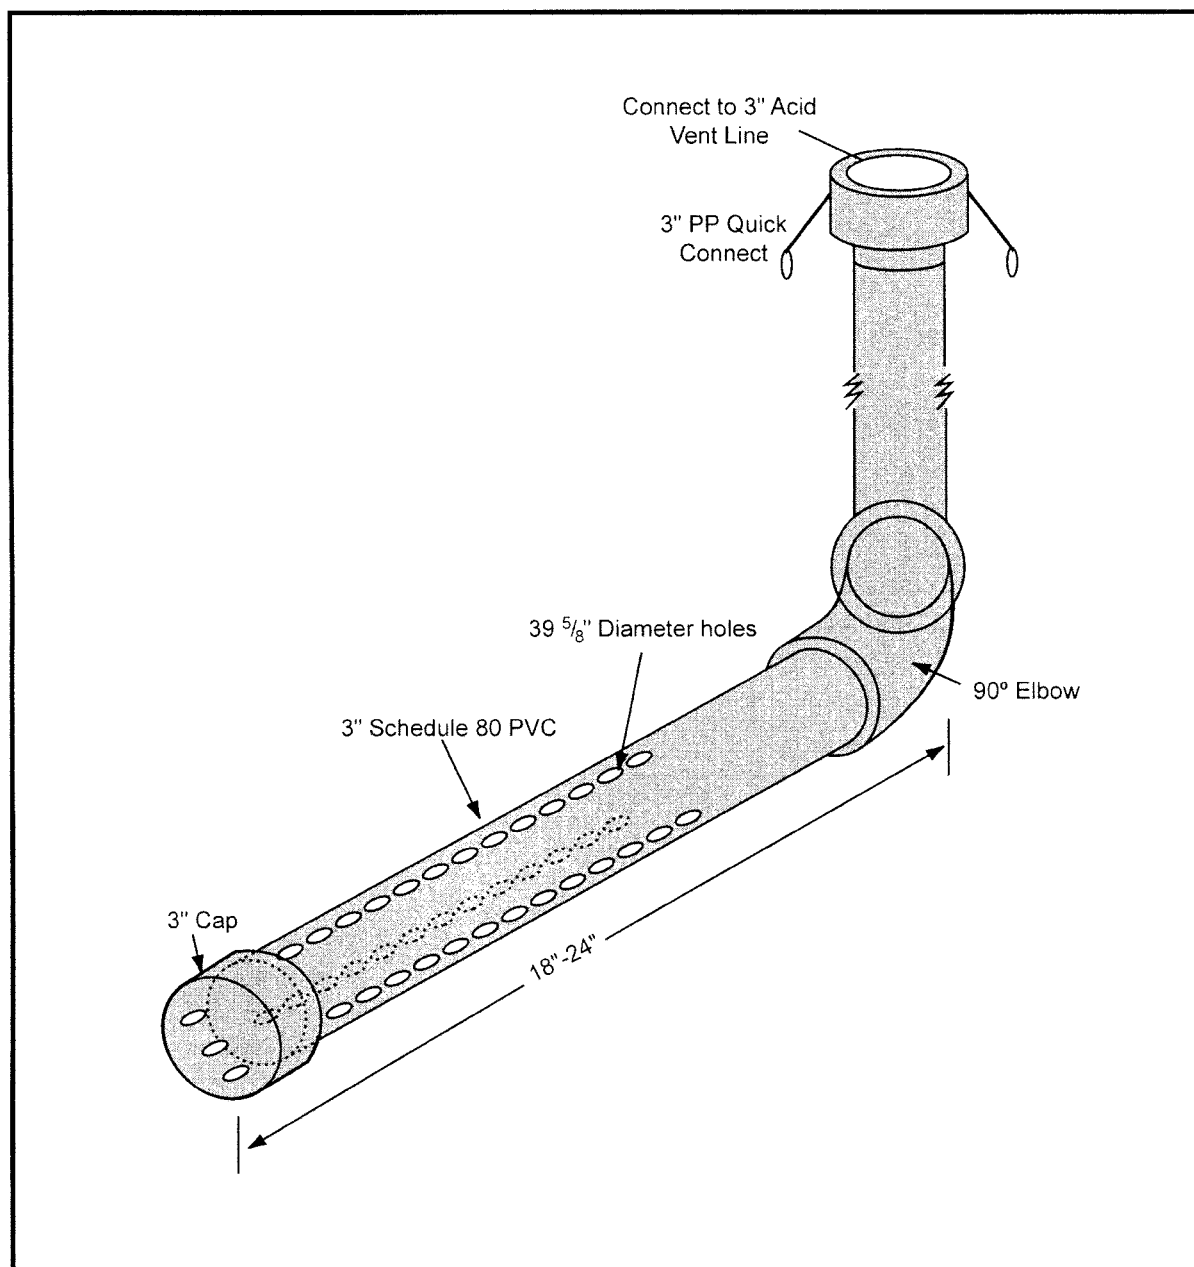
Figure 3: Diffuser Section of Vent System
(not to scale)

Inadequate maintenance permitted the diffuser section to become clogged with solids, further reducing the scrubber's capacity to vent the pressure buildup in the HCl tank. Surpass had no written procedure for maintaining or inspecting the scrubber system. Maintenance procedures would have been improved by developing detailed procedures for testing and adjusting the scrubber solution--including the frequency of tests, the parameters (pH, specific gravity, etc.) to be measured, and the acceptable range of those parameters. Maintenance results should be documented in order to provide a historical basis for revising the procedures.

Surpass and other facilities should maintain environmental control systems to ensure continuous reliability and effective operation. Based on the system design, the known failure history, and engineering judgement, Surpass and similar facilities should evaluate how long the scrubber solution can be used before it needs to be replaced; develop detailed procedures for inspecting, testing, and adjusting the scrubber solution-- including the frequency of tests, the parameters (pH, specific gravity, etc.) to be measured, and the acceptable range of those parameters; and establish control mechanisms to ensure that preventive maintenance is performed correctly. Maintenance procedures should be written. Maintenance results should be documented in order to provide a historical basis for revising the procedures.

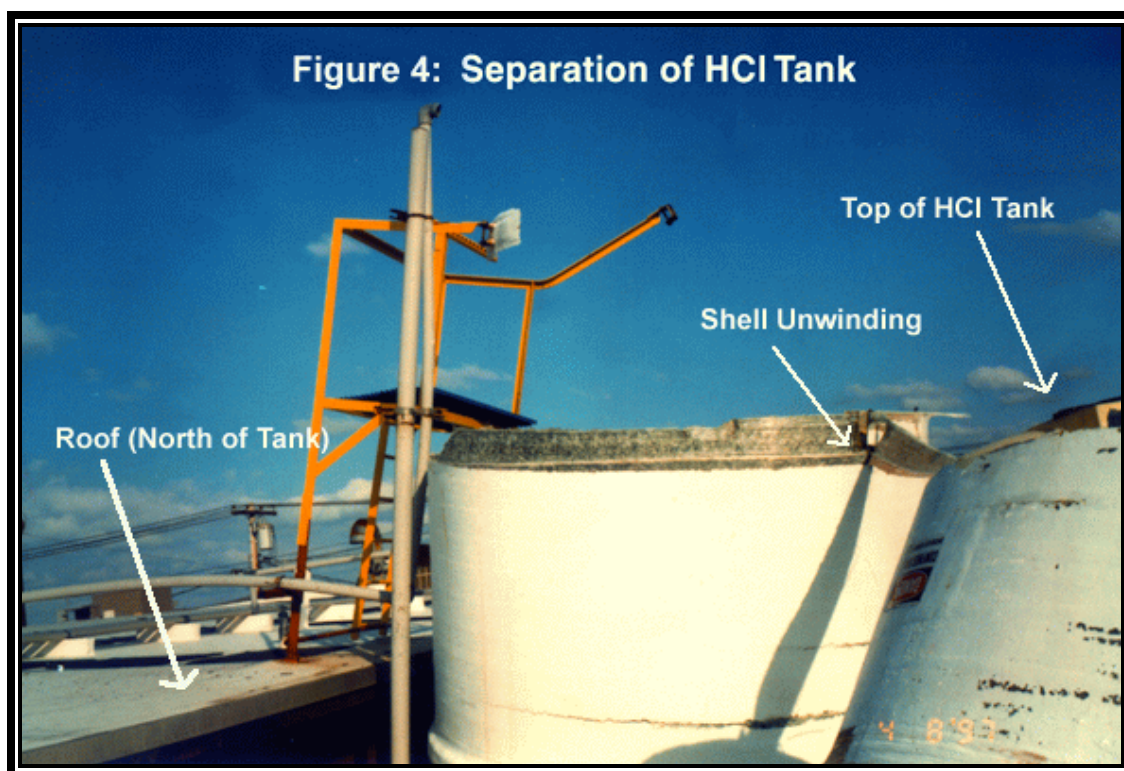
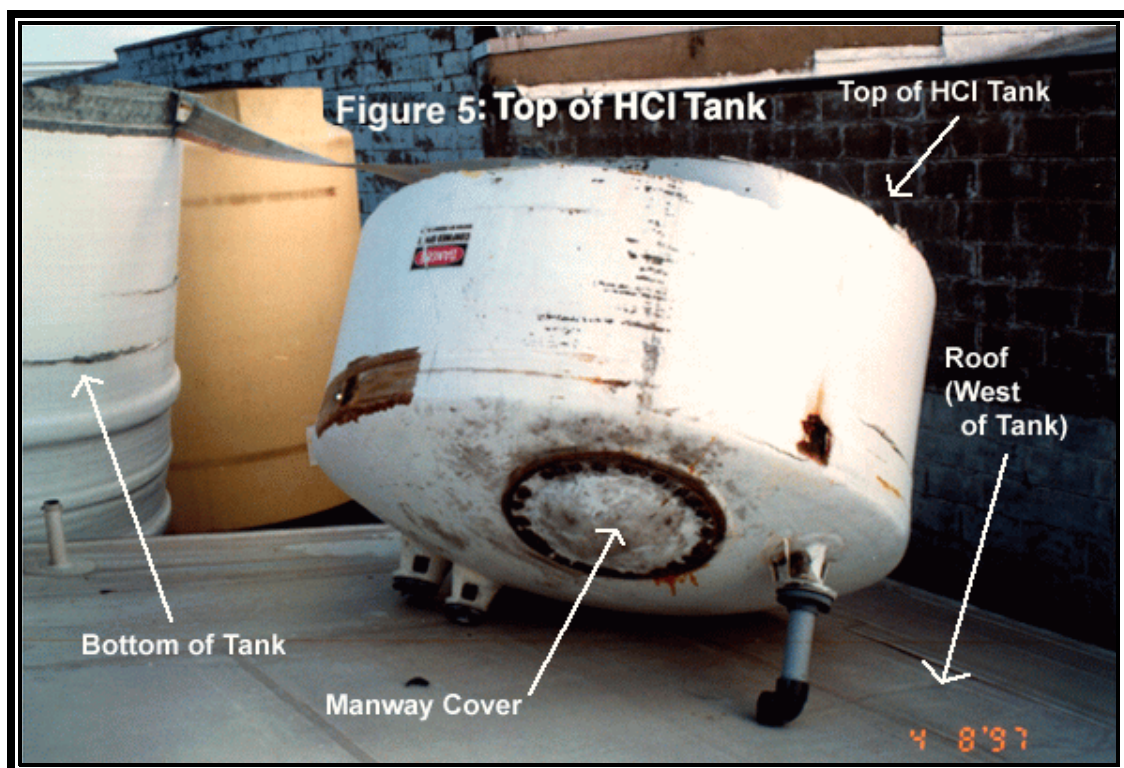
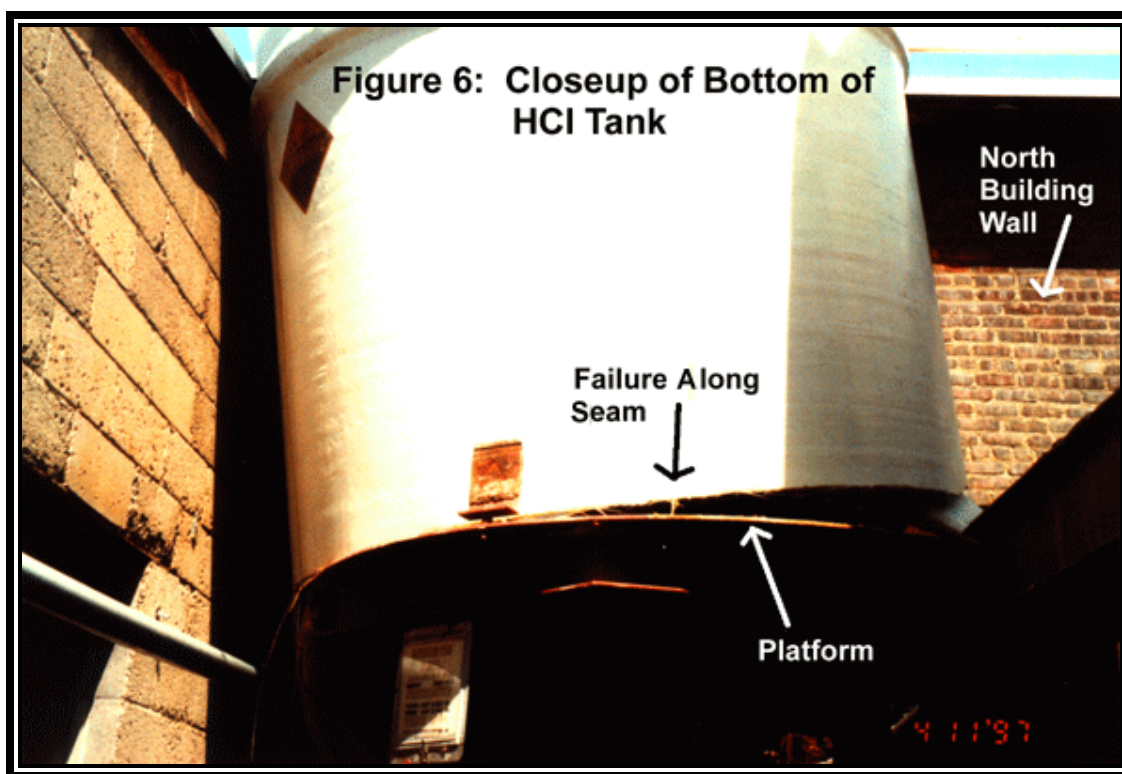
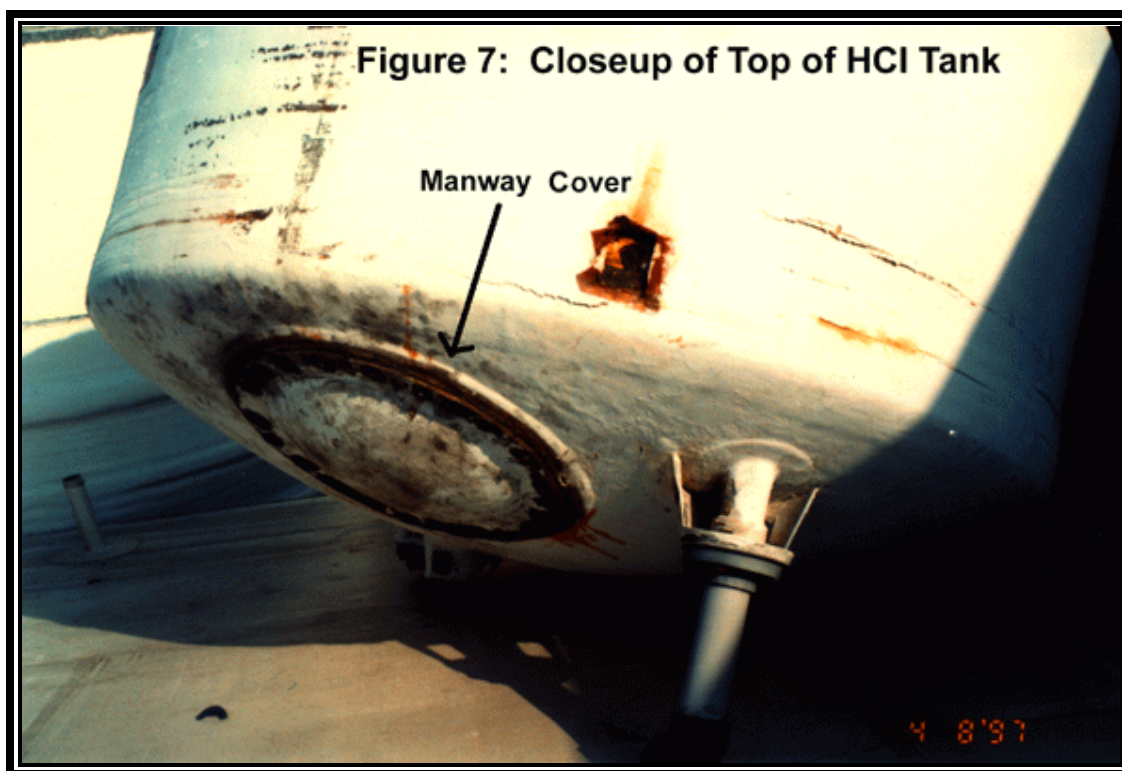
The HCl tank head separated at a point about 5 feet from the top of the tank and flew about 15 feet west to the roof of an adjacent building. **Figure 4** shows the separated tank after the incident, and **Figure 5** shows the top of the tank. The bottom of tank failed in the knuckle area where the cylindrical part of the HCl tank meets the flat bottom, as shown in **Figure 6**. The tank bottom remained on the platform. The cylindrical part of the fiberglass shell began to unwind itself at the top edge (see **Figures 4 and 5**). The shell also remained on the platform but collapsed, leaning toward the west building wall (see **Figure 6**). The scrubber tank was not affected by the tank failure; it was found intact in its original position after the incident, as shown in **Figure 7**.

At the time of rupture, the HCl tank contained about 4,800 gallons of material. The failure of the HCl tank caused a sudden surge of liquid over the secondary containment wall. The force of the liquid also caused a break in the masonry of the secondary containment wall. Surpass has estimated that as a result of this release, about 150 gallons were absorbed by soil within the property boundary and about 2,300 gallons entered storm drains located on Broadway. The storm drains emptied into an underground stream, the Patroon Creek, a tributary of the Hudson River. Surpass also estimated that 1,900 gallons were contained within the secondary containment dike and that 400 gallons entered a nearby building through a window in the north wall and through an exhaust fan in the west wall.

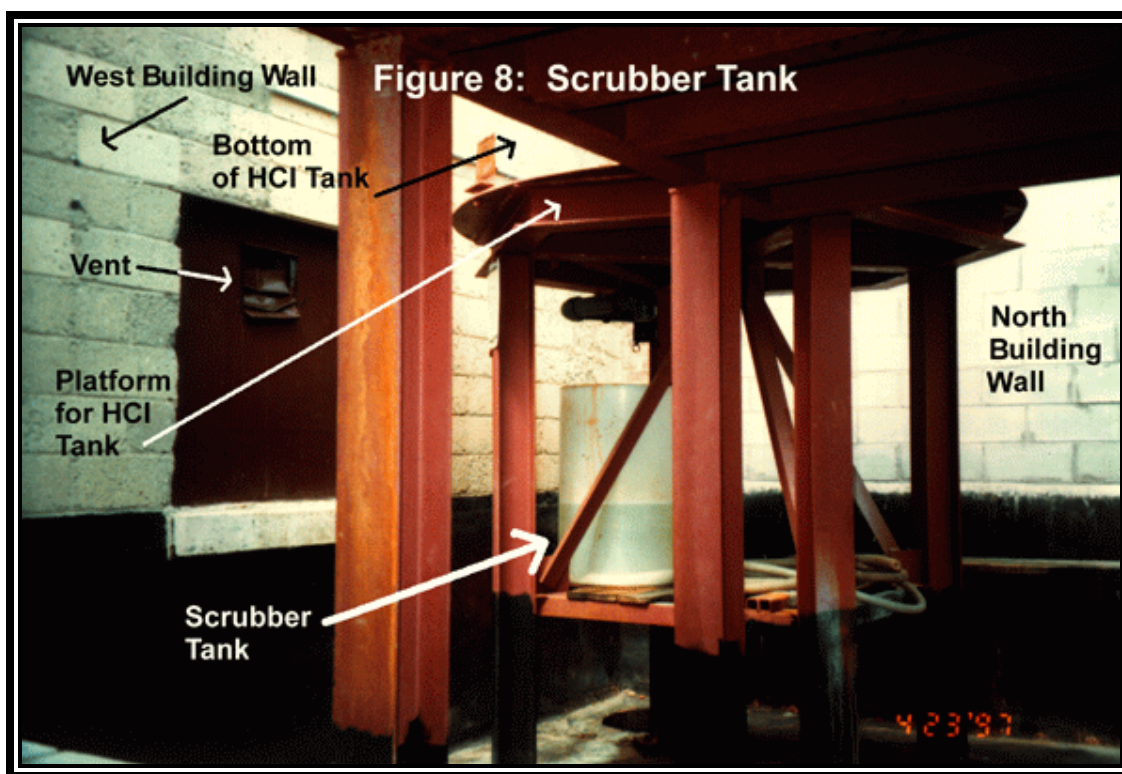
- The scrubber tank was not affected by the tank failure; it was found intact in its original position after the incident. (See **Figure 8**.)
- After the incident, the diffuser in the scrubbing tank was removed by disconnecting the vent line quick connect and removing the lid from the scrubber tank. The holes in the diffuser were found to be clogged with a white crystalline substance, as shown in **Figure 9**. This substance was sodium chloride, according to laboratory analysis.

- A layer of white crystalline material was also found in the bottom of the scrubber tank. This substance also was sodium chloride, according to laboratory analysis.

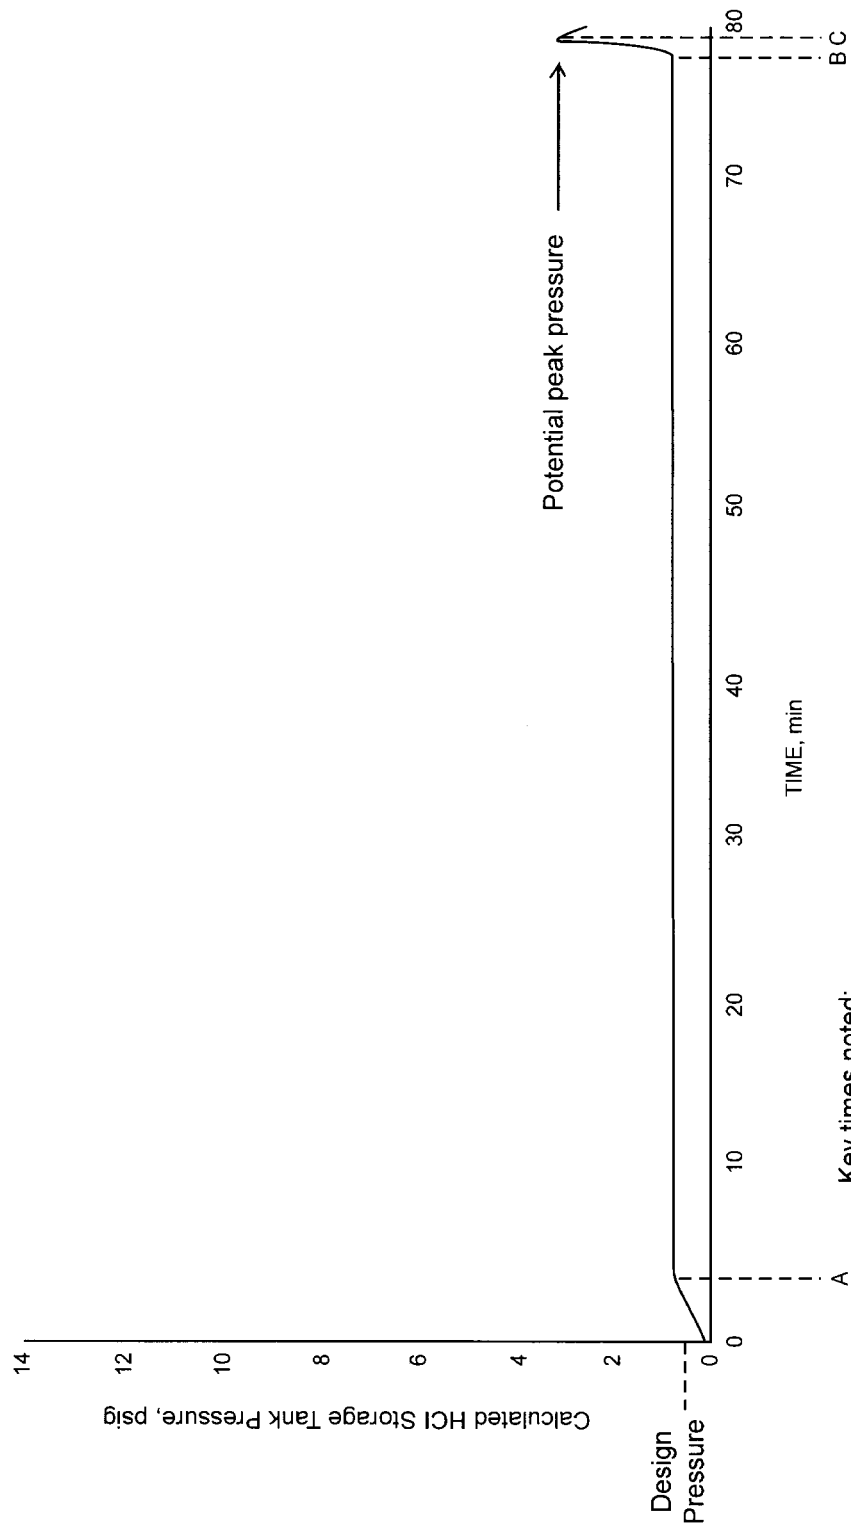
Figure 10
Modeled HCl Storage Tank Pressure
Scenario: No Fouling of Diffuser Openings

A - HCl storage tank pressure exceeds hydrostatic pressure of solution in scrubber tank.

C - Potential peak pressure as modeled for scenario.

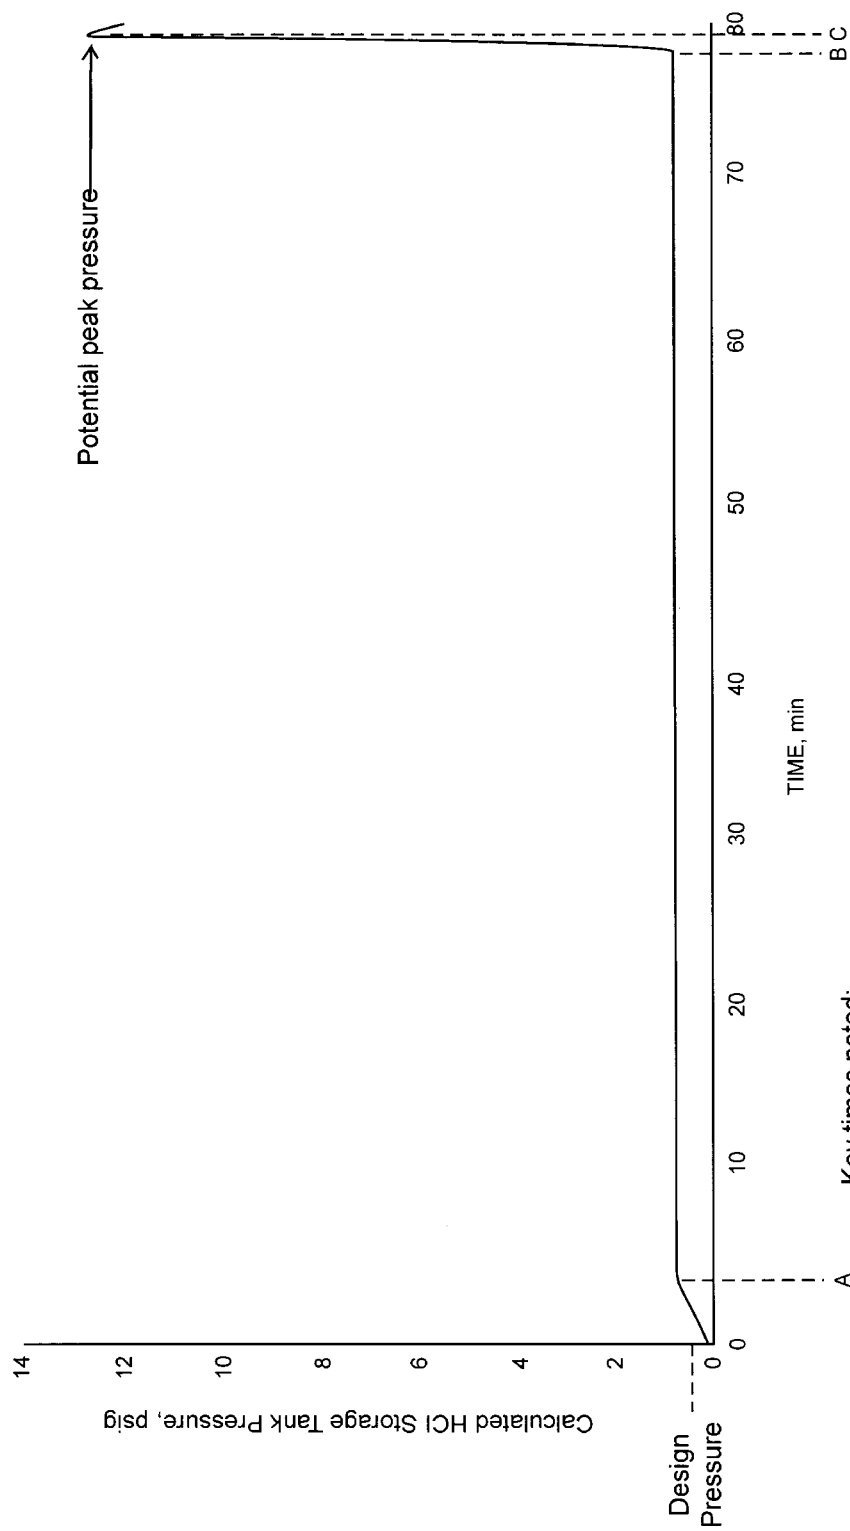
Figure 11
Modeled HCl Storage Tank Pressure
Scenario: 84% Fouling of Diffuser Openings

- A - HCl storage tank pressure exceeds hydrostatic pressure of solution in scrubber tank.
- B - Pressurized air from truck's cargo tank flows into HCl tank.
- C - Potential peak pressure as modeled for scenario.
