Tosco Avon Refinery Martinez, California

EPA550-R-98-009
November 1998

EPA Chemical Accident Investigation Report

**Tosco Avon Refinery
Martinez, California**

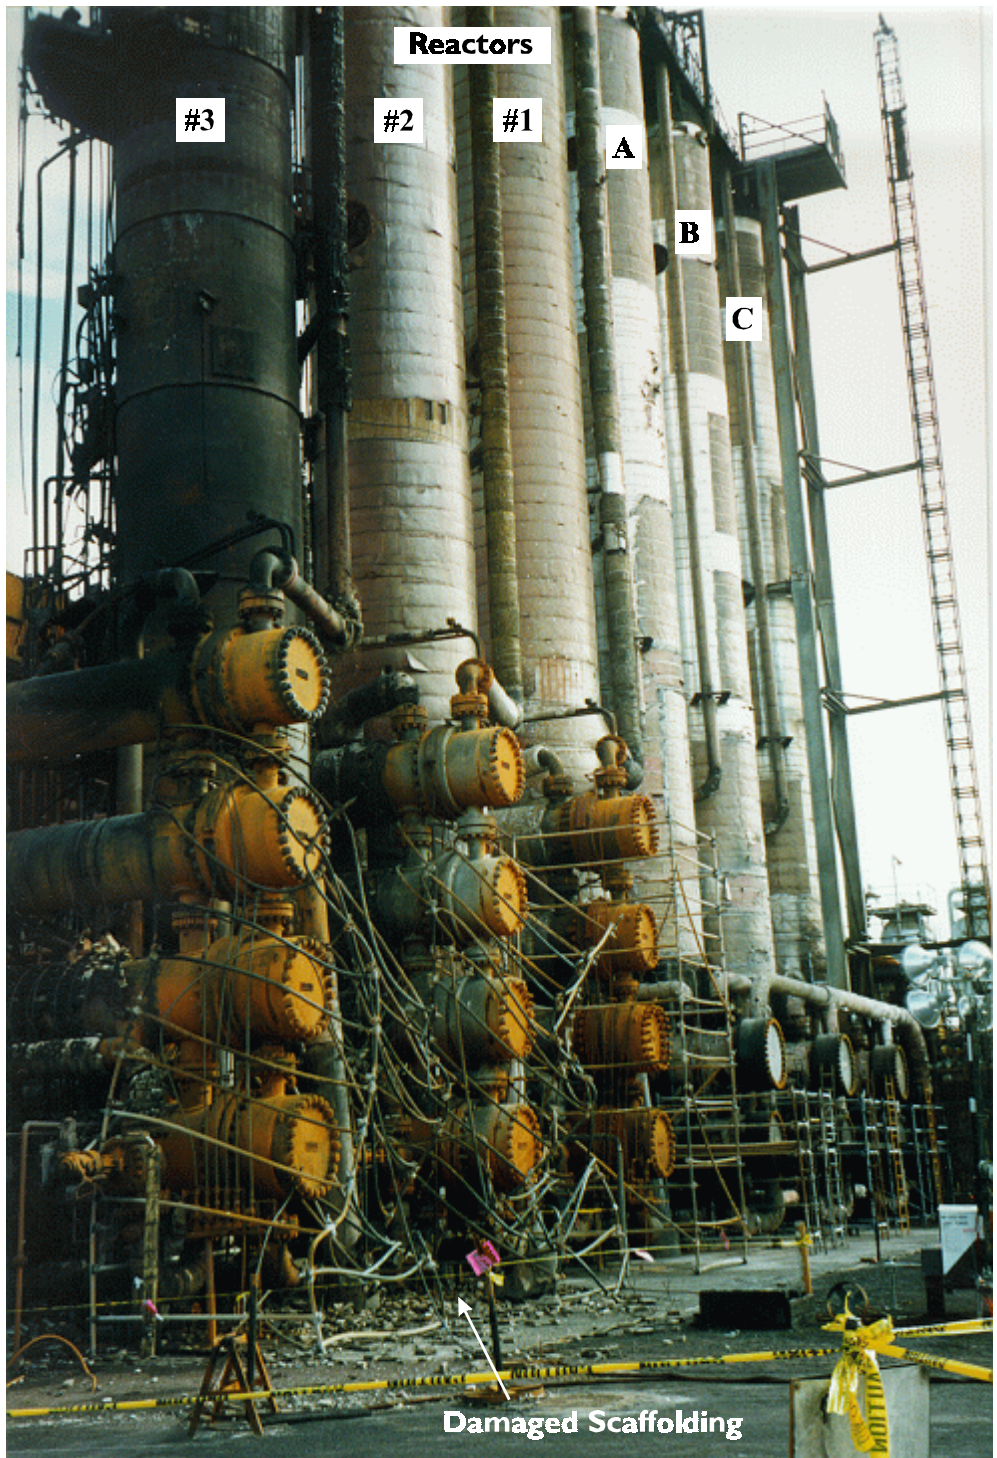
Figure 9 First and Second Stage Reactors

The rupture created about an 18 inch long tear in the Reactor 3 effluent piping. The photographs in Figures 9-13 show some of the resulting damage. The fire melted a light pole on the road next to the reactors. The lower part of a metal ladder on Reactor 3 was damaged by the heat. Scaffolding around the Stage 1 and 2 reactors was misshapen from the heat of the fire, but there did not appear to be much blast damage. The fire fighting equipment next to Reactor Road (see Figure 6) was damaged. Wooden platforms near the unit were charred. The six reactors were covered with asbestos insulation overlaid with aluminum, which was blackened by the fire. A large valve on the fire water piping near the road was damaged.

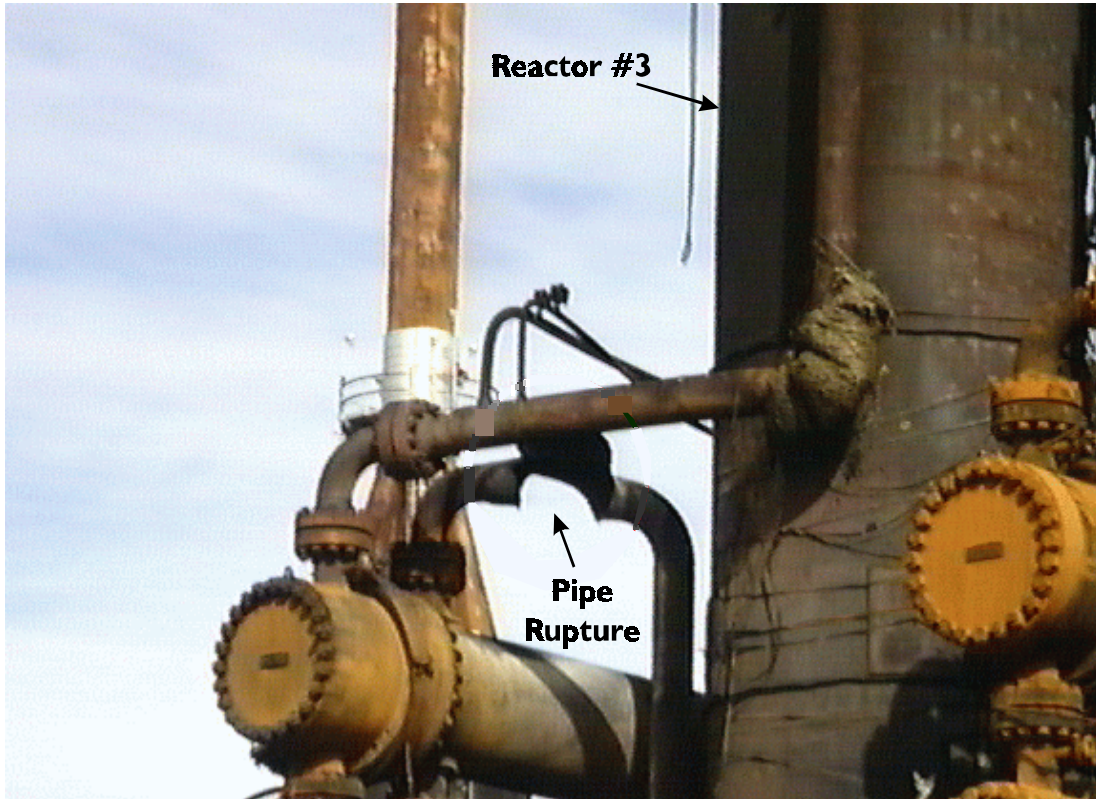
Figure 10 Reactor 3 Effluent Piping Rupture

Several Tosco and contractor employees reported hearing a pop or crack sound, followed by two explosions, one small and one bigger. A horizontal straight section of 12" diameter Reactor 3 effluent piping had ruptured just upstream of a 12"x 10" diameter reducer. Beyond the reducer, the 10" diameter pipe entered the top of the 40-foot high feed/effluent exchanger structure for Reactor 3. The hydrocarbon and hydrogen mixture released from the pipe rupture apparently autoignited very shortly after the initial release, causing a fireball over 100 feet high.

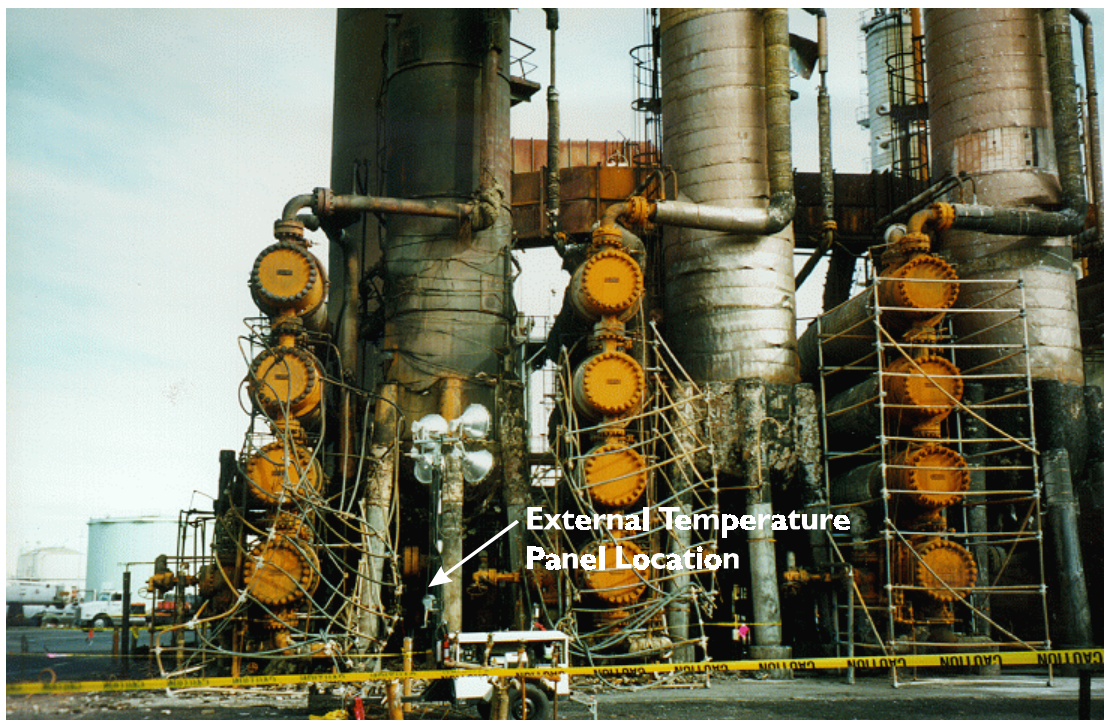
Figure 11 Field Panel Location

A Tosco Hydrocracker operator, who was in the process of checking the temperature panel located at the base of Reactor 3, was killed. He was severely burned as a result of being in close proximity to the fire from the ruptured pipe. According to the coroner, he died of third-degree burns on 100 percent of his body and smoke inhalation. A total of 46 personnel were injured; eight were Tosco employees and 38 were contractor personnel. Injuries consisted of a fractured foot, emotional trauma, headaches, ringing ears, cuts and scrapes, and twisted knees. Thirteen injured personnel were taken by ambulance to local hospitals, treated and released. There were no reported injuries to the public or other offsite personnel.
