SUBJECT: Unannounced Inspection of KCBX Terminals Company  
Chicago, Illinois

Facility: KCBX Materials Terminal

Inspection Date: May 10, 2012

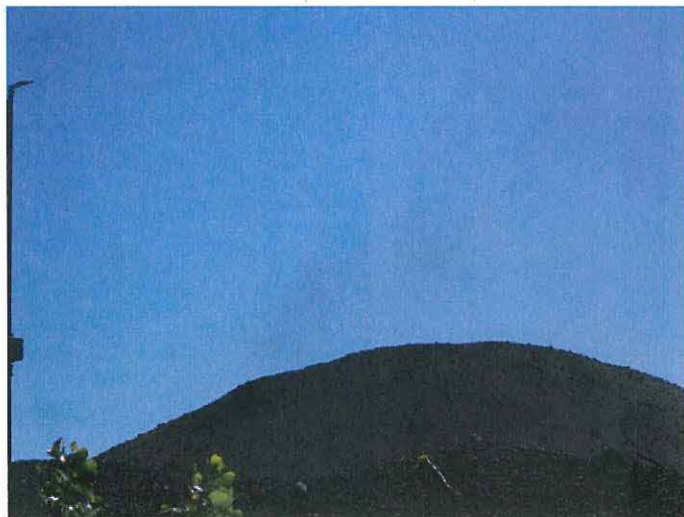
On May 10, 2012, Roshni Brahmabhatt, Ray Cullen, Danny Marcus, and I drove around the plant site and stopped in various locations to see if coal dust was crossing the property line. While driving around, I saw coal dust coming off a coal pile on the western side of the property. I estimated the maximum opacity to be 15%. Figure 4 shows a picture of this pile. This picture does not coincide with the point in time of maximum instantaneous opacity. After driving around the property, we met Joe Kotas, an inspector for the Illinois Environmental Protection Agency (IEPA), outside the facility and then drove up to the gate, showed our credentials, and parked the car in the parking lot.

**Figure 1:** Coal pile with particulate emissions that was read at 15% opacity (but the picture does not correlate with that moment in time)

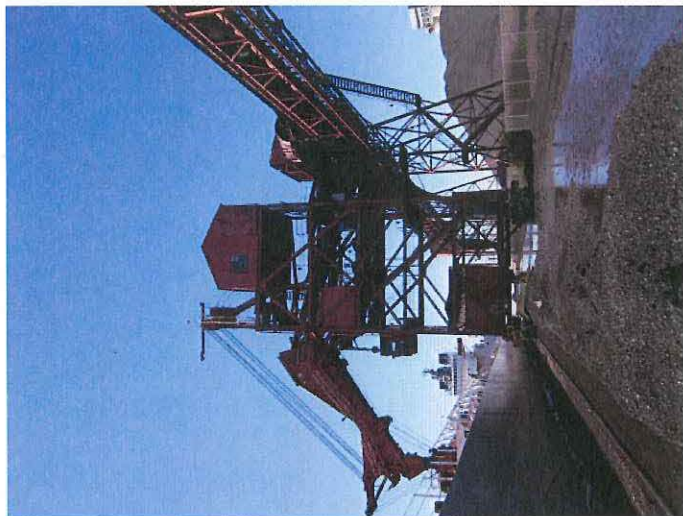
- The coal piles were fairly wet and it looked as if the water cannons had just been used. There were standing puddles in many places as shown in the pictures at the end of the report.
- Mr. Cullen used the range finder and determined that one of the piles was 54 feet high.
- There was an odor by the screening area.

Figure 4: Conveyor to vessel with a large puddle, suggesting the Facility may have been overwatered

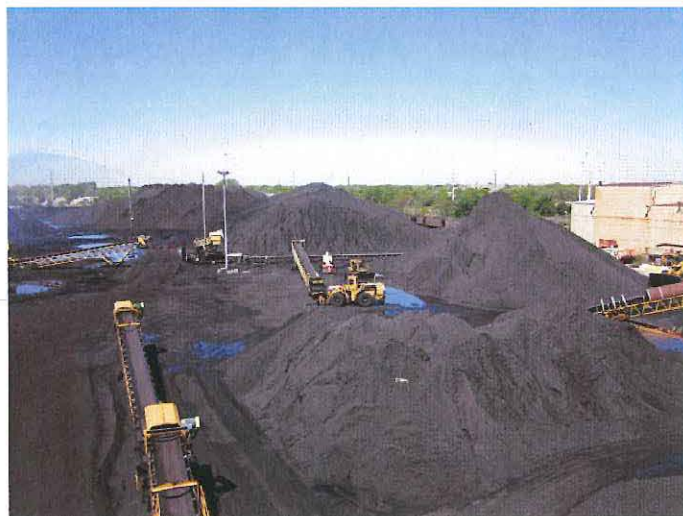
Figure 9: View from a catwalk of the property with many large puddles

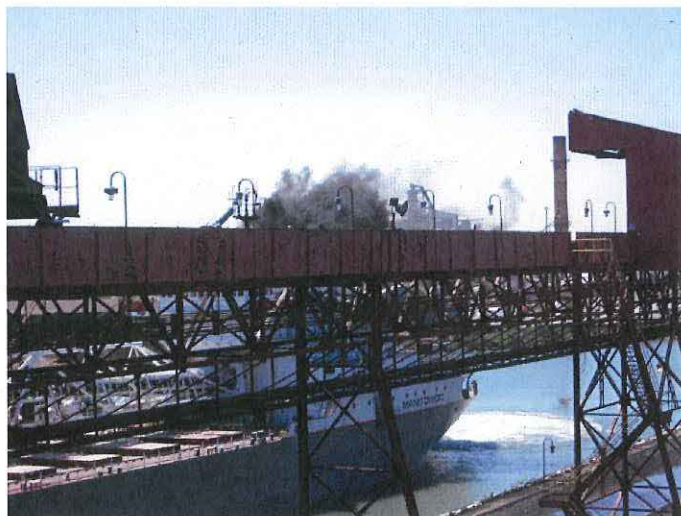
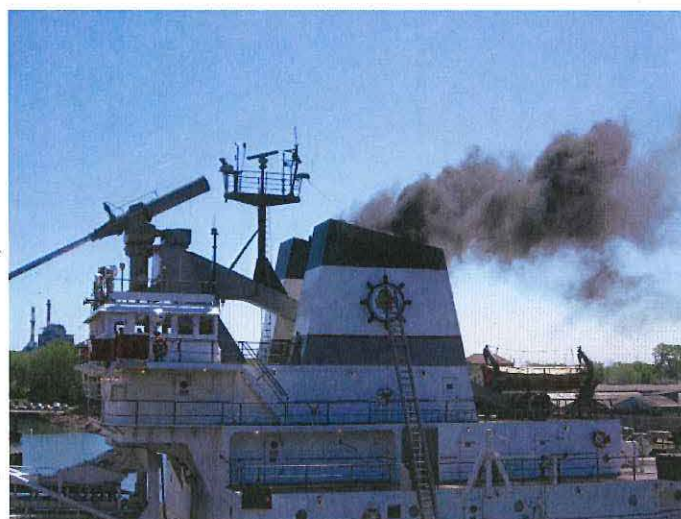
- I observed a large ship that was being loaded with coal to have an instantaneous opacity of 100% at its stack.
- Mr. Kotas said, based on the activities he had seen at the Facility before, it did not look like the Facility was operating.

Figure 10: Smoke with 100% opacity coming off the Manitowoc (vessel being loaded with bulk materials)

Figure 11: Another view of the vessel being loaded with 100% opacity smoke
