INTERPRETATION OF AERIAL IMAGERY

GRENADA CORPORATION

GRENADA, MISSISSIPPI

MAY 17, 2016

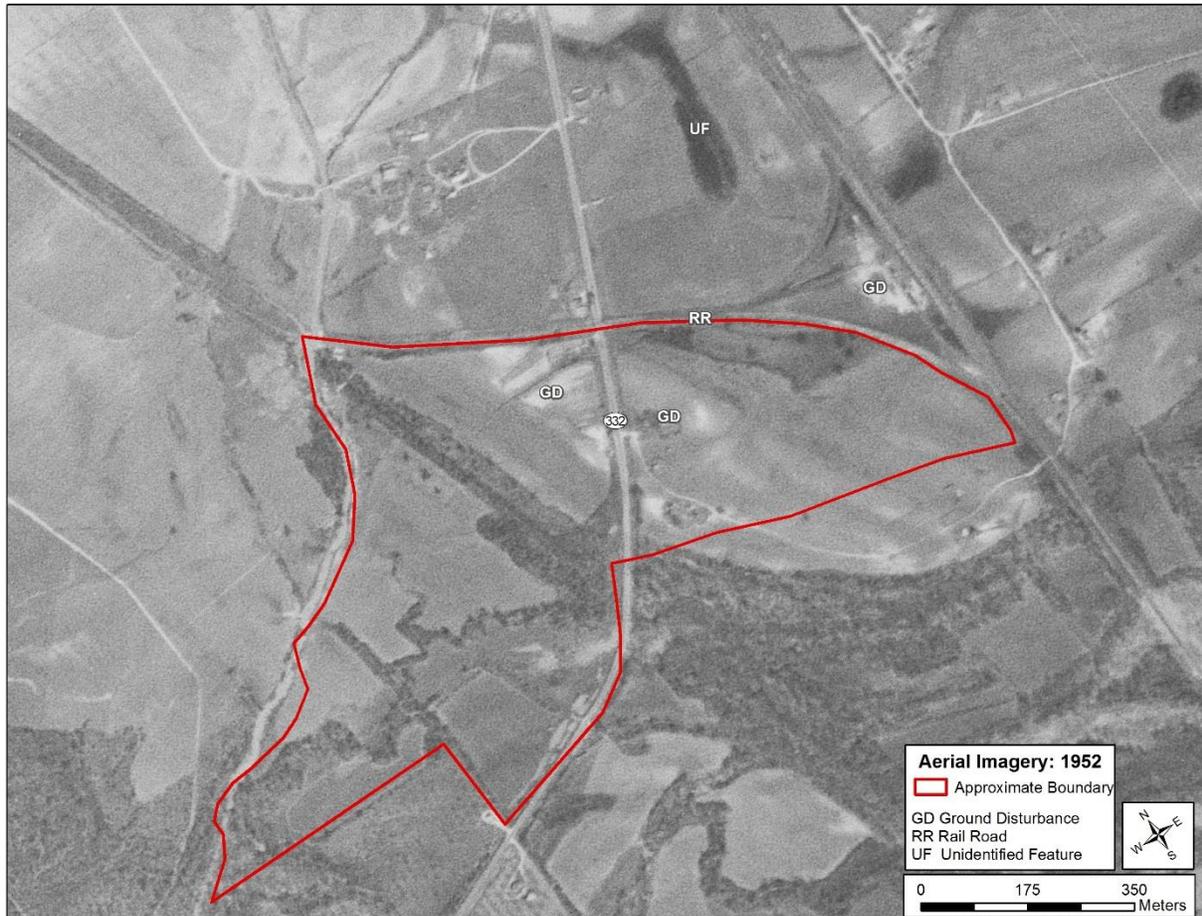
Aerial Imagery Interpretation **Image 1: Year 1952**

- The property is still undeveloped and consists mainly of agricultural land.
- A Railroad and Route 332 visible along the northern border.
- Some Ground Disturbance (GD) is visible to the west of Route 332.
- Some Ground Disturbance is visible to the east of Route 332.
- The residential area, located north of the property boundary, is still undeveloped. A dark form either from a ground disturbance or affected soil, is visible and labeled as an Unidentified Feature (UF).

1952 – Imagery shows post construction condition of the property, but the imagery is of poor quality. There is little evidence of activity on or offsite. One area for potential investigation could be the dark area labeled “Unidentified Feature” (UF) to the north of the

property boundary. Based on the aerial image alone, it is difficult to determine the cause of the discoloration. Often, features like this are labeled as a “ground disturbance” if it is clear there was some sort of vegetation cleared, or, an “affected soil” if a release appears to have occurred. The images are not clear enough for a determination. This feature is visible until construction of the residential area is underway in 1979.

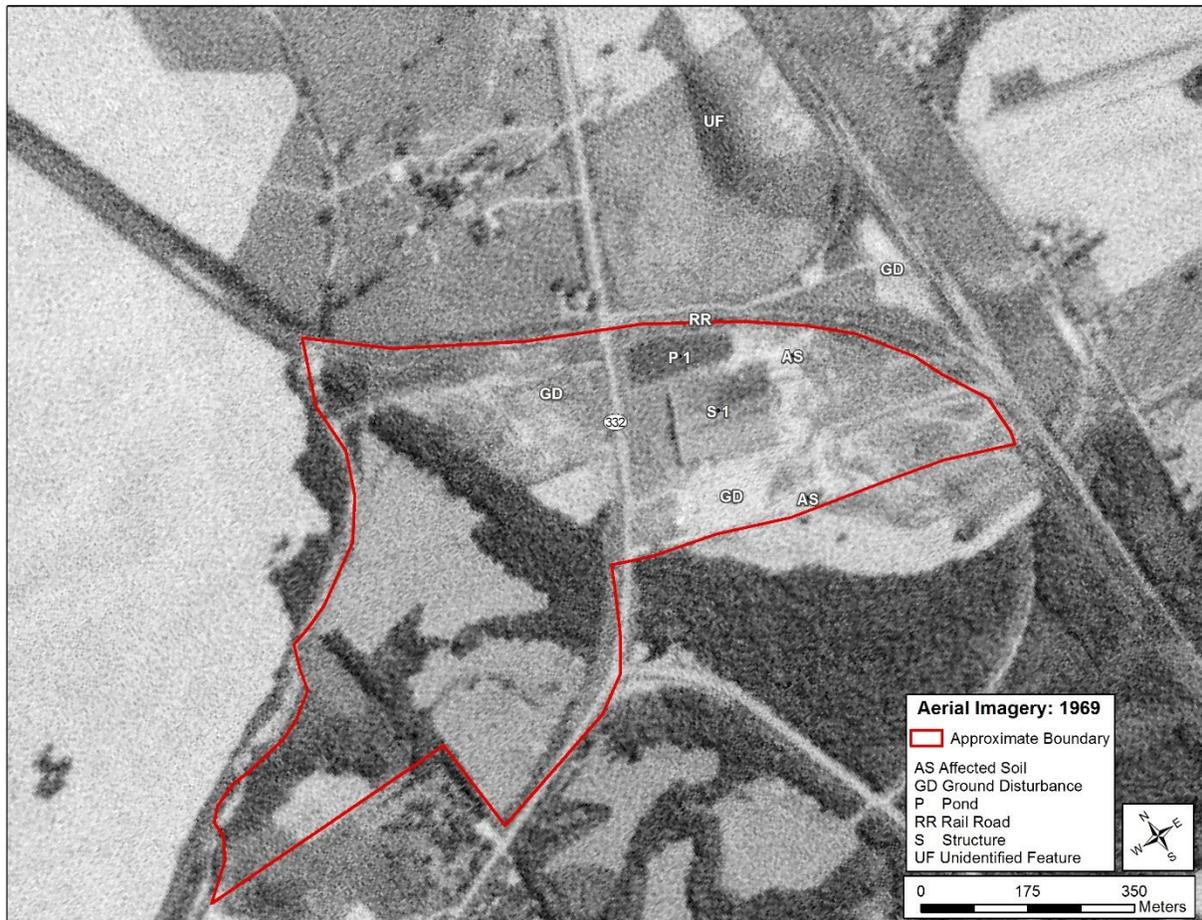
Aerial Imagery Interpretation **Image 2: Year 1969**

- Resolution is low for a detailed interpretation.
- The main warehouse building is now visible (S1).
- Pond 1 (P1) is now visible. It is used as an Equalization Lagoon.
- A Ground Disturbance exists to the west of Route 332. Based on previous inspection reports, this may be an Outfall Ditch.
- Affected soil (AS) and a Ground Disturbance are visible in the southeastern end of main property.
- The UF is still visible in the undeveloped residential area north of the property boundary. Construction of the neighborhood does not appear to have started yet so the cause of the dark area is undetermined.

1969 – The imagery shows the beginning stages of development both within the facility property boundary and adjacent property to the north.

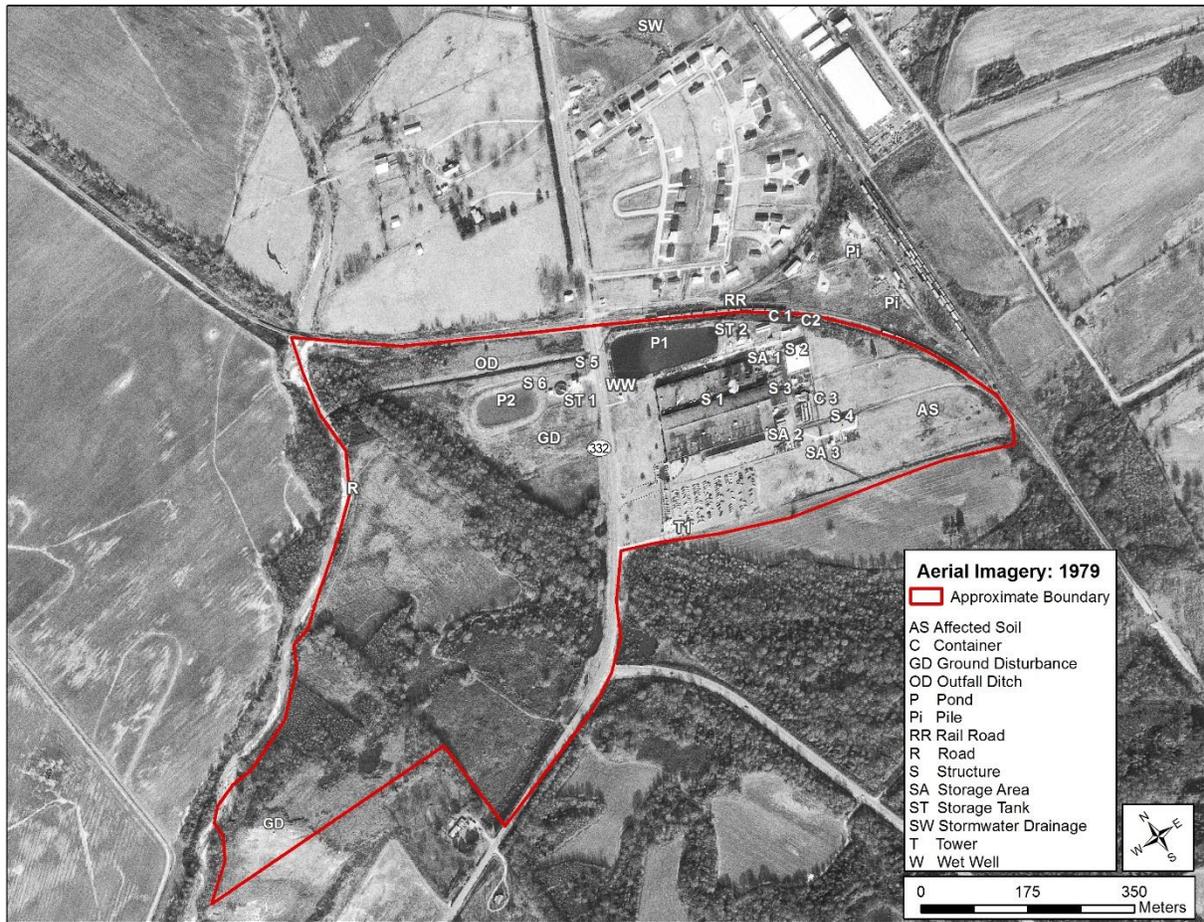
Aerial Imagery Interpretation **Image 3: Year 1979**

- The facility is fully operational with significant construction since 1969. There are several new buildings present, Structures 1-6 (S 1-6) are visible in the northeastern portion of the property.

- Storage Tank 1 (ST 1) is now visible and functions as a part of the Wastewater Treatment Plant.
- Fuel Storage Tank 2 (ST 2) is now visible.
- Tower 1 (T1) is now visible.

- The Outfall Ditch (OD) is present, and referred to as SWMU 7 in previous inspection reports.
- Initial development of residential housing to northeast of facility is present.

- Wet well (WW) is visible in the north and central portion of the property.
- Pond 2 (P2) is now visible. It is referred to as SWMU 4 Sludge Lagoon in historic inspection/monitoring reports.

- Historic equipment/dumping/activity has occurred in the far northeastern corner and outside of the property boundary (Pi).
- Paved surfaces are now present around the entire facility.

- Possible water feature (P3) in very north end of property, connected to the adjacent stream. In some images, this appears outside of the property boundary and in others appears inside the property boundary.

- A roadway is present and leads to P3.
- Potential storage containers (C1-3) are visible in the northeastern portion of the property.
- Potential Storage Areas (SA1-3) exist along eastern side of the facility.

- Possible Affected Soil (AS) exists on the far eastern side of property. The ground is discolored compared to the surrounding area. The discoloration appears to be in several small, dark spots, possibly from stressed vegetation.

- Significant changes have occurred in the residential area north of the property boundary since 1969. The top of the UF that transected the area is now a suspected Stormwater Runoff area (SW) and located directly north of the residential area.

- There appears to be a storage area located northeast of the facility property boundary and railroad track (Pi).
- Affected Soil (AS) is also identified in the eastern portion of the property where vegetation appears to have been removed and “discoloration” is visible. It is unclear what the cause of the discoloration is, but it appears in the image as small dark spots.
- Construction to the north of property boundary has progressed. The dark area is only visible north of the new homes built since 1969.

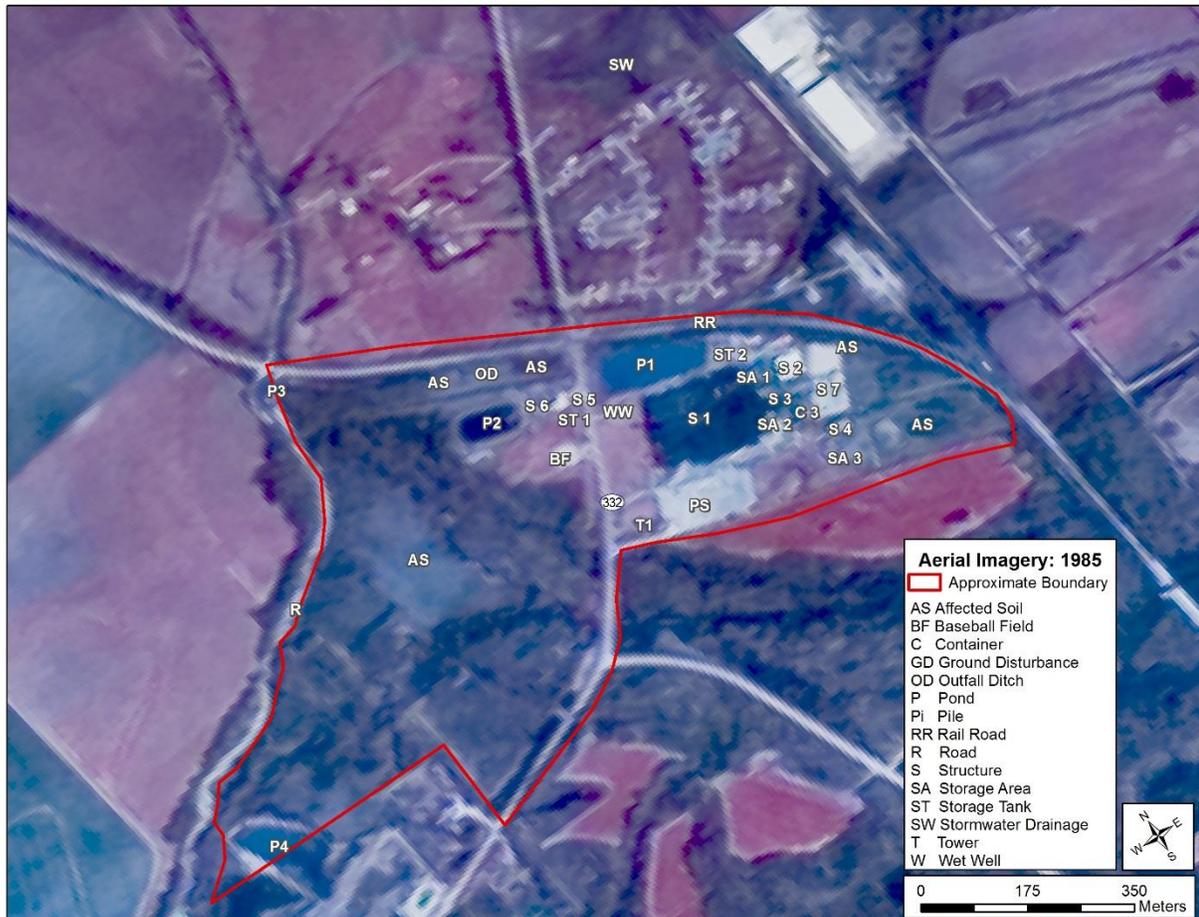
Aerial Imagery Interpretation Image 4: Year 1985

- This year appears to have “Color-Infrared” (CIR) imagery qualities depicting vegetation in red tones and soil in blue, green and white tones.
- Piles are still visible in the northeast corner of property. They do not appear to be permanent and therefore could be some type of gravel or soil storage area. The contents of the “piles” cannot be determined from the aerial photograph.

- Another Pond (P3) is present at the western corner of the property.
- A Baseball Field (BF) is now visible on the west side of Route 332.
- There appears to still be a potential AS to the north of Storage Tank 1 (ST1).

- A new Structure (S7) is present to the east of the main facility (S1).
- Possible Affected Soil (AS) is still present to the east of SA 3.
- Possible AS exists along Outfall Ditch (OD) located north of the property boundary.

- A new Pond (P4) is located in the southwestern corner of the property and appears to extend off the property boundary.
- Darkened ground areas, identified as possible Affected Soil (AS) are located near the Outfall Ditch.

- The residential area north of the property boundary appears to be more developed since 1979. The SW area appears as a dark form to the north.

1985 – The imagery has some CIR qualities and indicates vegetation in tones of red and pink, as well as, areas with tones of dark blue, green and white.

- A baseball field is identified in the north and central area of the property (white) with adjacent land in tones of pink. This can be attributed to the time of year (March), poor or stressed vegetation, or low chlorophyll content.
- Additional “pink” areas can be seen near the wet well (WW) and Storage Area 3 (SA3).
- Construction in the residential area north of the property boundary appears to be nearly completed. The SW area is visible due to the dark green and blue tones. Due to the CIR qualities to this image, the colors can be attributed to a higher concentration of chlorophyll in this area.

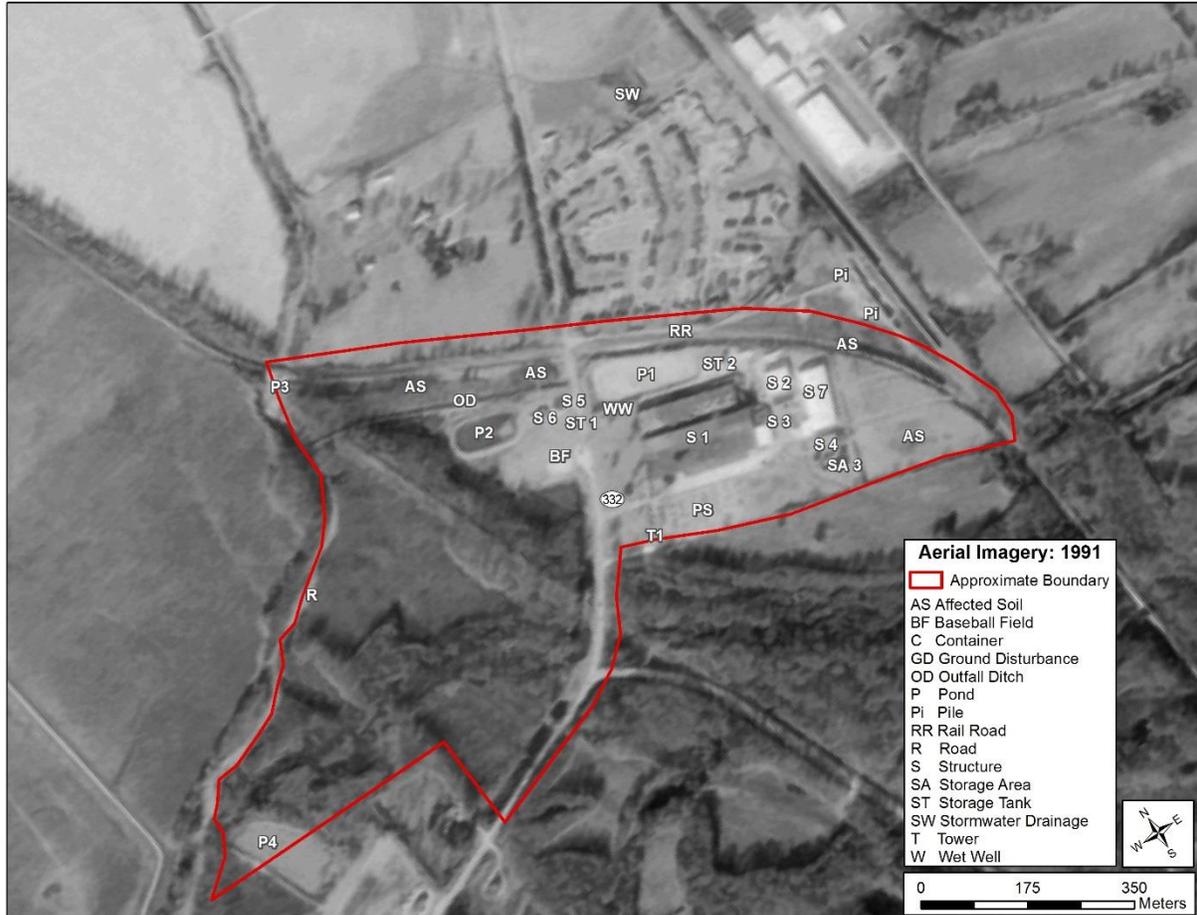
Aerial Imagery Interpretation Image 5: Year 1991

- Imagery appears black and white with very little to no changes visible since 1985.
- No new construction is visible and features on site appear to be the same as the 1985 image.

1991 – There are no visible changes from 1985 to 1991.

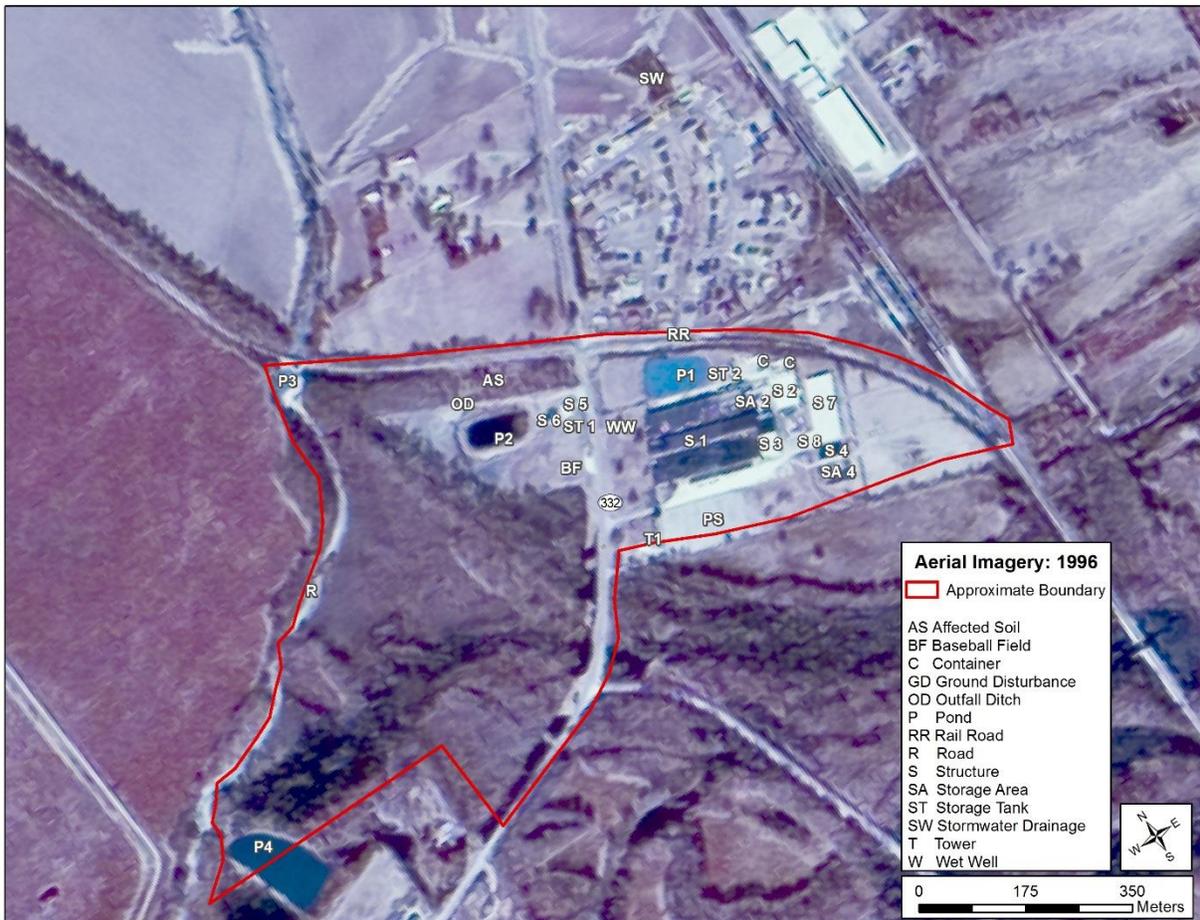
Aerial Imagery Interpretation Image 6: Year 1996

- This year appears to have Color-Infrared (CIR) qualities.
- A large pond (P4) is visible in the southwest portion of the property and may extend off site.
- There is a reflective difference between Pond 1 and 2 which could be due to the water constituents, water level, or material containing water. CIR imagery reflects a variation in colors based on the components that make up a given surface body of water, building material, etc.
- A new Structure 8 (S8) is visible adjacent and to the southwest of S7.
- SW, located north of the residential area, appears to be very prominent. CIR imagery depicts areas with dense vegetation in tones of dark green, The SW area appears to be much darker than the surrounding area.

- The imagery is from February, which could contribute to the tones of pink surrounding the facility.
- White, likely indicating paved surfaces, is very visible along with Pond 1 and 2 in vibrant blue.
- The reflective quality of P1 and P2 appear differently in the imagery. This could be attributed to a difference in the water constituents, amount of water in the ponds, or the material lining each pond.
- Similar to 1985, the SW area, north of the residential area, has a very defined dark shape relative to the surrounding soil. CIR qualities in the image depict thick vegetation in dark green and blue tones.

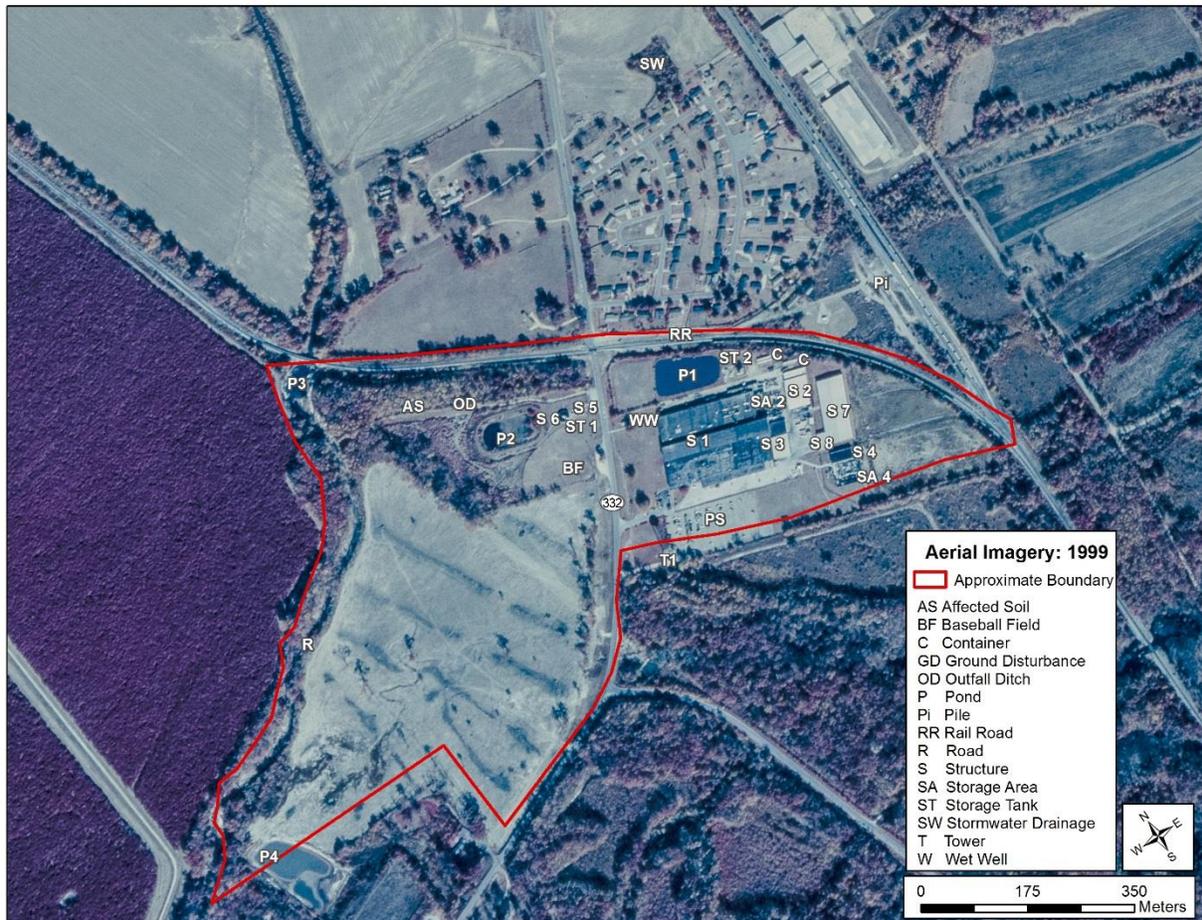
Aerial Imagery Interpretation Image 7: Year 1999

- This imagery contains Color-Infrared (CIR) qualities.
- Mass deforestation occurred in the southwest portion of property since 1991.
- P2 appears to have a very little water compared to previous years.

- Discolored vegetation is still present along Outfall Ditch (CIR imagery shows healthy vegetation as varying shades of red).
- It is possible that some distressed vegetation is present along the Outfall Ditch due to the variation in colors of the vegetation surrounding the ditch. Often shades of pink indicate unhealthy vegetation or low chlorophyll levels in the vegetation present (see “Recommendations and Areas for Further Investigation” section for a description on CIR imagery).

- Containers are still present in the northeast side of main facility (S1).
- There are little to no changes visible in the residential area north of the property boundary.

- The storage area(s), Pi, to the northeast of the property boundary appear to have prominent access roads, changes in piles and storage practices. One pile is now visible, compared to two piles in previous years.

- Located to the south of the facility area and adjacent to Storage Area 4 (SA 4) and surrounding Ponds 1 and 2 (P 1 & 2) appear pink.
- Another possible explanation for the pink coloration of the vegetation surrounding the Outfall Ditch could be the time of year, this imagery is from November and not an active growing season.
- There are also signs that a large area of vegetation was removed in the southern portion of the property. Land appears smooth and light blue green.
- The storage piles (Pi) to the northeast of the facility boundary have reduced in quantity from 2 piles to 1 pile.

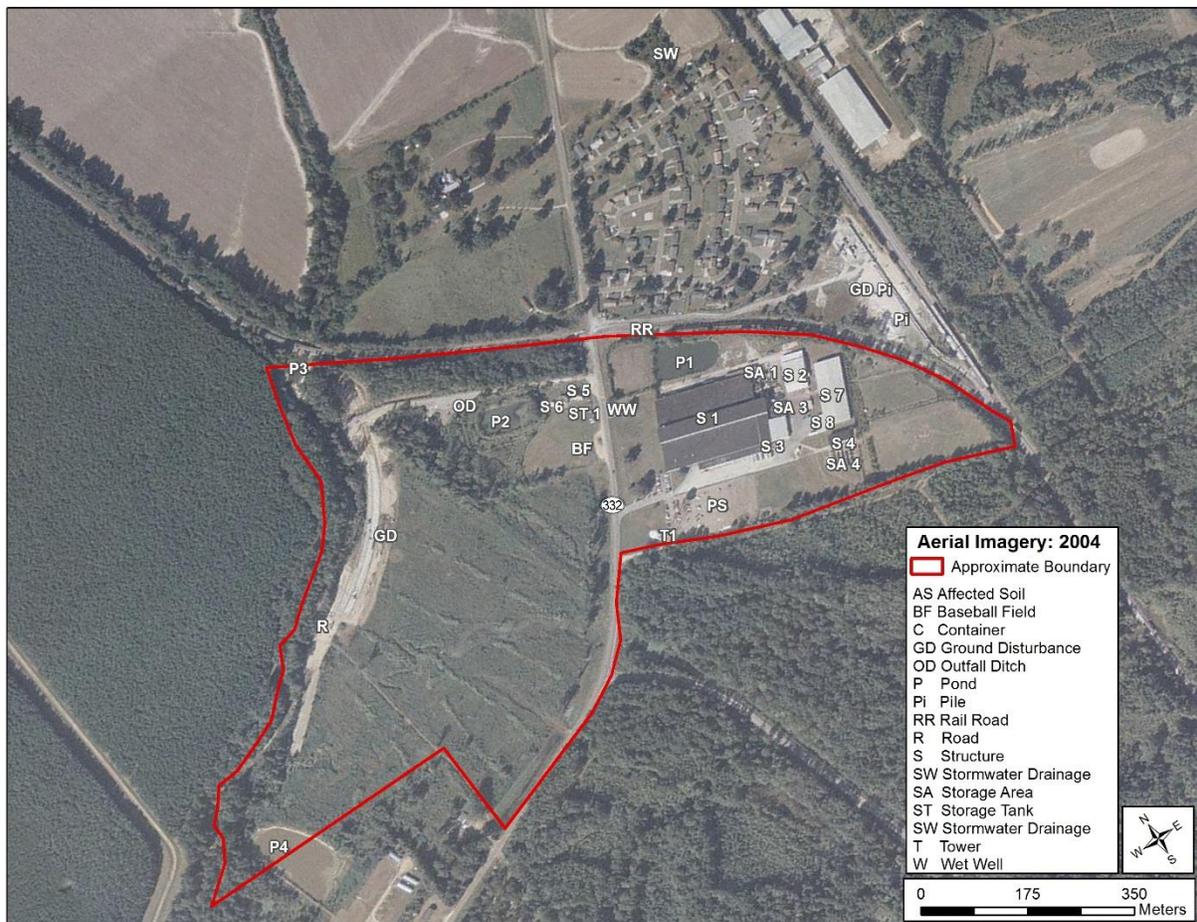
Interpretation Image 8: Year 2004

- There is an increase in the soil disturbance outside of the northeastern side of the property boundary labeled Pi (pile).
- Piles are visible along the outer northeastern property line.
- A Ground Disturbance is visible along the western edge of the property leading to P3. It could be the development of an access road.
- Storage Tank 2 appears to have been removed (refer to Image 7: Year 1999 to see the location of Tank 2 labeled “ST 2”).
- Vegetation in the SW area is very dense.
- The storage areas labeled Pi now have two, more defined piles of a material stored to the northeast of the facility’s property boundary. A larger ground disturbance is also visible in the area surrounding the Pis.

- Piles (possibly for storage or disposal) are visible.
- A large Ground Disturbance is visible along the western border of the property.
- Storage Tank 2 was removed (according to historic monitoring reports).

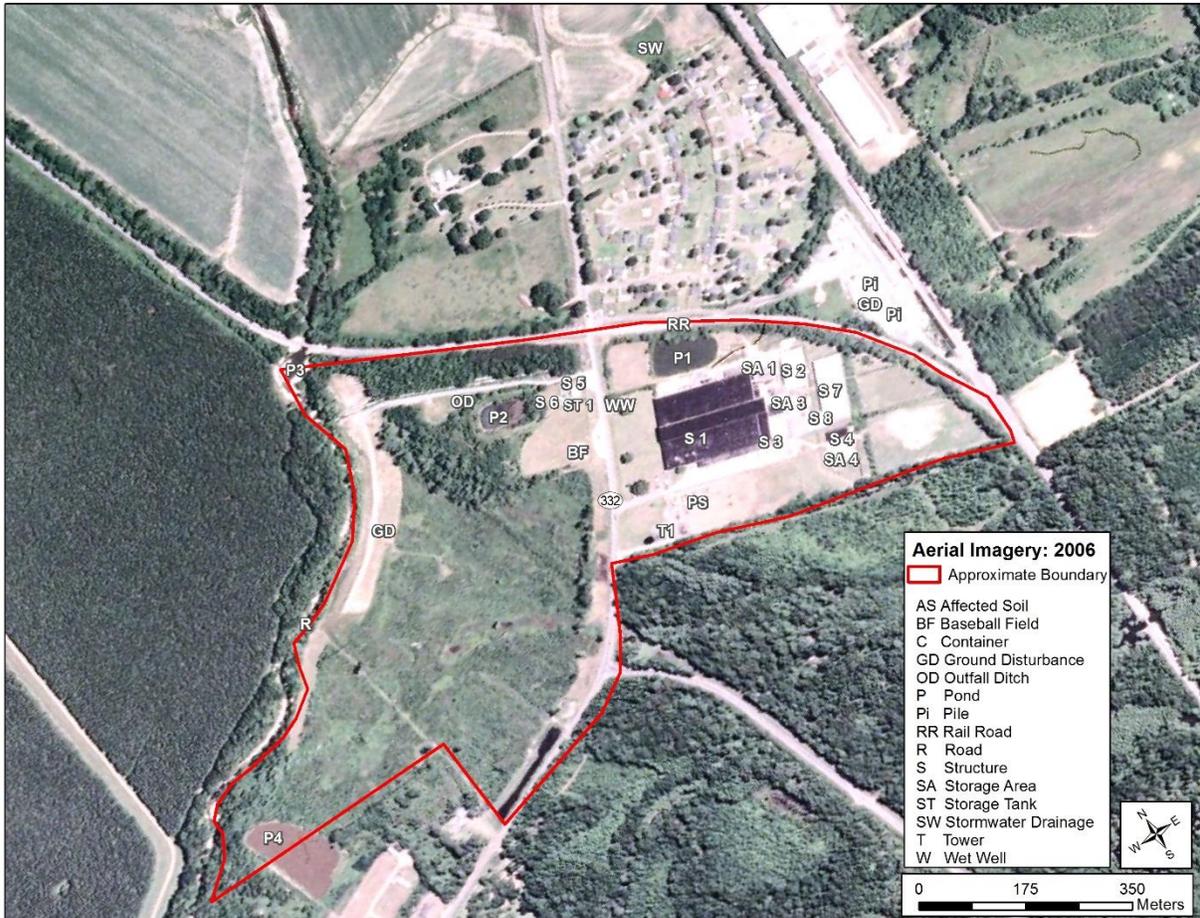
Interpretation Image 9: Year 2006

- No changes are observed in the facility or surrounding property since 2004.

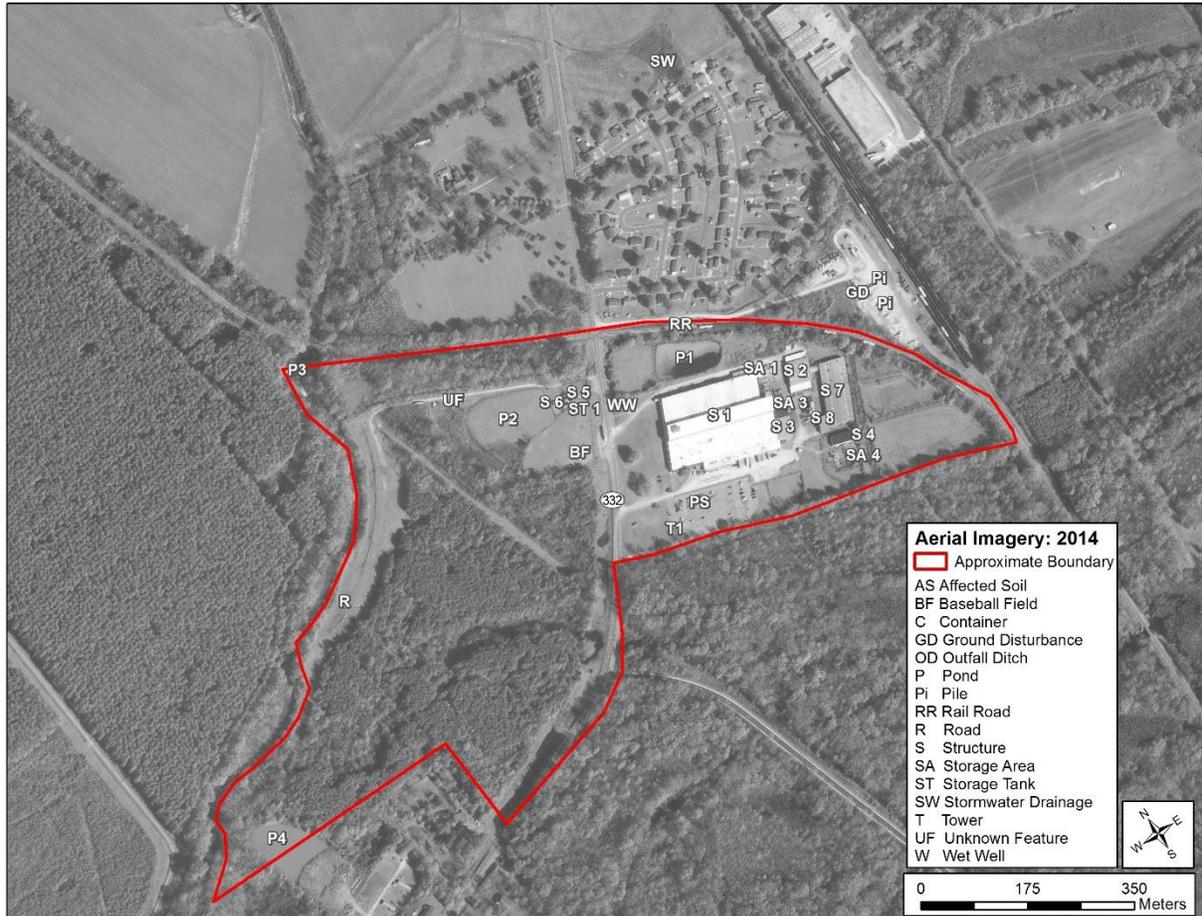
Interpretation Image 11: Year 2014

- Unidentified Features (UF) are still visible along the northern edge of the former location of P2.
- No other changes are observed since 2010.

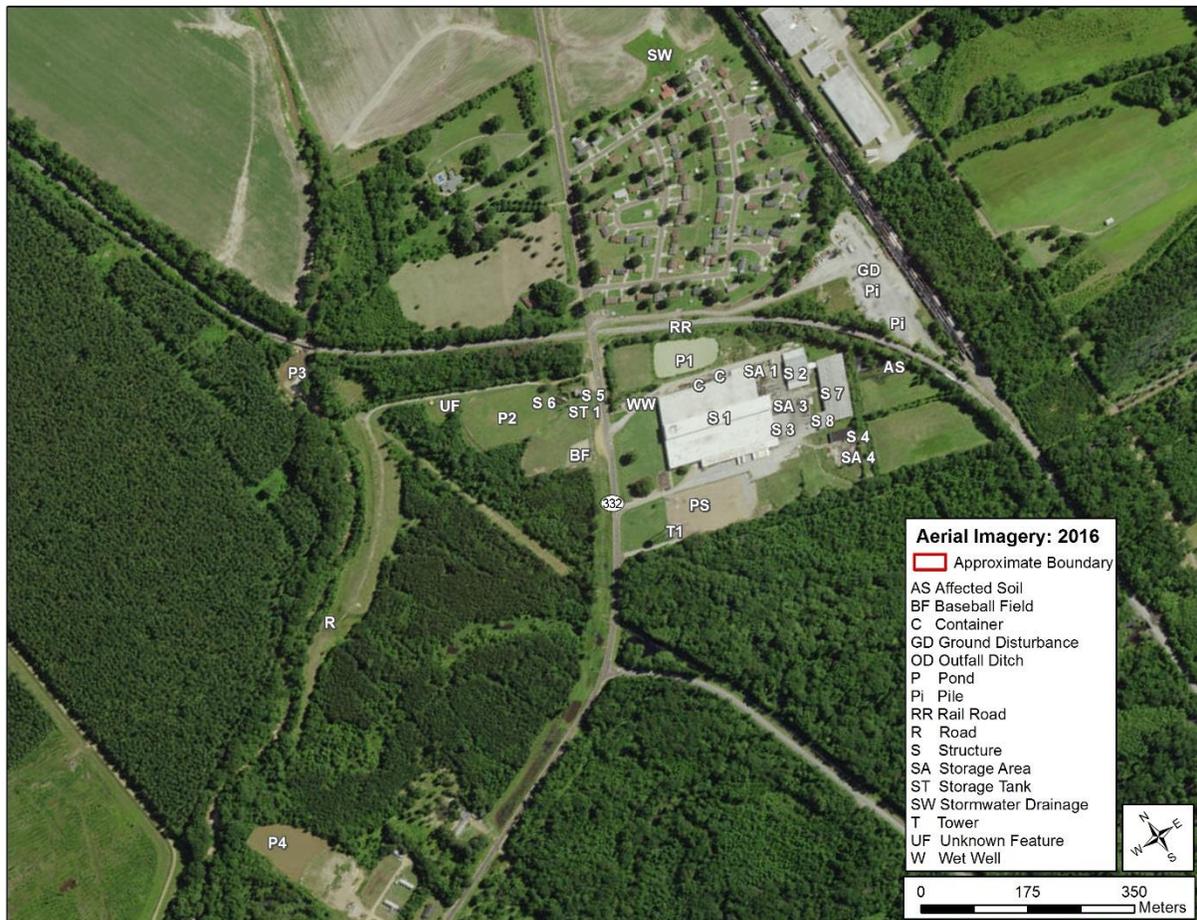
Interpretation Image 12: Year 2016

- A new area with potentially Affected Soil (AS) is visible in the northeastern area of the property (darker soil area).
- A potential waste storage area is located between S1 and P1 along the main building (S1). Storage Containers (C) are visible along the northern side of the main building.
- Potential waste storage areas are present between S1 and S3 (labeled C).
- A potential waste storage area is present near S6.
- The Unidentified Feature (UF) is still visible to the west of the historic location of P2, but some “equipment” or “debris” appears to have been removed since 2014.
- The SW area located to the far north of the residential area has not changed and still appears to be dense with vegetation.
- The Pi areas and GD to the northeast of the facility’s property boundary appear to be larger possibly due to heavy use.

- Changes from 2014 to 2015/2016 mainly include additional potential Waste Storage Containers and an Unidentified Feature still present near the former location of P2.
- There is also Affected Soil along the northeastern property boundary.
- The SW area to the north of the residential area is still visible with a clear shape and thicker vegetation than surrounding soil.
