Appendix I

Letter from EPA Documenting Problems with Manufacturer D Device

The purpose of this letter is to document EPA's observations and provide Hazardous Material Specialist, Inc. (HMS) with a copy of the sampling data collected during testing of the Hazardous Material Specialist Fluorescent Lamp Disposal and Mercury Vapor Recovery System in Ashland, Virginia on February 27, 2003 and Phoenix, Arizona on March 26, 2003. The Equipment Validation Phase I and Real World Testing tasks in the Mercury Lamps Drum Top Crushers (DTC) Study are designed to evaluate how efficiently DTC devices capture mercury vapors emitted while crushing fluorescent lamps. Airborne mercury samples were collected and measured per the Sampling and Study Plan and following the NIOSH analytical methods. Furthermore, two Jerome mercury vapor analyzers were employed to collect and measure real-time airborne concentrations. Once the data has been collected, the results of the two studies are reviewed and compared against published mercury exposure limits. The results from the DTC device study are compared against the Occupational Safety and Health Administration (OSHA) regulated Permissible Exposure Limit (PEL

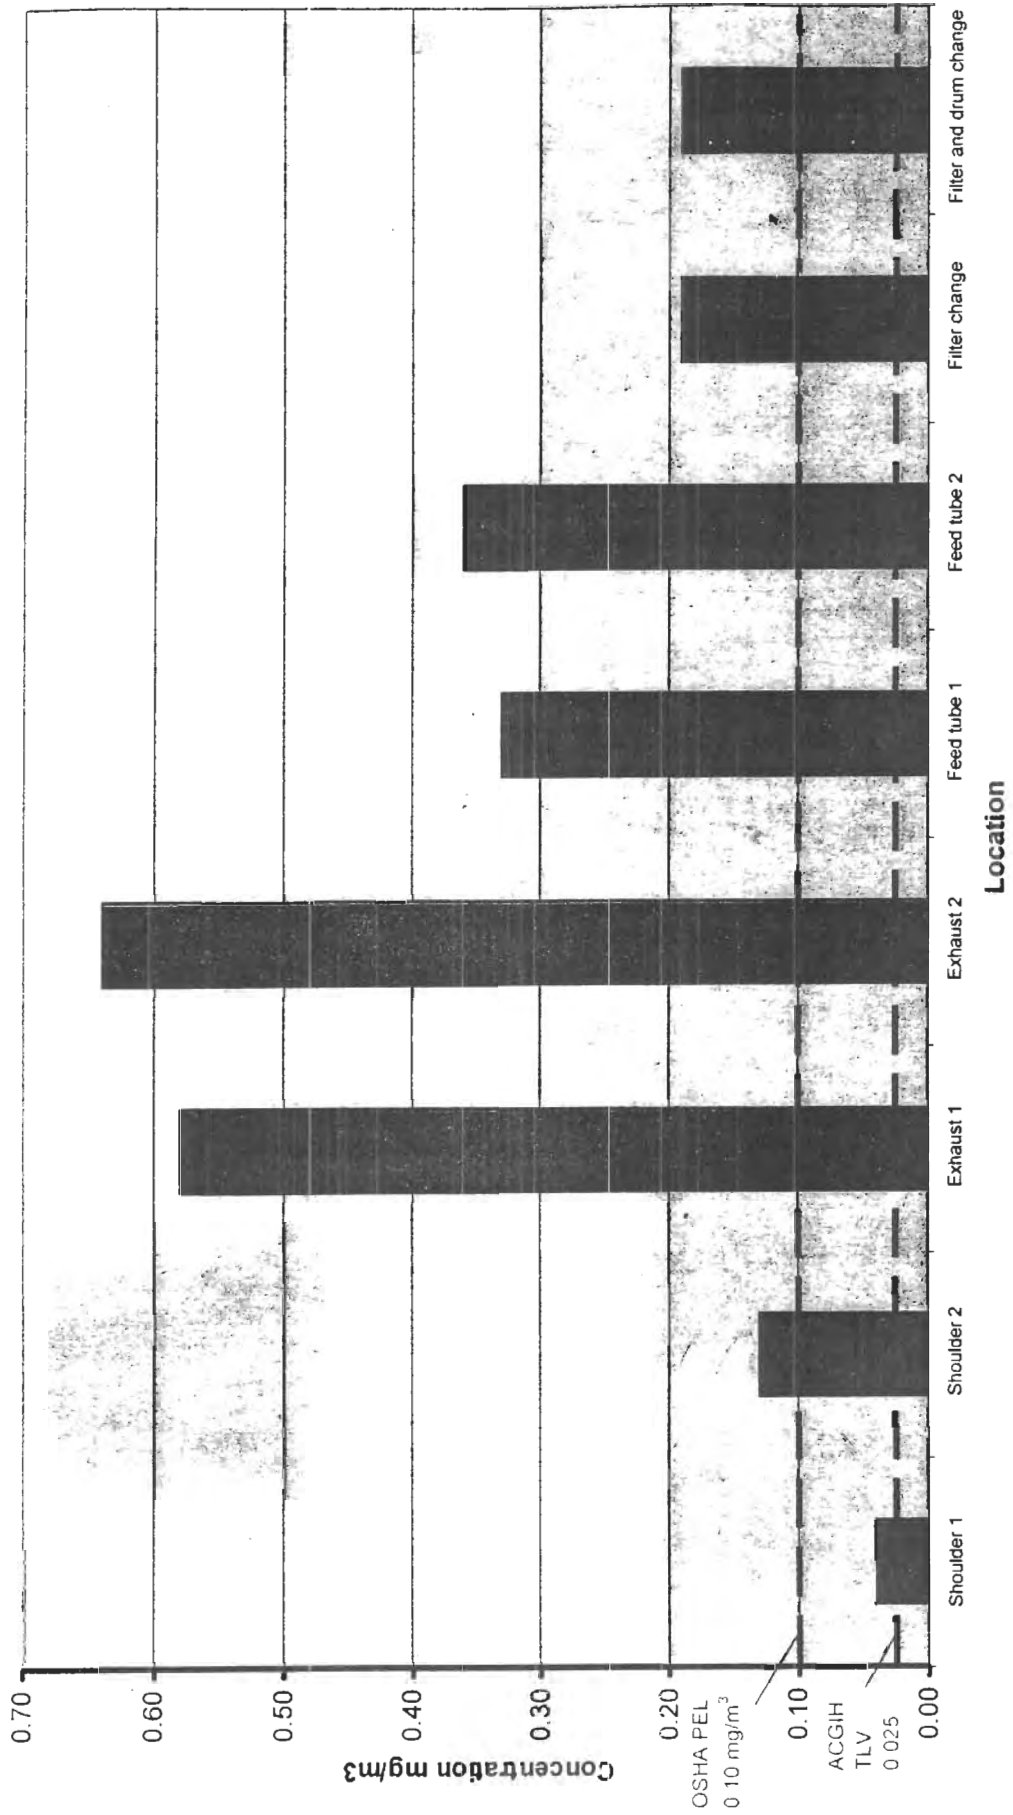
Ashland, VA AERC Facility Analytical Air Results February 2003

Analysis of the analytical air sample results indicate that the HMS device was not efficient in capturing and retaining mercury vapor, and exceeded OSHA PEL and ACGIH TLV exposure limits. Out of eight samples collected during the operation of this device, one sample did not exceed the OSHA PEL, while the remaining seven samples did exceed the OSHA PEL (reference the "Ashland, VA AERC Facility Analytical Air Results February 2003" graph.)

OSHA PEL
0.10 mg/m³

ACGIH
TLV
0.025

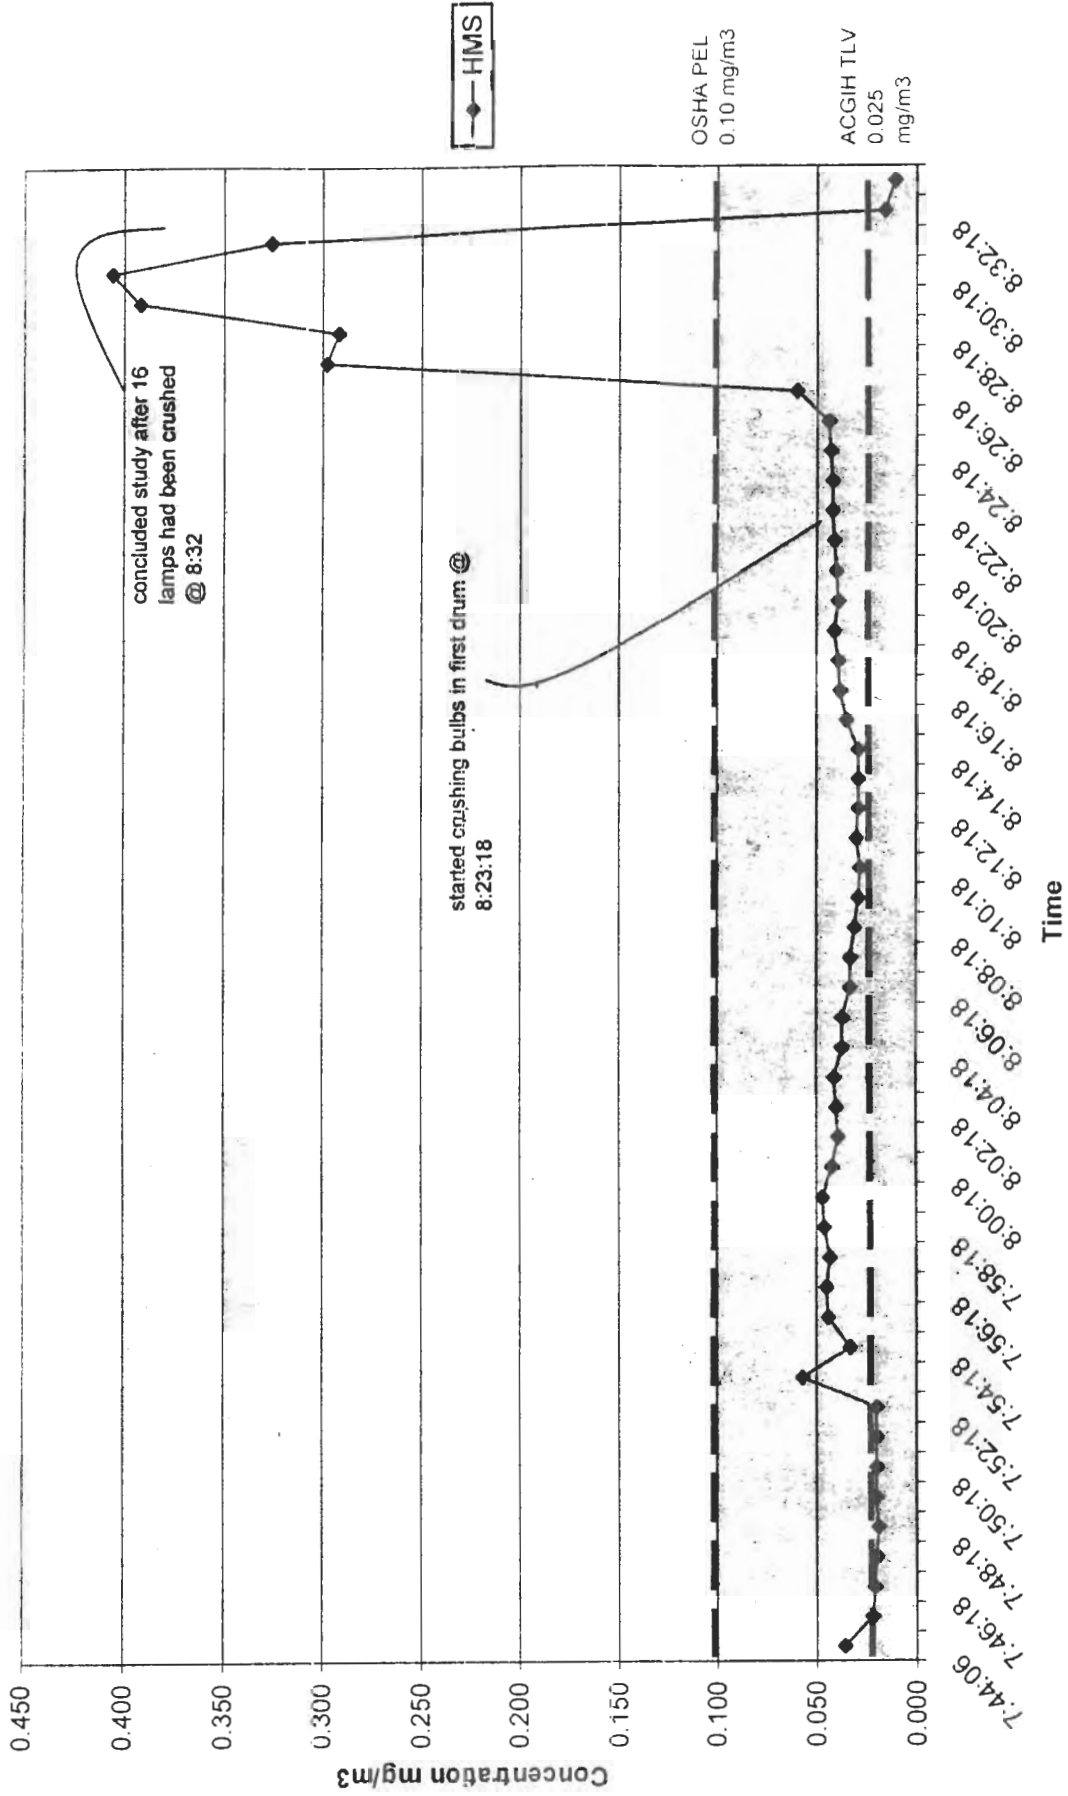
Phoenix, AZ EPSI Facility Jerome Hg Vapor Analyzer Direct Reading Air Results March 2003

exceeded the OSHA PEL after processing only 16 lamps (see attached "Phoenix, AZ EPSI Facility Jerome Hg Vapor Analyzer Direct Reading Air Results March 2003" graph and "Phoenix, AZ EPSI Facility Analytical Air Results March 2003" graph.)

concluded study after 16
lamps had been crushed
@ 8:32

started crushing bulbs in first drum @
8:23:18

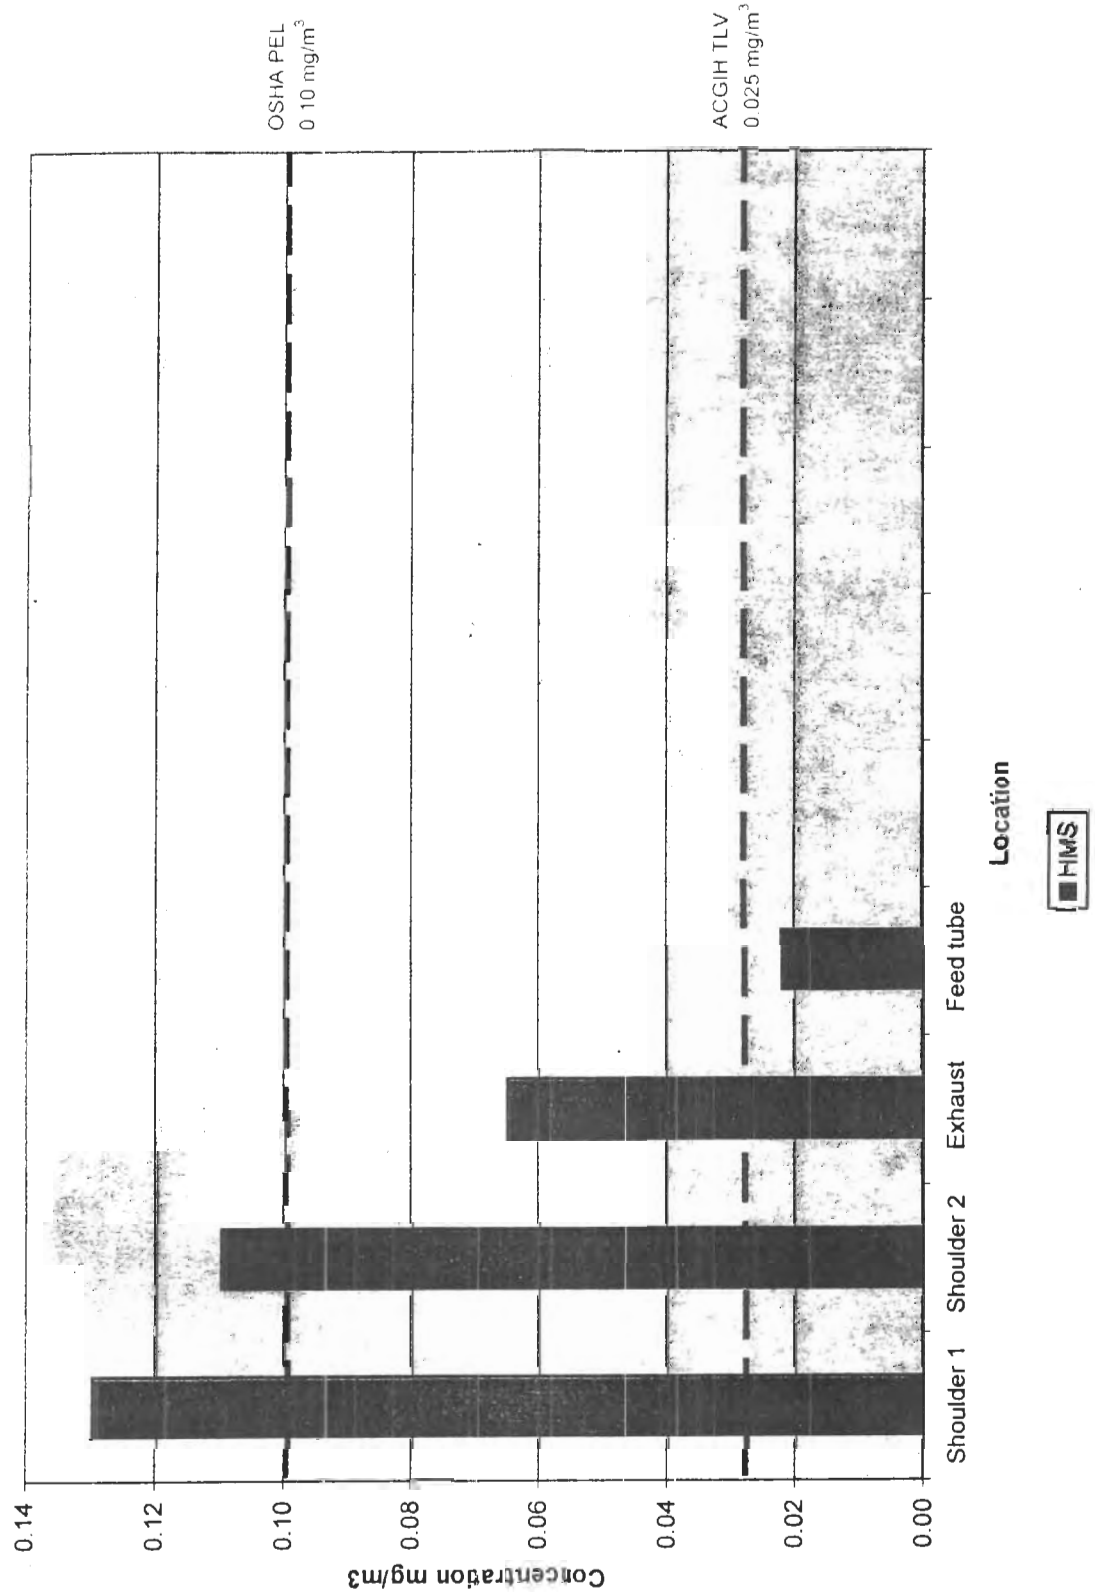
Phoenix, AZ EPSI Facility Analytical Air Results March 2003

To meet testing protocols established for this study each DTC device vendor was required to provide one machine that would be used throughout the entire test. Changing the design of the machine not only violated the testing protocol, which would make HMS ineligible to continue participation in the study, but also eliminated an opportunity to verify that repairs to the machine originally tested in Ashland, Virginia had corrected the mercury vapor release problem. Since the unit was damaged when received in Phoenix, EPA could not perform the complete "Real World" testing of the unit. However, EPA decided to take some Jerome readings and air samples of the HMS device with the cracked filter assembly. With this type of damage mercury levels

EPA recommends that HMS conduct an independent test of a machine that is identical to models that are in use in the field. This test should include processing of enough lamps to fill a drum in order to determine if the machine is operating in a manner to effectively control mercury emissions. If elevated mercury levels are detected, then HMS will need to take appropriate action to correct the problem and notify all facilities that are utilizing this equipment as outlined in Item (4) of the HMS fax from Mr. Edward Domanico to EPA (Subject: Findings on Malfunctioning Bulb Machine Tested in 1st EPA Validity Test") dated March 19, 2003.
