# Assessment of Dam Safety

## Coal Combustion Surface Impoundments (Task 3)

Allegheny Energy

R. Paul Smith Station

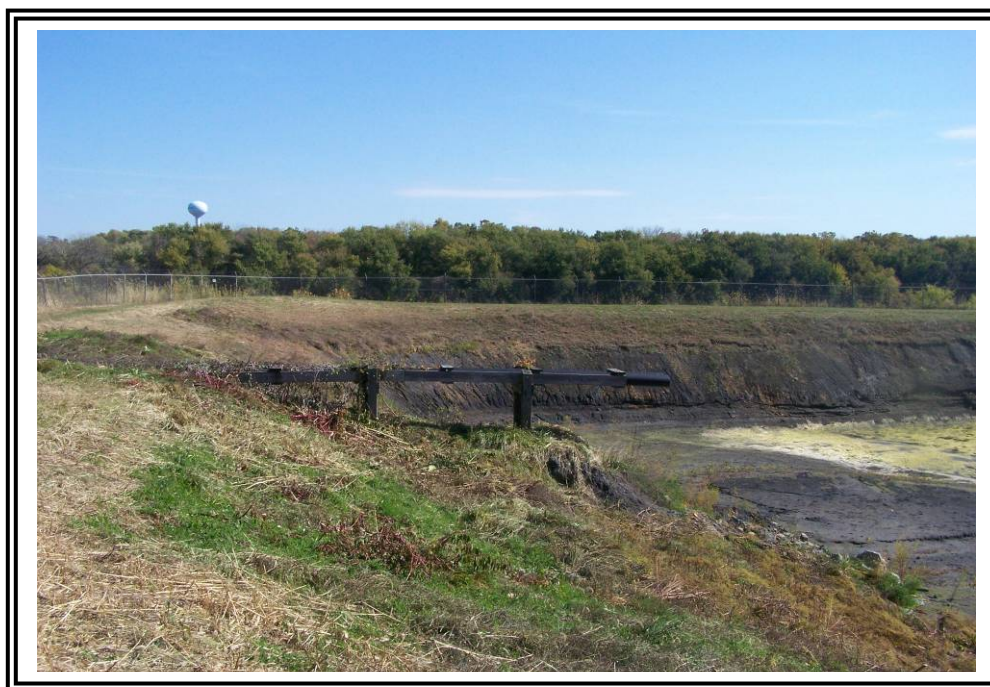
3

Upstream slope of north dike at Pond #3, looking east.  
Irregularity of slope related to remaining ash from recent dredging operations.

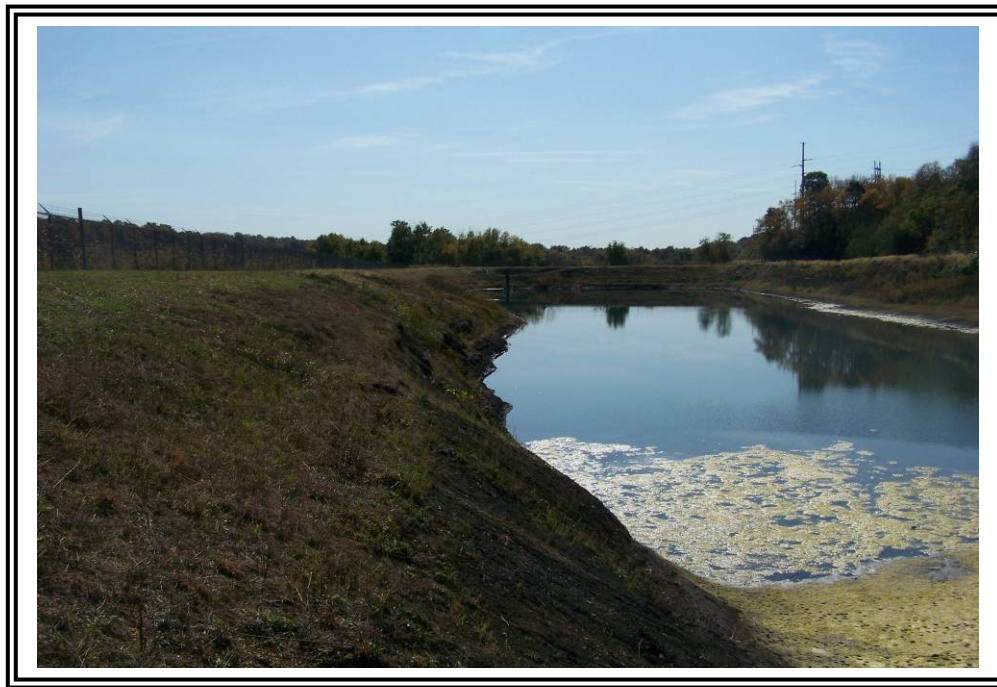
7

Upstream slope of east dike at Pond #3, looking south. Irregularity in slope related to over excavation during recent dredging operations.

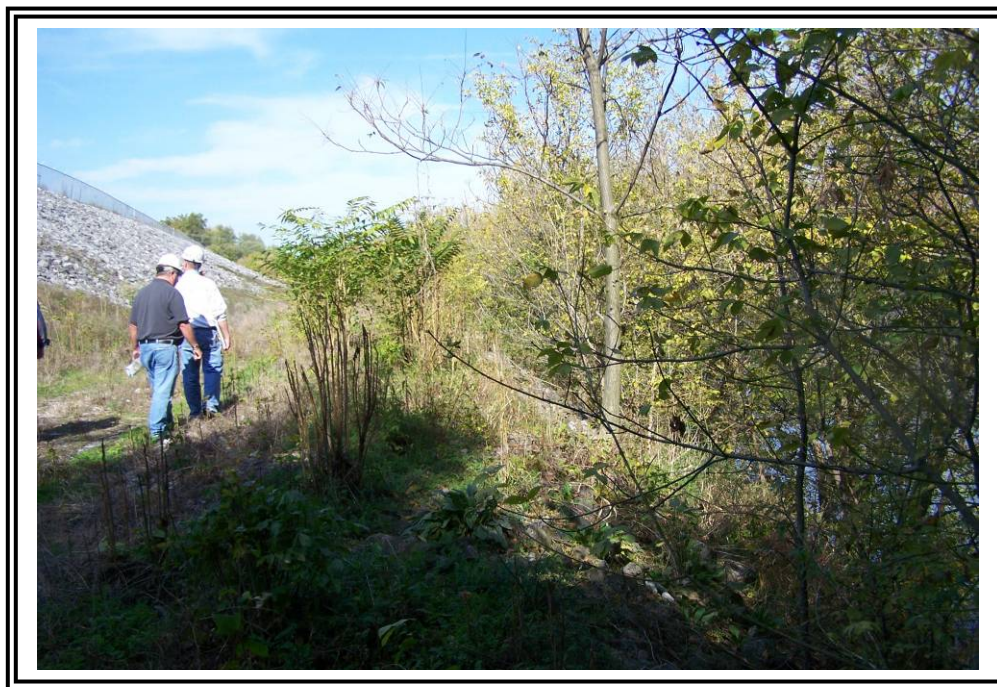
9

Trees growing in stone buttress on east dike of Pond #3, looking north.

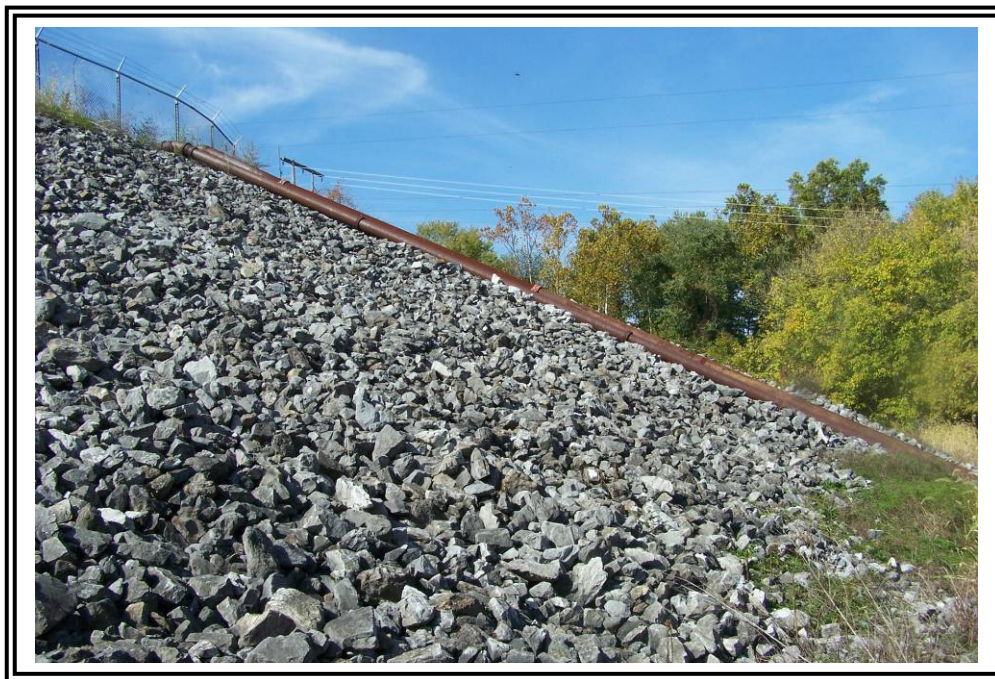
12

Sluice lines from R Paul Smith Station at northeast corner of Pond #3 service both Pond #3 and Pond #4. Hardened steel line to dike crest and are replaced approximately every 15 years as routine maintenance.

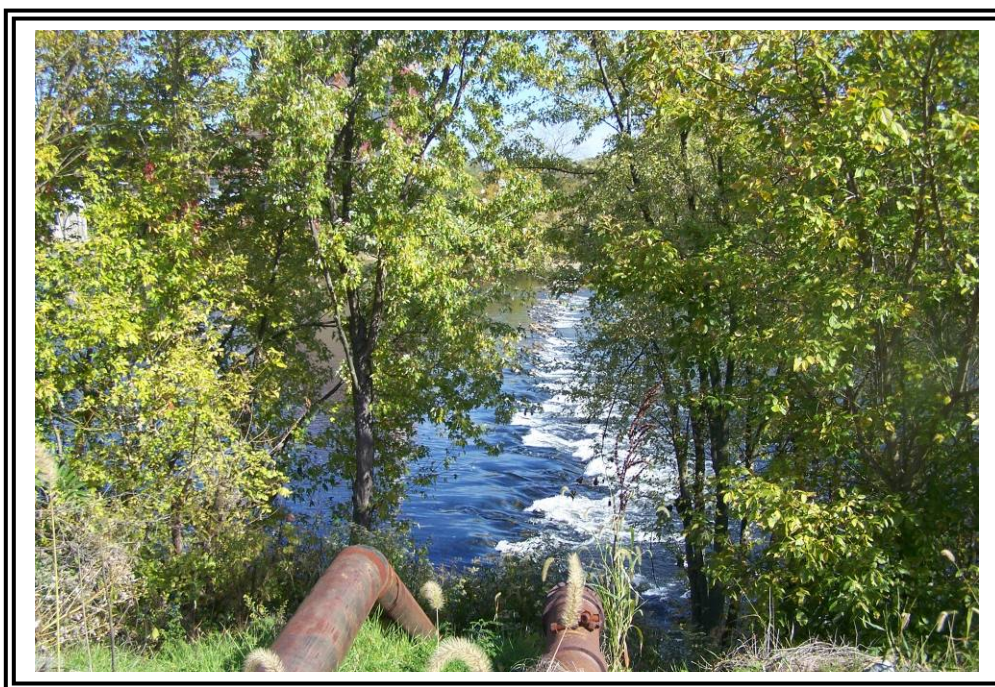
13

Slice lines from R Paul Smith Station traverse the Potomac River are hardened steel and protected with rip rap. The sluice lines are replaced approximately every 15 years as routine maintenance.

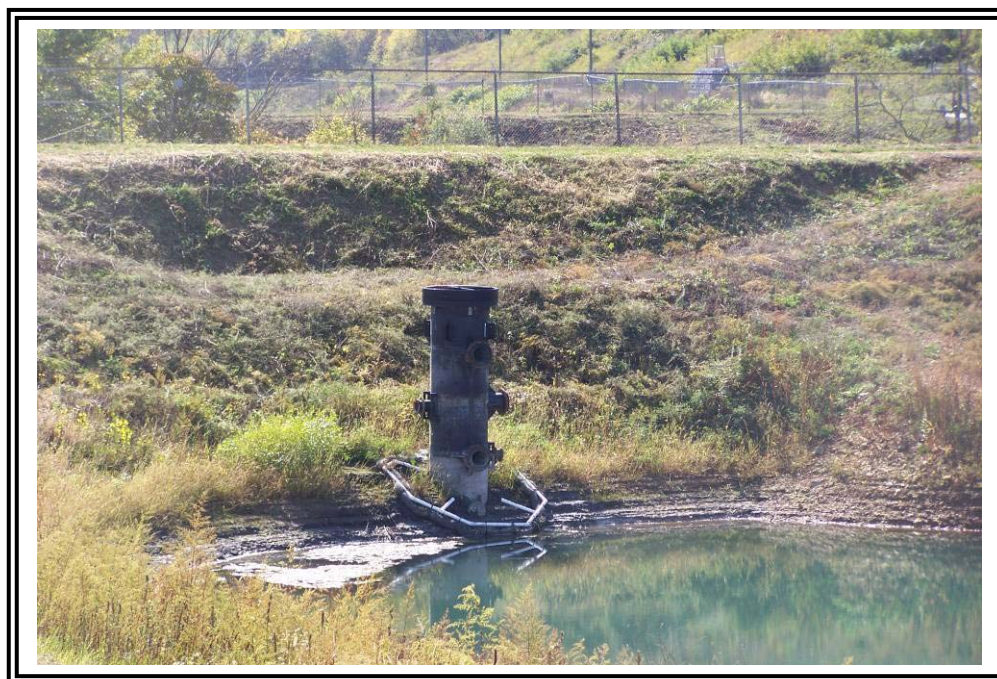
16

Upstream slope of south dike of Pond #3 looking south and decant structure.  
Bench is remnant of an access road built when the decant structure was replaced in 1997.

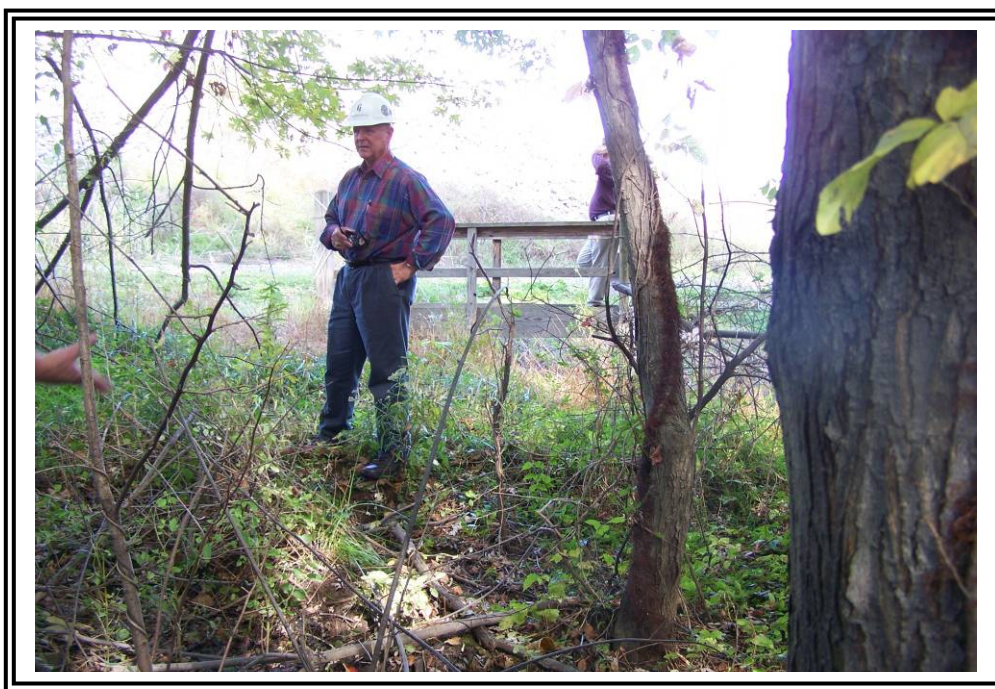
An area of possible seepage has been noted and observed in past inspection reports about 35 feet from the toe of the south dike near the outlet pipe discharge point. This area is shown in Photos 21 and 22. CHA did not observe flow or deposition of sediment in the seepage area, and Allegheny Energy indicated that it is likely related to natural drainage between Ponds #3 and #4, but that they had not definitively determined this so they continue to make observations as if it were seepage. The ground surface in this seepage area is about 4 feet below the elevation of standing water in the recently dredged pond that was observed in the pond during CHA's visit.

Possible (and previously noted) seepage area south of south dike of Pond #3 looking north.  
Possibly related to natural drainage between Ponds #3 and #4.

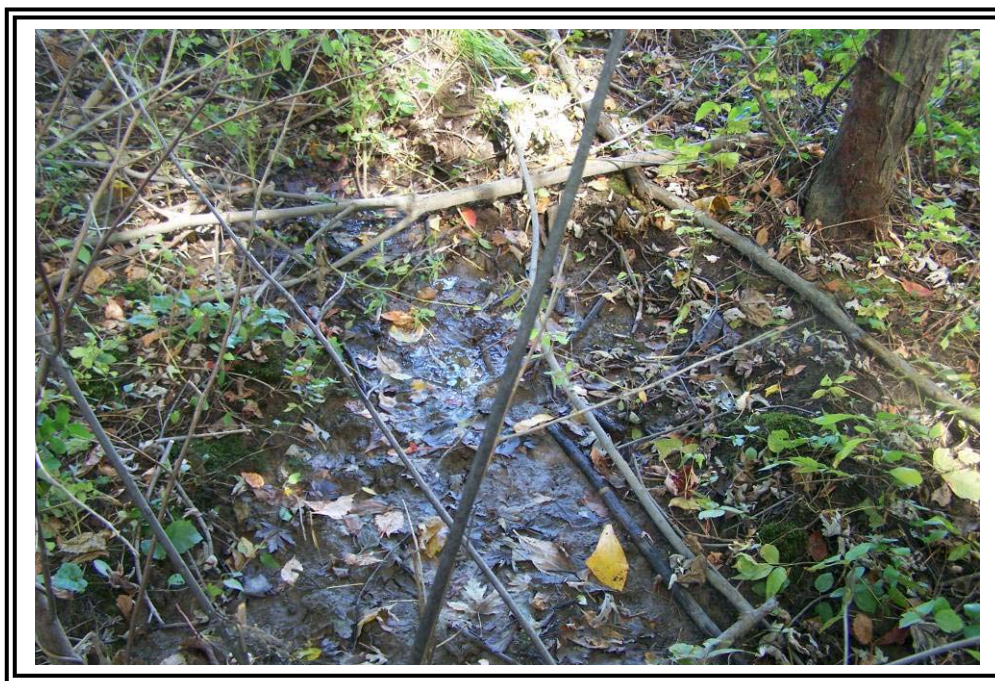
22

Close up of possible seepage area. No obvious flow and no observed deposition of sediment.

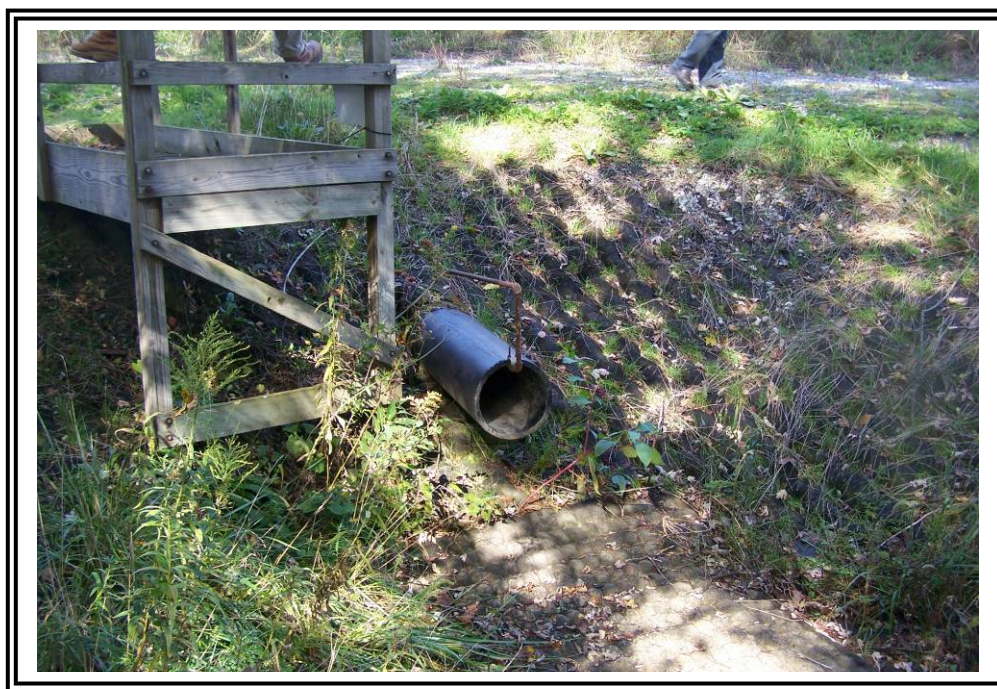
23

Outlet pipe from the decant structure. Pond currently dewatered/dredged below the decant elevation.

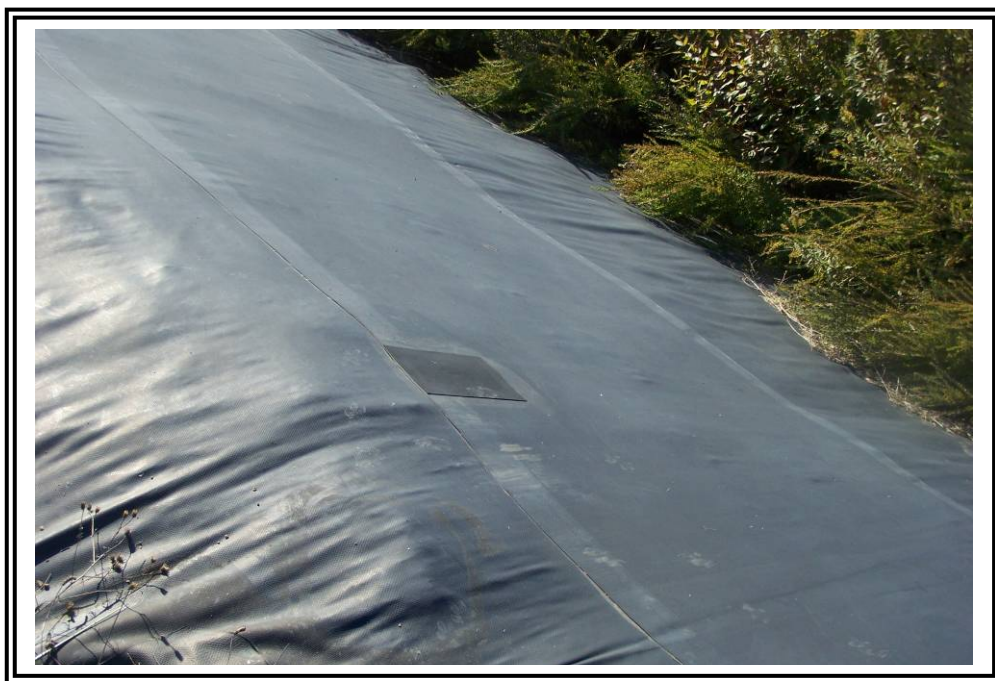
30

Routine maintenance includes patching holes on the hypalon liner created by animals walking on the liner.

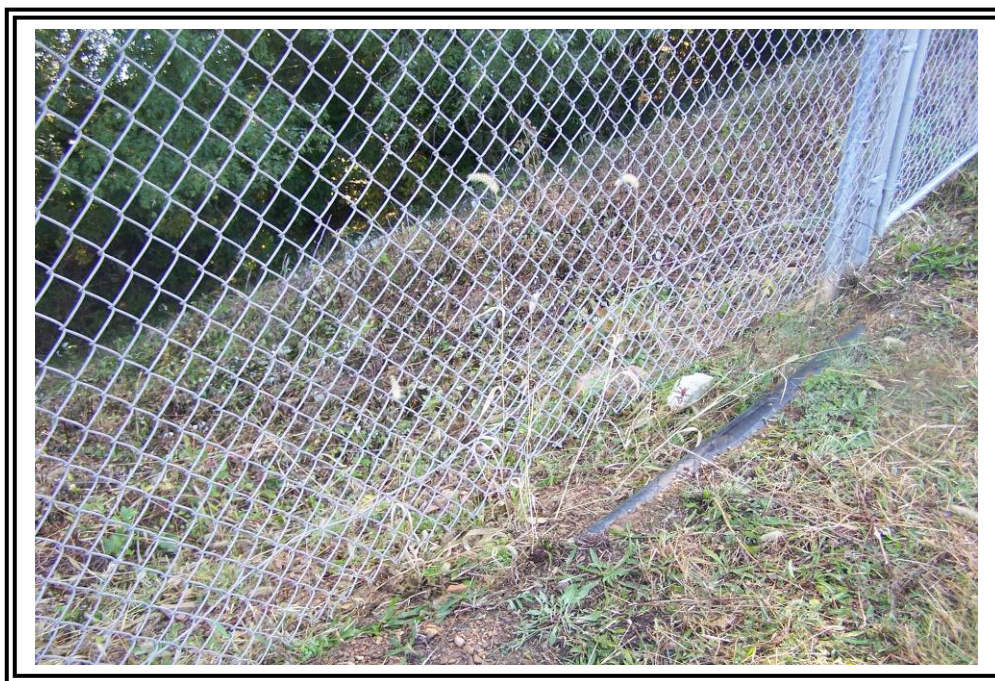
36

- Several areas of surface erosion and sloughing were observed. Near the northeast corner, surface erosion has occurred at the fence line as shown in Photo 36. This feature was noted in previous inspection reports and according to Allegheny Energy personnel, has remained unchanged in many years. A similar area of surface erosion was noted near location marking tag #30. Between marking tags #56 and 57, a clump of woody vegetation stumps appeared to be inhibiting sheet flow along the slope surface but rather forcing erosion rills to develop around it.

Surface erosion at downstream slope/crest on east dike at Pond #4.  
This erosion has been noted in previous inspection reports and has not changed in many years.

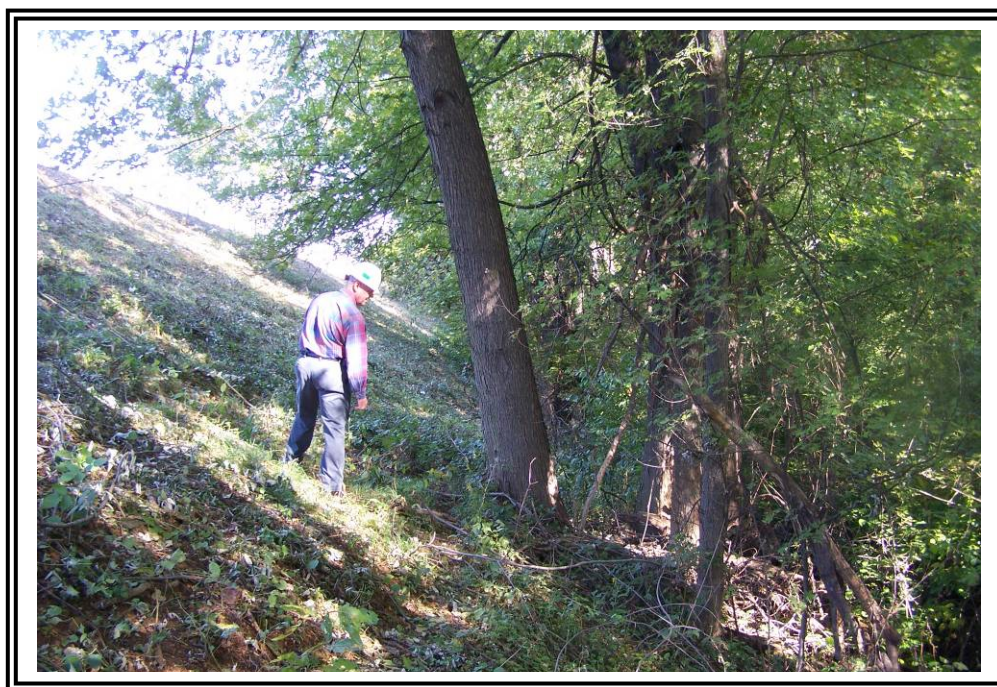
37

- The natural slope between the toe of the Ash Pond #4 dike and the Potomac River is covered with trees. For the most part, these trees start at the toe of the dike. However, in a few locations, such as that shown in Photo 37, large trees are actually within the toe of the east dike. Low hanging branches from these trees beyond the toe of the dike are encroaching on the dike as shown in Photo 40. Small shrubs were observed on the south dike as shown in Photo 47.

Large tree at toe of east dike slope at Pond #4, looking north.

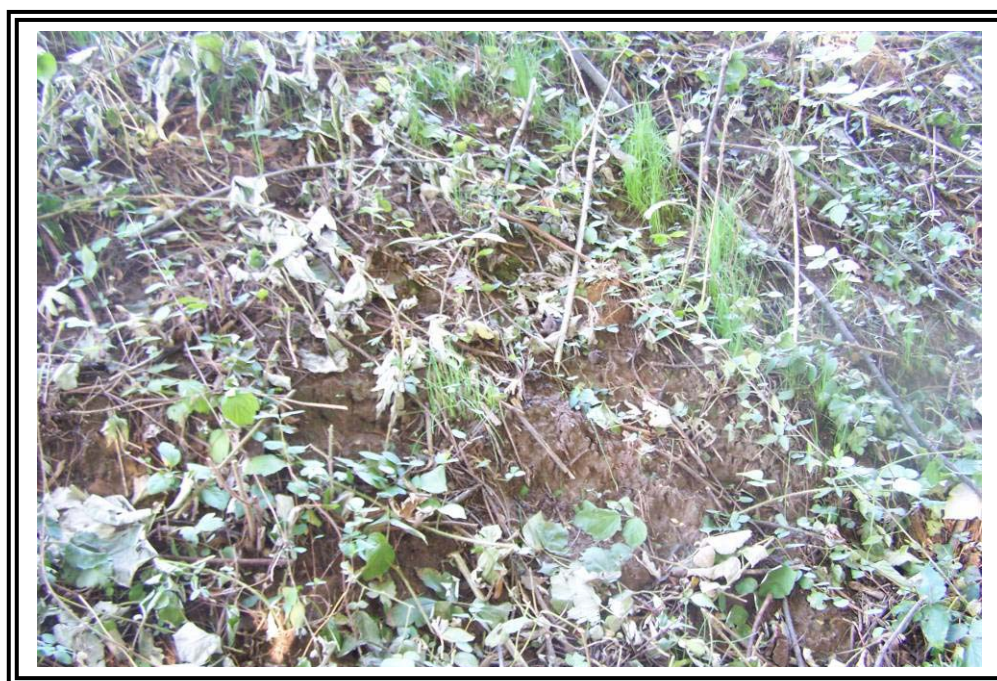
38

Erosion/surficial sloughing on east dike at Pond #4. Surface soil soft.

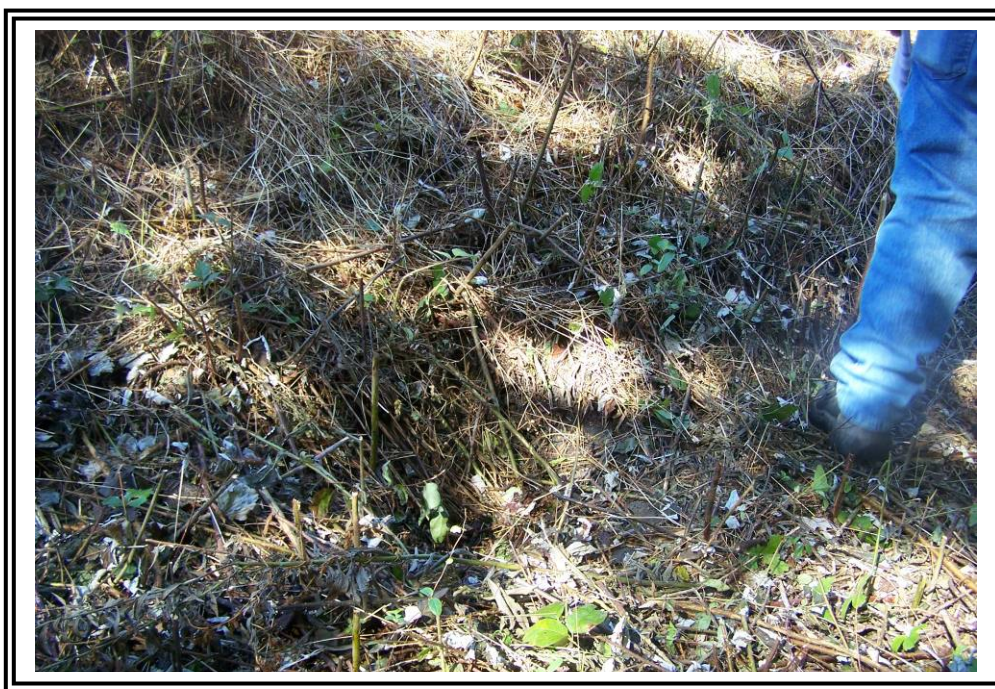
39

- Filled in rodent holes were observed on the downstream slopes as shown in Photo 39. Allegheny Energy described burrowing rodents as an ongoing problem at this site, and that they routinely fill rodent burrows as found, and each spring perform rodent control

Filled in rodent holes on east dike at Pond #4. Rodent control is performed each spring and observed holes are filled as part of routine maintenance of the dikes.

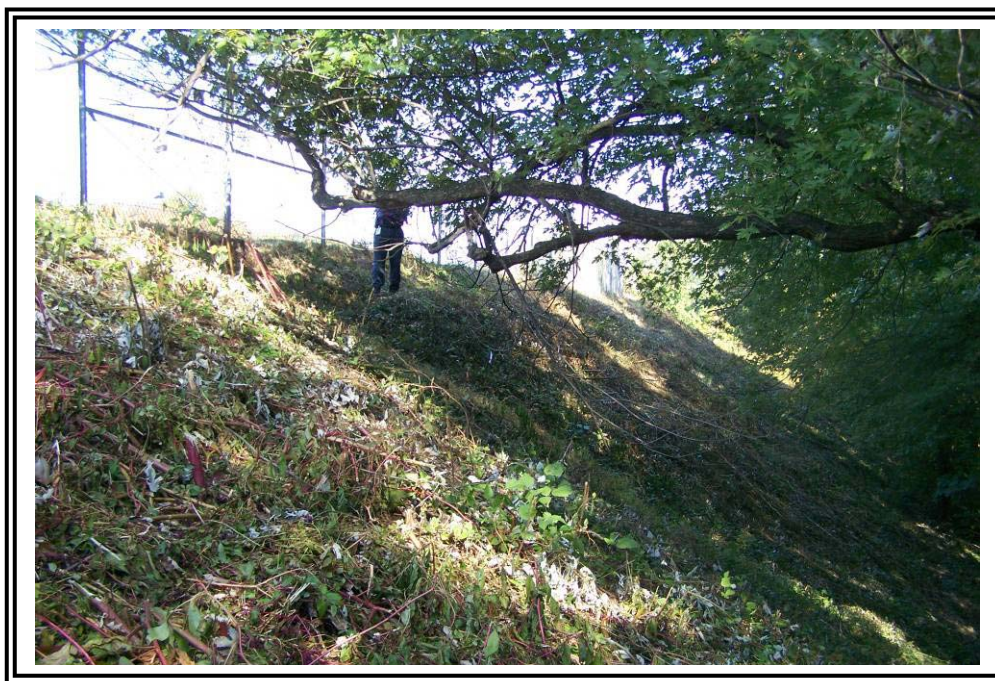
40

Adjacent tree branches near east dike slope at Pond #4.

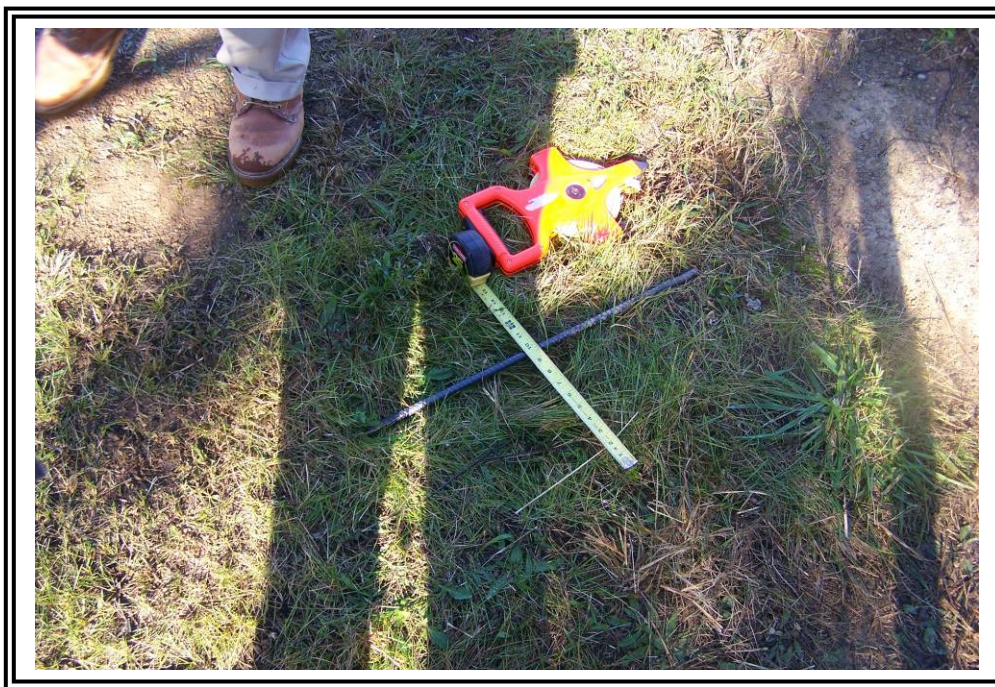
41

Depression about 2 inches deep and 18 inches in diameter on crest of east dike in approximate area of outlet pipe.

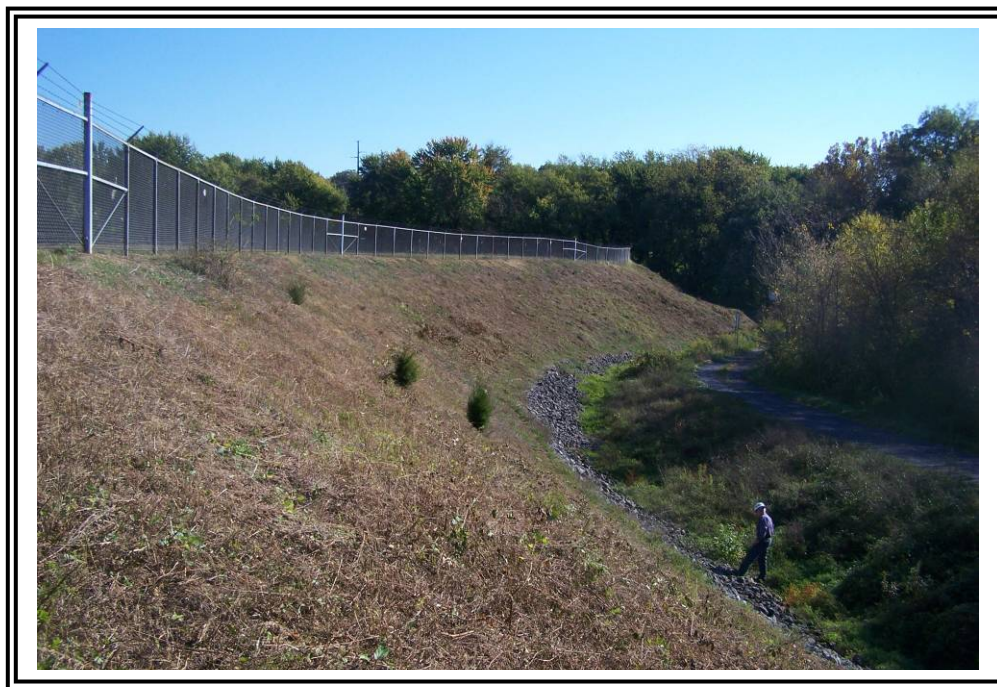
47

Small trees on downstream slope on south dike at Pond #4, looking east.

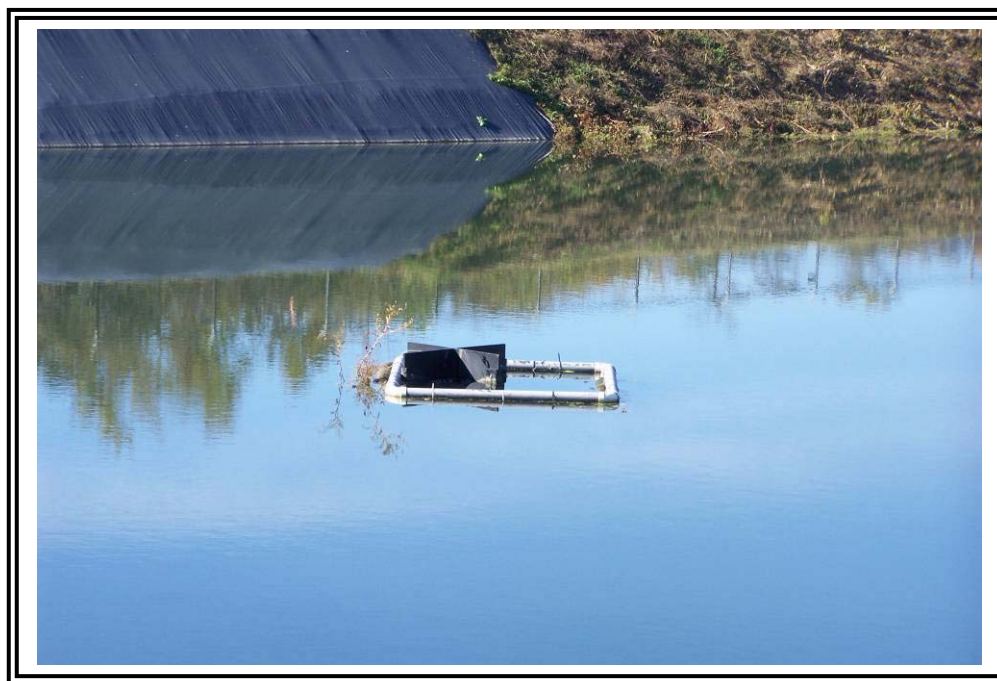
48

Ash Pond #4 discharges through an HDPE riser in the southeast corner of the pond as seen in Photo 48. Allegheny Energy indicated this structure was the same as the one observed in Ash Pond #3. At the time of CHA's site visit the water level in Ash Pond #4 was at the top crest of the decant structure. The decant structure discharges beneath the south dike through a 14-inch diameter HDPE sliplined into the original CMP pipe as described in Section 1.3.2. The discharge end of the pipe is seen in Photo 49 and discharges into a rip rap lined channel to the Potomac River as shown in Photo 50.

Decant structure in the southeast corner of Pond #4.
