Assessment of Dam Safety Coal Combustion Surface Impoundments (Task 3) Final Report

Allegheny Energy

R. Paul Smith Station

April 21, 2010

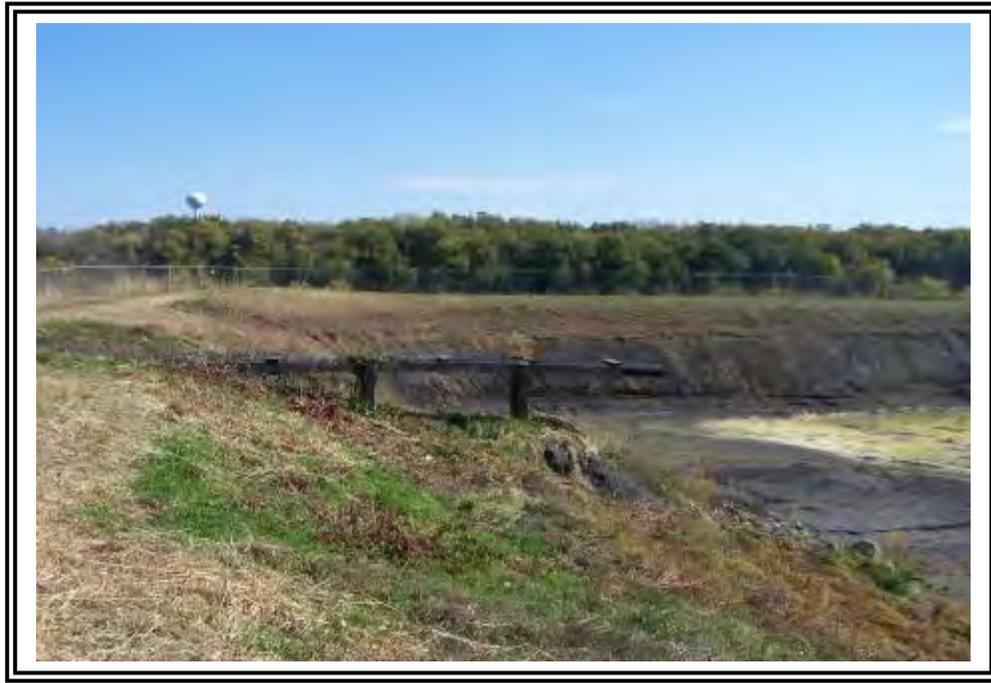
3

Upstream slope of north dike at Pond #3, looking east.
Irregularity of slope related to remaining ash from recent dredging operations.

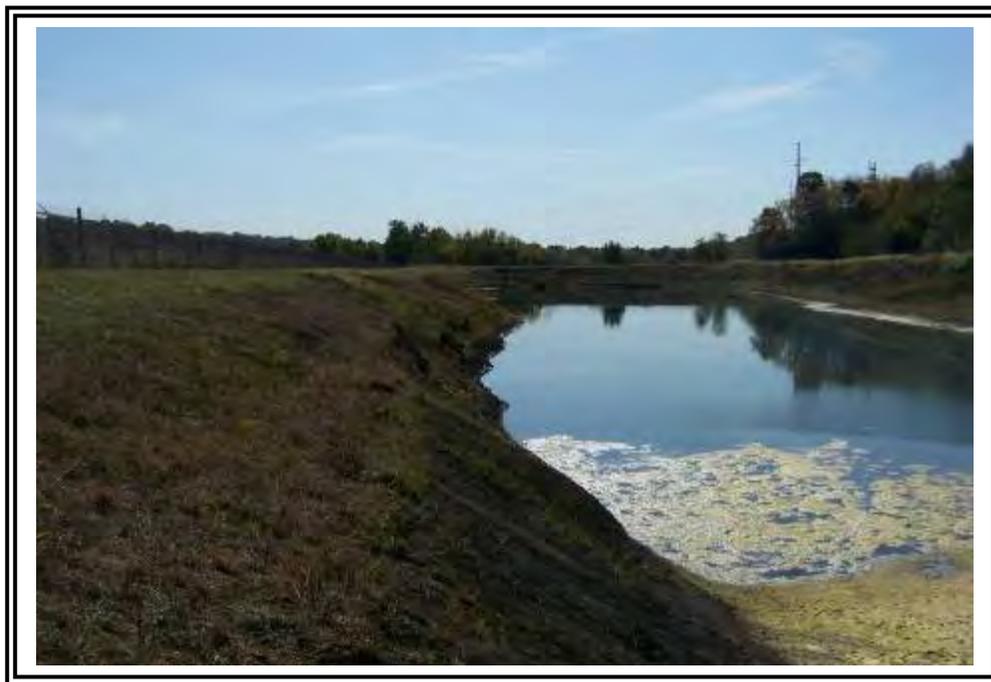
7

Upstream slope of east dike at Pond #3, looking south. Irregularity in slope related to over excavation during recent dredging operations.

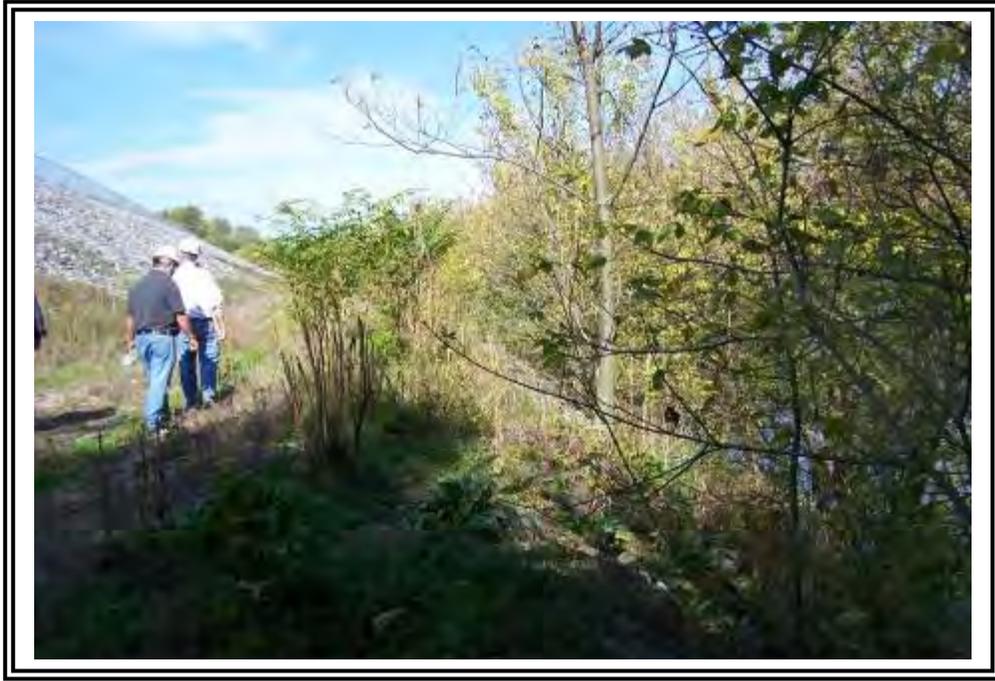
9

Trees growing in stone buttress on east dike of Pond #3, looking north.

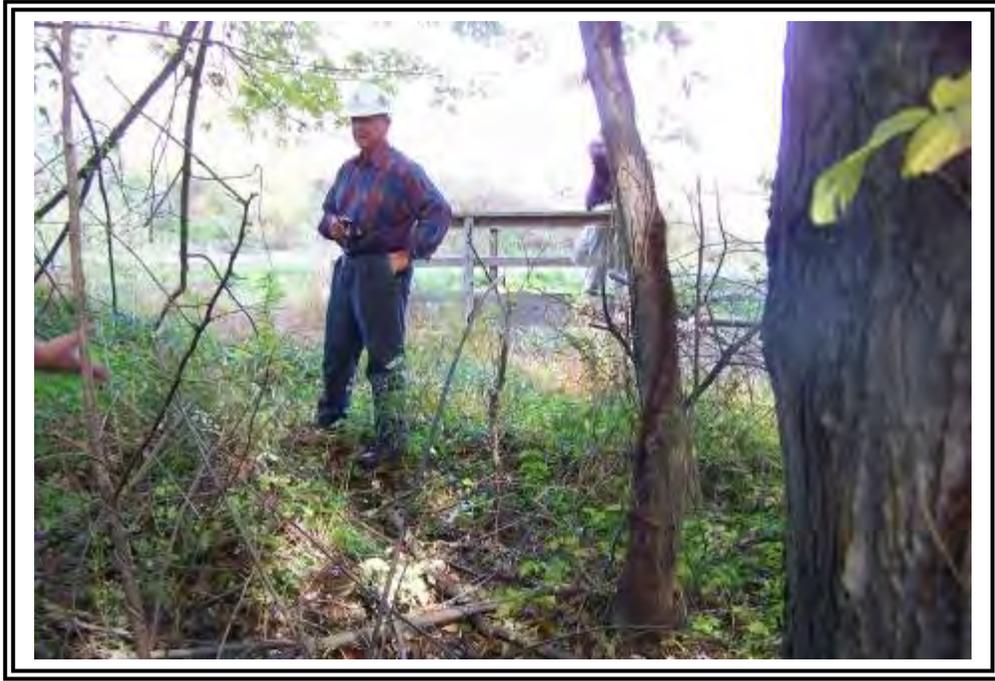
An area of possible seepage has been noted and observed in past inspection reports about 35 feet from the toe of the south dike near the outlet pipe discharge point. This area is shown in Photos 21 and 22. CHA did not observe flow or deposition of sediment in the seepage area, and Allegheny Energy indicated that it is likely related to natural drainage between Ponds #3 and #4, but that they had not definitively determined this so they continue to make observations as if it were seepage. The ground surface in this seepage area is about 4 feet below the elevation of standing water in the recently dredged pond that was observed in the pond during CHA's visit.

Possible (and previously noted) seepage area south of south dike of Pond #3 looking north. Possibly related to natural drainage between Ponds #3 and #4.

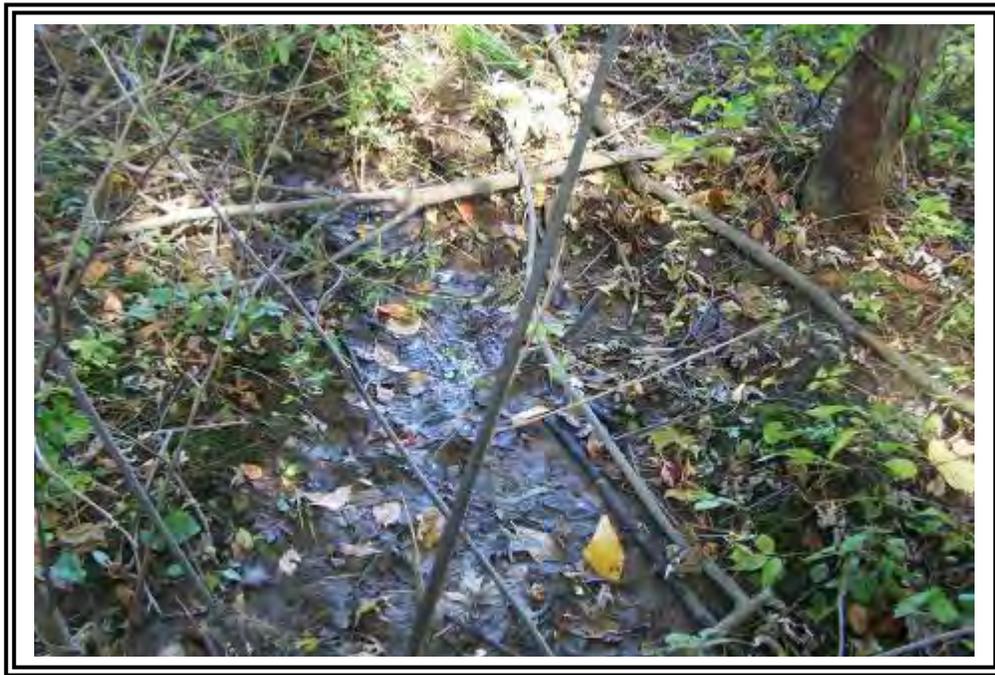
22

Close up of possible seepage area. No obvious flow and no observed deposition of sediment.

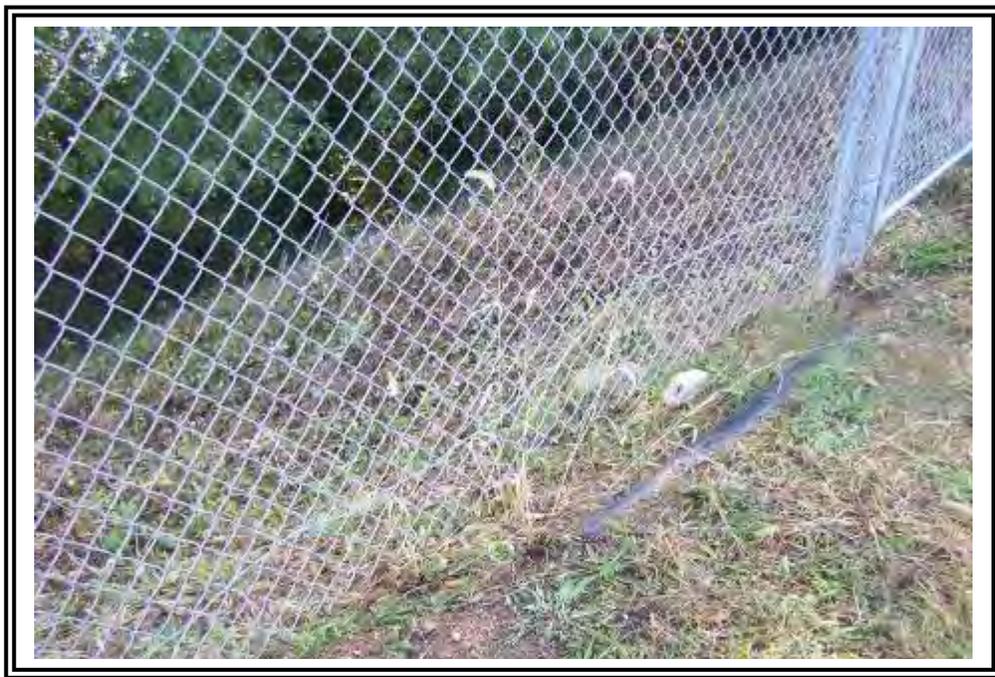
36

- Several areas of surface erosion and sloughing were observed. Near the northeast corner, surface erosion has occurred at the fence line as shown in Photo 36. This feature was noted in previous inspection reports and according to Allegheny Energy personnel, has remained unchanged in many years. A similar area of surface erosion was noted near location marking tag #30. Between marking tags #56 and #57, a clump of woody vegetation stumps appeared to be inhibiting sheet flow along the slope surface but rather forcing erosion rills to develop around it.

Surface erosion at downstream slope/crest on east dike at Pond #4.
This erosion has been noted in previous inspection reports and has not changed in many years.

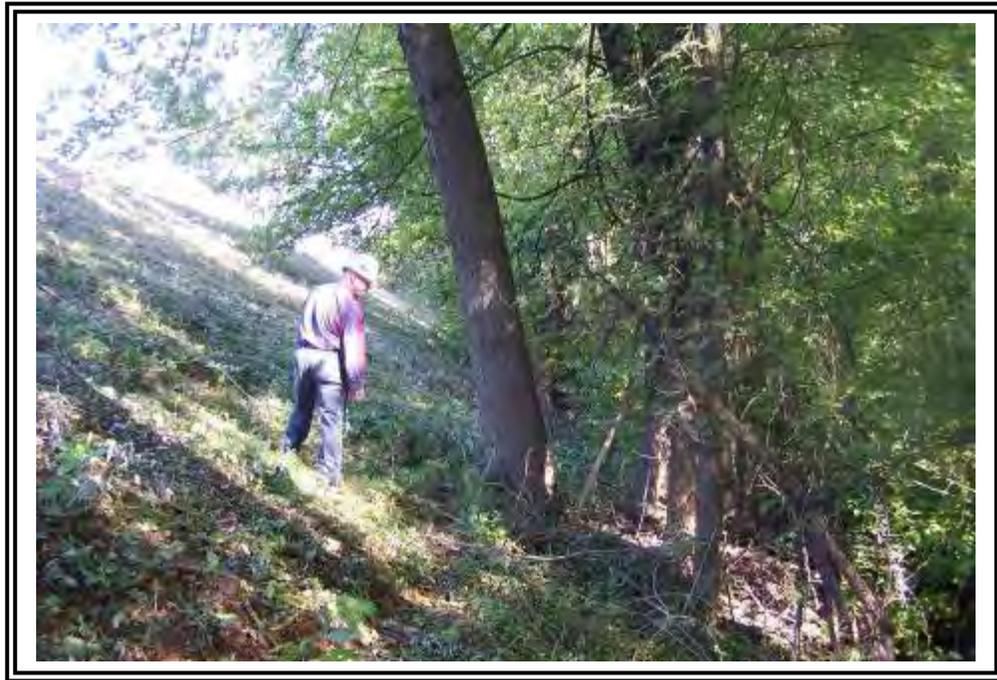
37

- The natural slope between the toe of the Ash Pond #4 dike and the Potomac River is covered with trees. For the most part, these trees start at the toe of the dike. However, in a few locations, such as that shown in Photo 37, large trees are actually within the toe of the east dike. Low hanging branches from these trees beyond the toe of the dike are encroaching on the dike as shown in Photo 40. Small shrubs were observed on the south dike as shown in Photo 47.

Large tree at toe of east dike slope at Pond #4, looking north.

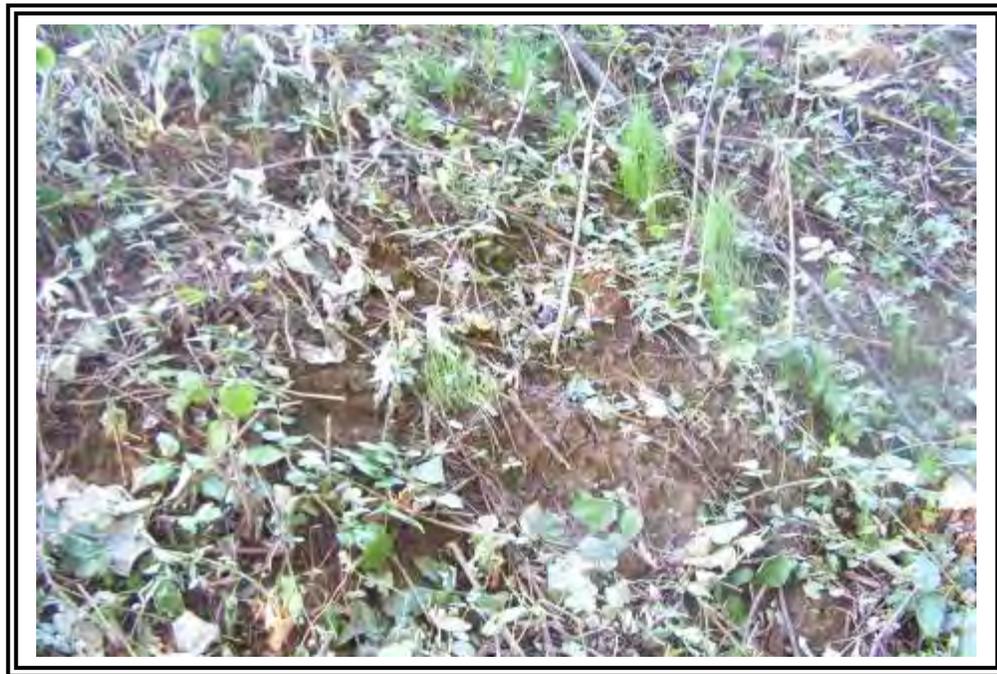
38

Erosion/surficial sloughing on east dike at Pond #4. Surface soil soft.

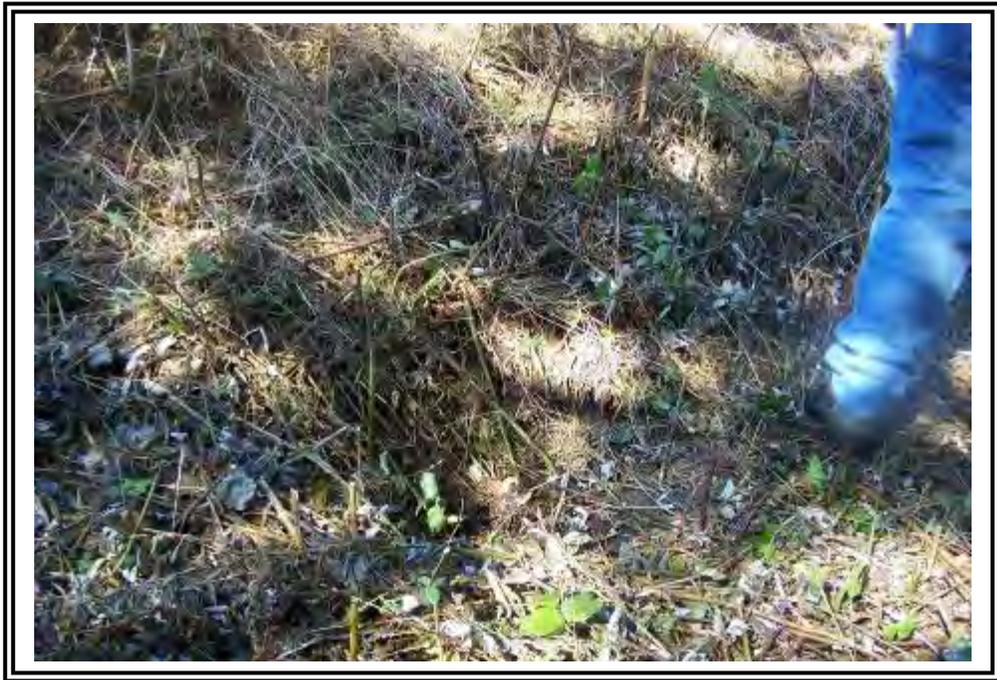
39

- Filled in rodent holes were observed on the downstream slopes as shown in Photo 39. Allegheny Energy described burrowing rodents as an ongoing problem at this site, and that they routinely fill rodent burrows as found, and each spring perform rodent control

Filled in rodent holes on east dike at Pond #4. Rodent control is performed each spring and observed holes are filled as part of routine maintenance of the dikes.

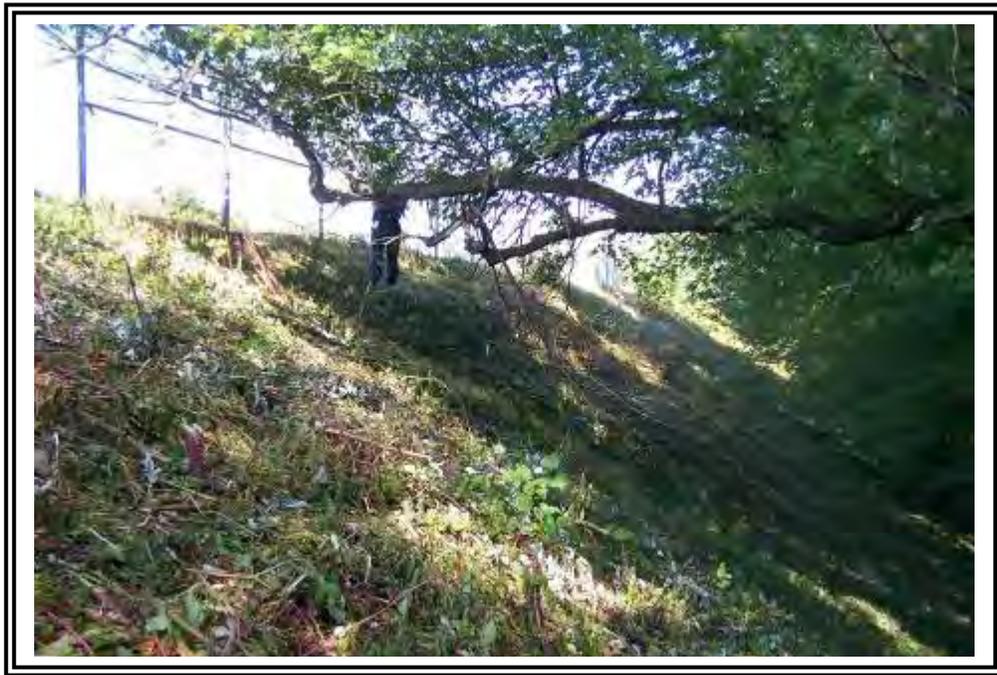
40

Adjacent tree branches near east dike slope at Pond #4.

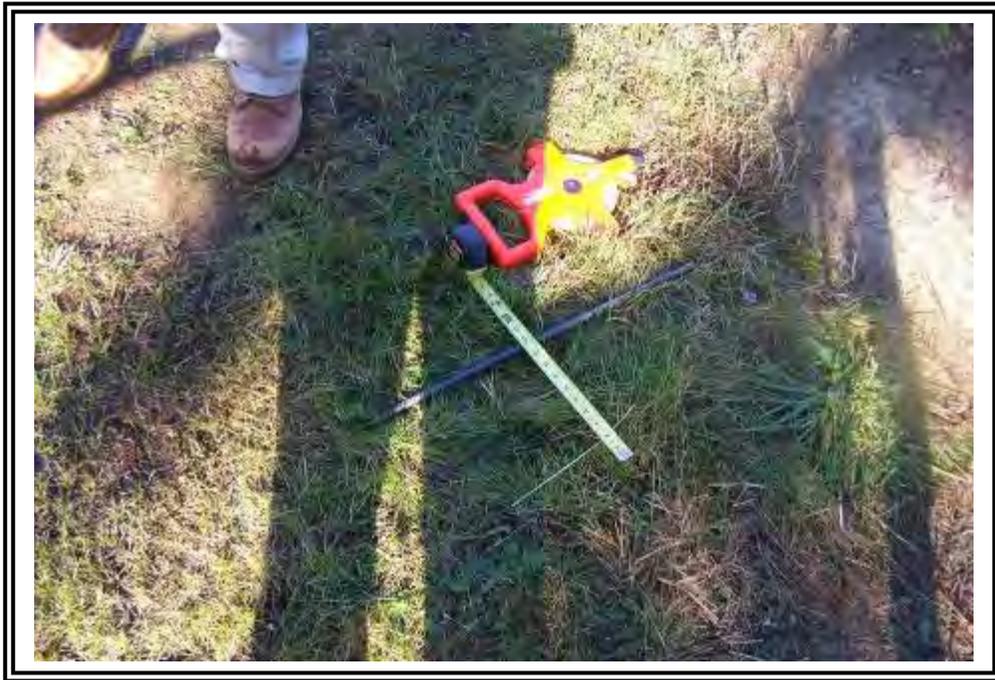
41

Depression about 2 inches deep and 18 inches in diameter on crest of east dike in approximate area of outlet pipe.

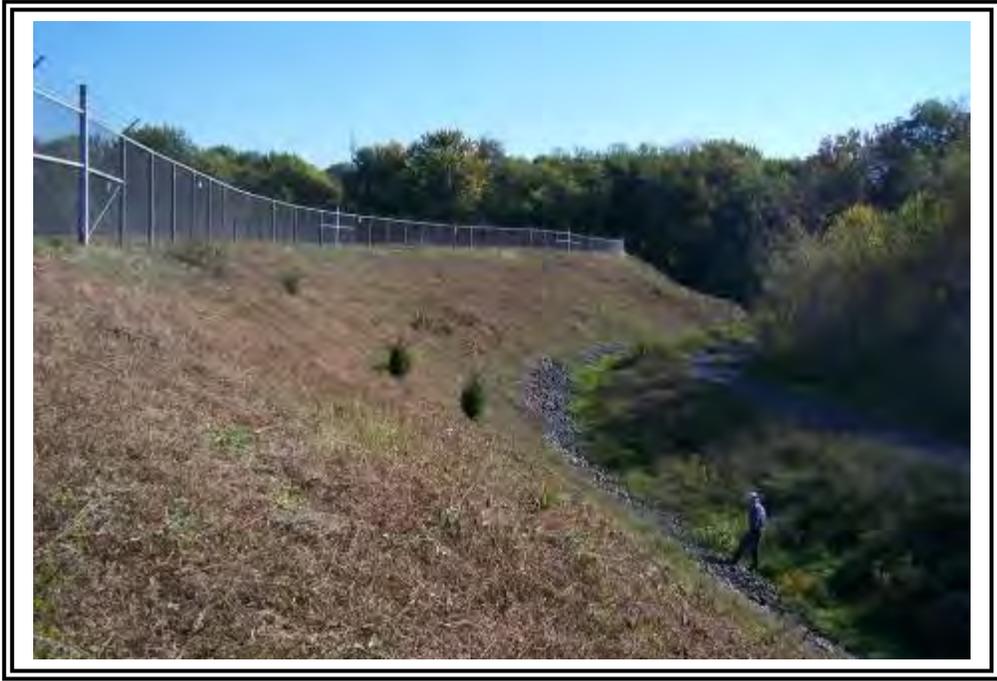
47

Small trees on downstream slope on south dike at Pond #4, looking east.
