Dam Safety Assessment of CCR Impoundments

HATFIELD'S FERRY POWER STATION

March 4, 2013

Hatfield's Ferry Power Station

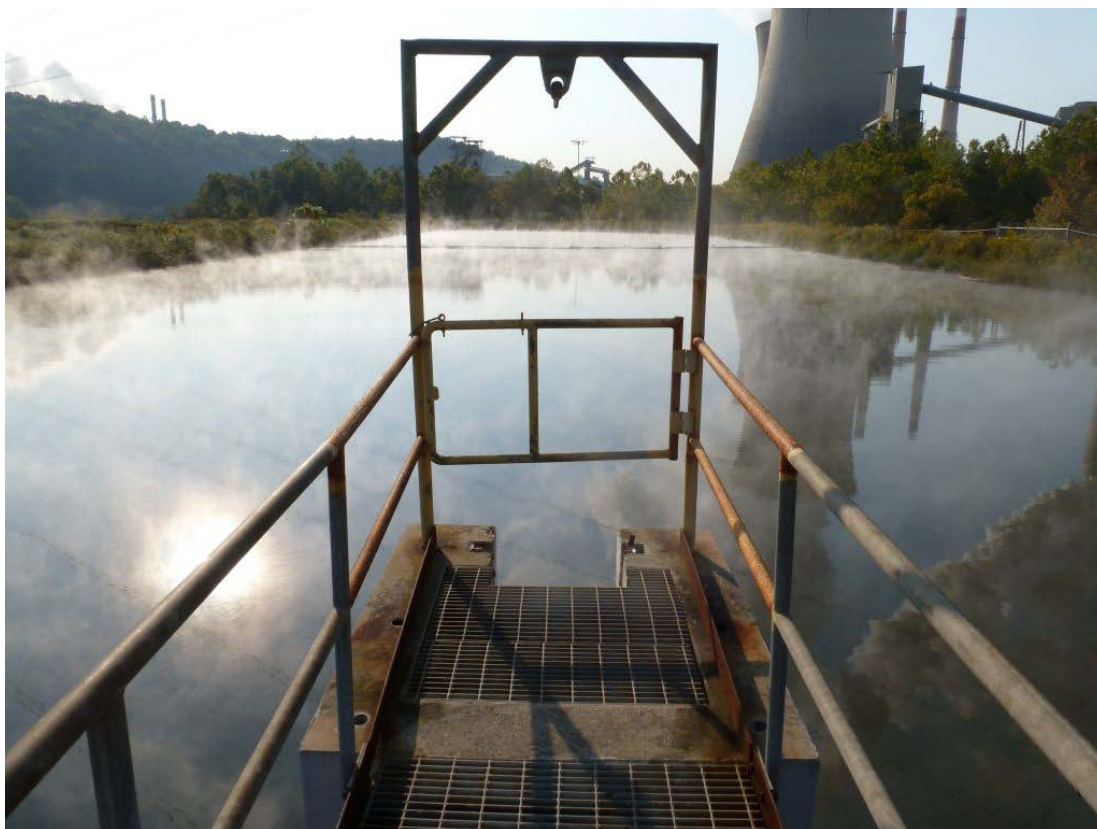
Photo Number:
1

Description:
Ash Settling
Basin 1 in
operation, view
from outlet
tower.

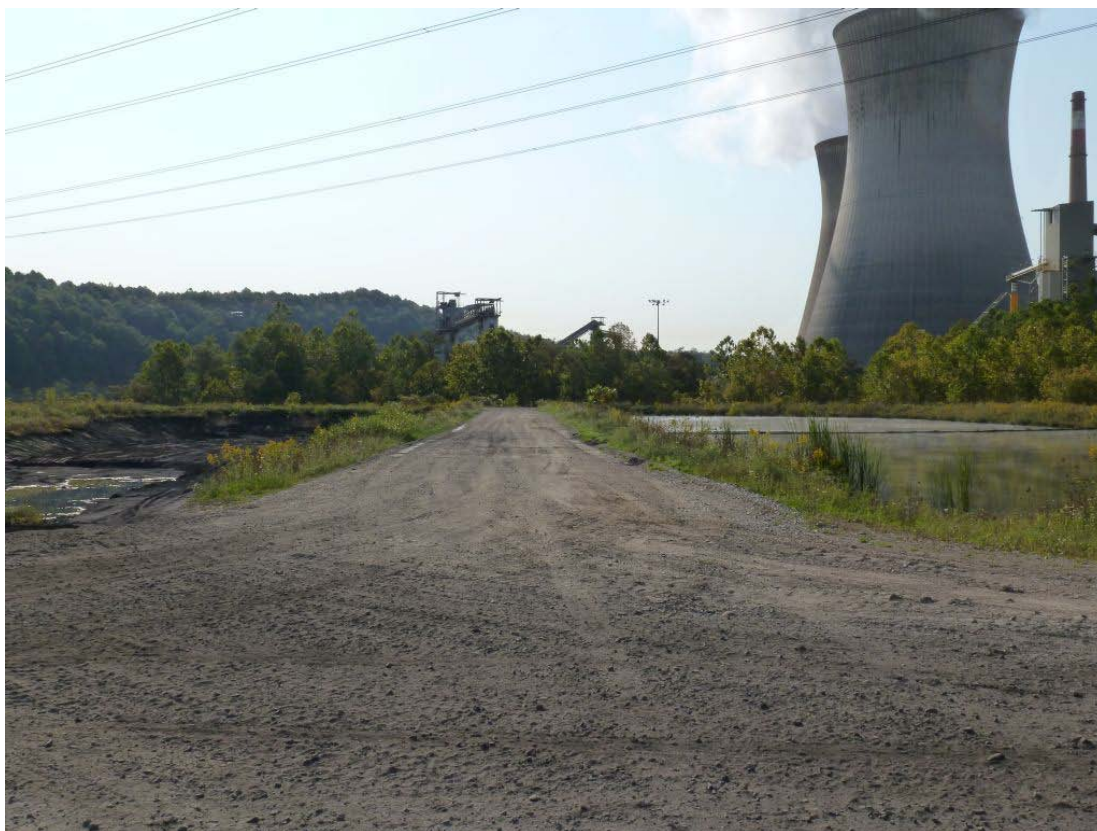
Photo Number:
2

Description:
Divider dike
between 2 Ash
Settling Basins.
Basin 1 in
operation on
right. Drained
Basin 2 on left.

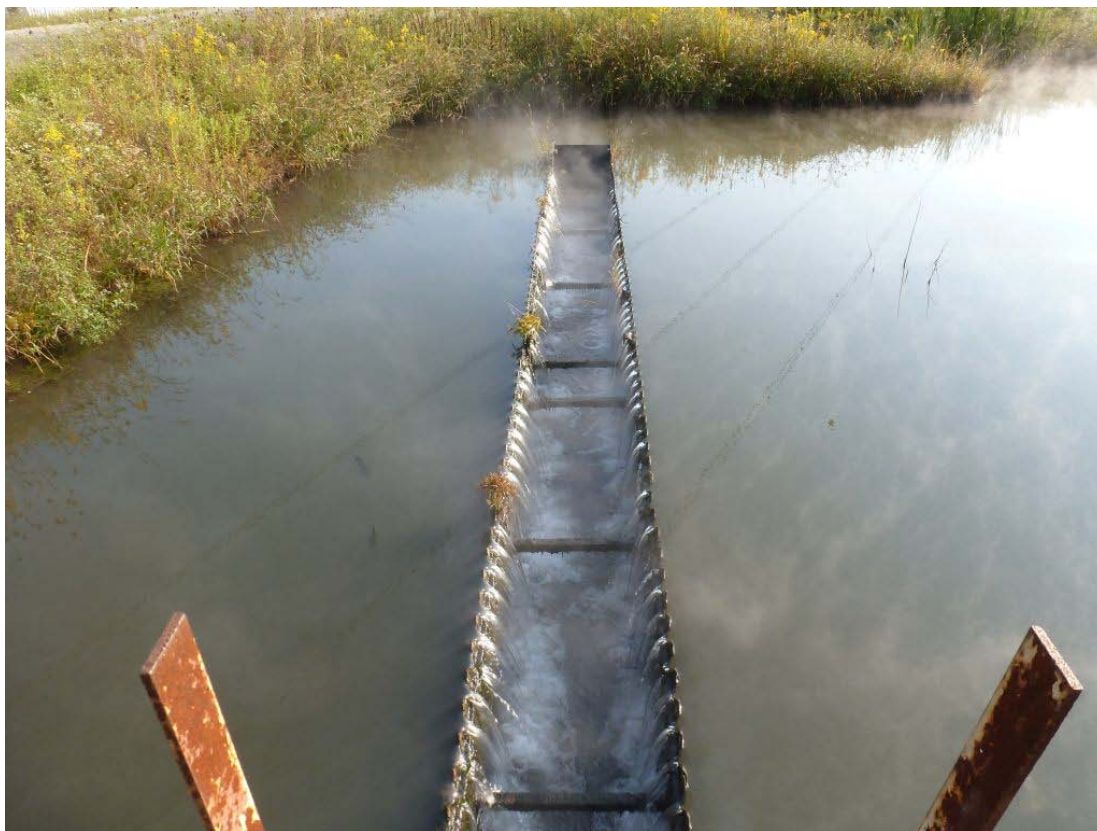
- Plant personnel stated that the adjustable stop plates for draining the lagoons are operational.
- Metal outflow weir troughs and other metal components were rusted, but the outlet works showed no other significant signs of wear.

Orientation:
NEDescription:
Weir trough in
operation in
Ash Settling
Basin 1.

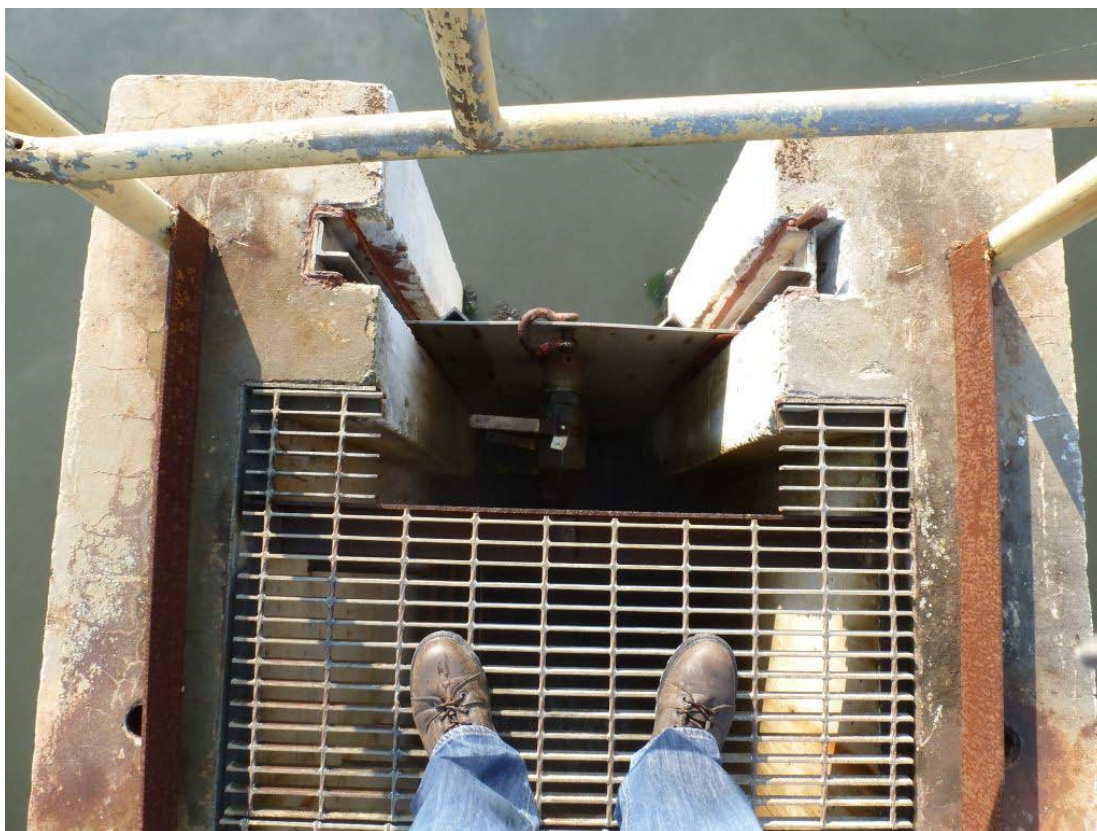
Date:
9/25/12Photo Number:
5Photographer:
DDWOrientation:
SEDescription:
Concrete outlet
tower with
adjustable stop
plate in Ash
Settling Basin 1.

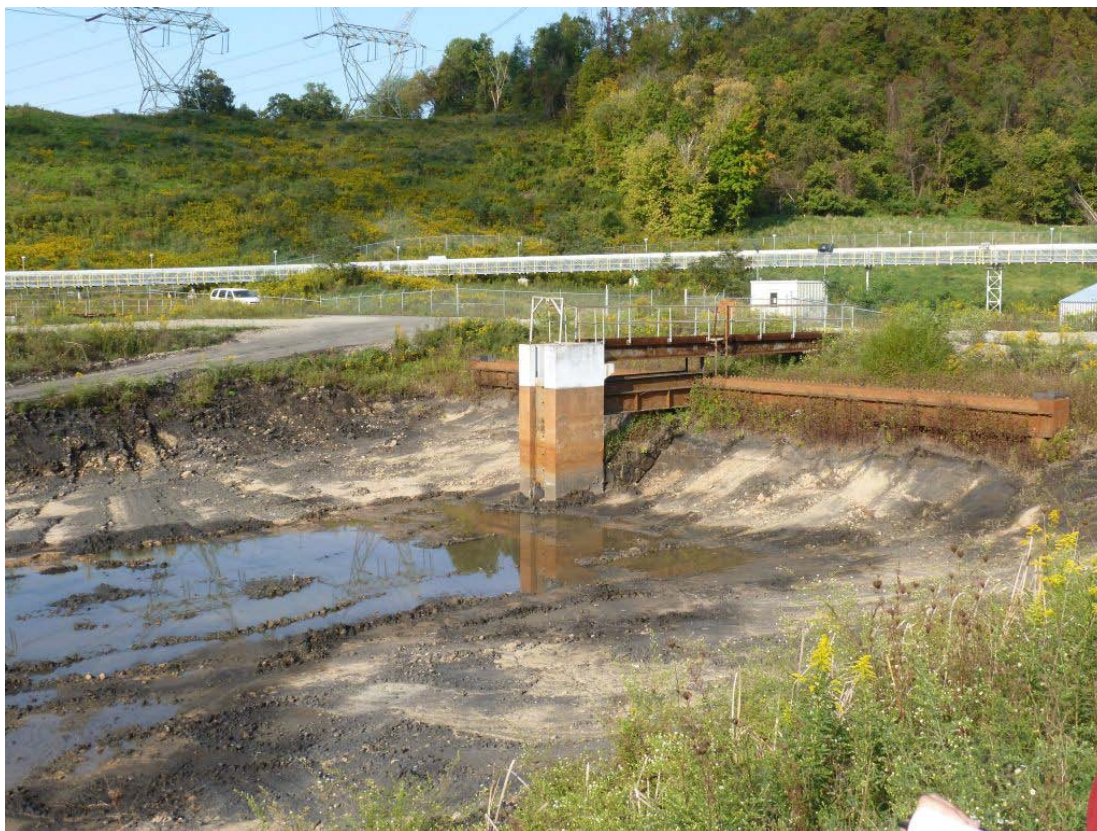
Orientation:
WDescription:
Ash Settling
Basin 2 bottom,
inboard slopes,
concrete outlet
tower, and weir
trough.

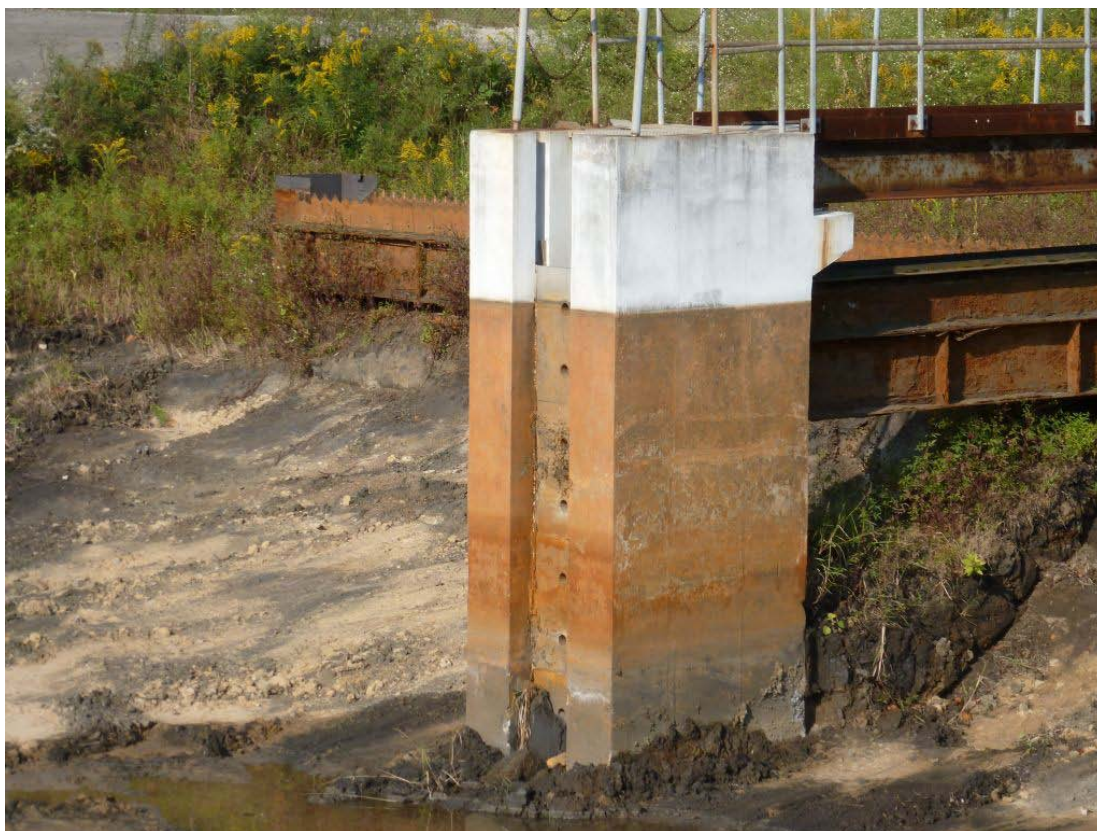
Date:
9/25/12Photo Number:
7Photographer:
DDWOrientation:
WDescription:
Exposed
concrete outlet
tower with
adjustable stop
plate in Ash
Settling Basin 2.

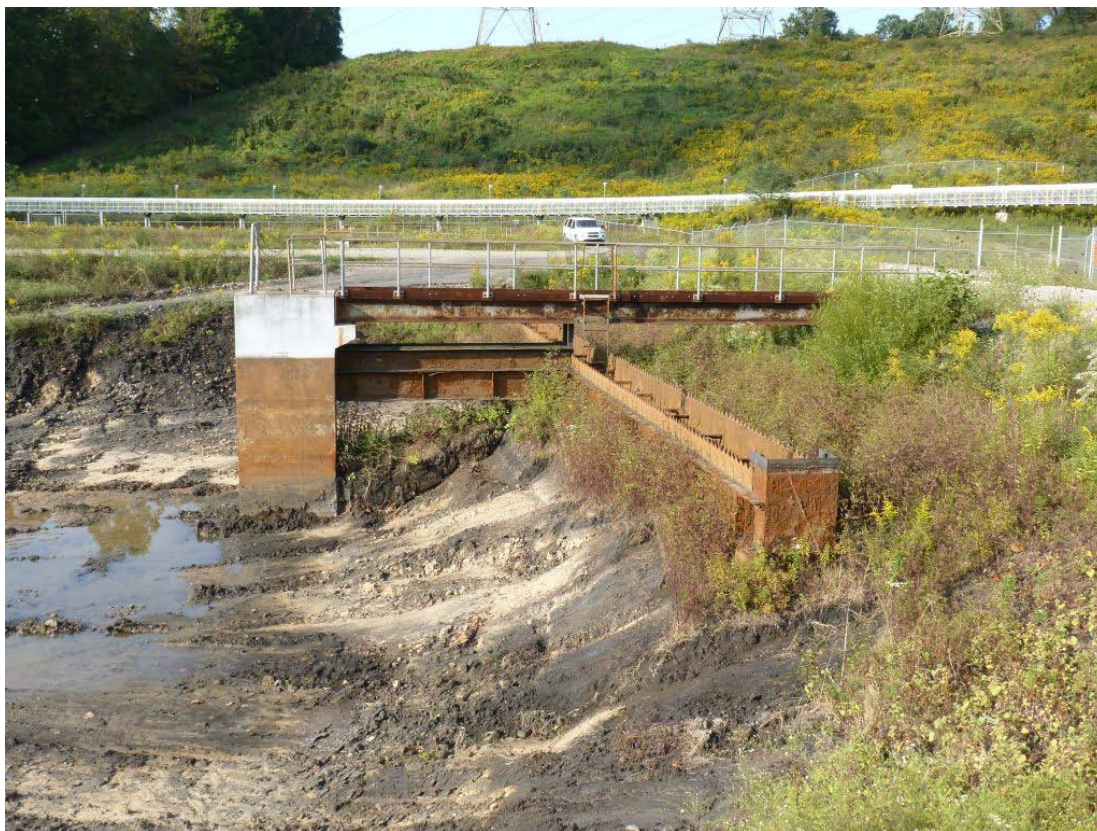
Photo Number:
9

Description:
Ash Settling
Basin 2 inboard
slopes near
concrete outlet
tower and weir
trough.

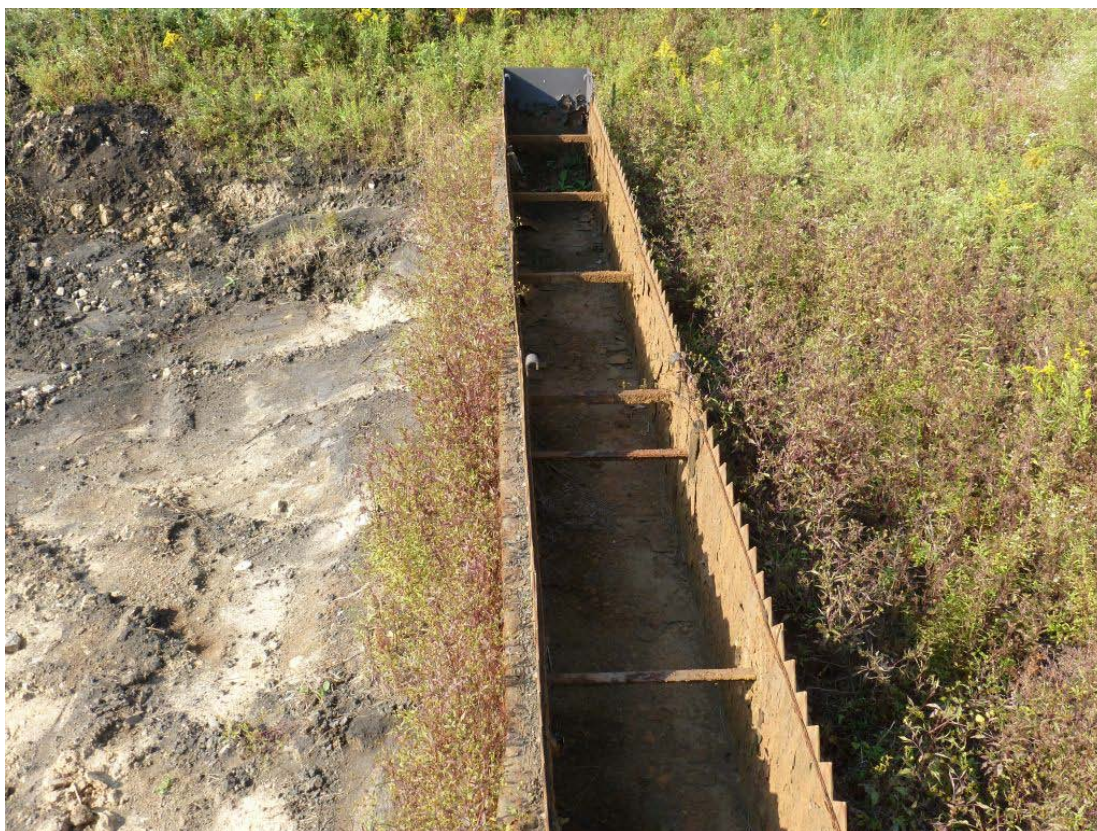
Photo Number:
10

Description:
Weir trough out
of operation in
Ash Settling
Basin 2.

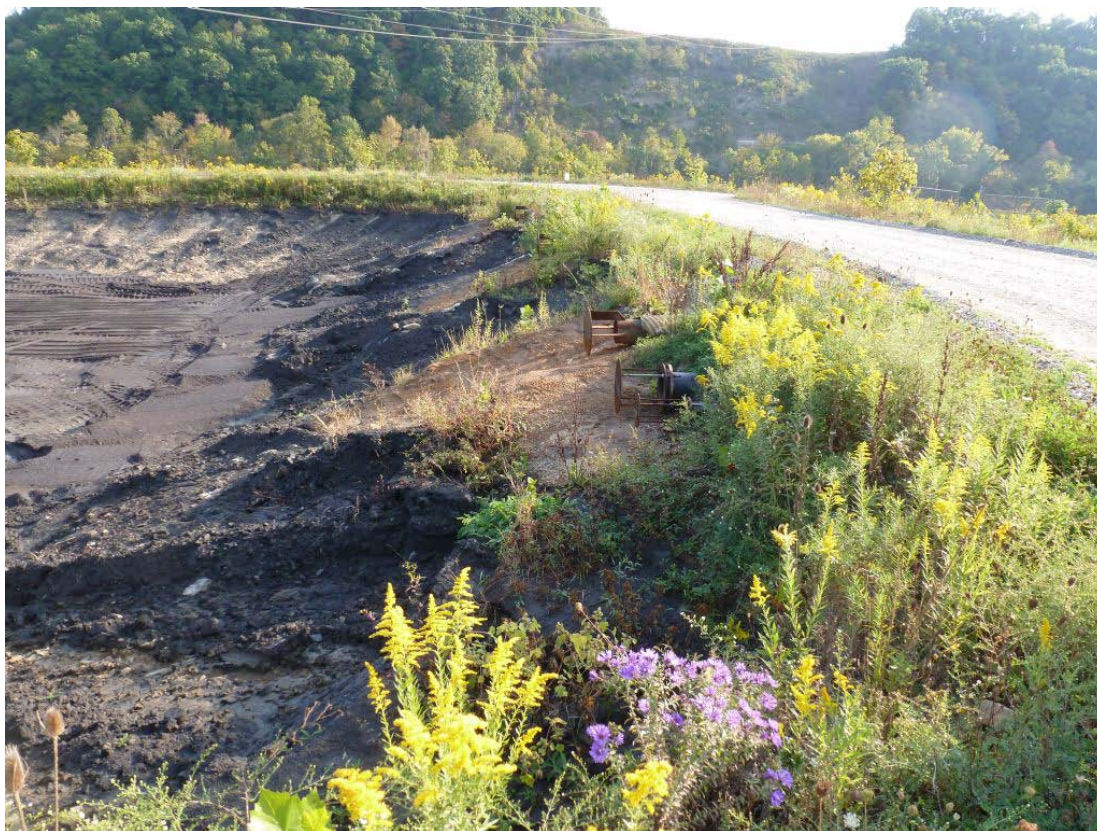
Inflow pipes on
inboard slope of
drained Ash
Settling Basin 2.

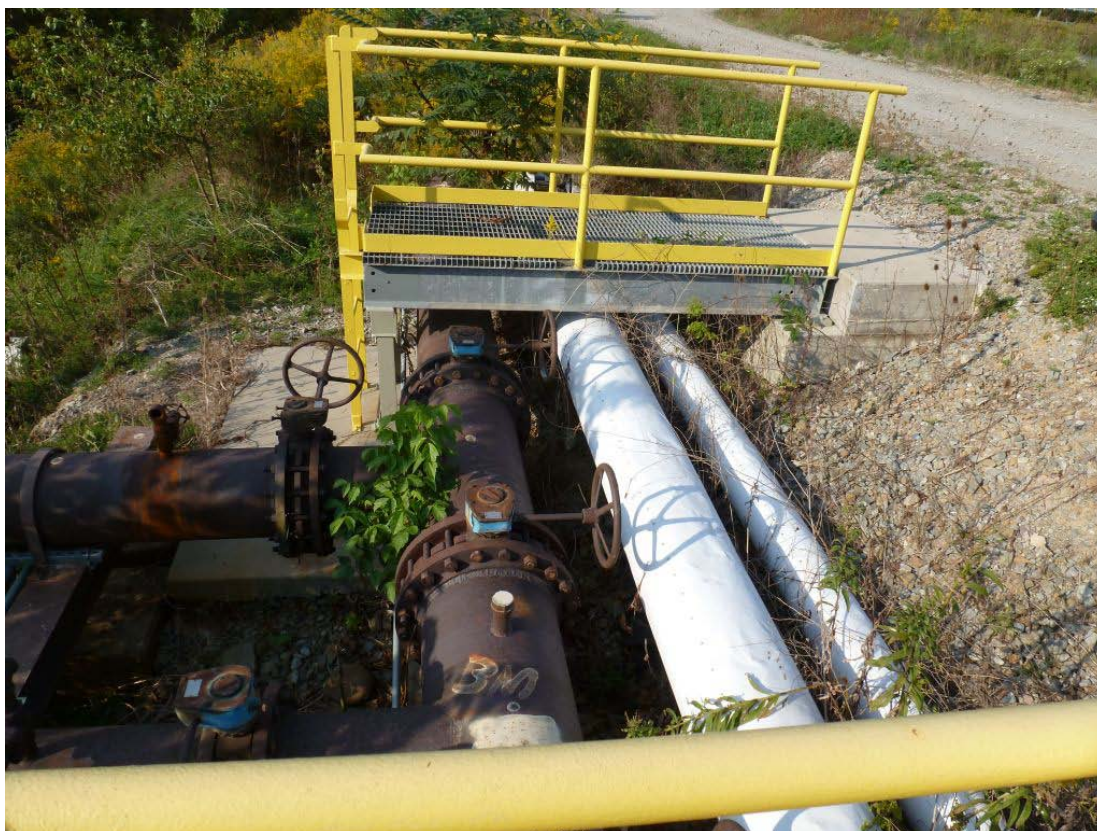
Ash Setting
Basin inflow
pipes and valves
near top of
southern
embankment
outboard slope.

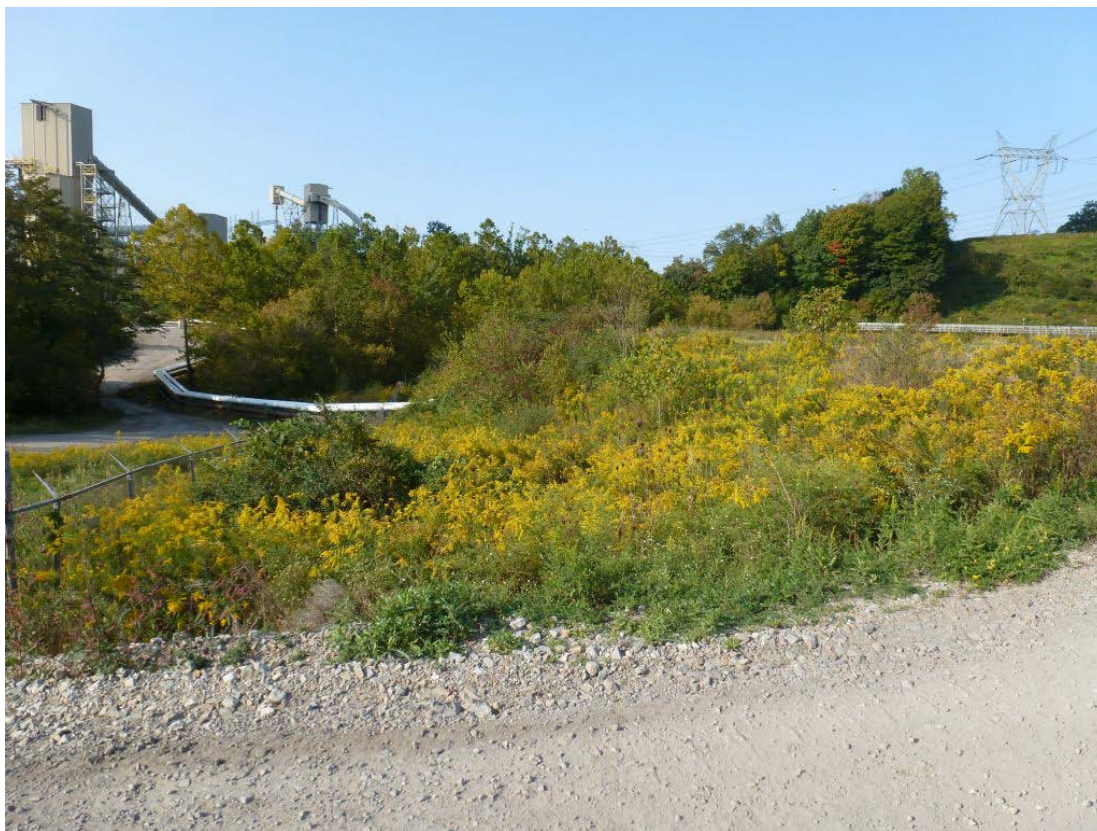
Access road and
southern
embankment of
Ash Settling
Basins.

- Cutting tall grass on the inboard slopes and maintaining a mowed condition so the slopes can be inspected.
- Clearing trees and shrubs on the southern embankment outboard slope, cutting tall grass and maintaining a mowed condition.
- Clearing any trees and shrubs on the remaining constructed portions of the outboard slopes, cutting tall grass and maintaining a mowed condition. Limits of constructed outboard slopes can be identified from the lagoon construction drawings and should be noted with field markers. Slopes around the lagoon access road, outside the lagoon outboard slopes, do not need to be cleared or mowed.
- A geotechnical investigation and slope stability analysis should be performed to assess embankment stability in accordance with applicable dam safety criteria.

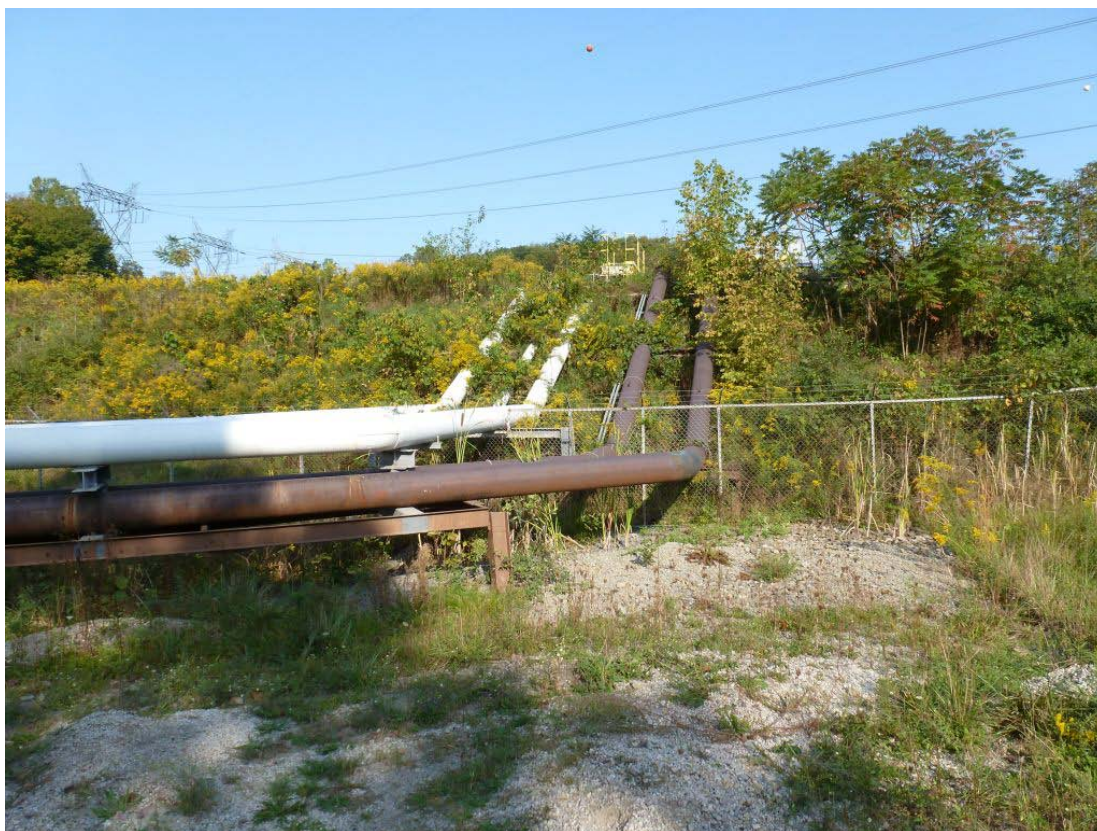
Inflow pipes
along southern
embankment of
Ash Setting
Basins.

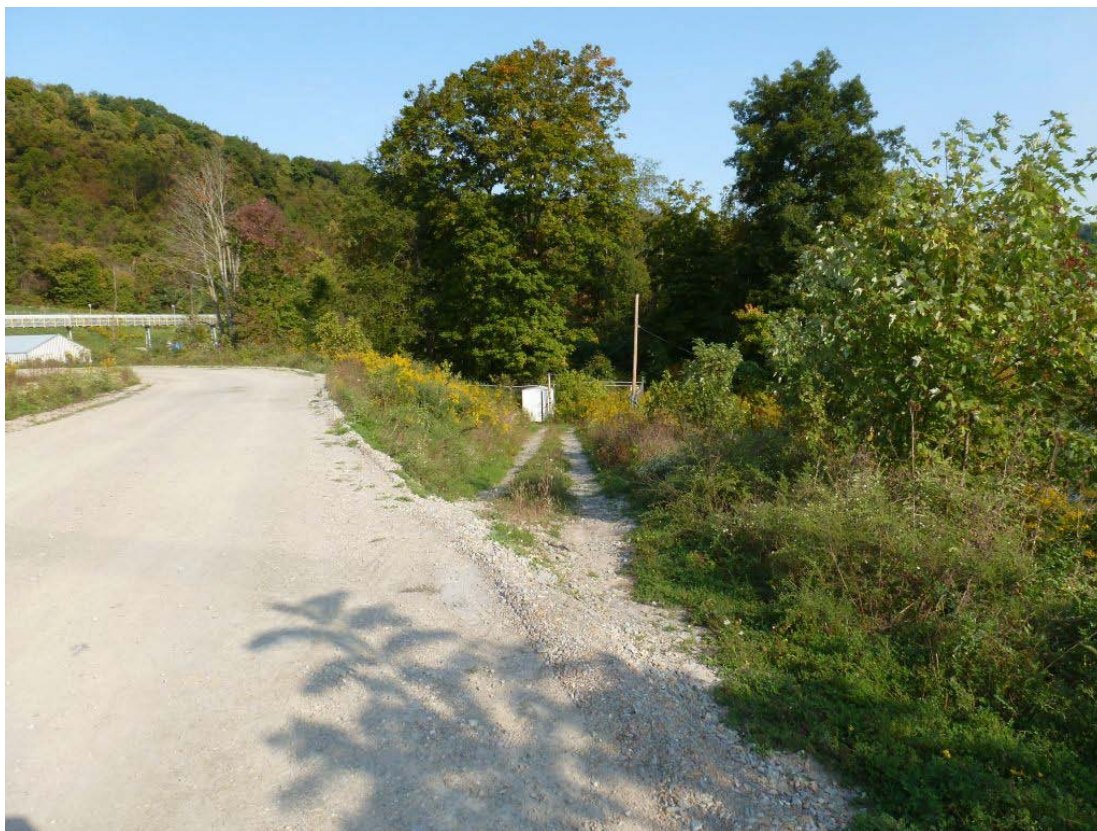
Photo Number:
17

Description:
Access road to
Monongahela
River on Ash
Settling Basin 2
eastern
embankment.

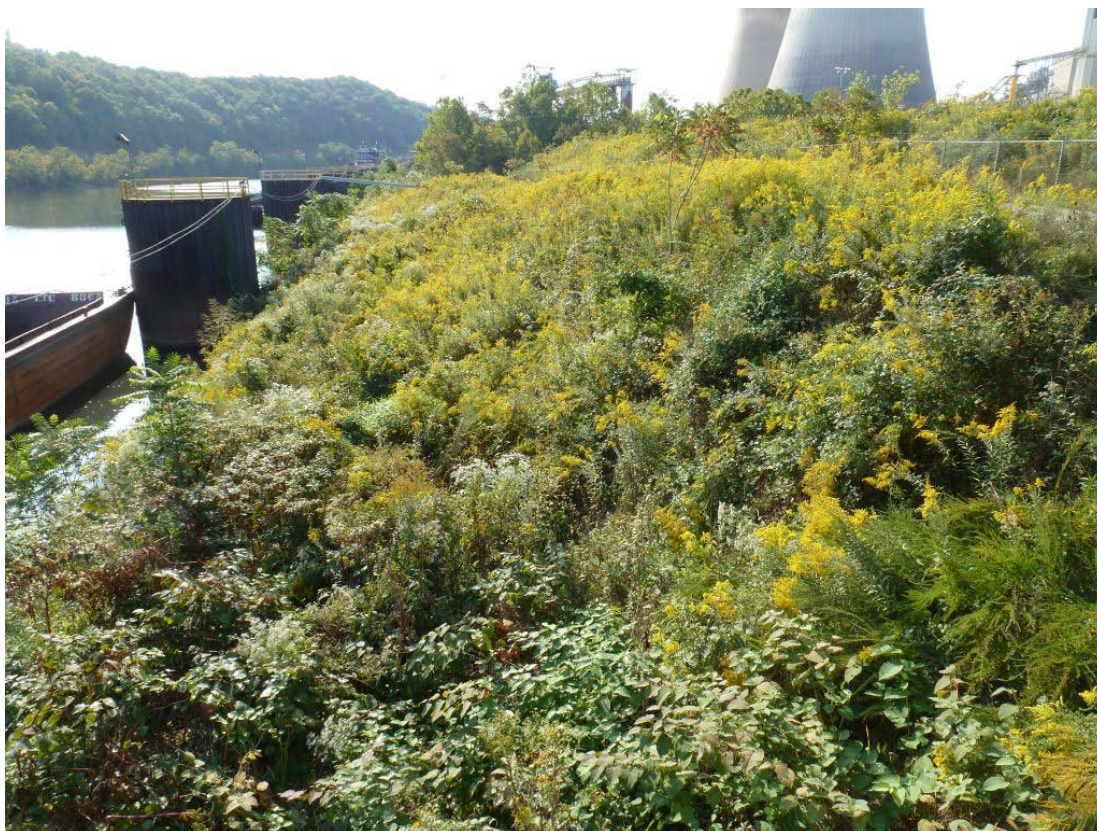
Photo Number:
18

Description:
Natural
riverside slope
along
Monongahela
River and toe of
constructed
eastern
embankment of
Ash Settling
Basin 2.
Planted as
mitigation area.
