**DRAFT REPORT
ROUND 7 DAM ASSESSMENT
ASSOCIATED ELECTRIC COOPERATIVE, INC.
NEW MADRID POWER PLANT
ASH POND 1 & 2 AND SLAG POND 1 & 2 IMPOUNDMENTS
NEW MADRID COUNTY, MISSOURI**

January 14, 2011

Re: Round 7 Dam Assessment - Draft Report
EPA Contract No. EP10W001313
Associated Electric Cooperative, Inc. New Madrid Power Plant
Ash Pond 1 and 2 Impoundments and Slag Pond 1 and 2 Impoundments
New Madrid County, Missouri

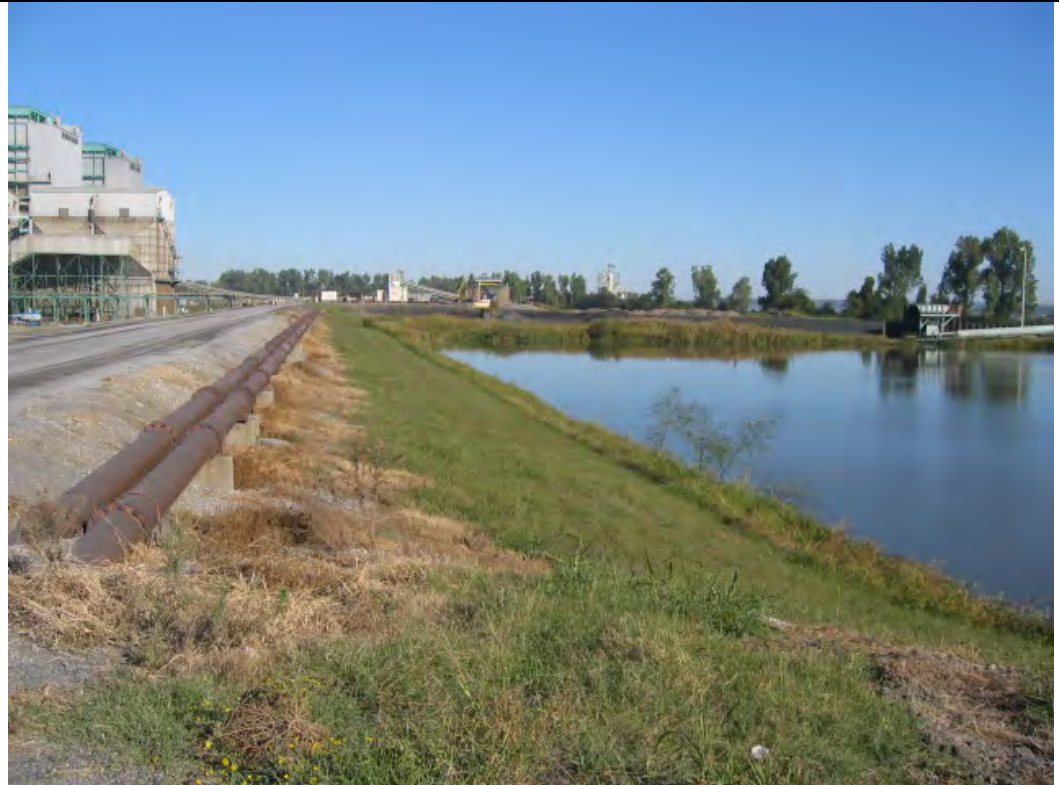
Photo No. 1	Date: 10/6/10
Direction Photo Taken: Northwest

Description:
Upstream slope of the Slag Pond 2 Impoundment (SP2).

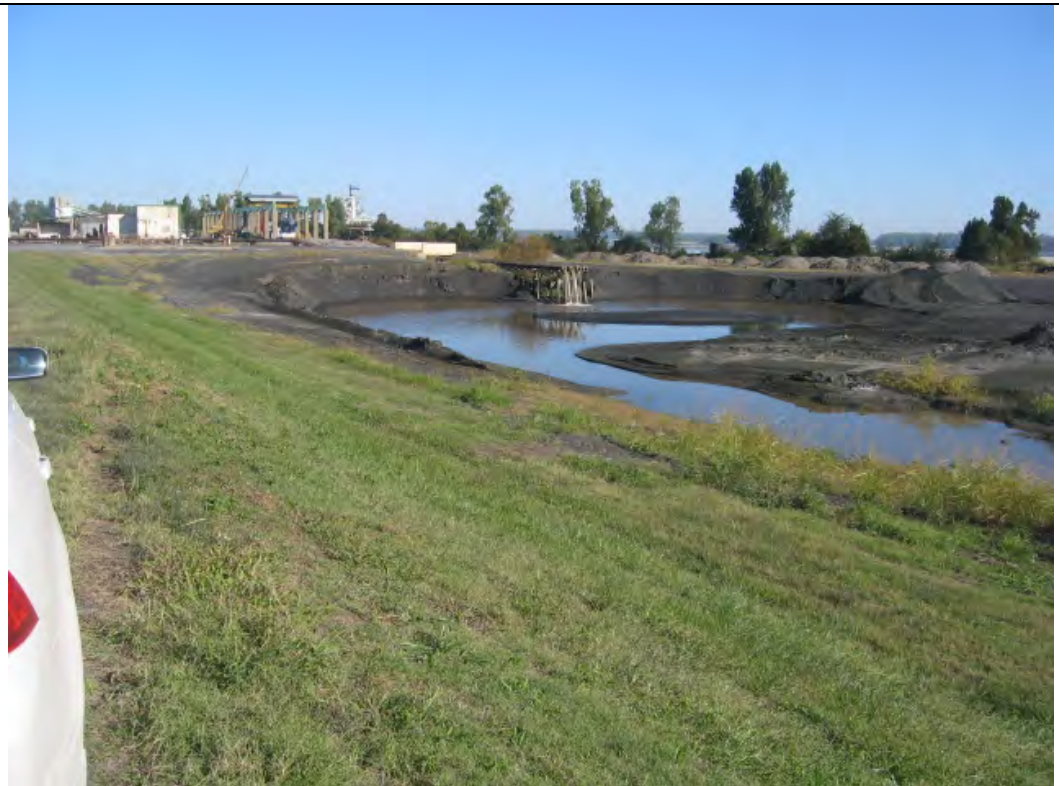
Photo No. 2	Date: 10/6/10
Direction Photo Taken: North

Description:
Upstream slope of the SP2.

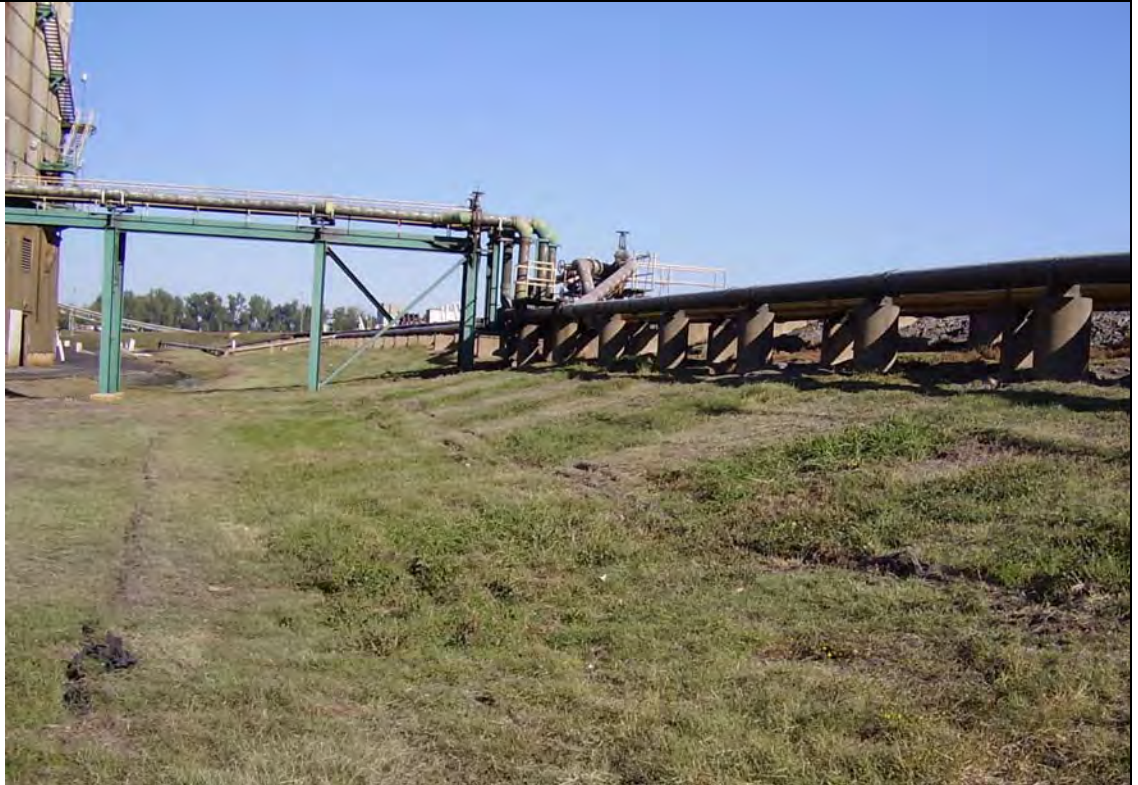
Downstream slope of the
SP2 with examples of the
sloughing of the slope.

7. Evaluate the cause of sloughing on the western embankment of the AP1 Impoundment and SP2 Impoundment.
8. Evaluate the impact of toe removal on the stability of the western embankment of the SP2 Impoundment; repair if necessary.

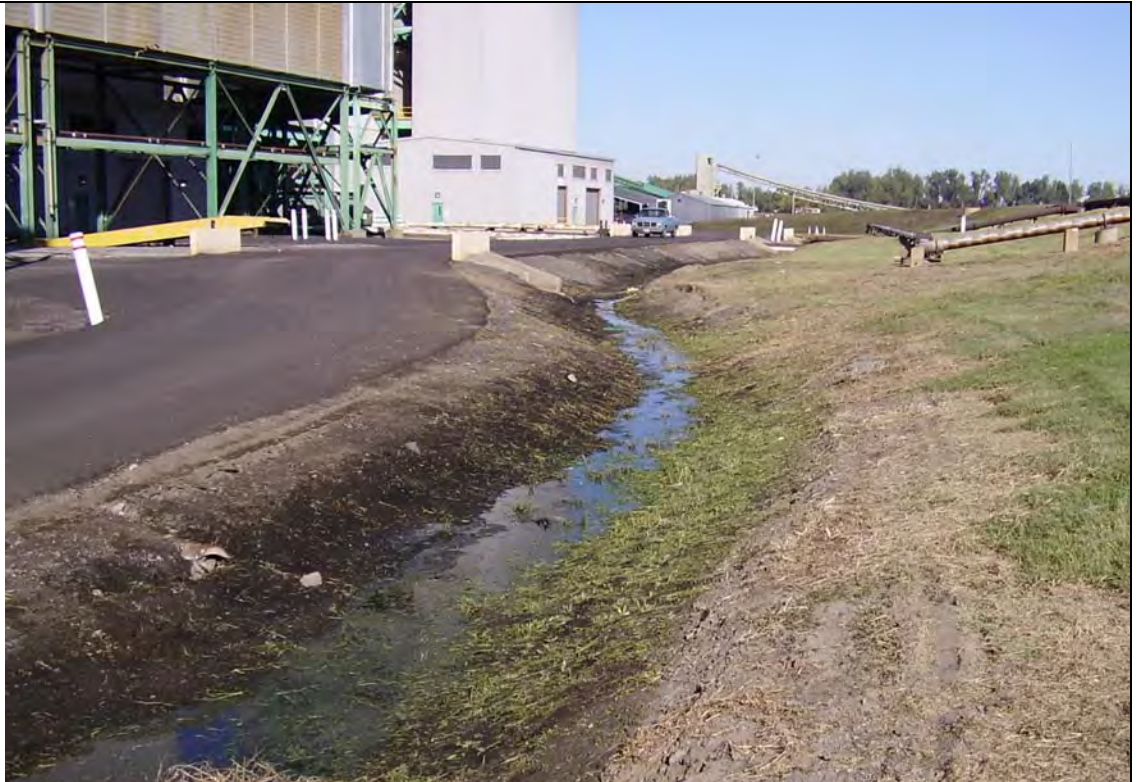
Downstream slope of the
SP2 showing the drainage
ditch excavated into the toe.

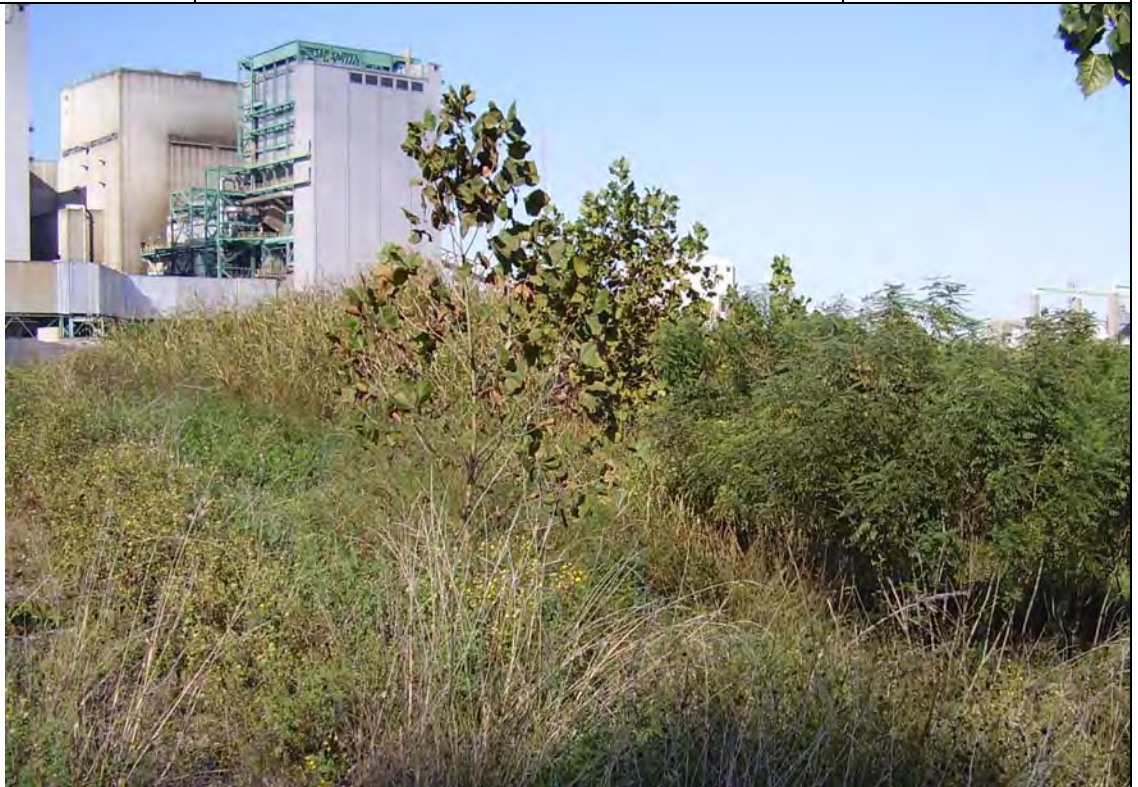
Trees present on the
downstream slope of the
northeast portion of the SP2.

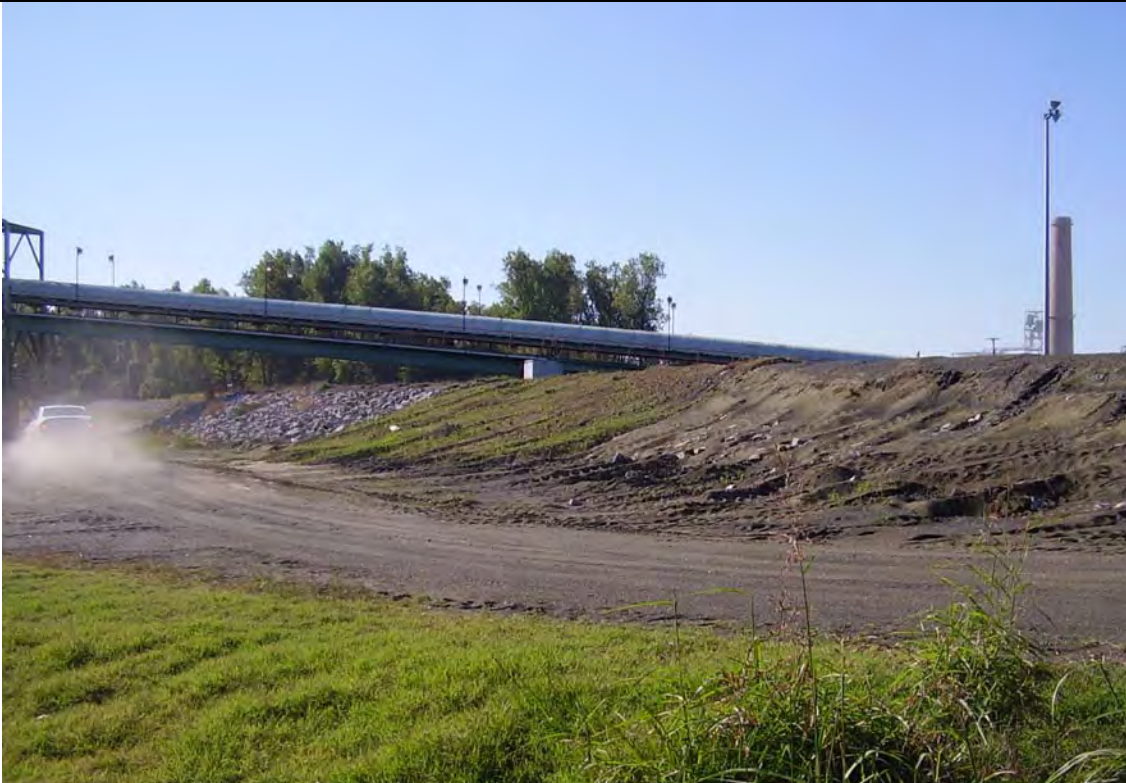
Photo No. 25	Date: 10/6/10
Direction Photo Taken: Southeast

Description:
Erosion of the downstream slope of the SP2.

1. Repair sloughed soil on the western embankment of the AP1 Impoundment.
2. Repair areas of erosion on the AP1 Impoundment, SP1 Impoundment, AP2 Impoundment, and SP2 Impoundment.
3. Repair rutting present on the SP2 Impoundment crest access road.

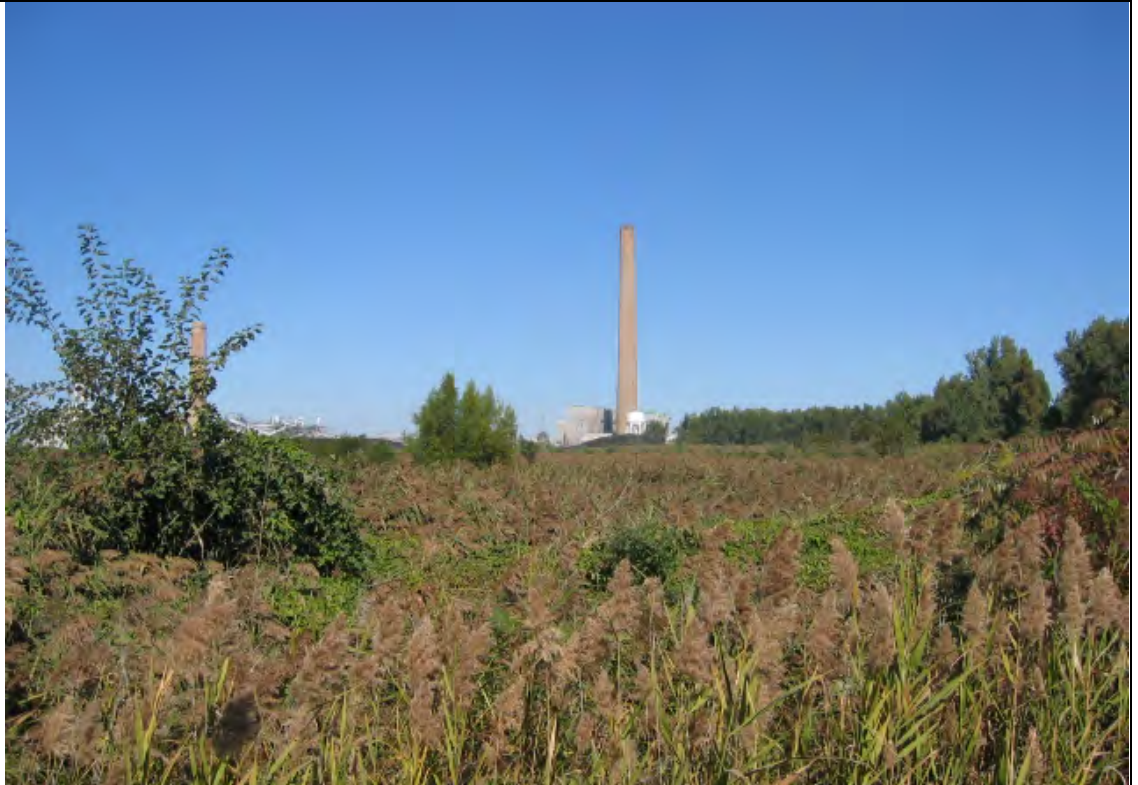
Description:
Long grass and trees present
on the upstream areas of
SP1.

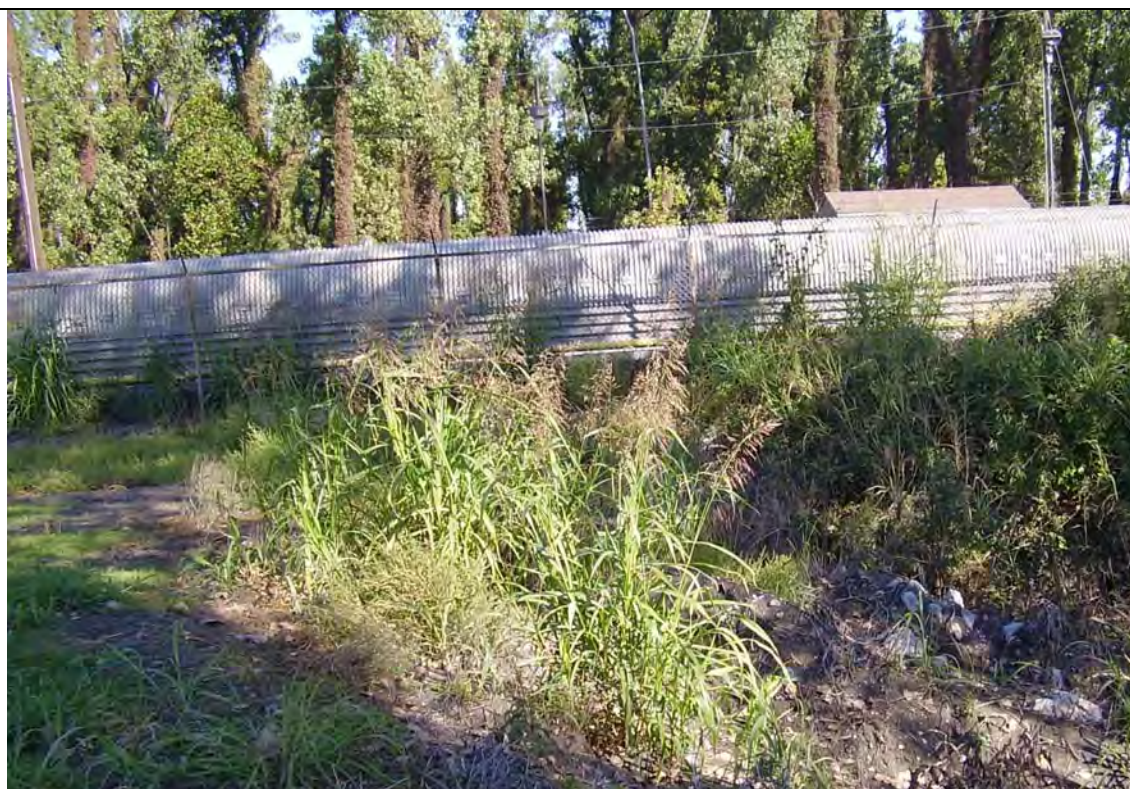
Photo No. 38	Date: 10/6/10
Direction Photo Taken: North

Description:
Erosion on the downstream slope of the SP1.

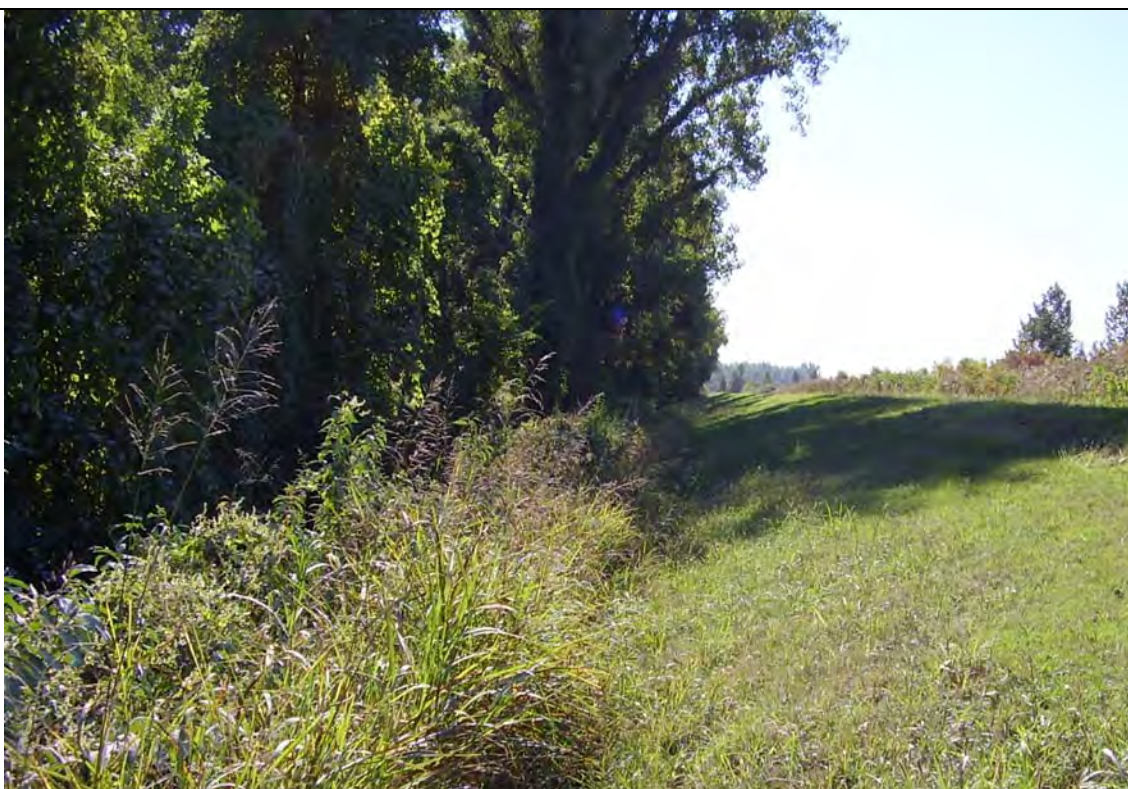
Photo No. 40	Date: 10/6/10
Direction Photo Taken: Southeast

Description:
Trees on downstream slope of the SP1.

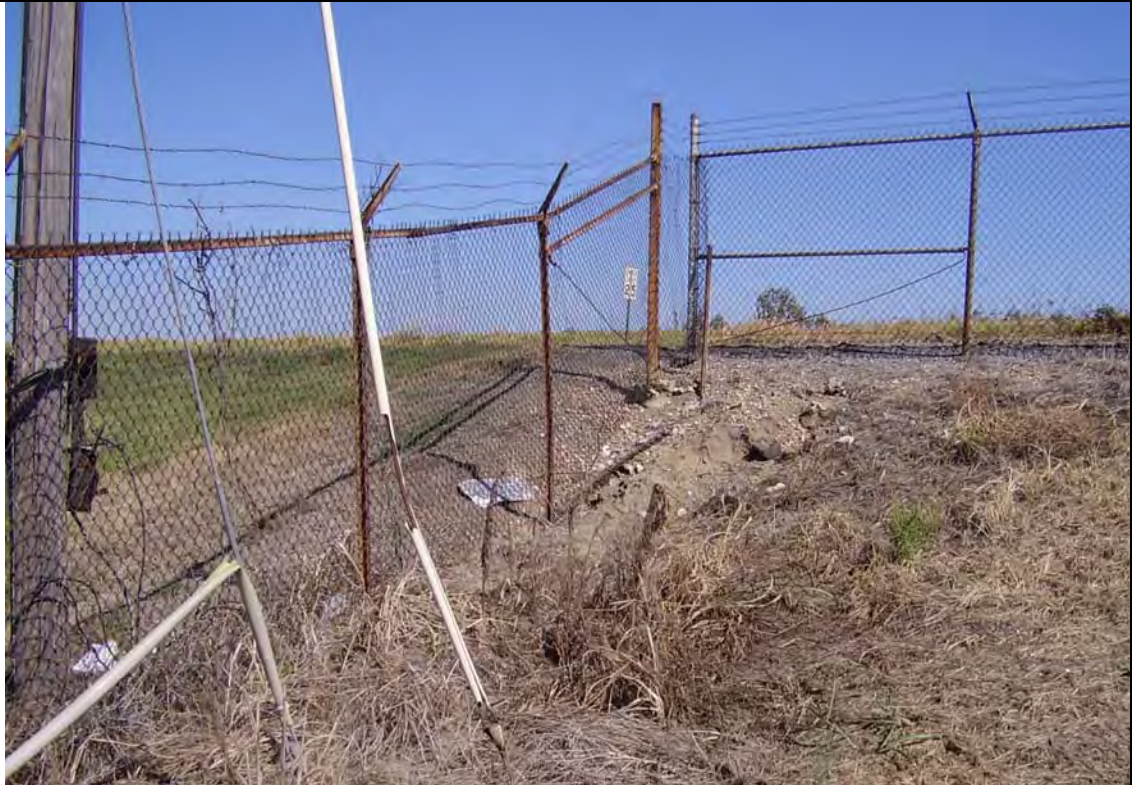
Description:
Erosion of downstream slope
of the AP1.

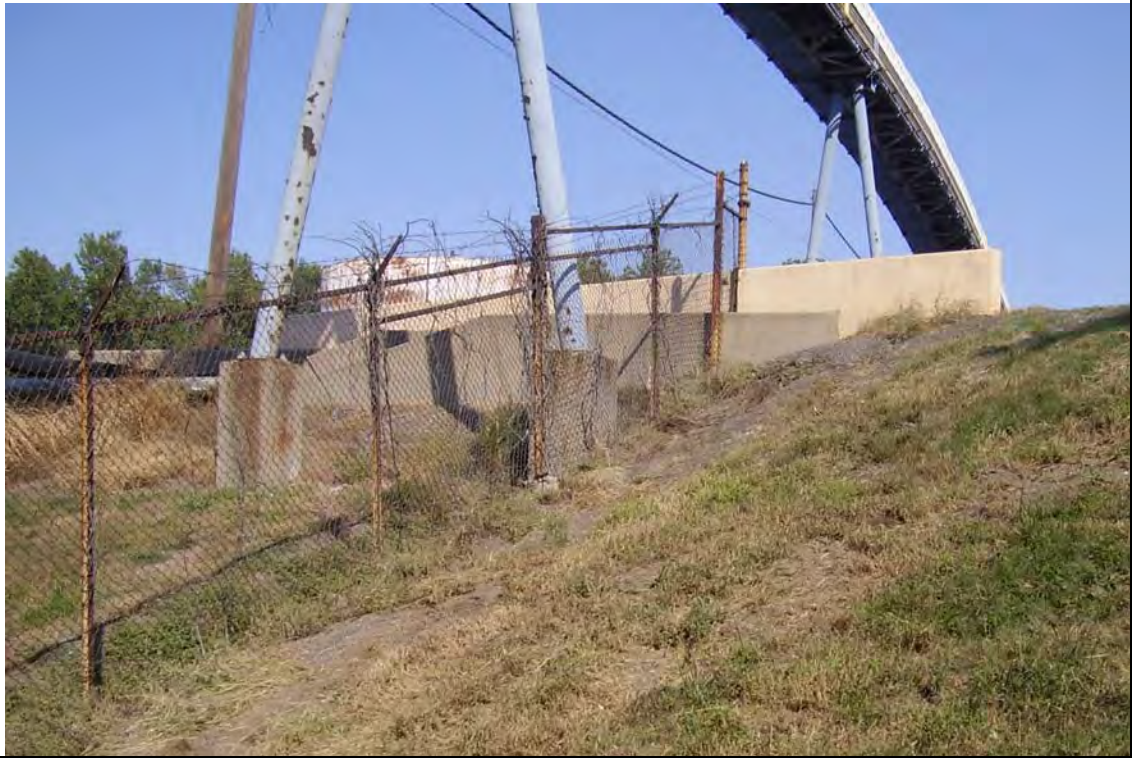
Downstream slope of the AP1 showing erosion of the slope and crest near the road abutment.

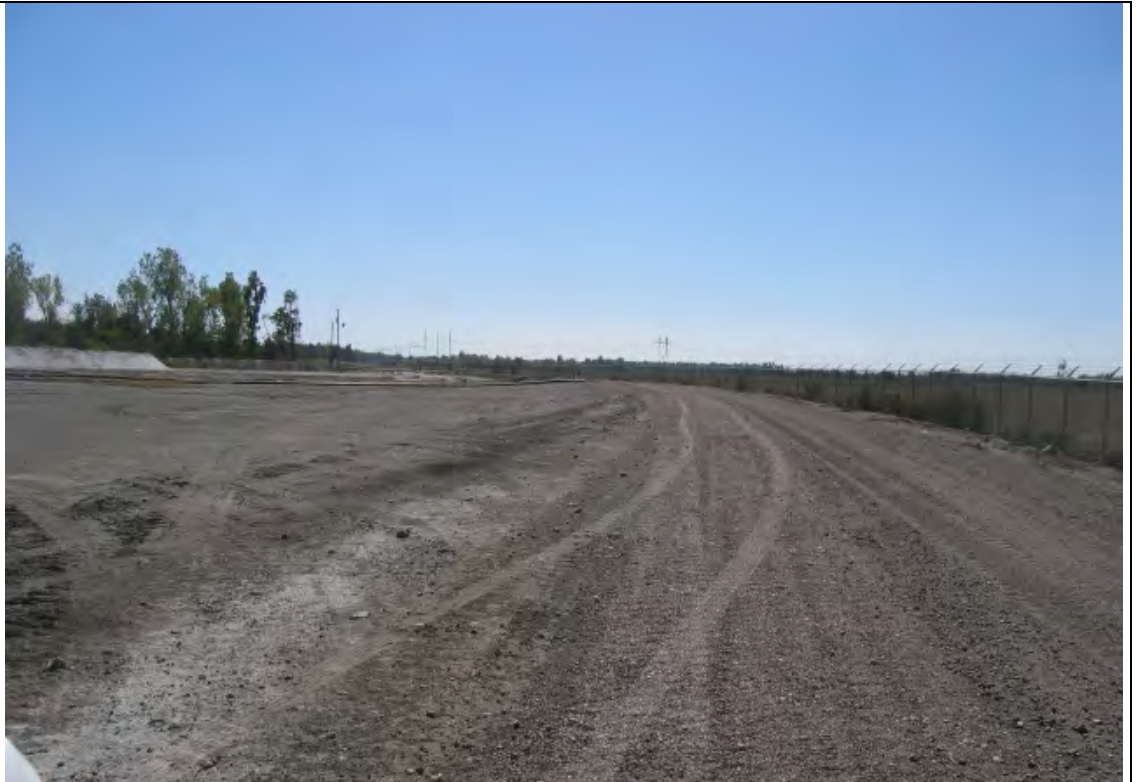
Description:
Upstream slope of the AP2
showing area where ash has
been filled and graded to
match the crest elevation.

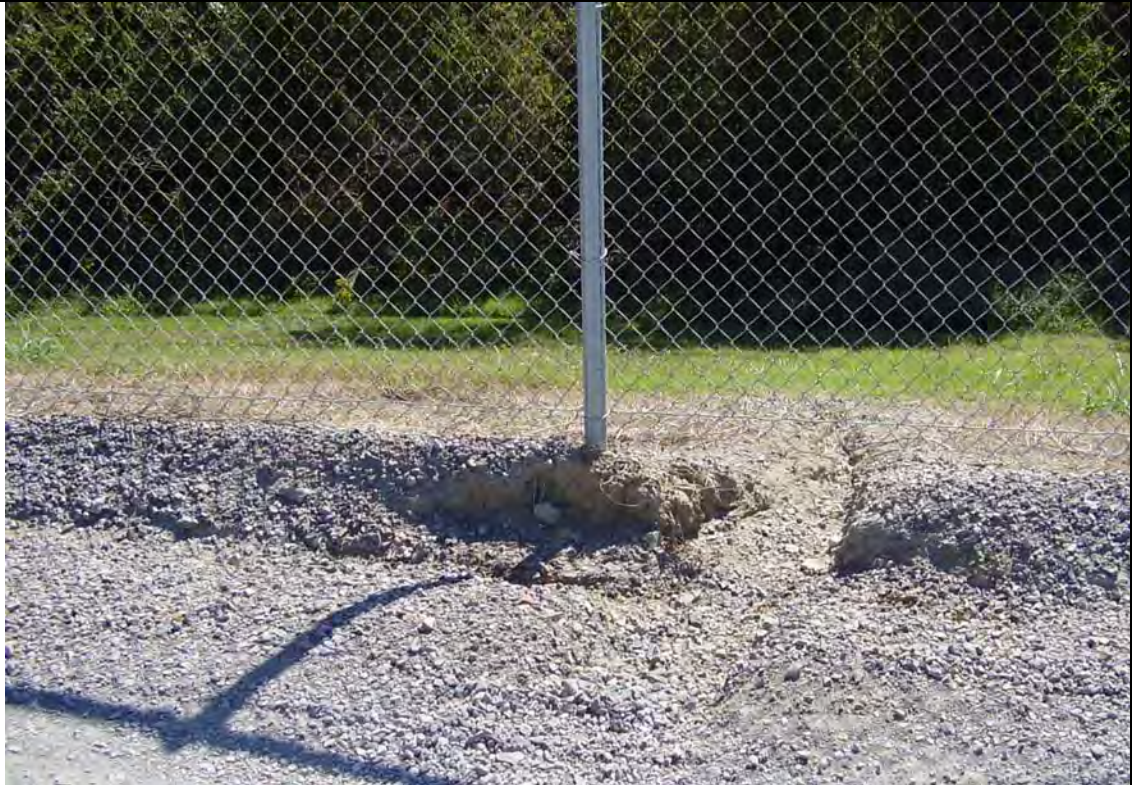
Erosion of the gravel access
road on the crest of the AP2.

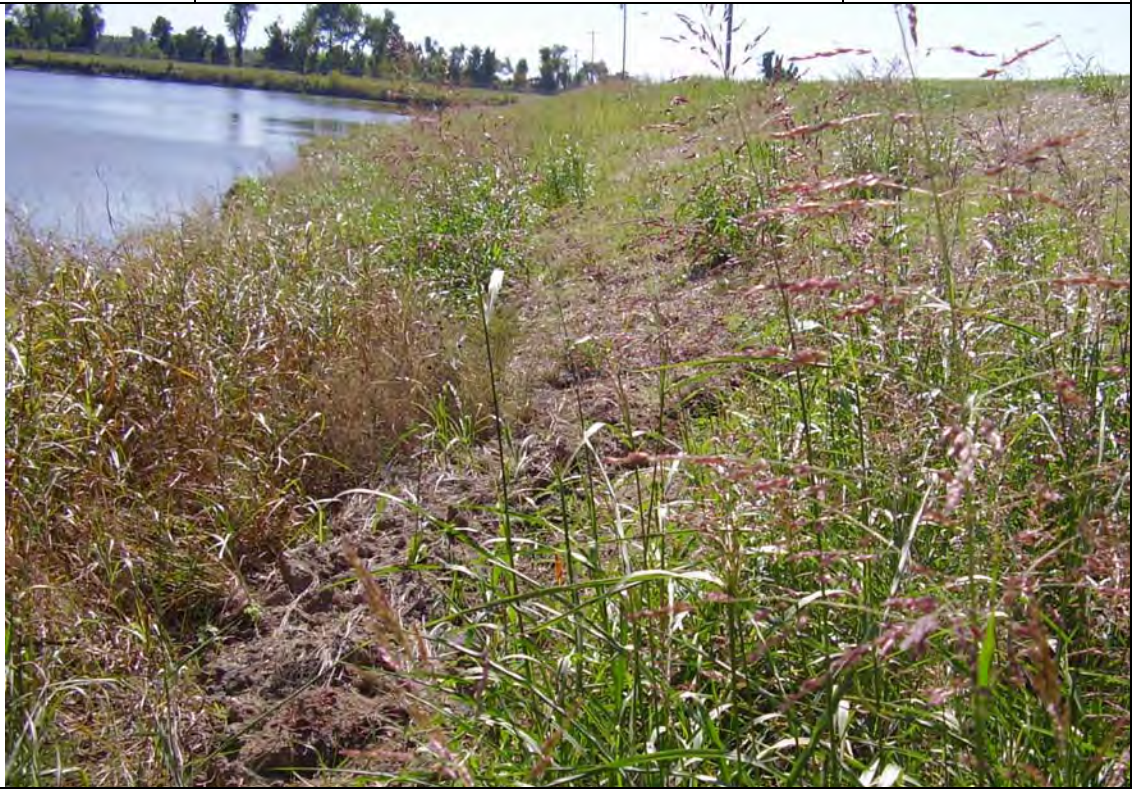
Rutting of the downstream
slope due to equipment.

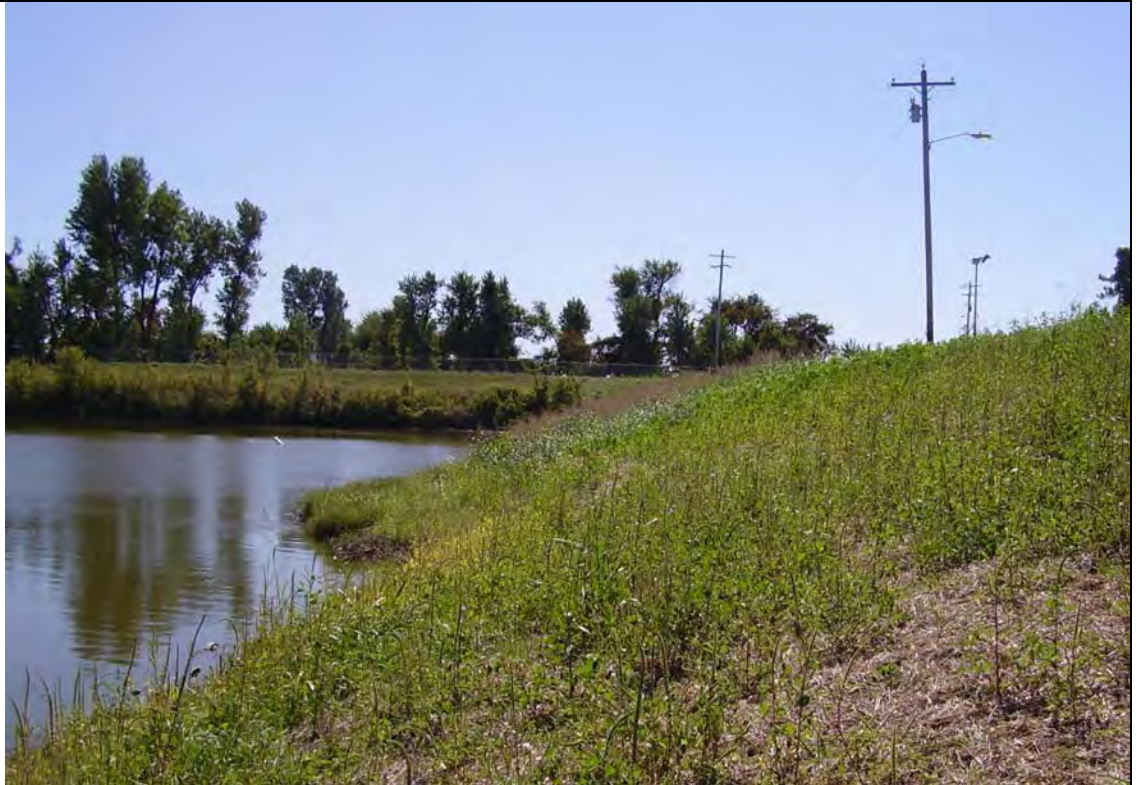
Description:
Downstream slope of the
AP2 showing sparse
vegetation typical of the
slope.
