DRAFT
Specific Site Assessment for
Coal Combustion Waste
Impoundments at
Thomas Hill Energy Center

Clifton Hill, Missouri

December 2010
Project Number: 092884

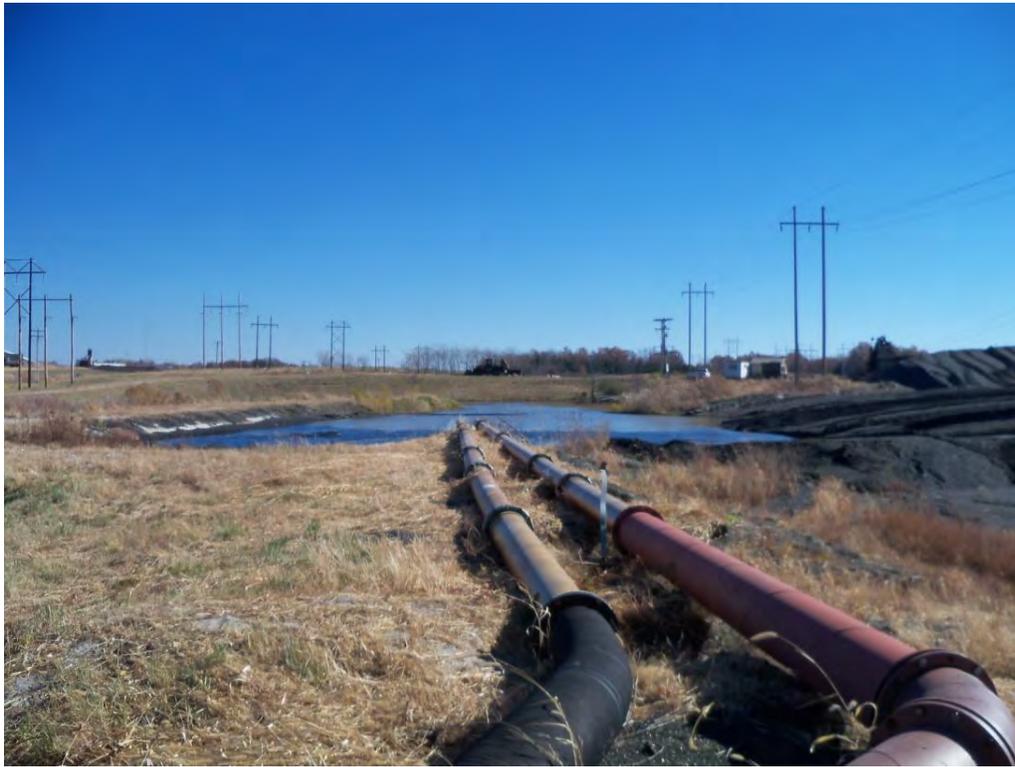
Photo 1 – Looking east at Slag Dewatering Basin inlet.

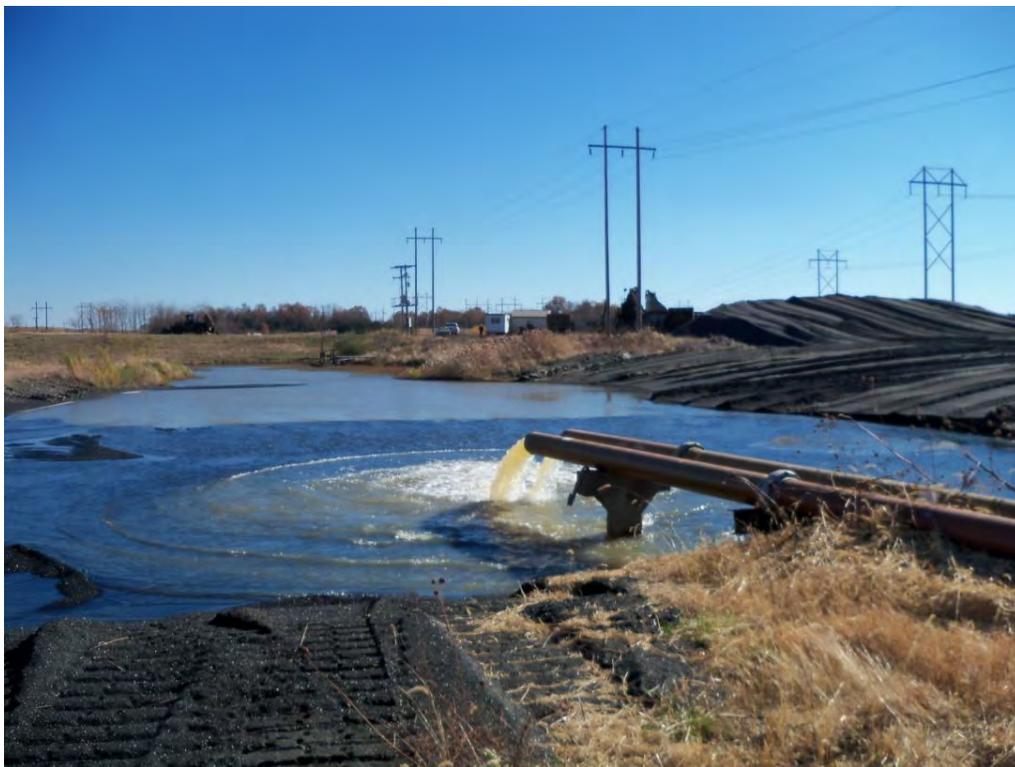
Photo 2 – Inlet pipes discharging into the Slag Dewatering Basin.

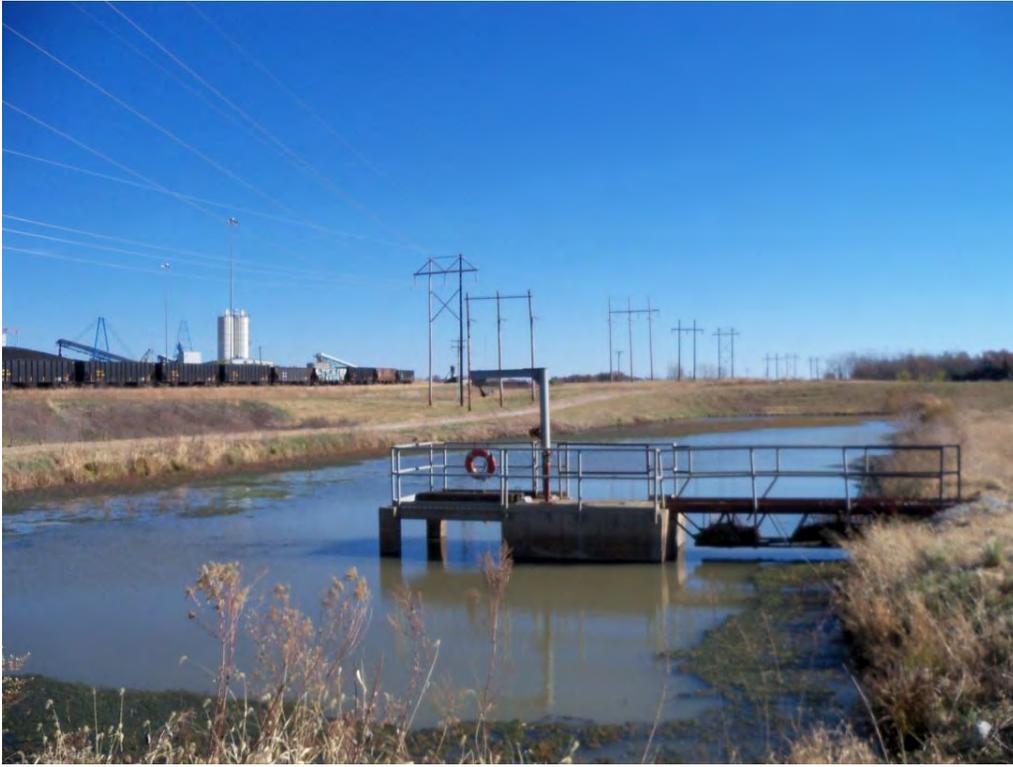
Photo 3 – The outlet structure for the Slag Dewatering Basin.

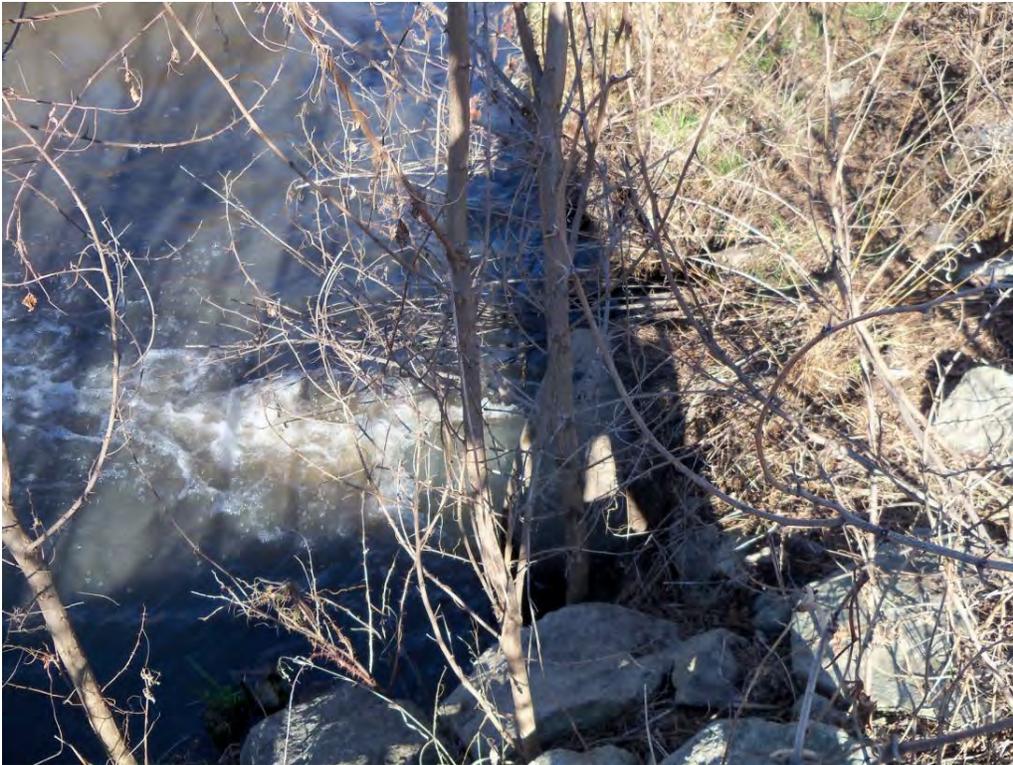
Photo 4 – Water from the Slag Dewatering Pond being discharged into the ditch to Ash Pond, Cell No. 2.

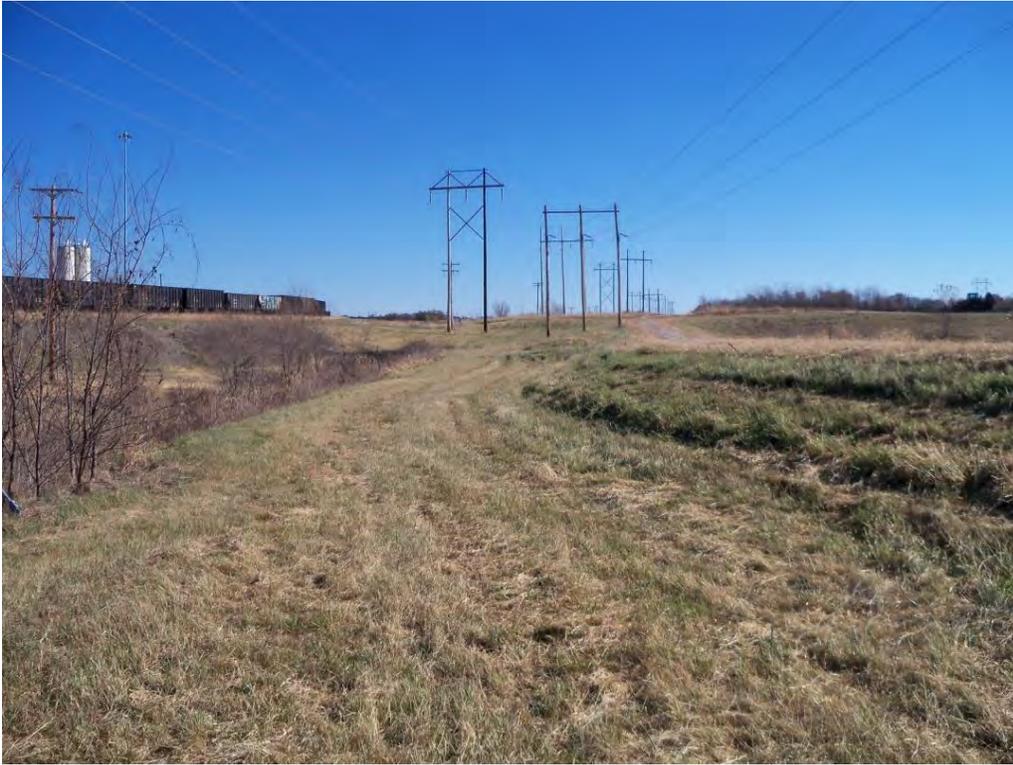
The downstream slope of the dike at the Slag Dewatering Basin generally has well-established grass growth, which provides some erosion protection (Photos 5 and 6). No scarps, sloughs, depressions or other indications of slope instability or signs of erosion were observed during the inspection of the impoundment.

Photo 5 – The north downstream dike for the Slag Dewatering Pond.

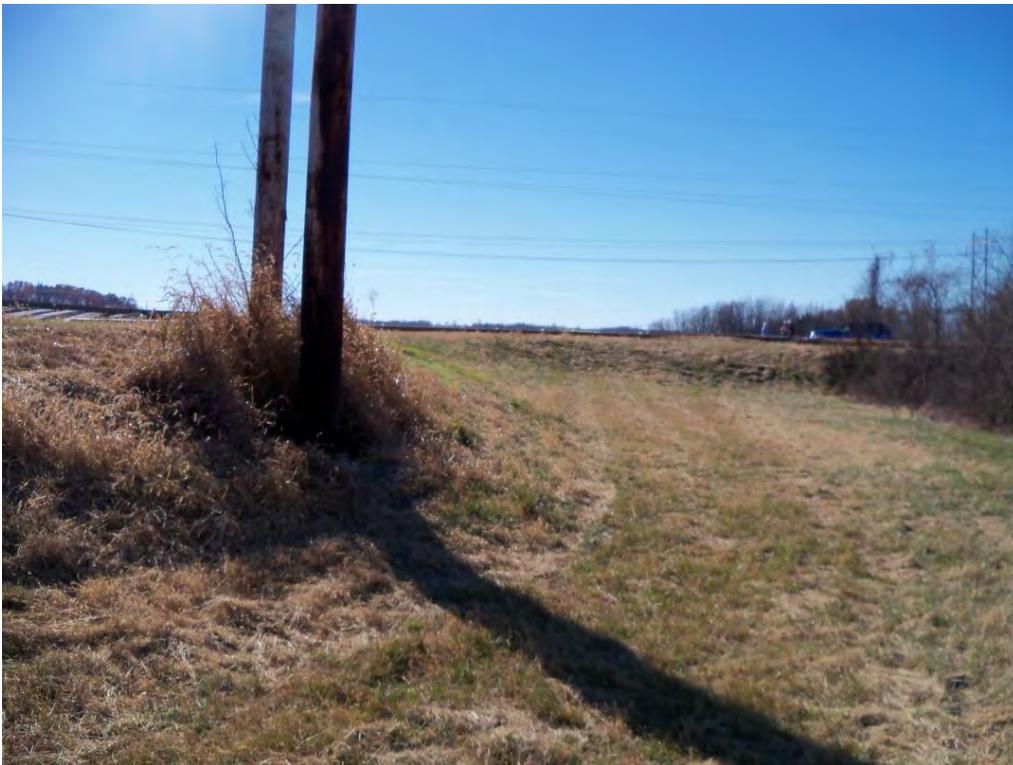
Photo 6 – The downstream slope of the west dike to the Slag Dewatering Pond.

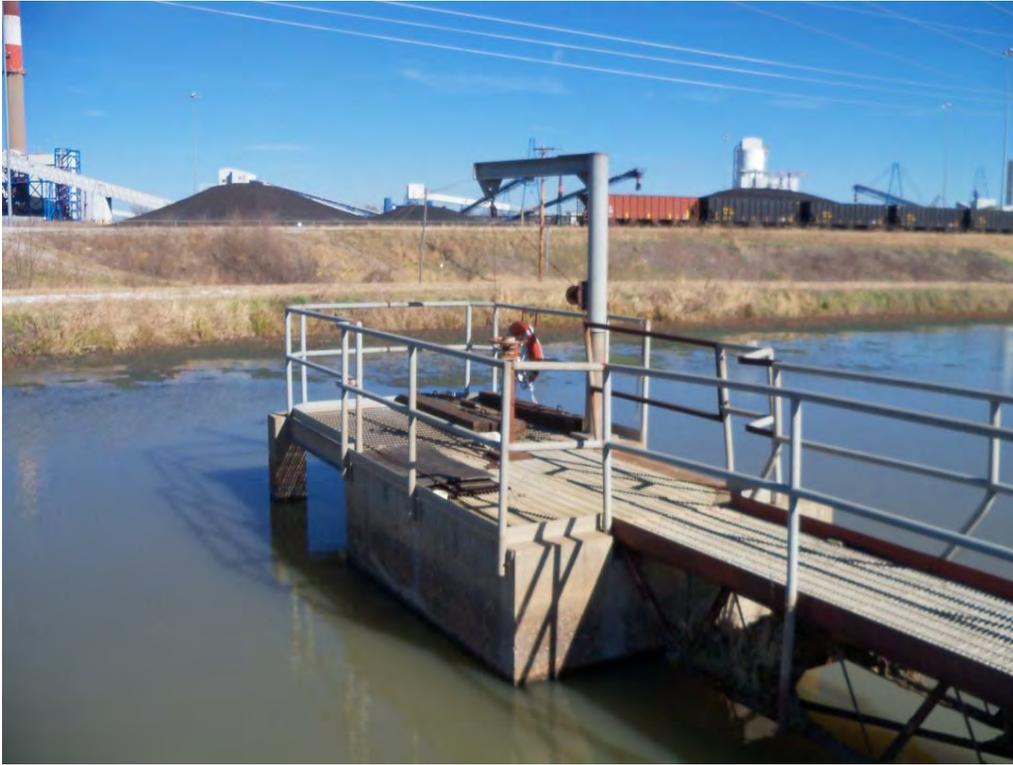
Photo 7 – The outlet structure for the Slag Dewatering Pond.

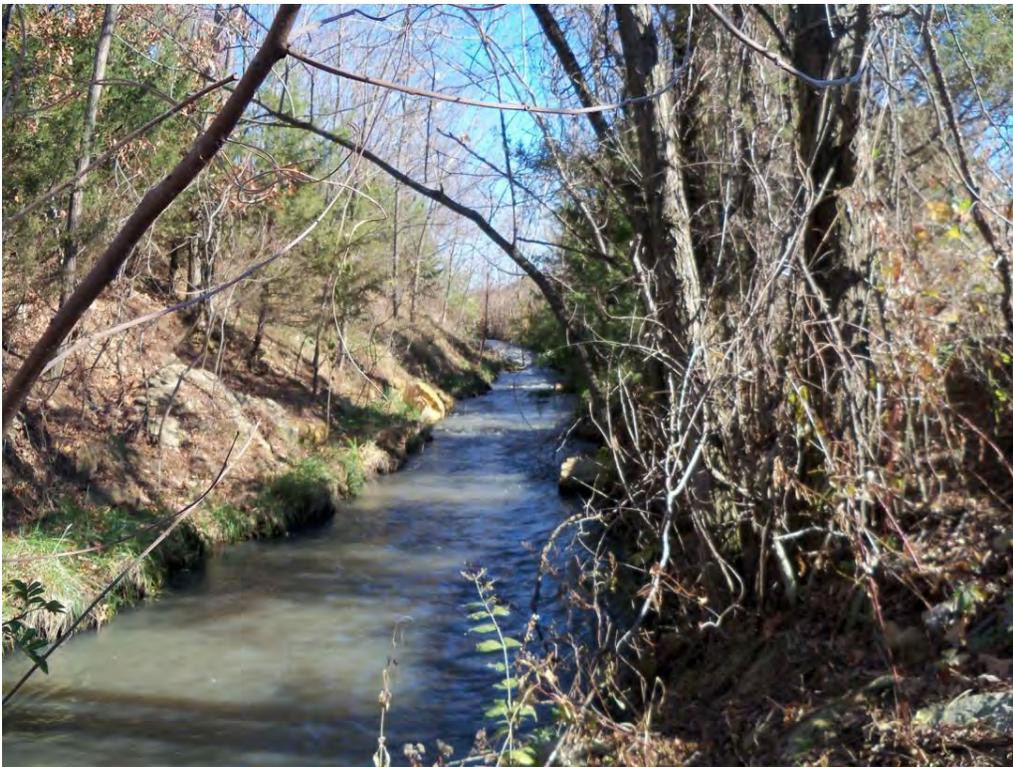
Photo 8 – The ditch from the plant that conveys water to Ash Pond – Cell No. 2.

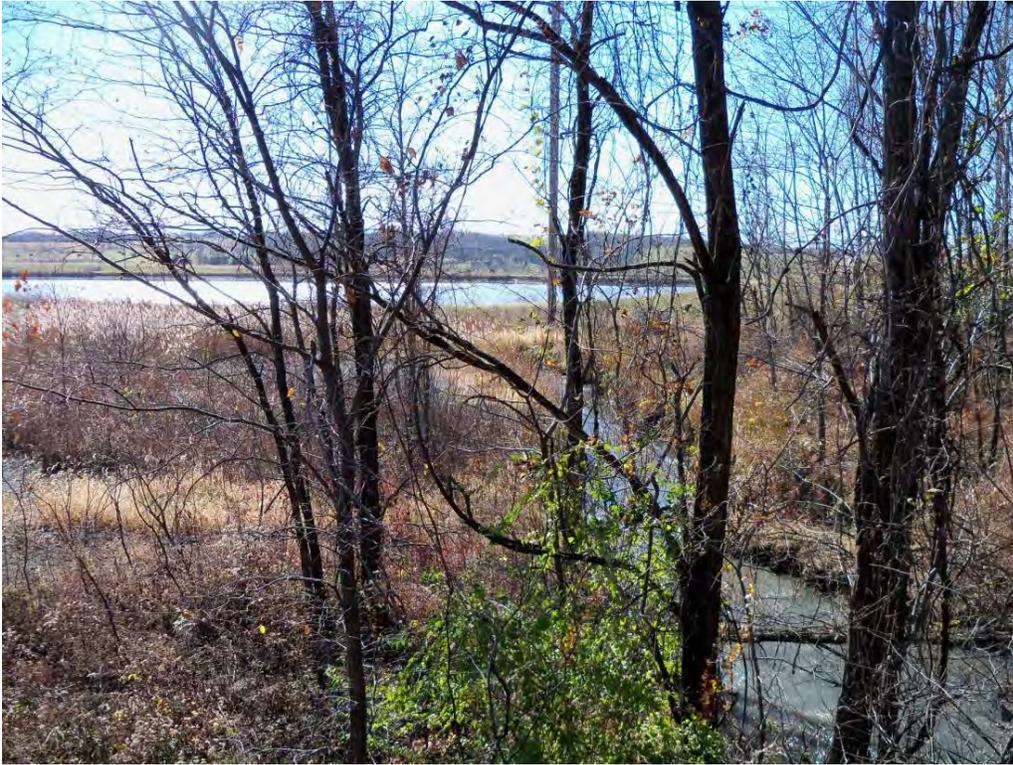
Photo 9 – The ditch outlet into Ash Pond – Cell No. 2.

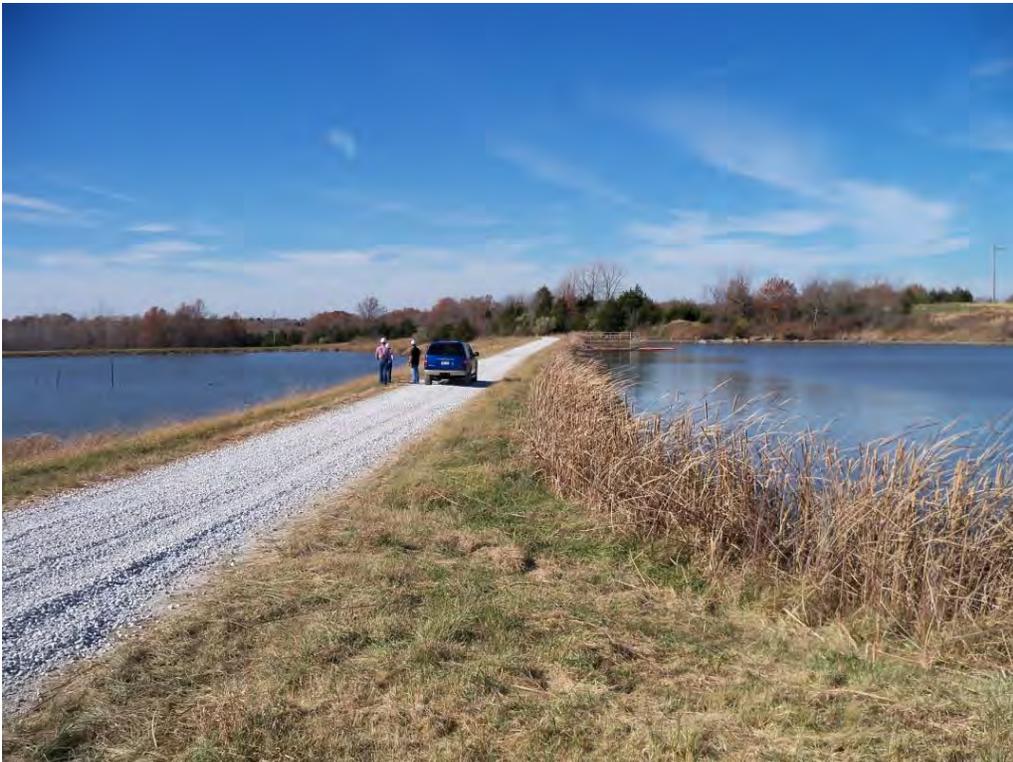
The upstream slope (Photos 10, 14, 15 and 18) of the dike at the Ash Pond – Cell No. 2 is partially covered with small riprap near the toe and well established grass growth near the crest of the embankment. The remaining slope is unprotected. No scarps, sloughs, depressions or other indications of slope instability or signs of erosion were observed during the inspection of the impoundment.

Photo 10 – Taken at the east abutment, looking west at the Upstream dike slope and dike crest for the Ash Pond – Cell No. 2. Note to the left of the dike is the Ash Pond – Cell No. 3 pond.

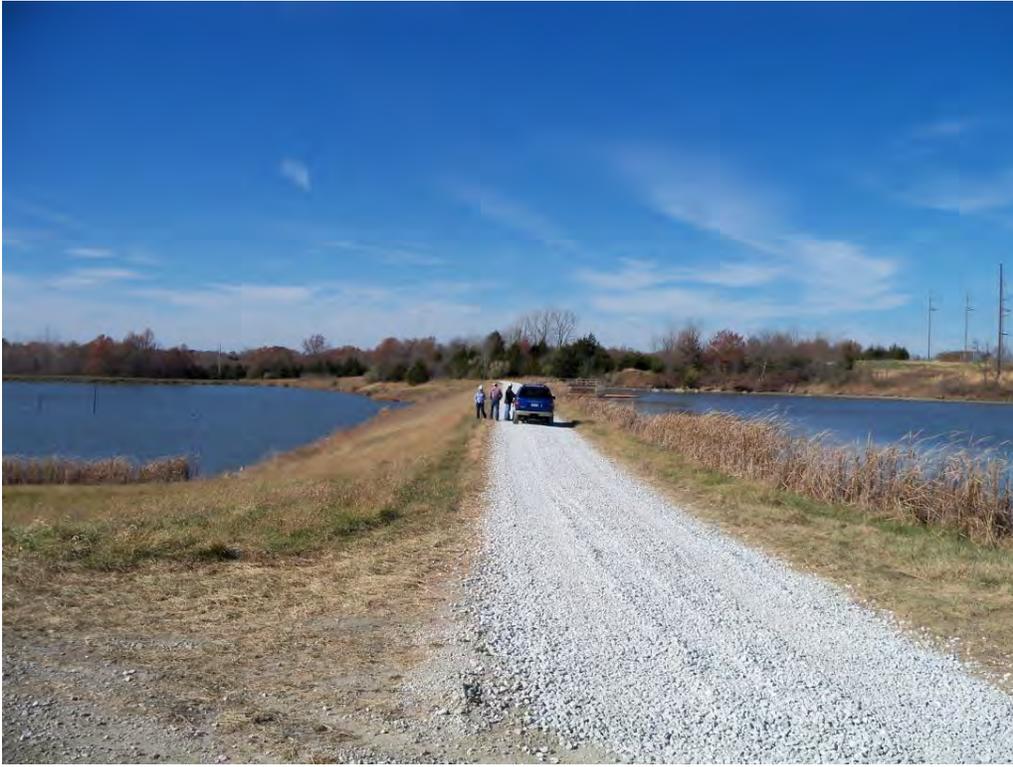
The downstream slope (Photos 11 and 17) of the dike at the Ash Pond – Cell No. 2 (which is also the upstream slope of Ash Pond – Cell No. 3) has well-established grass growth, which provides some erosion protection. At the toe of the slope is Ash Pond – No. 3. The lower 10 feet of the slope is rip rap with small to medium size rock. No scarps, sloughs, depressions or other indications of slope instability or signs of erosion were observed during the inspection of the impoundment.

Photo 11 – Taken from the east dike abutment looking west at the dike crest and downstream slope for the Ash Pond – Cell No. 2 dike.

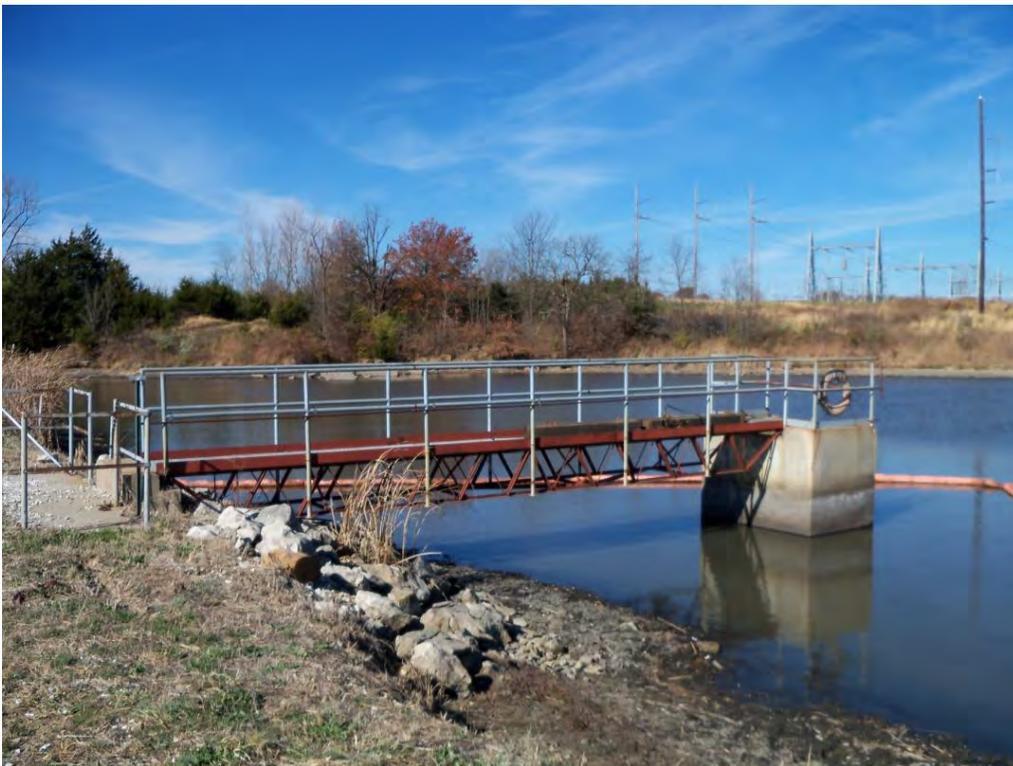
Photo 12 – The outlet structure for the Ash Pond – Cell No. 2.

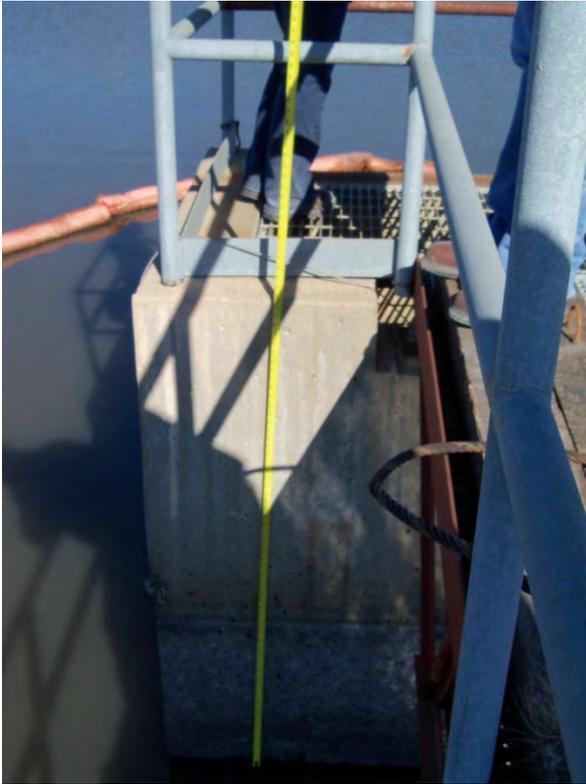
At the time of our inspection on November 9, 2010, the Ash Pond – Cell No. 2 water level was observed to be at an approximate elevation of 713 feet (Photo 13). The water surface of Ash Pond – Cell No. 2 is controlled by the outlet structure that discharges into the Ash Pond – Cell No. 3.

Photo 13 – Measuring the Ash Pond – Cell No. 2 pond level at the time of the inspection.

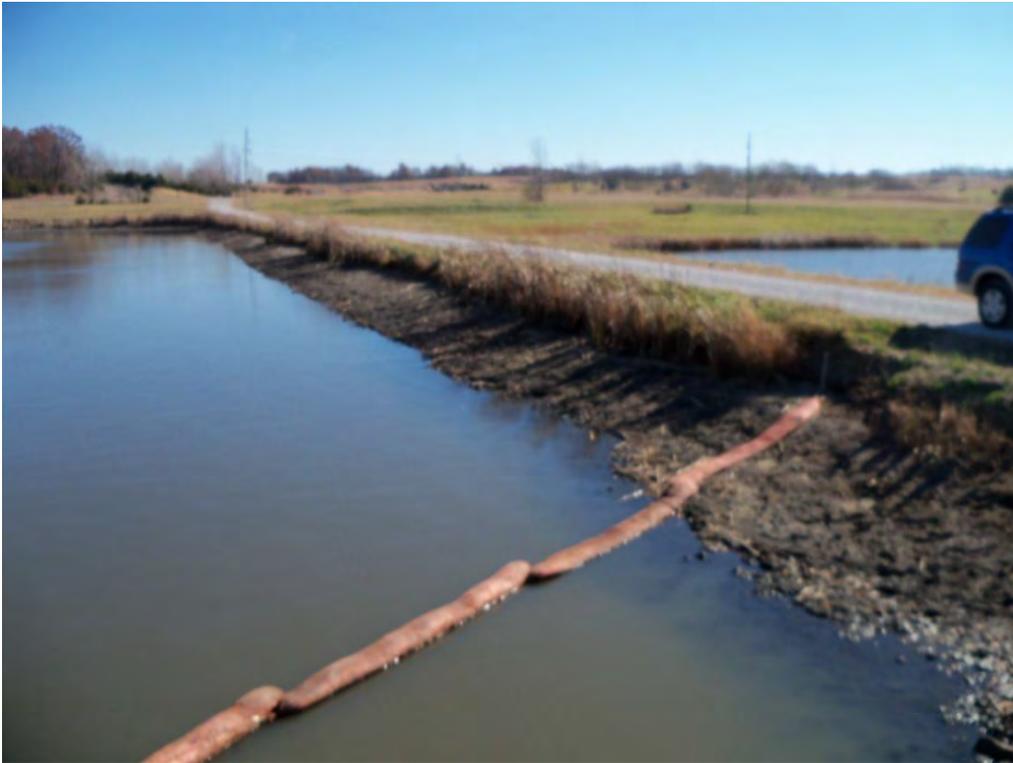
Photo 14 – Taken from the outlet structure looking east at the upstream dike slope.

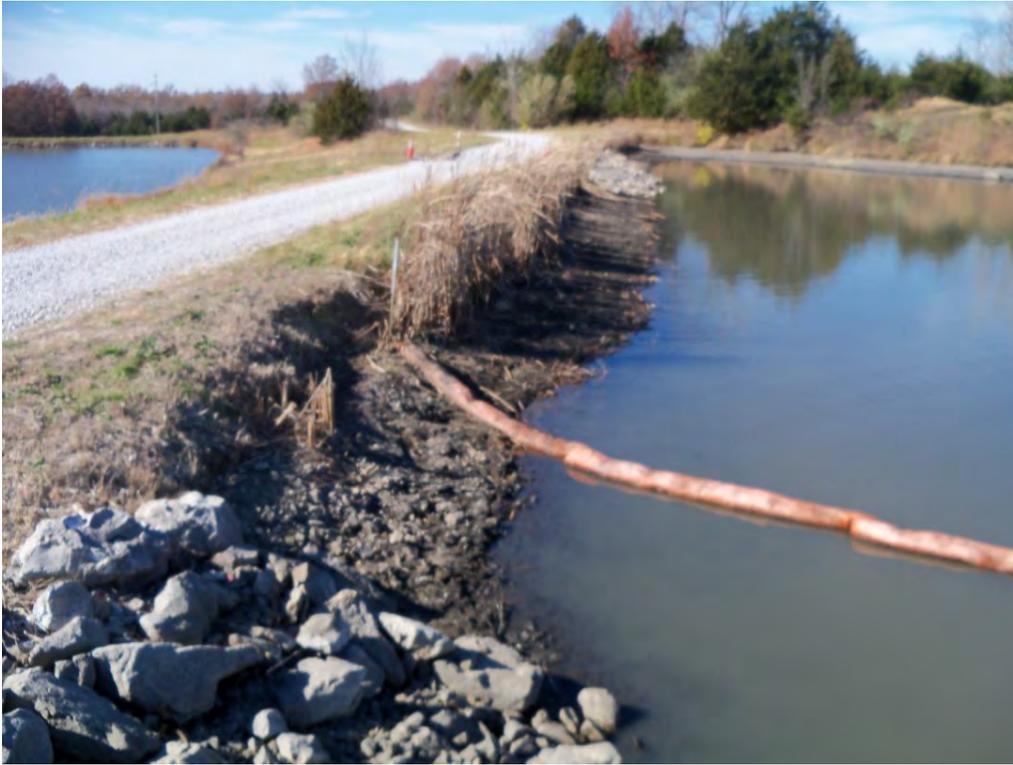
Photo 15 – Taken from the outlet structure looking west at the upstream dike slope.

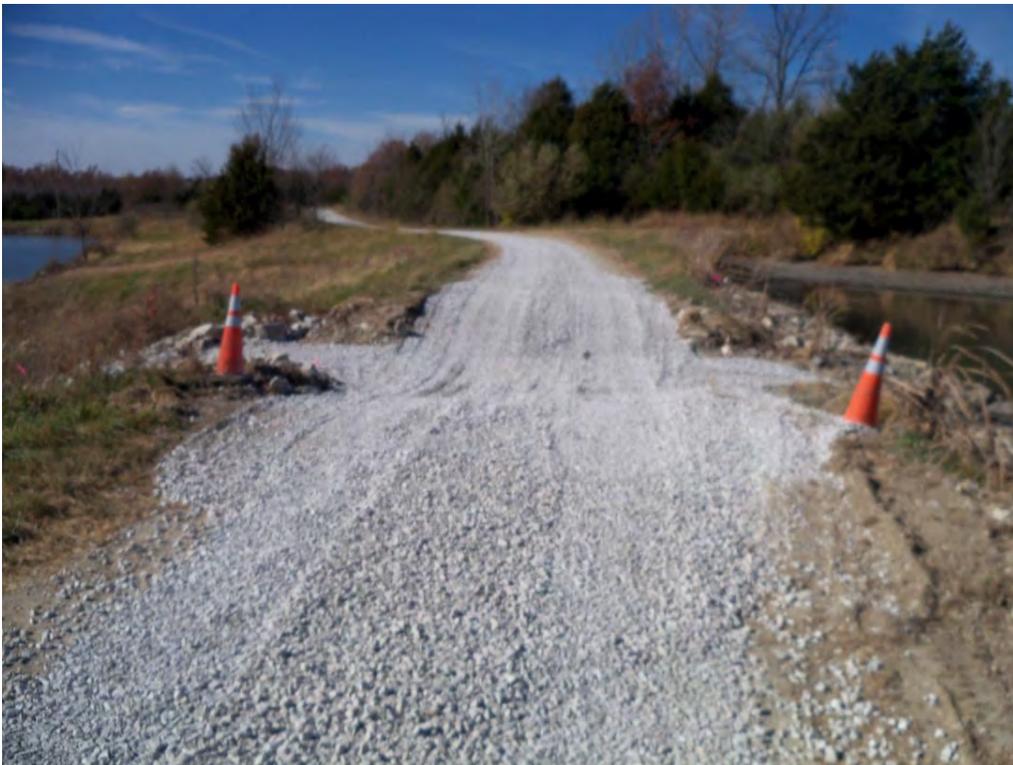
Photo 16 – The Ash Pond – Cell No. 2 emergency spillway.

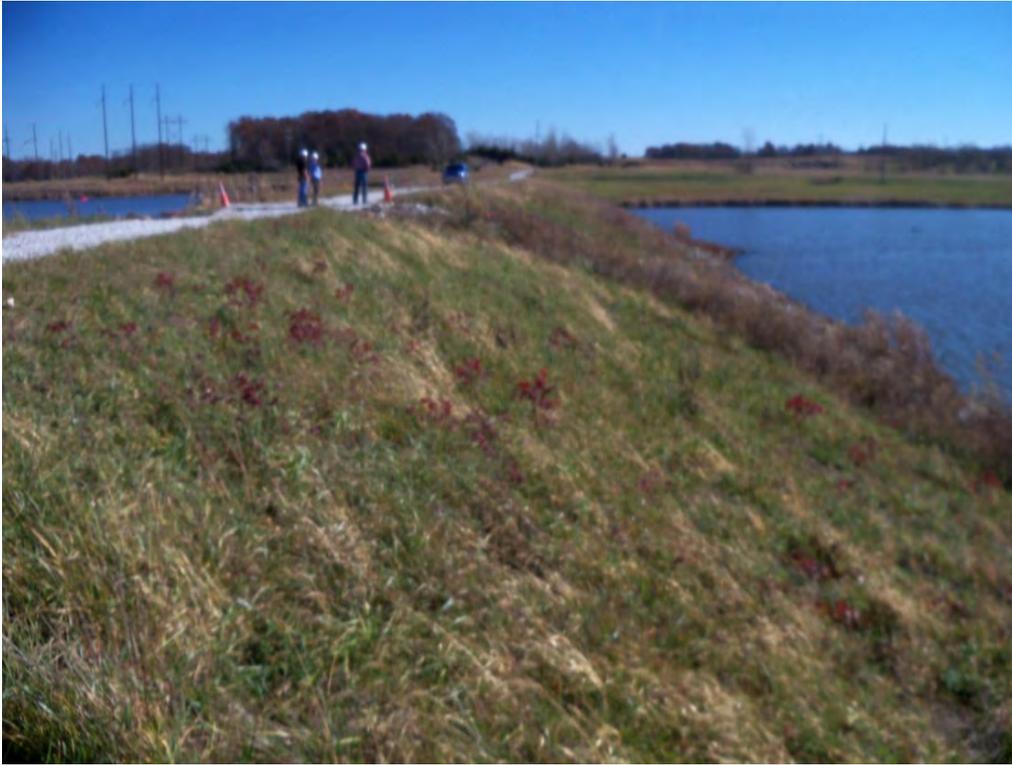
Photo 17 – Taken from the west abutment looking east at the downstream dike slope for Ash Pond – Cell No. 2.

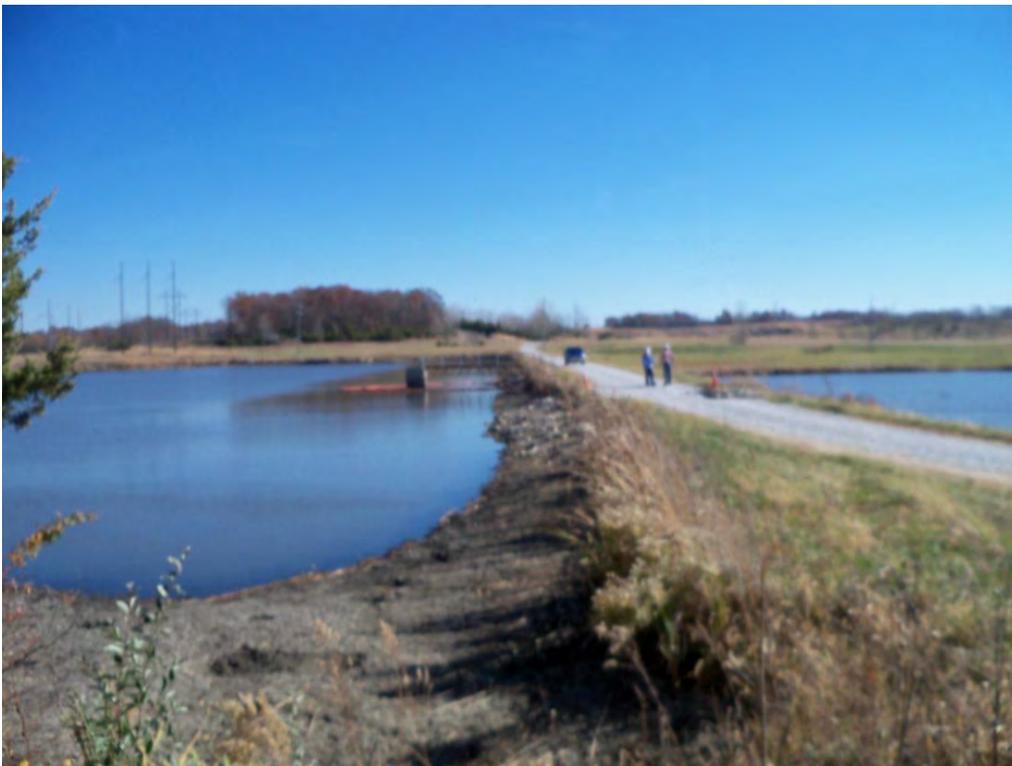
Photo 18 – Taken from the west abutment looking east at the upstream dike slope for Ash Pond – Cell No. 2.

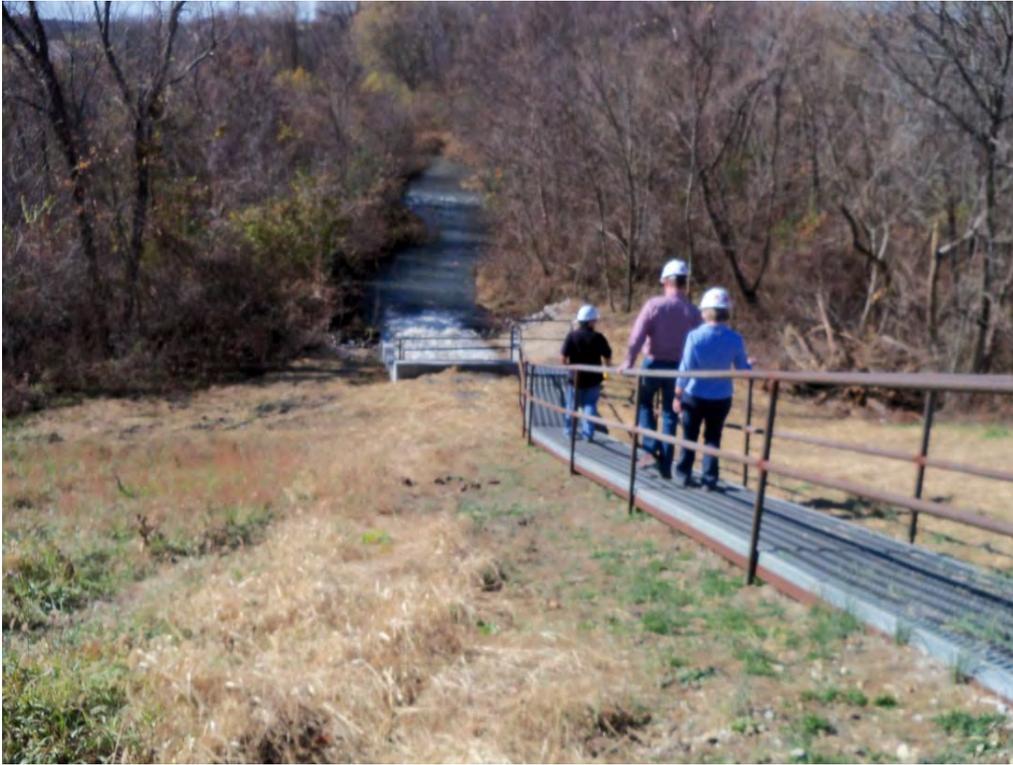
Photo 19 – Water from Ash – Pond No. 3 being discharged at NPDES Outlet No. 001.
