# **Dam Safety Assessment of CCW Impoundments**

## **Joppa Plant**

**United States Environmental Protection Agency  
Washington, DC**

May 27, 2010

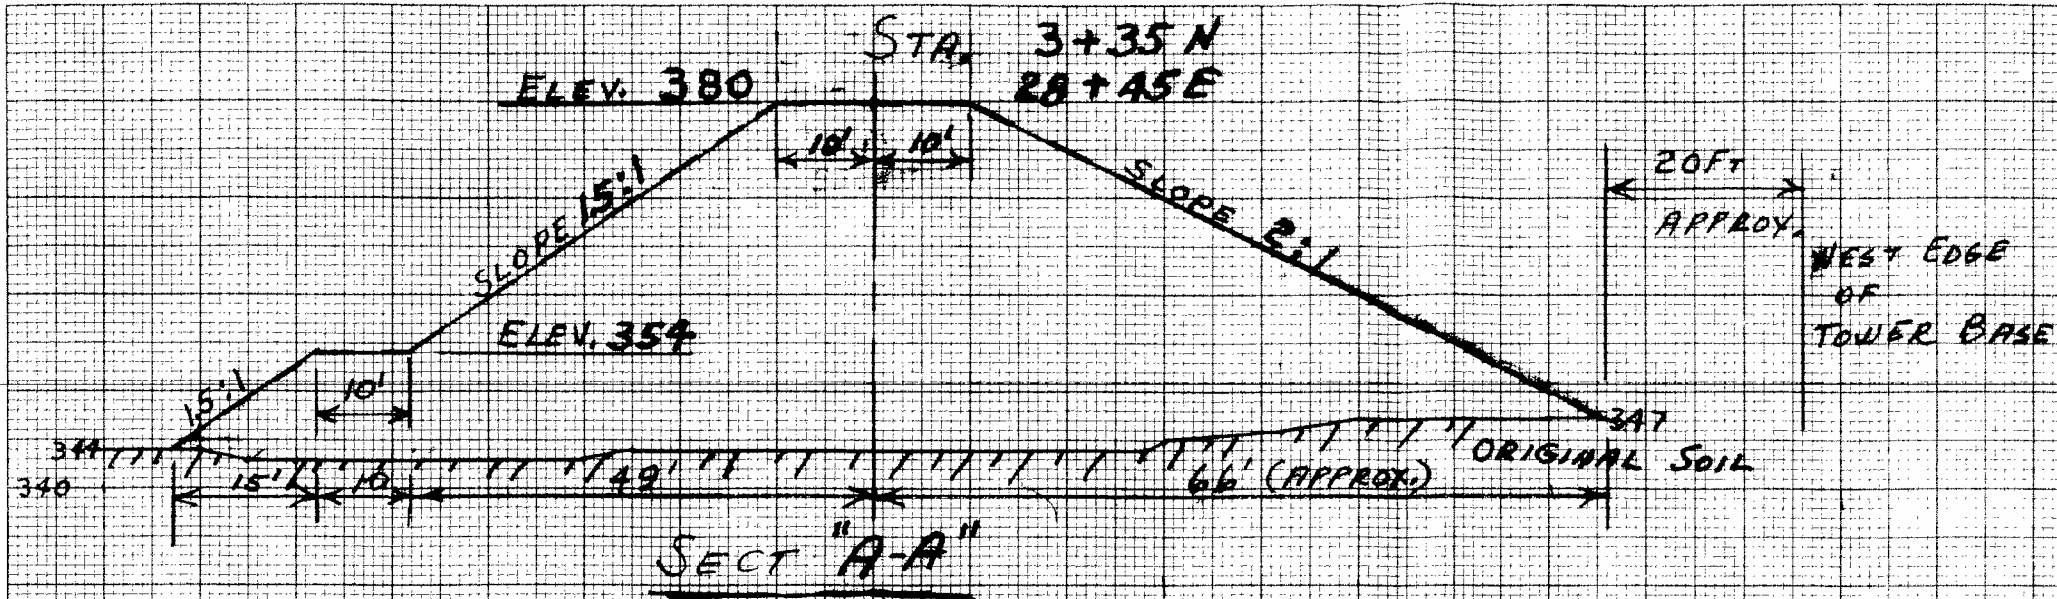
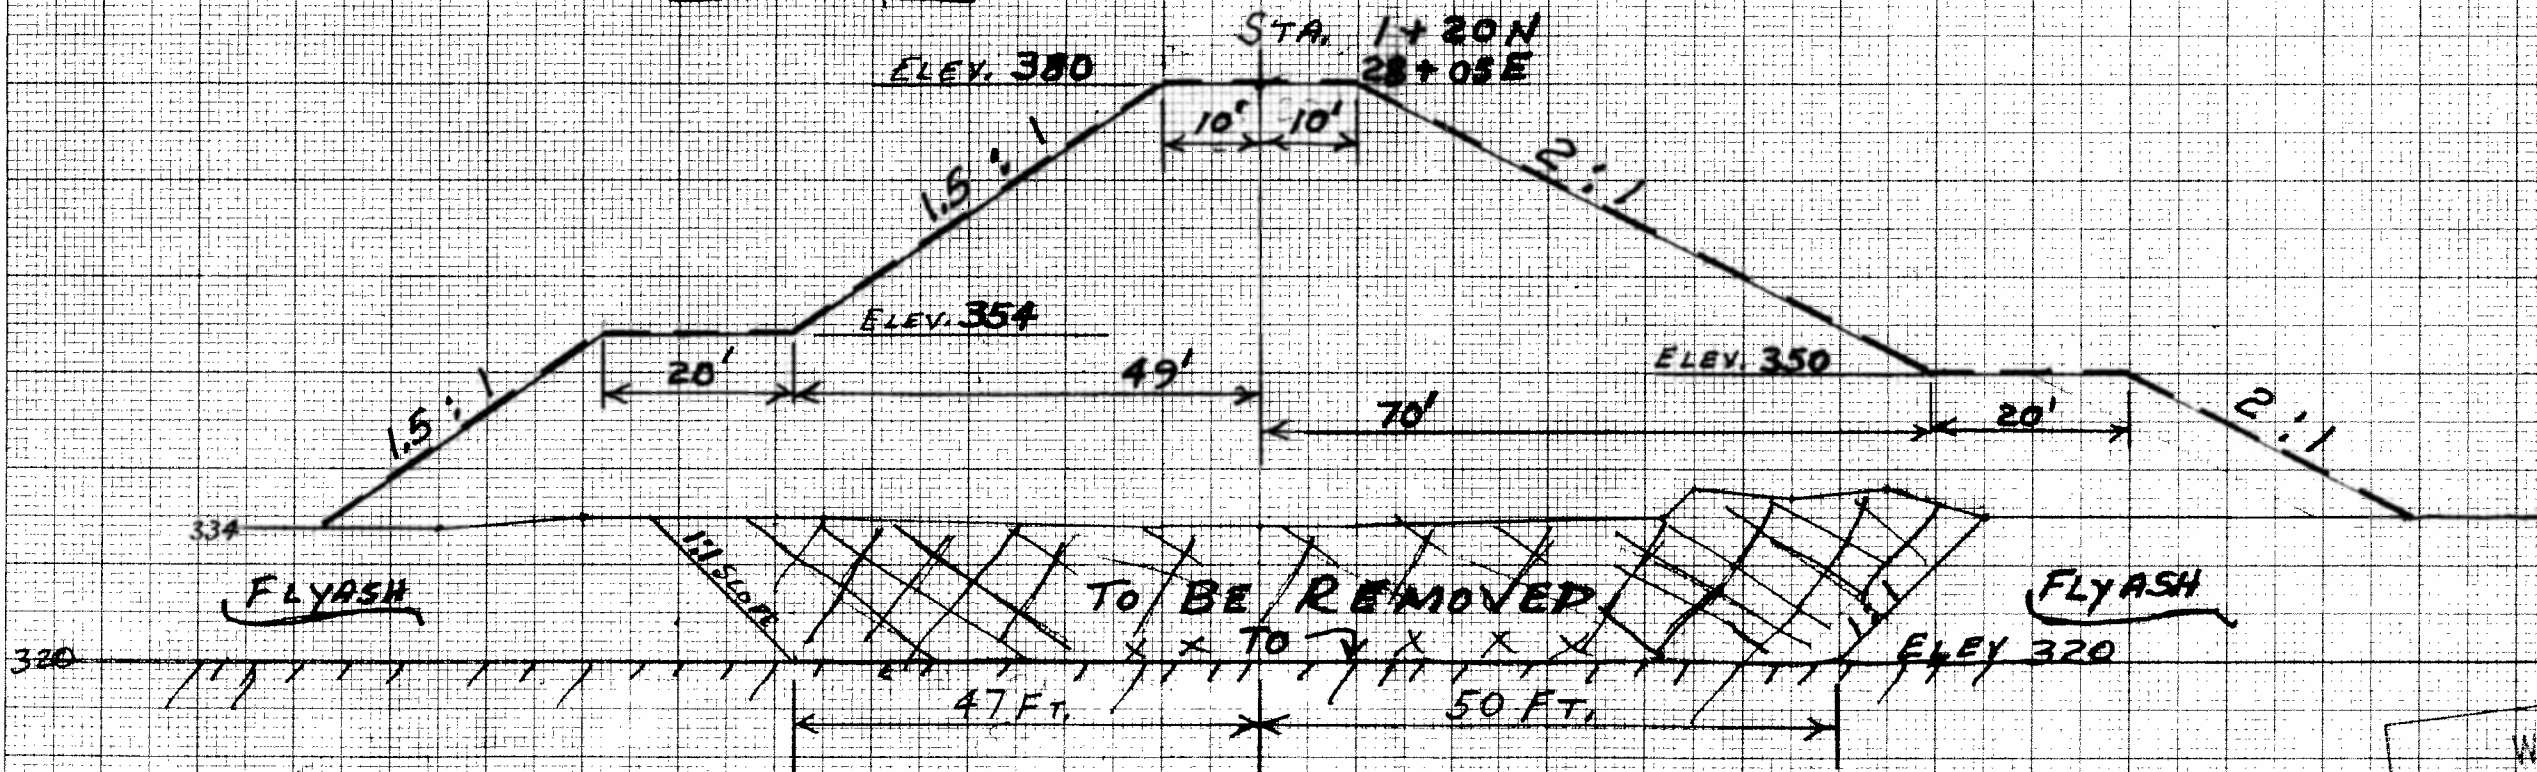
EEI Drawing AP-109, Sheet 1

- The outboard slope is steeper than generally recommended for dam and dike construction. The design drawings (See attached EEI Drawing AP-109) indicate the slope should be 2H:1V, but the observed slope appeared to be steeper and matched the 1.5H:1V slope of the Northern Pond.

- Based on Drawing AP-109, Sht. 1 (attached), the Southern Pond embankment was keyed into a suitable foundation through a layer of fly ash for a portion of the embankment. Section A-A, which is indicative of construction in the area near the power lines (Dwg. 4229-8211, Sht. 1), indicates that this section of the embankment was not keyed into the underlying foundation.

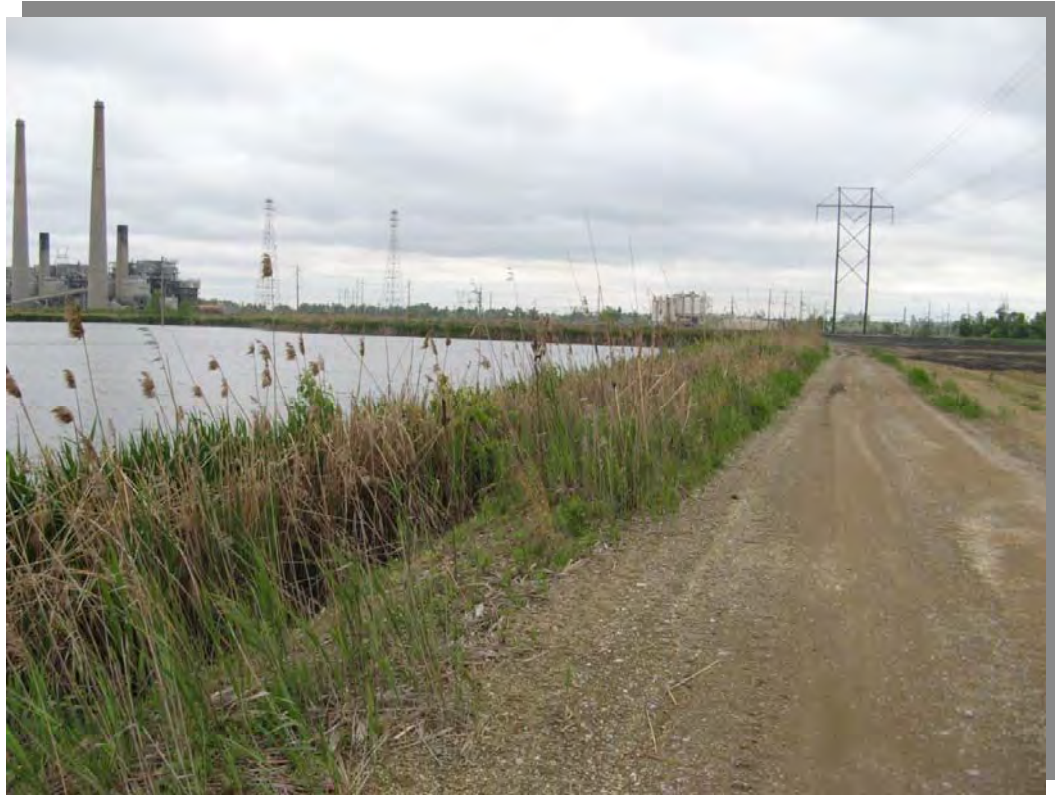
Photo 1 – Central Dike, looking west. Note vegetative growth on inboard slope of Southern Pond.

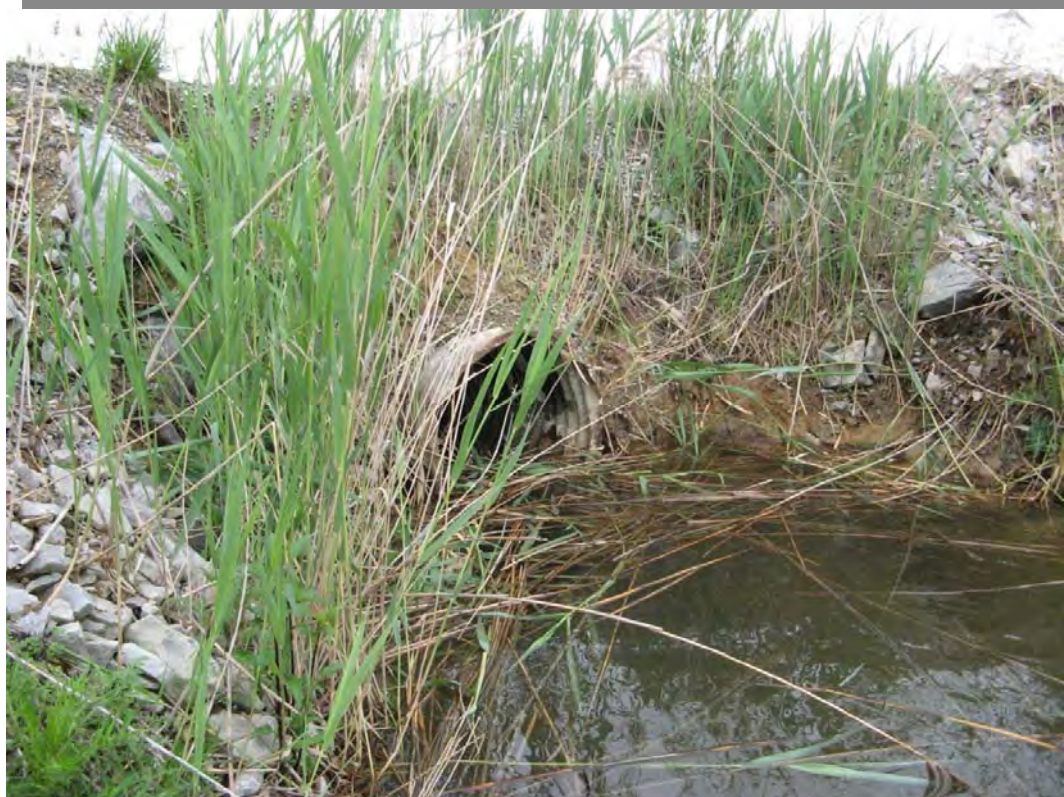
- The 24-inch connecting pipe does not have a control structure (gate, valve, stoplogs, etc.) to regulate the amount of flow between the impoundments. Riprap has been placed, or fallen into, the opening of the pipe and was observed within the pipe, near its midpoint. The riprap limits the capacity of the pipe and may have slightly raised the water surface elevation in the Southern Pond (Photos 2 & 3).

Photo 2 – Central Dike Culvert entrance in Southern Pond.  
Note water surface elevation in pond in relation to pipe invert.

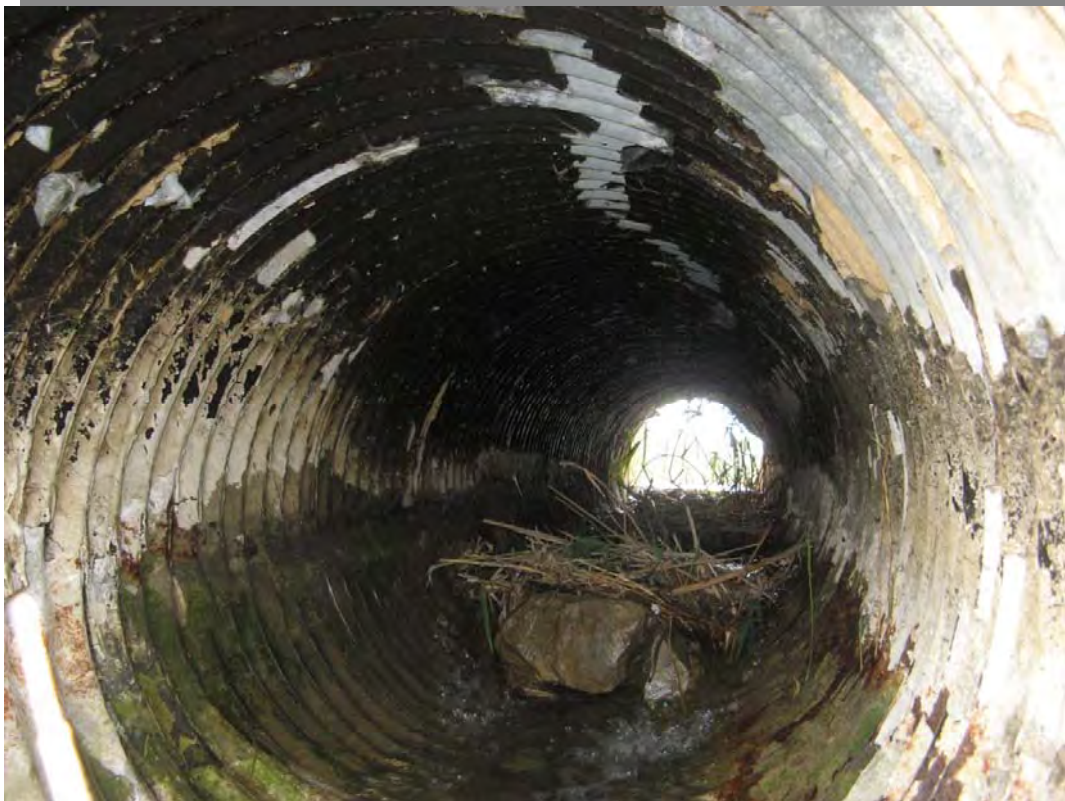
Photo 3 – Interior of Central Dike Culvert. Note riprap “dam” limiting pipe’s capacity.

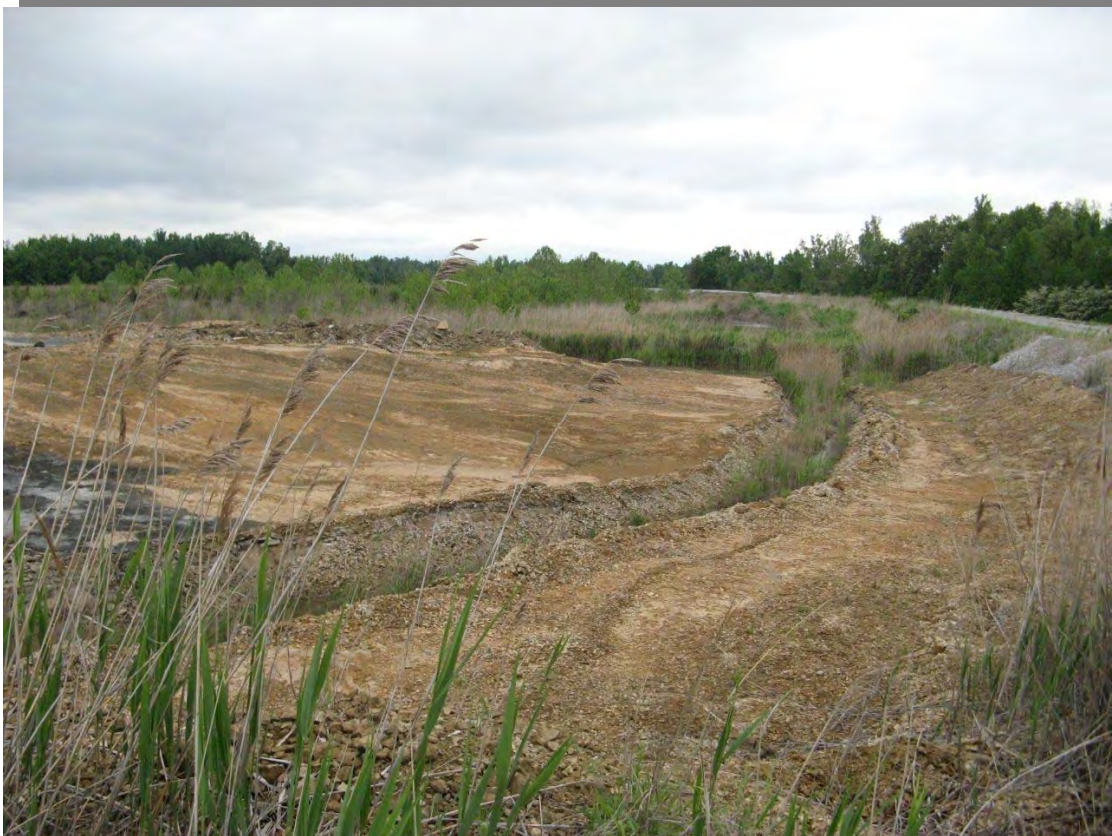
Photo 4 – Interior of Northern Pond, looking north from Central Dike.  
Channel to direct flow from Culvert to Pond outlet structure.

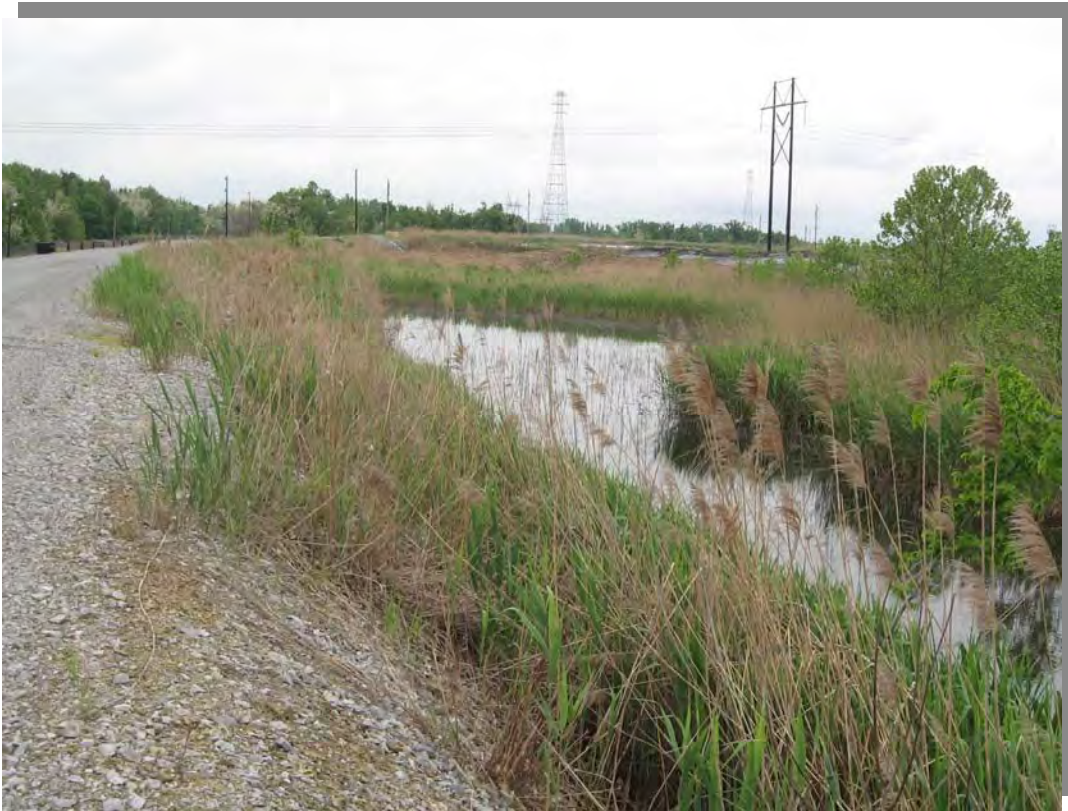
Photo 5 – Interior of Northern Pond, looking south from northern corner.  
Note vegetative growth on inboard slope..

- Inboard slopes – keep vegetation under control to allow for visual inspection of the exposed portion of the slope above the waterline.
- Additional studies – perform geotechnical investigation, cross-sectional topographic survey, and slope stability analyses of critical sections. Install piezometers to check phreatic levels within the embankment. Analyze for normal pool with steady state seepage, maximum surcharge pool, and seismic loading conditions and, depending on the results of the analyses, consider alternatives for stabilizing the embankments and control the seepage.

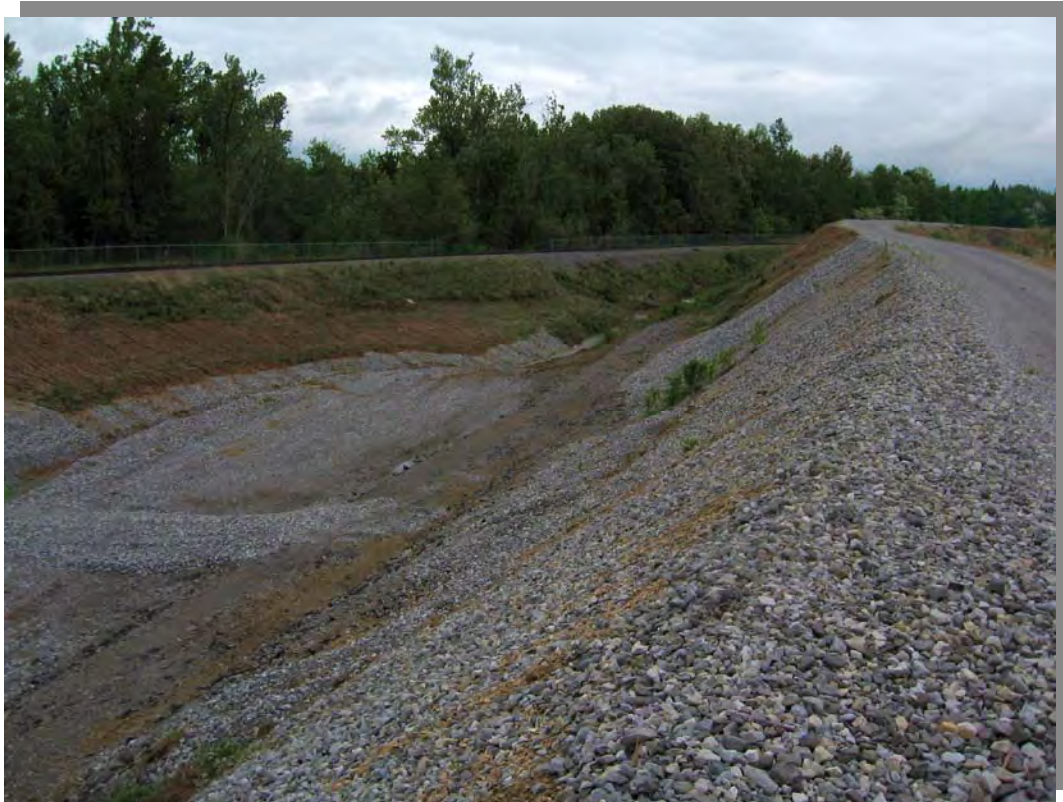
Photo 6 – Outboard slope of Northern Pond near the northern end.

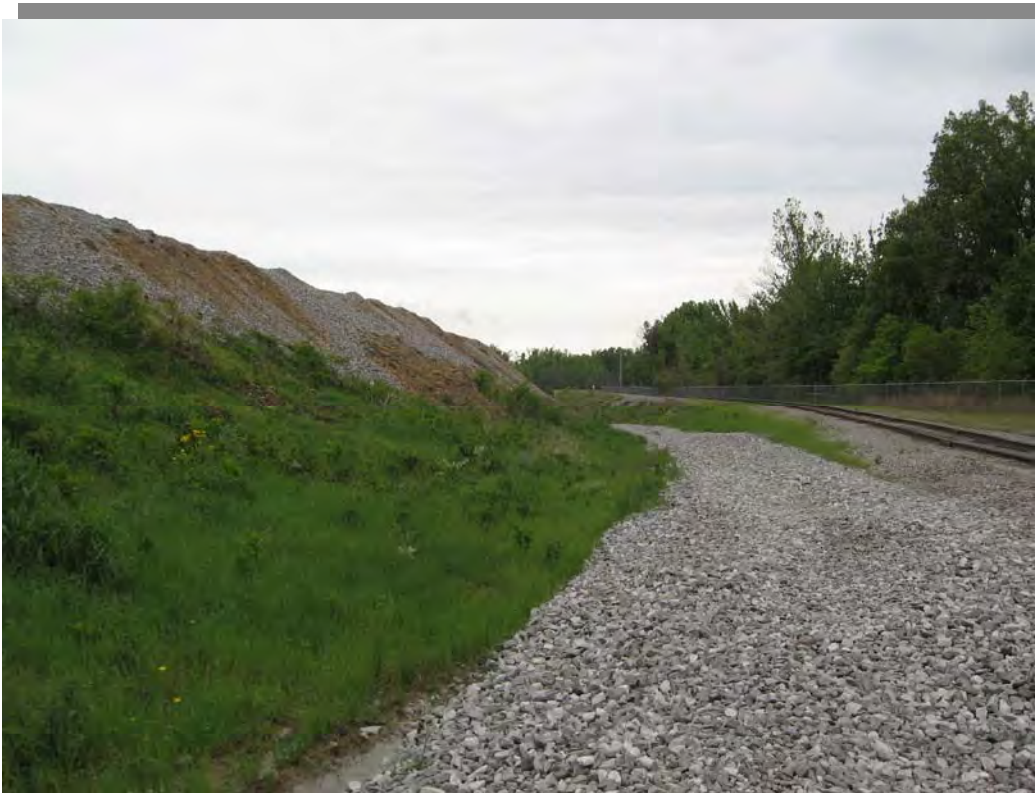
Photo 7 – Outboard slope of Northern Pond near the northern end.  
Note repairs near the crest.

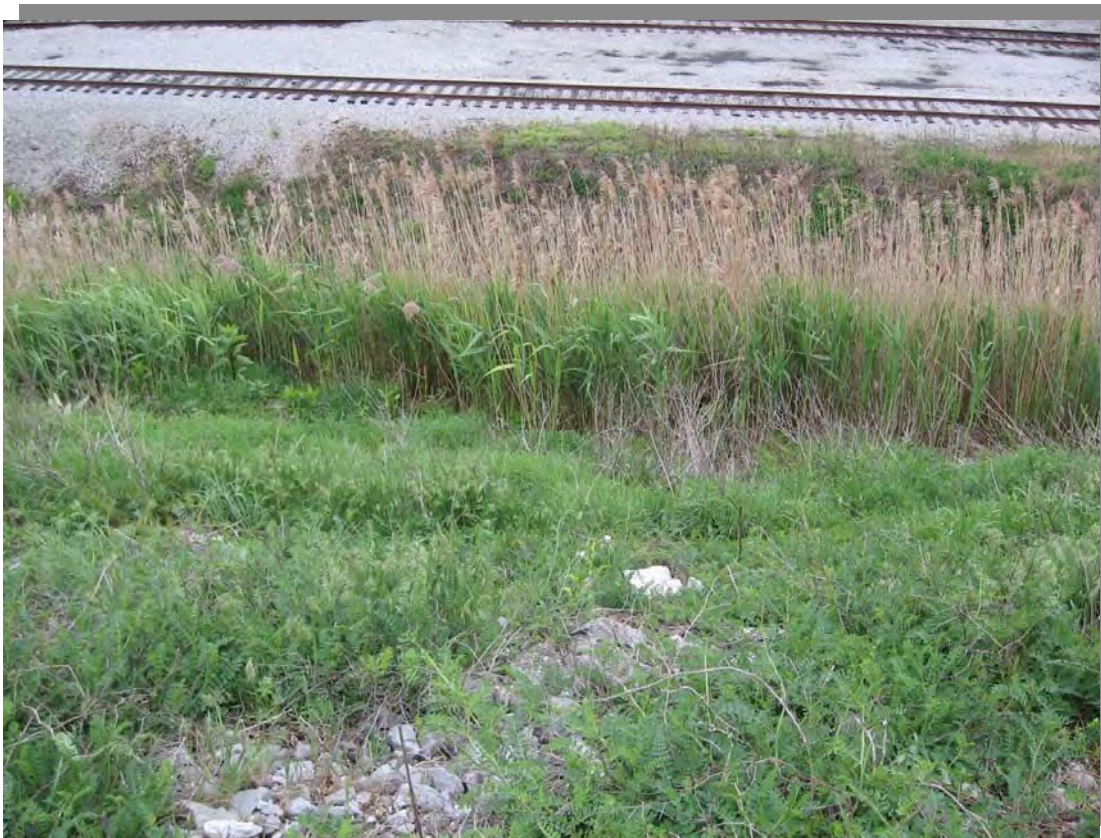
Photo 8 – Outboard slope of Northern Pond near the northern end.  
Note reedy grasses at toe.

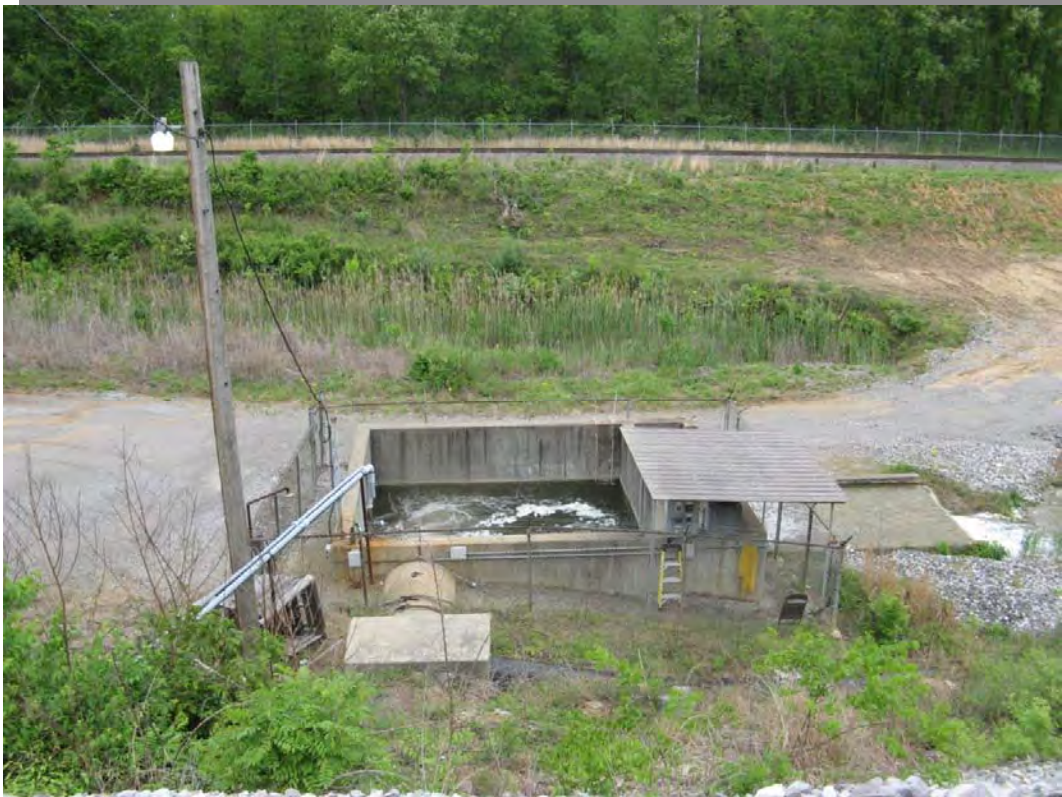
Photo 9 – pH balance outlet structure. Note HDPE pipe running parallel to toe (Southern Pond discharge) joining with concrete pipe (Northern Pond discharge) outside of structure.

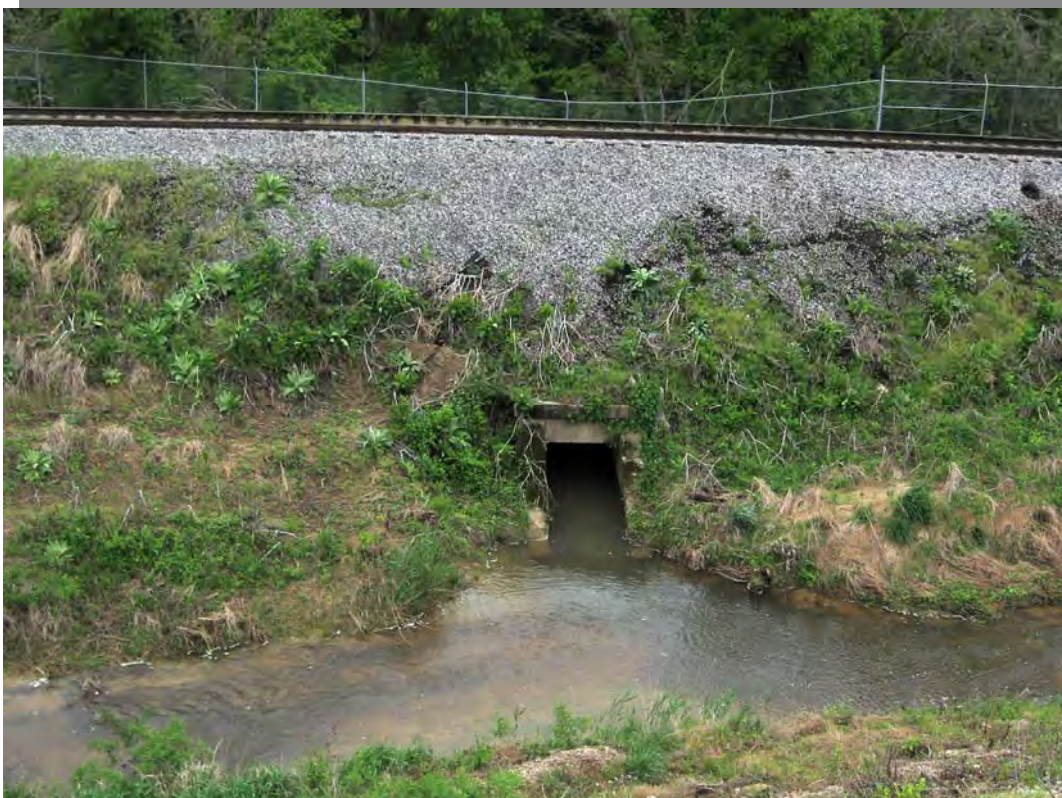
Photo 10 – Runoff from drainage area east of Ash Pond merging with Pond effluent..

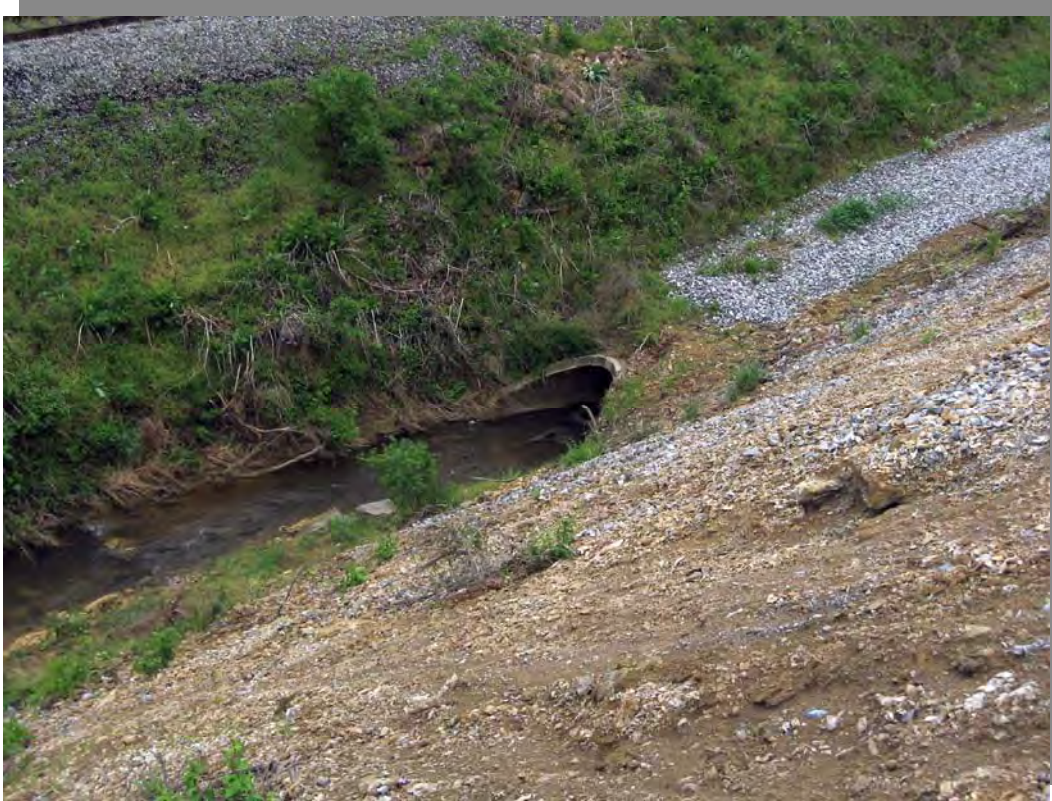
Photo 11 – Ash Pond outlet channel transitioning from open channel to underground culvert.

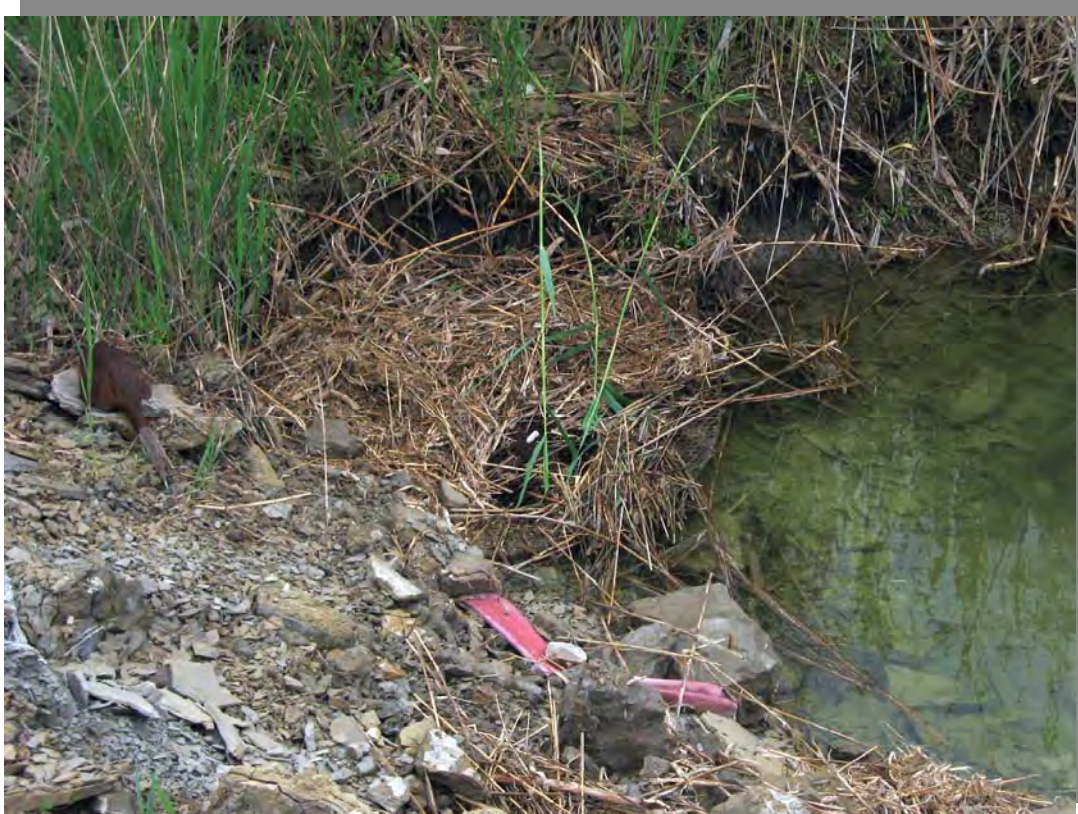
- A crushed-stone access road was constructed over the length of the crest. The road appears to be in good condition with no rutting, erosion or standing water observed.
- The outlet structure was covered with dried reeds but appeared to be in good condition and functioning normally (Photo 12).

Photo 12 – Northern Pond outlet structure, located at northern end of impoundment.

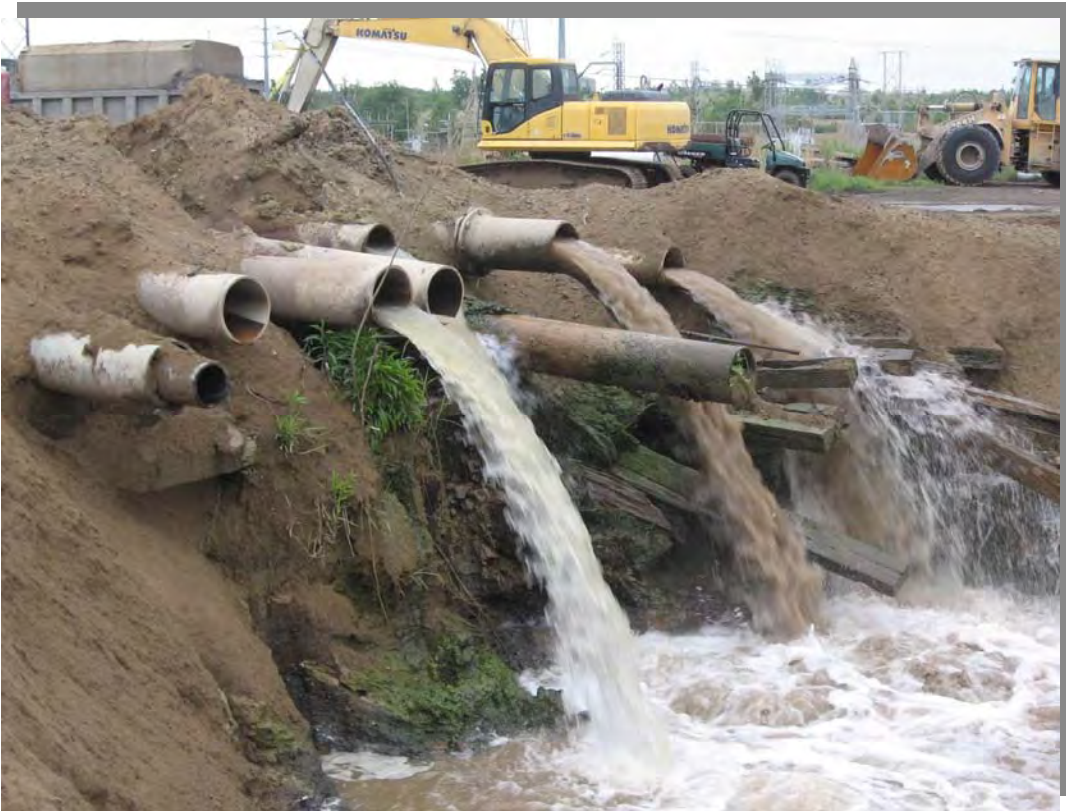
Photo 13 – CCW discharge from Joppa Plant into Ash Pond at southwestern corner of Southern Pond..

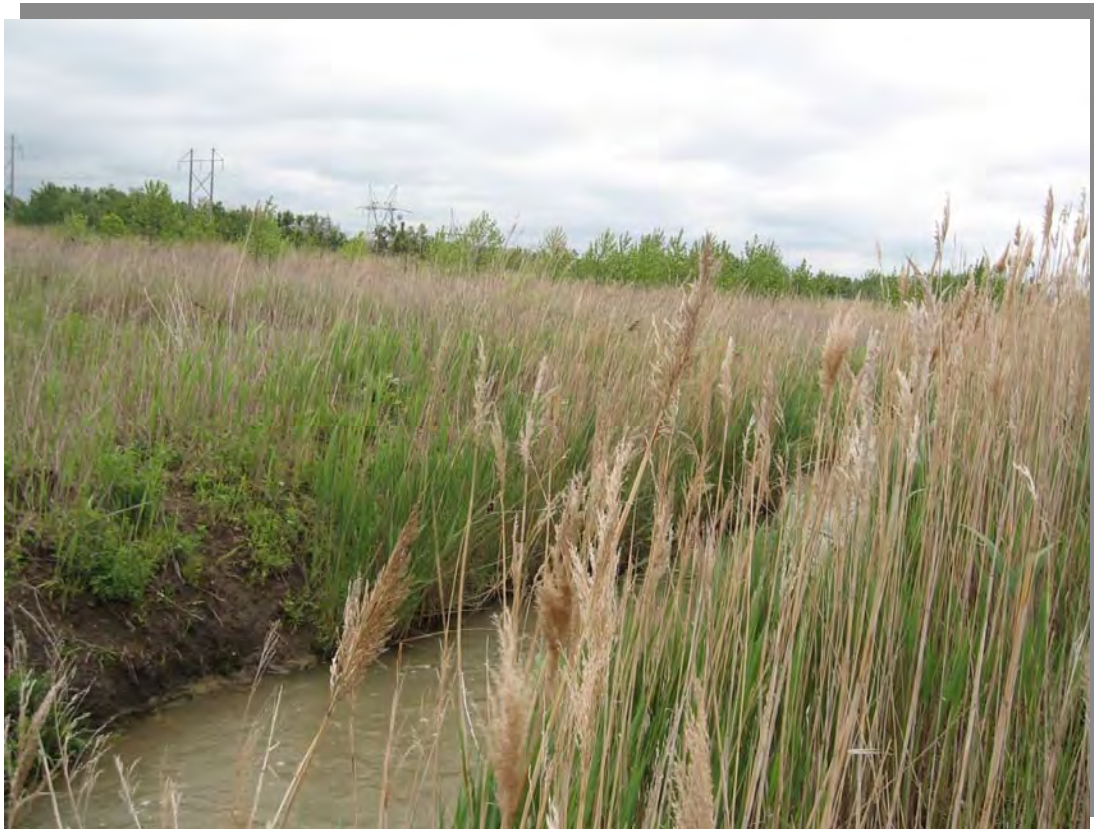
Photo 14 – Channel dredged into CCW that conveys inflow from pipes to eastern side of Southern Pond.

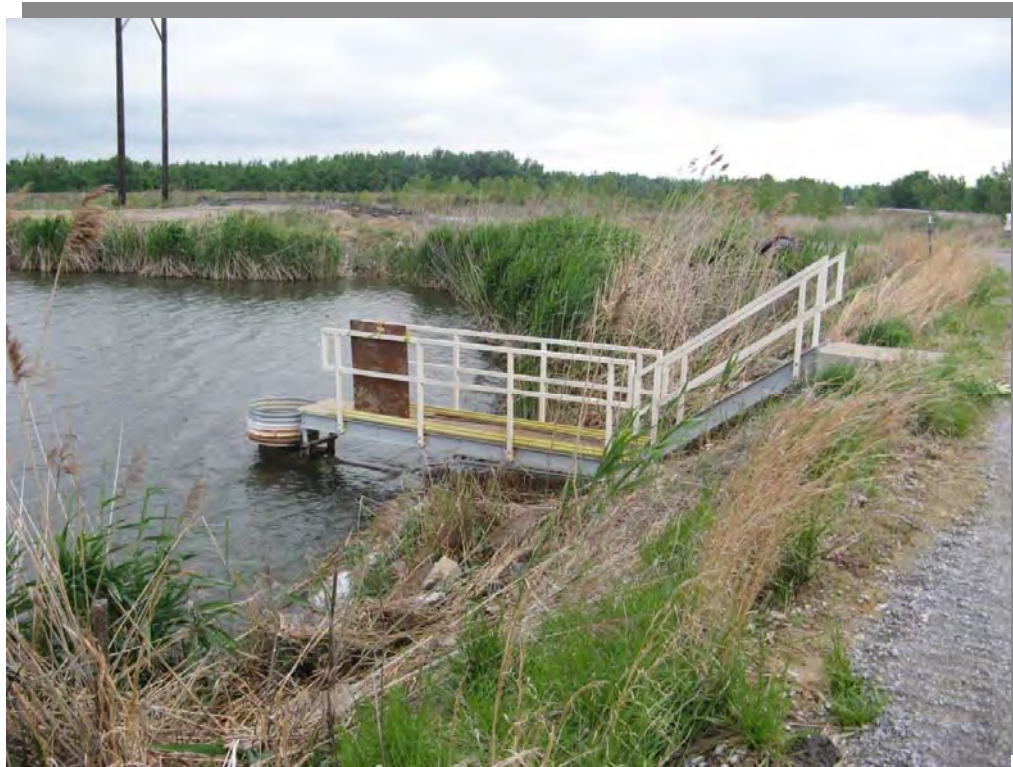
Photo 15 – Southern Pond primary outlet structure.

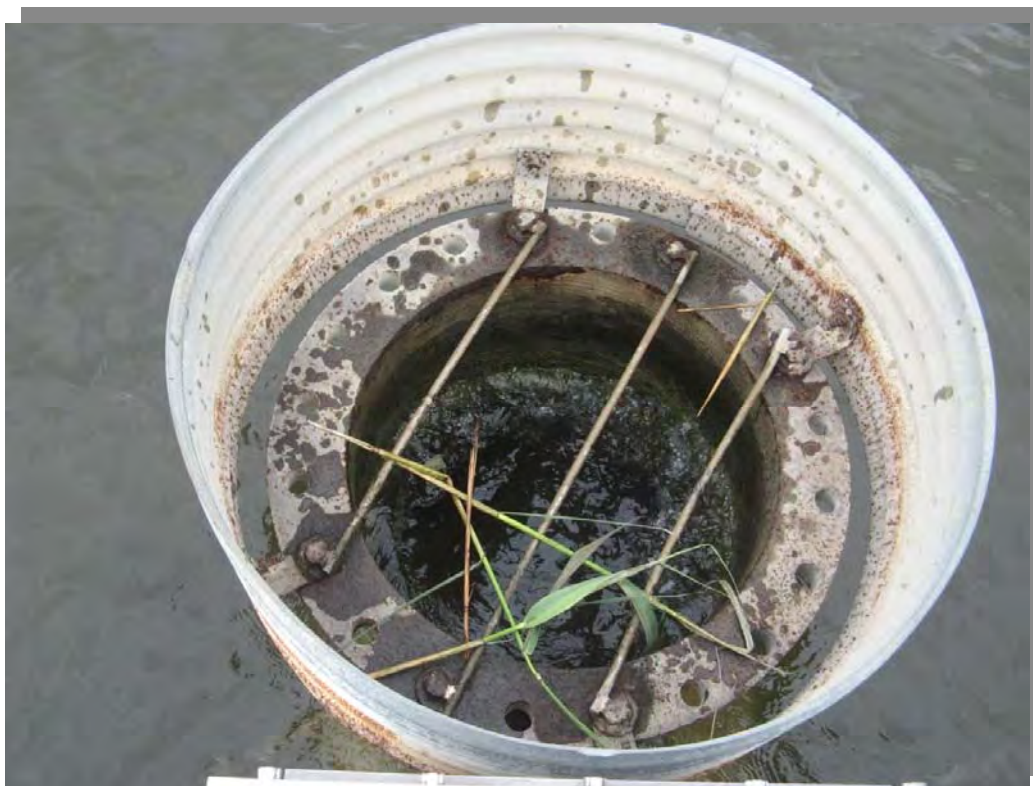
Photo 16 – Interior of Southern Pond primary outlet structure.

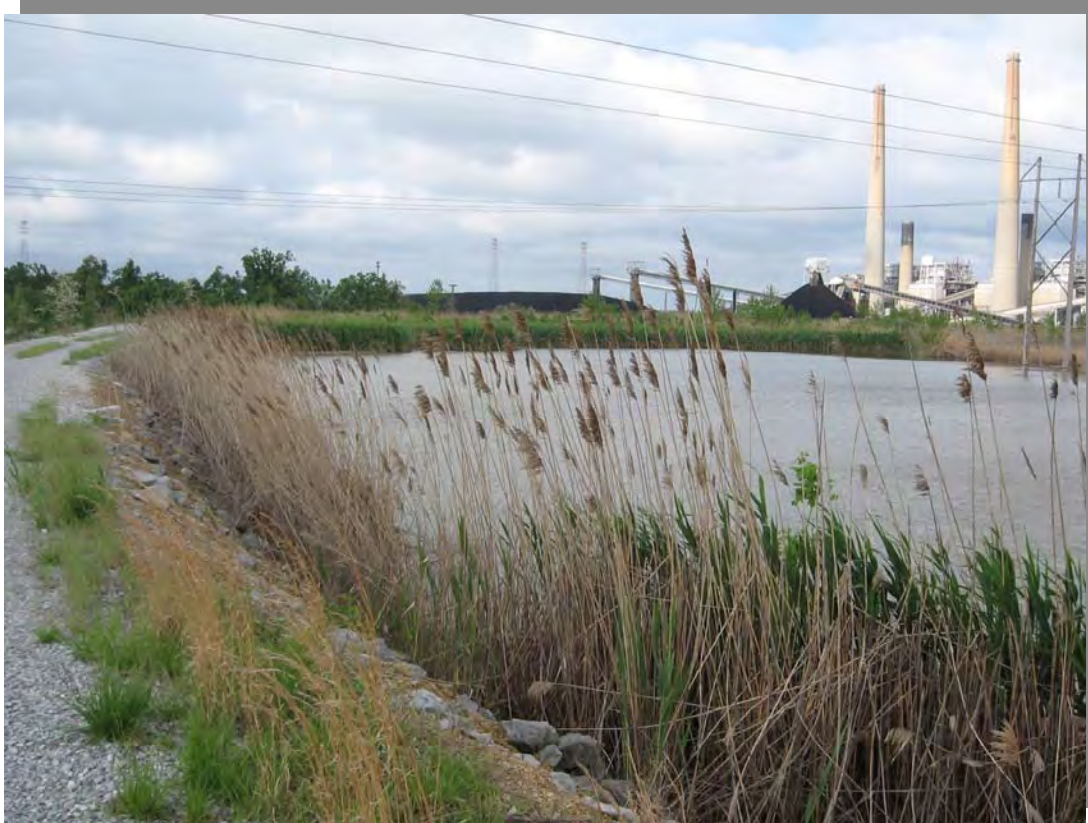
Photo 17 – Interior of Southern Pond, looking south from primary outlet structure.

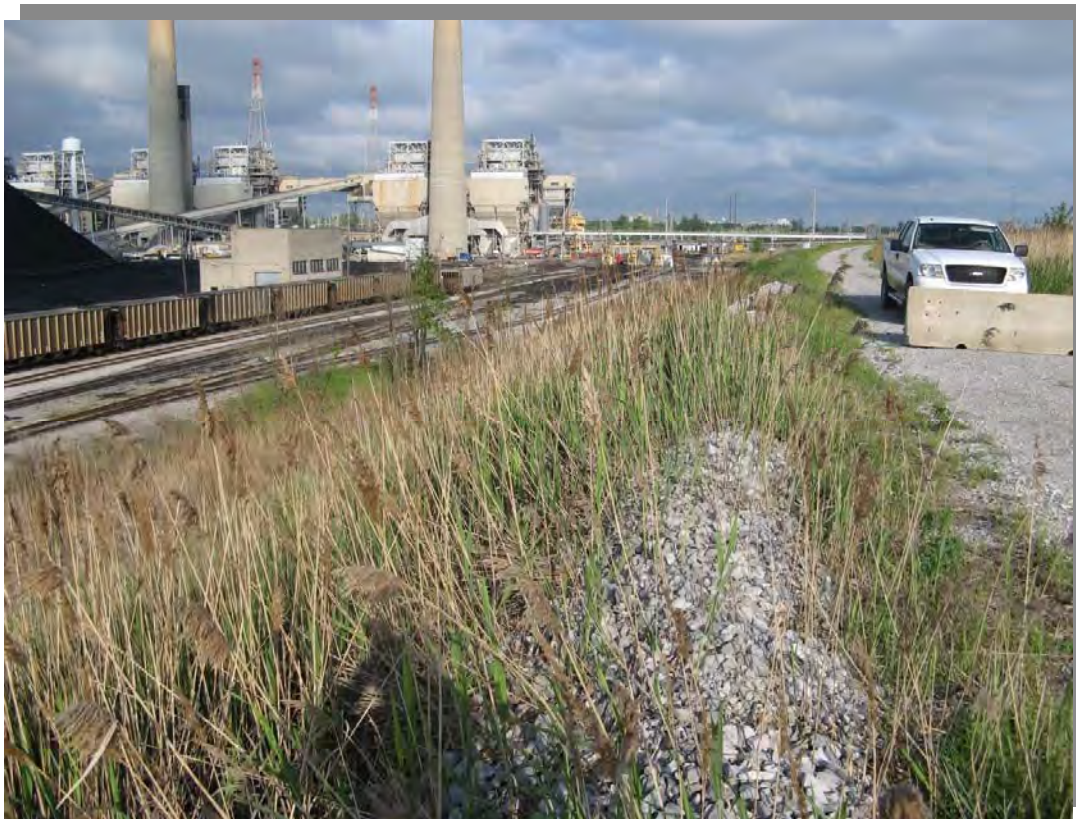
Photo 18 – Outboard slope of southern embankment of Southern Pond.  
Note Jersey barrier blocking vehicular access to eastern embankment.

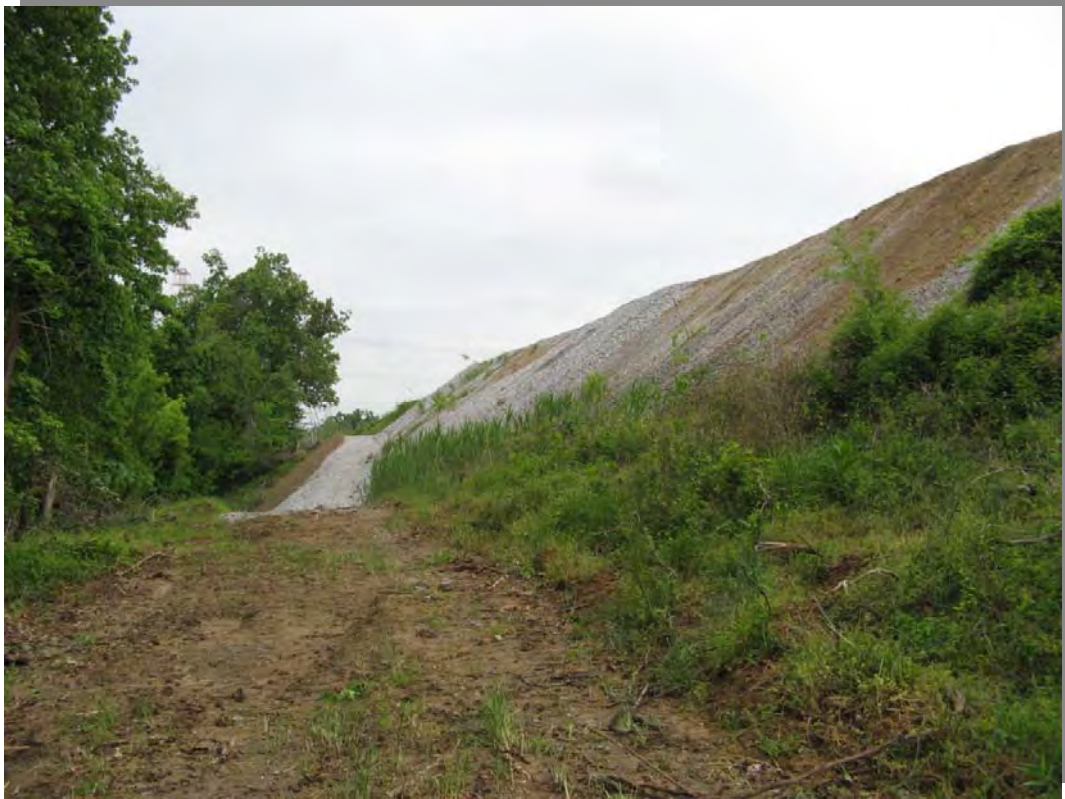
Photo 19 – Outboard slope of eastern embankment of Southern Pond.  
Note repairs near crest and partially completed access road along toe.

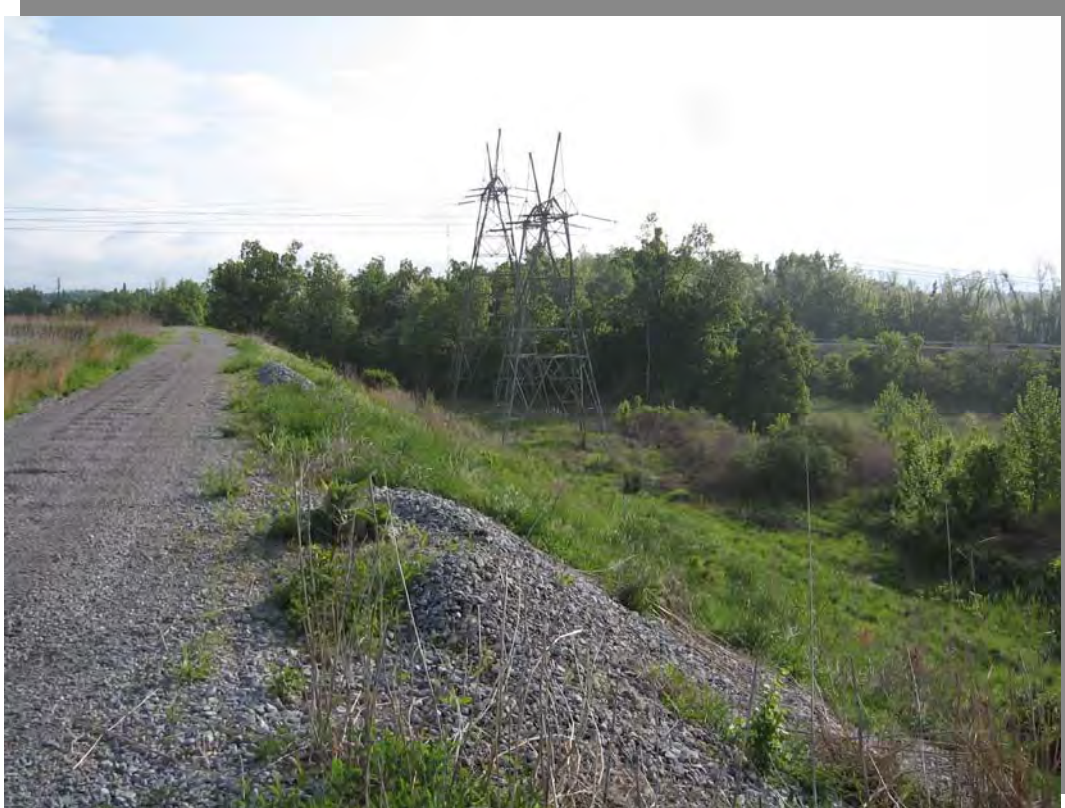
- Surface erosion, sloughs and slides were observed along the outboard slope. The most significant erosion was observed in the area below the power lines that cross the Southern Pond (Photos 20 - 22).

Photo 20 – Outboard slope of Southern Pond near power lines.

- Outboard slopes – remove deleterious vegetation and continue regular maintenance of the slopes; repair any areas of sloughs, slides and erosion.
- Outboard toe – investigate the extent of seepage, monitor the seepage on a regular basis, and develop alternatives for treating the deteriorated sections of the embankment.

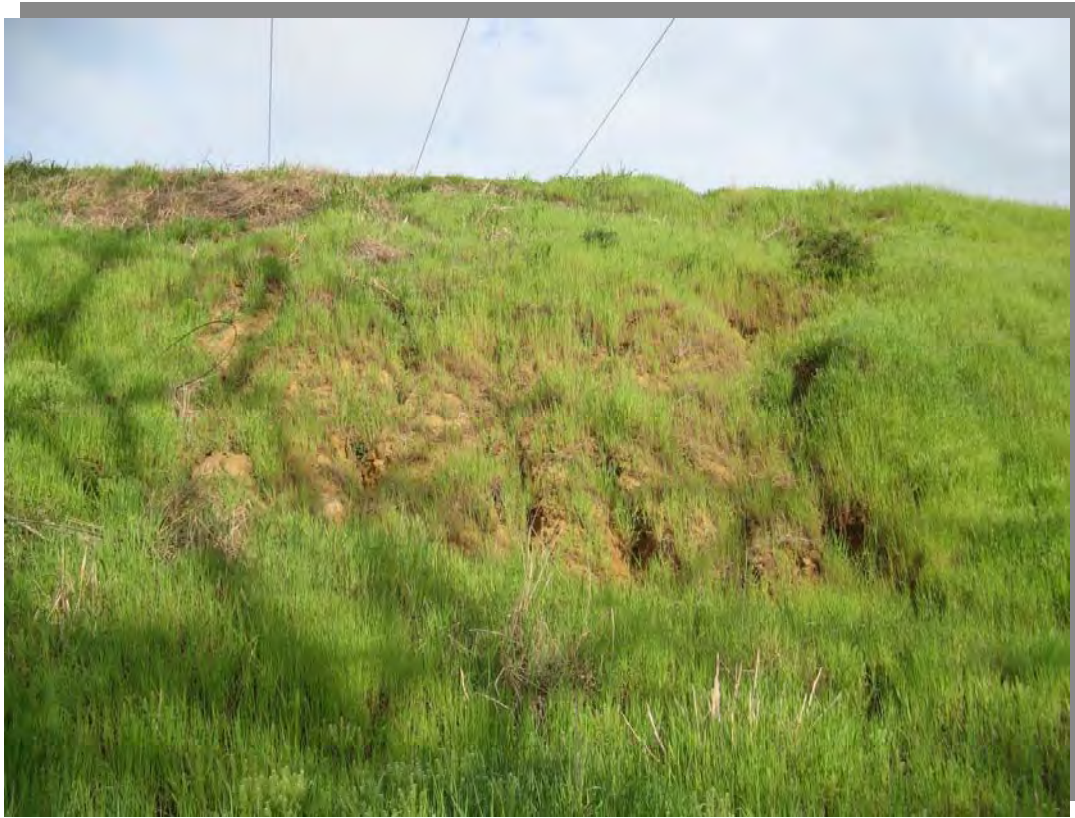
| Inspection Issue # | Comments |
|---|---|
| 17, 18, 19 | Scarps and sloughing of embankment observed in area below power lines that cross the South Pond (Eastern embankment of South Pond). Erosion of lower portion of berm observed approximately 100' south of power lines. |

Photo 21 – Erosion on east embankment of Southern Pond below the power lines.
