# **Dam Safety Assessment of CCW Impoundments**

## **Joppa Plant**

**United States Environmental Protection Agency  
Washington, DC**

May 27, 2010

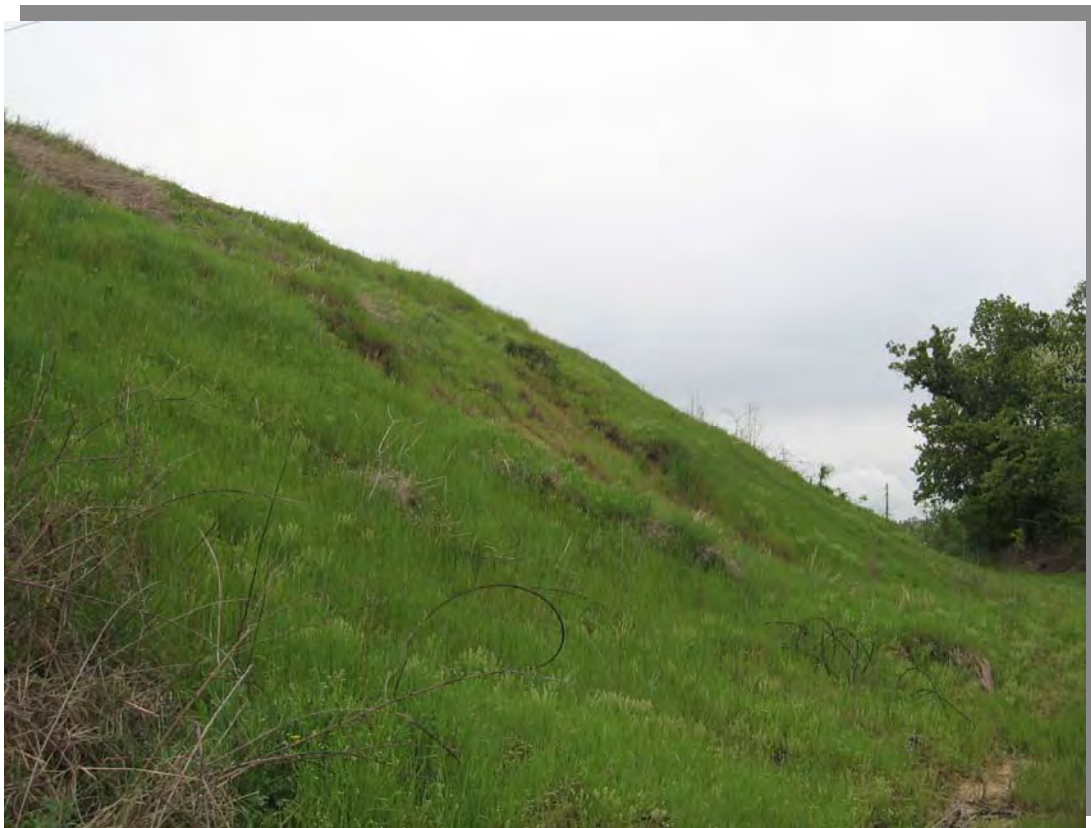
- Surface erosion, sloughs and slides were observed along the outboard slope. The most significant erosion was observed in the area below the power lines that cross the Southern Pond (Photos 20 - 22).

| Inspection Issue # | Comments |
|---|---|
| 17, 18, 19 | Scarps and sloughing of embankment observed in area below power lines that cross the South Pond (Eastern embankment of South Pond). Erosion of lower portion of berm observed approximately 100' south of power lines. |

Photo 22 – Slides and sloughs on east embankment of Southern Pond, approximately 200 feet south of power lines.

- Outboard slopes – remove deleterious vegetation and continue regular maintenance of the slopes; repair any areas of sloughs, slides and erosion.
- Outboard toe – investigate the extent of seepage, monitor the seepage on a regular basis, and develop alternatives for treating the deteriorated sections of the embankment.

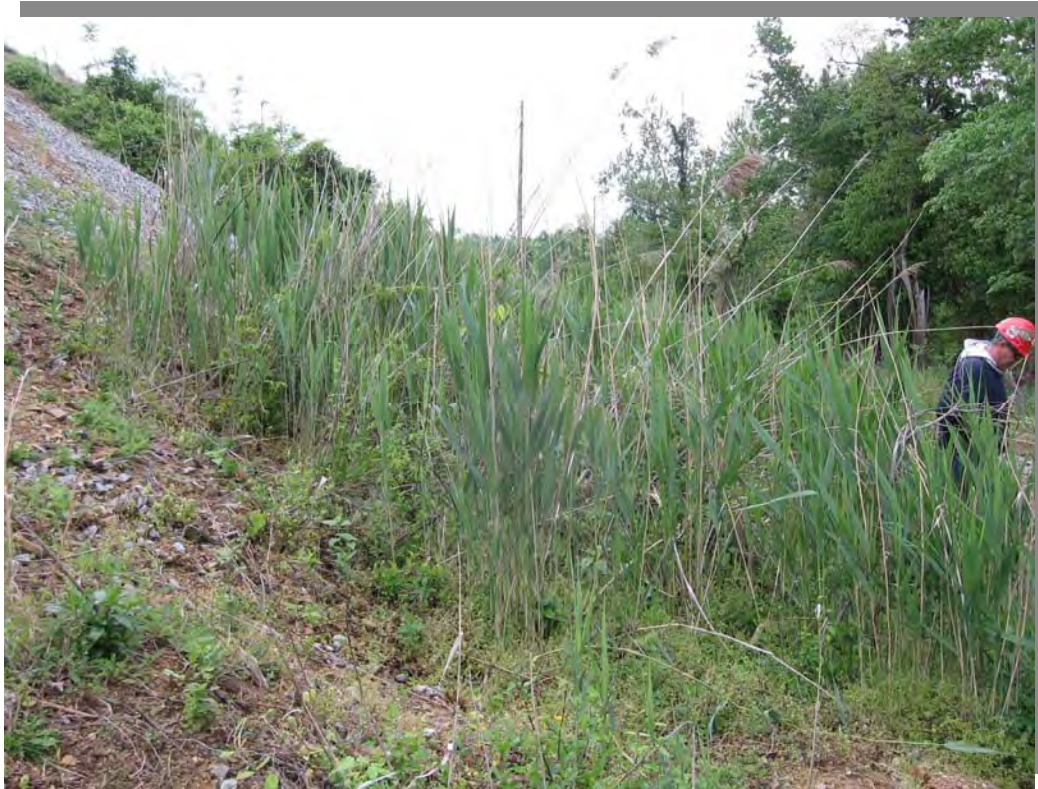
- Seepage was observed in multiple locations along the outboard toe of the embankment. The most significant area of seepage is located approximately 500 feet north of the power lines (Photos 23 & 24). Other areas where seepage was observed include an area approximately 200 feet south of the power lines and along the southern embankment of the Southern Pond. The approximate locations of seepage are identified on Figure 3.

| Inspection Issue # | Comments |
|---|---|
| 21 | Seepage observed at various locations along the toe of the eastern embankment on South Ponds. Seepage area extends approximately 100', starting approximately 500' North of power lines. Seepage was also observed on the Southern embankment of the South Pond in the area facing the coal piles. Evidence of seepage on the embankment slope was observed in this location, but seepage was not. |

Photo 23 – Outboard toe of Southern Pond eastern embankment approximately 500 feet north of power lines. Note reedy grasses indicating moist conditions, signs of seepage.

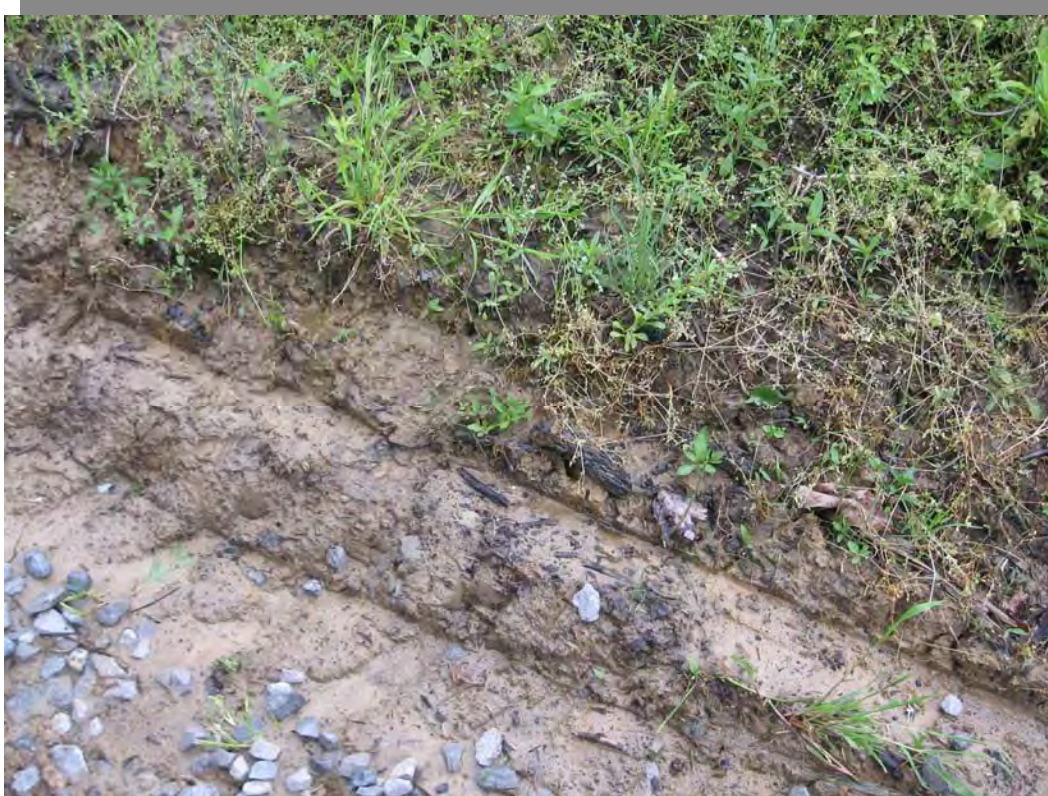
Photo 24 – Seepage at toe of east embankment of Southern Pond, near location indicated in Photo 23 above.

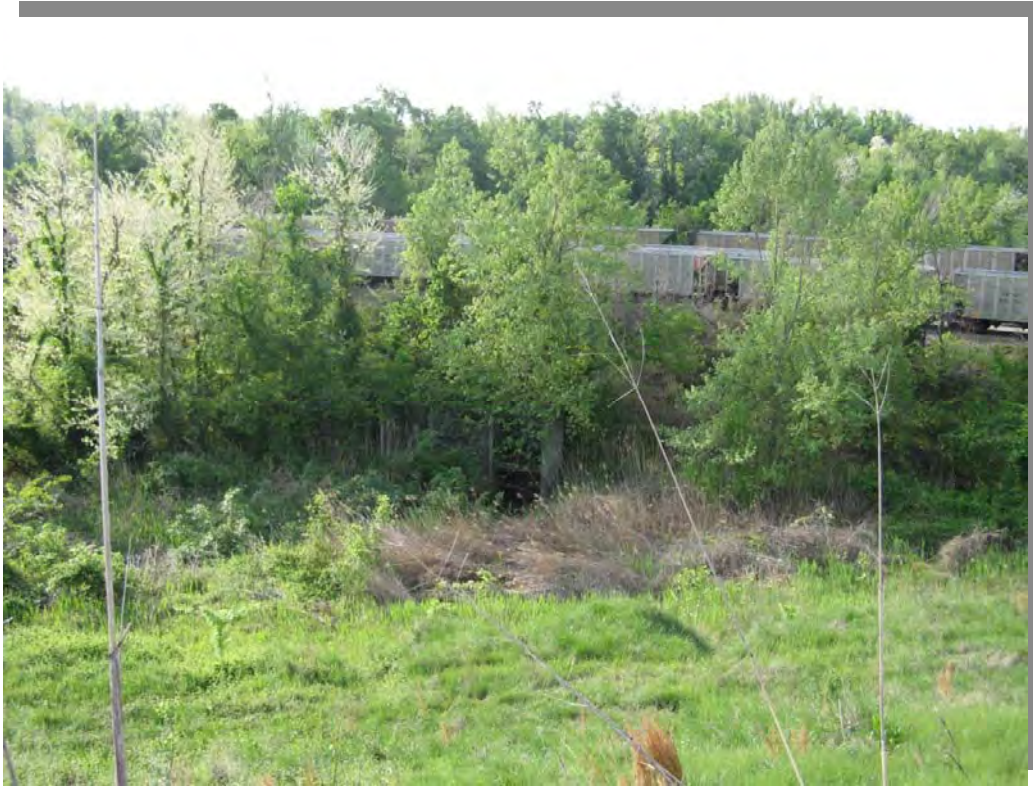
Photo 25 – Ash Pond outlet channel pass-through below EEI railroad siding.
