# Dam Safety Assessment of CCW Impoundments

## Joppa Plant

September 24, 2010

**O'BRIEN & GERE**  
[www.obg.com](http://www.obg.com)

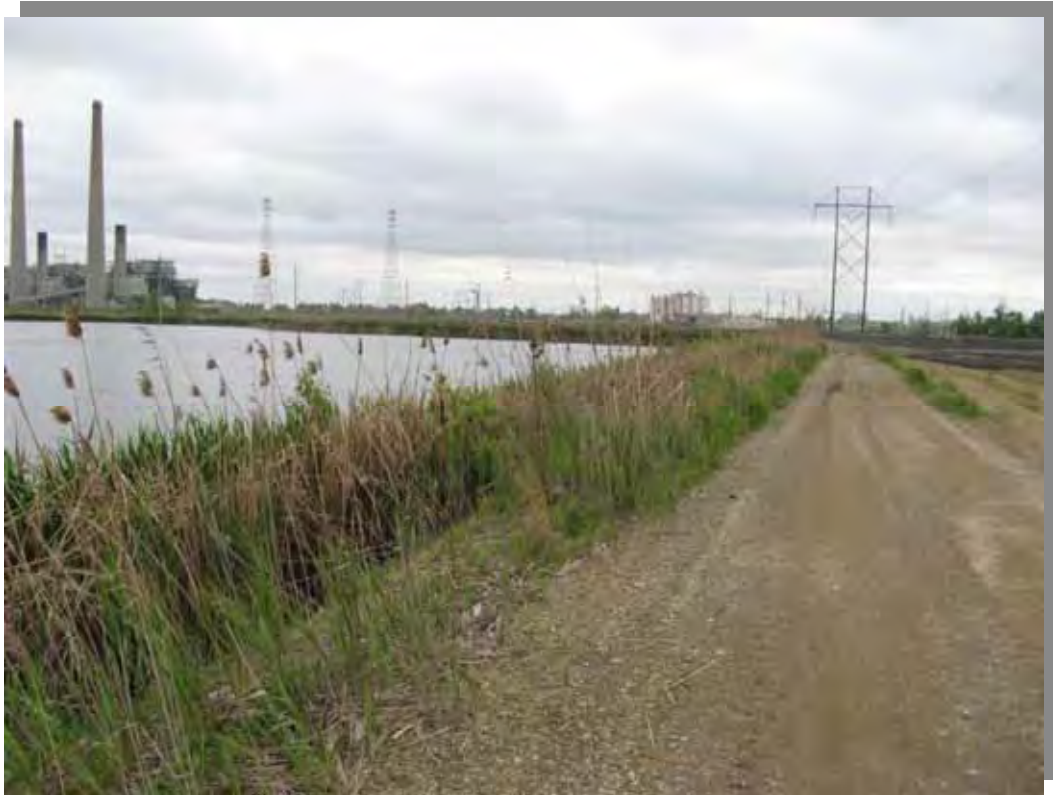
Photo 1 – Central Dike, looking west. Note vegetative growth on inboard slope of Southern Pond.

- Inboard slopes – keep vegetation under control to allow for visual inspection of the exposed portion of the slope above the waterline.
- Additional studies – perform geotechnical investigation, cross-sectional topographic survey, and slope stability analyses of critical sections. Install piezometers to check phreatic levels within the embankment. Analyze for normal pool with steady state seepage, maximum surcharge pool, and seismic loading conditions and, depending on the results of the analyses, consider alternatives for stabilizing the embankments and control the seepage.

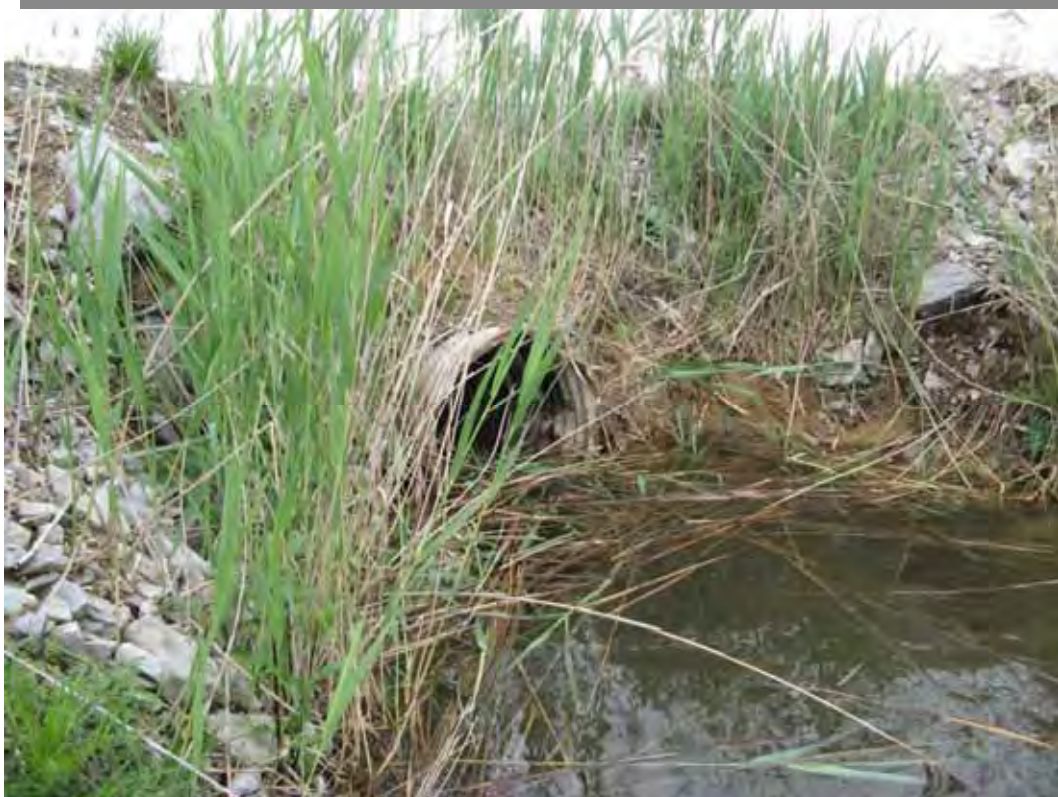
- The 24-inch connecting pipe does not have a control structure (gate, valve, stoplogs, etc.) to regulate the amount of flow between the impoundments. Riprap has been placed, or fallen into, the opening of the pipe and was observed within the pipe, near its midpoint. The riprap limits the capacity of the pipe and may have slightly raised the water surface elevation in the Southern Pond (Photos 2 & 3).

Photo 2 – Central Dike Culvert entrance in Southern Pond.  
Note water surface elevation in pond in relation to pipe invert.

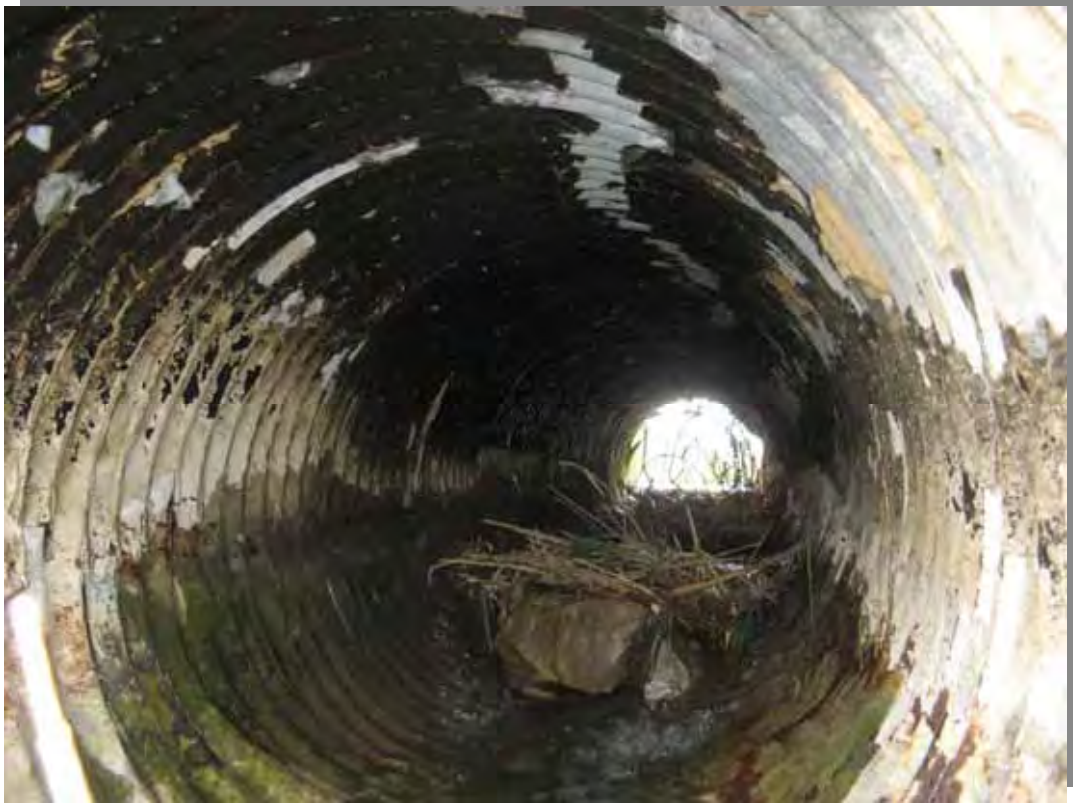
Photo 3 – Interior of Central Dike Culvert. Note riprap “dam” limiting pipe’s capacity.

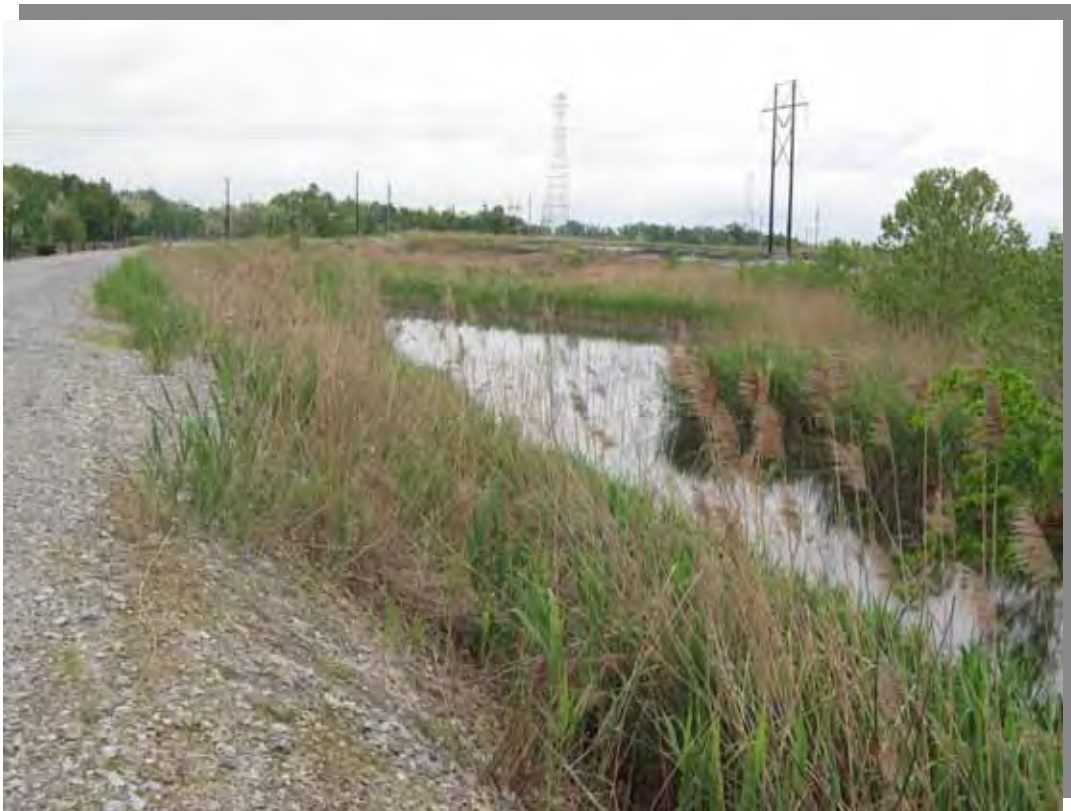
Photo 5 – Interior of Northern Pond, looking south from northern corner.  
Note vegetative growth on inboard slope..

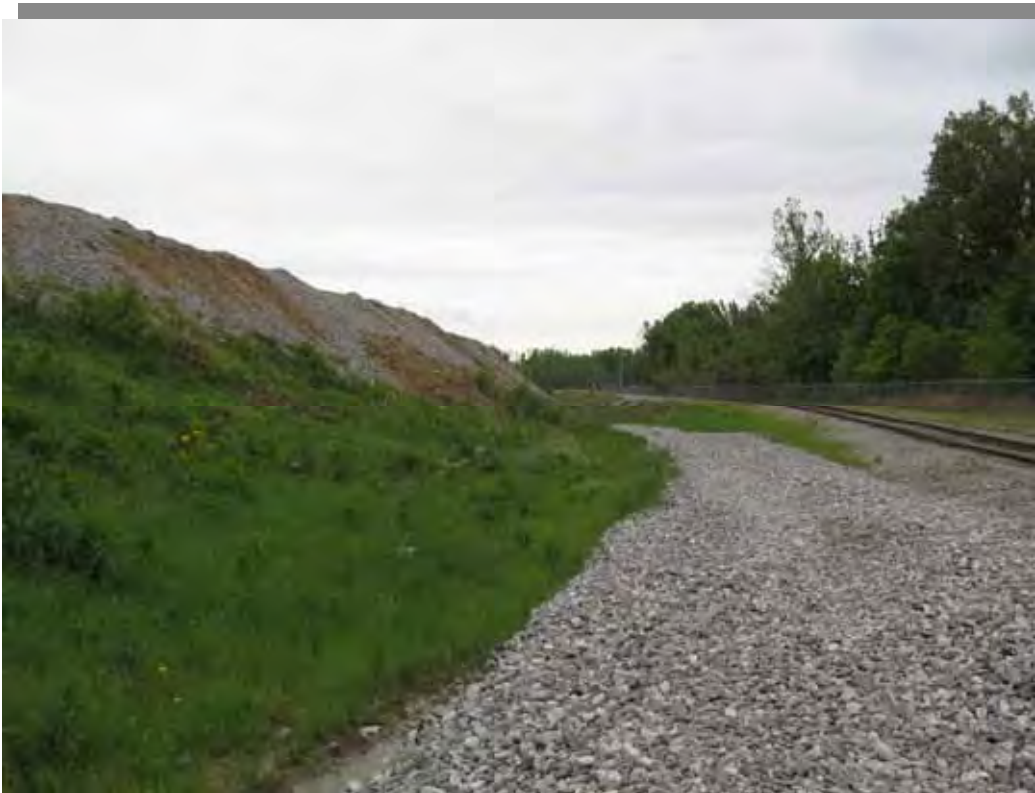
- The outboard slope is steeper than generally recommended for dam and dike construction, and surface erosion has occurred. EEI procedure is to dump rockfill over the eroded areas to prevent the deterioration from spreading.

Photo 7 – Outboard slope of Northern Pond near the northern end.  
Note repairs near the crest.

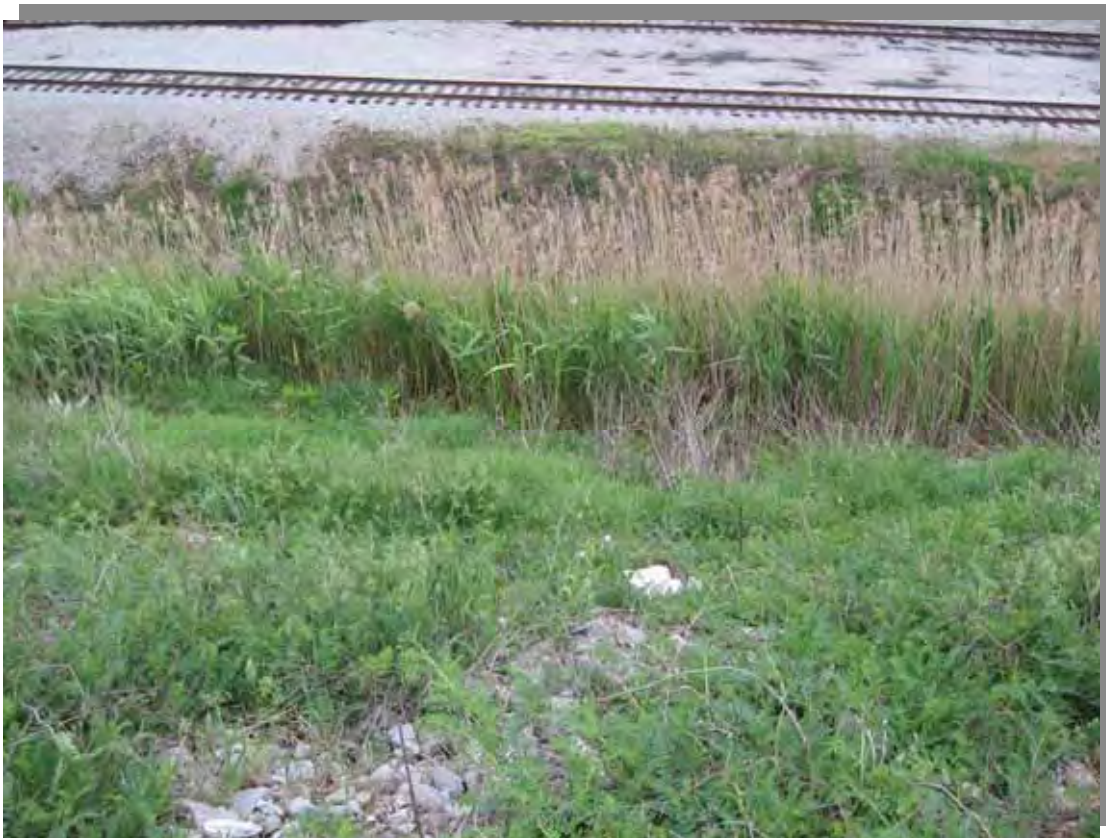
- The outboard toe area was generally well drained, although some standing water was observed in the area of the Central Dike and further north near the drainage channel culvert entrance.

Photo 8 – Outboard slope of Northern Pond near the northern end.  
Note reedy grasses at toe.

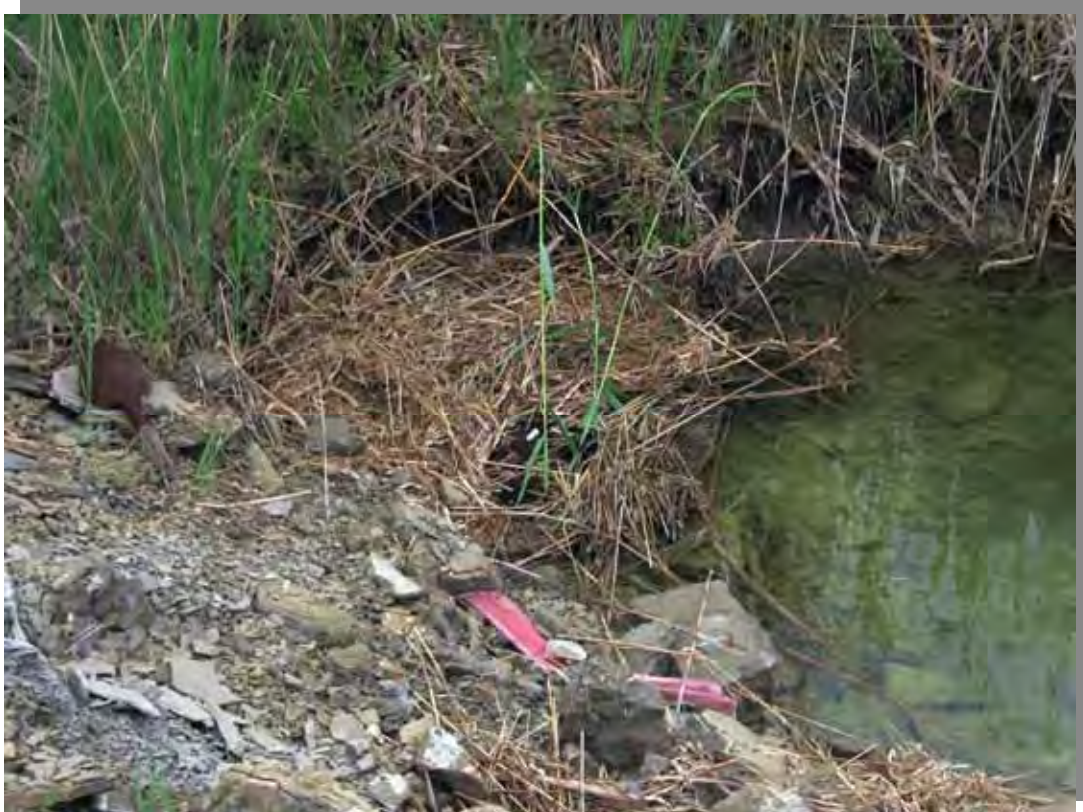
- A crushed-stone access road was constructed over the length of the crest. The road appears to be in good condition with no rutting, erosion or standing water observed.
- The outlet structure was covered with dried reeds but appeared to be in good condition and functioning normally (Photo 12).

Photo 12 – Northern Pond outlet structure, located at northern end of impoundment.

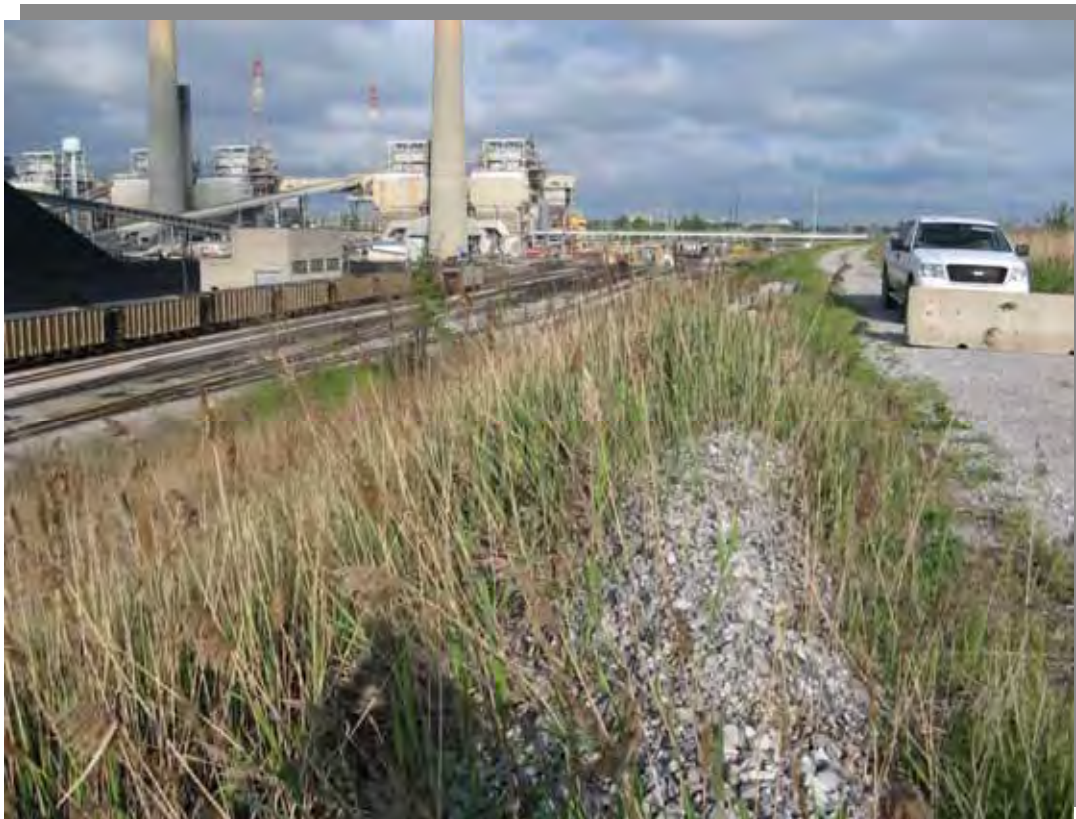
- A crushed-stone access road was constructed over the length of the crest. The road appears to be in good condition with no rutting, erosion or standing water observed. Jersey barriers prevent vehicular traffic from using the access road along the eastern half of the southern embankment and along the eastern embankment south of the Central Dike. The barriers were installed as a safety precaution to prevent vehicular traffic from crossing below the power lines when they started to sag.

Photo 18 – Outboard slope of southern embankment of Southern Pond.  
Note Jersey barrier blocking vehicular access to eastern embankment.

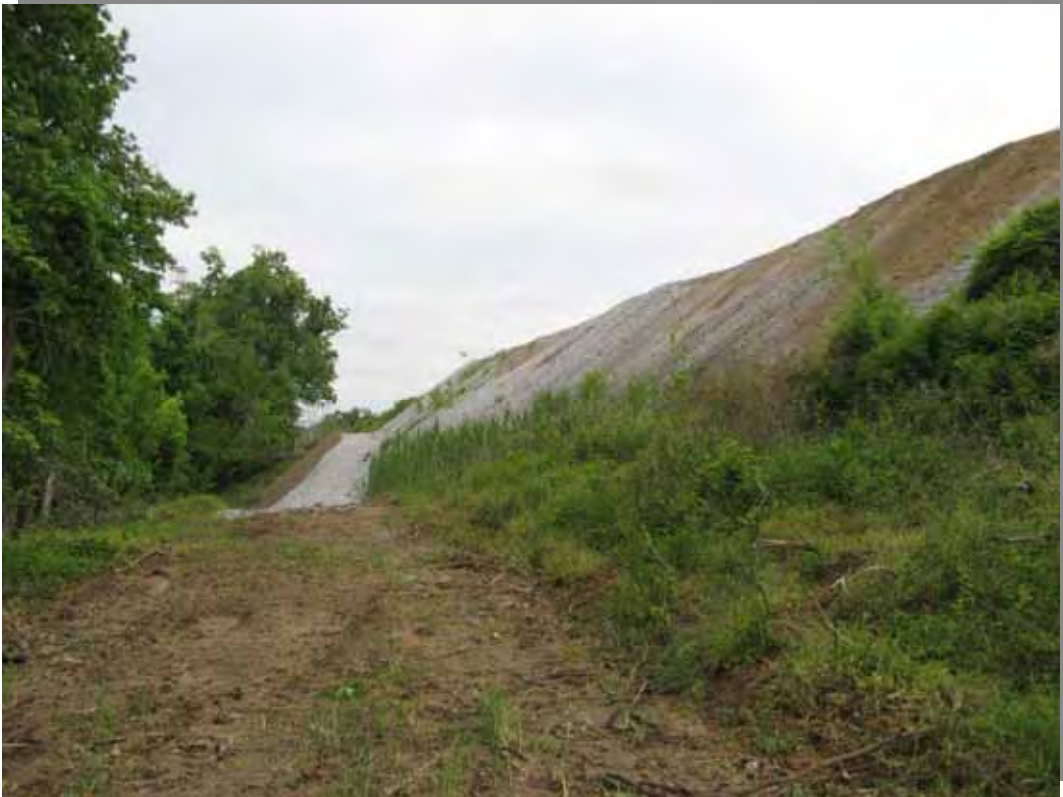
- EEI is in the process of constructing an access road along the outboard toe of the embankment. Wet conditions and vegetation have prevented the project from being completed.

Photo 19 – Outboard slope of eastern embankment of Southern Pond.  
Note repairs near crest and partially completed access road along toe.

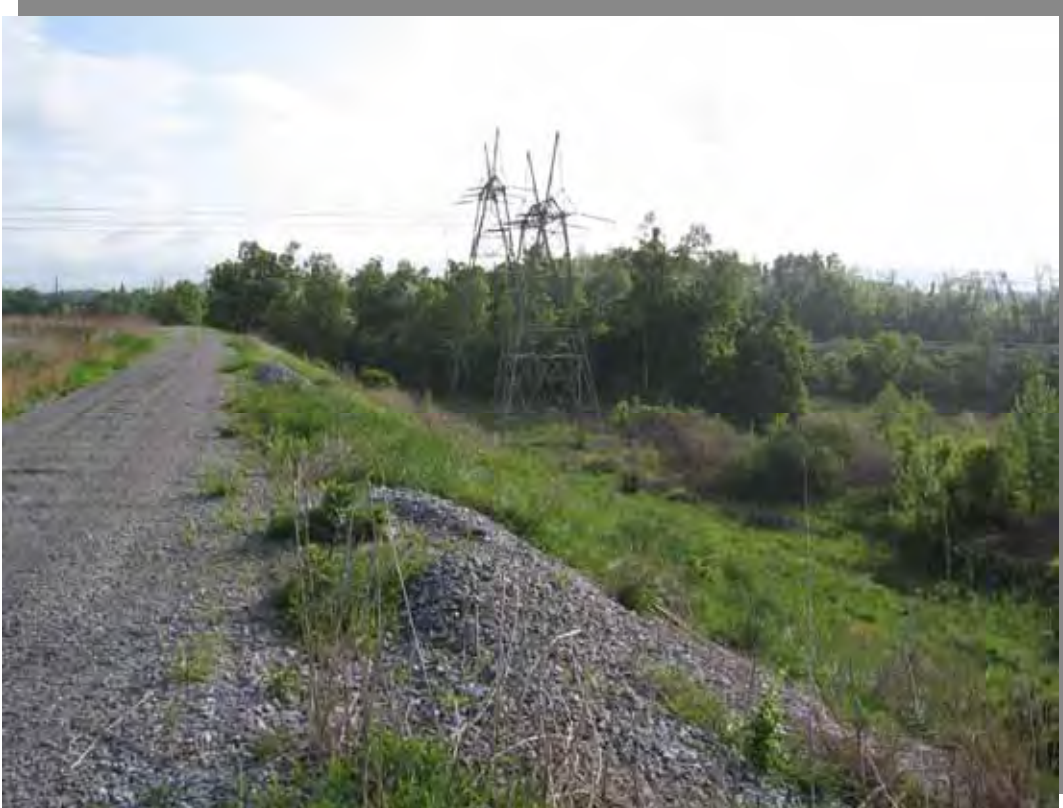
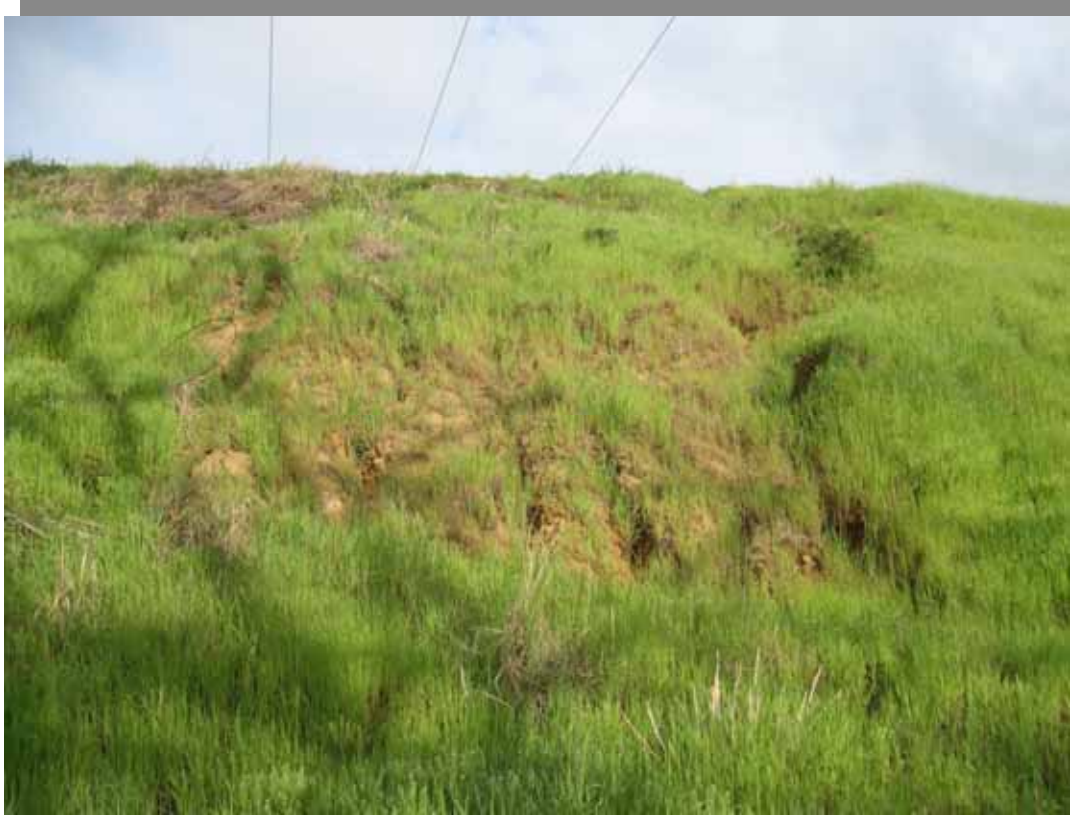
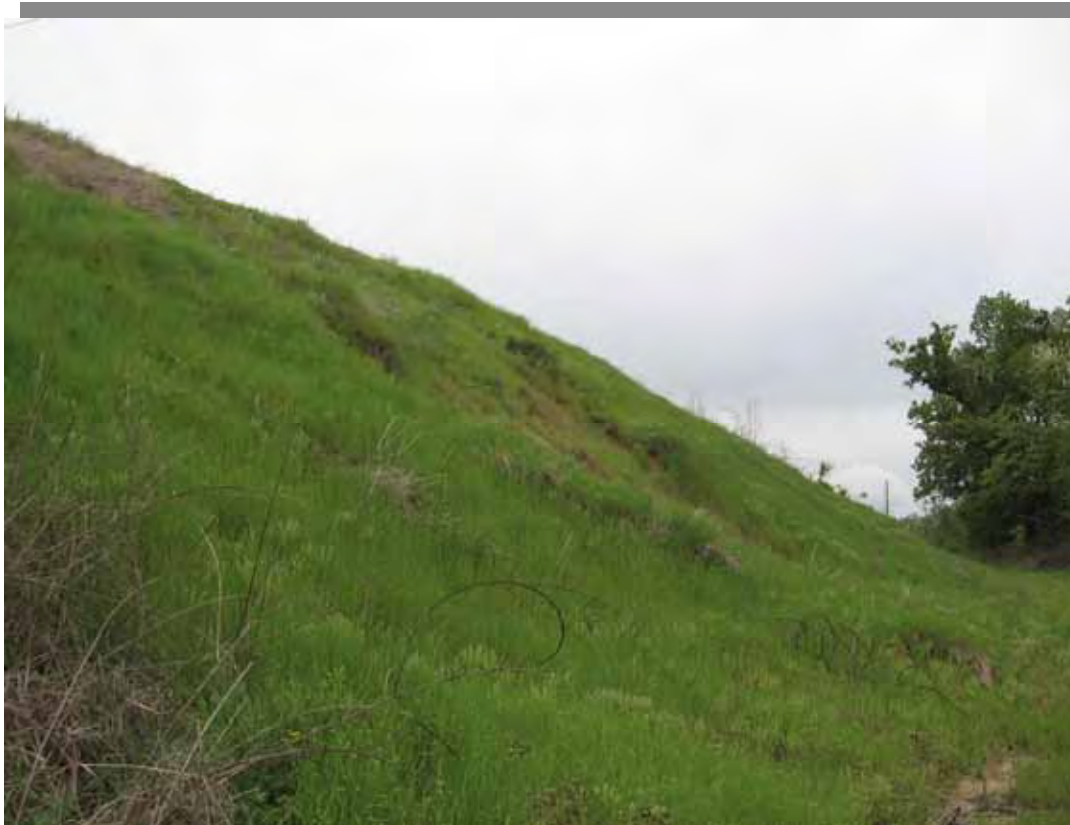
- Surface erosion, sloughs and slides were observed along the outboard slope. The most significant erosion was observed in the area below the power lines that cross the Southern Pond (Photos 20 - 22).

| Inspection Issue # | Comments |
|---|---|
| 17, 18, 19 | Scarps and sloughing of embankment observed in area below power lines that cross the South Pond (Eastern embankment of South Pond). Erosion of lower portion of berm observed approximately 100' south of power lines. |

Photo 20 – Outboard slope of Southern Pond near power lines.

Photo 21 – Erosion on east embankment of Southern Pond below the power lines.

Photo 22 – Slides and sloughs on east embankment of Southern Pond, approximately 200 feet south of power lines.

- Outboard slopes – remove deleterious vegetation and continue regular maintenance of the slopes; repair any areas of sloughs, slides and erosion.
- Outboard toe – investigate the extent of seepage, monitor the seepage on a regular basis, and develop alternatives for treating the deteriorated sections of the embankment.

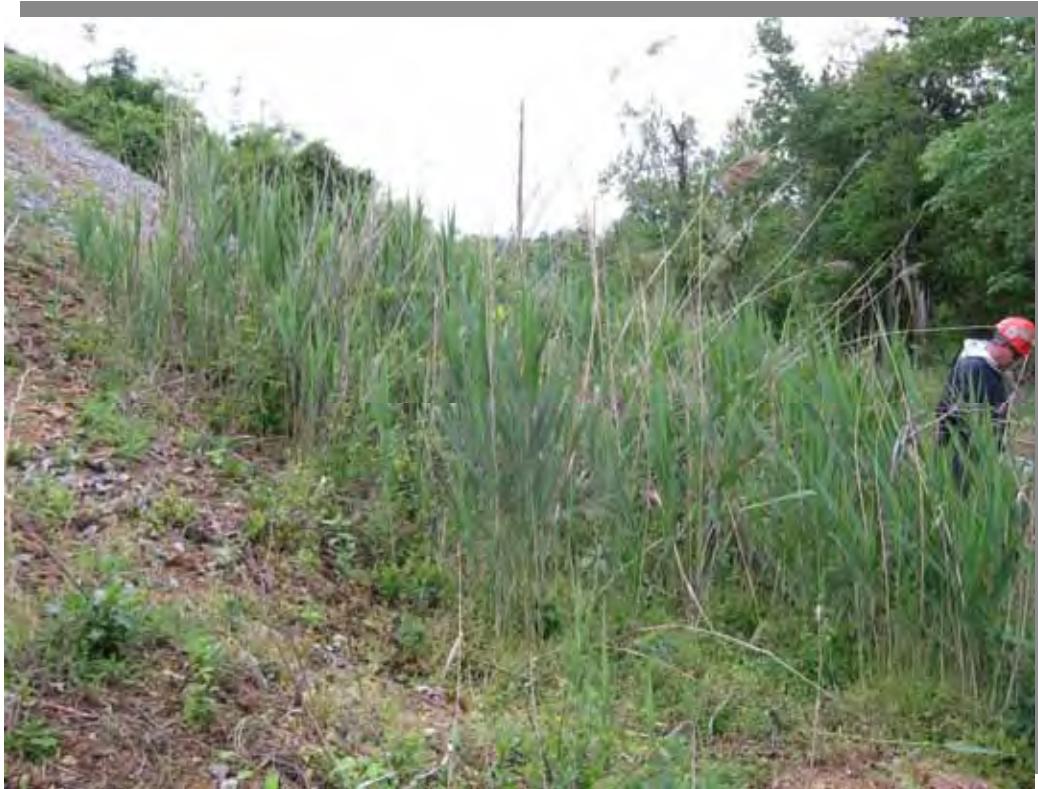
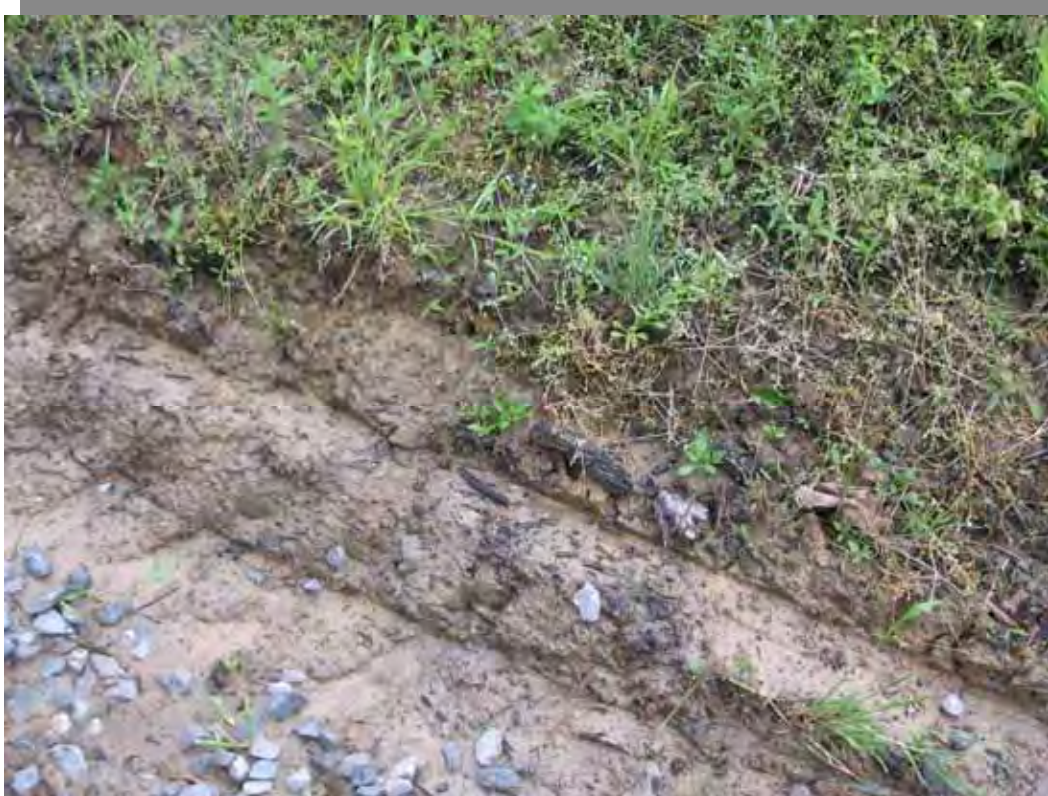
- Seepage was observed in multiple locations along the outboard toe of the embankment. The most significant area of seepage is located approximately 500 feet north of the power lines (Photos 23 & 24). Other areas where seepage was observed include an area approximately 200 feet south of the power lines and along the southern embankment of the Southern Pond. The approximate locations of seepage are identified on Figure 3.

| Inspection Issue # | Comments |
|---|---|
| 21 | Seepage observed at various locations along the toe of the eastern embankment on South Ponds. Seepage area extends approximately 100', starting approximately 500' North of power lines. Seepage was also observed on the Southern embankment of the South Pond in the area facing the coal piles. Evidence of seepage on the embankment slope was observed in this location, but seepage was not. |

Photo 23 – Outboard toe of Southern Pond eastern embankment approximately 500 feet north of power lines. Note reedy grasses indicating moist conditions, signs of seepage.

Photo 24 – Seepage at toe of east embankment of Southern Pond, near location indicated in Photo 23 above.

Consideration should be given to inspections by licensed dam safety engineers on a regular basis to document the continued proper maintenance and operation of the Ash Pond. This is especially critical for the portion of the Southern Pond embankment where seepage was observed.
