**Coal Combustion Waste Impoundment  
Task 3- Dam Assessment Report**

*John E. Amos Plant (Site 26)*

*Bottom Ash Dam  
American Electric Power  
St. Albans, West Virginia*

**Project # 0-381  
Assessment of Dam Safety  
Coal Combustion Surface Impoundments  
For the REAC Program**

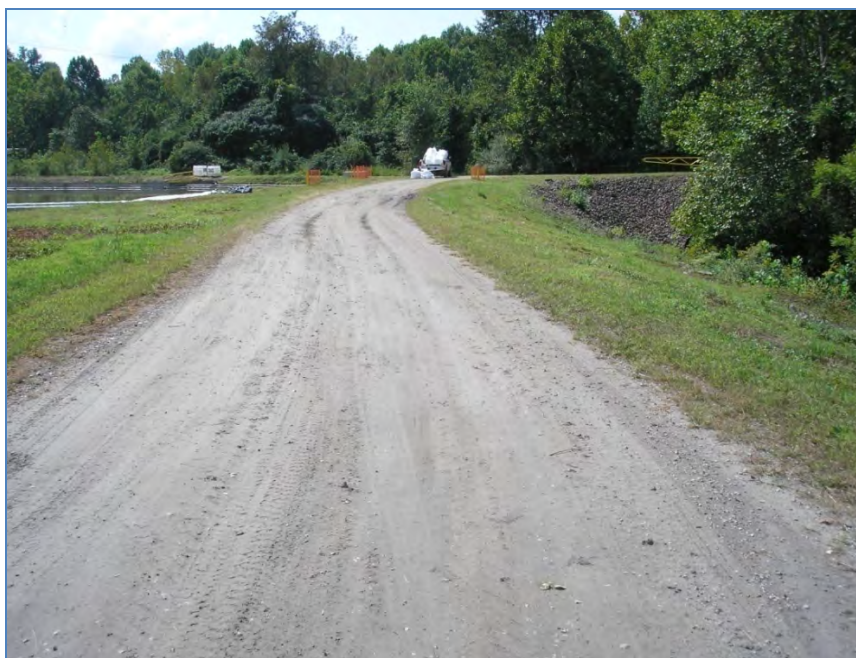
The crest had no signs of any depressions, tension cracks or other indications of settlement or shear failure, and appeared to be in satisfactory condition. Figure 5.2.1-1 shows the crest of the main dam of the Bottom Ash Complex.

Figure 5.2.1-1 Crest of Main Dam Bottom Ash Complex Looking Westward.

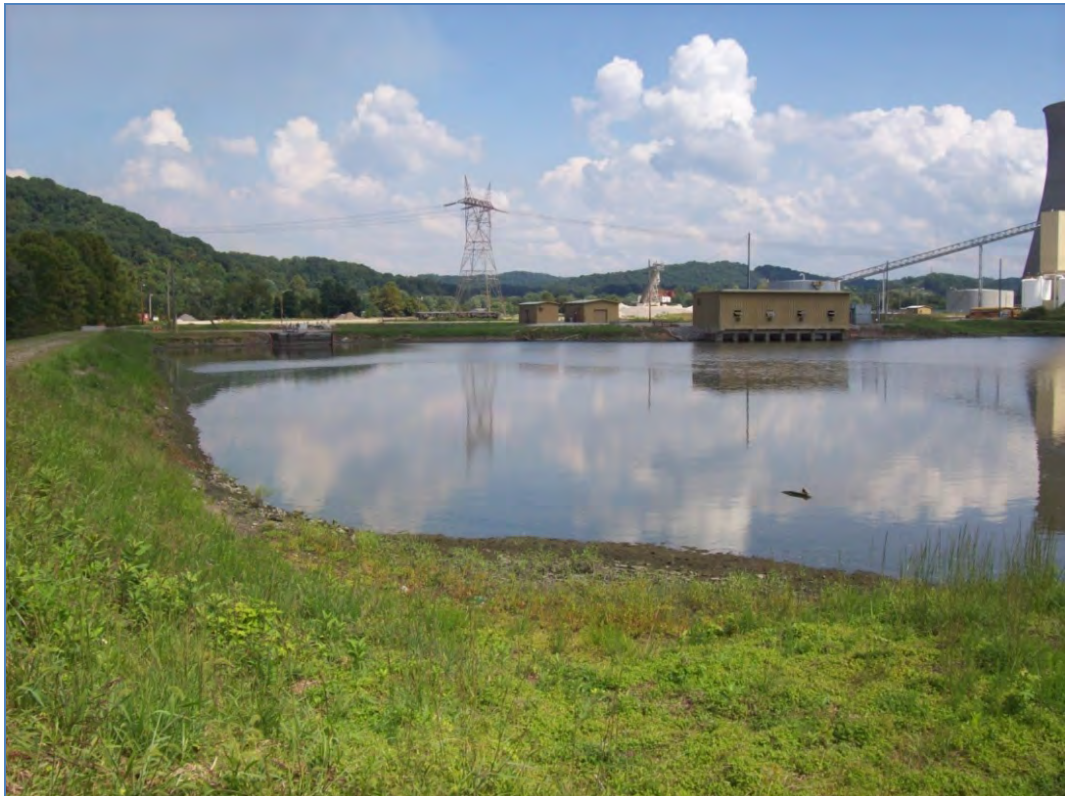
The upstream slope mostly consists of unprotected compacted soil except for part of the upstream face of the Pond 1B which remains heavily vegetated with woody plants. Figure 5.2.2-1 shows the upstream slope of the main dam embankment (on the left side of the picture) on the north side of Area No. 3 where it is protected with scattered grass. Scarps, sloughs, bulging, cracks or scraps or depressions or other indications of slope instability or signs of erosion were not observed.

Figure 5.2.2-1. The upstream Slope of the Main Dam (the Embankment on the Left Side of the Picture)

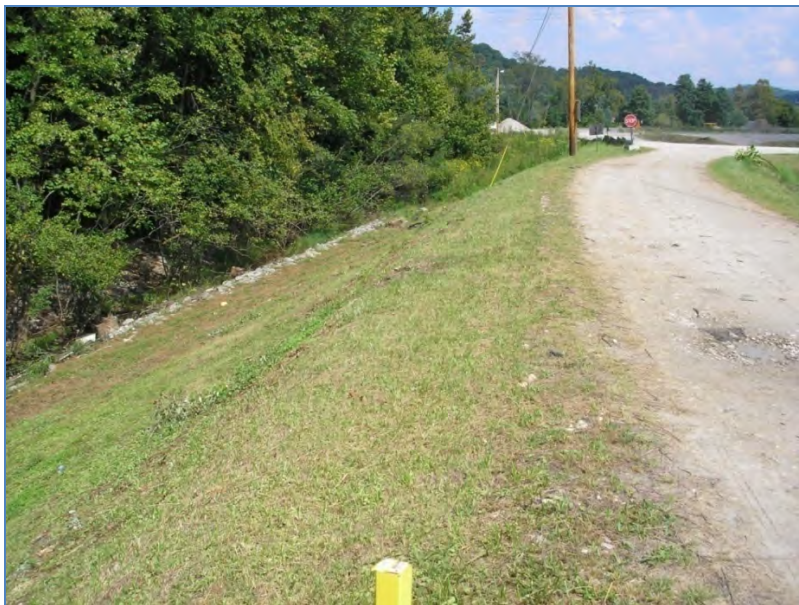
The downstream slope is protected with some grass. Scarps, sloughs, depressions or other indications of slope instability or signs of erosion or uncontrolled seepage were not observed. Figure 5.2.3-1 shows the downstream slope of the center area of the main dam. Scattered rip-rap was observed along a section of the lower slope as shown in this picture.

Figure 5.2.3-1. Downstream Slope at the Center Area of Bottom Ash Complex Main Dam (Looking Eastward).

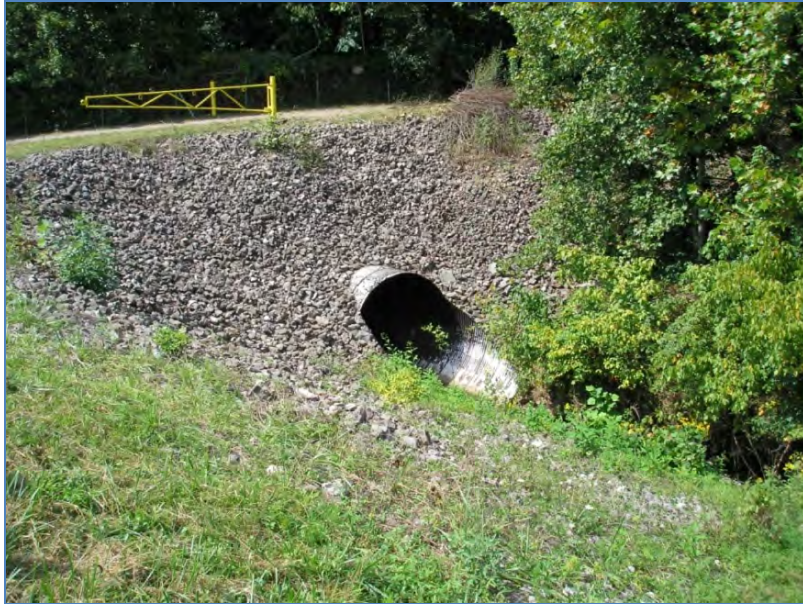
The abutments and groin areas appeared to be in good condition. Figure 5.2.4-1 shows the West Abutment of the main dam is protected with rip-rap. Culvert in this picture carries Bill's Creek beneath the West Abutment.

Figure 5.2.4-1. West Abutment of Bottom Ash Complex Main Dam.

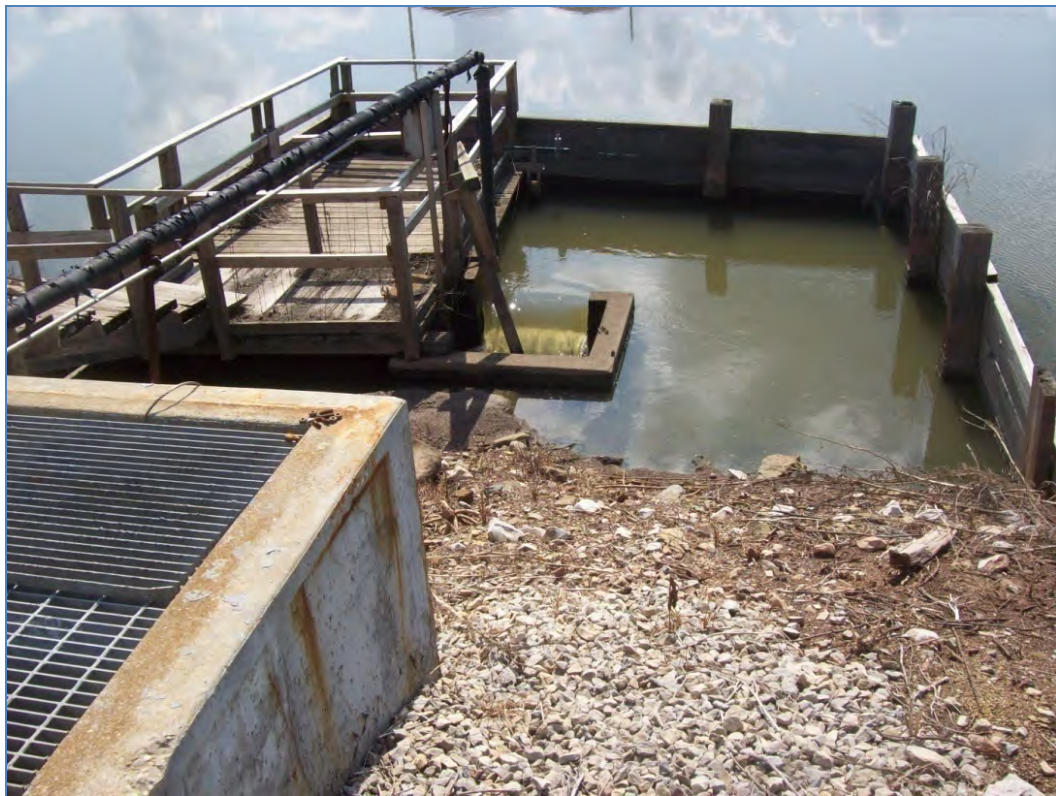
Currently there are two principal spillway outlets, one with a low inlet and one with a high inlet. The low inlet is an overflow structure with inlet crest elevation of 576.1 ft and a discharge capacity of 28.2 cfs which is the reservoir drain capacity. This drop inlet structure consists of a square concrete box approximately 36 inches on each side with an approximately 24 inches long weir on the west side. The outlet pipe is a 24 inch corrugated metal pipe which takes the water from the Treatment Basin to the outfall at Kanawha River. The primary overflow structure was observed to be working properly, discharging flow from the pond, and visually appeared to be in satisfactory condition. There was no sign of clogging of the spillway and the water exiting the outlet was flowing clear. Figure 5.3.1-1 shows the low inlet overflow structure.

Figure 5.3.1-1. Low Inlet Overflow Outlet Structure at the North Corner of the Treatment basin.

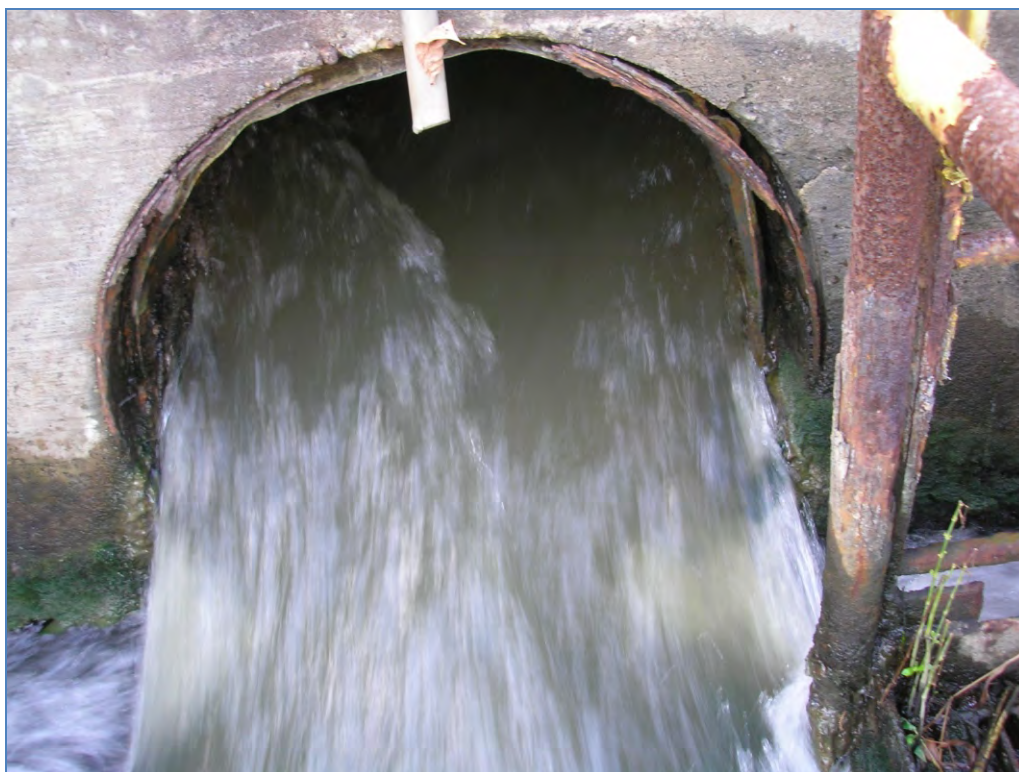
The outlet pipe is a 24 inch corrugated metal pipe which takes the water from the Treatment Basin to the outfall at Kanawha River. Figure 5.3.2-1 shows the outlet end of the Treatment Pond Spillway discharging water to Kanawha River. There is a minor crack on the headwall of the outlet section. The visible section of the outlet conduit seemed to be in good condition with no sign of flow blockage.

Figure 5.3.2-1 The outlet of the Treatment Pond Spillway Discharging Water to Kanawha River.

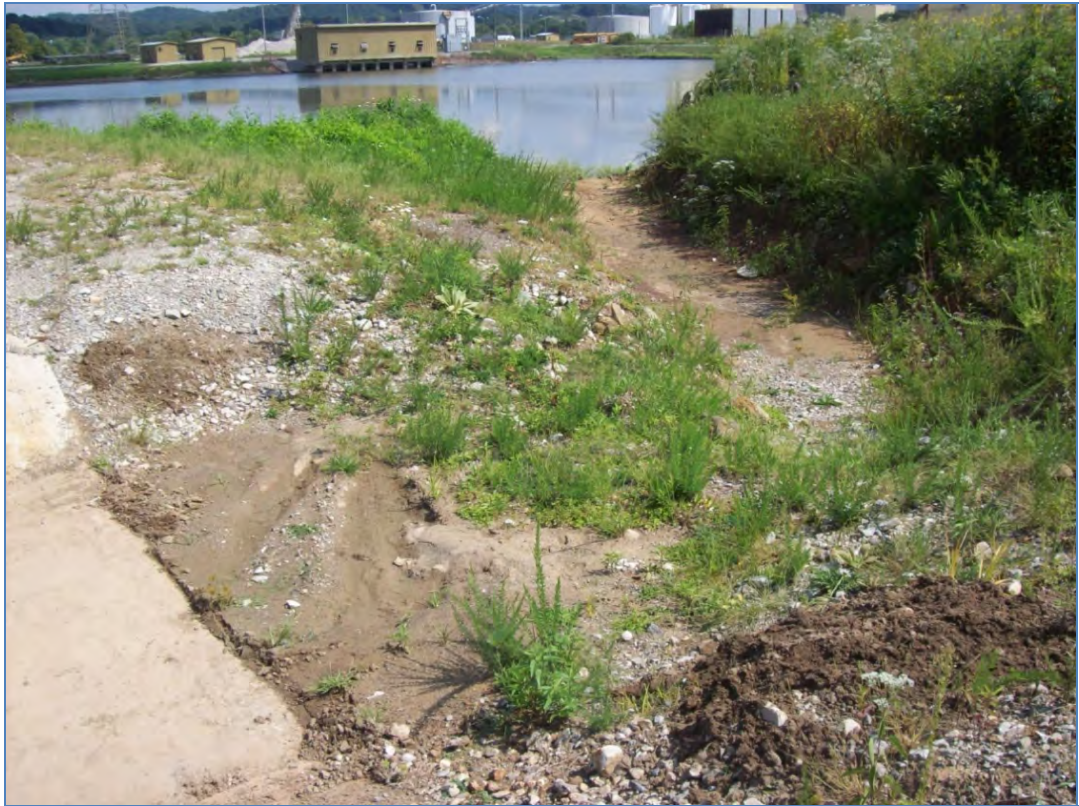
The high inlet spillway is an overflow section with invert elevation of 584 ft. This structure is designated as emergency spillway in some dam documents. This spillway is a concrete trapezoidal channel roughly 2 ft deep, 10 ft wide at the bottom and 22 ft wide at the top. A small channel has been excavated in the earthen embankment to act as an approach channel to direct spilling flow toward the overflow spillway. This channel is shown in Figure 5.3.3-1. The upstream side of the concrete spillway is visible on the left side of the spillway. The entrance channel is partially blocked. This probably will present no major hindrance of the discharge through the overflow spillway as the water rises above the invert of the spillway. Figure 5.3.3-2 shows the downstream view of the emergency spillway. The overflow spillway is in

Figure 5.3.3-1. Approach Channel to Emergency Spillway Excavated to on the Main Dam Embankment. The Upstream Side of the Overflow Concrete Spillway is Visible on the Left Side of the Picture.

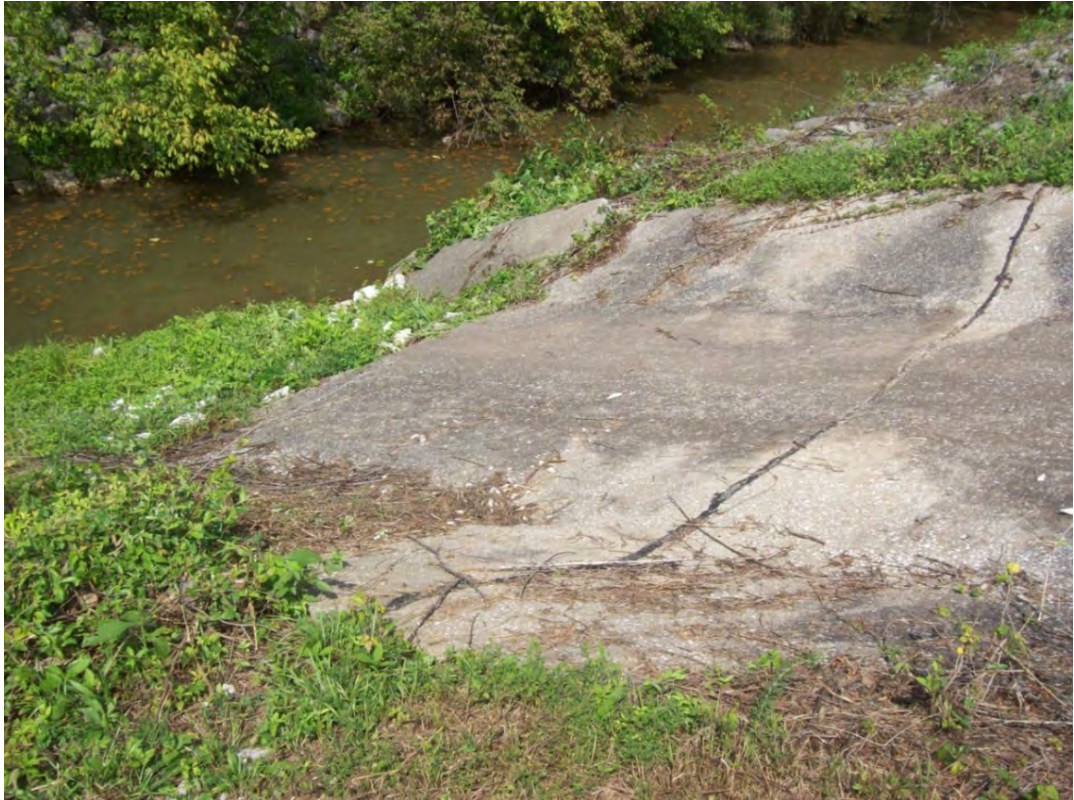
fair condition. The lower portion of the concrete on the downstream side has broken off. The broken concrete section filled with rip-rap and covered with grass is visible on the downstream side of the spillway in Figure 5.3.3-2. Photo 58 in Doc 07 offers a closer view of the broken section. The concrete on the slope needs to be monitored and repaired with sign of further deterioration. Other than the concrete breakage, the spillway appeared to be in good condition with no sign of clogging.

Figure 5.3.3-2. The Downstream View of the Emergency Spillway. The Broken concrete Section Filled with Rip-rap and Covered with Grass is Visible on the Downstream Side.

- Upon approval of the proposed upgrades to the Bottom Ash Pond complex, proceed with due speed to implement the improvements.
- The observed crack in the concrete spillway discharge channel and the vegetation in the joints should be sealed and repaired as needed, especially if the spillway is not removed with the proposed modifications to the complex;

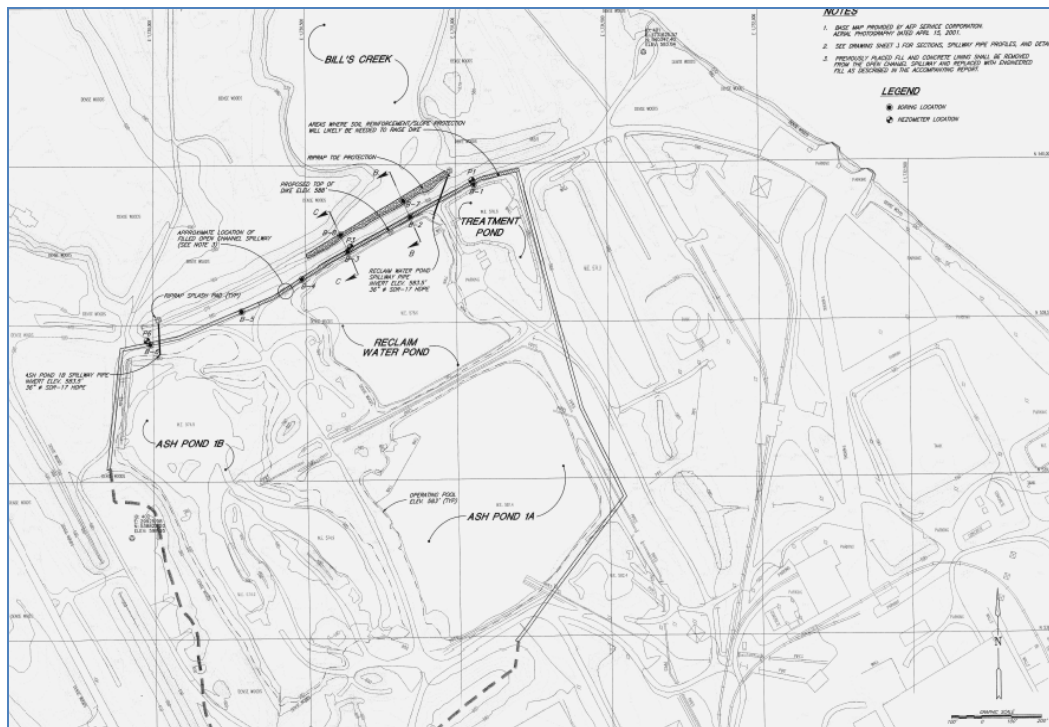
There was no instrumentation plan provided. Figure 9.2.1-1 shows the location of the piezometers and the borings used for the dam modification study (image from Appendix A- Doc 04).

Figure 9.2.1-1- John Amos Bottom Ash Pond Piezometer and Boring Locations for the Dam Modification Study.
