Coal Combustion Waste Impoundment

Task 3- Dam Assessment Report

John E. Amos Plant (Site 26)

*Fly Ash Dam Complex
American Electric Power
St. Albans, West Virginia*

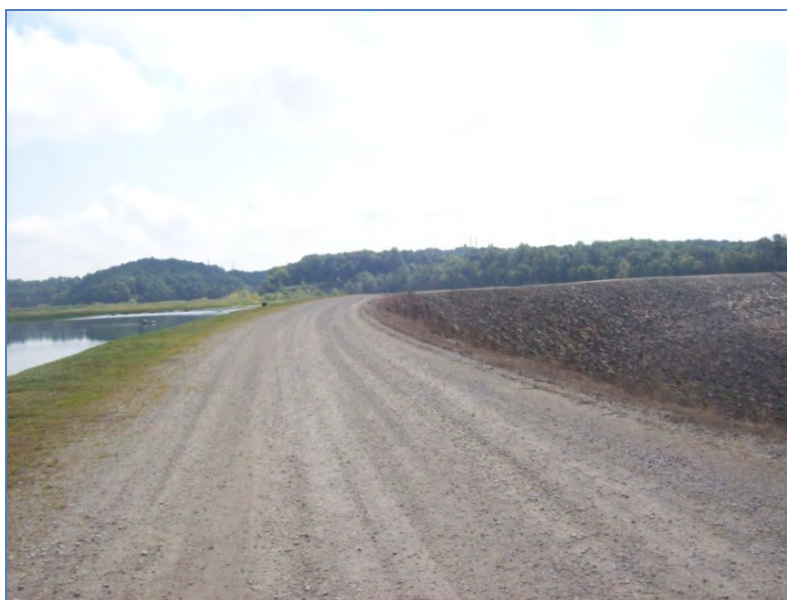
The dam crest had no signs of any depressions, tension cracks or other indications of settlement or shear failure, and appeared to be in satisfactory condition. Previous inspection reports reviewed by Dewberry indicated minor surface cracking in the clays on the upstream face. The cracking was described as “the result of desiccation”. Photographs included with the reviewed report supported the desiccation description. The data did not indicate cracking along the crest or downstream face of the dam. Figure 5.2.1-1 shows the conditions of the dam crest.

Figure 5.2.1-1. Photo Showing the Dam Crest.

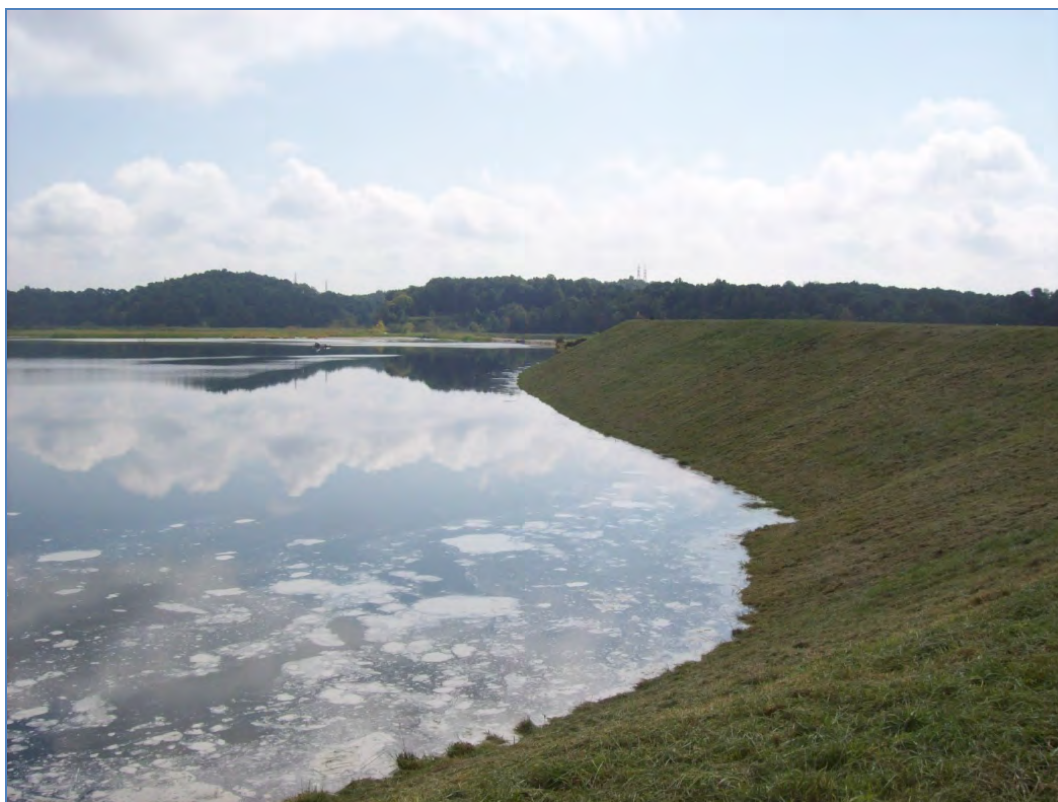
The upstream slope is protected with grass. There were no observed scarps, sloughs, bulging, cracks or scraps or depressions or other indications of slope instability or signs of erosion. Figures 15 and 16 in Appendix B show the upstream slope. Figure 5.2.2-1 depicts part of the upstream slope of the dam embankment.

Figure 5.2.2-1. Photo Showing the Upstream Slope.

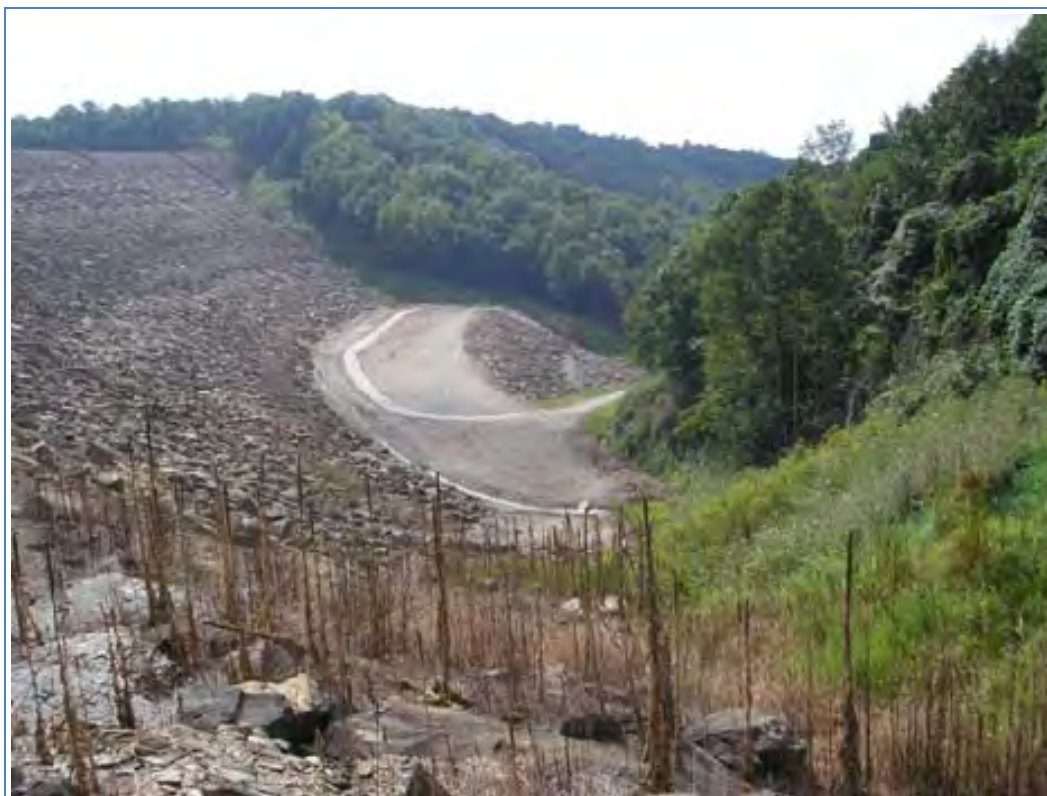
Figure 5.2.3-1. Downstream Slope from North Abutment,

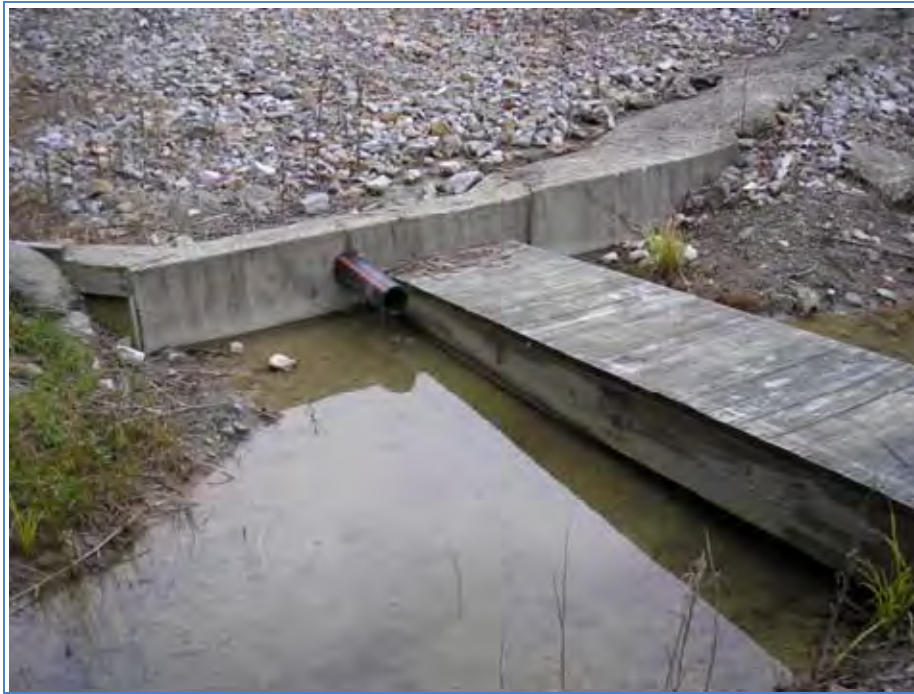
Figure 5.2.3-2. Seepage Collection Basin, Downstream Embankment.

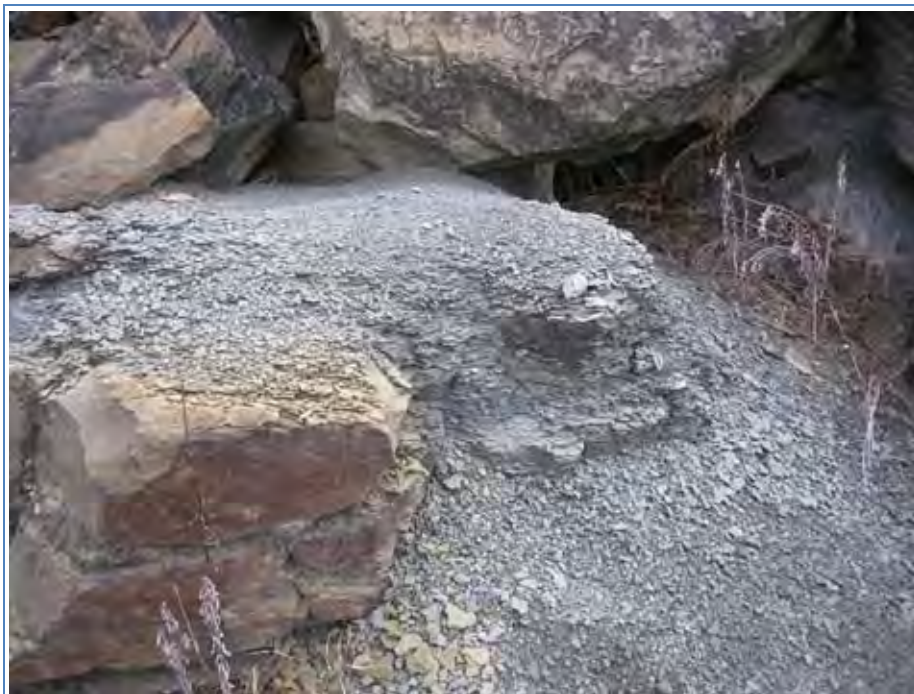
The photographs included in the WV- Dam report indicated deterioration was limited to moderate to severe weathering of approximately 10 percent of the sandstone and shale rip-rap on the downstream face of the dam. Weathering is reported to be most apparent below the bench at approximately Elevation 716 ft in the downstream slope. During the 9/8/09 dam inspection, Dewberry personnel observed weathered rip-rap on isolated spots on the downstream slope (see Figure 5.2.3-3).

Figure 5.2.3-3. Weathered Rip-Rap at Downstream Slope.

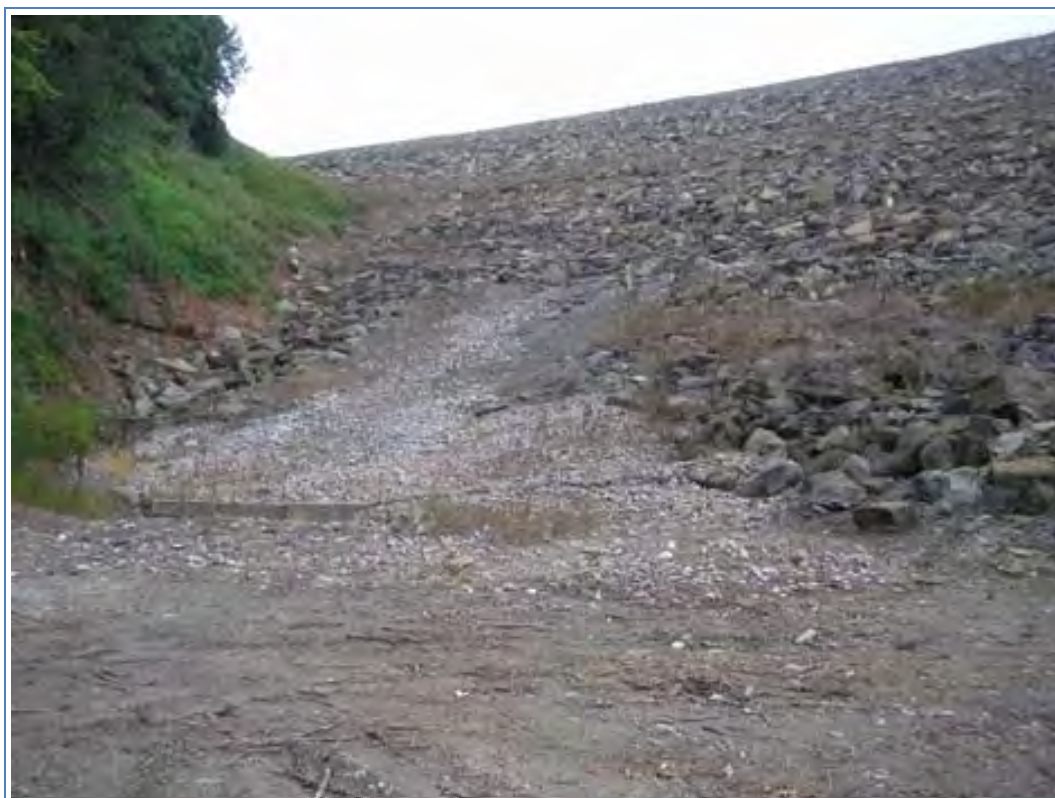
Erosion or uncontrolled seepage was not observed along either groin. The abutments and groin areas appeared to be in excellent condition. The groin slopes are protected with rip-rap. Figure 5.2.4-1 shows the Abutment/Groin at the "716 Bench".

Figure 5.2.4-1. Downstream North Abutment/Groin at "716 Bench".

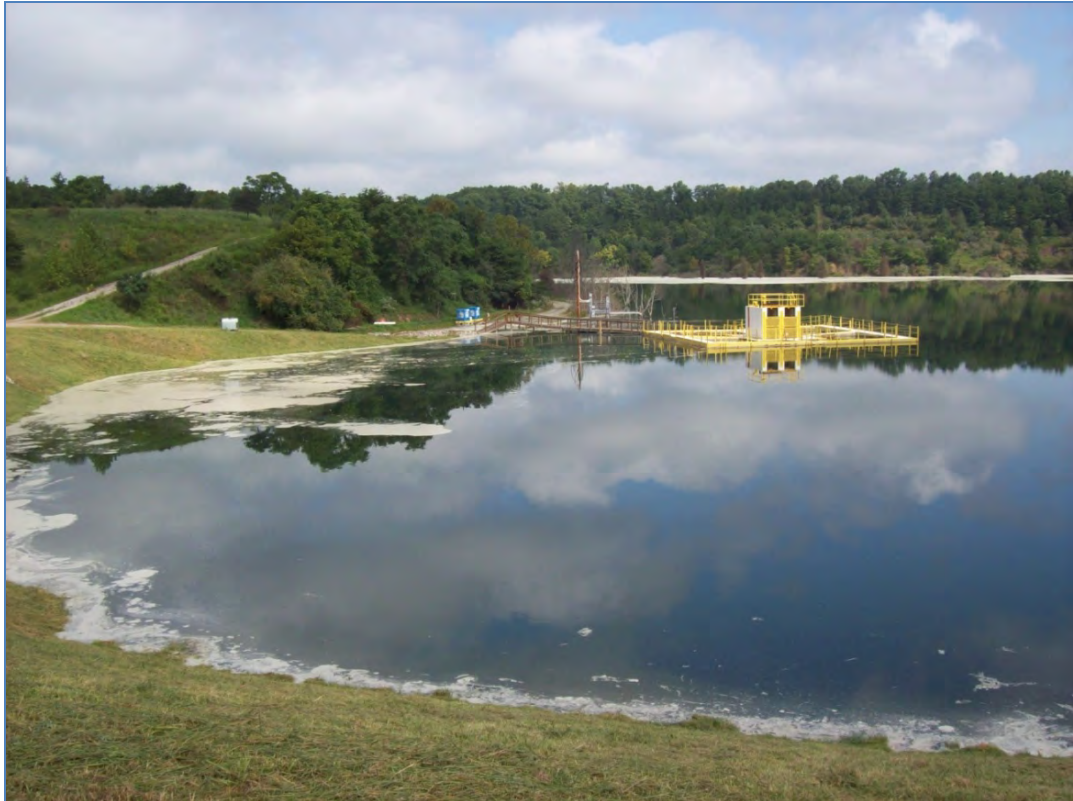
The primary overflow structure was observed to be working properly, discharging flow from the pond, and visually appeared to be in satisfactory condition. There was no sign of clogging of the spillway and the water exiting the outlet was flowing clear. Figure 5.3.1-1 shows the main outlet structure and the floating pier around it within the reservoir.

Figure 5.3.1-1. Outlet Structure (Principal Spillway) and the Floating Pier Around it on the Northwest End of Dam.

- Repair access stairs and walkways to monitoring points if the dam is not expanded;
- Evaluate the cause of movement restrictions of floating docks around the decant riser and repair wooden walkway to overflow structure;

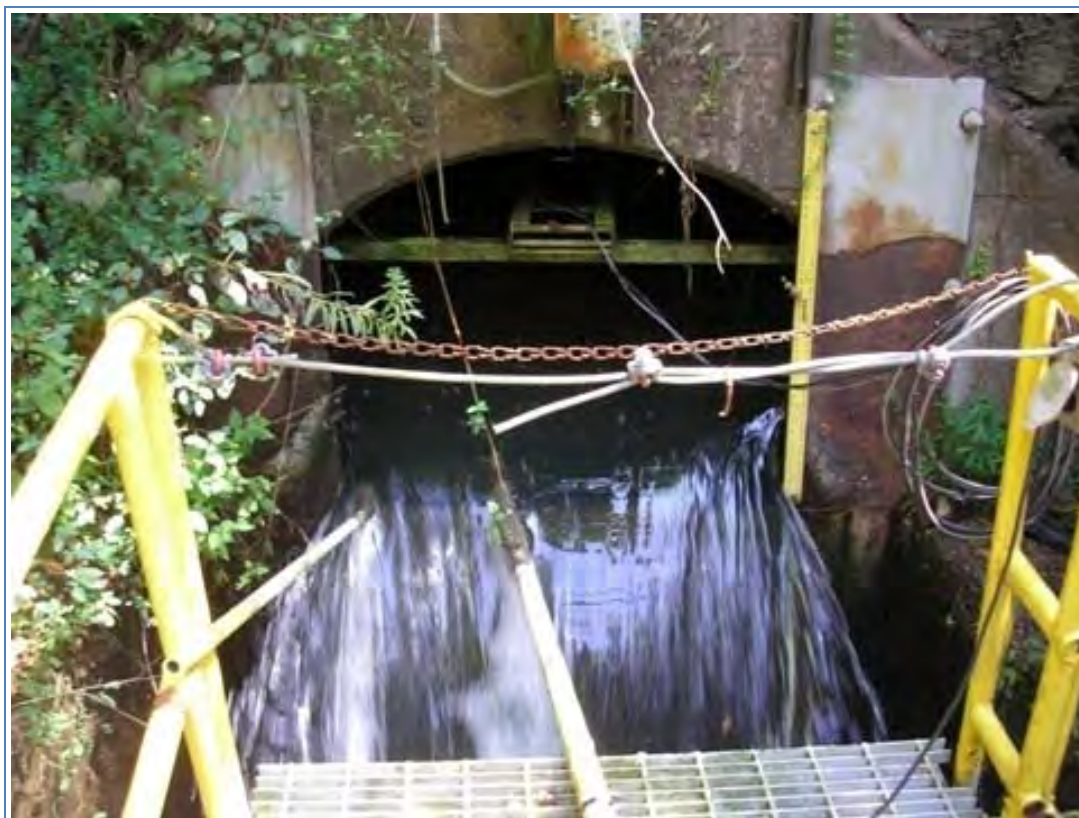
The outlet conduit appeared to be in good shape and operating normally with no sign of clogging and the water exiting the outlet was flowing clear. Figure 5.3.2-1 shows the water discharging from the main spillway tunnel outfall.

Figure 5.3.2-1. Main Spillway Tunnel Outfall.

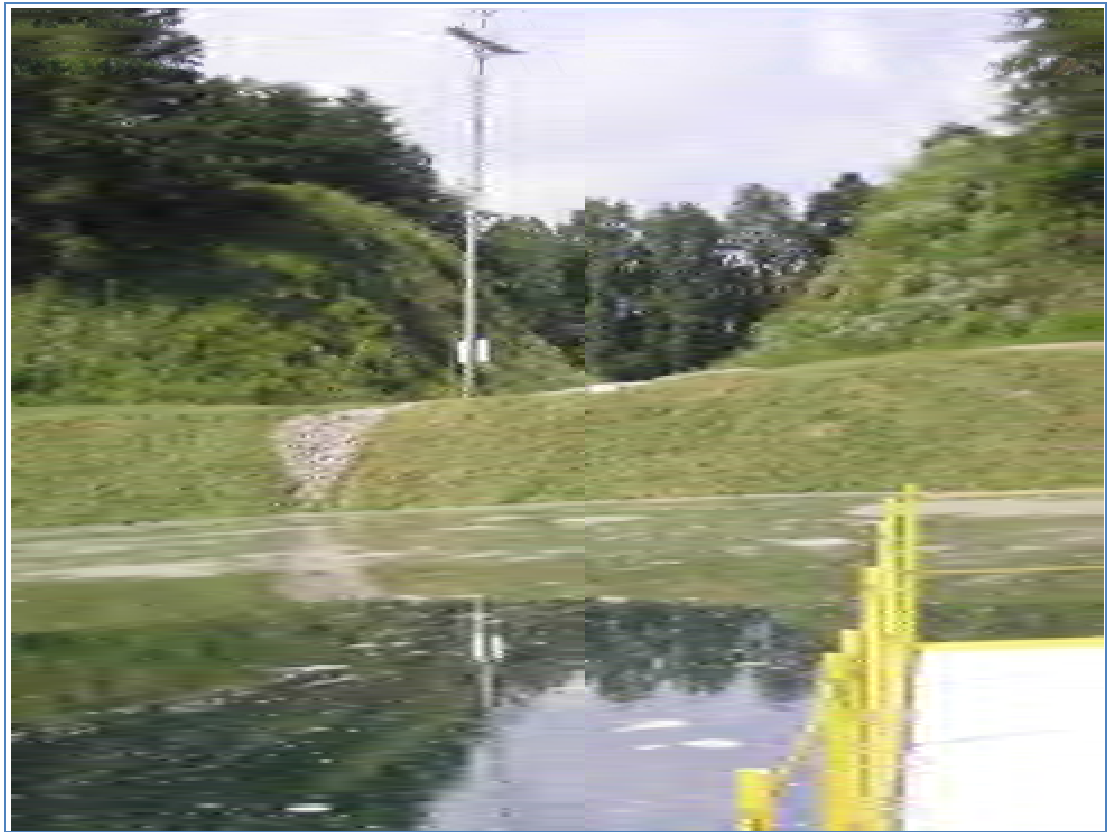
The emergency spillway appeared to be in good condition with no sign of clogging.

Figure 5.3.3-1. Emergency Spillway at the North end of Dam.
