Assessment of Dam Safety Coal Combustion Surface Impoundments (Task 3) Final Report

American Electric Power
Cardinal Power Plant
Brilliant, Ohio

December 9, 2009

CHA Project No. 20085.1080.1510

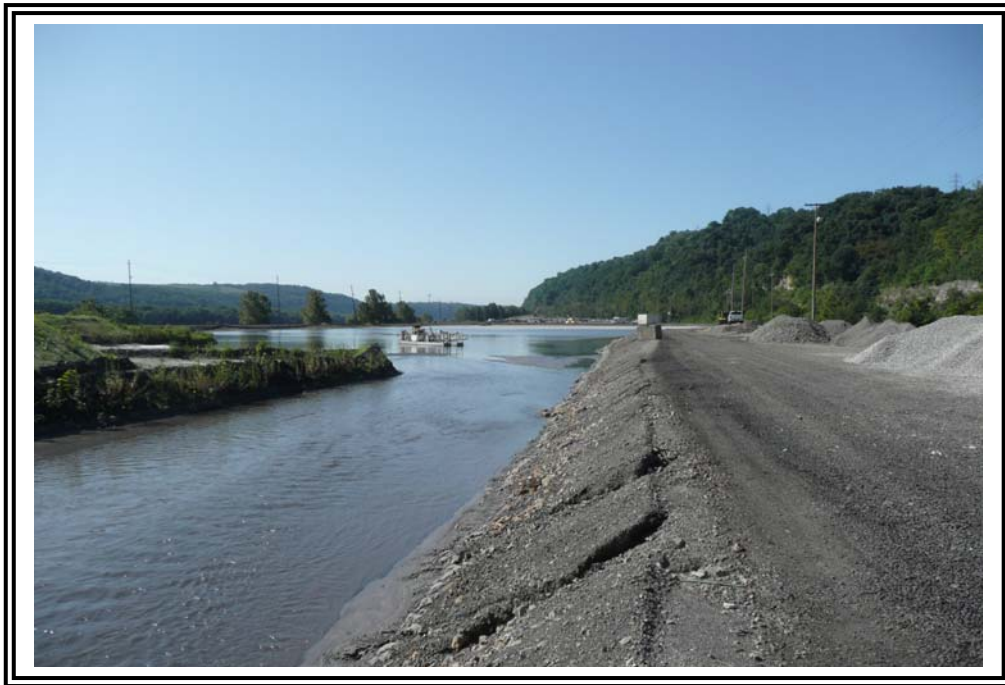
8

Upstream slope and crest of west dike looking south. Note erosion rills in granular surface

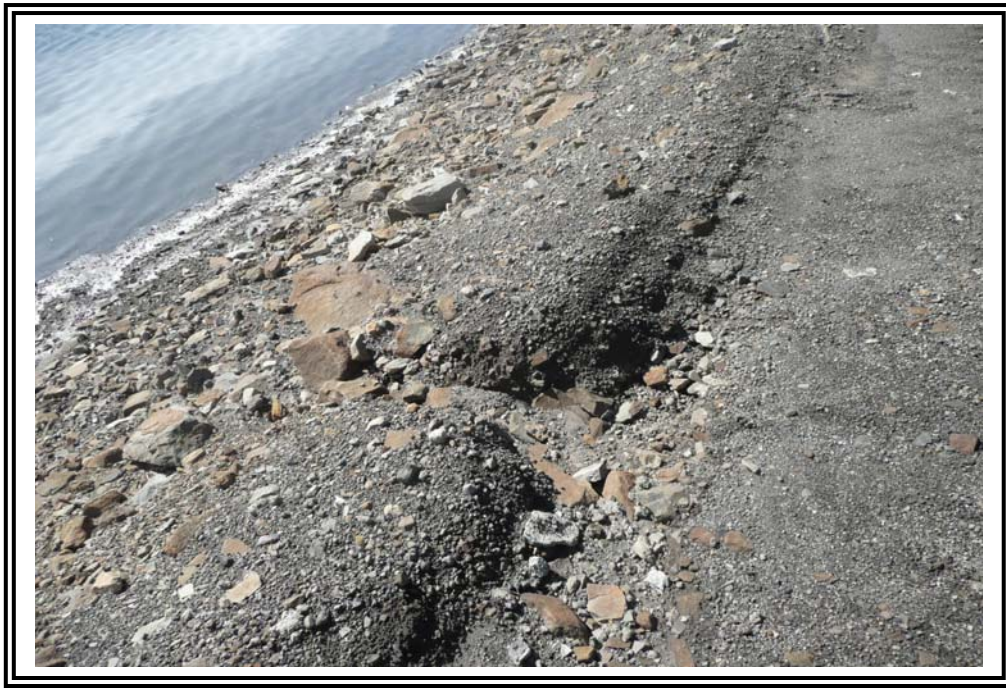
11

Up-close view of erosion noted in Photo #11 showing large rock fragments in dike material.

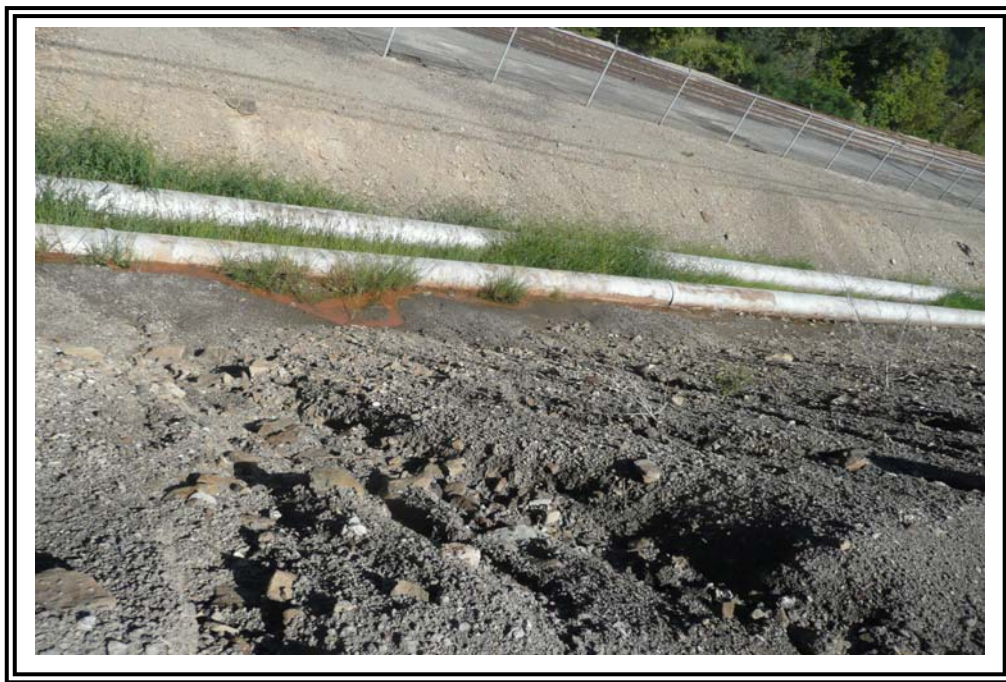
The dike toe area terminates in a drainage swale that also functions as a pipe trace for the recirculation pipes. This drainage swale conveys runoff and other facility surface flow into the site sump located at the north end of the Bottom Ash Pond and pumps that water into the pond. During the site visit, standing water was observed in the drainage swale along approximately 2/3 of the dike length. This water had a reddish brown color in some areas where the pipes had been partially submerged, however it was difficult to determine if the water coloration was due to corrosion or loss of pipe coating. An attempt to probe the toe area in the standing water indicated firm conditions. Given the 30-foot width of the dike and the fairly low head differential of about 5 feet, the water in the swale is not likely hydraulically connected to the pond. However, the grass growth in the swale at that area does suggest that water collects there and stands for a period of time. Photos 12 and 13 show the water collected in this area of the toe swale.

Downstream slope of the west dike, looking west. Note surface erosion and reddish brown water collecting in drainage swale around pipes showing signs of apparent corrosion and loss of coating.

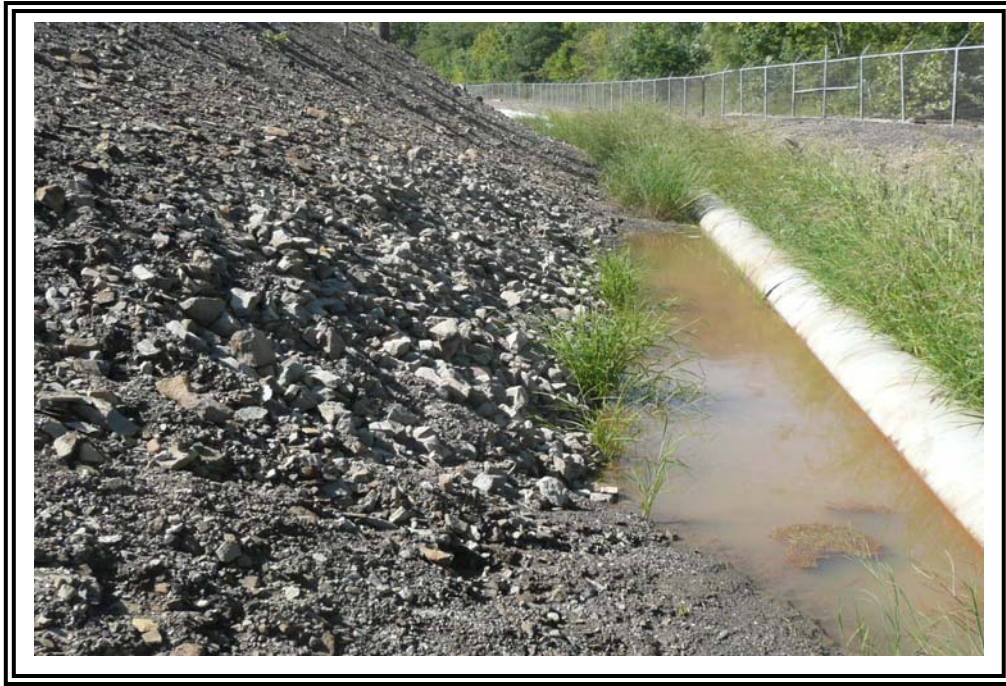
13

Toe of west dike where drainage has collected in pipe swale, looking south. Soil difficult to probe more than a few inches.

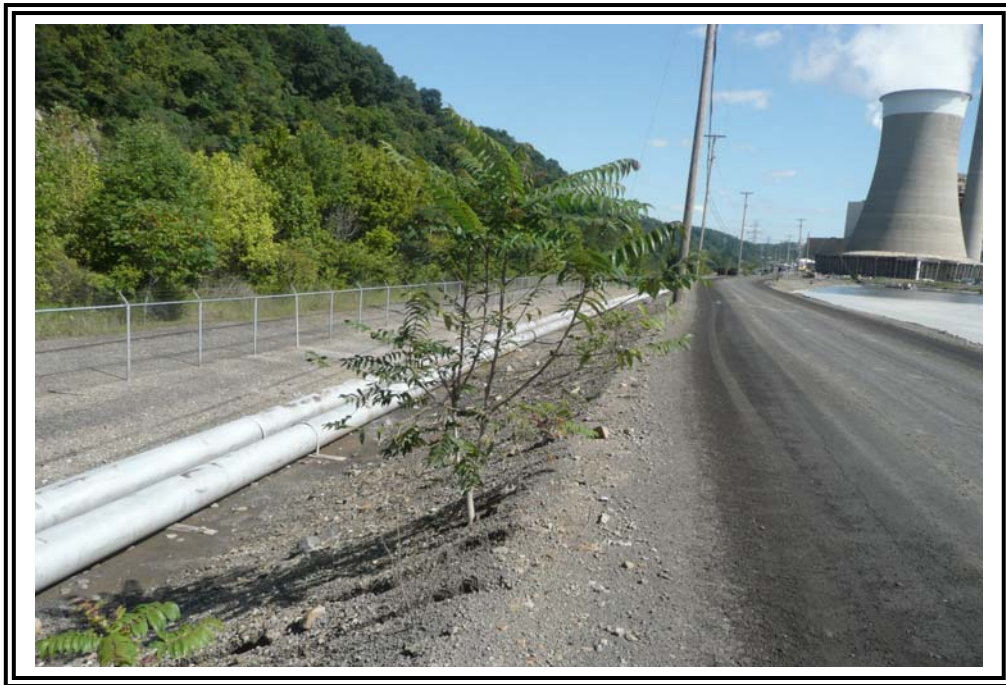
Isolated woody vegetation was observed along the west dike. Photo 15 shows an example of this plant growth.

Wooded vegetation becoming established on downstream slope of west dike, looking north.

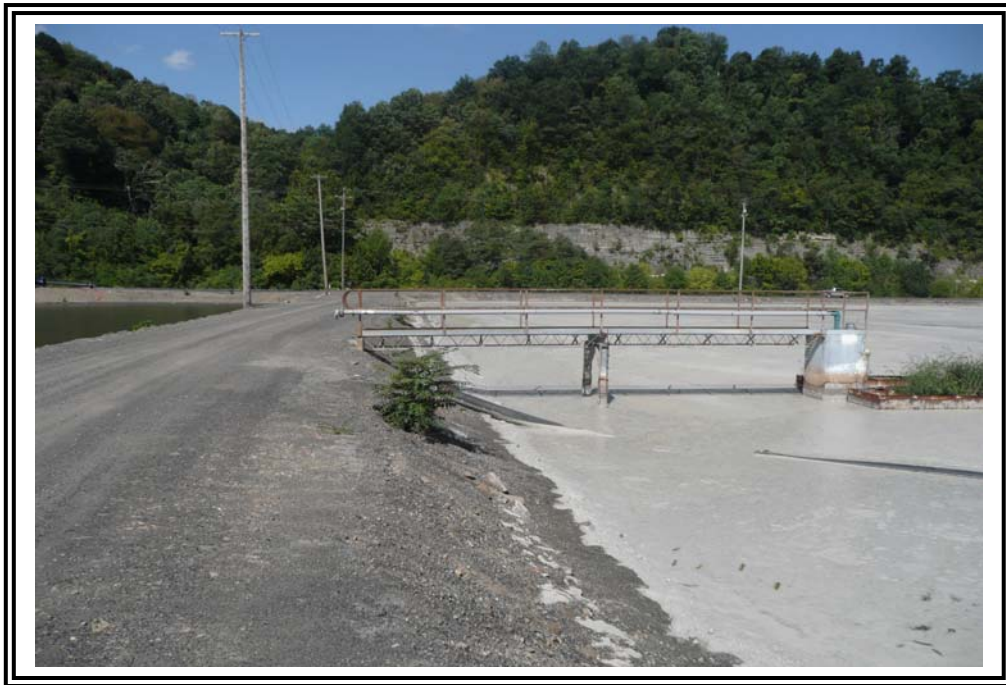
19

Upstream slope and crest of separator dike, looking west. Note isolated vegetation.

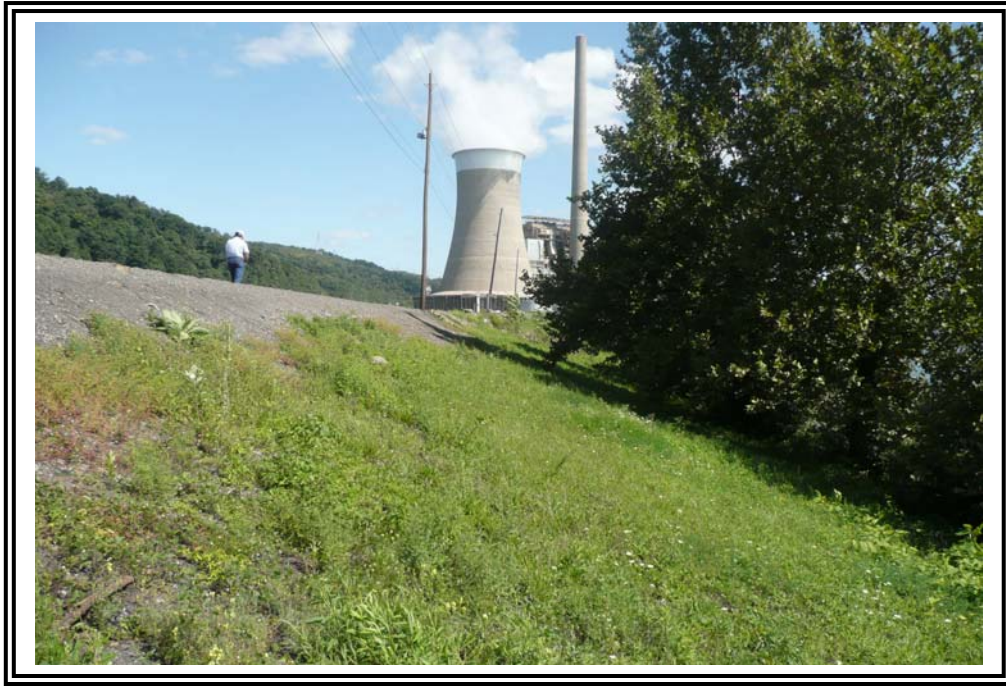
23

The downstream face of the dike was generally vegetated up to within about 3 to 5 feet of the crest as shown in Photos 22 and 23. In areas adjacent to the river a change in vegetation from grasses and weeds to heavier broad leafed plants and woodier brush and trees can be observed. Based upon the available topographic mapping and older design plans, this vegetation change appears to be where the constructed slope transitions to the river bank. Several of the trees were fairly mature on the order of 16 to 24 inches in diameter. Photos 24, 25, 27, and 28, show examples of this vegetation change. Soil conditions in the slope at these vegetation changes were firm to hand probing and did not exhibit excessive moisture.

Downstream slope of east dike, looking north, showing effect of routine grading activities at the crest where vegetation is not established.

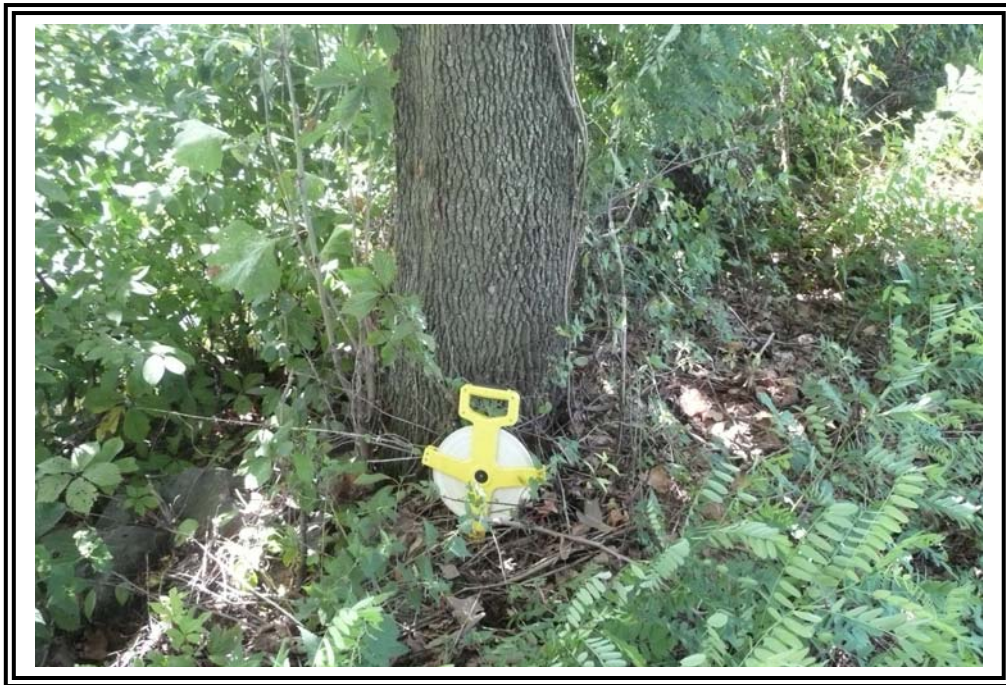
25

Close-up of one of the larger trees at the river bank edge along west dike.

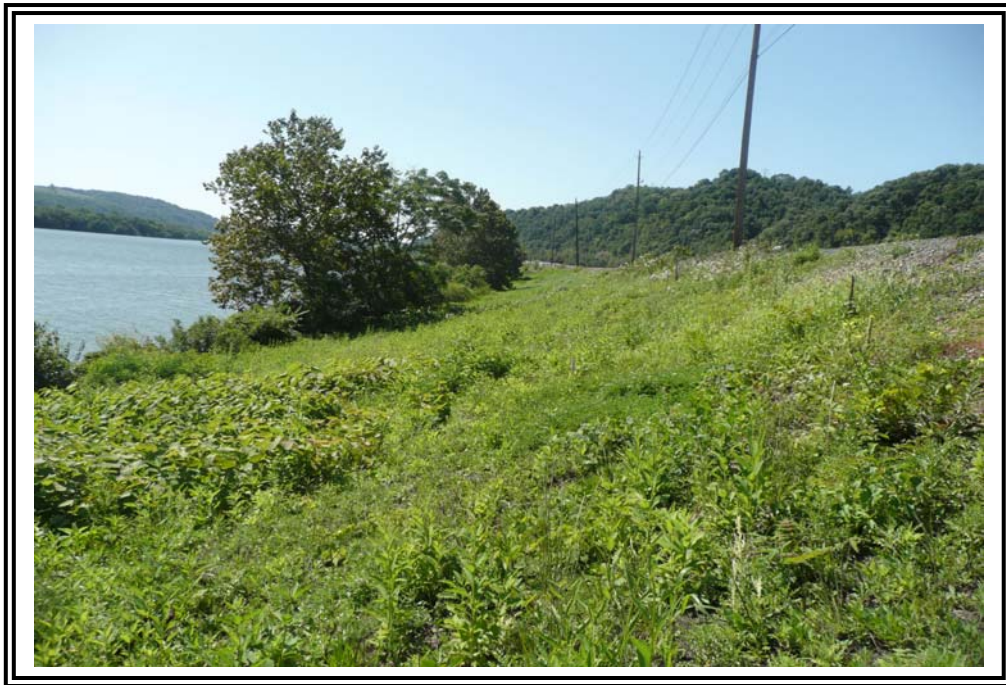
27

Downstream slope of east dike, looking south. Typical loss of vegetation shown at crest and change in vegetation shown adjacent to river bank.

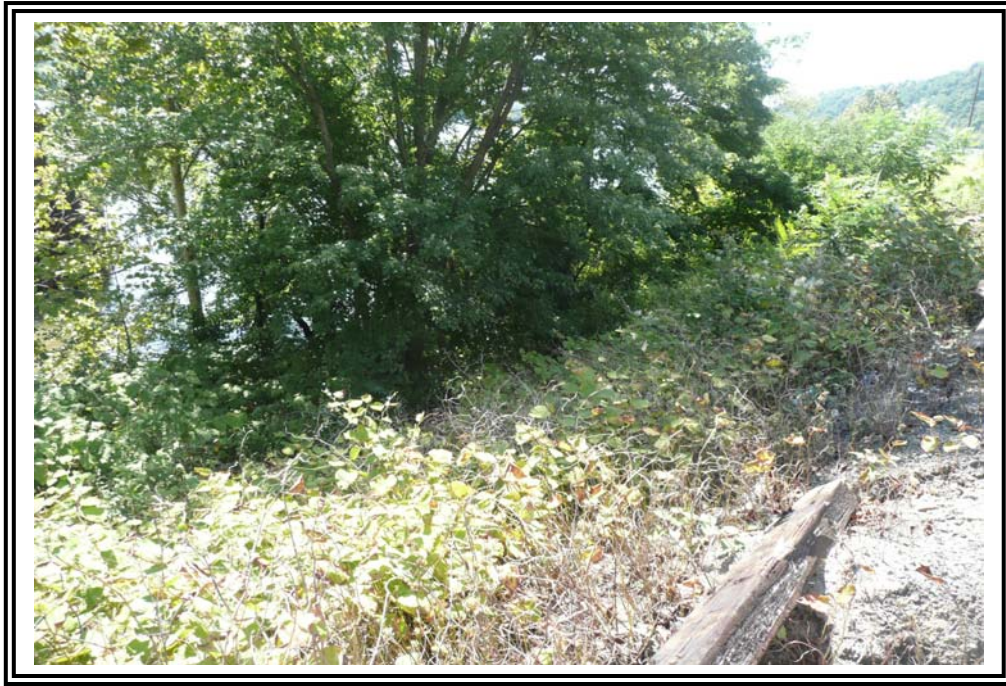
31

Downstream slope areas in the northern extremity of the basin adjacent to the incised face of the pond had heavier brush and tree growth as shown in Photo 31. This area of the slope also adjacent to the portion of the pond where a container dike for boiler cleaning chemical tank is located and where interior dikes temporarily store dredged bottom ash intermittently as a part of the plant recycling process. These features are shown in Photos 29 and 32. A paved crest was also observed in this area as shown in Photo 30. Material deposits due to grading activities can also be seen in Photo 30.

Downstream slope of east dike at northern extent of pond showing heavy vegetation and debris.

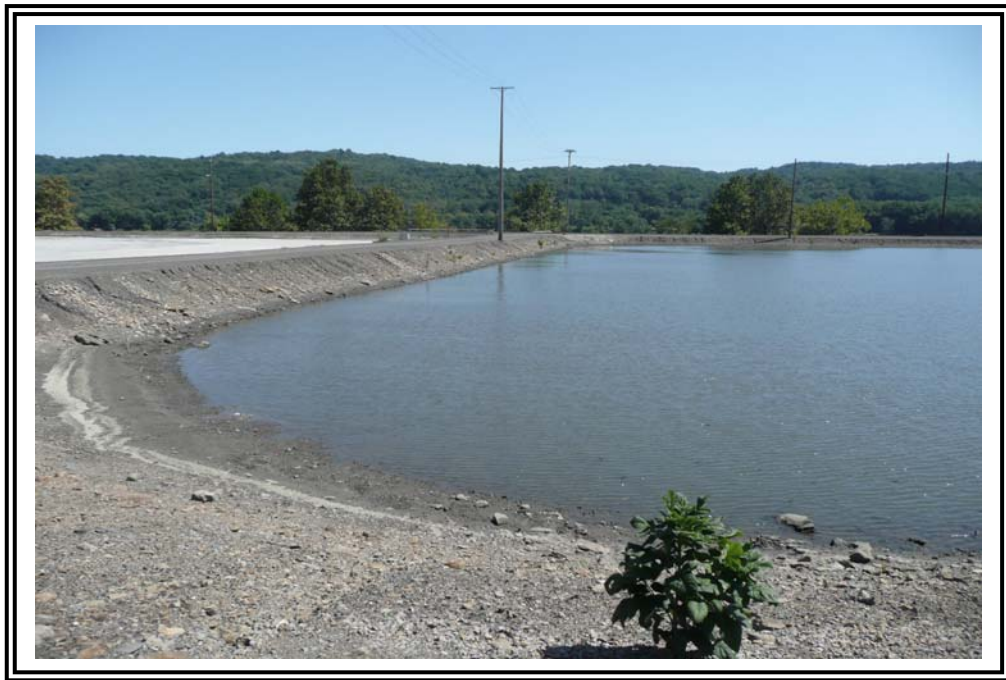
34

The separator dike has a general granular surface and is sparsely vegetated in similar fashion to the west dike as shown in Photos 16 and 34. Erosion features typical of the west dike are evident on this dike which is also about 10 feet wider at the crest than shown in the original site drawings (total measured width of approximately 31 feet). No unusual slumps or bulges were observed in the upstream or downstream slope.

Downstream slope of the separator dike on the north side of the pond.
Erosion features noted in separator dike slope.

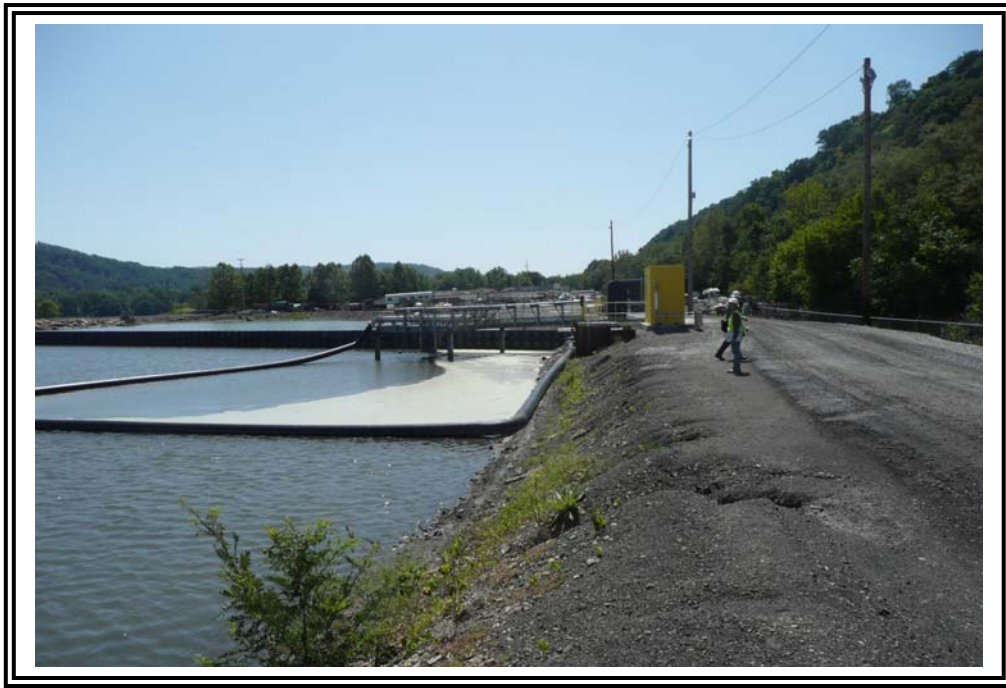
37

Upstream slope and crest of west dike, looking south. Note erosion feature and isolated brush. Vinyl sheet pile wall is in background.

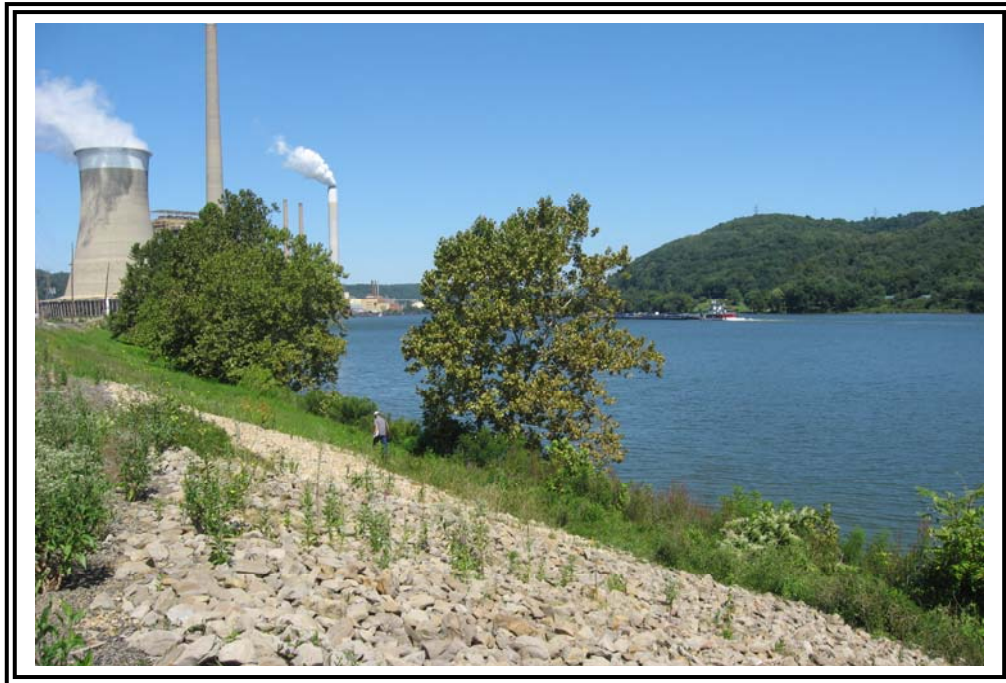
46

The downstream face has had a stone slope repair apparently as a result of seepage (Photo 46). This area covers roughly half of the Recirculation Pond dike length and appeared dry during the site visit with no outward signs of seepage. Beyond the slope protection area, the downstream slope is vegetated with the exception of the top few feet at the crest where sight grading activities have affected the vegetation growth (Photos 49 and 50).

Looking north on east dike at stone facing in area of apparent seep.
Seepage was not readily observed during site visit.

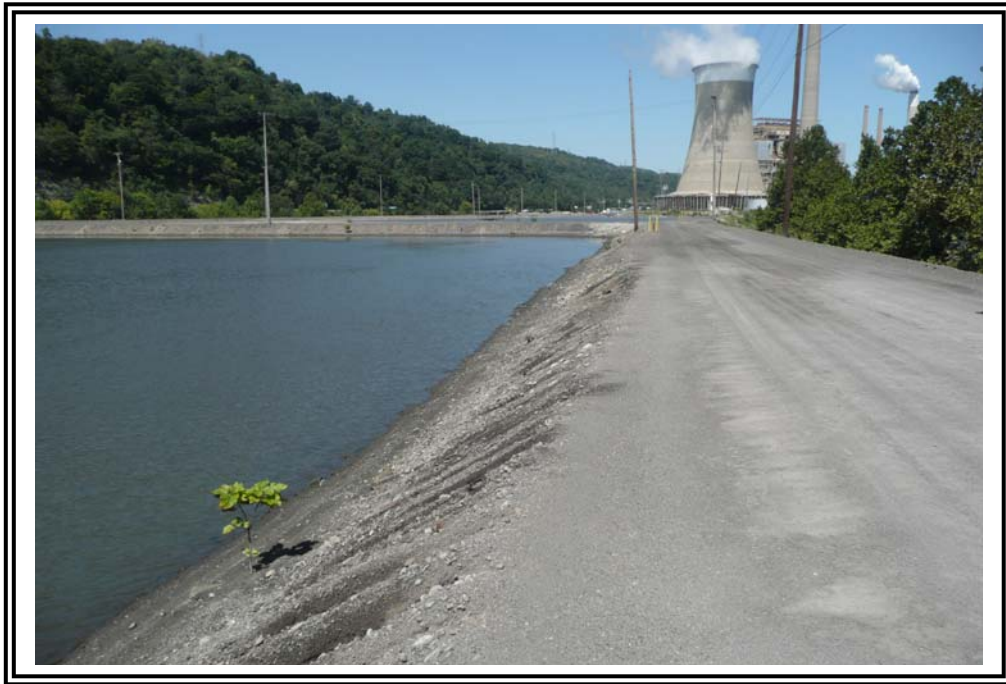
48

The crest area of the east dike does not show indications of abrupt changes in horizontal alignment and the slope areas show no obvious signs of slope instability such as scarps or sloughs. Little to no vegetation cover was observed on the upstream face and large slope protection stone has been placed on the slope face in areas adjacent to the outfall. Minor erosion features as a result of concentrated water flow could be observed on the upstream face on most of the dike. Photos 47, 48, and 42 show the typical conditions of the crest and upstream slope.

Crest and upstream slope of east dike at vinyl wall, looking north. Note typical erosion and sparse vegetation.

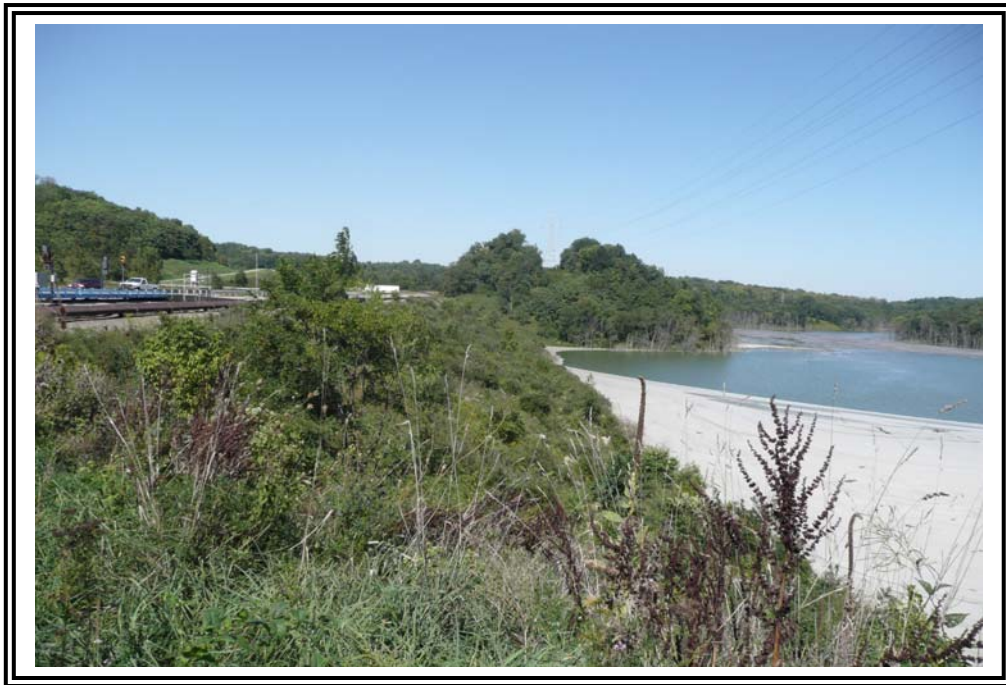
The downstream slope is heavily vegetated and armored with large rip rap (Photos 51 and 52). This rip rap has deteriorated over time and the heavy vegetation obscured much of it, giving it the appearance of having been randomly placed (Photos 59 and 60). Heavy vegetation was also observed in the north (left) abutment groin (Photos 57 and 58).

Downstream slope from right (south) abutment near crest. Note heavy wooded vegetation.

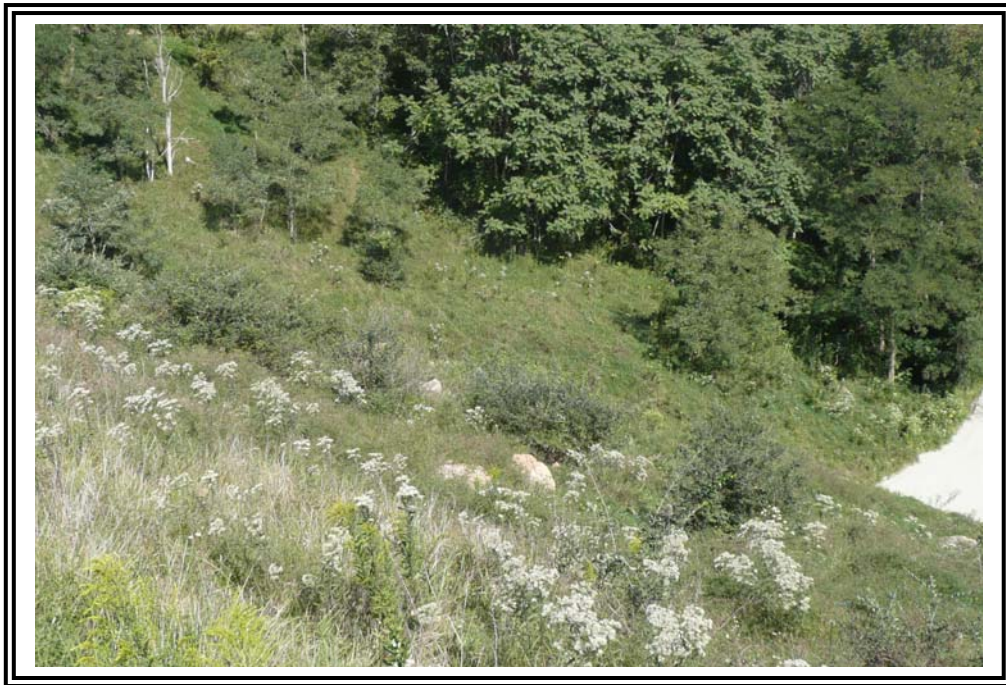
59

Downstream slope showing sporadic rip-rap (boulders).

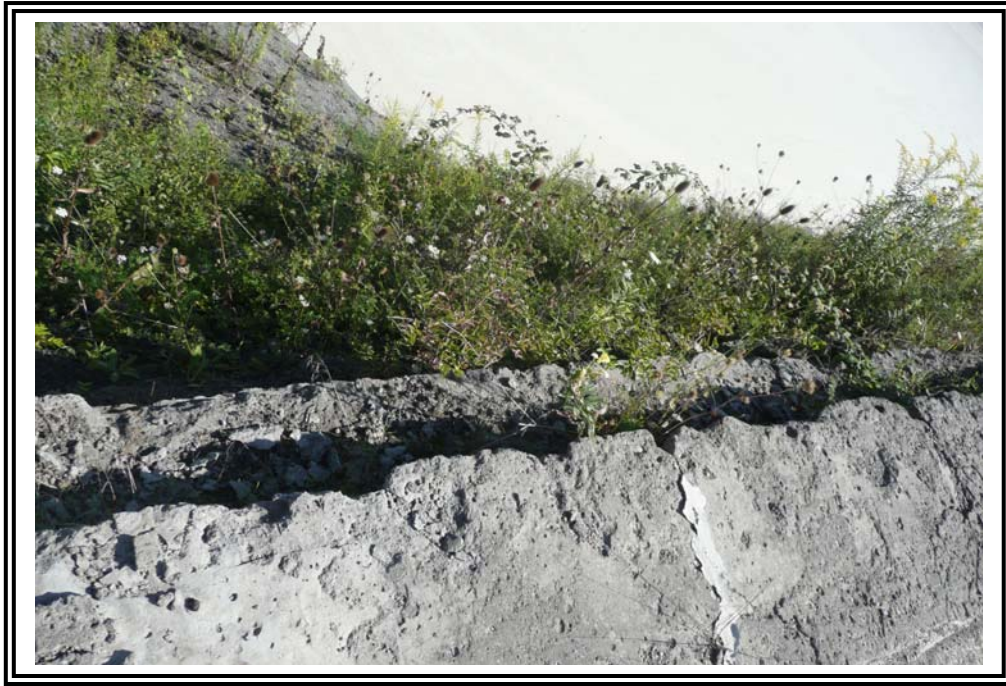
Weathering effects were also observed in the roller compacted concrete surface during the site assessment. These occurred in the form of edge spalling and isolated erosion (Photos 69 and 72) in the outer surfaces of the material.

Close-up at weathered roller compacted concrete (RCC) surface and sealed crack on crest at upstream face.
Note vegetation below crest level.

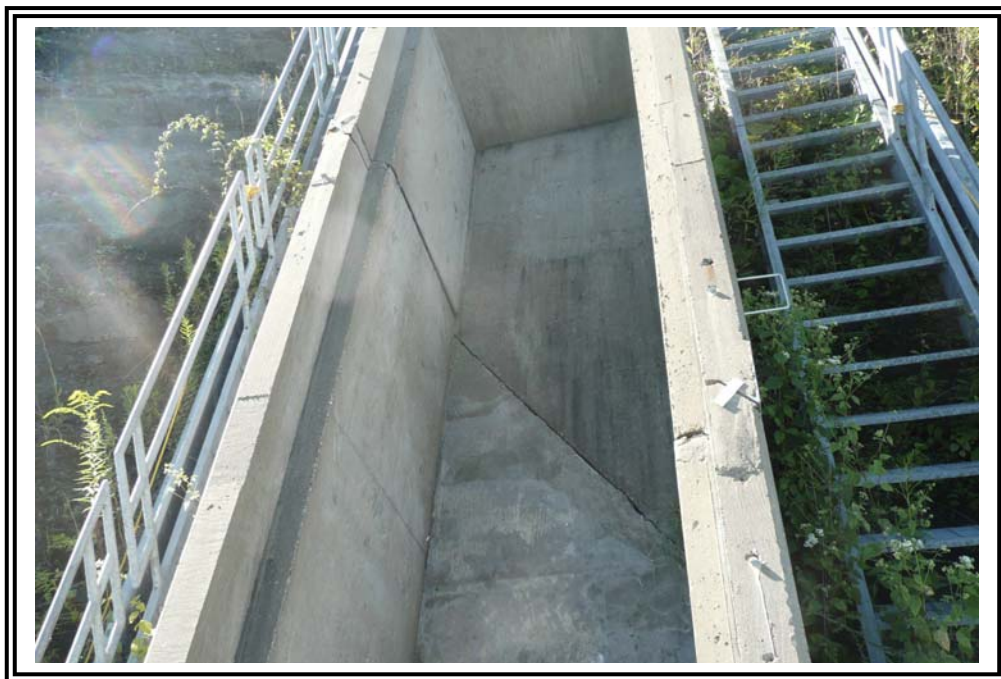
74

Inclined spillway looking at upstream face. Note diagonal construction deformation joint. Joint was formed to allow for some deformation due to crack in RCC during construction.

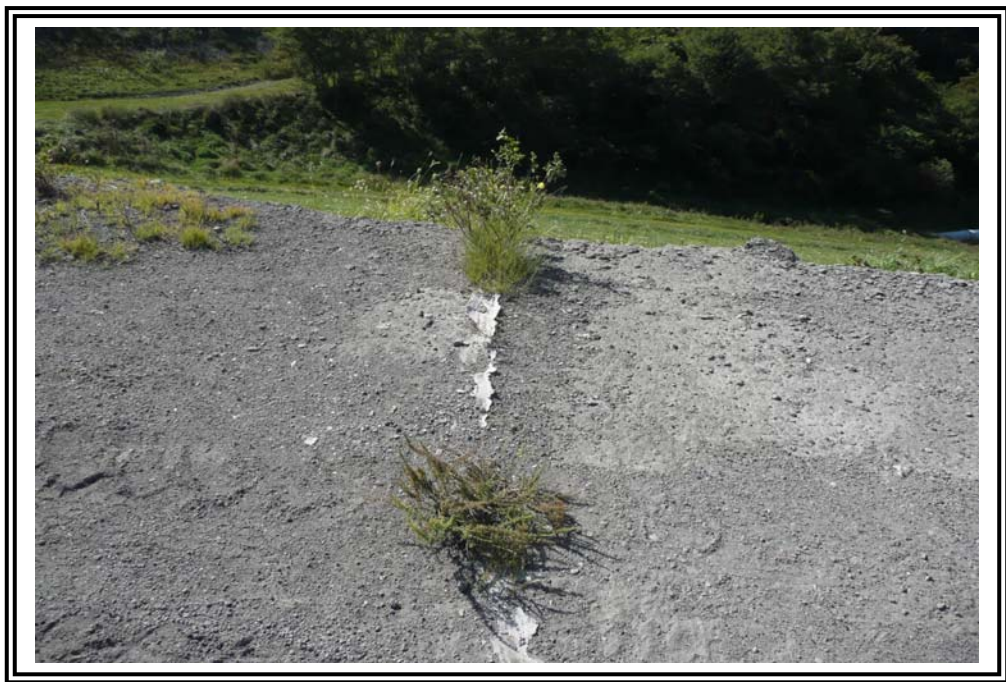
78

Two distinct cracks sealed with caulking were also observed in the crest adjacent to the west (right) abutment and spillway (Photo 78). These cracks apparently occurred during the RCC construction as a result of differential settlement between the RCC crest supported directly on the

Surface expression of sealed crack at crest in RCC that initiated the diagonal joint in the inclined spillway.

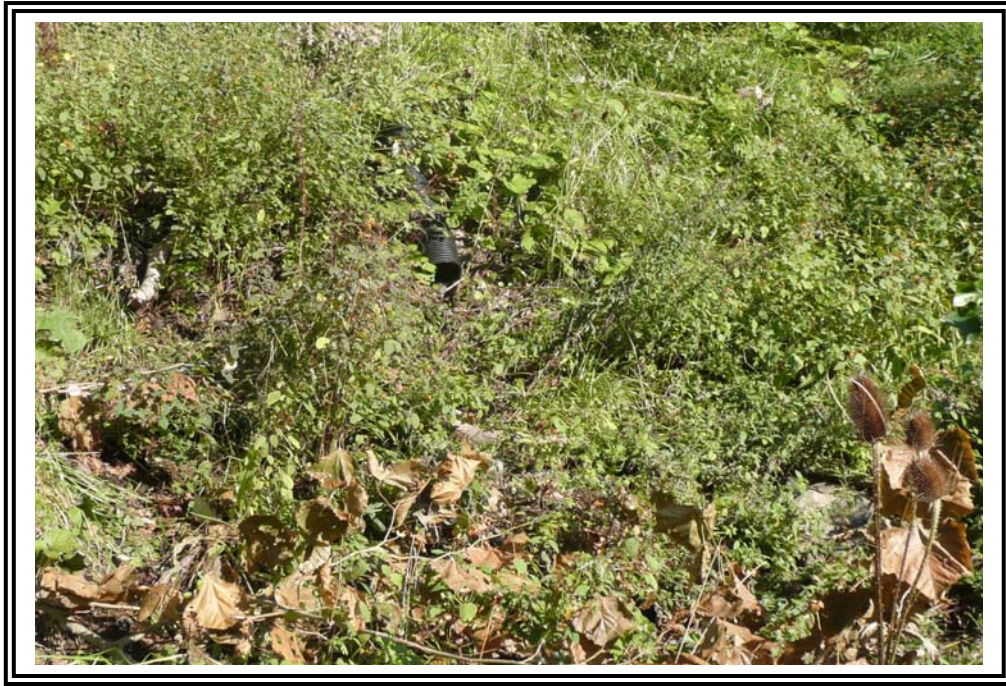
89

Active drain exiting from natural hillside feeding into right (west) groin. Note brush vegetation.

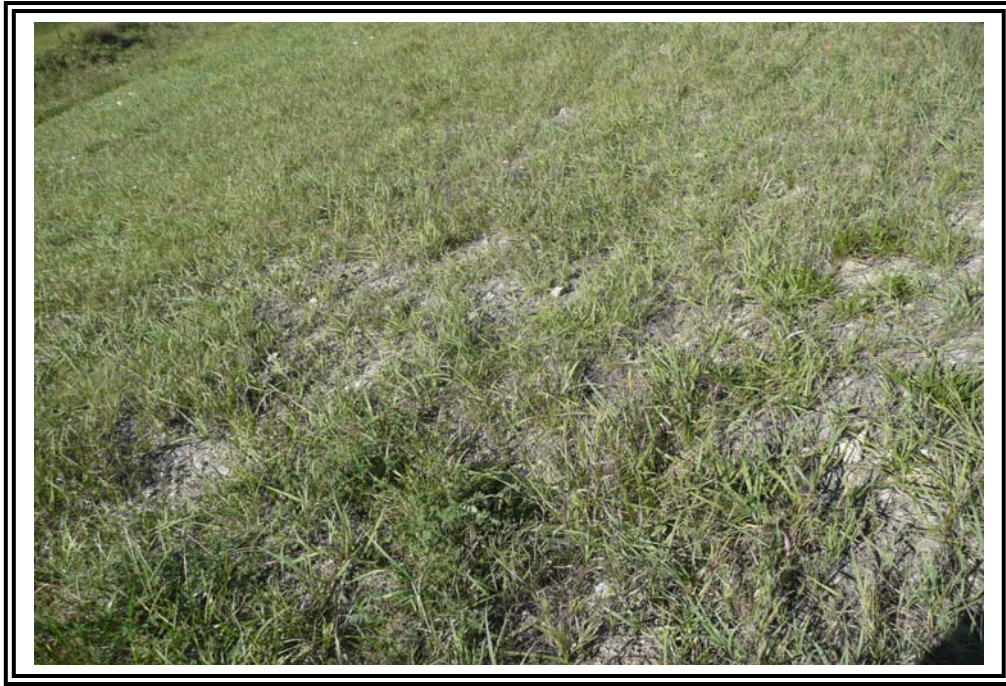
103

Isolated loss of grass cover and possible erosion on upper portion of downstream slope above slope groin.
