**Coal Combustion Residue Impoundment
Round 9 - Dam Assessment Report**

*Clinch River Power Plant
Ash Pond Management Units
Appalachian Power
d/b/a American Electric Power
Carbo, VA*

Dewberry & Davis, LLC
Fairfax, Virginia

Under Contract Number: EP-09W001727
December 2011

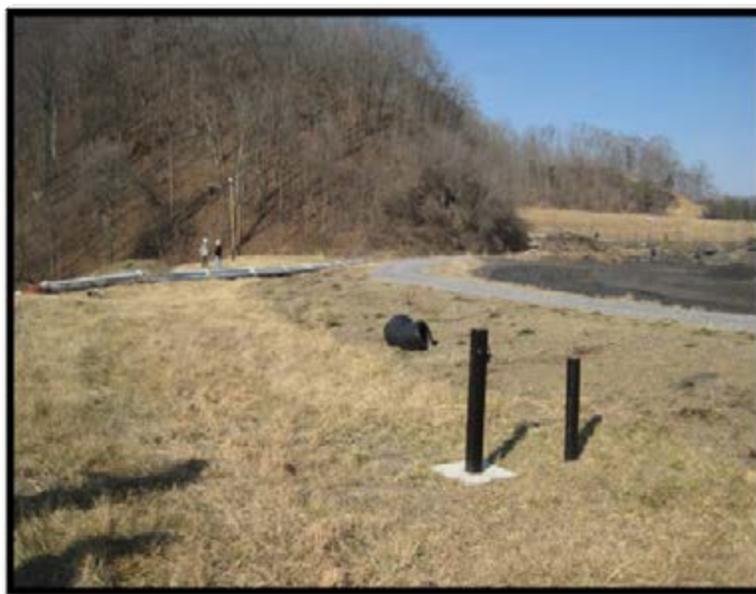
The crest of the perimeter dike had no significant signs of depressions, tension cracks or other indications of settlement or shear failure. Figure 5.2.1-1 and Figure 5.2.1-2 shows the typical crest conditions along the perimeter dike.

Figure 5.2.1-1: Crest, West. Clinch River Power Plant to left not seen in this figure.

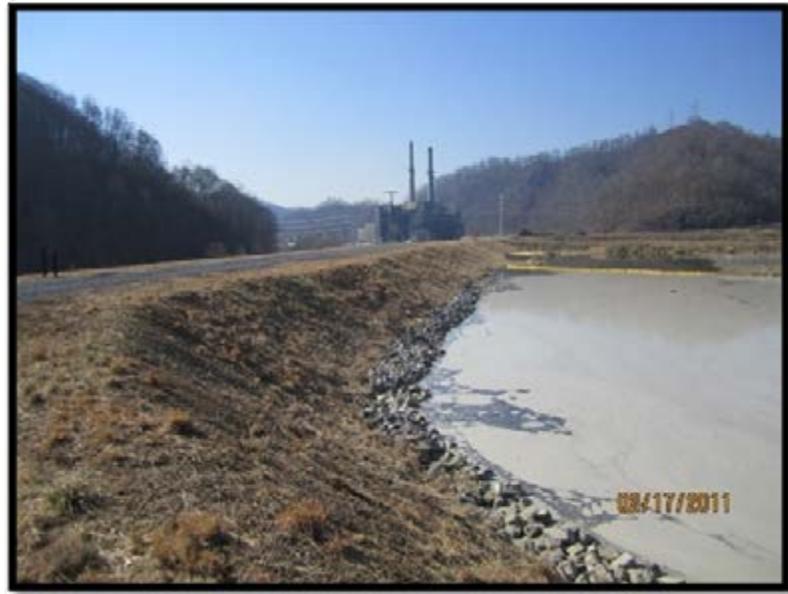
The visible upstream slope of the perimeter dike, including all groins, had adequate and well maintained cover of grasses/weeds. The upstream slope below the permanent pool was not observed. There were no obvious signs of scarps, bulging cracks, depressions or other indications of slope instability. Rip-rap armoring was observed at operating pool elevations to mitigate wave erosion. Figure 5.2.2 shows a representative upstream slope section of the perimeter dike looking south.

Figure 5.2.2: Upstream slope, South. Plant shown in background.

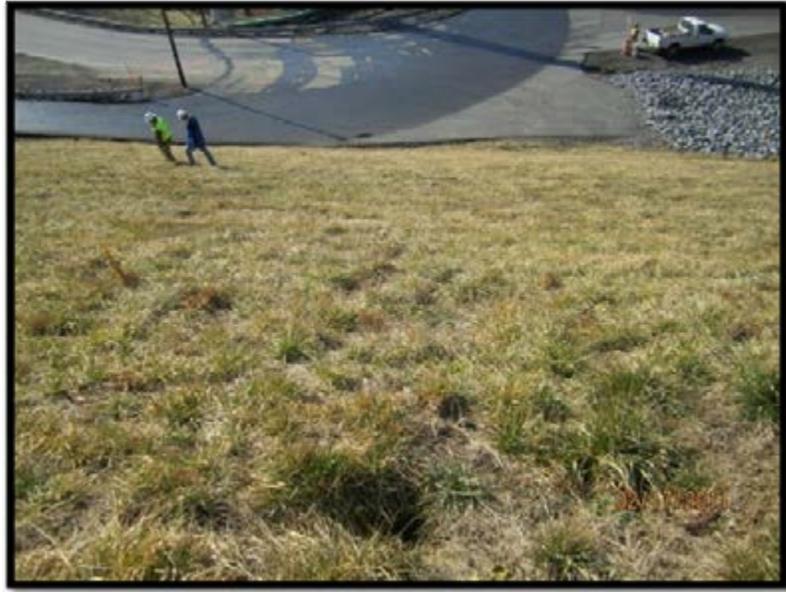
The visible downstream slope of the perimeter dike had adequate and well maintained cover of grasses/weeds as well as rip-rap armoring and inverted filter. A paved access road from Route 665 runs up the downstream slope of the perimeter dike to its crest. An animal burrow was observed along the downstream slope of the perimeter dike. The burrow hole was small in size and near the crest. No scarps, sloughs, bulging, cracks, depressions or other indications of slope instability were observed along the downstream slope. Figures 5.2.3-1 thru 5.2.3-3 show representative downstream slope sections of the perimeter dike.

Figure 5.2.3-1: Downstream slope near access road entrance off Route 665. Note animal burrow near the crest.

It is recommended that all animal burrows located along the perimeter dike of Ash Pond 1 and Ash Pond 2 be backfilled in accordance with standard geotechnical engineering practices for dams, and monitored for future reoccurrence.

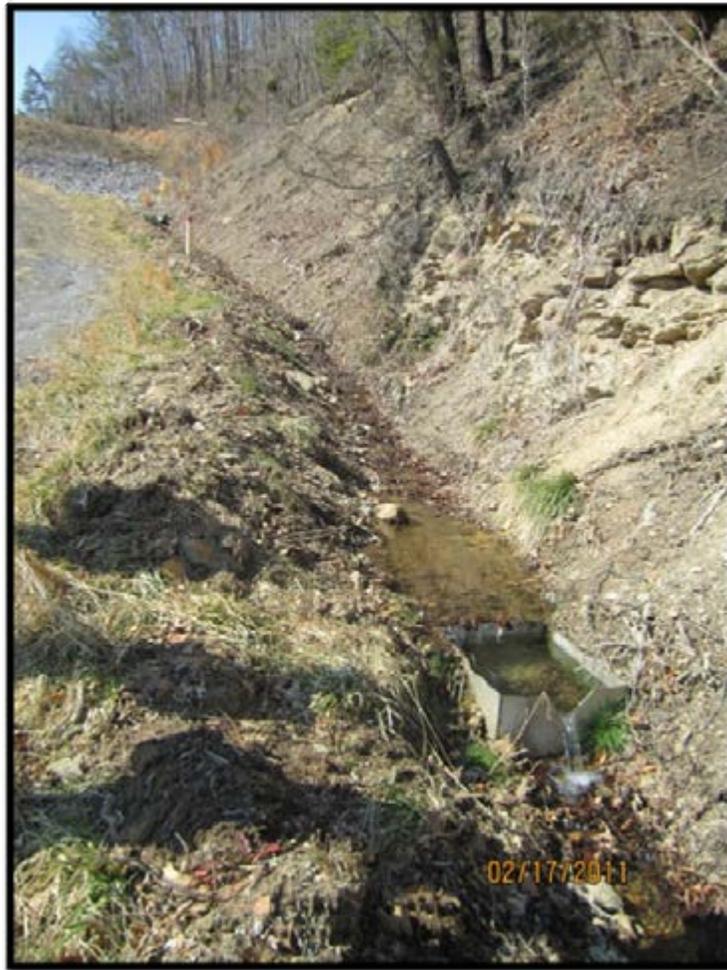
The perimeter dike has two abutments; the south and north abutments. Both abutment contacts consist of a drainage ditch. The south ditch shows some signs of erosion due to wet weather flow runoff from the adjacent hillside. The north ditch appeared in better condition with some stone and a v-notch weir that is used to monitor seepage, which was present on the day of the assessment. Apart from some minor erosion along the south abutment ditch, both abutments were well maintained. There were no observed scarps, sloughs, bulging, cracks, depressions or other indications of slope instability. Figures 5.2.4-1 and 5.2.4-2 show south and north abutment contacts.

Figure 5.2.4-1: North abutment ditch. Note upstream riprap and v-notch weir used to monitor seepage.

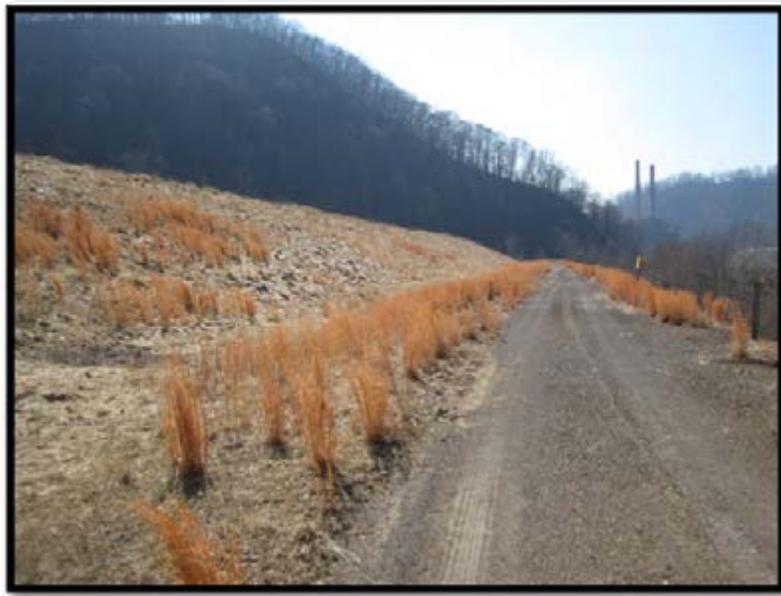
Figure 5.3.1-1: Lower dike crest, South.

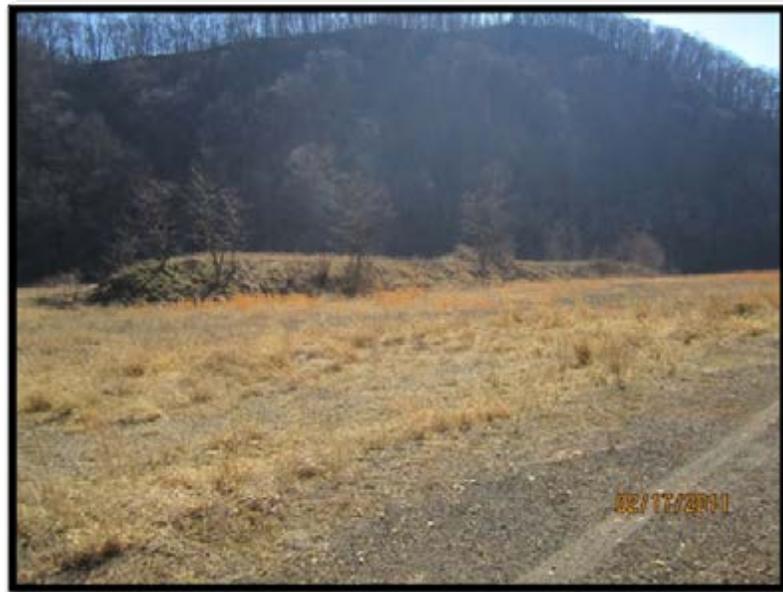
The downstream slopes of the dikes are covered in high grass/weeds. The upper dike had some areas of tree growth. Significant tree growth between the toe of the lower dike and Dumps Creek made visual observations difficult. Based on what could be observed there were no scarps, sloughs, bulging, cracks, depressions or other indications of slope instability along any portion of the dikes. Figures 5.3.3-1 thru 5.3.3-3 show representative sections of the downstream slopes and toe.

Figure 5.3.3-1: Remaining portion of upper dike, Southeast. Note tree growth on downstream slope.

It is recommended that all underbrush and trees be removed from the Ash Pond 2 perimeter dike in accordance with VA DCR DSFM requirements.

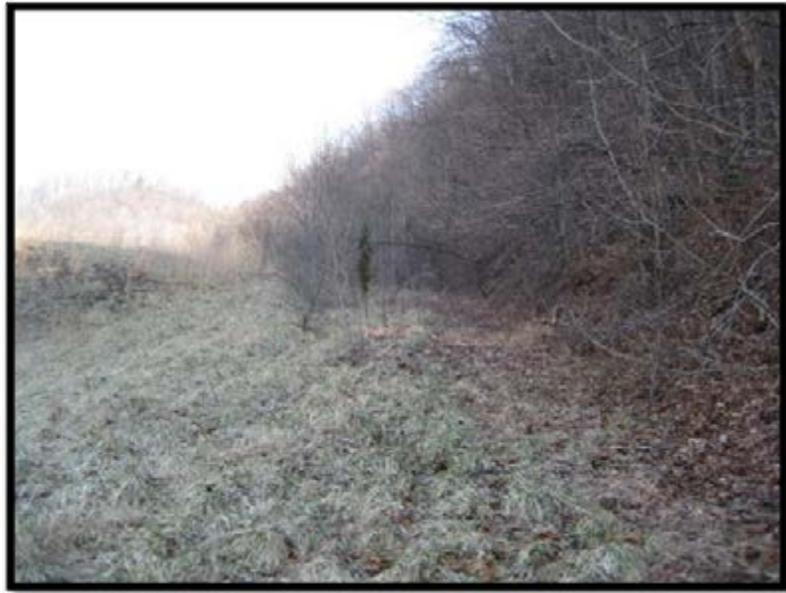
There were no observed scarps, sloughs, bulging, cracks, depressions or other indications of slope instability at dike abutments and groin areas of upper dike. Significant tree growth was observed along south abutment as shown in Figure 5.3.4.

Figure 5.3.4: South abutment. Note tree growth to the right along hillside; Ash Pond 2 is to the left.

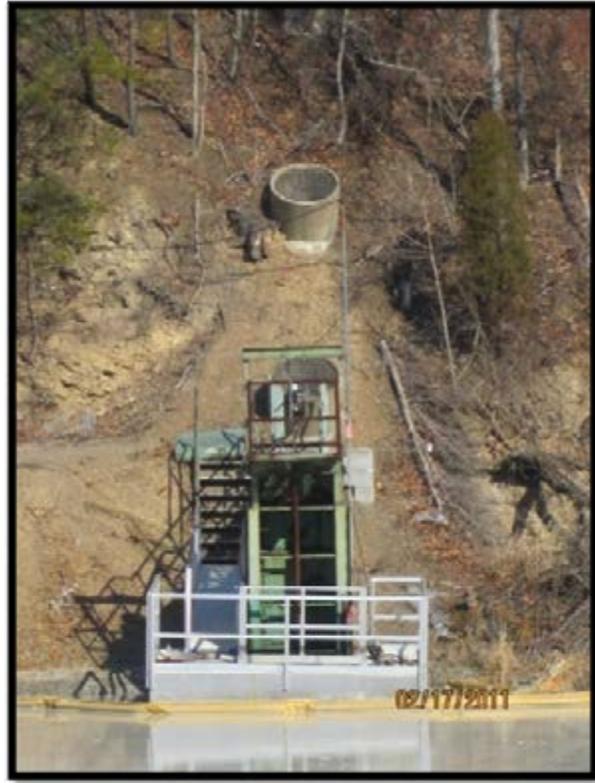
The overflow spillway structure for Ash Pond 1 is located in the north corner of the facility (Figure 5.4.1-1). The structure appeared to be in satisfactory condition and operating as designed. There were no obvious signs of trash and/or debris around the intake. Water was observed entering the spillway but could not be seen exiting the spillway as the outfall pipe consists of a long storm sewer that outfalls into the existing reclaim pond below its permanent pool.

Figure 5.4.1-1: Overflow spillway structure

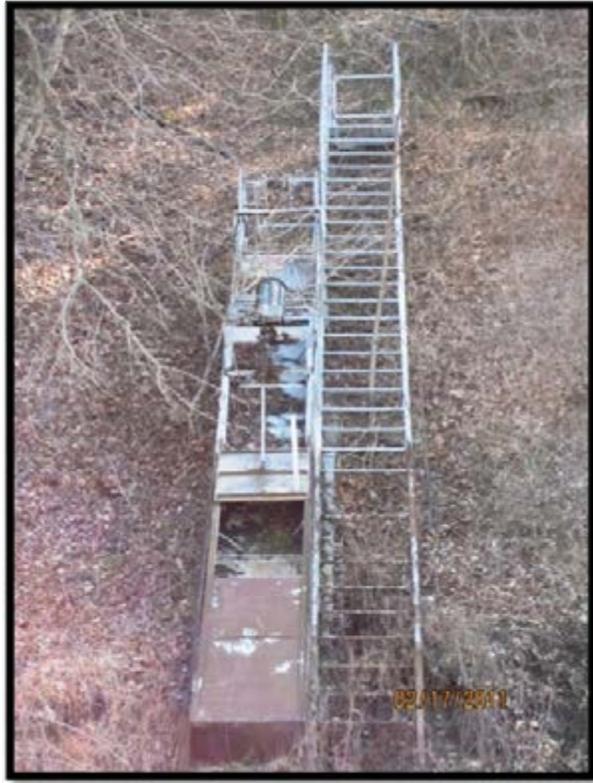
The Virginia DCR representative who participated in the onsite visit indicated particular concern that, as noted above, runoff is migrating into the ash residuals and there is no corresponding outlet for accumulating water.

Figure 5.4.1-2: Ash Pond 2 overflow structure.
