# Assessment of Dam Safety

## Coal Combustion Surface Impoundments (Task 3)

American Electric Power

Conesville  
Generating Station

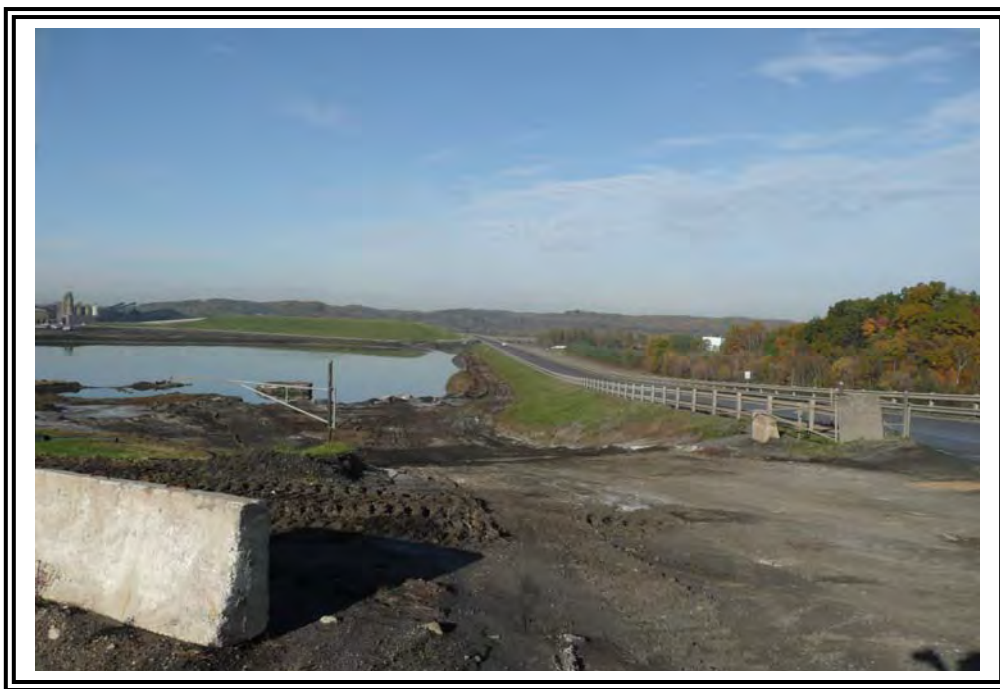
1

Looking west across the north corner of the Fly Ash Pond along upstream slope of North Haul Road Dike.  
The plant and closed FGD area are in the background.

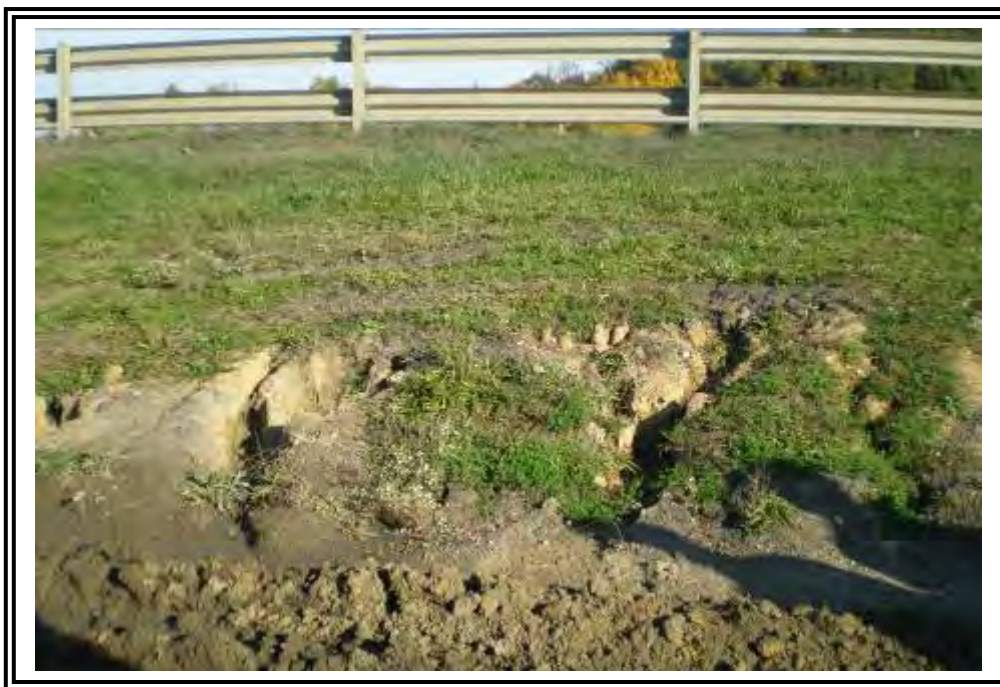
3

Erosion rills from haul road run off on the upstream slope of the North Haul Road Dike.

The crest of the Northern Haul Road and Coal Haul Road dikes had intermittent erosion rills and subsequent loss of grass cover resulting from water flow from storm events and dust control water spray. These erosion rills should be filled in with compacted material and otherwise stabilized. CHA recommends on-going maintenance and/or a change to the surface treatments to reduce erosion from run-off. The facility may consider adding curbing with road side gutters to collect runoff, direct it toward designated concrete lined ditches or rock protected outfalls.

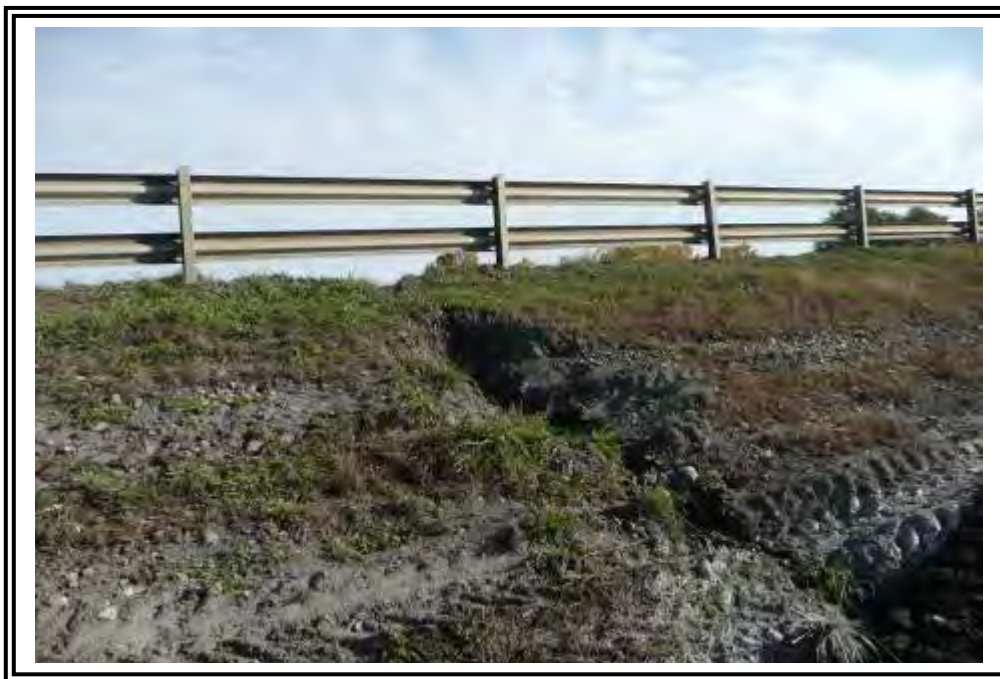
4

Large erosion rill and rutting on the upstream slope of the North Haul Road Dike.

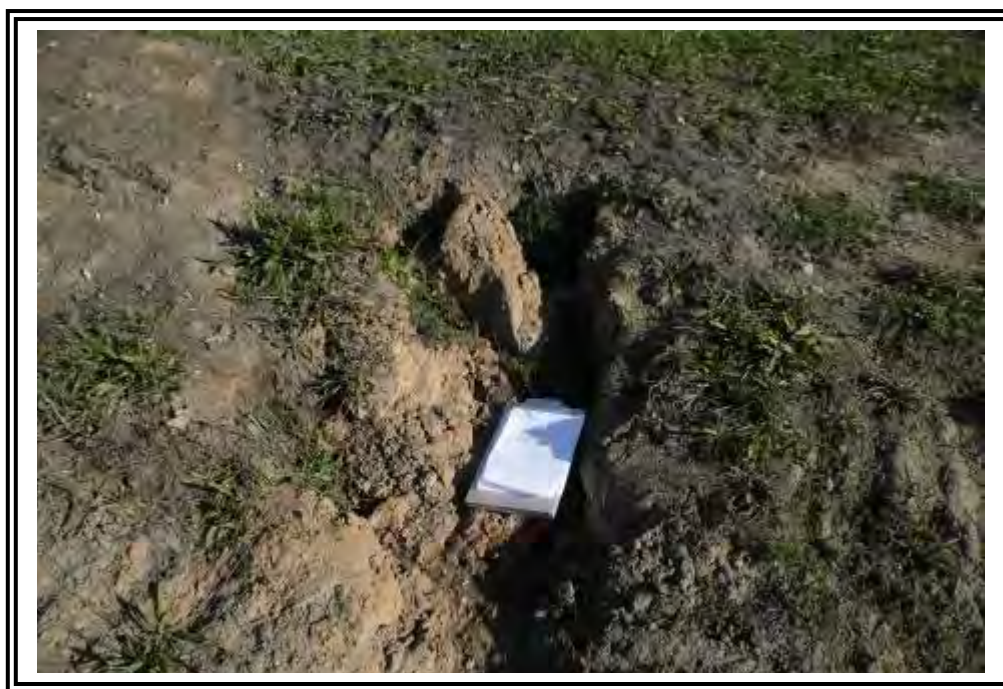
5

A close up of a large erosion rill and loss of vegetation on the upstream slope of the North Haul Road Dike.

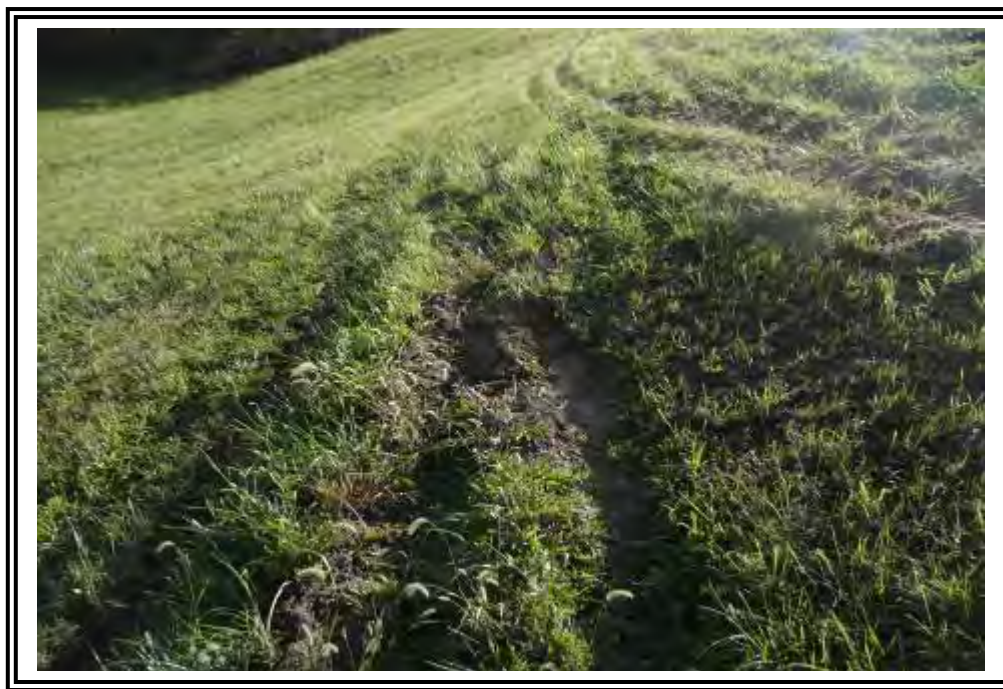
11

Close up of rutting and loss of vegetation on the downstream slope of the North Haul Road Dike.

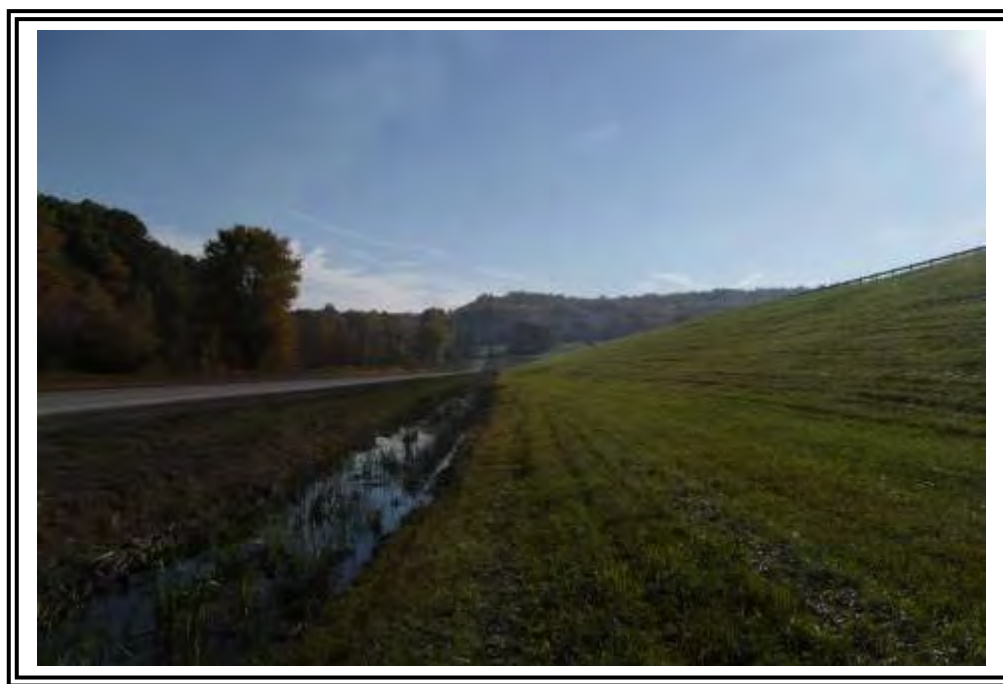
12

Toe of the North Haul Road Dike, looking east.  
Standing water in the road ditch along toe can be seen in left of photo.

Standing water and wetlands growth was observed between the Northern Haul Road Dike and County Road 273. This growth appears to be the result of water backing up into the drainage ditch at the toe of the dike from a poorly drained, swampy area on the north side of County Road 273. As a result, flow through the culvert below County Road 273 is restricted and runoff cannot be effectively conveyed from the ditch. CHA recommends drainage in this area be corrected so water is not standing/saturating the toe of the dike and observations of seepage, if any, can be seen. Additionally, weed growth has obstructed flow through the measurement weir and corresponding observations. The growth obstructing the weir should be cleared.

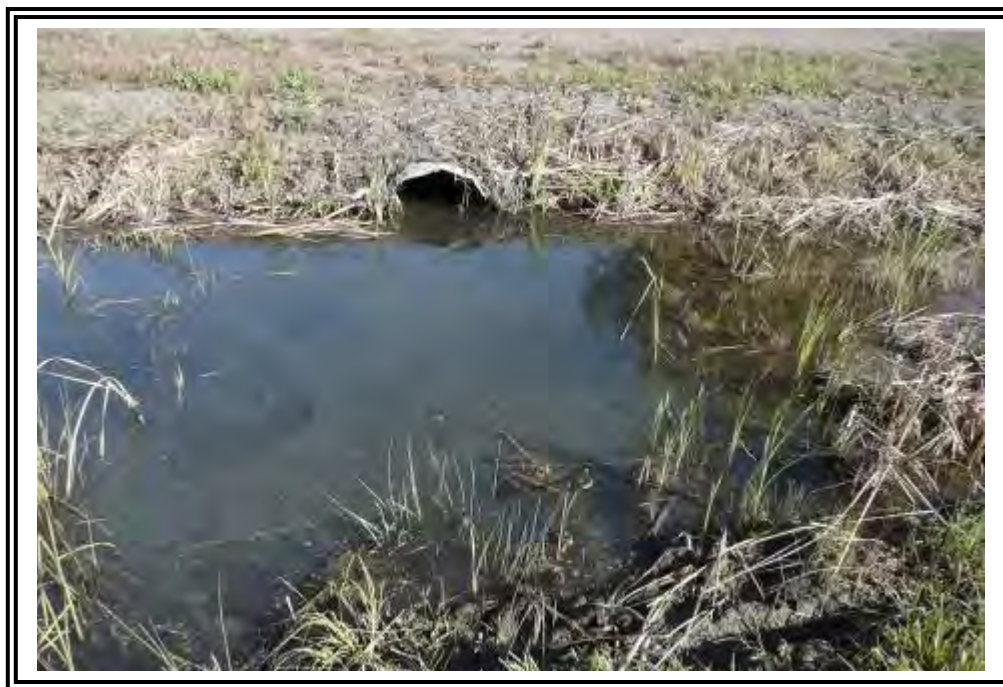
13

Close up of the half submerged drainage pipe under the county road.

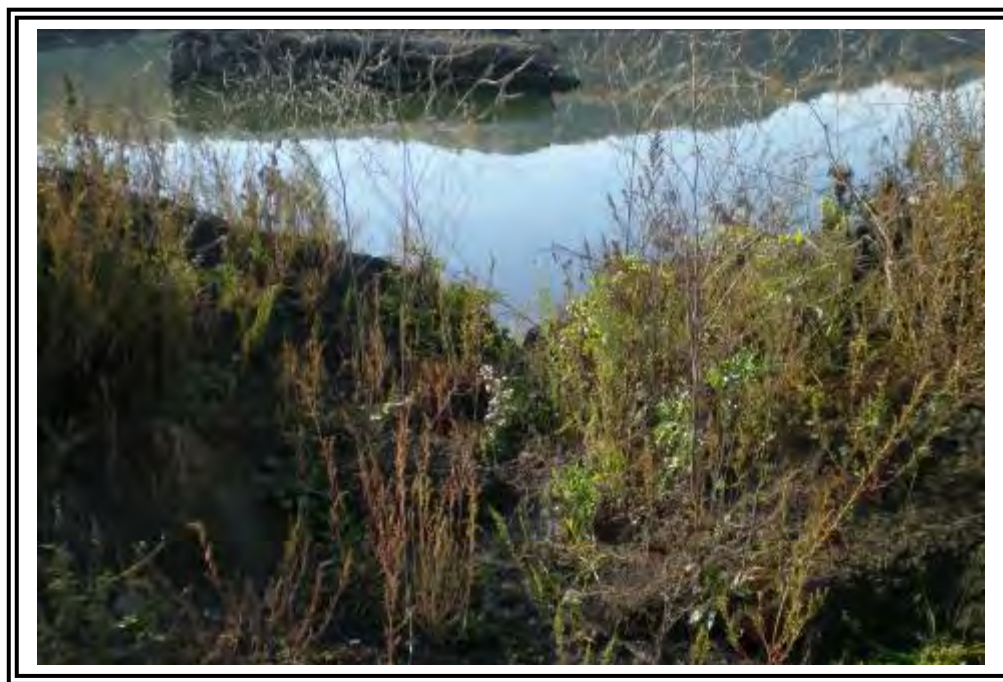
14

Vegetation and erosion rill at edge of Fly Ash Pond and construction road adjacent to the North Haul Road Dike.

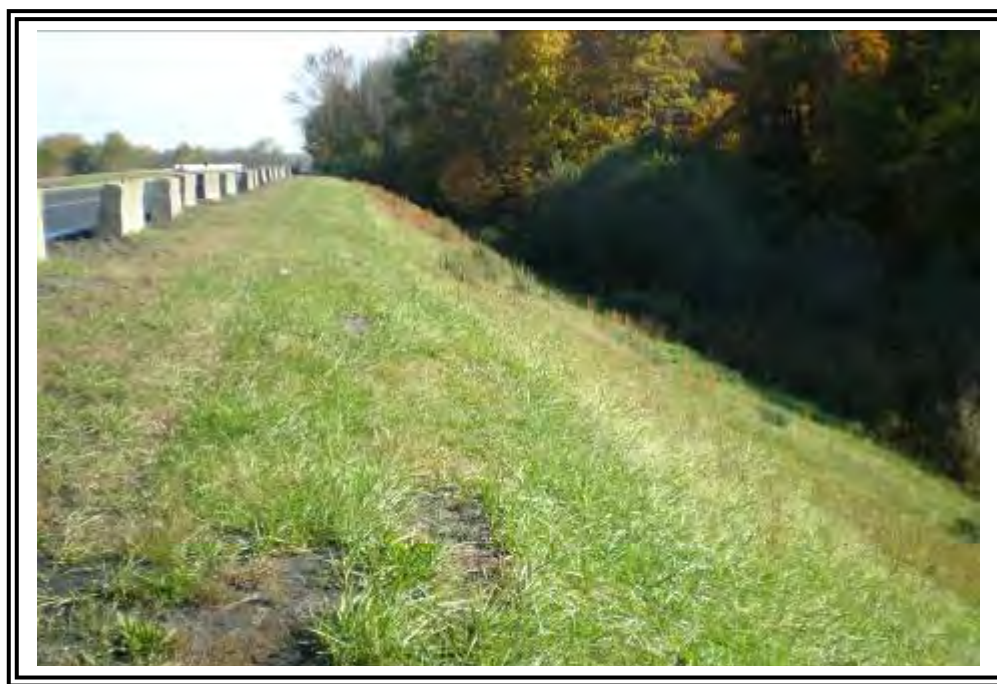
20

Looking northeast along downstream slope of the Coal Haul Road Dike. Small trees and moderate vegetation lower on the slope can be seen in the shade in the right of the photo.

Brush growth was observed on the downstream slope of the Coal Haul Road Dike adjacent to the Fly Ash Pond. The woody vegetation should be removed under the supervision of a Professional Engineer.

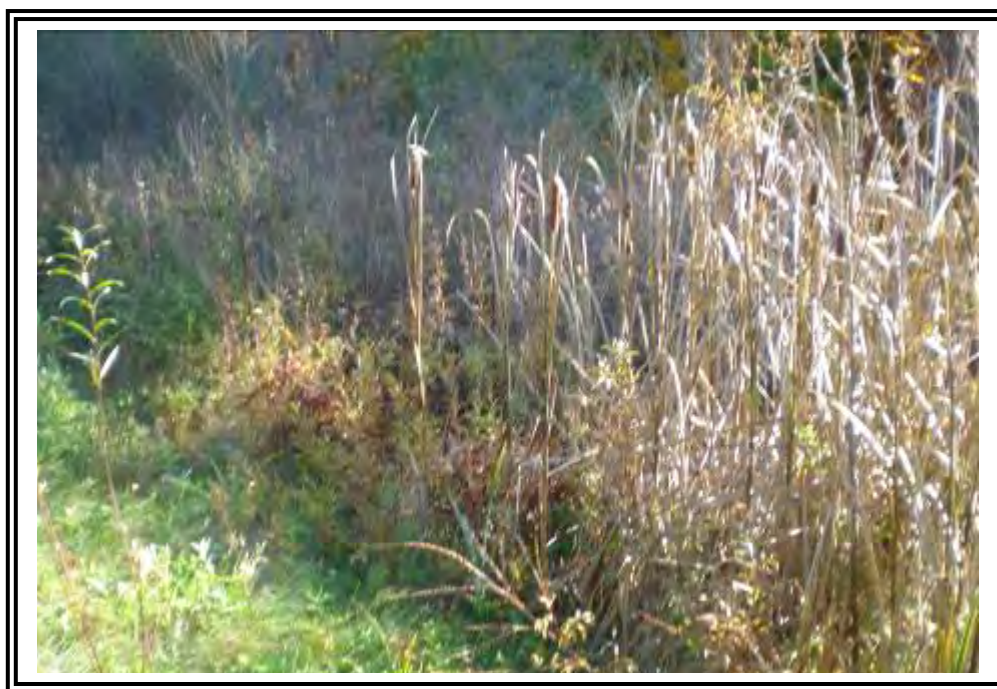
23

Heavy vegetation near the toe of the Coal Haul Road Dike.

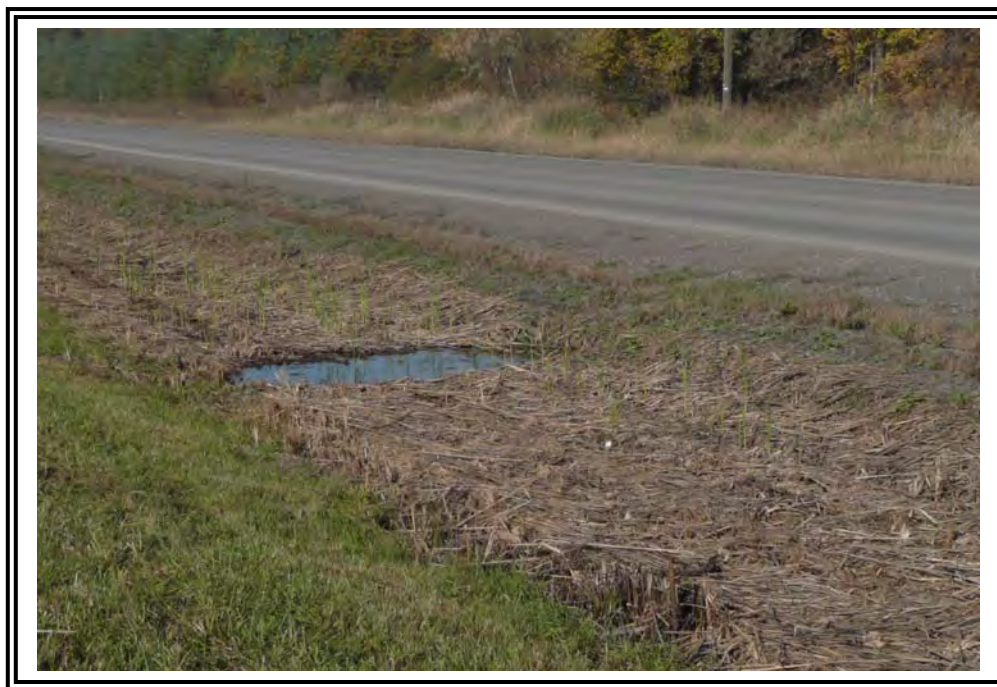
49

Recently mowed cattail growth in drainage swale at toe of the North Haul Road Dike and County Route 273.

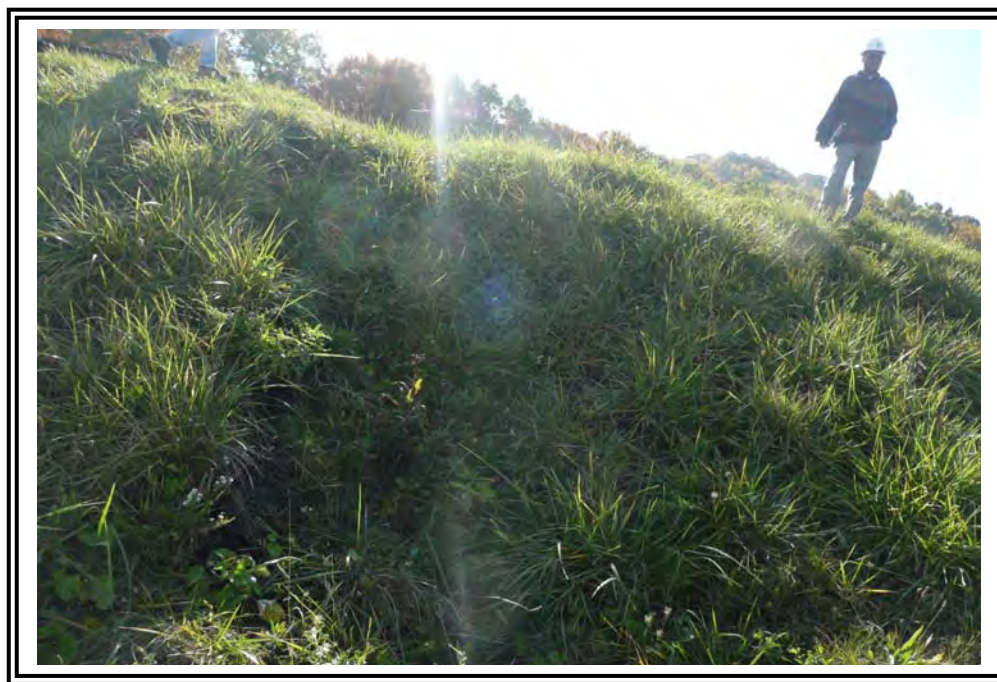
50

Grassed older erosion rill in upstream slope of Coal Haul Road Dike.

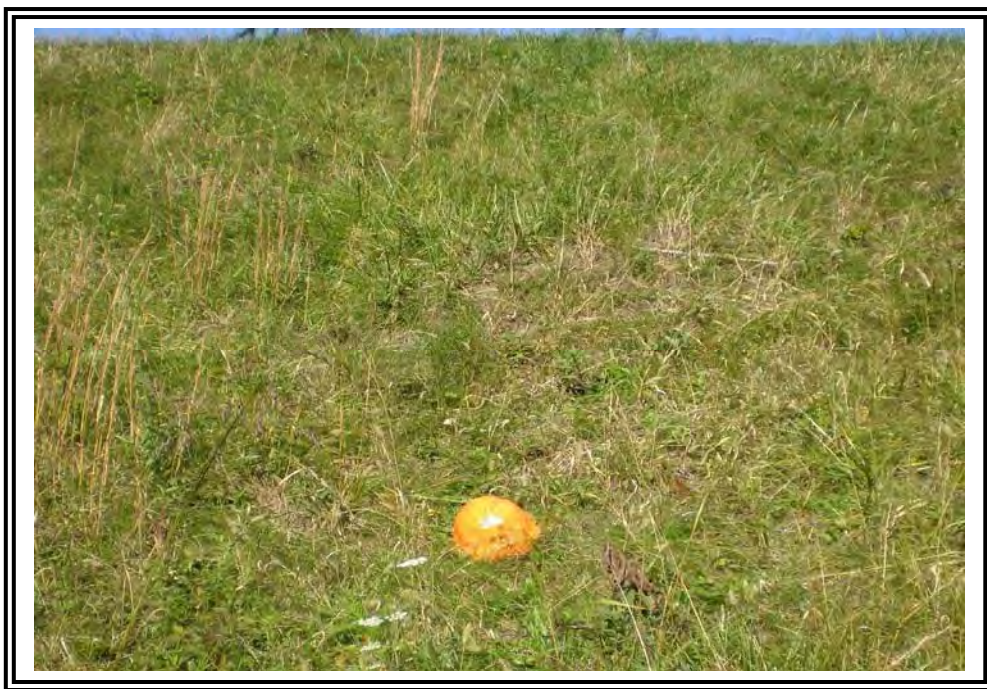
51

Grassed erosion rill on downstream slope of Coal Haul Road Dike. Hard hat is in bottom of rill.

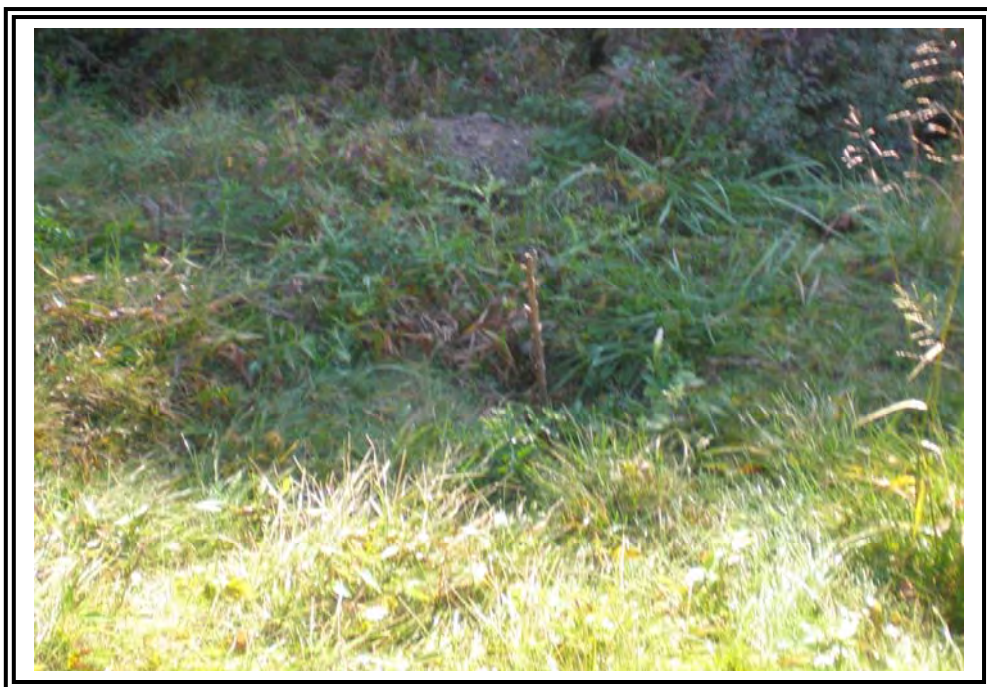
53

Open rodent burrow in area of older collapsed burrows that have become erosion rills (stick is in burrow) in Coal Haul Road Dike.

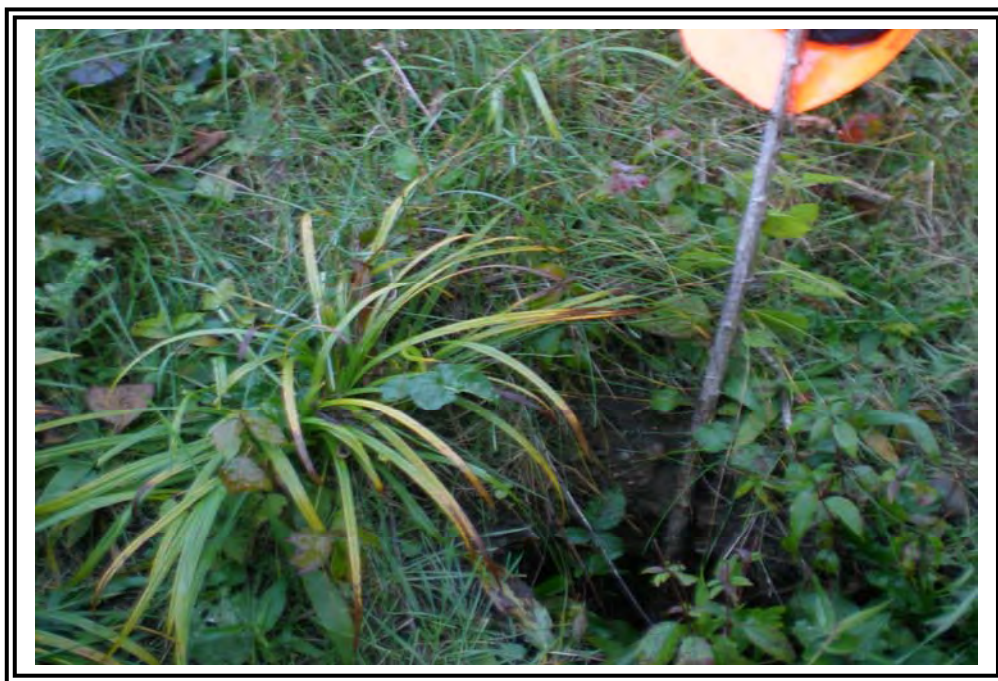
54

Another rodent burrow on downstream slope of Coal Haul Road Dike.

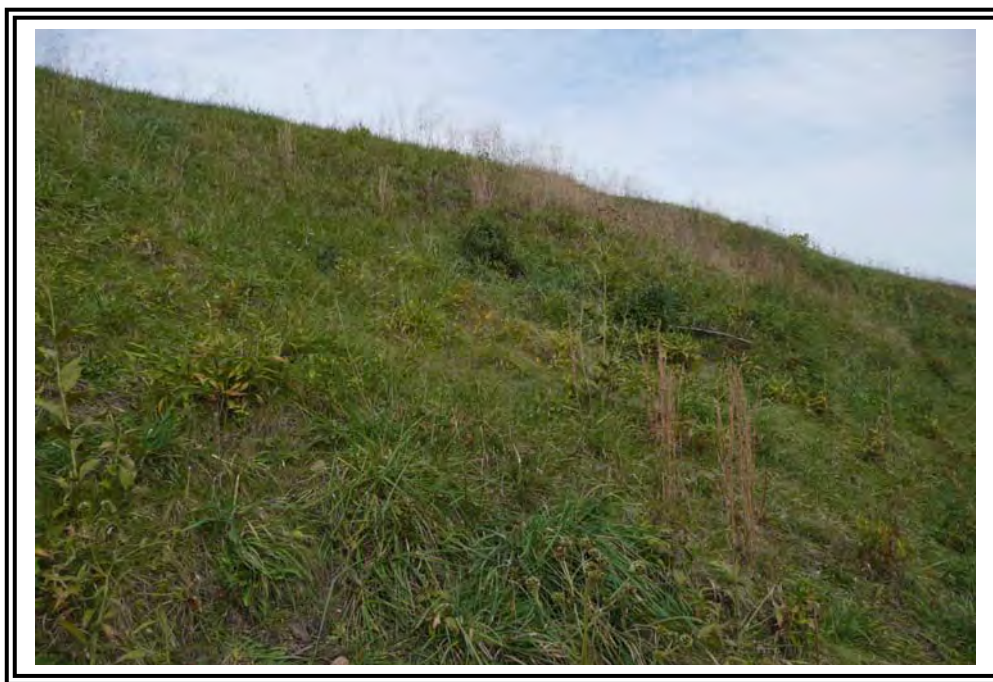
56

Grass covered deformation on downstream slope of Coal Haul Road Dike.

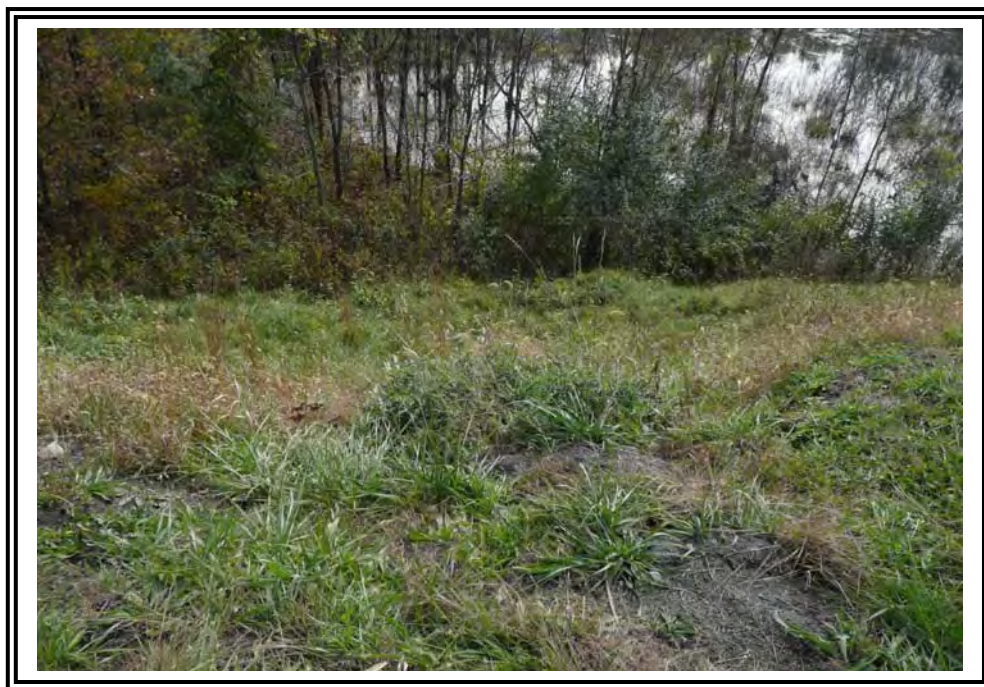
In addition to the erosion features, a scarp with an adjacent depression and slump was also observed on the downstream slope along with older grass covered deformation features likely the result of surficial soil softening, concentrated runoff from the roadway, and dust control efforts. In the case of the latter, finer grained coal dust, soil, and other debris is washed or swept from the road onto the slope and build up over time. These are shown in Photos 47, 48, and 56. Examples of the soil and dust transport from the roadway with subsequent grass cover loss can be seen in Photos 57 and 58.

Example of soil and coal dust transport and intermittent grass cover loss near crest of Coal Haul Road Dike.
