**Coal Combustion Residue Impoundment  
Round 9 - Dam Assessment Report**

*Northeastern 3 & 4 Station*

*Bottom Ash Basin*

*AEP Public Service Company of Oklahoma  
Oologah, Oklahoma*

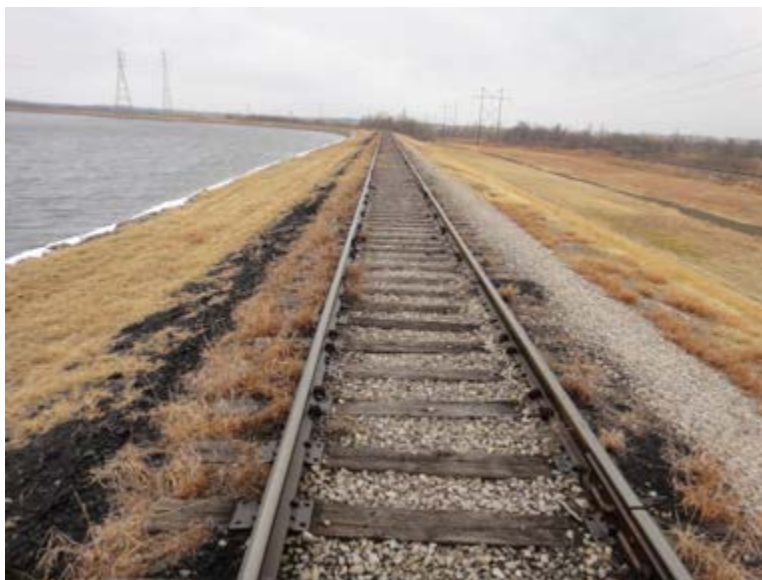
The crest of the West Embankment showed no signs of depressions, tension cracks, or other indications of settlement or shear failure, and appeared to be in satisfactory condition. A railroad track tops the crest of the embankment for its entire length. Vegetation is present within the track's ballast. Figure 5.2.1-1 shows the conditions of the crest of the West Embankment.

Figure 5.2.1-1. Photo showing railroad on crest and vegetation on the inside slope of West Embankment.

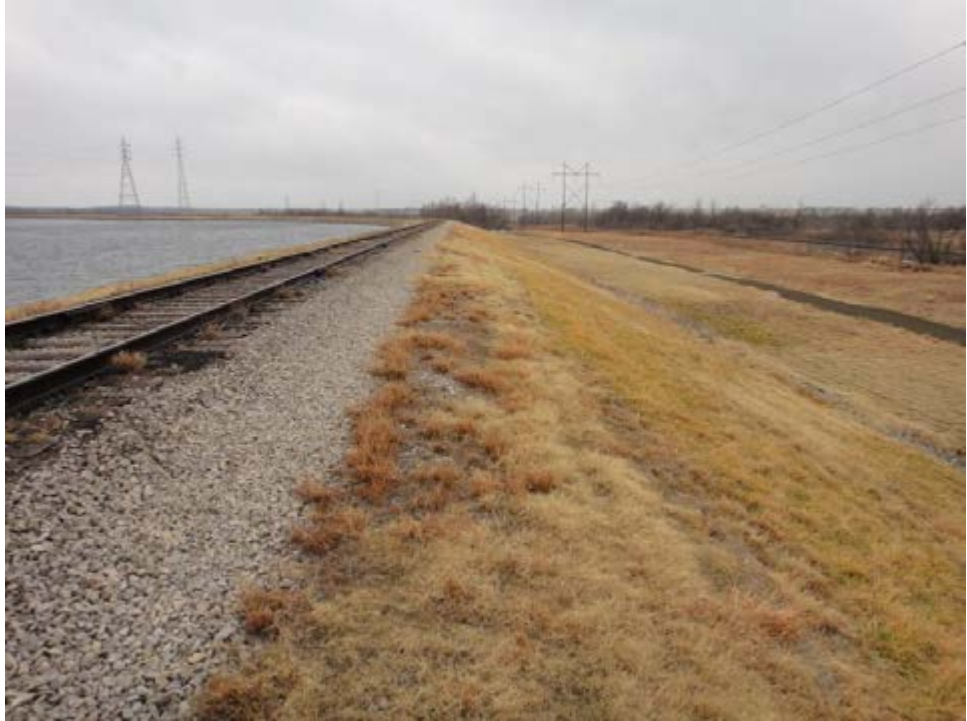
There were no observed scarps, sloughs, bulging, cracks, or depressions indicating slope instability or signs of erosion. The outside slope of the West Embankment was uniformly graded and covered with mowed grass. Rock riprap that is part of the toe drain drainage system is visible. The outside slope and toe appears to be in satisfactory condition. Figures 5.2.3-1 and 5.2.3-2 show the general condition of the outside slope and toe of the West Embankment.

Figure 5.2.3-1. West Embankment outside slope condition.

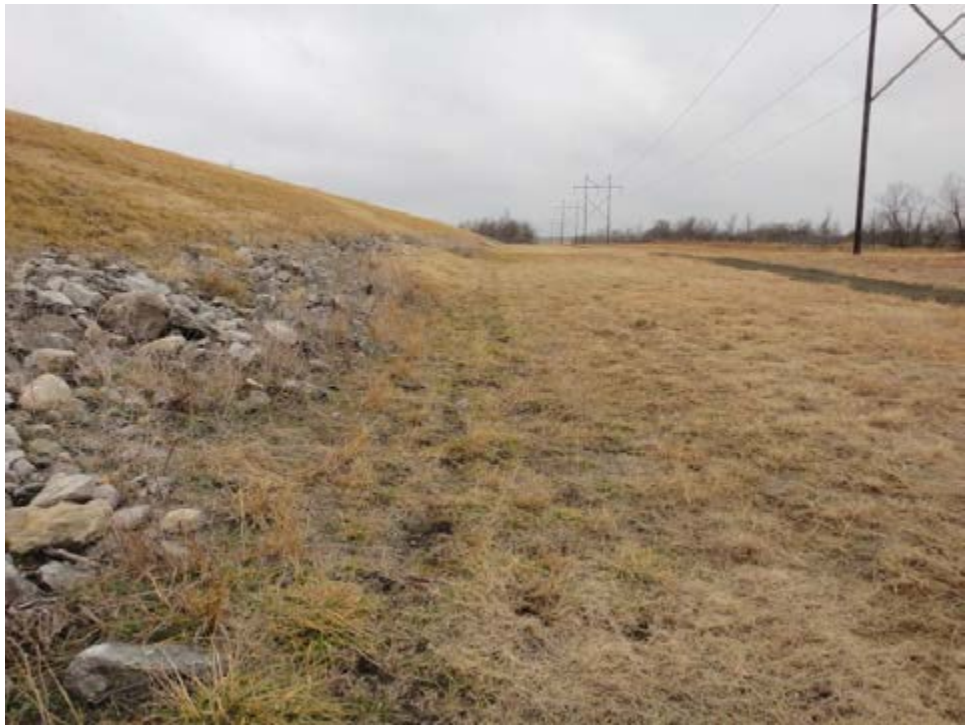
Figure 5.2.3-2. West Embankment toe conditions.

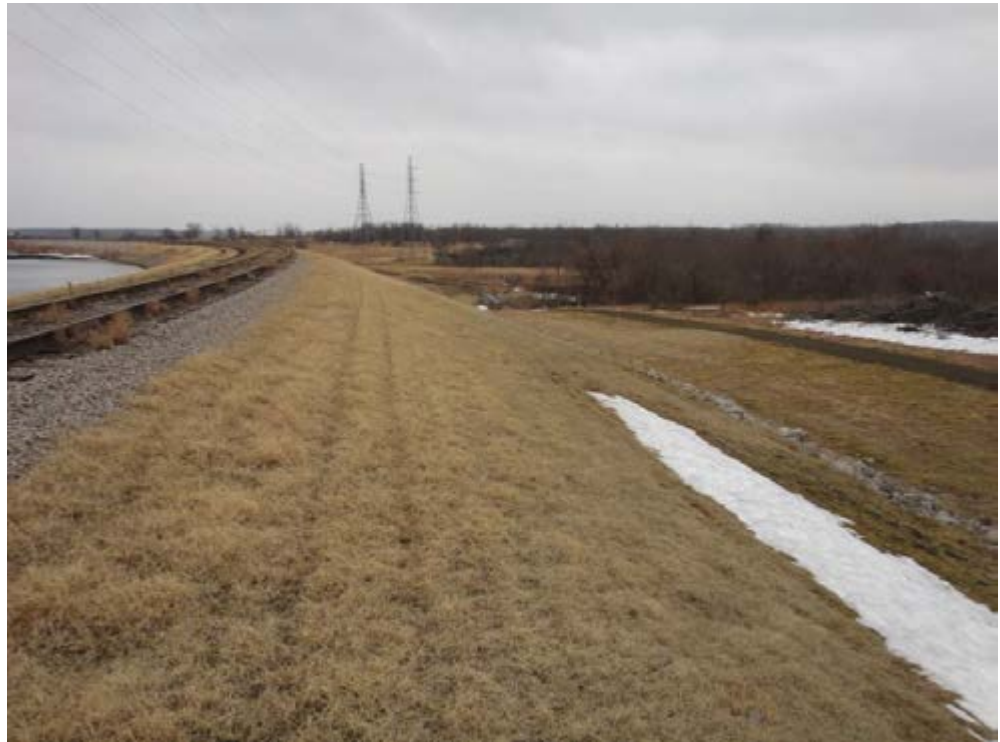
The crest of the South Embankment showed no signs of depressions, tension cracks, or other indications of settlement or shear failure, and appeared to be in satisfactory condition. A railroad track tops the crest of the embankment for its entire length. Vegetation is present within the track's ballast. Figure 5.3.1-1 shows the conditions of the crest of the South Embankment.

Figure 5.3.1-1. Figure showing the South Embankment crest condition.

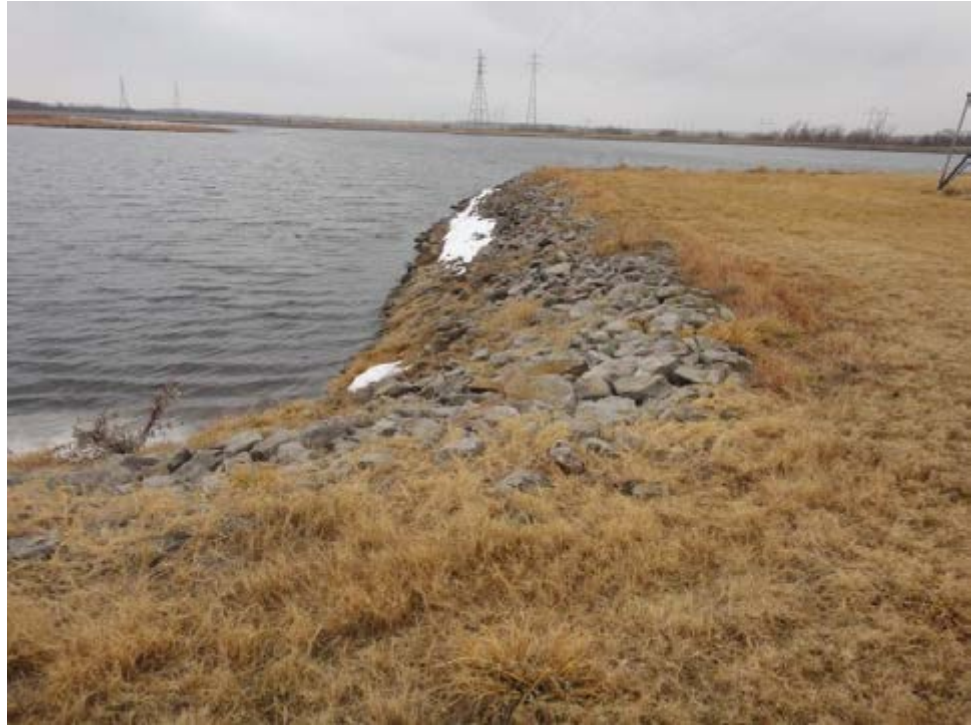
The South Embankment's inside slope is generally grass covered, with the exception of the access road and embankment slope riprap. Figure 5.3.2-1 shows these areas.

Figure 5.3.2-1. South Embankment inside slope condition.

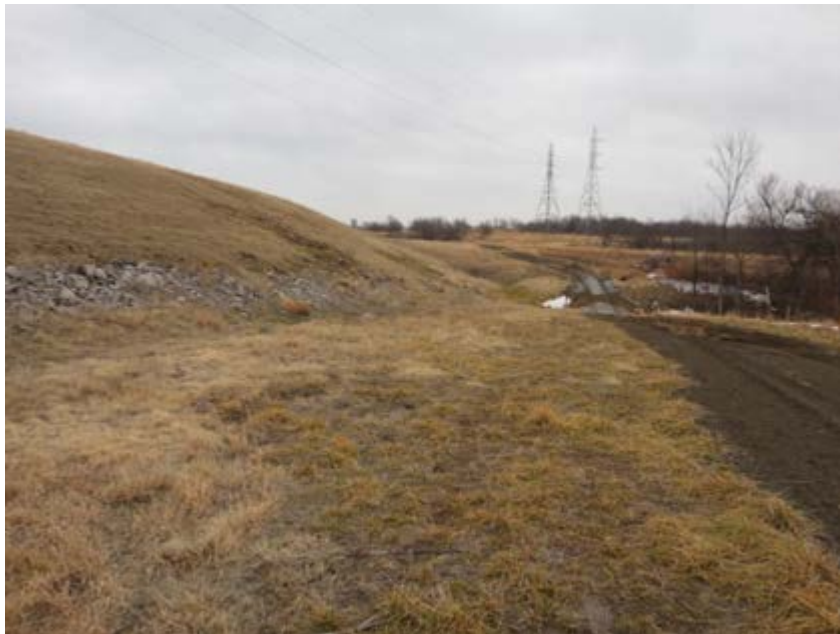
There were no observed scarps, sloughs, bulging, cracks, or depressions indicating slope instability or signs of erosion. The outside slope of the South Embankment was uniformly graded and covered with mowed grass. Rock riprap that is part of the toe drain drainage system is visible at the toe of slope. The outside slope and toe appears to be in satisfactory condition. Figure 5.3.3-1 shows the general condition of the outside slope and toe of the South Embankment.

Figure 5.3.3-1. Condition of South Embankment outside slope and toe.

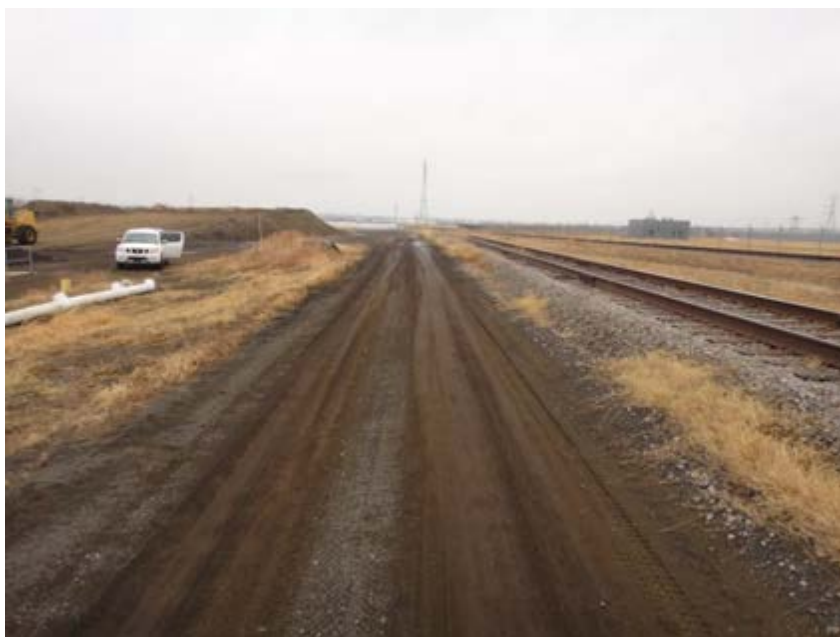
The outside slope of the abutments and groin were uniformly graded and covered with mowed grass. Erosion or uncontrolled seepage was not observed along either groin. Figures 5.3.4-1 shows the representative condition of the abutments and groin.

Figure 5.3.4-1. Southern Groin.

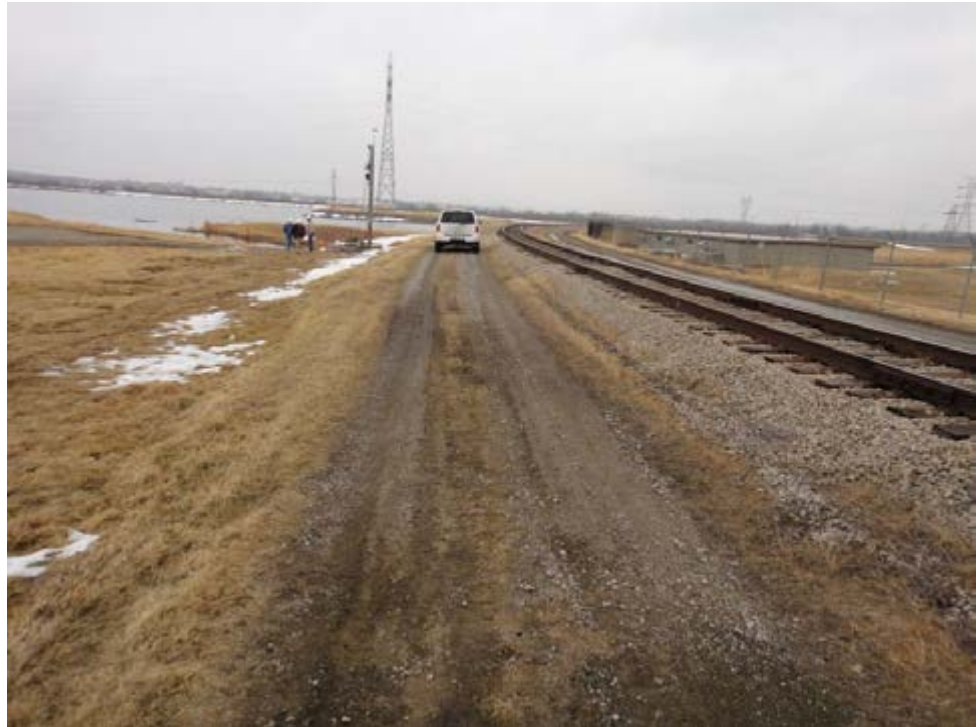
The crest of the North Embankment showed no signs of depressions, tension cracks, or other indications of settlement or shear failure, and appeared to be in satisfactory condition. Two access roads and a railroad track top the crest of this embankment for nearly its entire length. Figure 5.4.1-1 shows the conditions of the crest of the North Embankment.

Figure 5.4.1-1. North embankment crest with two access roads and railroad track at the east end

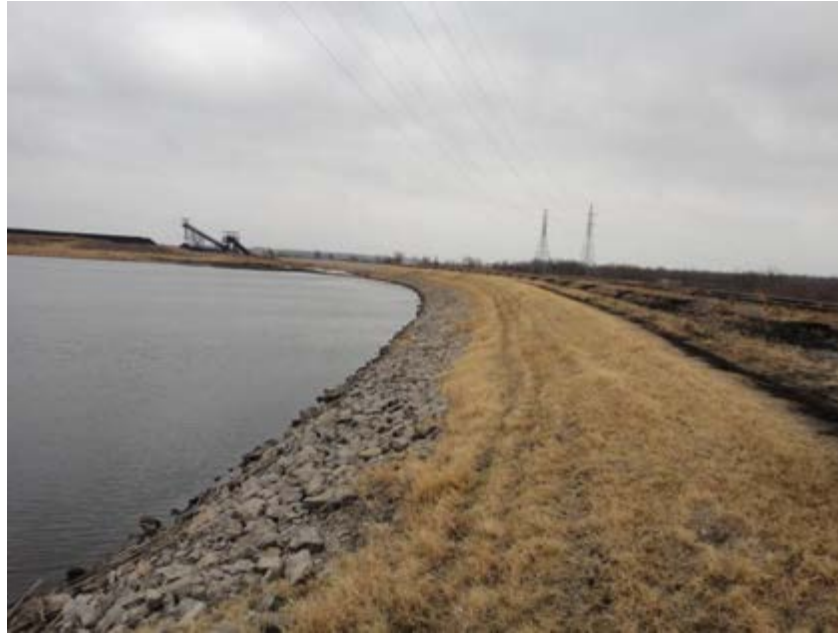
The North Embankment's inside slope is generally grass covered, with the exception of the embankment slope riprap. Figure 5.4.2-1 shows these conditions.

Figure 5.4.2-1. Conditions of inside slope of North Embankment.

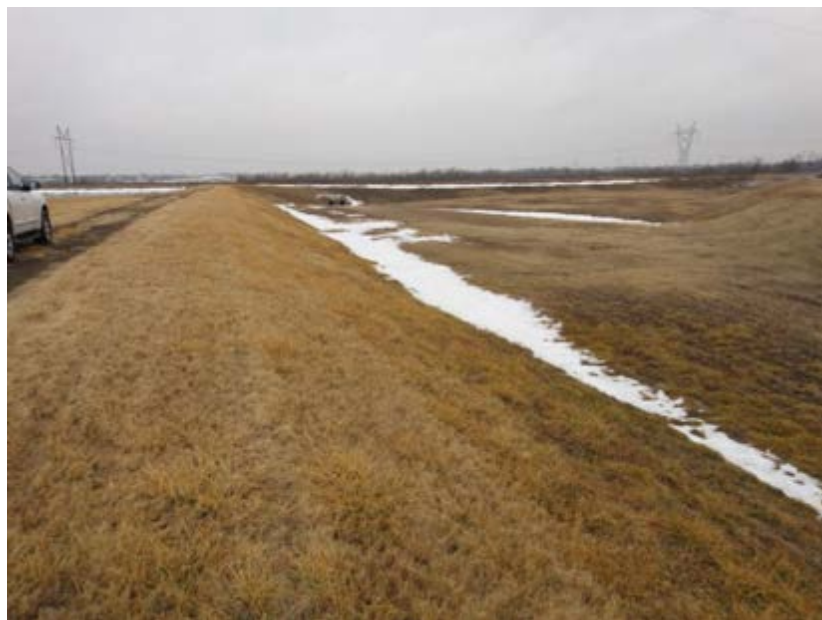
There were no observed scarps, sloughs, bulging, cracks, or depressions indicating slope instability or signs of erosion. The outside slope of the North Embankment abuts other facilities of the Plant. It is uniformly graded and covered with mowed grass. This slope appears to be in satisfactory condition. Figure 5.4.3-1 shows the general condition of the outside slope of the North Embankment.

Figure 5.4.3-1. Outside slope of North Embankment.

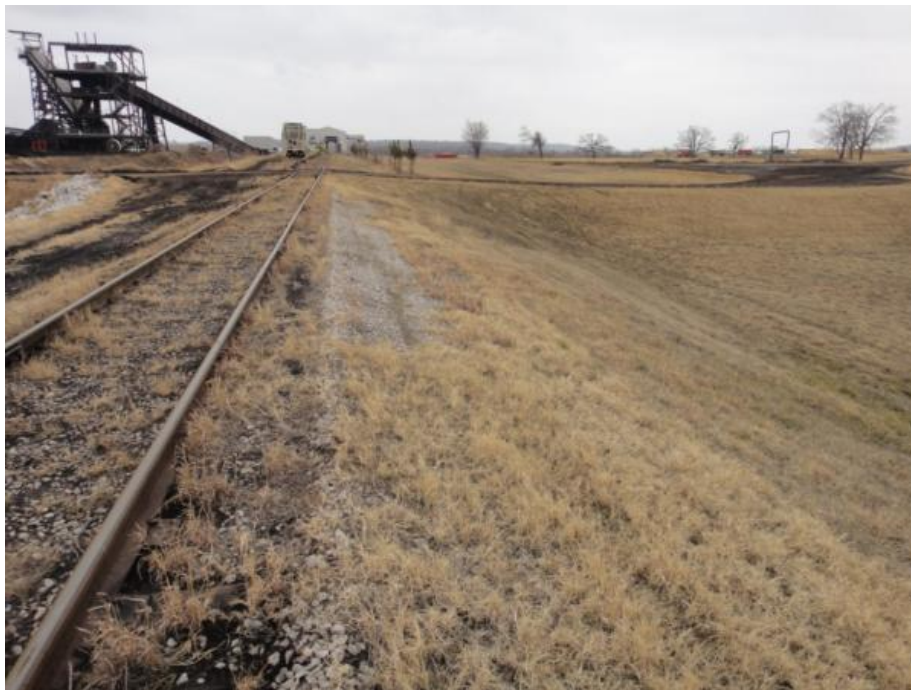
There were no observed scarps, sloughs, bulging, cracks, or depressions indicating slope instability or signs of erosion on the groins of the North Embankment.

Figure 5.4.4-1. Northern Groin.

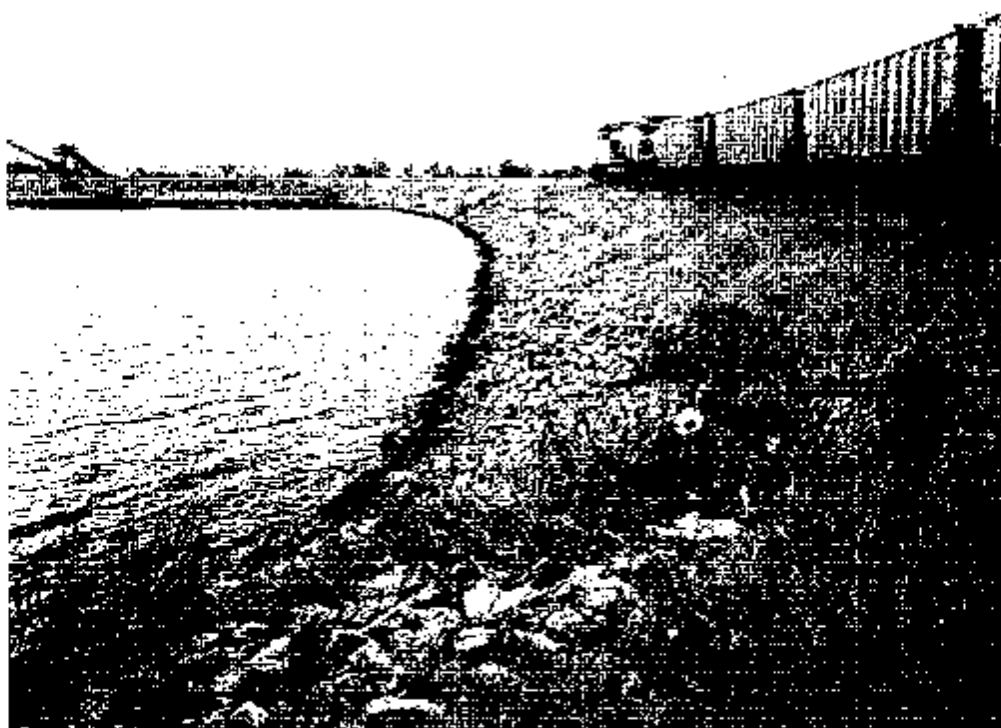
Photo 8. Upstream slope at western portion of south embankment with a few areas of minor vegetative overgrowth and riprap in good condition.

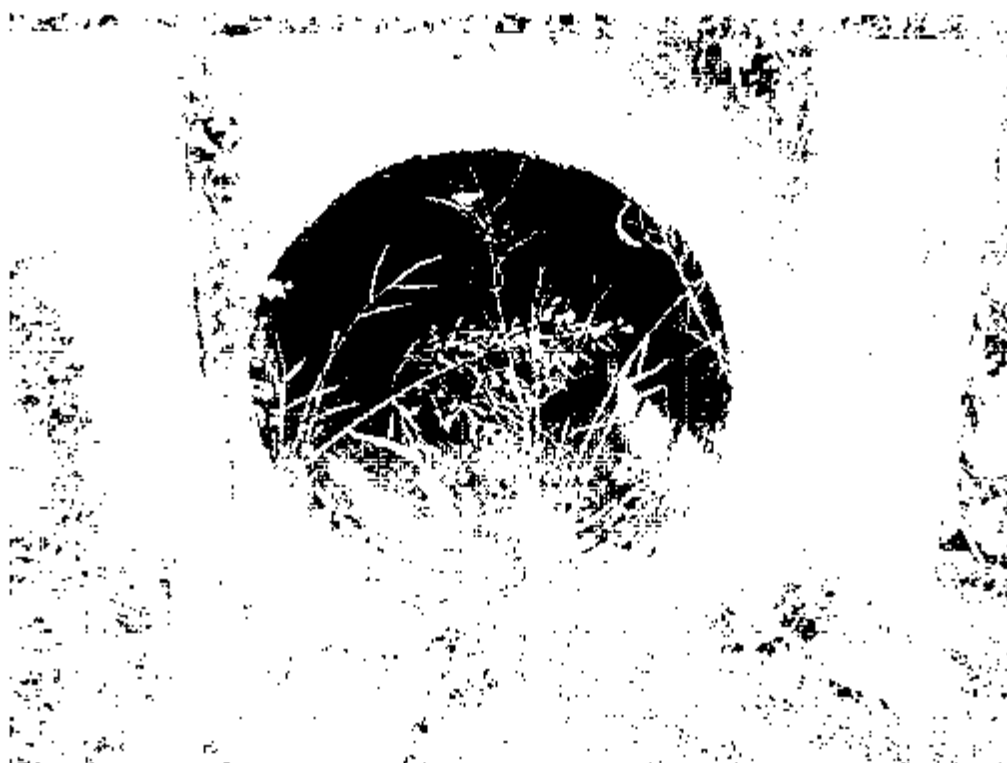
Photo 3. The entrance to the spillway discharge culvert had a minor amount of vegetative overgrowth and the pipe was excessively corroded.

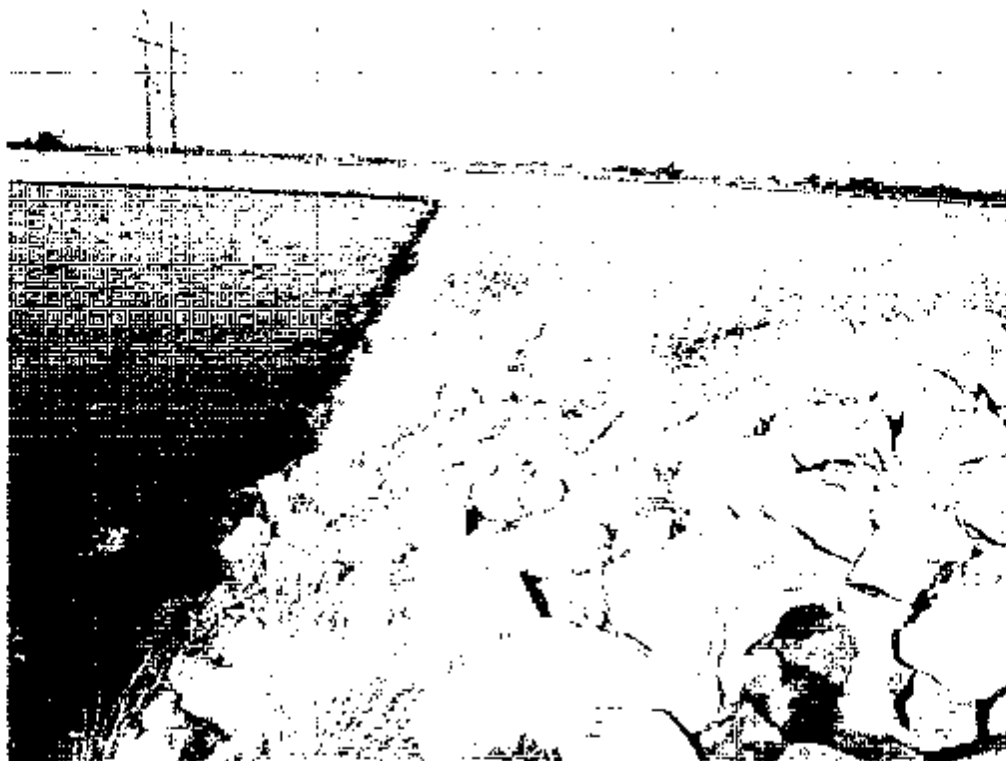
Photo 7. Upstream slope of north embankment with a few areas of minor vegetative overgrowth and riprap in good condition.

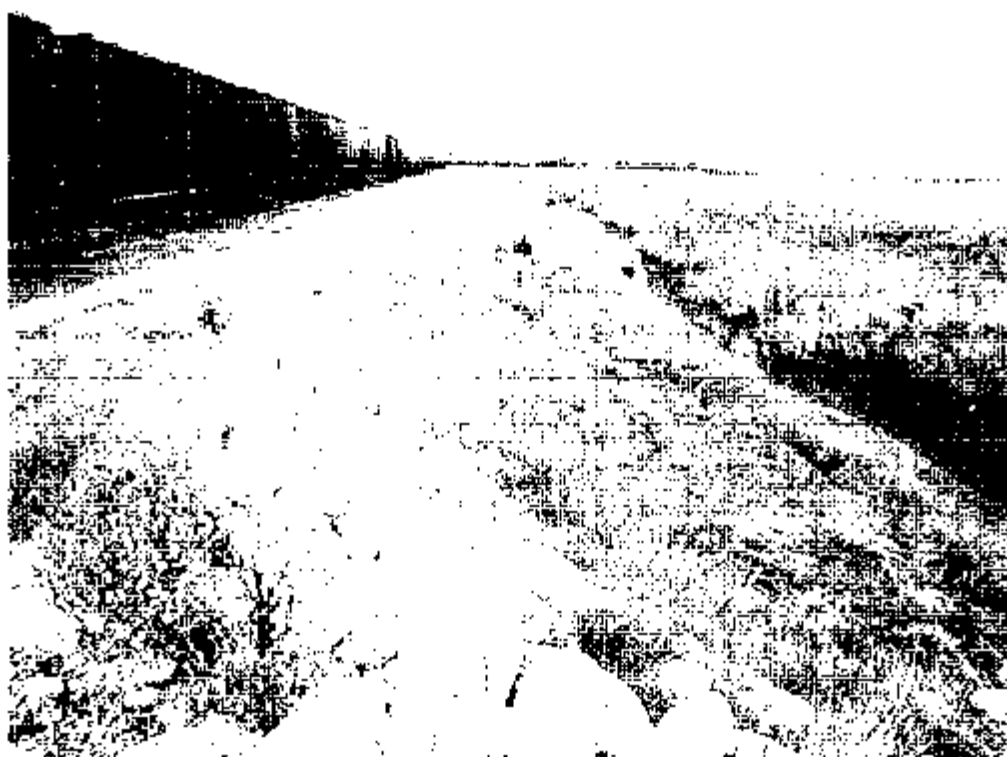
Photo 10. Repaired upstream slope at eastern portion of south embankment in good condition.

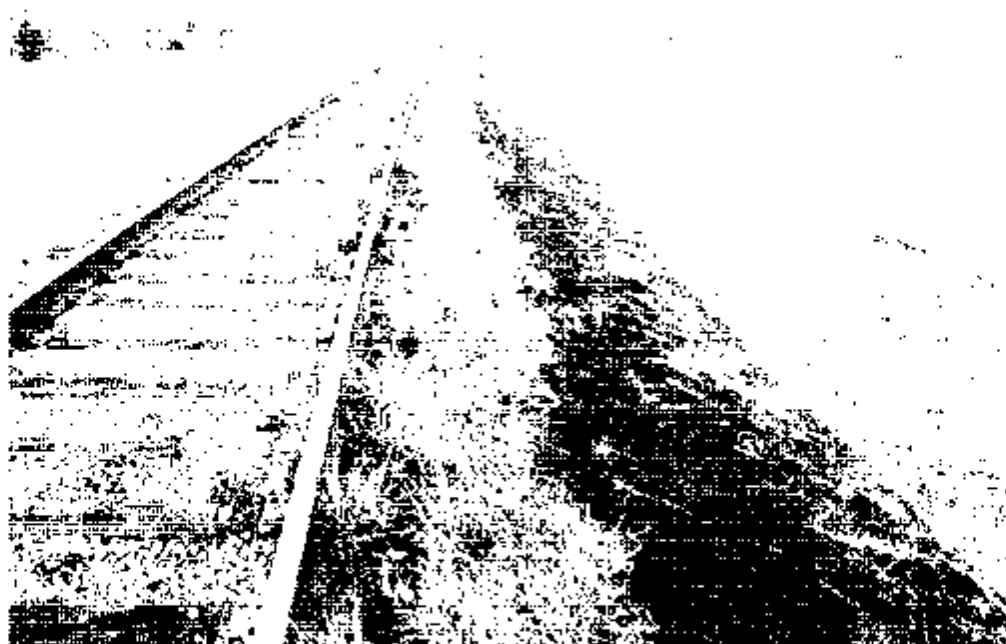
Photo 12. Typical view of crest, in good condition, along the west embankment.
