**Coal Combustion Residue Impoundment  
Round 9 - Dam Assessment Report**

***Oklahoma Power Station***

***Wastewater Evaporation Pond 6 – WMU 001***  
***American Electric Power***  
**Vernon, Texas**

**April 2011**

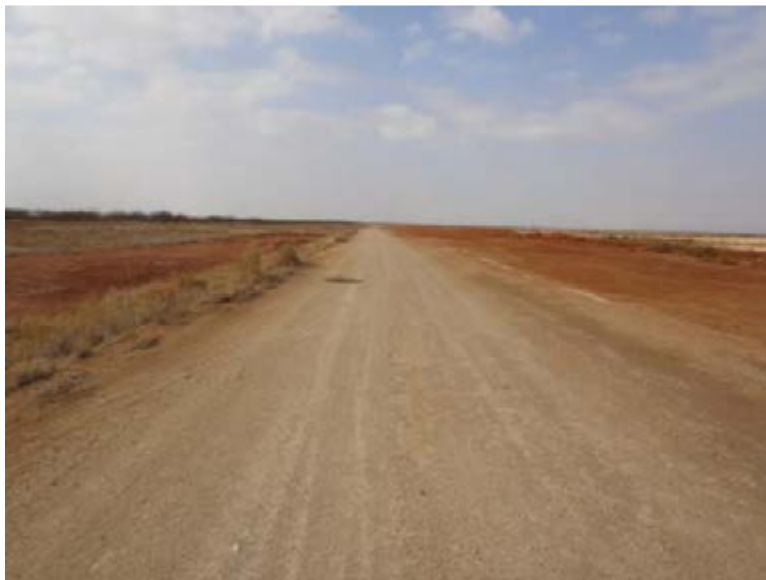
The crest of the South Embankment showed no signs of depressions, tension cracks, or other indications of settlement or shear failure, and appeared to be in satisfactory condition. Figure 5.2.1-1 shows the conditions of the crest of the South Embankment.

Figure 5.2.1-1. Figure showing the South Embankment crest and outside slope conditions.

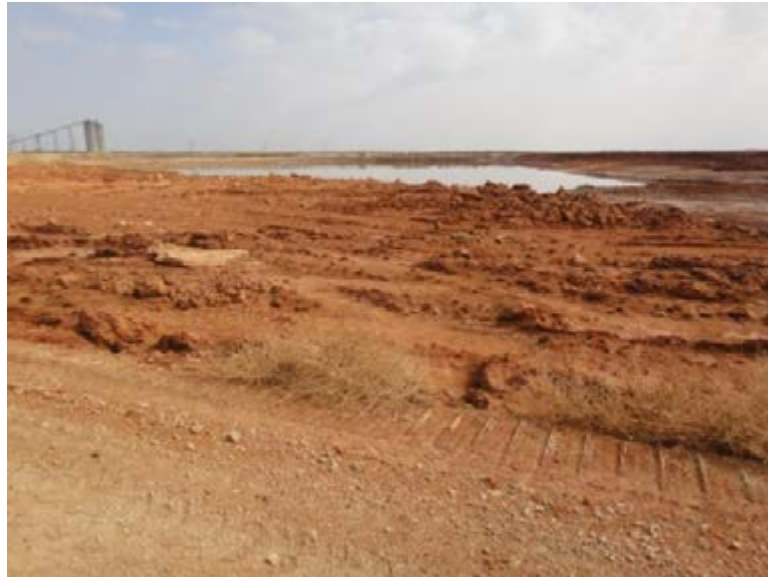
The South Embankment's inside slope has been filled up to the crest elevation with native soil, effectively eliminating this slope on the east end of the embankment. Figure 5.2.2-1 shows these areas.

Figure 5.2.2-1. Figure showing the South Embankment lack of inside slope.

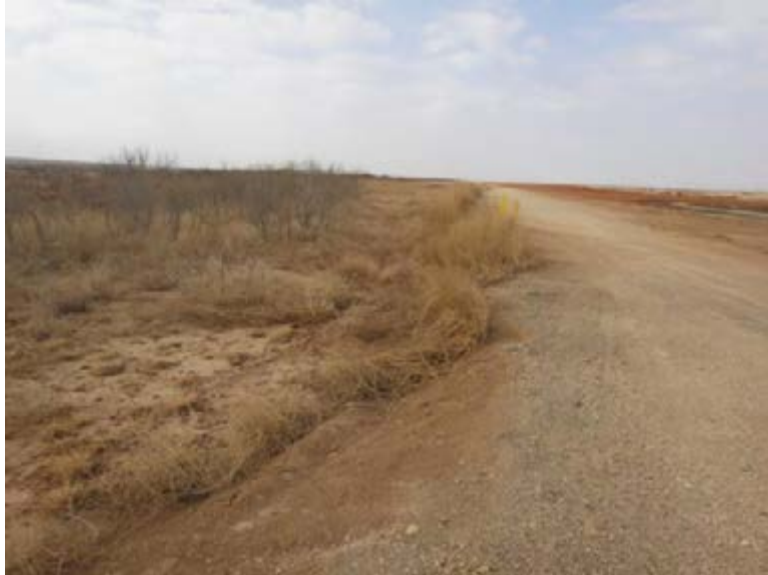
There were no observed scarps, sloughs, bulging, cracks, or depressions indicating slope instability or signs of erosion. The outside slope of the South Embankment was covered with sparse overgrown vegetation. The outside slope appears to be in good condition. Figure 5.2.3-1 shows the general condition of the outside slope of the South Embankment.

Figure 5.2.3-1 general good condition of the outside slope of the South Embankment.

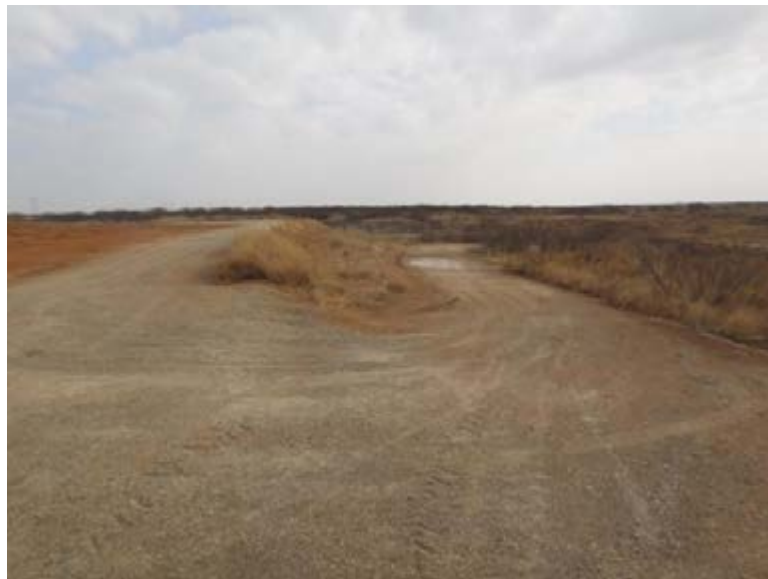
The outside slope of the abutments and groin were uniformly graded and covered with sparse grass. Erosion or uncontrolled seepage was not observed along either groin. Figure 5.2.4-1 shows the general condition of the Abutments and Groin.

Figure 5.2.4-1. Southern Groin.

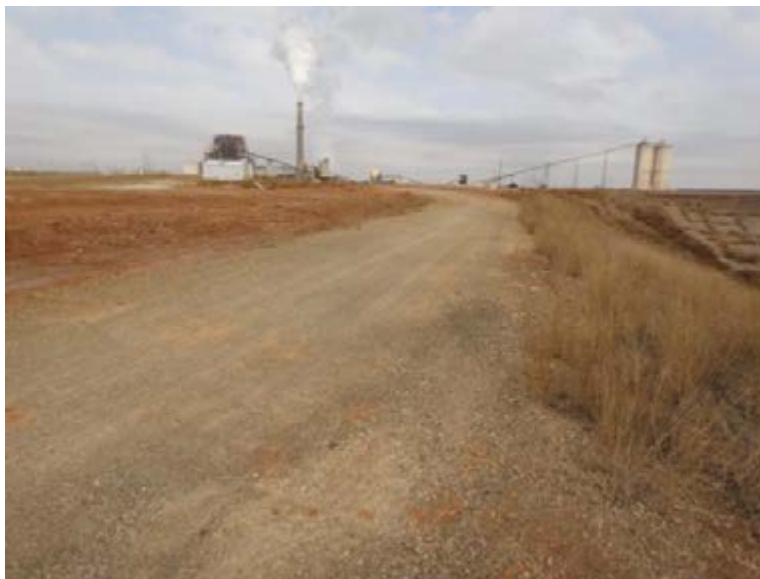
The crest of the East Embankment showed no signs of depressions, tension cracks, or other indications of settlement or shear failure, and appeared to be in satisfactory condition. Figure 5.3.1-1 shows the conditions of the crest of the East Embankment.

Figure 5.3.1-1. Figure showing the East Embankment crest and outside slope conditions.

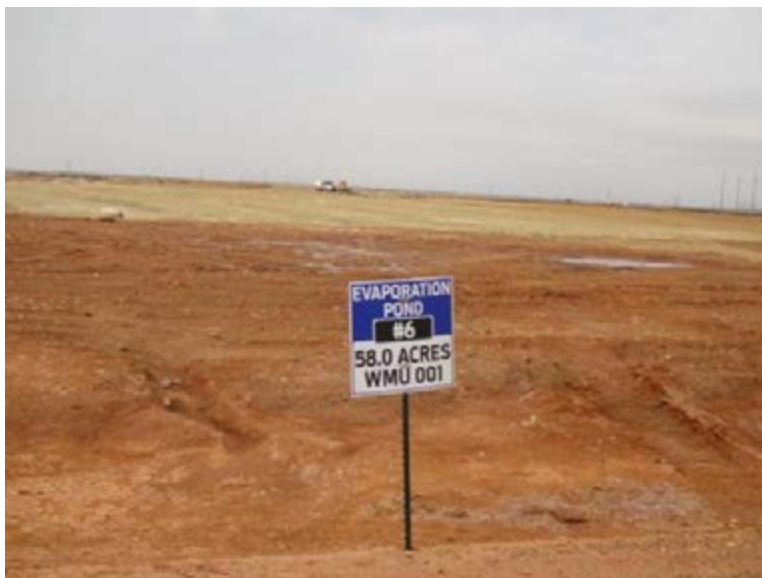
The East Embankment's inside slope is non-existent with the waste in the pond being allowed to remain in place up to near the crest elevation of the embankment. The Pond appears to be allowed to fill up with solid ash waste working its way east to west. This condition can be viewed in Figure 5.3.2-1.

Figure 5.3.2-1. East Embankment, lack of inside slope.

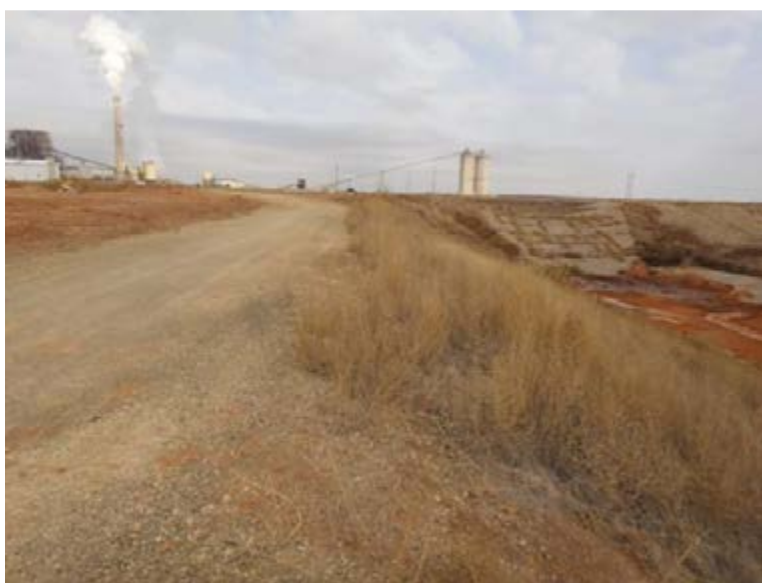
There were no observed scarps, sloughs, bulging, cracks, or depressions indicating slope instability or signs of erosion. The outside slope of the East Embankment is the upstream slope of the Emergency Spillway. It is uniformly graded and covered with sparsely overgrown grass. Figure 5.3.3-1 shows the general condition of the East Embankment's crest, outside slope and groin.

Figure 5.3.3-1. Crest, outside slope and groin of East Embankment.

There were no observed scarps, sloughs, bulging, cracks, or depressions indicating slope instability or signs of erosion on the groins of the East Embankment. The top right-side of Figure 5.3.3-1 shows the general condition of the East Embankment's groin.

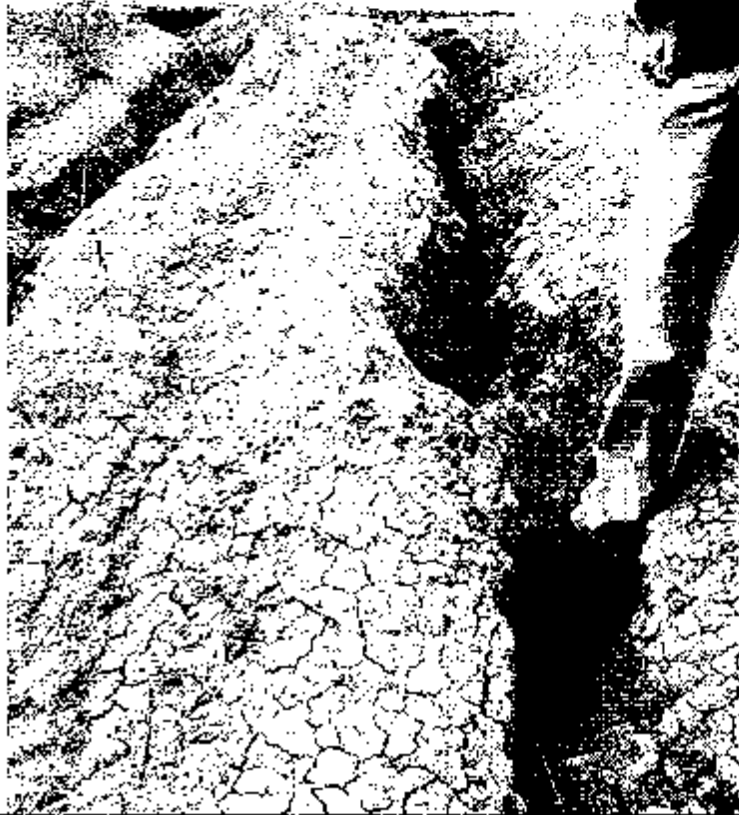
Photo # 6

Close up view of erosion gullies on Pond #6.

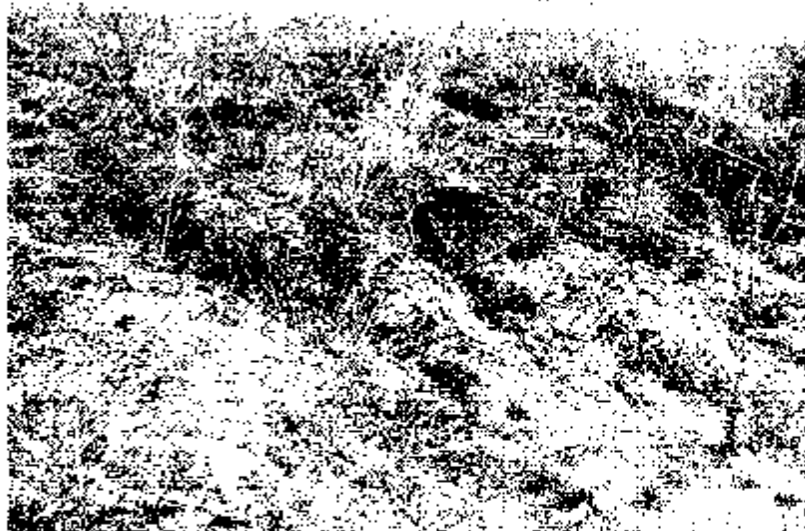
Photo # 7

Downstream side of west embankment at Wastewater Evaporation Pond #9. Notice erosion gullies.

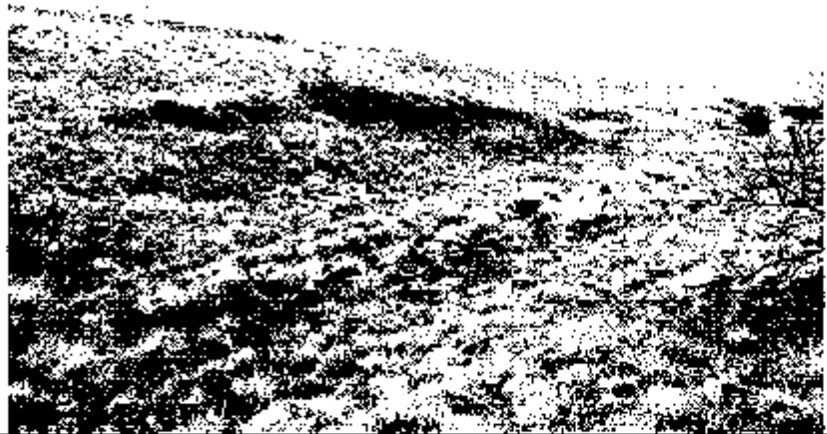
Photo # 11

Erosion slough on west  
embankment at northern  
end of Pond #8.

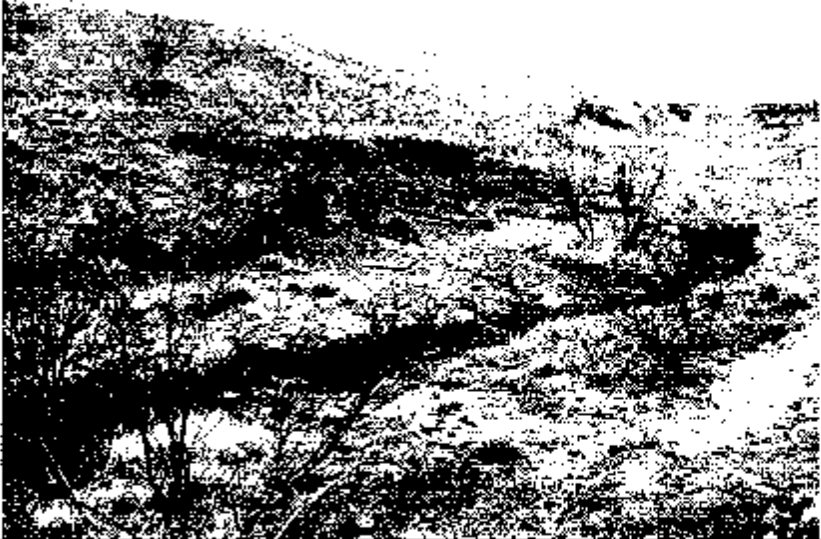
Photo # 14

Erosion channel at northern toe of embankment for Pond #8.

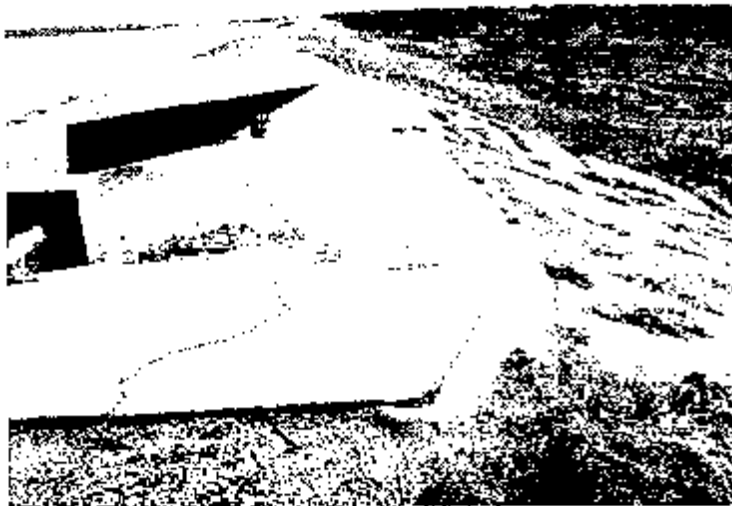
**Photo 2**

Pond #7 photo taken in March 2010 showing spillway control section in generally poor condition with extensively cracked concrete elements. The concrete wall blocking potential flow through the spillway is at the left in the photo.

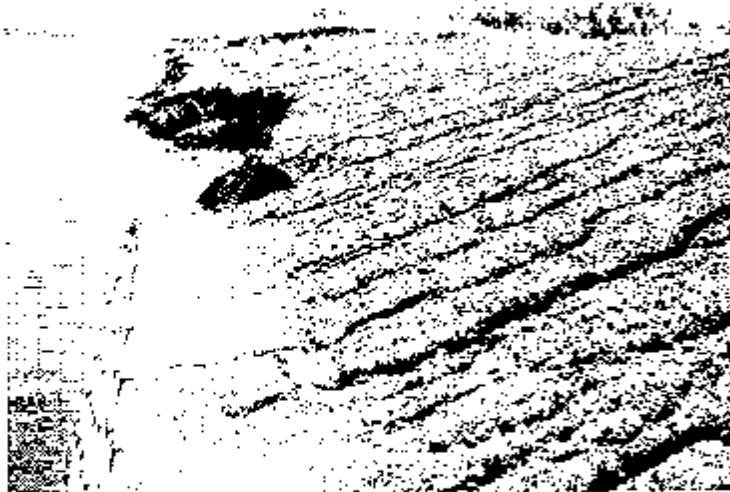
**Photo 13**

Pond #7 upstream slope area above the east end of the shore protection revetment around the spillway, looking east, with many erosion rills forming on the barren ground and embankment erosion beyond the end of the revetment (opposite view from Photo 12).

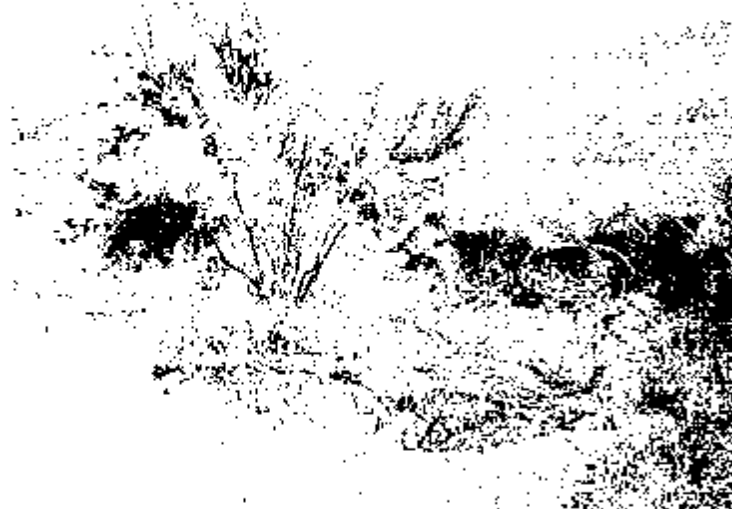
**Photo 18**

Significant erosion cutting at the toe of the north end of the downstream slope at Pond #8.
