Report of Dam Safety Assessment of Coal  
Combustion Surface Impoundments  
American Electric Power (AEP) and Southwest  
Electric Power Company (SWEPCO)  
H.W. Pirkey Power Plant, Hallsville, TX

AMEC Project No. 3-2106-0183.0003

November 2010

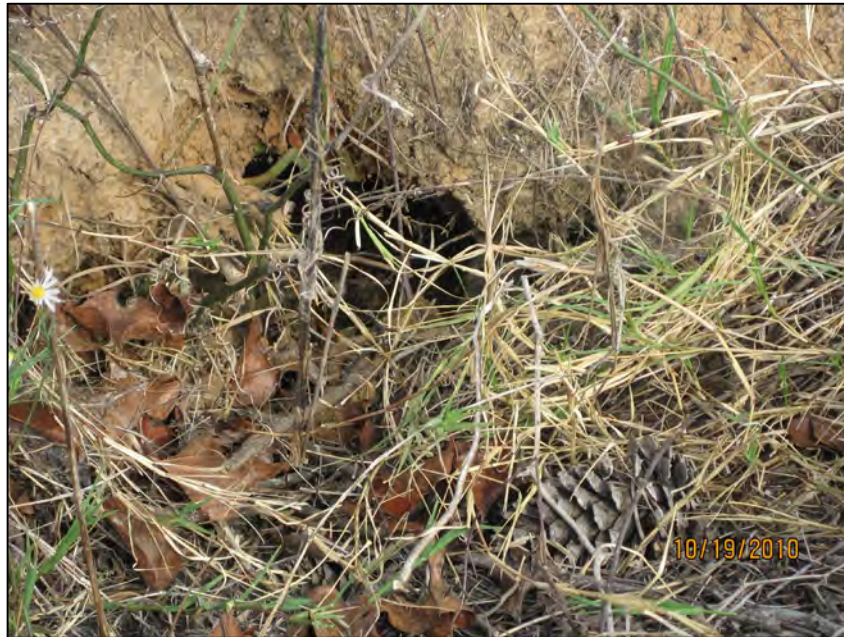
**WAP-9**

**ANIMAL BURROW ON SOUTH DOWNSTREAM EMBANKMENT**

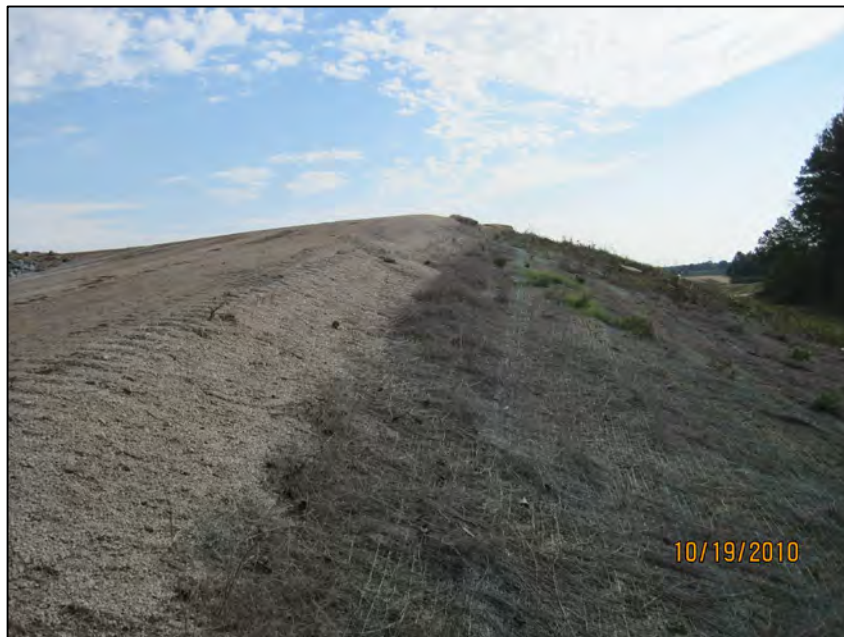
**WAP-10**

**SURFACE EROSION AT SOUTHWEST EMBANKMENT CORNER**

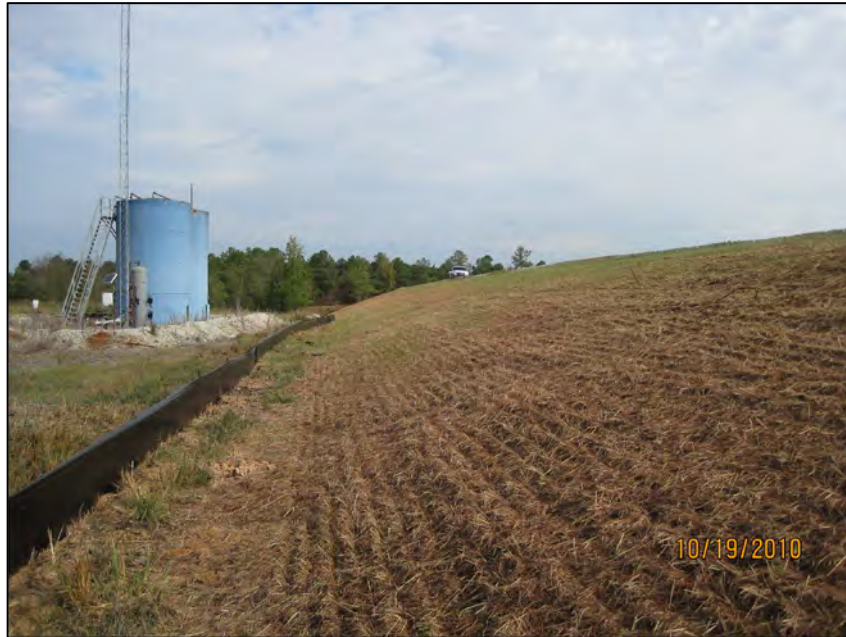
**WAP-11**  
**LOOKING NORTH ALONG WESTERN DOWNSTREAM**  
**EMBANKMENT AT RECENT SURFACE WORK**

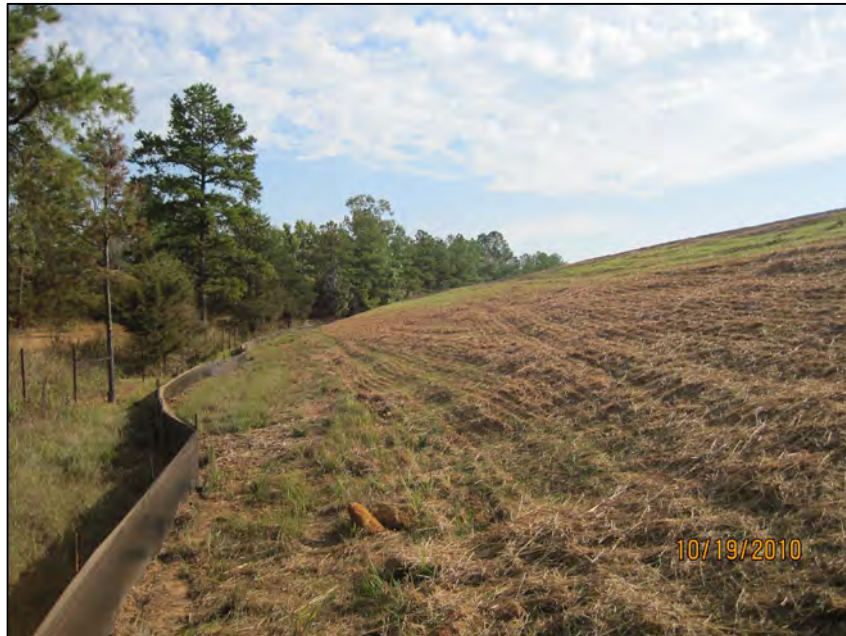
**WAP-12**  
**LOOKING NORTHEAST ALONG NORTHERN DOWNSTREAM**  
**EMBANKMENT AT RECENT SURFACE WORK**

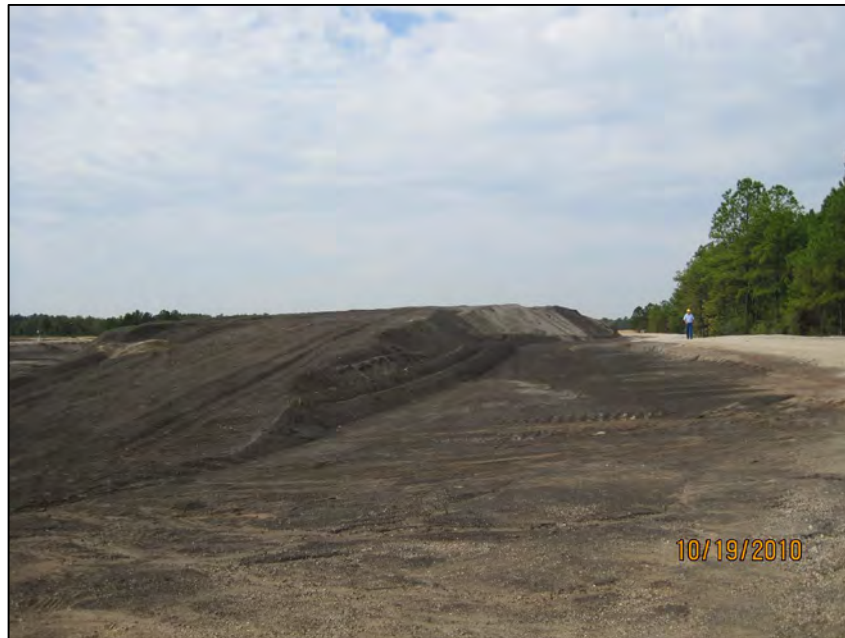
This pond is completely incised and was not in service during the site visit. Photos EAP-1, EAP-5, and EAP-6 show the interior of the East Ash Pond, as well as areas of stacked ash. A drainage swale, to redirect runoff flows away from the pond, exists outside the pond's southeast, east and north perimeter crest road. The crest road is gravel covered as shown on Photos EAP-2, EAP-10, and EAP-11. A piezometer was noted on the northwest crest road (Photo EAP-3). Photo EAP-8 illustrates a gas pipeline indicator located off the northeast crest road.

**EAP-6**  
**LOOKING SOUTHWEST FROM NORTHERN**  
**EMBANKMENT AT STACKED ASH**

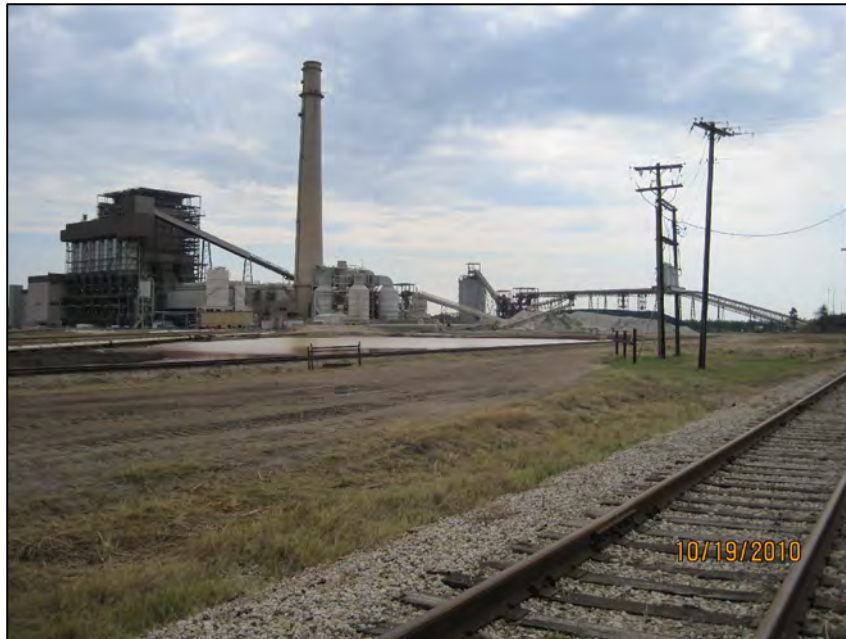
This pond is primarily incised. However, a road and railroad are located along its western boundary. The ground immediately to the west of the railroad slopes away steeply (Photos SP-1 and SP-2). Additionally, there is a below grade limestone unloading area beneath a portion of the railroad (Photo SP-3). A stormwater culvert was visible through the embankment south of the limestone unloading area (Photo SP-4). A monitoring well was noted at the southwest corner of the pond (Photo SP-5).

**SP-1**  
**RAILROAD TRACKS WEST OF SURGE POND-FROM**  
**NORTHERN CORNER LOOKING SOUTHEAST**

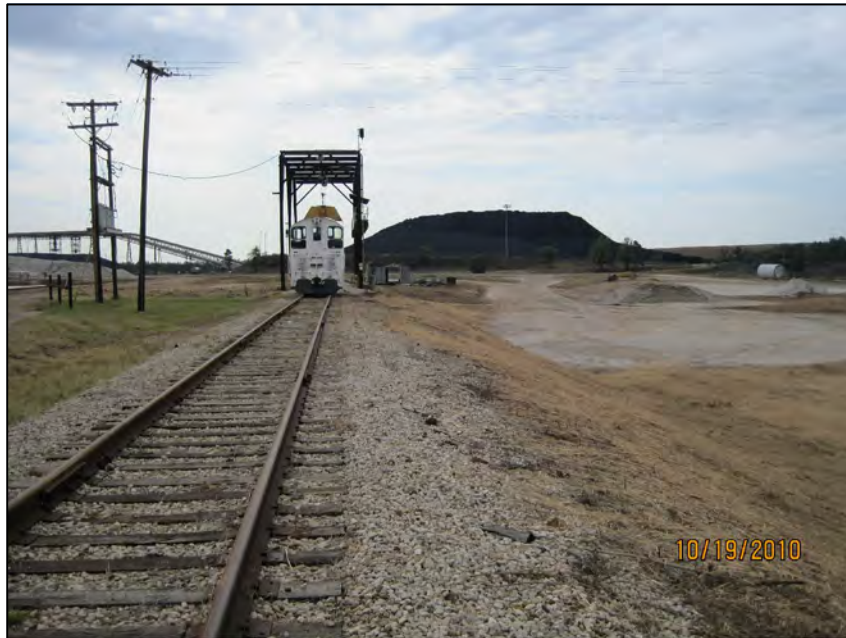
**SP-2**  
**NORTHWEST OF POND LOOKING**  
**SOUTH AT LIMESTONE UNLOADING AREA**

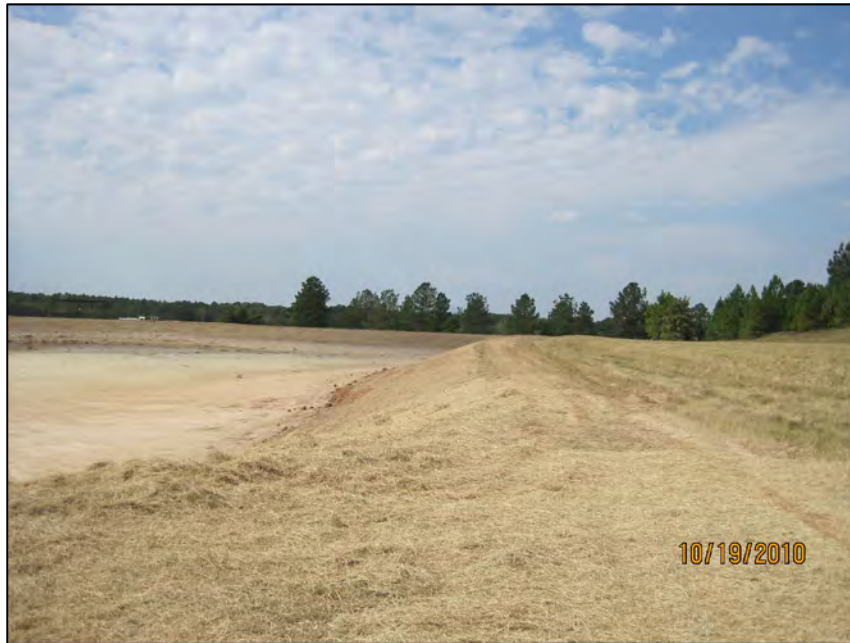
The northern portion of the Auxiliary Surge Pond is incised, while the remainder is diked (Photo ASP-1 and ASP-2). A piezometer was noted on the southwest corner of the pond embankment (Photo ASP-3).

**ASP-1**  
**LOOKING WEST FROM NORTHEAST**  
**CORNER EMBANKMENT**

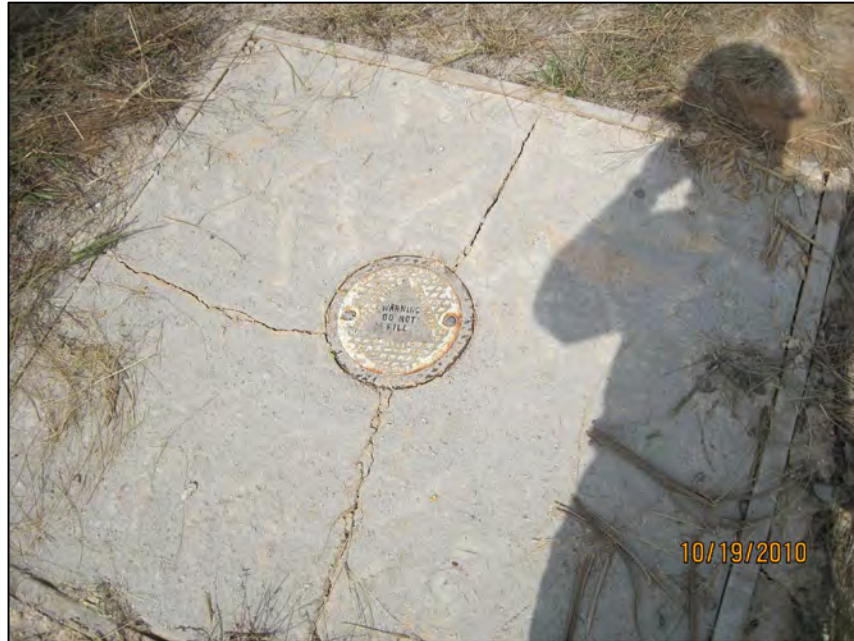
**ASP-3  
PIEZOMETER ON SOUTHWEST  
CORNER OF POND EMBANKMENT**

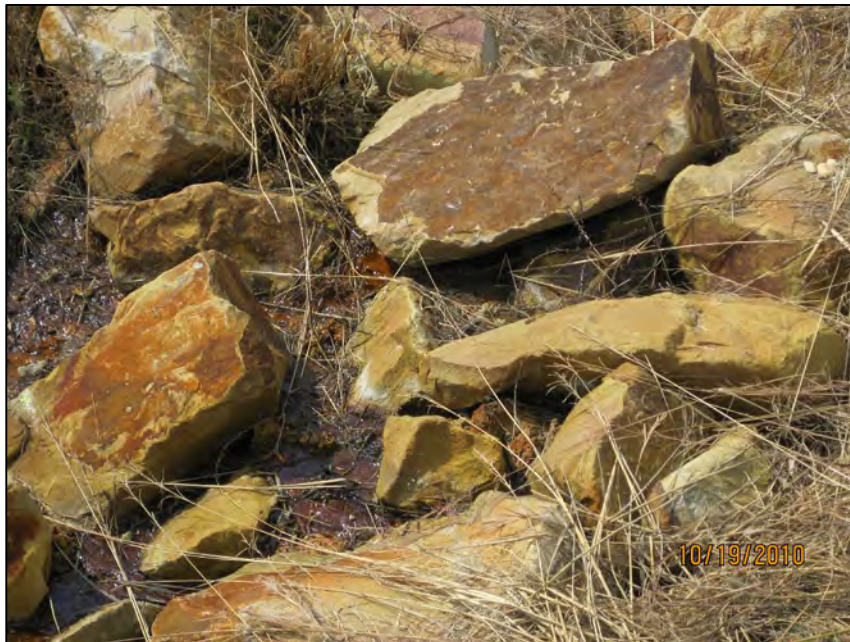
**LRP-4**  
**POSSIBLE SEEPAGE ON DOWNSTREAM SIDE OF**  
**EMBANKMENT ADJACENT TO NPDES OUTFALL 004**

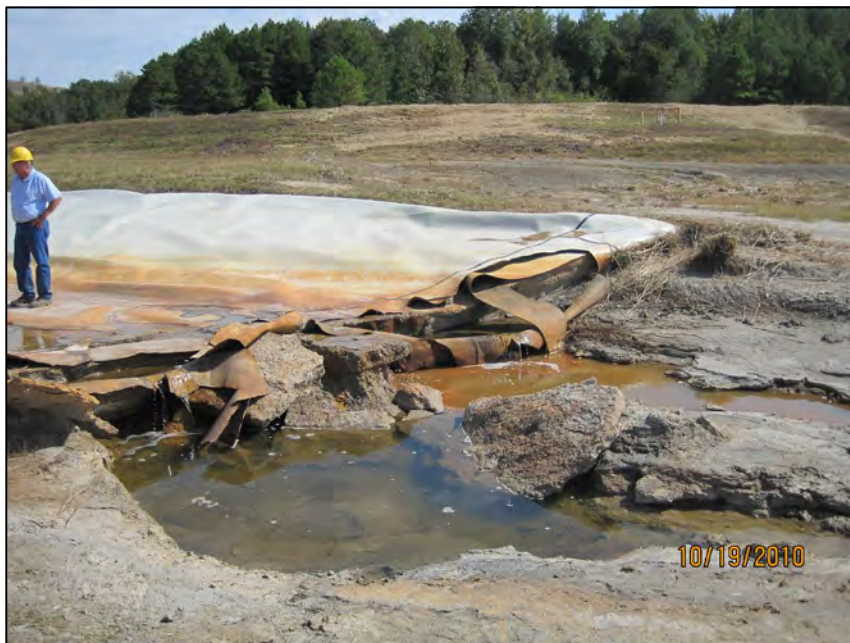
Flow enters the pond via a trapezoidal channel that is lined with 60 mil HDPE as shown on Photo LRP-6. A monitoring well was noted located to the southeast of the influent channel above the northern reach of the pond (Photo LRP-7).

**LRP-6**  
**LOOKING EAST AT DOWNSTREAM DISCHARGE OF 60**  
**ML HDPE LINED LANDFILL RUNOFF/LEACHATE CHANNEL**

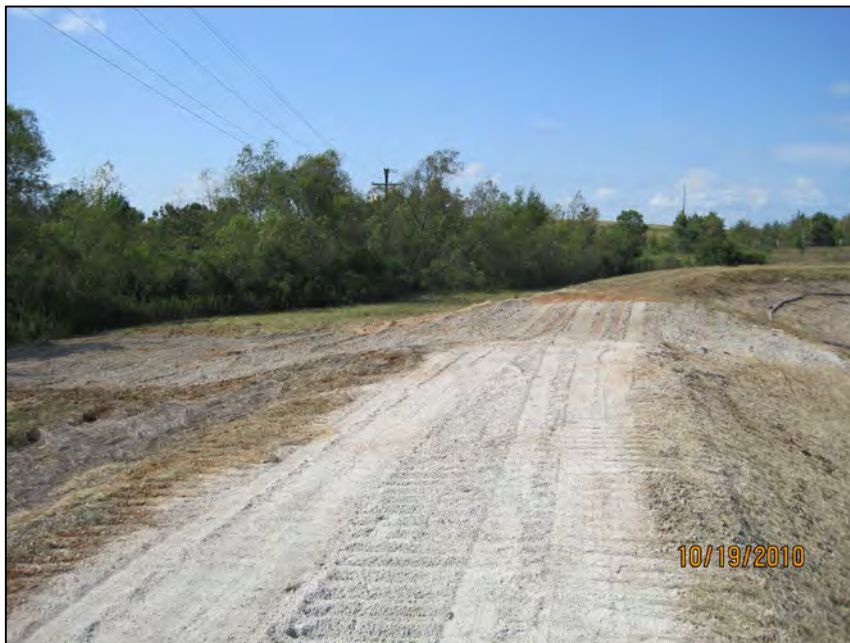
An emergency, earthen spillway was noted to exist to the west of the main discharge pipe, as shown on Photo LRP-8.

**LRP-8**  
**LOOKING WEST FROM CREST AT**  
**UNLINED EARTHEN EMERGENCY SPILLWAY**
