Report of Dam Safety Assessment of Coal  
Combustion Surface Impoundments  
American Electric Power (AEP) and Southwest  
Electric Power Company (SWEPCO)  
H.W. Pirkey Power Plant, Hallsville, TX

AMEC Project No. 3-2106-0183.0003

June 2011

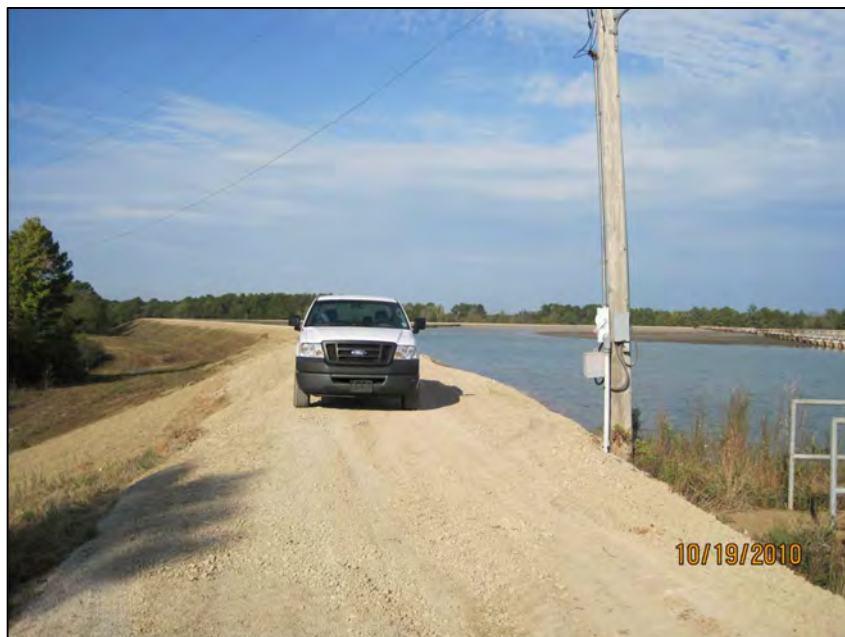
WAP-1  
CREST AT SOUTHEAST CORNER CREST LOOKING WEST

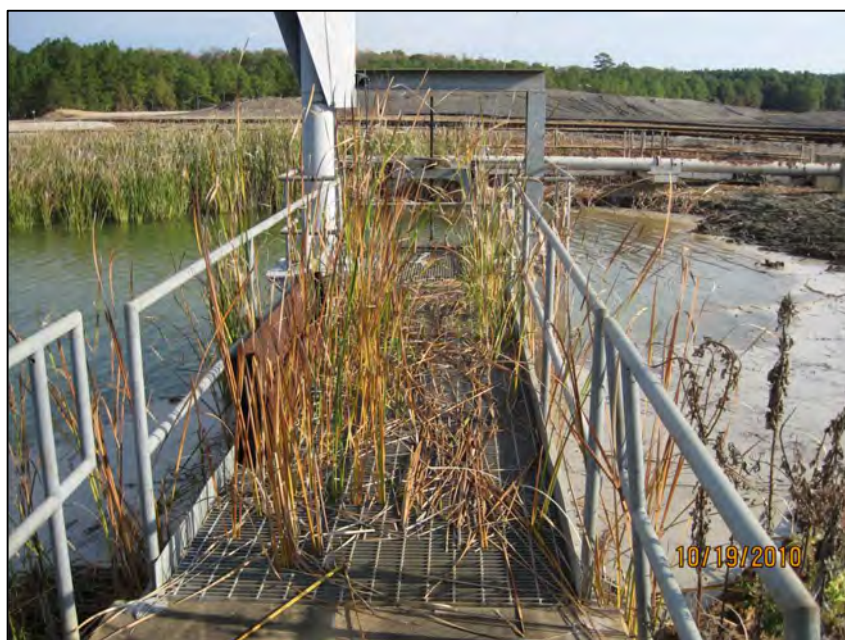
WAP-2  
TOP OF DISCHARGE STRUCTURE

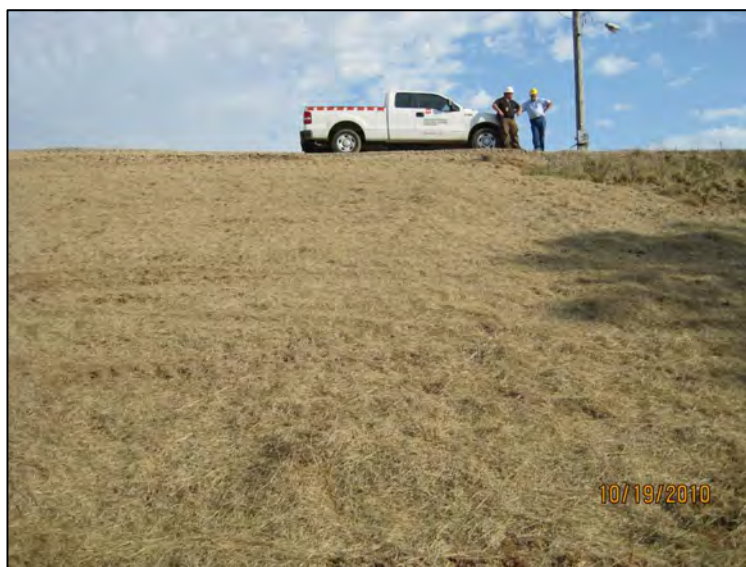
WAP-5

LOOKING NORTH UP DOWNSTREAM SLOPE AT SOUTHEAST CORNER

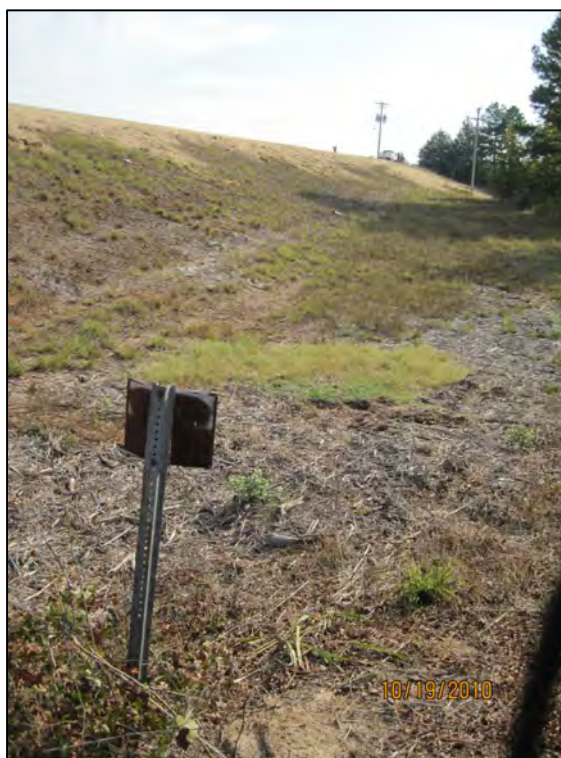
WAP-6

LOOKING EAST ON SOUTH DOWNSTREAM EMBANKMENT

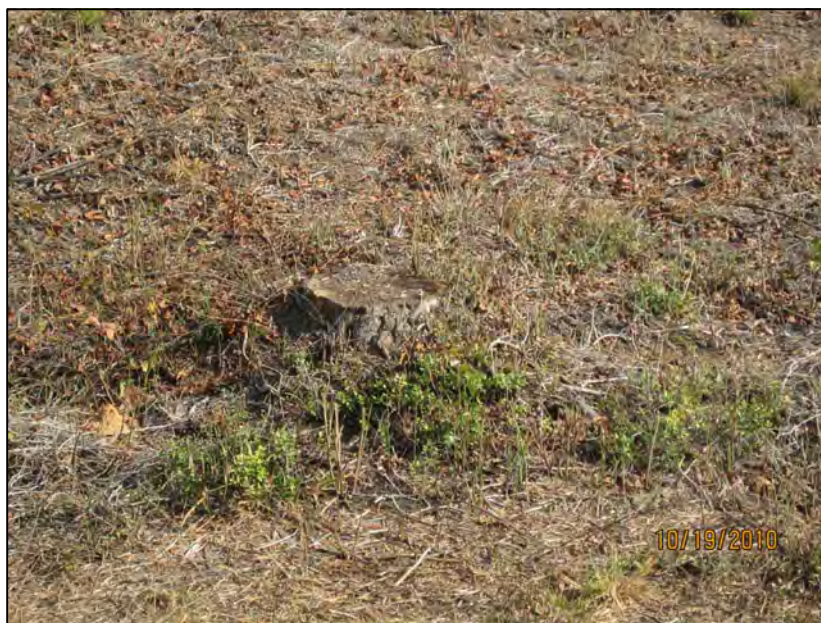
WAP-7  
STUMP ON SOUTH EMBANKMENT

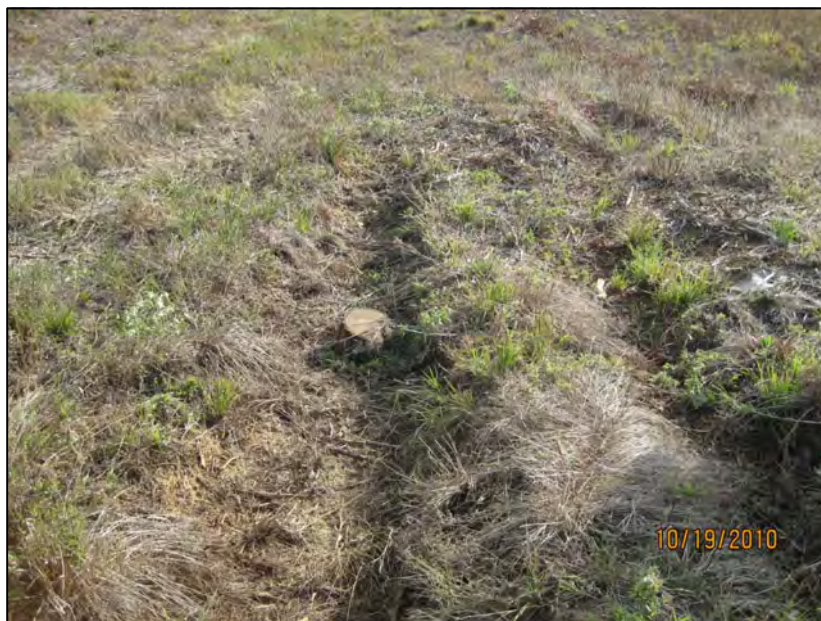
WAP-8  
RUTS AND STUMP ON SOUTH EMBANKMENT

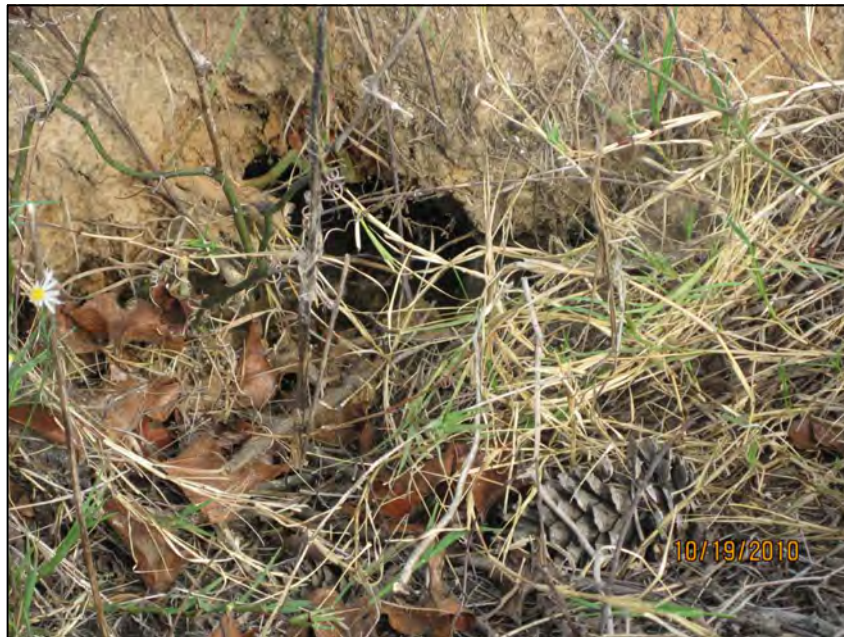
WAP-9

ANIMAL BURROW ON SOUTH DOWNSTREAM EMBANKMENT

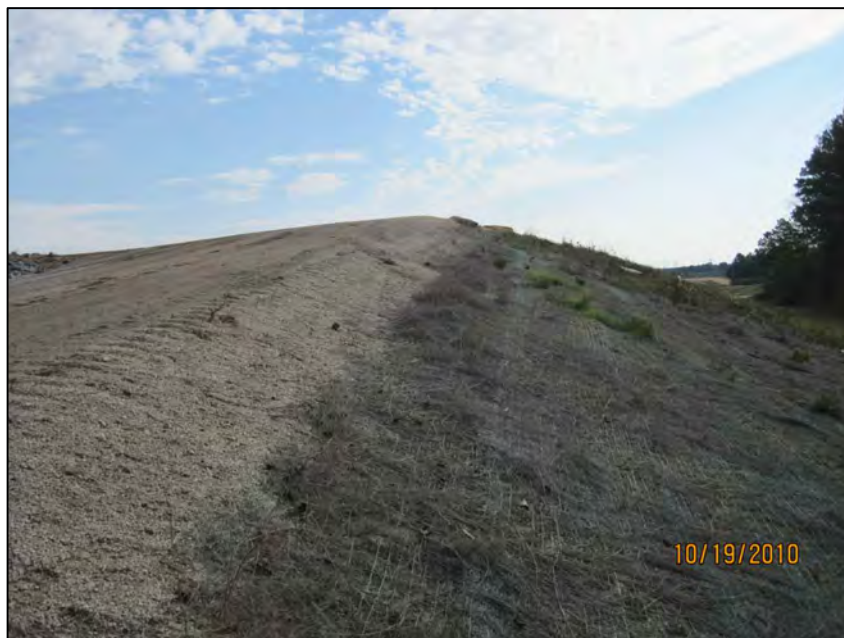
WAP-10

SURFACE EROSION AT SOUTHWEST EMBANKMENT CORNER

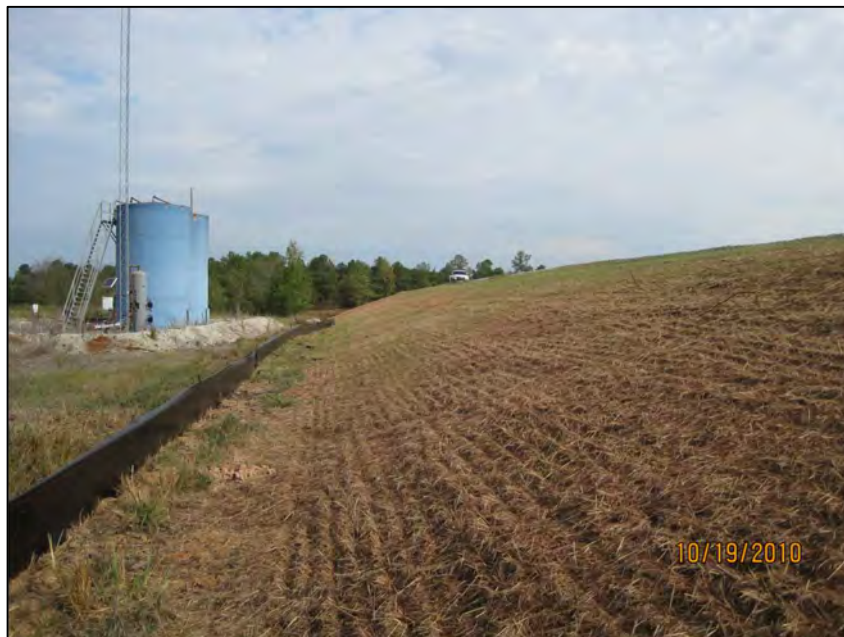
WAP-11

LOOKING NORTH ALONG WESTERN DOWNSTREAM  
EMBANKMENT AT RECENT SURFACE WORK

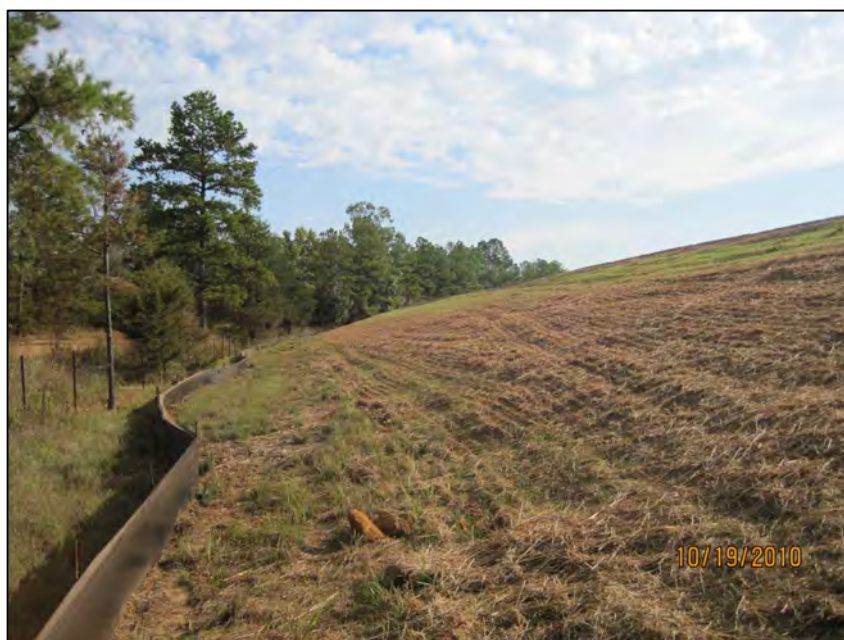
WAP-12

LOOKING NORTHEAST ALONG NORTHERN DOWNSTREAM  
EMBANKMENT AT RECENT SURFACE WORK

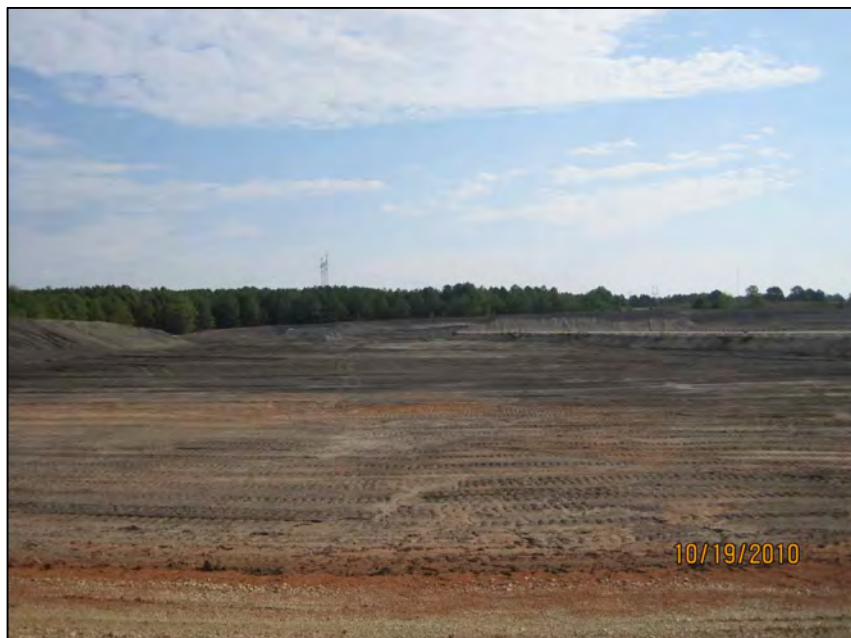
This pond is completely incised and was not in service during the site visit. Photos EAP-1, EAP-5, and EAP-6 show the interior of the East Ash Pond, as well as areas of stacked ash. A drainage swale, to redirect runoff flows away from the pond, exists outside the pond's southeast, east and north perimeter crest road. The crest road is gravel covered as shown on Photos EAP-2, EAP-10, and EAP-11. A piezometer was noted on the northwest crest road (Photo EAP-3). Photo EAP-8 illustrates a gas pipeline indicator located off the northeast crest road.

EAP-1  
LOOKING EAST ACROSS POND FROM WESTERN CREST

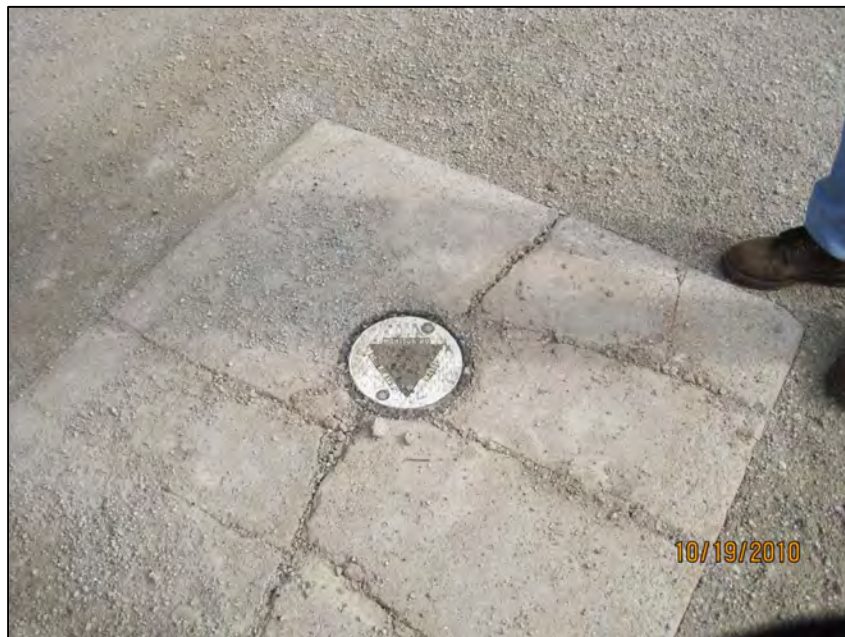
EAP-3  
PIEZOMETER ON CREST OF NORTHERN EMBANKMENT

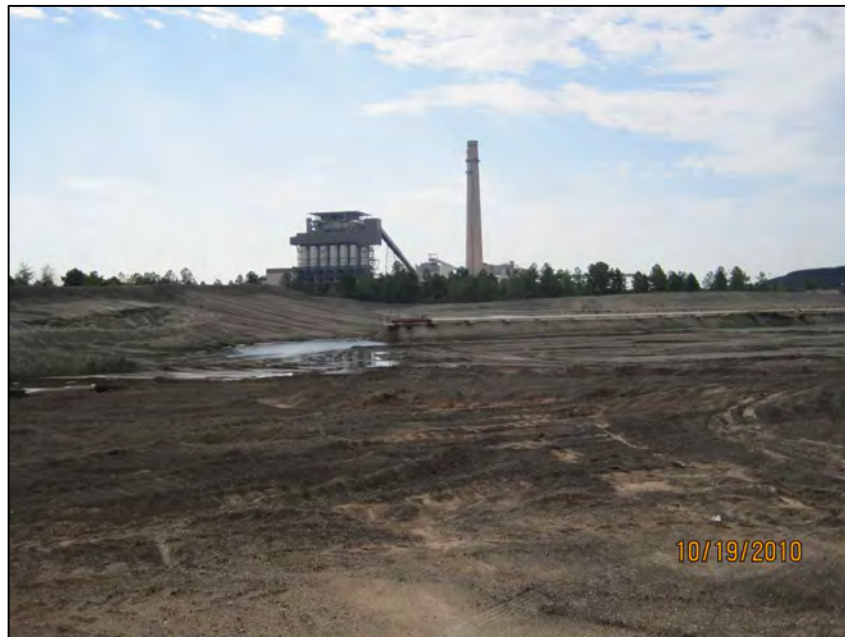
EAP-5  
LOOKING SOUTH FROM NORTHERN EMBANKMENT

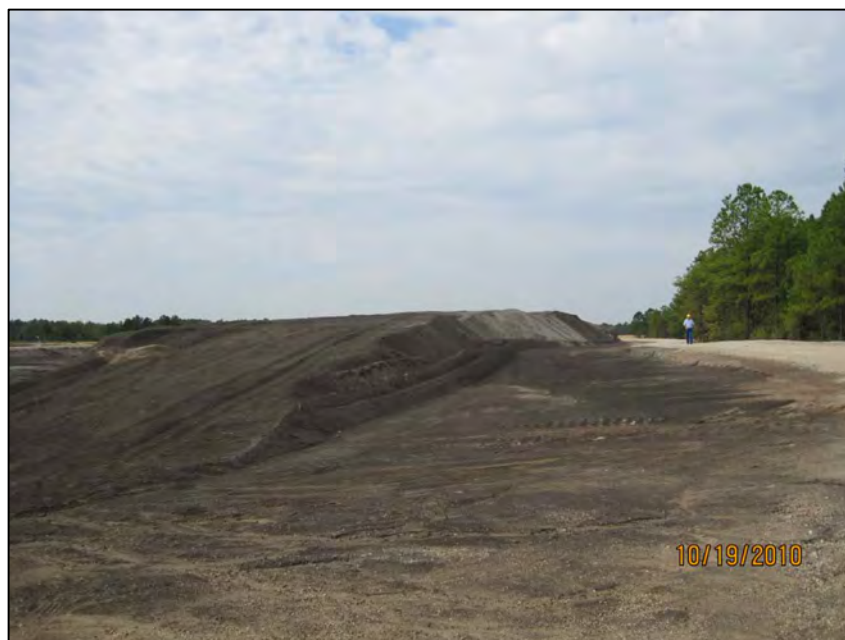
EAP-6  
LOOKING SOUTHWEST FROM NORTHERN  
EMBANKMENT AT STACKED ASH

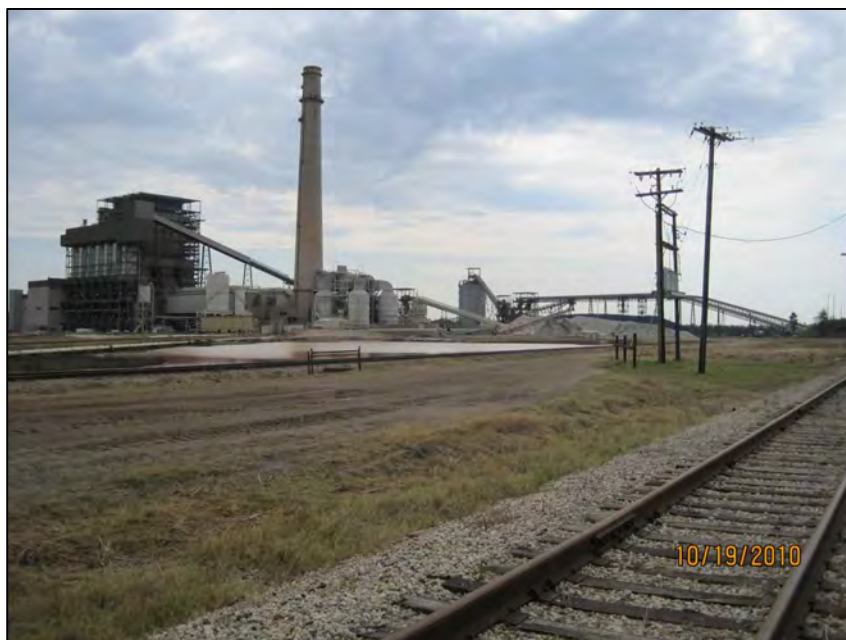
This pond is entirely incised. However, a road and railroad are located along its western boundary. The ground immediately to the west of the railroad slopes away steeply (Photos SP-1 and SP-2). Additionally, there is a below grade limestone unloading area beneath a portion of the railroad (Photo SP-3). A stormwater culvert was visible through the embankment south of the limestone unloading area (Photo SP-4). A monitoring well was noted at the southwest corner of the pond (Photo SP-5).

SP-1  
RAILROAD TRACKS WEST OF SURGE POND-FROM  
NORTHERN CORNER LOOKING SOUTHEAST

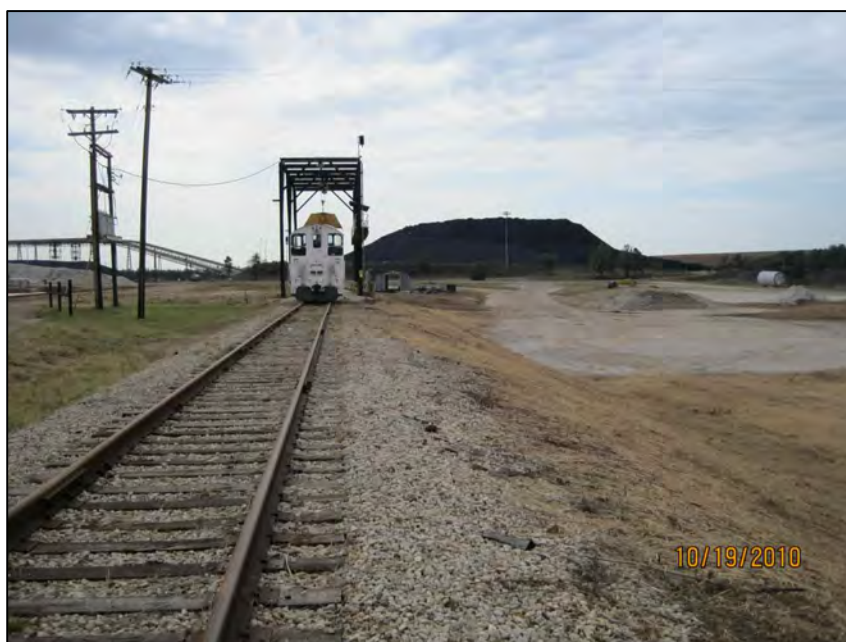
SP-2  
NORTHWEST OF POND LOOKING  
SOUTH AT LIMESTONE UNLOADING AREA

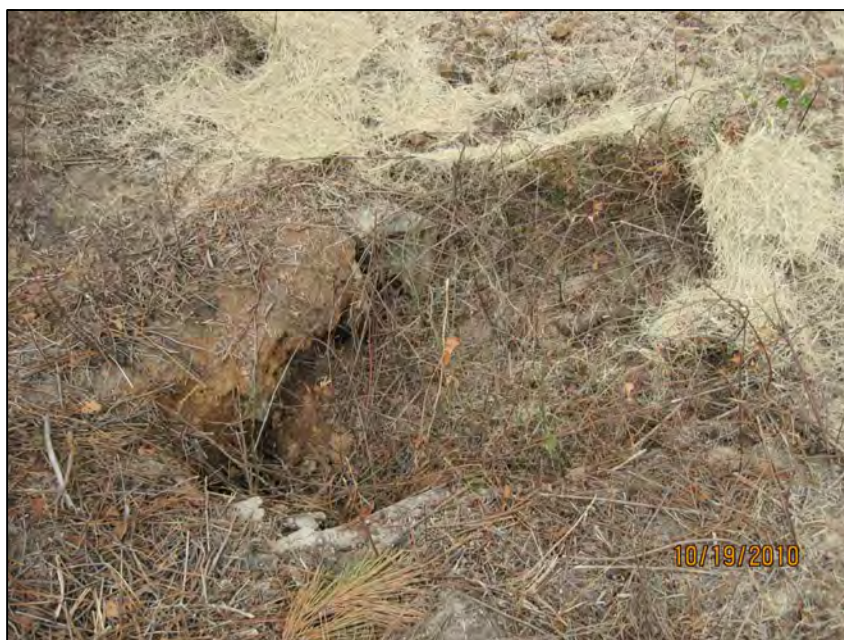
SP-4

STORM WATER CULVERT (18-INCH) THROUGH  
EMBANKMENT SOUTH OF LIMESTONE UNLOADER

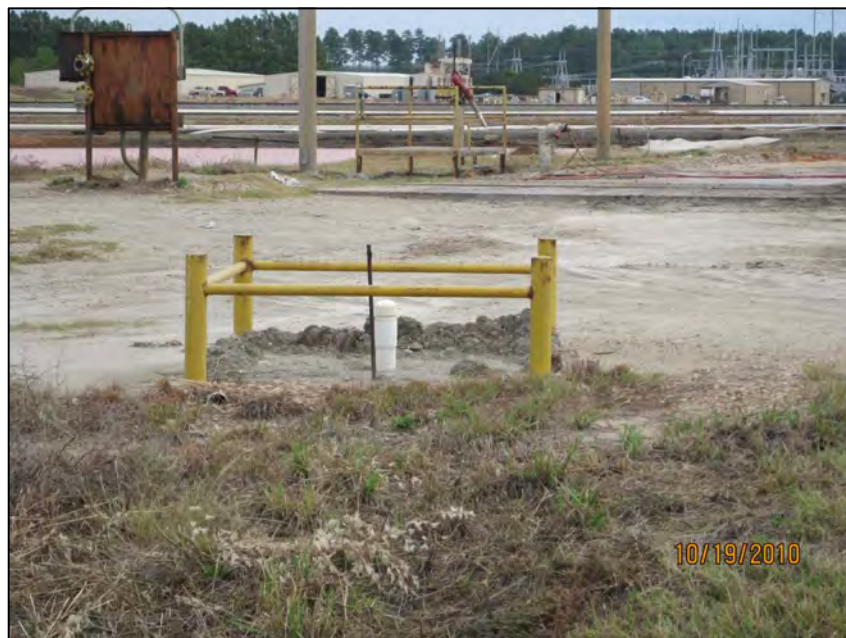
SP-5  
MONITORING WELL LOCATED ADJACENT  
TO SOUTHWEST CORNER OF POND

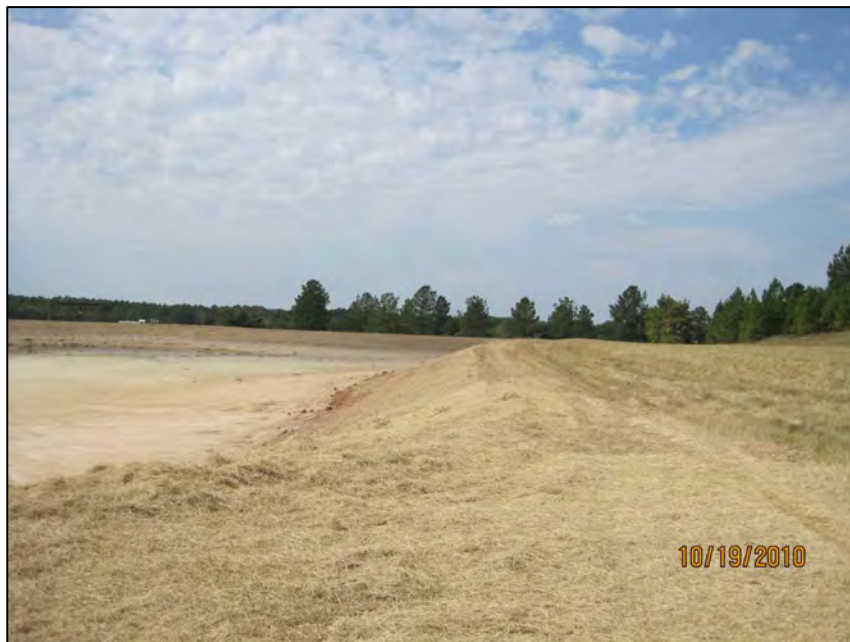
The northern portion of the Auxiliary Surge Pond is incised, while the remainder is diked (Photo ASP-1 and ASP-2). A piezometer was noted on the southwest corner of the pond embankment (Photo ASP-3).

ASP-1  
LOOKING WEST FROM NORTHEAST  
CORNER EMBANKMENT

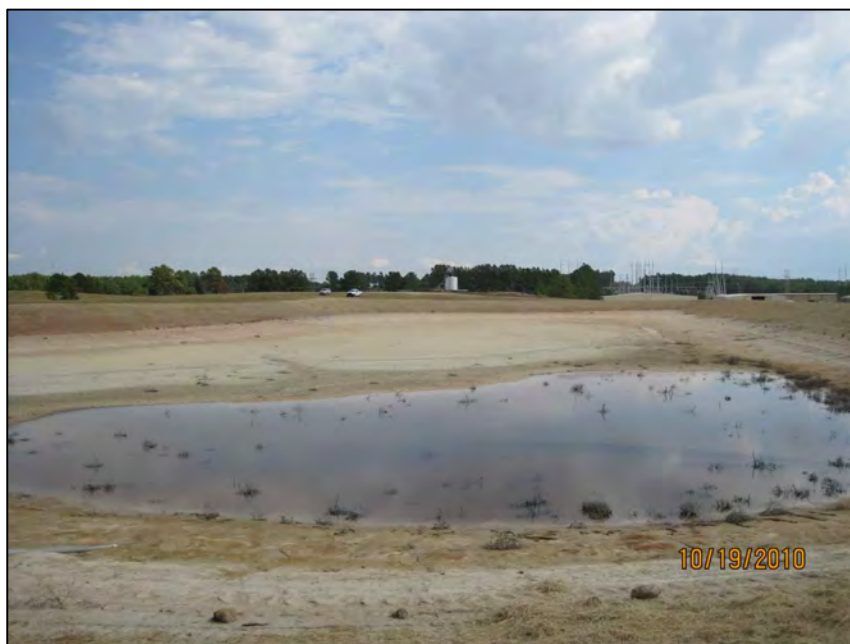
ASP-2  
LOOKING EAST ACROSS POND  
FROM WESTERN EMBANKMENT

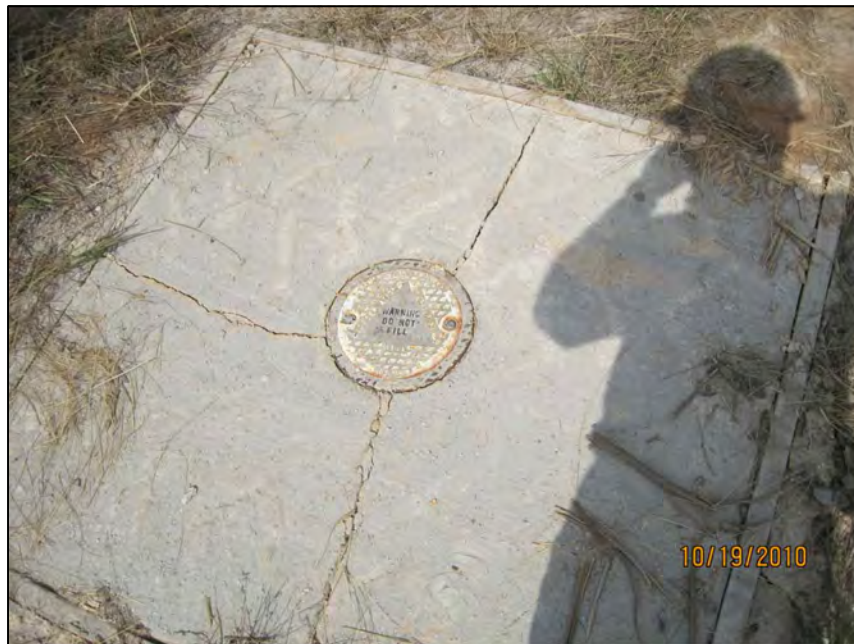
ASP-3  
PIEZOMETER ON SOUTHWEST  
CORNER OF POND EMBANKMENT

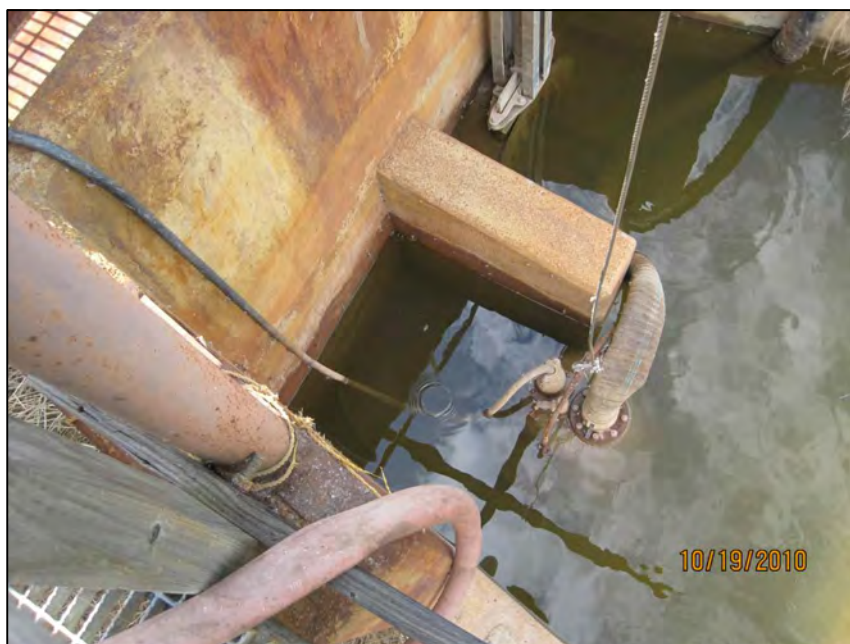
LRP-2  
POND DISCHARGE STRUCTURE-NPDES OUTFALL 004

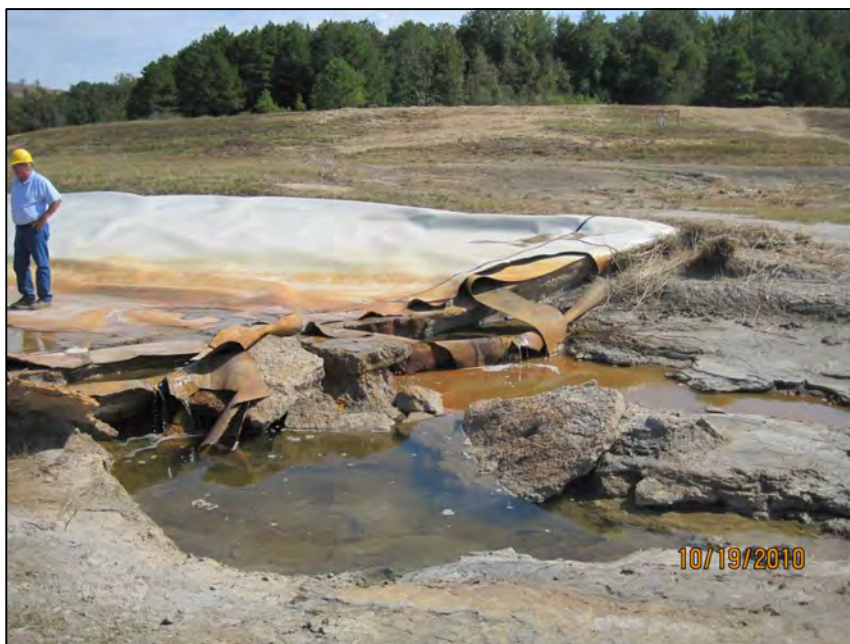
As shown on Photo LRP-6, flow enters the pond via a trapezoidal channel that is lined with 60-mil HDPE. A monitoring well was noted located to the southeast of the influent channel above the northern reach of the pond (Photo LRP-7).

LRP-6  
LOOKING EAST AT DOWNSTREAM DISCHARGE OF 60  
ML HDPE LINED LANDFILL RUNOFF/LEACHATE CHANNEL

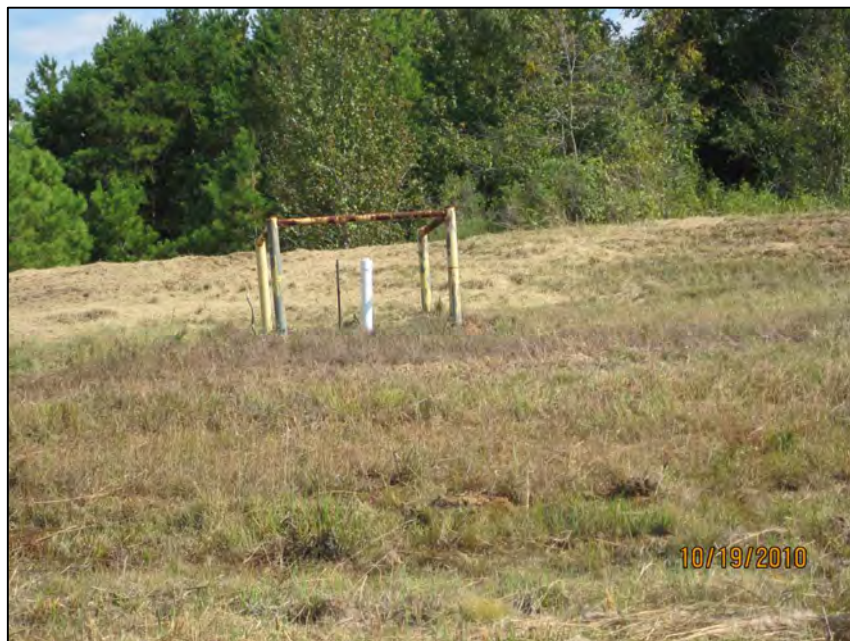
LRP-7  
MONITORING WELL ADJACENT TO  
NORTHEASTERN CORNER OF POND

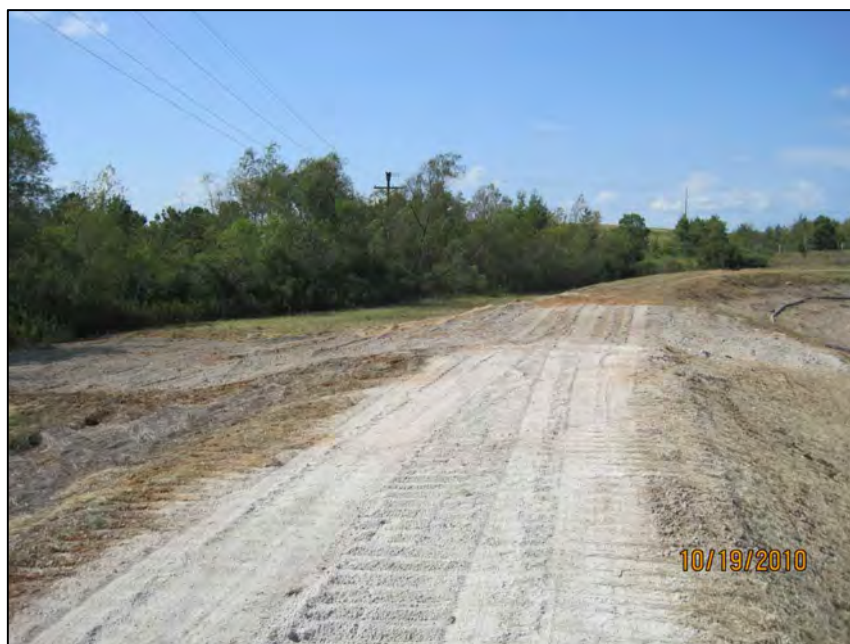
An emergency, earthen spillway was noted to exist to the west of the main discharge pipe, as shown on Photo LRP-8.

LRP-8  
LOOKING WEST FROM CREST AT  
UNLINED EARTHEN EMERGENCY SPILLWAY
