Dam Safety Assessment of CCW Impoundments

Rockport Power Plant

March 24, 2011

O'BRIEN & GERE
www.obg.com

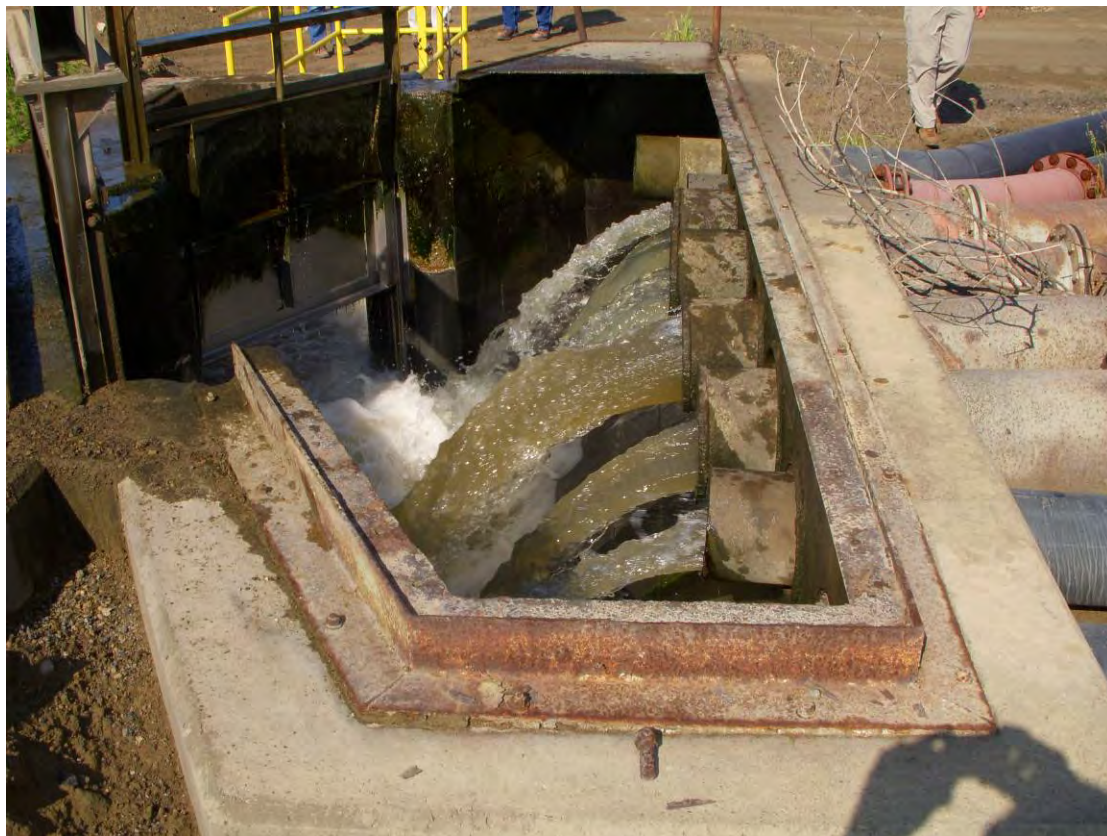
- Sluiced CCW enters the north end of the BAC into a diversion structure that directs flow into the East or West Bottom Ash Pond. (Appendix B, Photo 1)

CCW sluice discharge into diversion structure that directs flow into the east or west bottom ash pond

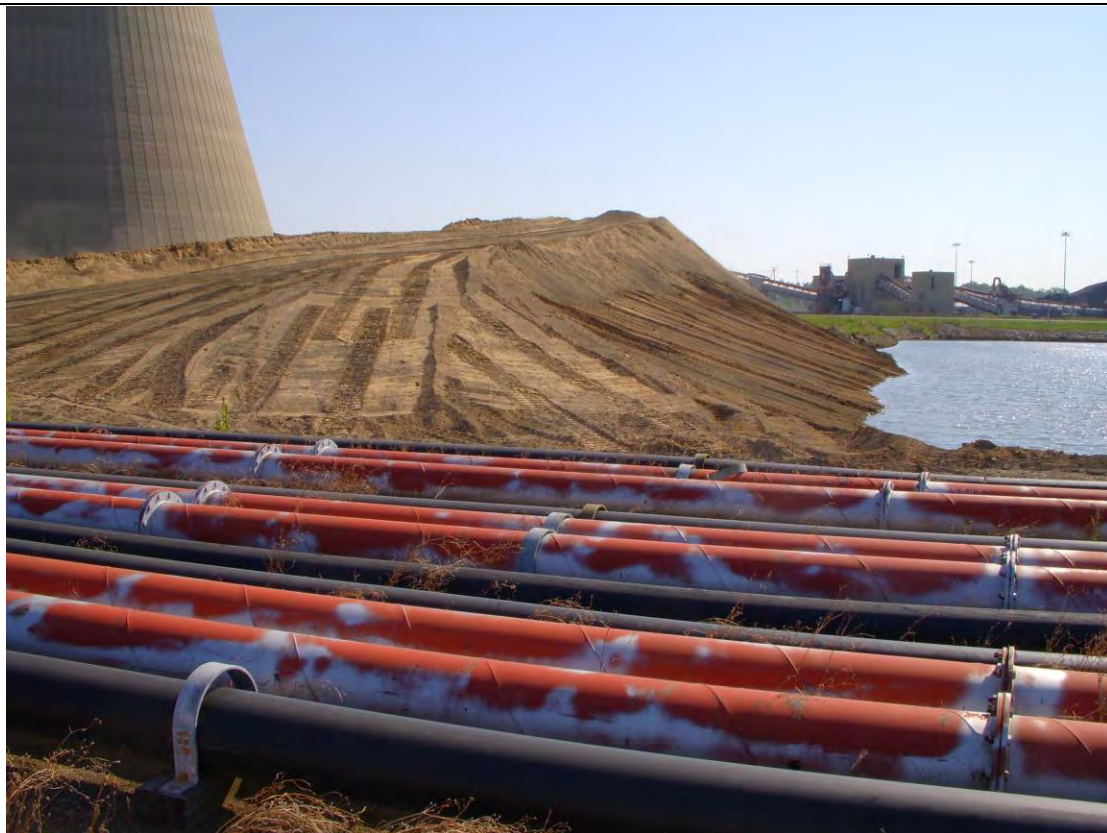
- Bottom ash excavated from the Bottom Ash Ponds is being stockpiled at the north end of the BAC.
- The poor drainage beyond the toe of the west dike and the erosion issues identified in previous inspection reports appeared to have been corrected.

Stockpiled bottom ash at north end of Bottom Ash Complex

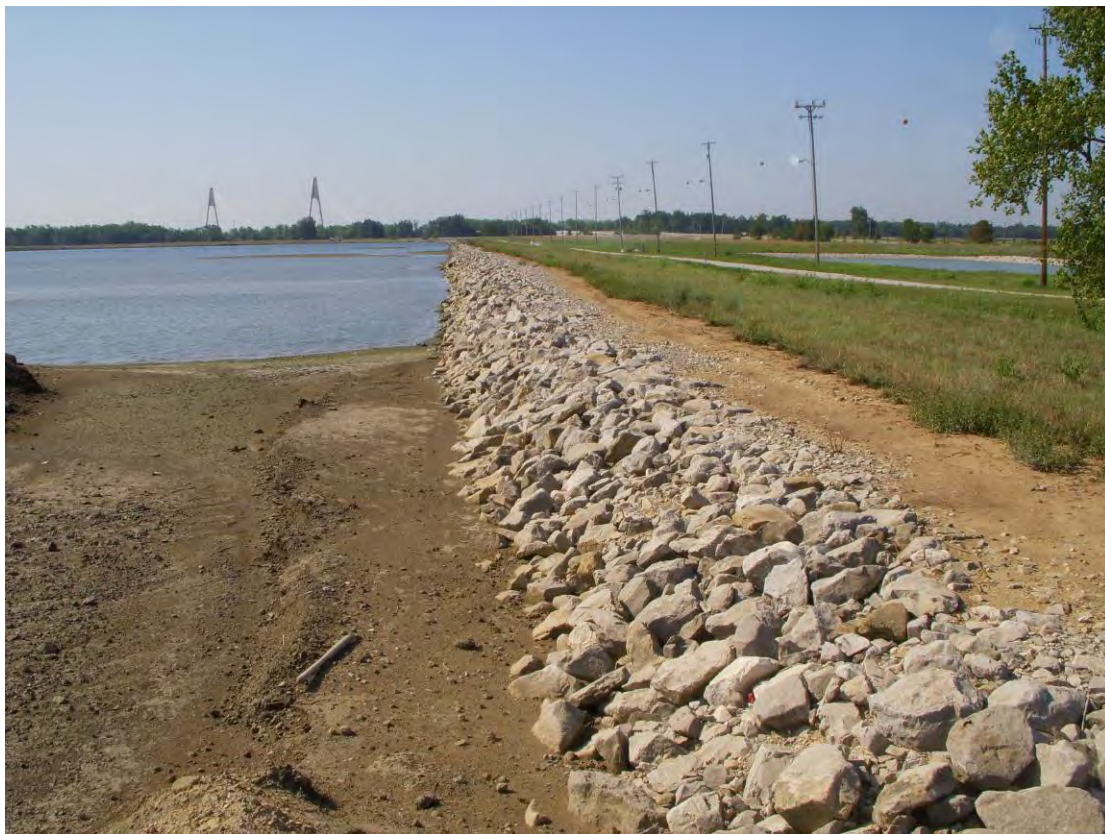
Photo Number:
3

- The outboard slope of the west dike of the West Bottom Ash Pond was observed to be covered with low grass. The grassy vegetation at the toe of the dike was somewhat higher than the vegetation on the slope. The inboard slope was lined with riprap that appeared to be in good condition. (Appendix B, Photos 3 and 4)

- At least 3 feet of freeboard was observed on the inboard slopes of all cells.
- The crest of the west dike was grassed and showed no signs of misalignment, cracking, or settlement. Some minor rutting on the crest of the west dike was observed.

Description:
Crest of West
Bottom Ash
Pond Dike

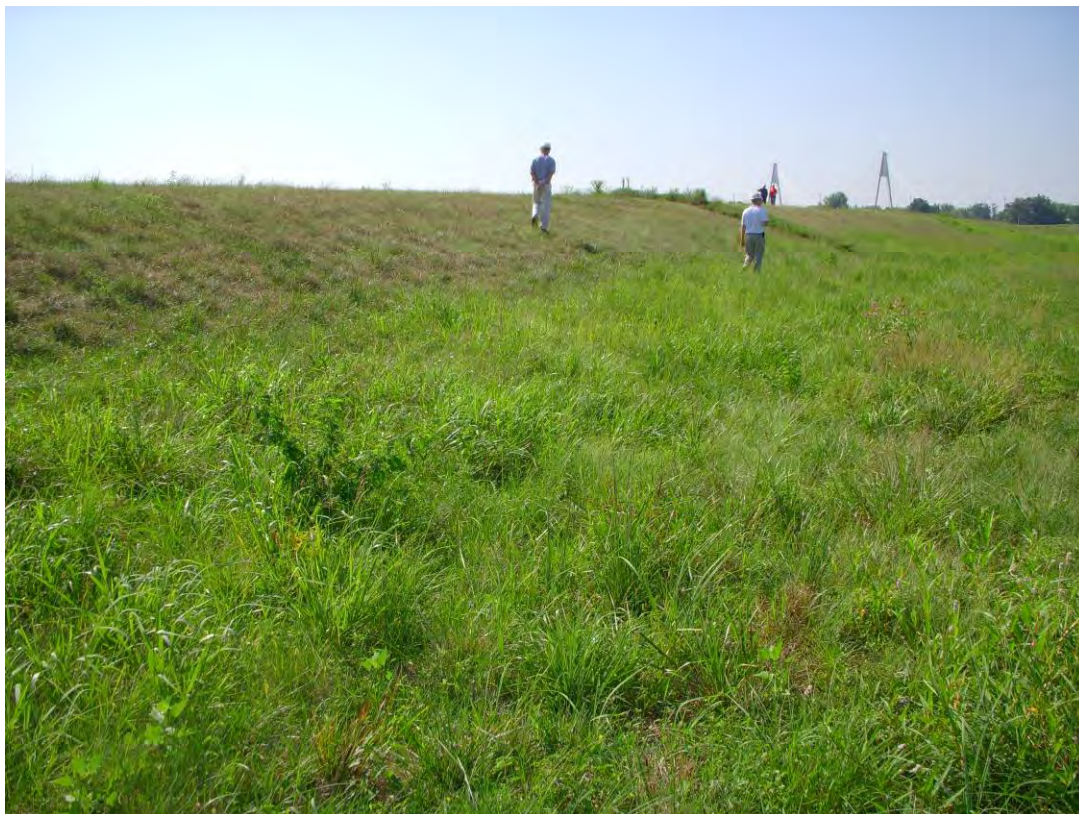
Photo Number:
4

Description:
Outboard slope
of west dike.

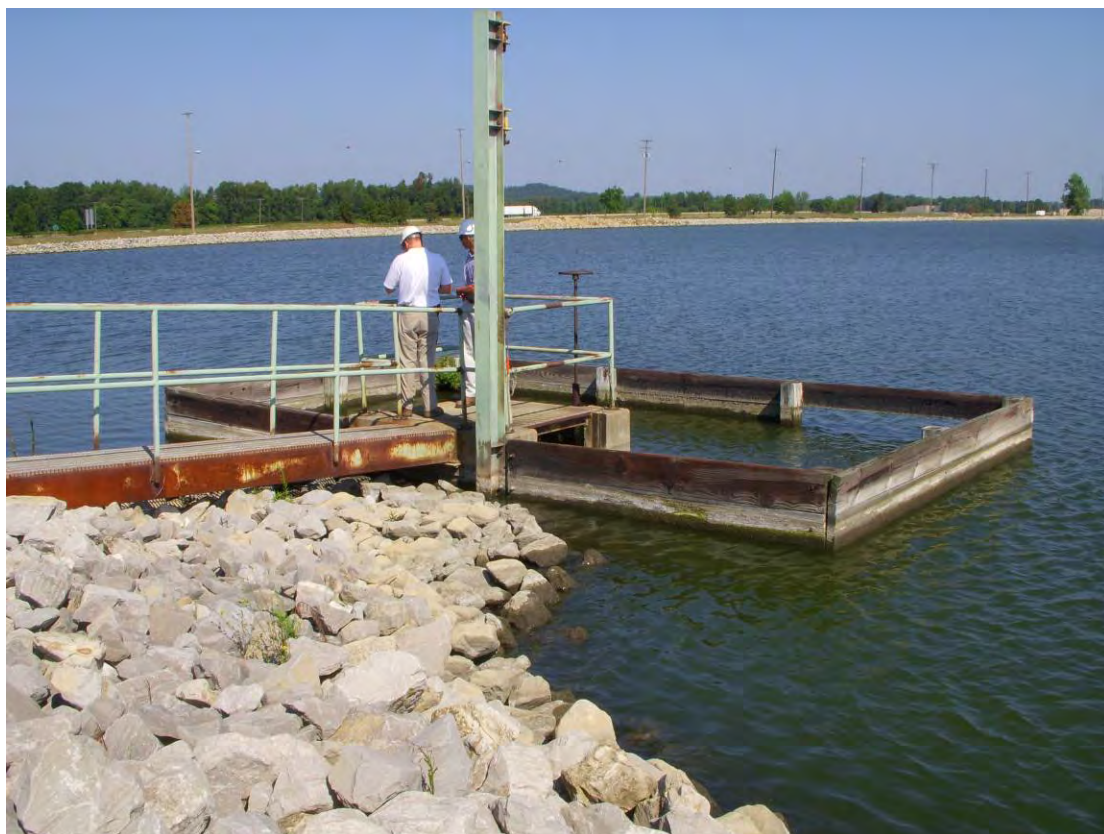
Photo Number:
5

- All of the discharge structures appeared to be functioning normally. The metal platform support members and railings exhibited some corrosion (rust).

Description:
Discharge
Structure No. 3
at south end of
west bottom
ash pond

The metal components of the various outlet structure access platforms and railings are exhibiting corrosion. A plan should be established to either paint or replace corroded members before their support capability is compromised.

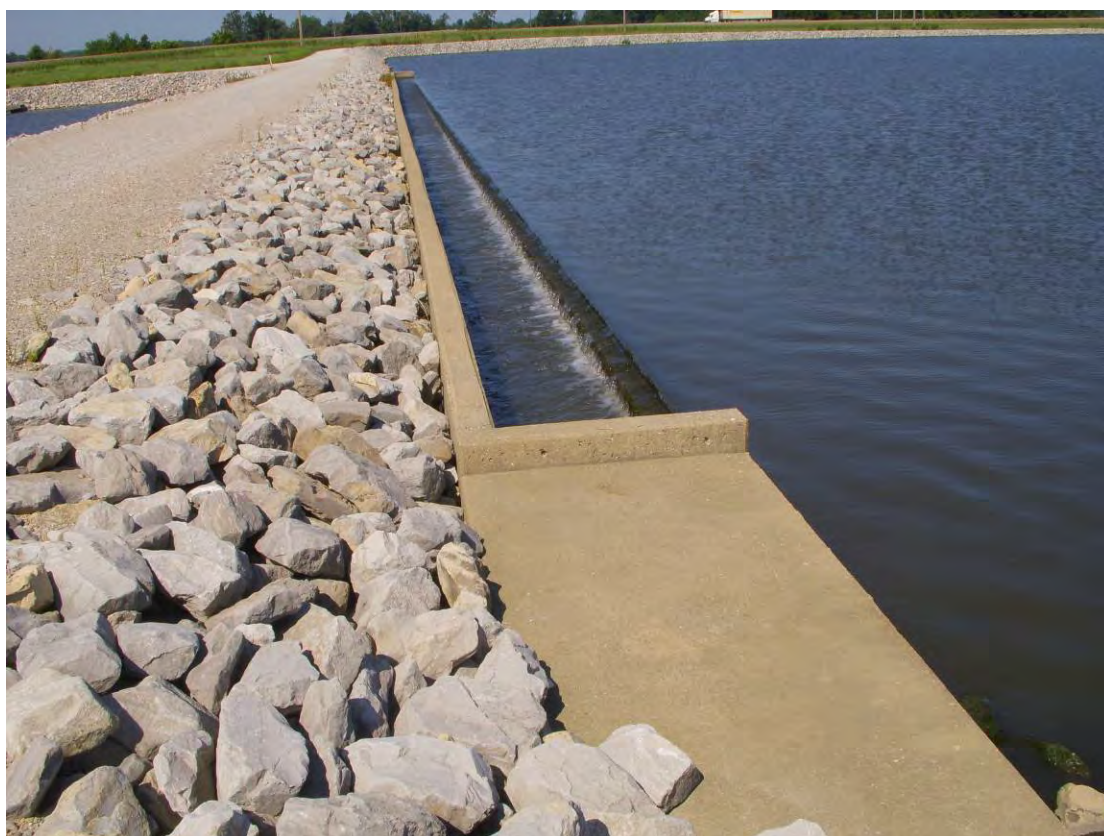
Photo Number:
6

Description:
Divider dike and
decanting weir
at south end of
west waste
water pond

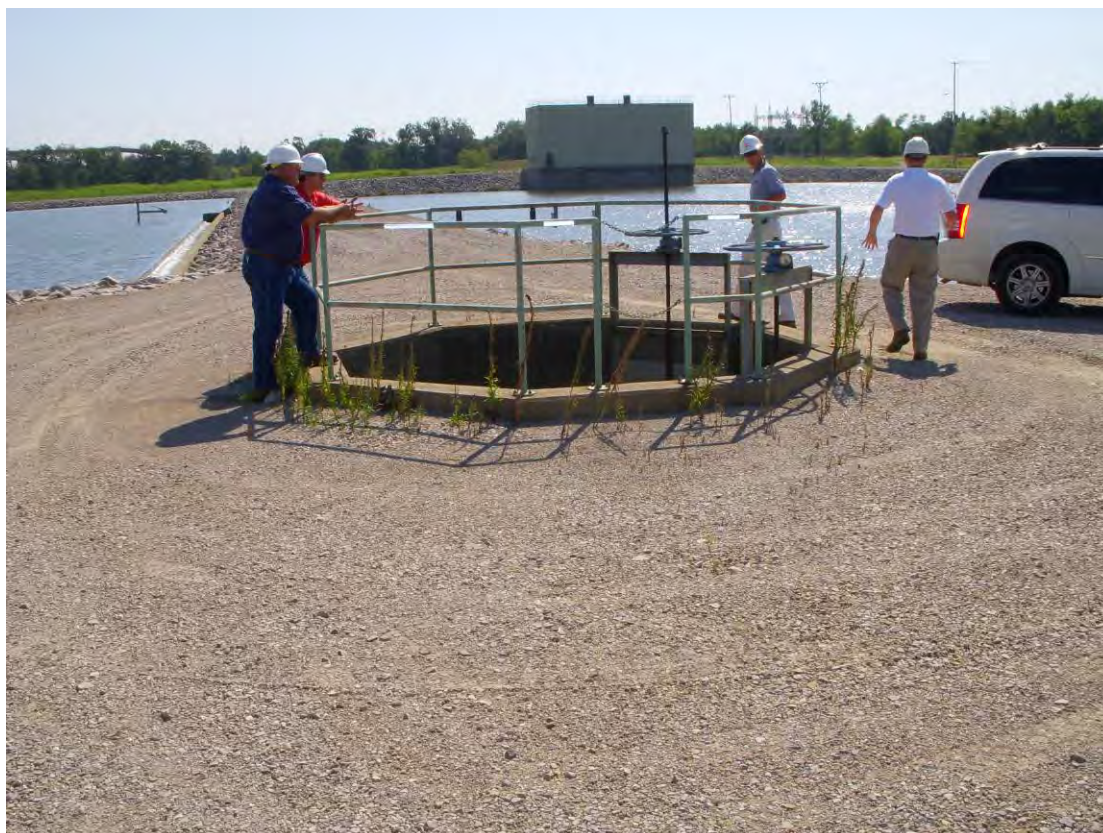
Photo Number:
7

Description:
Center
diversion
structure that
controls flow
between
wastewater
ponds and
reclaim/clear
water ponds

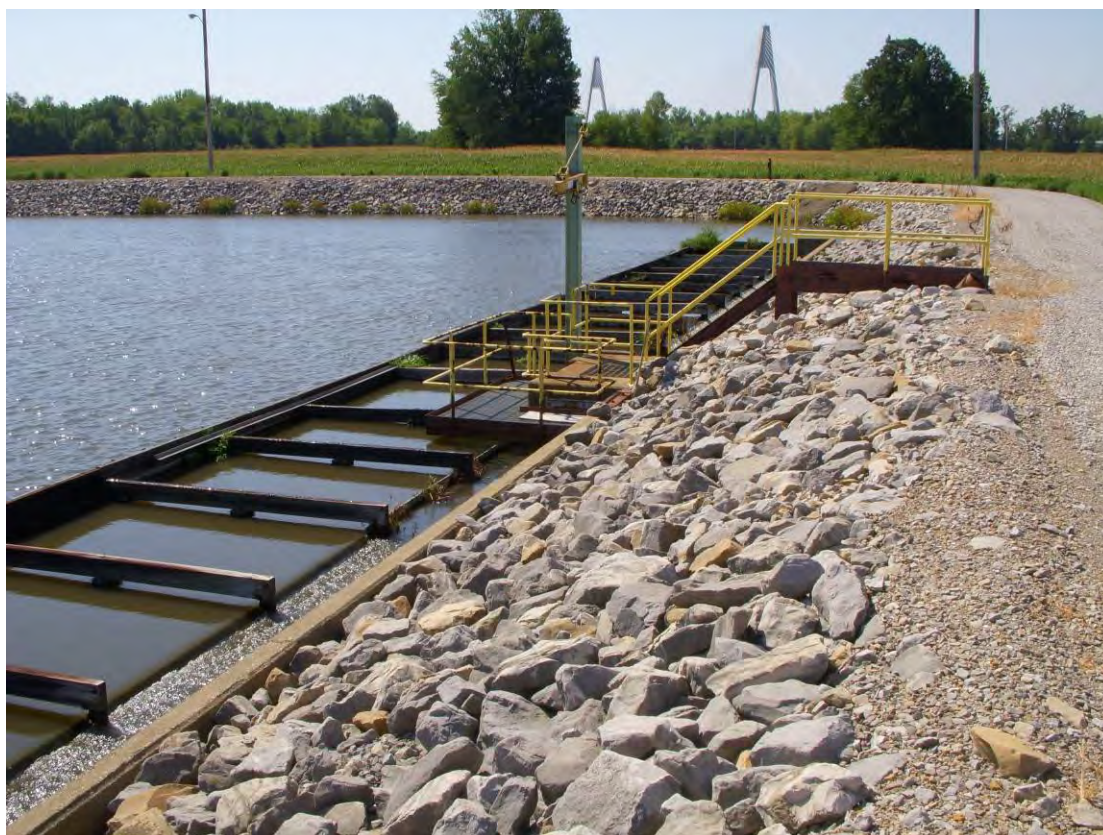
Photo Number:
8

Description:
Final outlet
structure
(Structure No.
10) at
clearwater
pond
