Assessment of Dam Safety Coal Combustion Surface Impoundments (Task 3) Final Report

American Electric Power
Big Sandy
Generating Station
Louisa, Kentucky

February 17, 2010

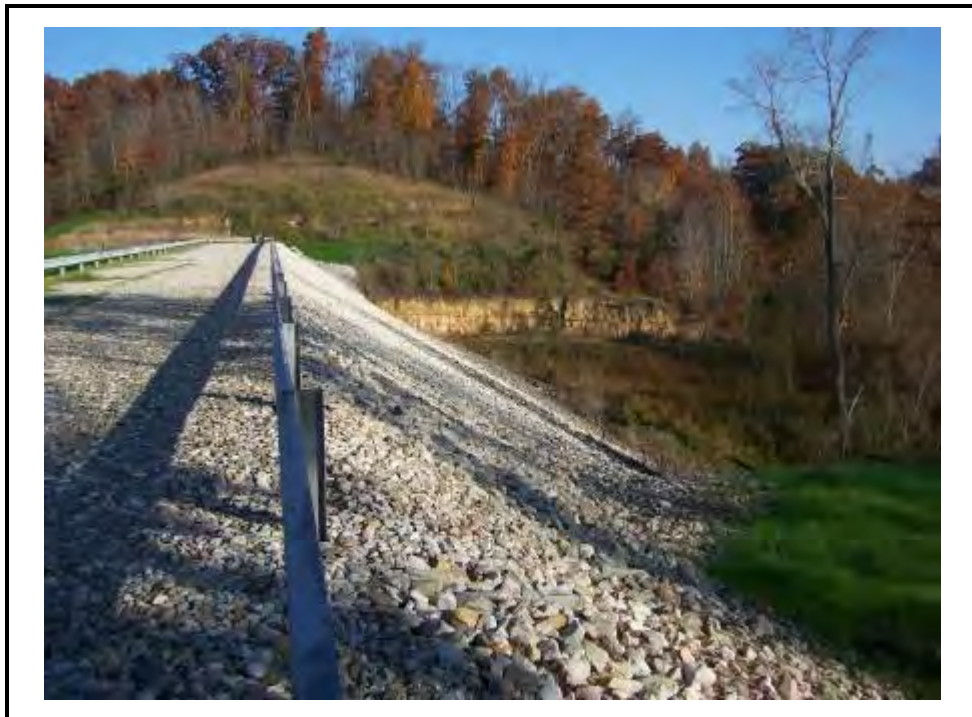
2

Downstream slope of Saddle Dam, looking north.

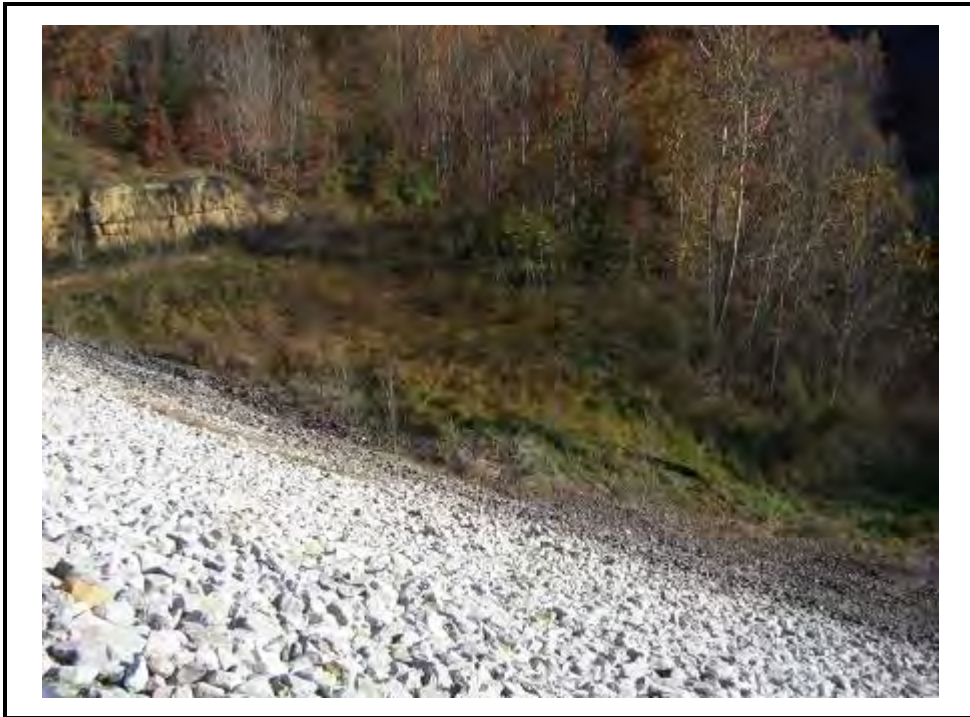
North downstream groin of Saddle Dam looking northeast. Bedrock in upper left is part of original emergency spillway channel which is now plugged.
Note small trees in groin have been sprayed with herbicide.

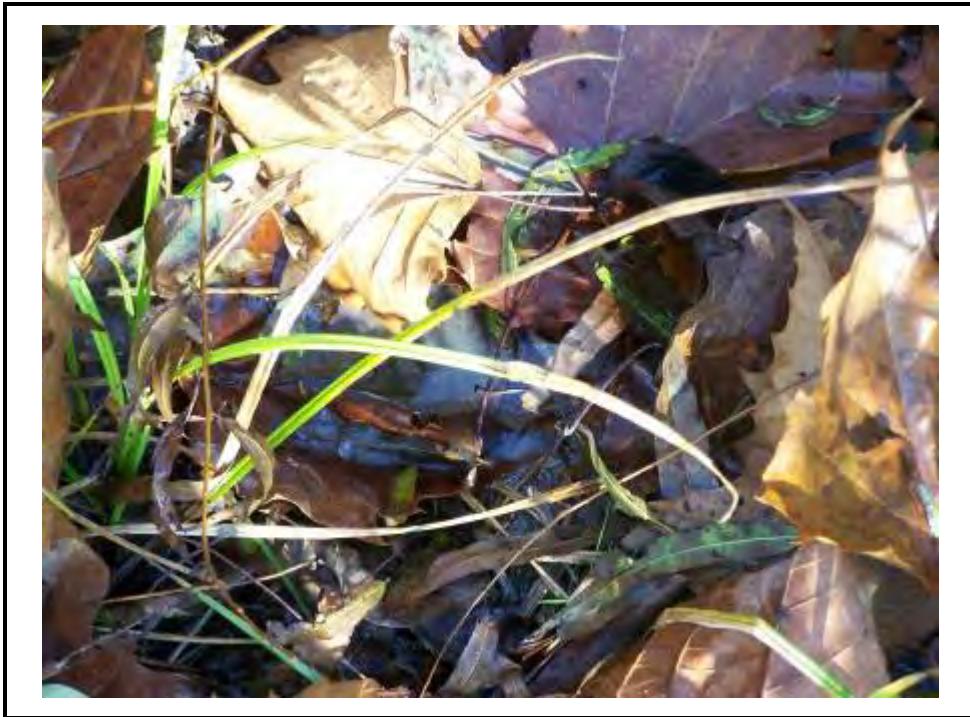
Toe drain outlet from under main portion of Saddle Dam.
Note the pipe is covered with vegetation.

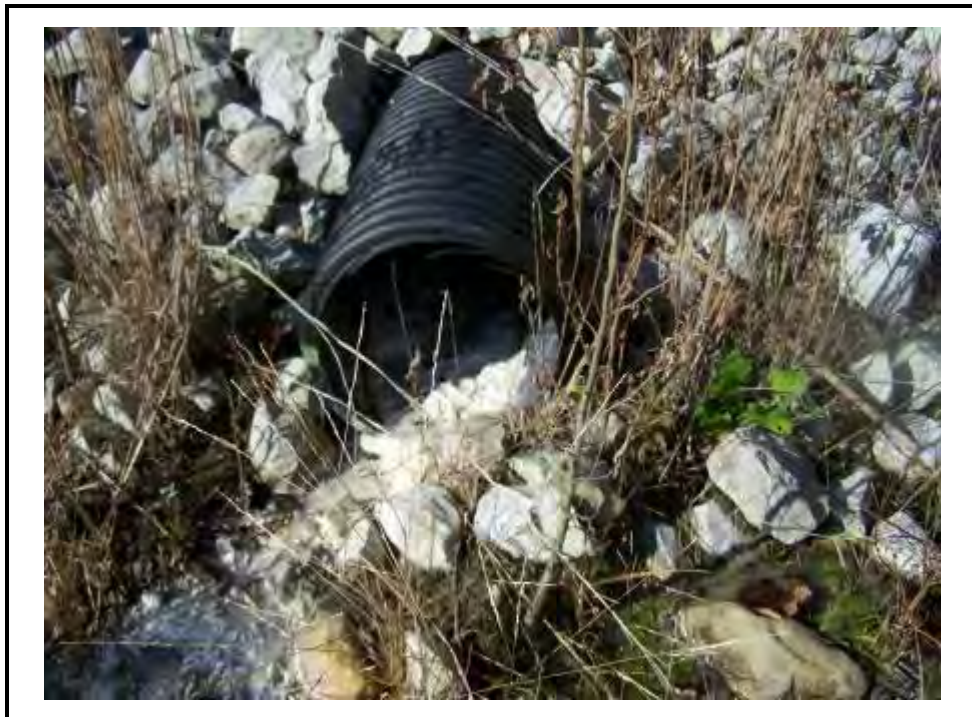
Seepage drain from original emergency spillway plug.
Note calcium deposits from granular fill used in filter blanket.

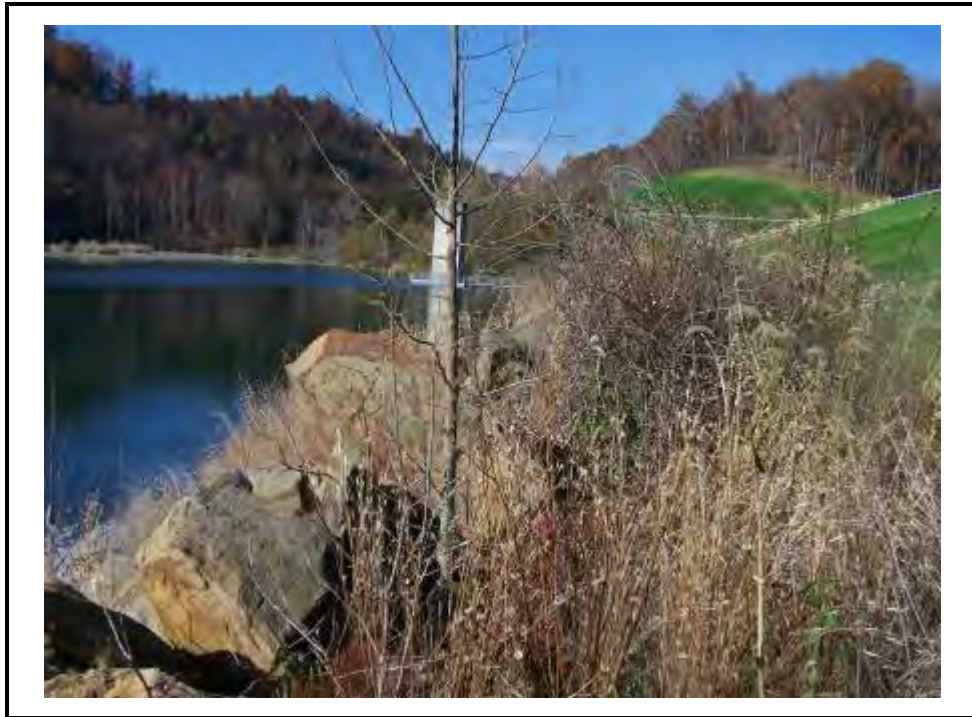
Brush and small trees in rip rap along the water line have been sprayed with herbicide at Horseford Dam.

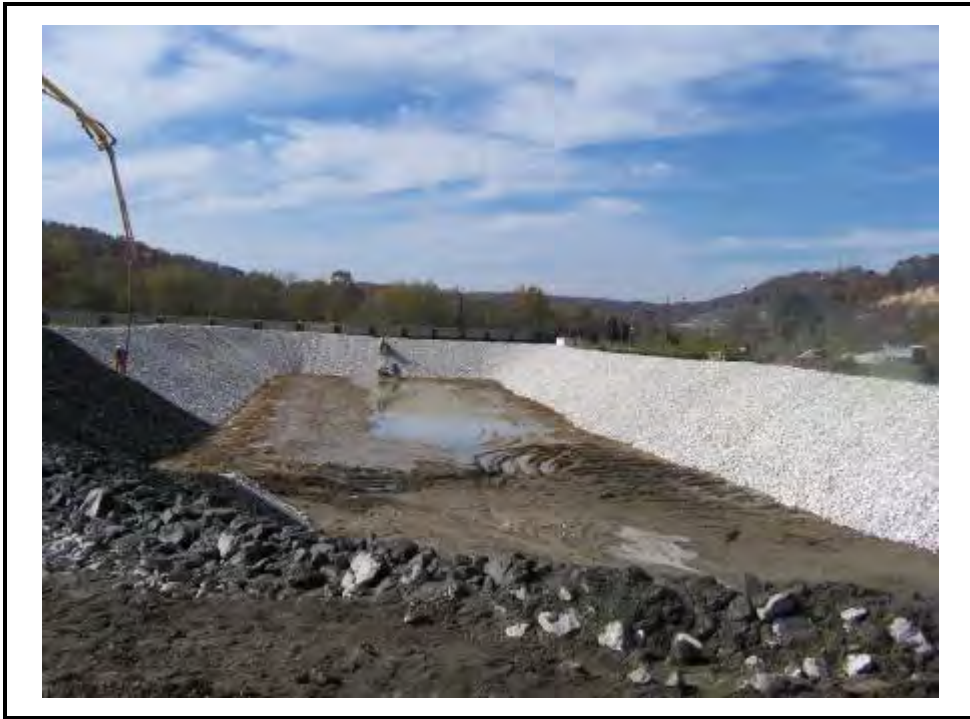
South Bottom Ash Pond looking west. AEP ws installing grouted rip rap on the inside slopes to reduce vegetation and erosion type maintenance.

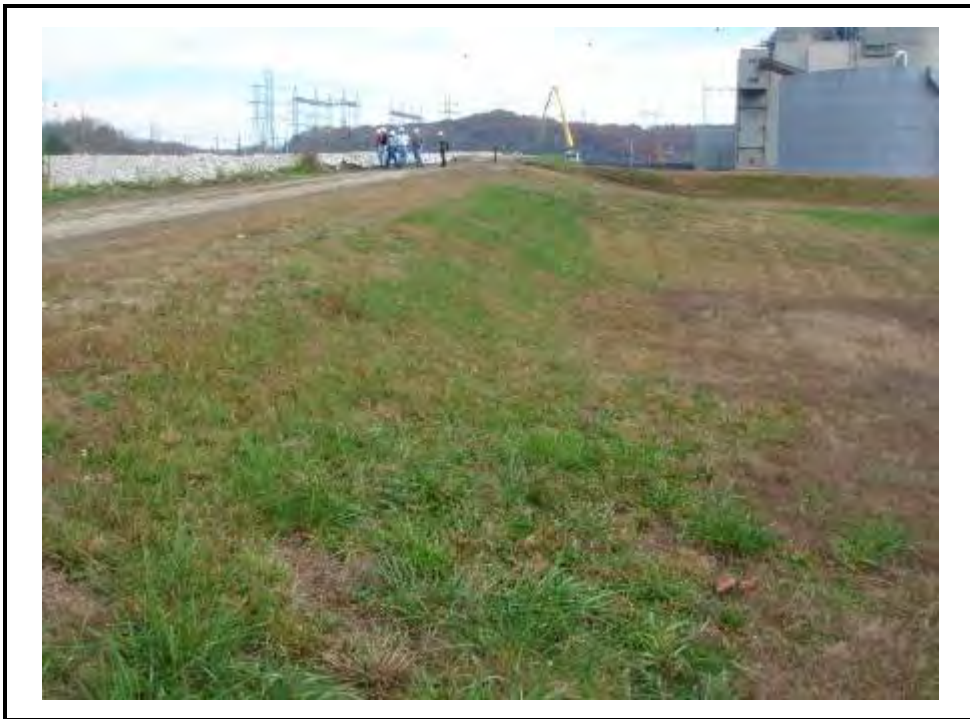
Sparse grass cover was observed on the downstream and upstream slopes of the south dike adjacent to the SCWP (Photos 46 and 47). Rip rap has been recently placed on the upstream slopes at the west end of the SCWP as shown in Photos 48 through 50.

Downstream slope of South Dike at Bottom Ash Complex adjacent to south clear water pond, looking east.

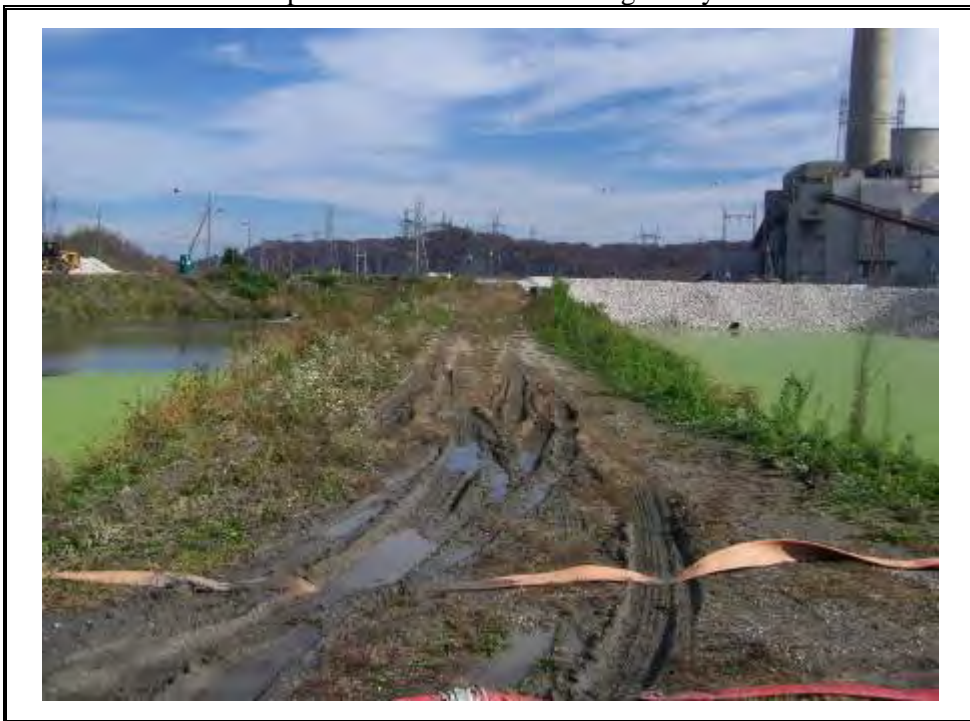
Standing water was observed in tire ruts on the crest of the splitter dike between the NCWP and SCWP as seen in Photo 56. Erosion has occurred at the water line on the northern toe of the splitter dike between the NCWP and SCWP due to wave action as seen in Photo 58. This mode of erosion is part of the reason for the current work to cover the slopes with grouted rip rap. Several bushes were observed growing on the west slope of the splitter dike between the NBAP and NCWP as shown in Photo 61. The crest of the splitter dike between the SBAP and SCWP is uneven as shown in Photo 63.

Crest of Splitter Dike between north and south Clearwater Ponds, looking east.

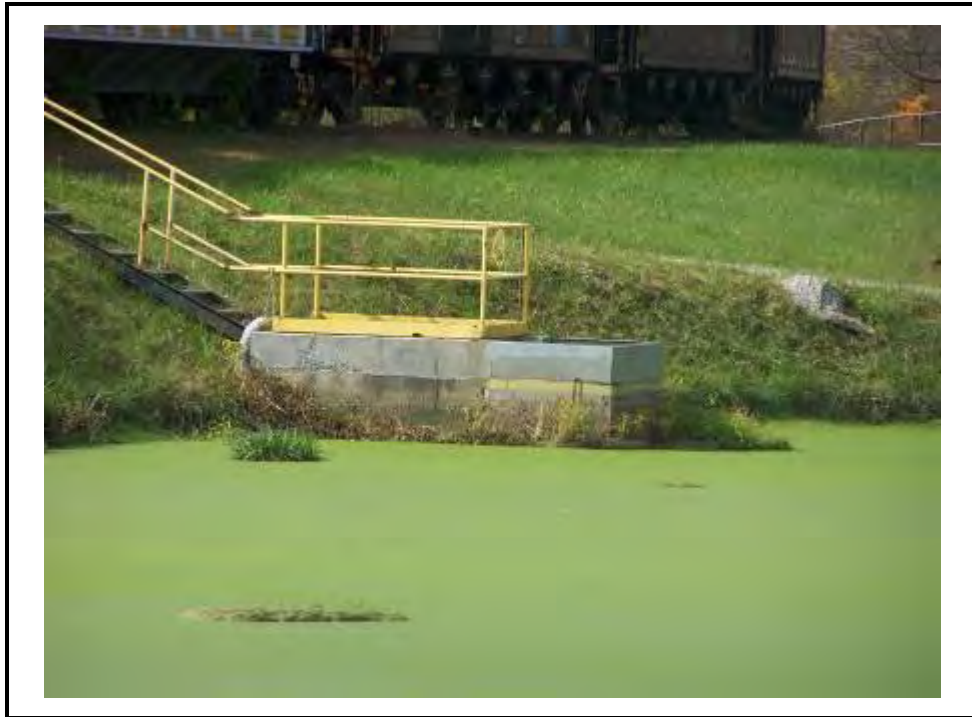
Close-up of non-permitted overflow to the Big Sandy River. Plant Personnel indicated that when water level reaches yellow line on the structure, pumping is initiated to Horseford Reservoir to prevent discharge to the river.

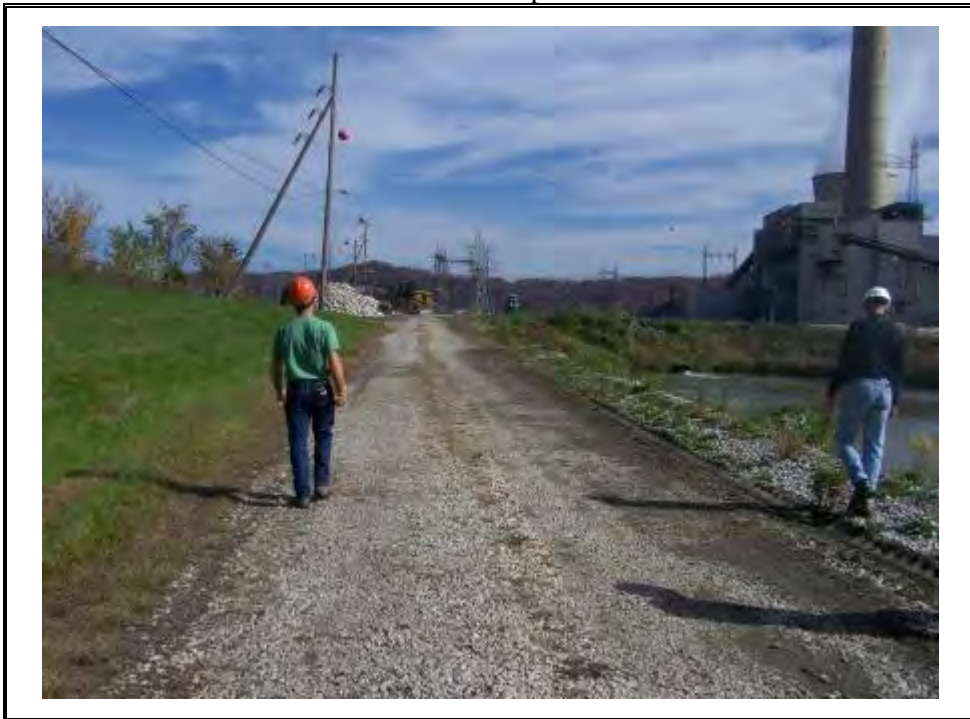
The western end of the north side of the NCWP is incised as shown in Photo 60. Tall grass was observed on the upstream slope of the north dike adjacent to the NBAP as shown in Photo 65. The standing water shown in the photo is from recent rain.

Crest of North Dike of Bottom Ash Complex along north Clearwater Pond where Bottom Ash Complex is incised.

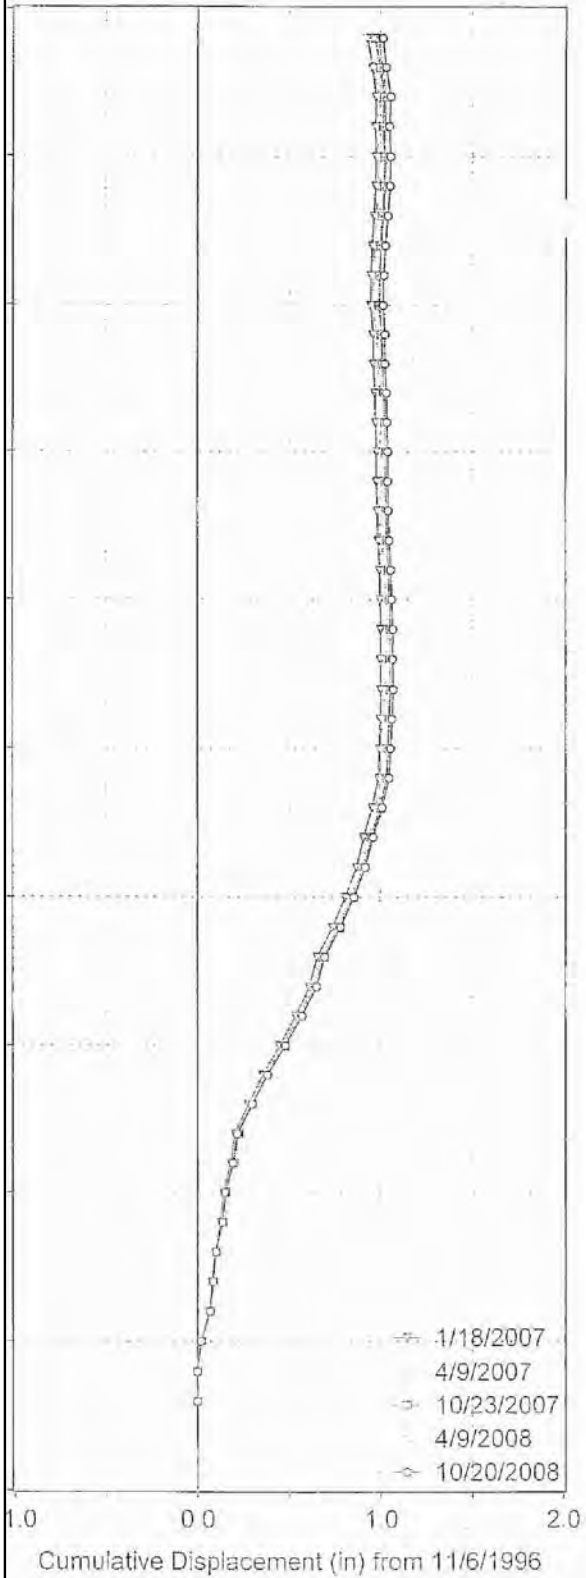
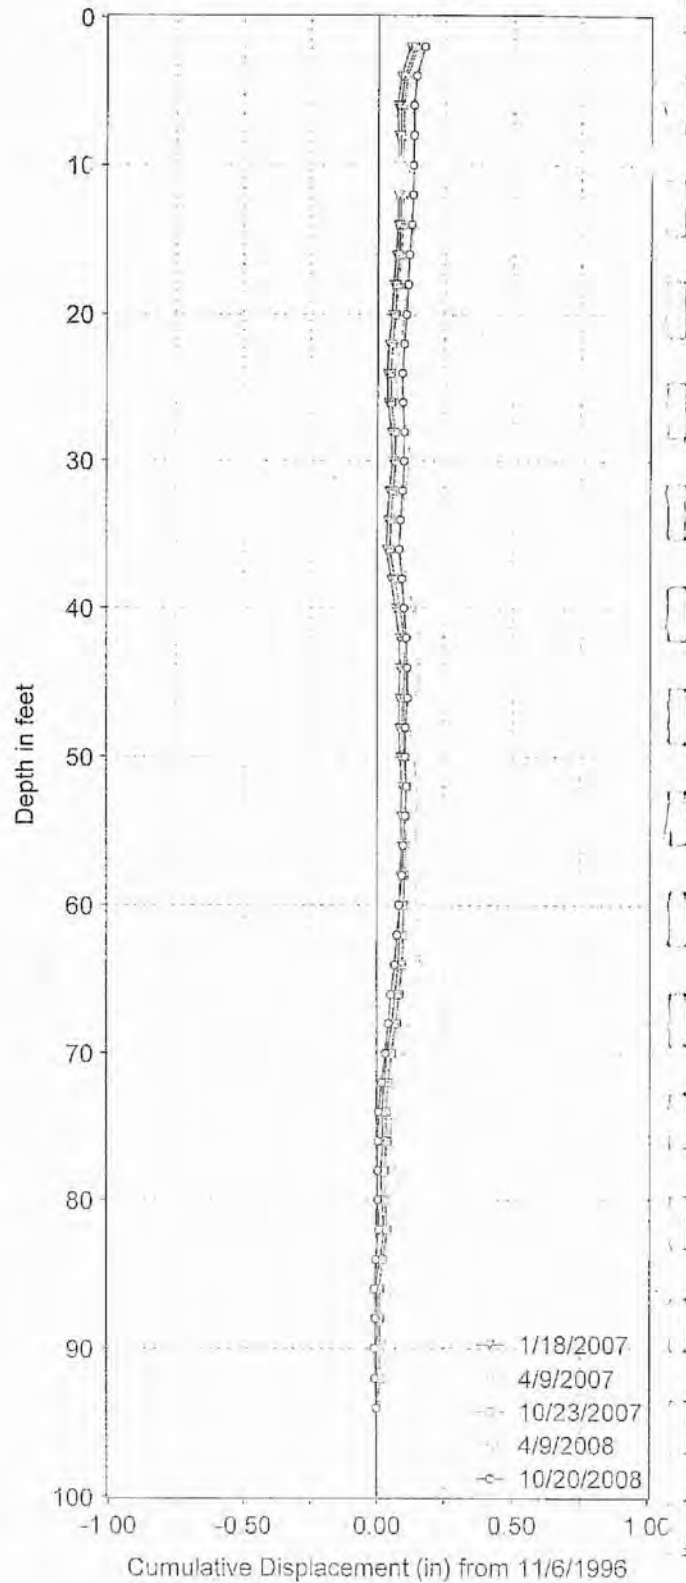
Inclinometer SI-1 is located in the crest of the berm at El. 590; a cumulative deformation plot is included in Figure 12A. The maximum movement in the downstream direction is approximately 1.07 inches. Inclinometer SI-2 is located on the downstream slope at approximately El. 665; a cumulative deformation plot is included in Figure 12B. The top of this instrument was struck by a bulldozer during a previous construction period resulting in the large displacements between El. 631 and 611 within the embankment fill indicated on the plot on Figure 12B. Accounting for this damage, AEP (2008) reported that the maximum movement in the downstream direction is approximately 1.04 inches.
