**Coal Combustion Waste Impoundment
Dam Assessment Report**

Site 25

***Fly Ash Pond & Bottom Ash Pond
American Electric Power
Philip Sporn Generating Plant
New Haven, West Virginia***

**Assessment of Dam Safety
Coal Combustion Surface Impoundments
For the REAC Program**

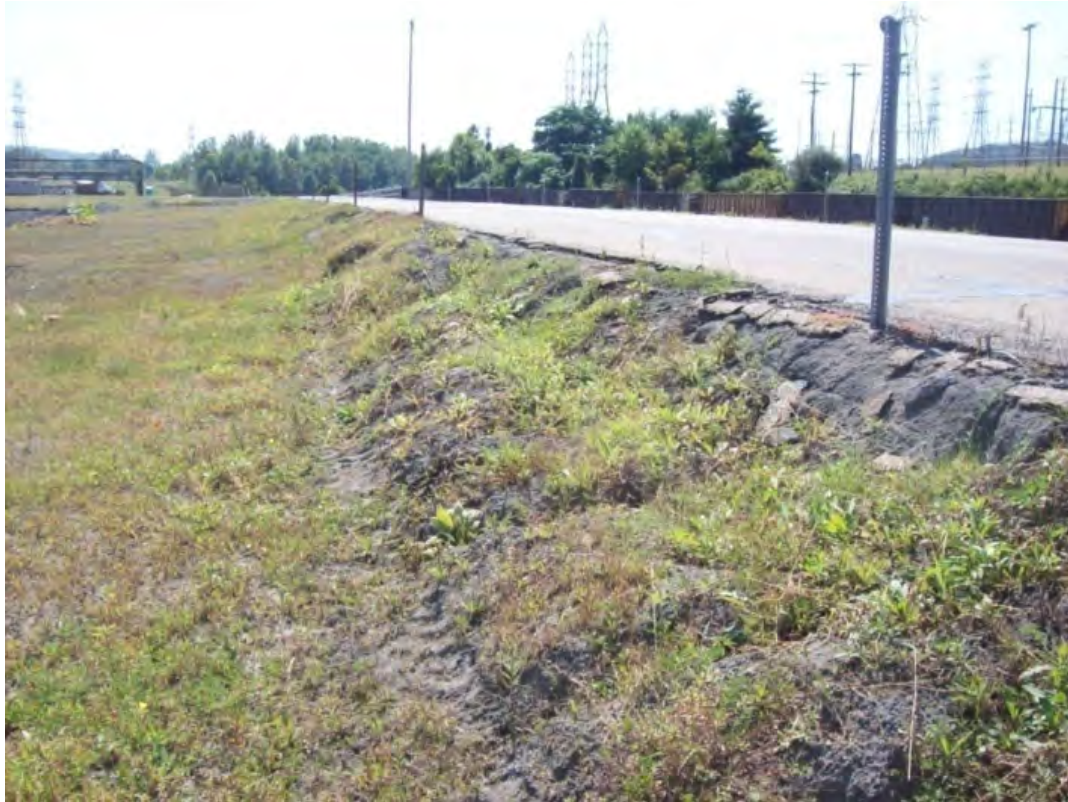
Bottom Ash Pond - The upstream slope is sparsely vegetated with tall grasses and other, wetland vegetation. Scarps, sloughs, depressions, bulging or other indications of slope instability were not observed. Erosion, most likely caused by storm water runoff from the road system along the crest, was observed along the northwest dike and is beginning to undermine the paved road (see photo below).

Facility access road adjacent to bottom ash fill, Bottom Ash Pond

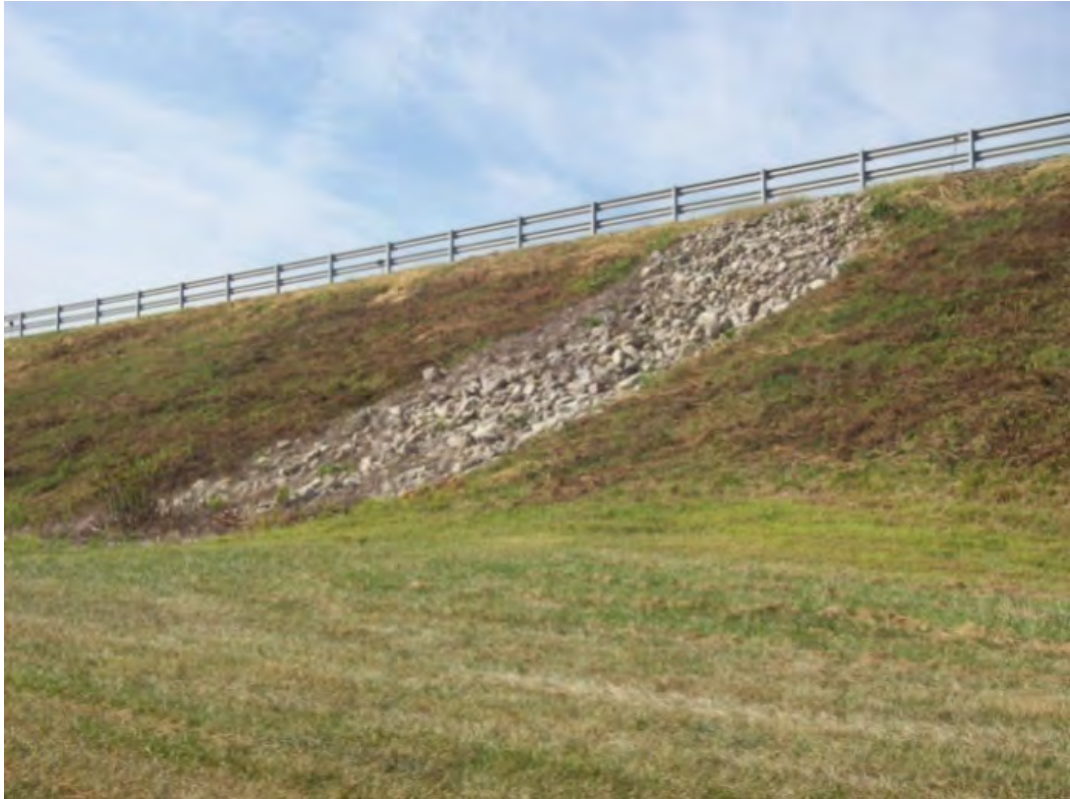
Slope erosion protection rip rap at East Dike, Fly Ash Pond

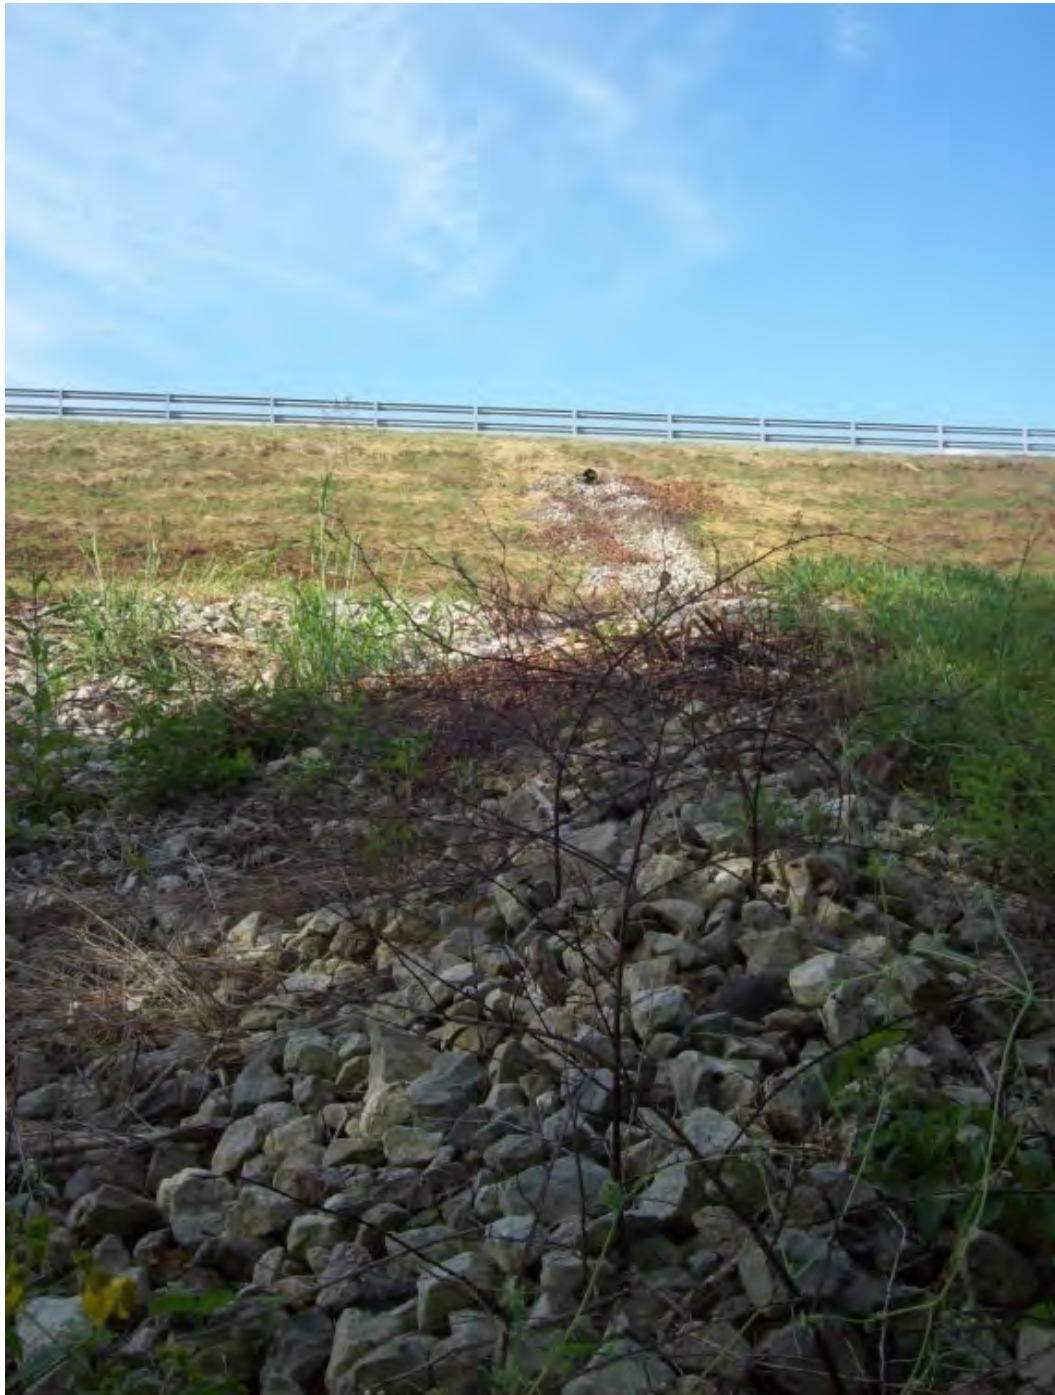
Fly Ash Pond – The highest embankment is along the east dike parallel to the Ohio River. The east dike is mostly grassed with a section of rip-rap placed to mitigate previous erosion resulting from point discharge of a storm drain along a roadway (see photos below and next page).

Erosion protection for road runoff, East Dike, Fly Ash Pond

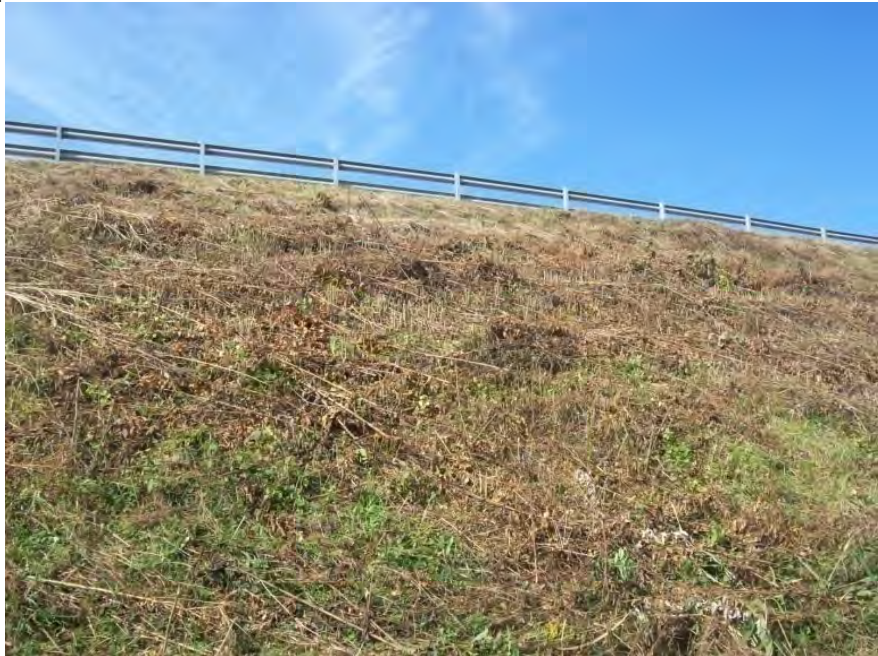
Isolated areas of the eastern dike have surface irregularities consistent with past surface sloughing (see photo below).

Maintenance for surface sloughing, downstream slope, East Dike, Fly Ash Pond

- Continue with proposed action plan to address sloughing along downstream slopes. AEP Proposed Action Plan is provided in Appendix C (Doc: Embankment Sloughing Repairs Attachment BMaster.pdf)
- Perform an assessment of the effect of railway-induced ground vibrations on embankments.
- Perform slope stability analyses under proper earthquake loading conditions for the upper sections of the eastern dike.
- Perform a site-specific study of the potential for liquefaction of foundation soils.

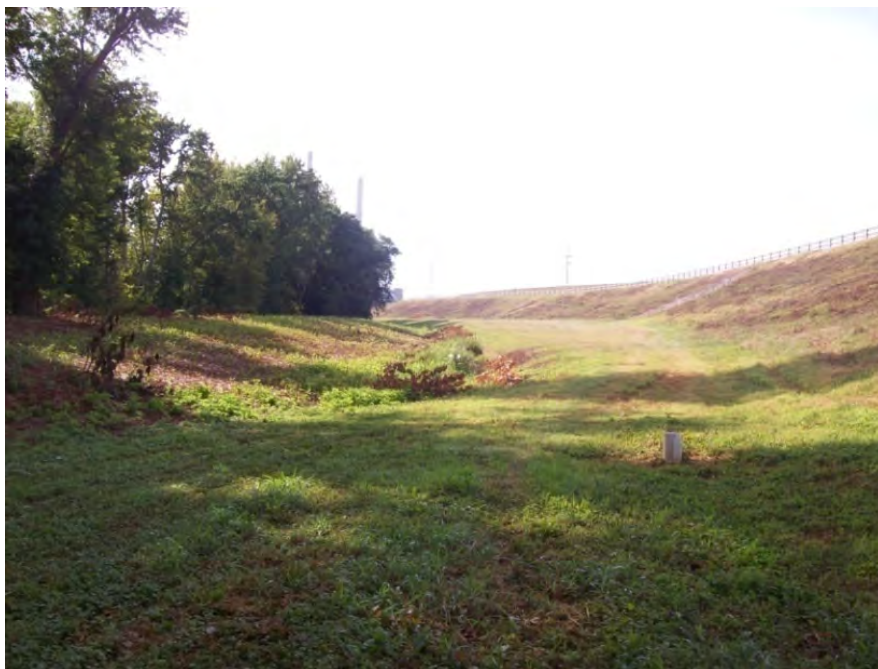
Standing water and wetland vegetation were present downstream of, and near the toe of, the eastern dike embankment (see photo below).

Downstream Toe, East Dike, Fly Ash Pond

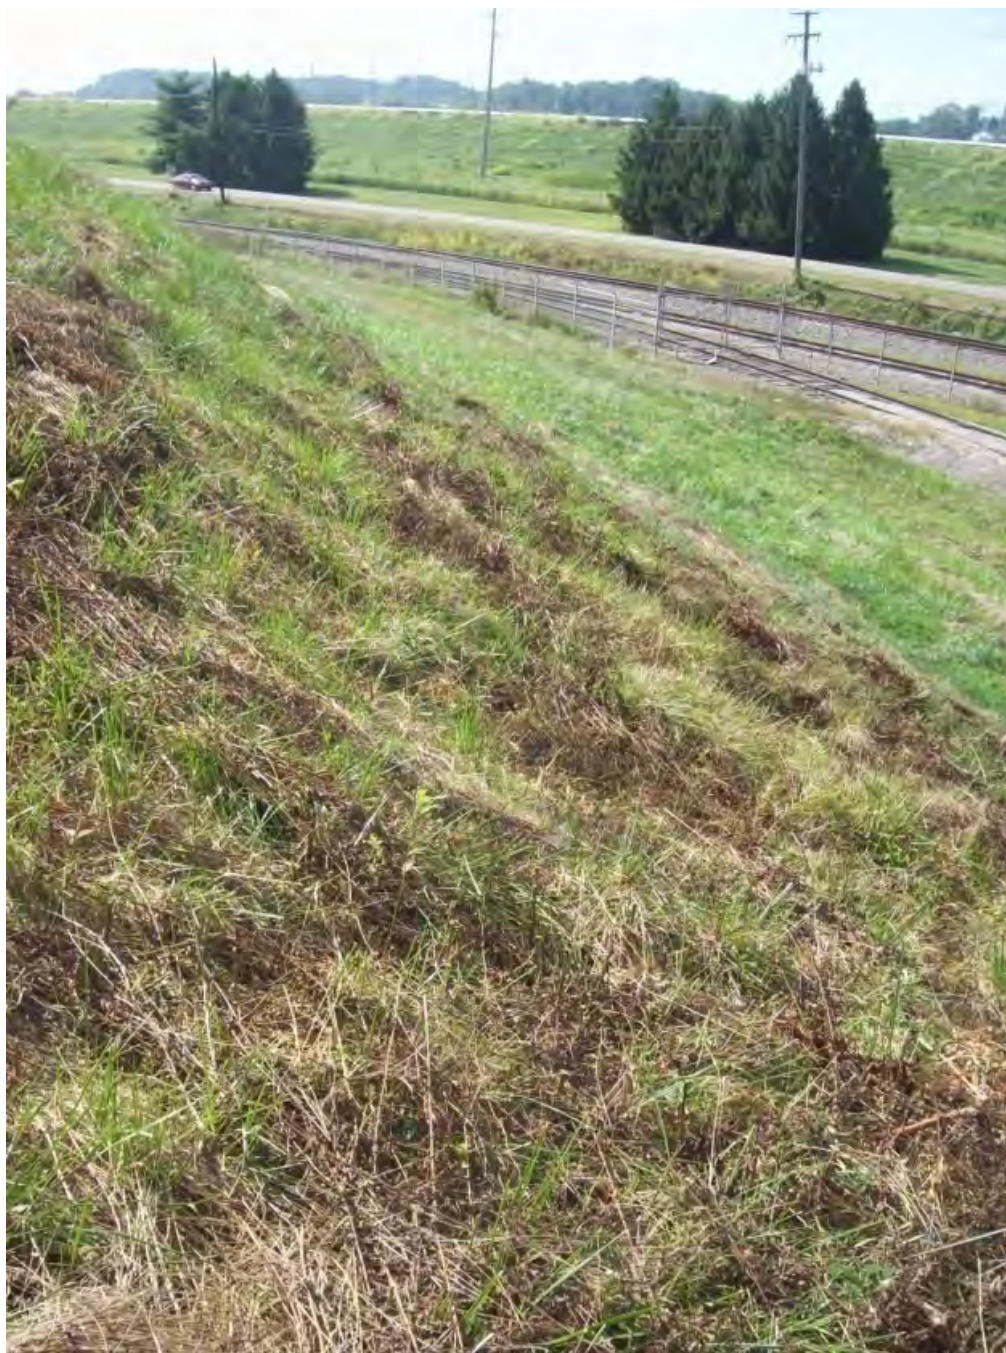
The western dike paralleling the railroad is mostly grassed with some portions covered by rip-rap. Much of the grassed embankment along the west dike is experiencing active surface sloughing (see photo below). The north and south diked embankments are grassed and no sloughing or erosion was observed. None of the diked embankments showed evidence of scarps, depressions, bulging or other indications of deep slope instability.

Surface erosion and sloughing on steep slope, Downstream Slope, West Dike, Fly Ash Pond

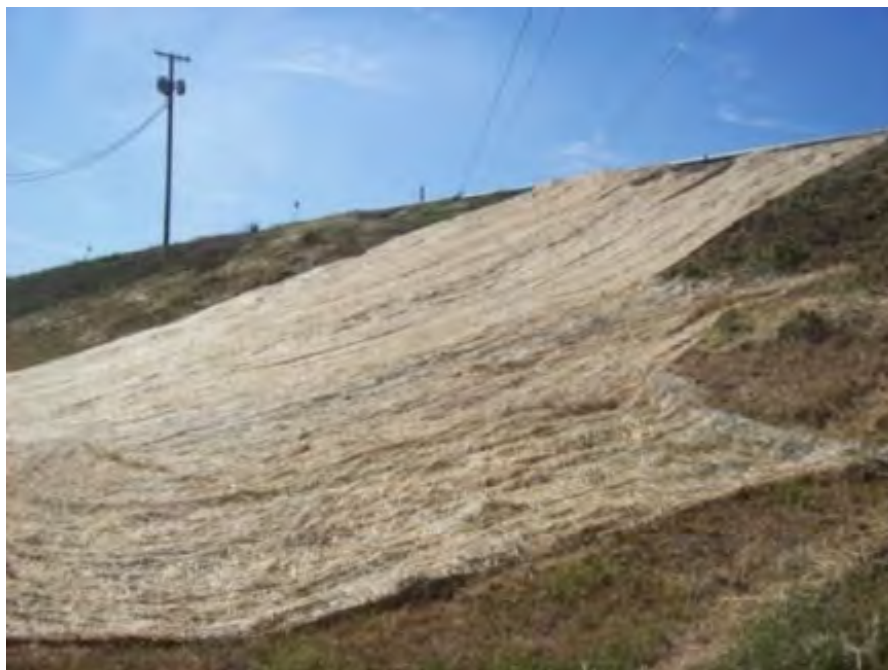
Geotextile for erosion remediation, Downstream Slope, East Dike, Bottom Ash Pond

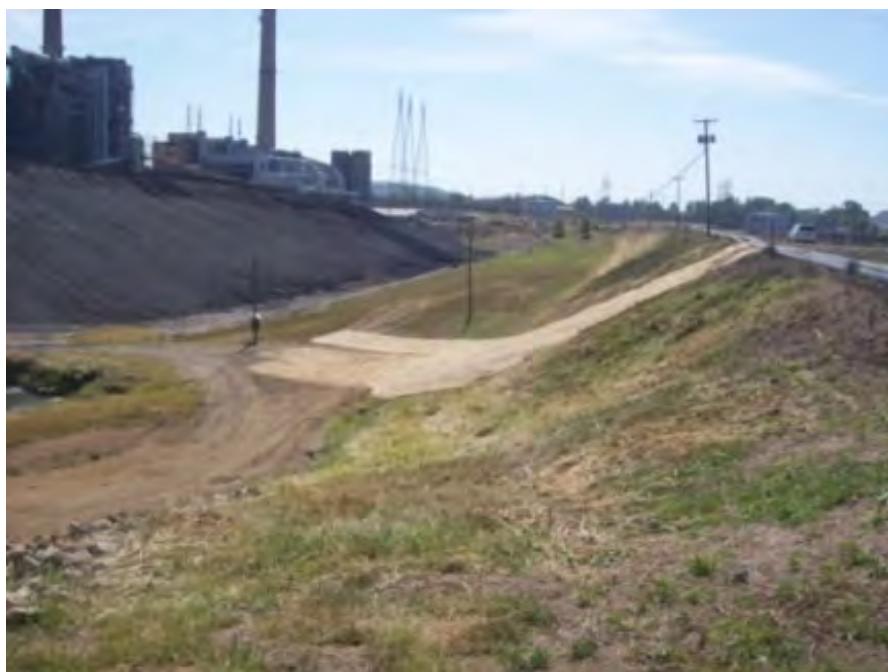
Bottom Ash Pond - The highest embankment impounding the Bottom Ash Pond is along the east dike parallel to the Ohio River. The upper section of the east dike is mostly grassed with a section of straw matting placed to facilitate grassing and mitigate erosion resulting from roadway storm water runoff. Isolated areas of the upper eastern dike have surface irregularities consistent with past surface sloughing.

Erosion remediation, Downstream Slope, East Dike, Bottom Ash Pond

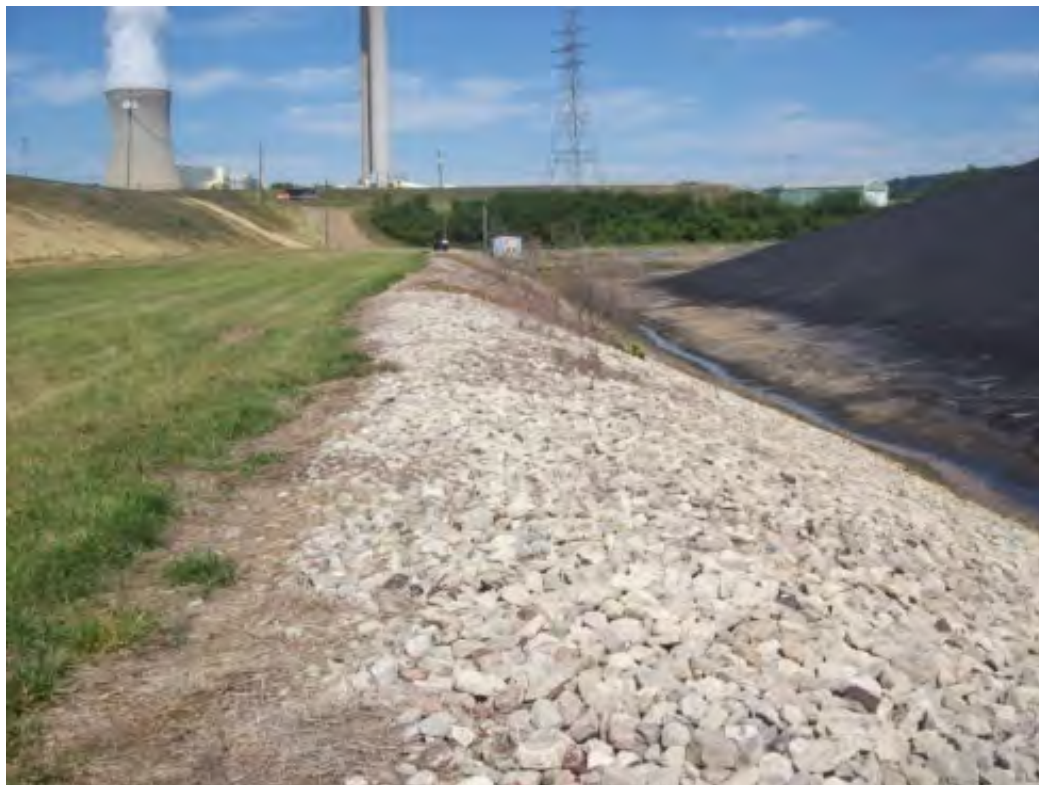
The lower portion of the east dike is covered by rip-rap and terminates at the coal storage yard where storm water runoff is collected and routed along the toe. The western dike paralleling the railroad is covered by rip-rap and no sloughing or erosion was observed. The north and south diked embankments are grassed and no sloughing or erosion was observed. None of the diked embankments showed evidence of scarps, depressions, bulging, or other indications of deep slope instability. However, while on-site, the railroad was in use and ground vibrations could be felt when the train stopped adjacent to the facility.

Rip rap along western dike, Bottom Ash Pond
