Comments received for CHA Draft Report (*July 6, 2009*, CHA Project No. 20085.1000.1510) for the Assessment of Dam Safety of Coal Combustion Surface Impoundments, American Electric Power – General James Gavin Power Plant, Cheshire, OH. Comments include;

Final Report  
Assessment of Dam Safety of Coal Combustion Surface Impoundments  
American Electric Power – General James Gavin Power Plant  
Cheshire, OH

**Gavin Plant  
US EPA Dam Assessment Inspection  
Civil Engineering Response to CHA Assessment of Ash Impoundments  
August 18, 2009**

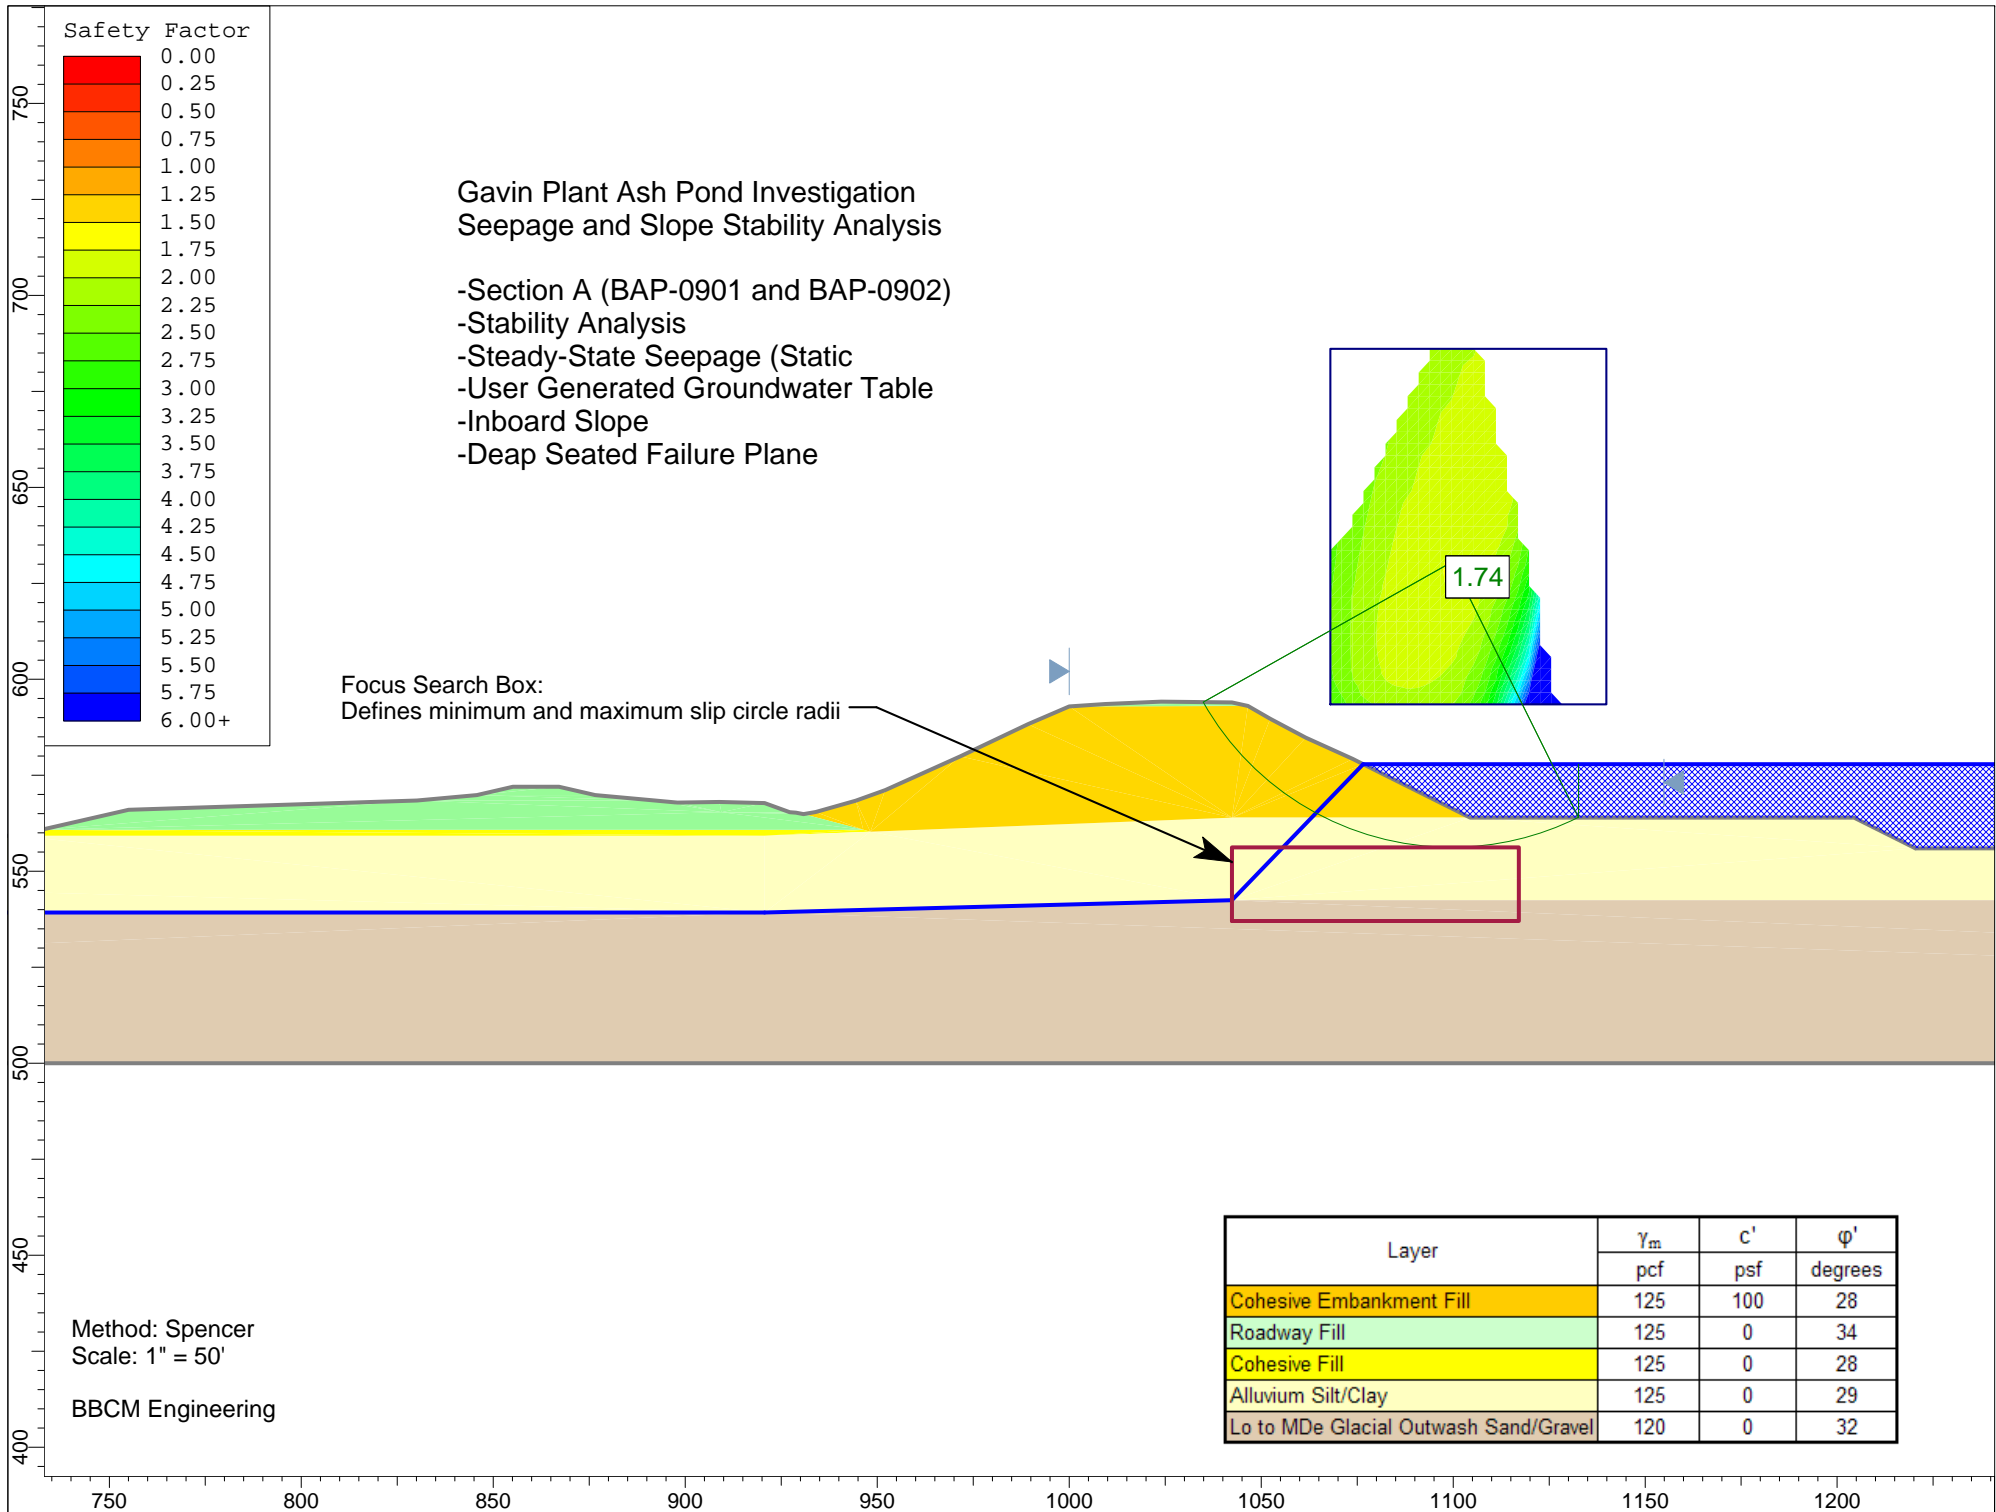
- The downstream slope stability outputs for the steady state load condition for Cross Sections A and B show failure planes within the embankment soils. If the alluvium silt/clay was modeled with a soft layer at the depth corresponding to the low sample effort the failure plain may actually fail within the alluvium foundation soils and not the embankment soils. We recommend that a model be prepared for this load case using the soil parameters for the soft alluvium layer described above.

- 4) *AEP’s consultant has performed additional analyses to force the failure plane through the weaker alluvium foundation material. Based on the design strength of 29 degrees, as documented in the report, a failure surface through this zone is not the critical surface as indicated by the factor of safety of 1.74 obtained in the additional analyses (see attached summary plot).*
