# Assessment of Dam Safety Coal Combustion Surface Impoundments Draft Report

American Electric Power  
General James Gavin  
Power Plant  
Cheshire, Ohio

July 2, 2009

CHA Project No. 20085.4000.1510

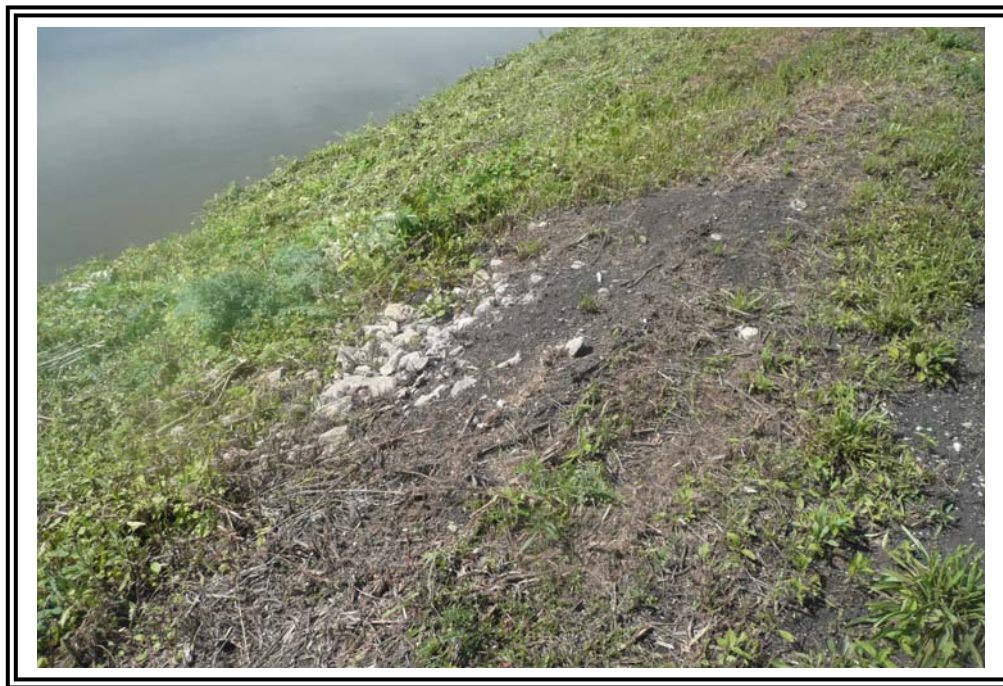
Along the west dike there are several signs of previous surface erosion features. AEP has repaired these as they occur. Photo 2 shows one of these repaired areas.

Erosion feature filling on the upstream slope of the west dike.

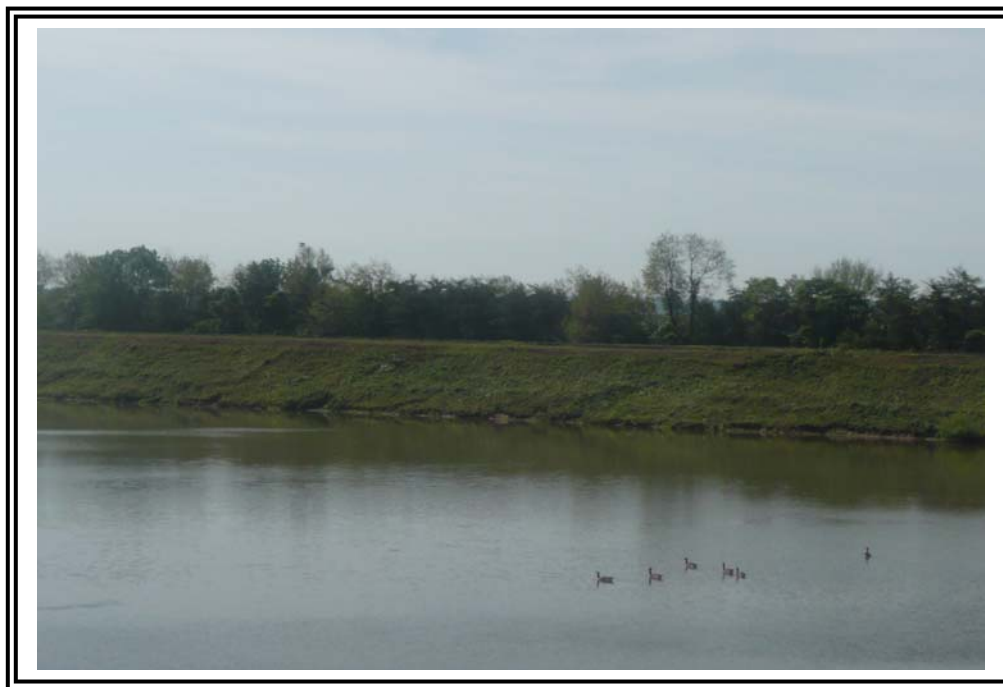
11

Upstream slope of the south dike, looking south. Note surficial sloughing.

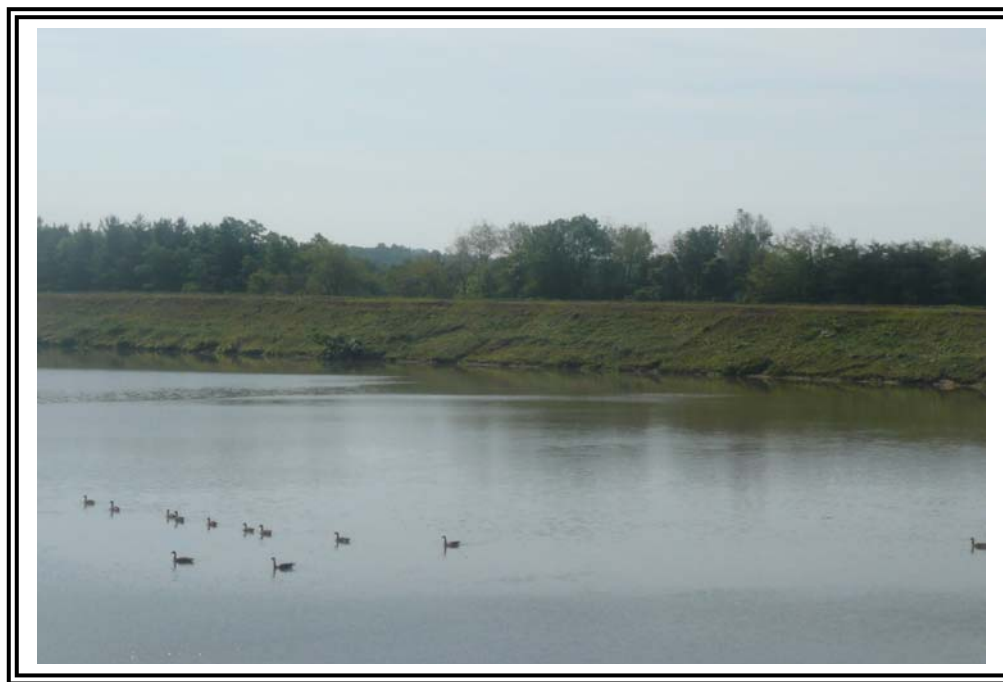
12

Upstream slope of the south dike, looking south. Note surficial sloughing.

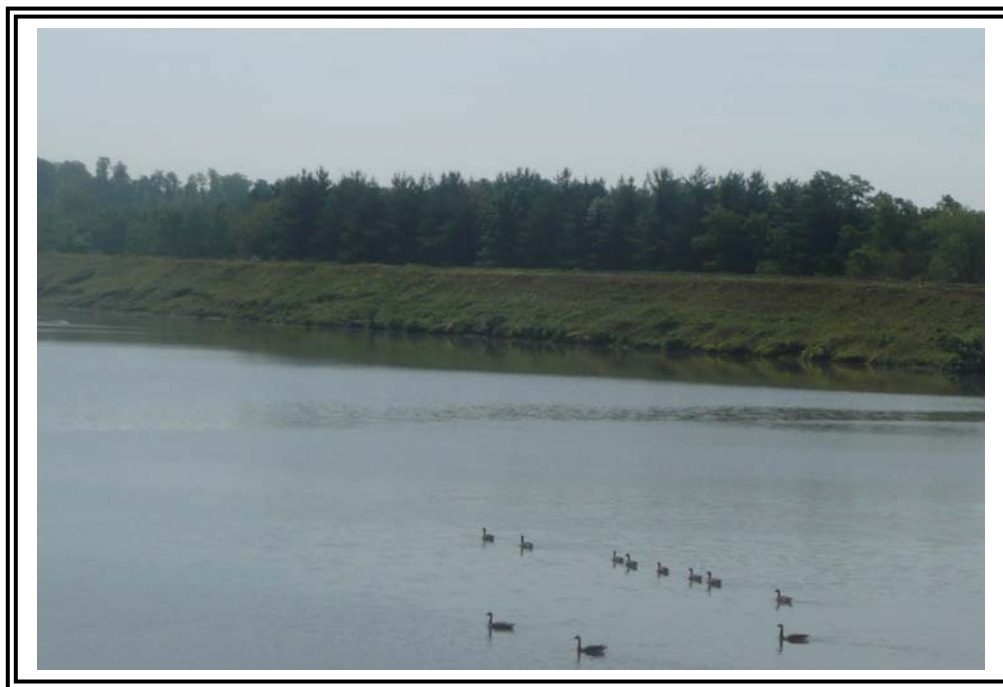
13

Upstream slope of the south dike, looking south. Note surficial sloughing.

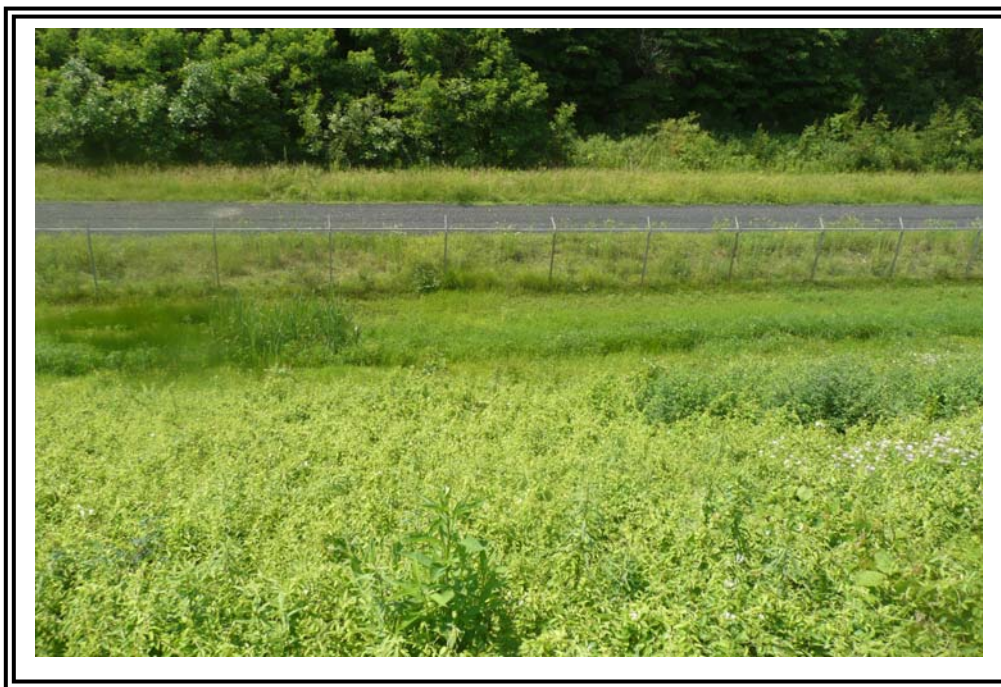
17

At about the mid point along the length of the south dike downstream slope, there is a wet area that has been noted in previous reports to be seepage. AEP personnel indicated that in February 2009 the storm water drainage from the field to the south of the Bottom Ash Pond was re-graded so rather than draining towards the Bottom Ash Pond, the runoff would run away from the Bottom Ash Pond. AEP indicated this appears to be largely improving the condition at the toe of the south dike. Piezometer readings indicate the groundwater table is about 18 feet below the toe of the south dike further suggesting that the observed water was perched on surface soil layers. No flow was observed in ponded water at the toe of the south dike.

Downstream slope of the south dike about mid-slope. Note cattails growing at the toe of the slope. This area has been reportedly a wet area, but AEP believes it is related to surface drainage and in the fall 2008 reset culverts crossing the adjacent access road to pitch away from the wet area and the conditions appears to be improving. Recent spring rains have resulted in standing water in this area.

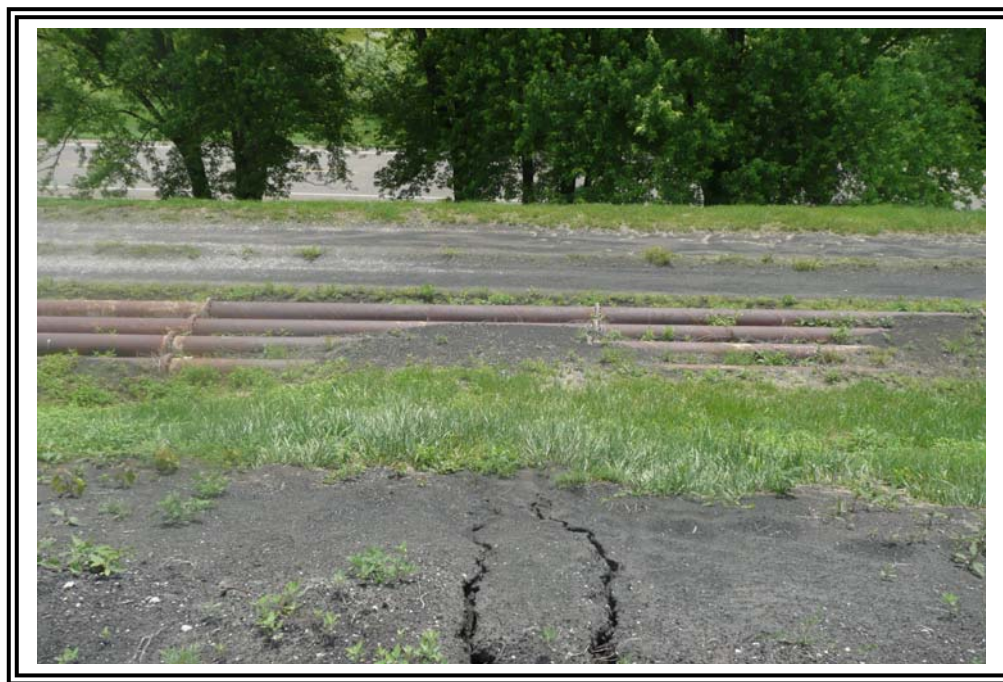
There were many areas of erosion gullies along the transition from the crest to the downstream slope. The deepest of these was 18 inches deep. There was evidence that the development of these is common and that AEP routinely repairs them as part of ongoing maintenance of the dikes. Photos 22 and 23 show a typical representation of these areas on the east dike.

Surface erosion features (typical) along graded ash at east dike upstream slope/crest transition.

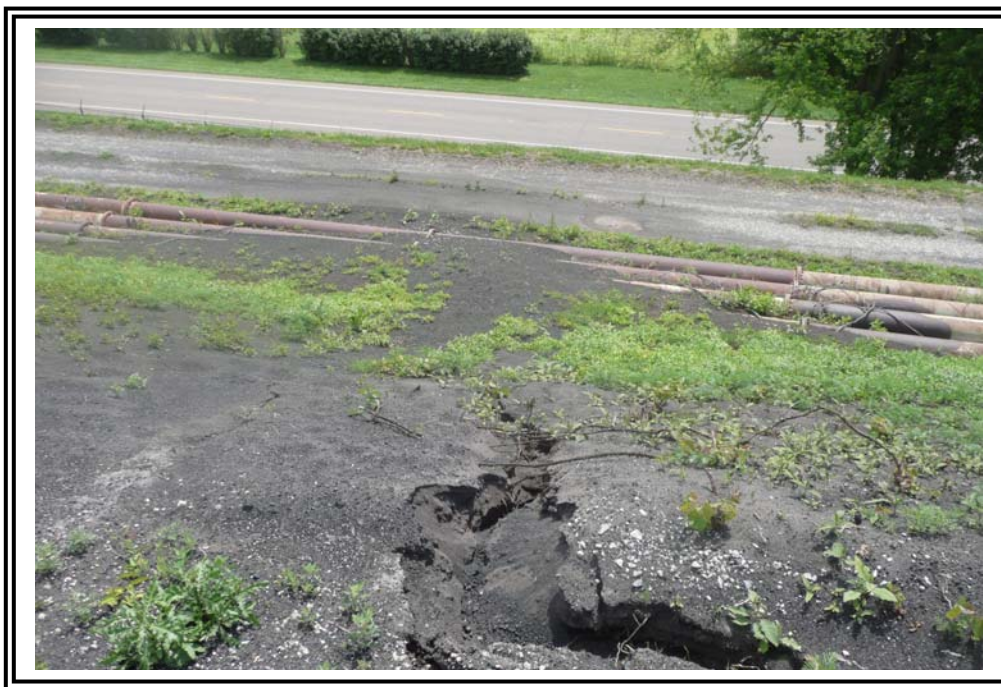
23

Surface erosion features (typical) along graded ash at east dike upstream slope/crest transition.

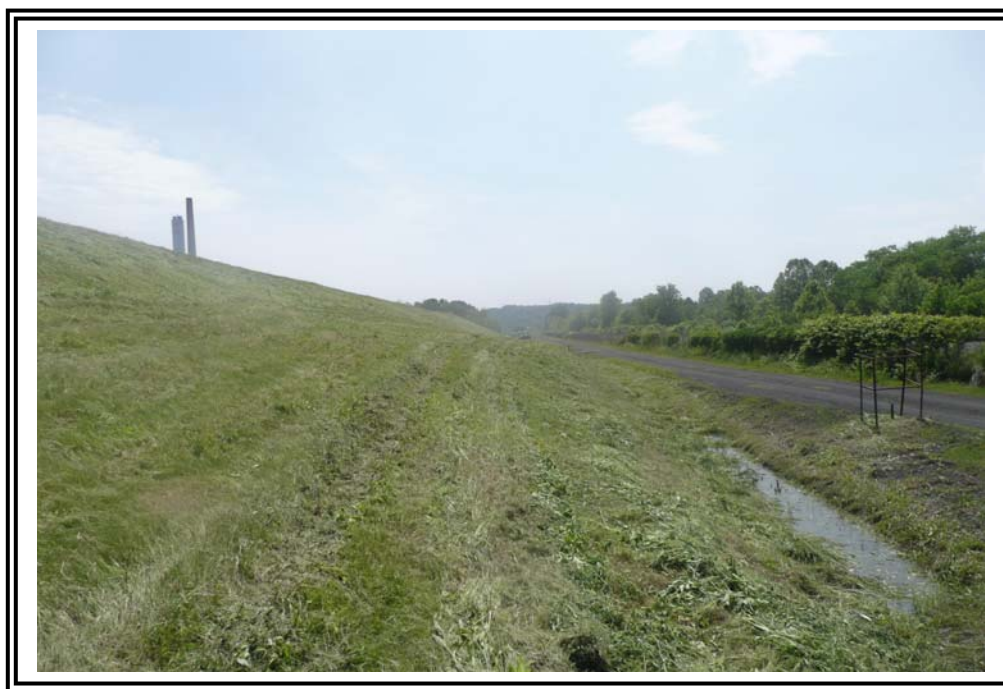
27

Previous reports indicated there is a bulge on the downstream slope of the west dike. CHA observed this area and did not see signs of current movement, nor an area above this slope where it appears that either the bulged soil came from or that the area was repaired. AEP should continue to monitor this area for changes as they have in the past.

Apparent bulge reported in previous reports along west dike. No signs of current movement.

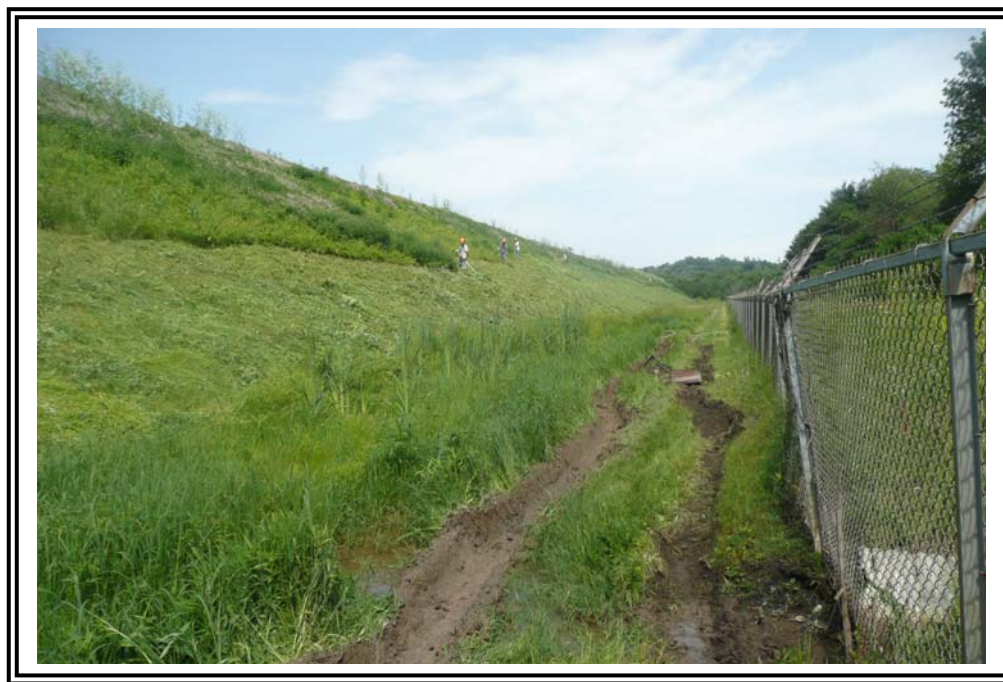
30

Downstream slope of south dike, looking east. Tractor ruts are in wet area at the toe where drainage backs up. This has been previously reported as a seepage area. Recent regrading to improve surface runoff appears to have dried this area and piezometer readings indicate the water table is below the toe of the dike.

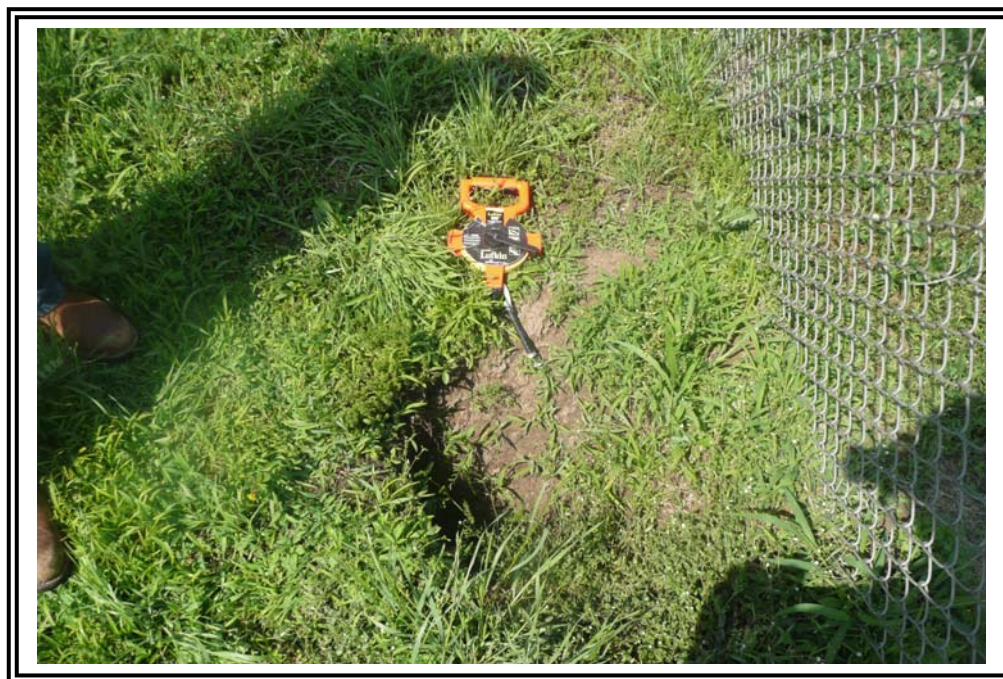
32

Along the east dike toe, several rodent holes were observed as shown in Photo 32. A few of these appeared to be plugged and AEP personnel indicated they have had to trap rodents from time to time. Some of the observed rodent holes may have been active, although it was difficult to distinguish.

Several rodent holes were noted on the downstream slope of the east dike. Some were plugged from previous AEP efforts to deter rodents and repair holes. Others were unidentifiable as active or abandoned holes.

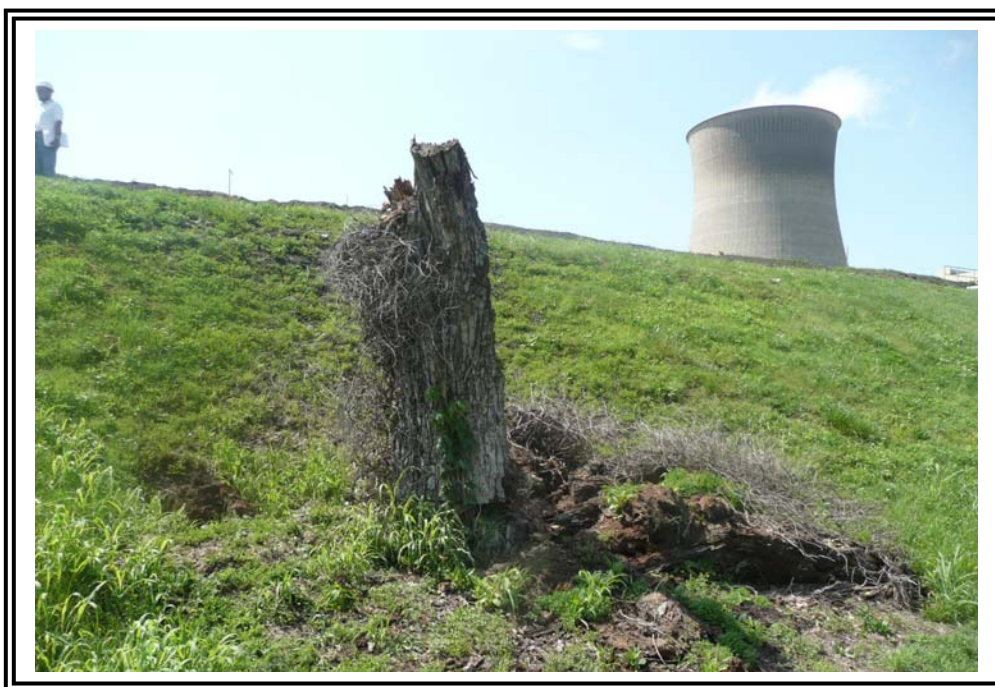
33

There are a few tree stumps along the toe of the east dike as shown in Photo 33. AEP personnel did not know when these trees were cut or why the bench with the access road was apparently constructed around them. These stumps should be monitored for decay and the stumps and associated root balls removed as a maintenance task in the next 2 to 5 years under the direction of a professional engineer.

Several tree stumps noted on the downstream slope of the east dike (others except this one were cut flush to ground surface). This is in the benched out area of the east dike.

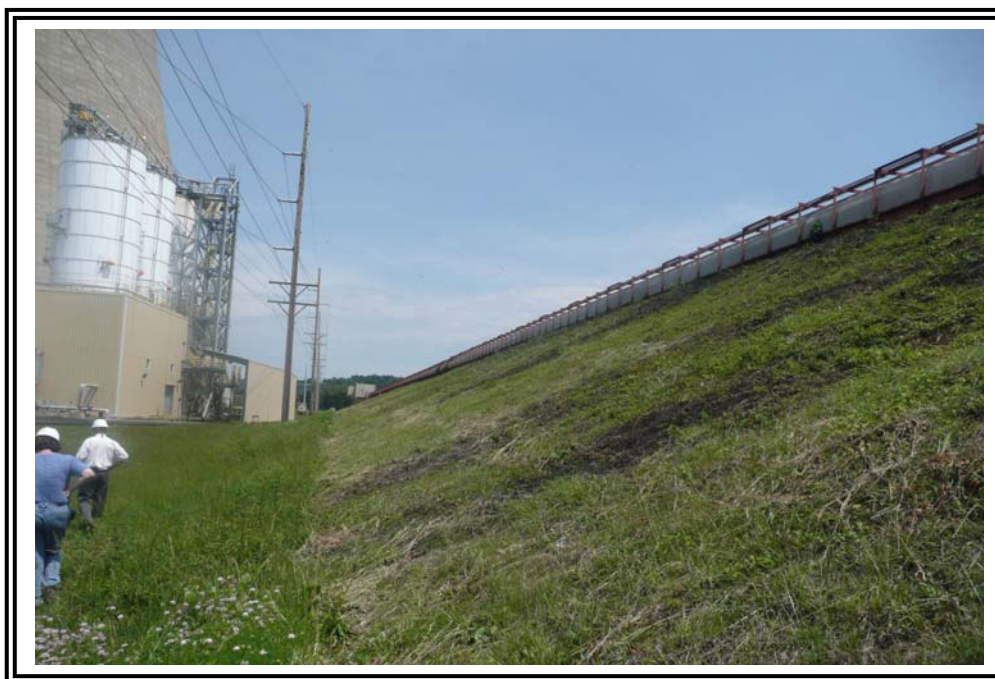
34

Downstream slope of north dike, looking east. Note dark areas in the grass on the slope are coal residue runoff from flushing the coal conveyor to remove dust buildup.

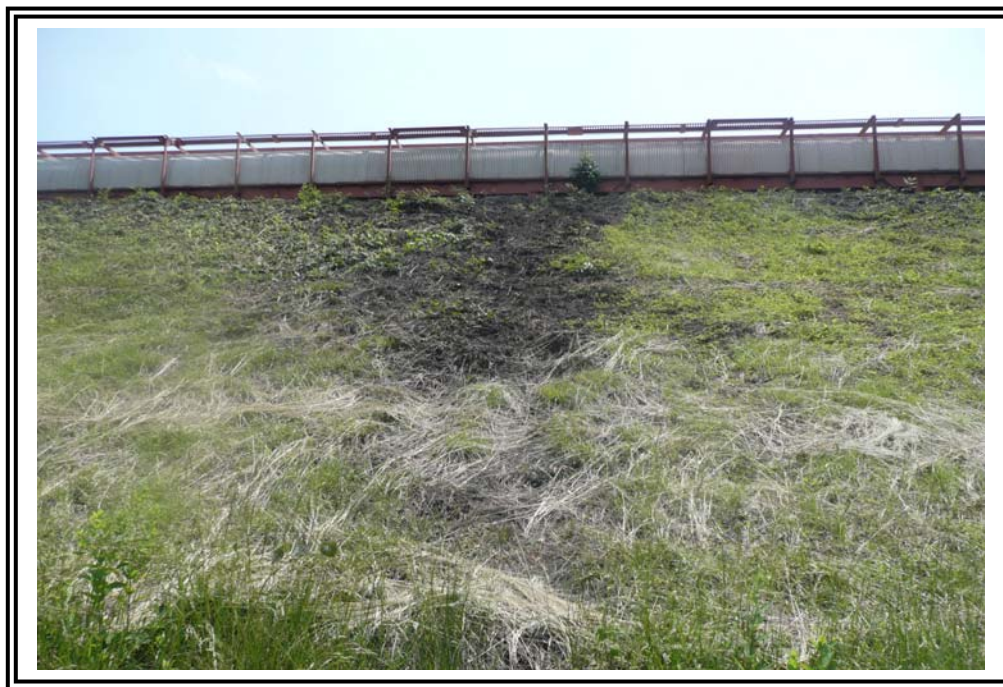
35

Close-up of one area of coal residue from coal conveyor flushing.

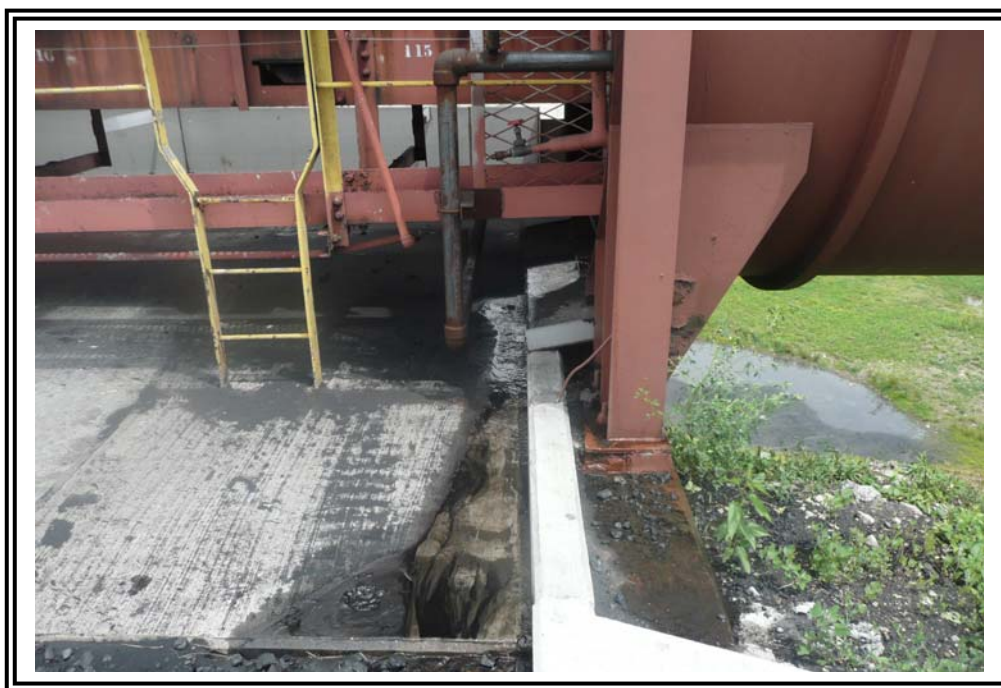
44

In 2008 a concrete pad and knee wall was placed under the coal conveyor at this location to minimize the impact of routine cleaning of the coal conveyor on the dike. The runoff now flows across the crest and drains to the pond.

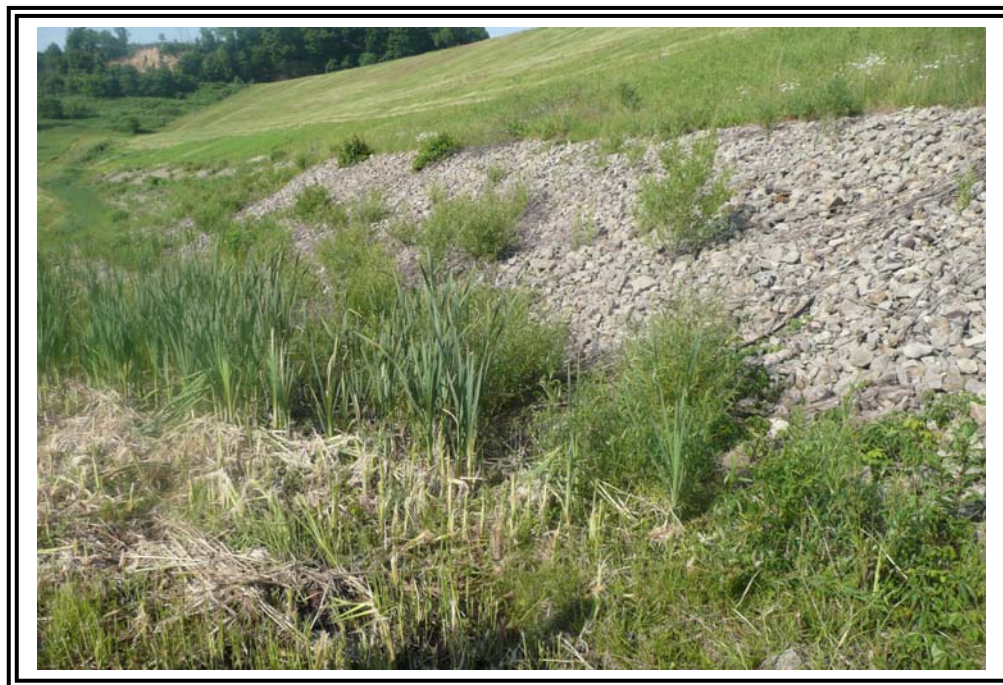
52

Toe drain area shows vegetative signs of being perennially wet.

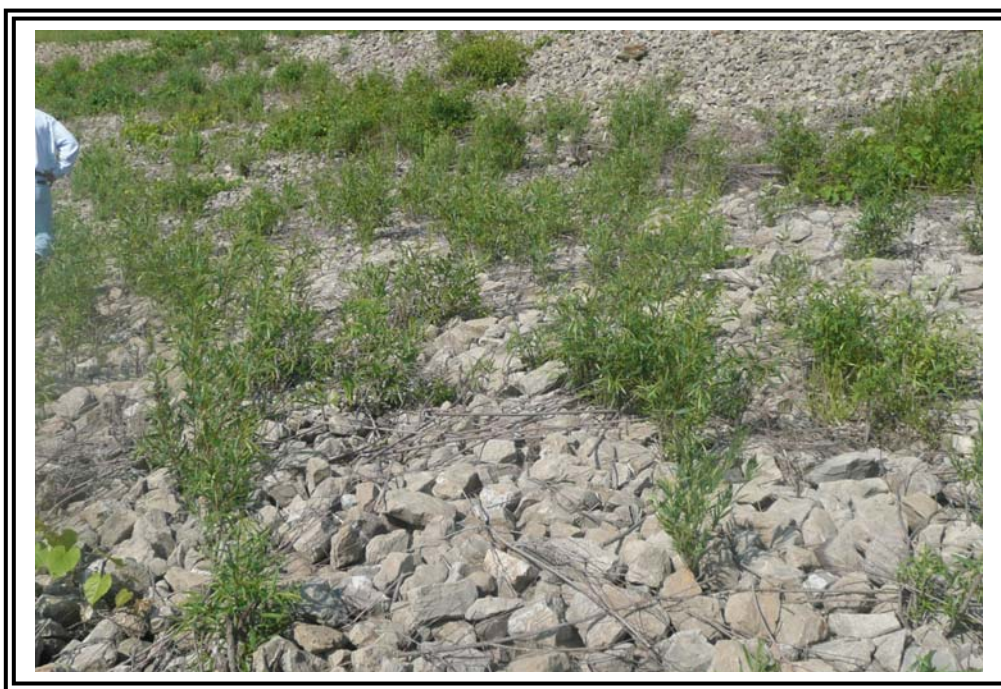
53

Vegetative growth within toe drain rip rap.

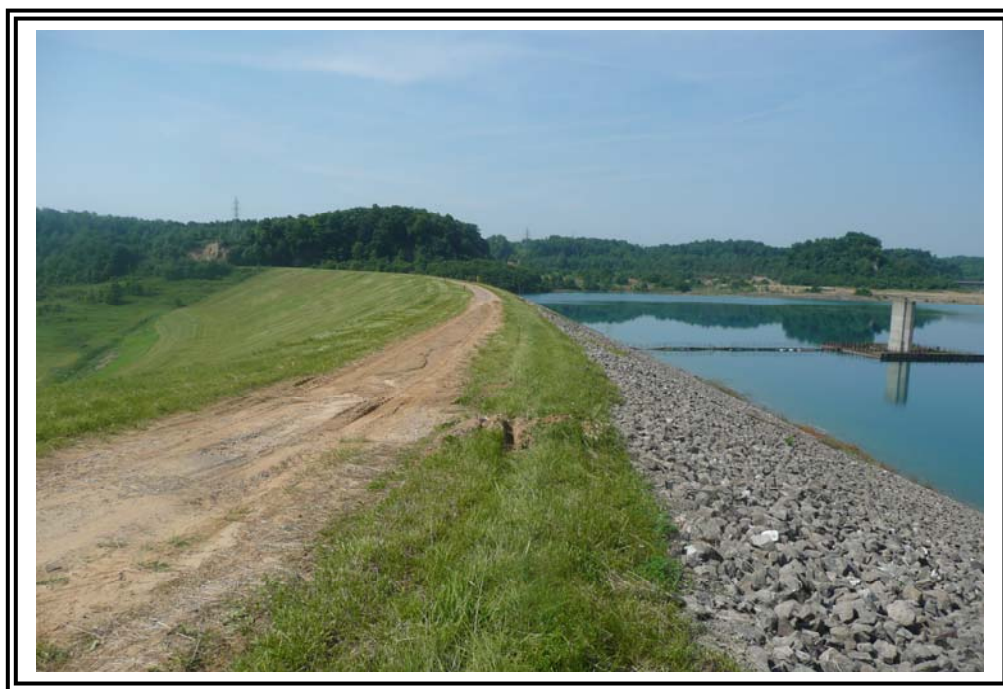
61

Dam crest from left (south) Abutment. Note area of tire ruts appears to be from wet area resulting from runoff from the abutment.

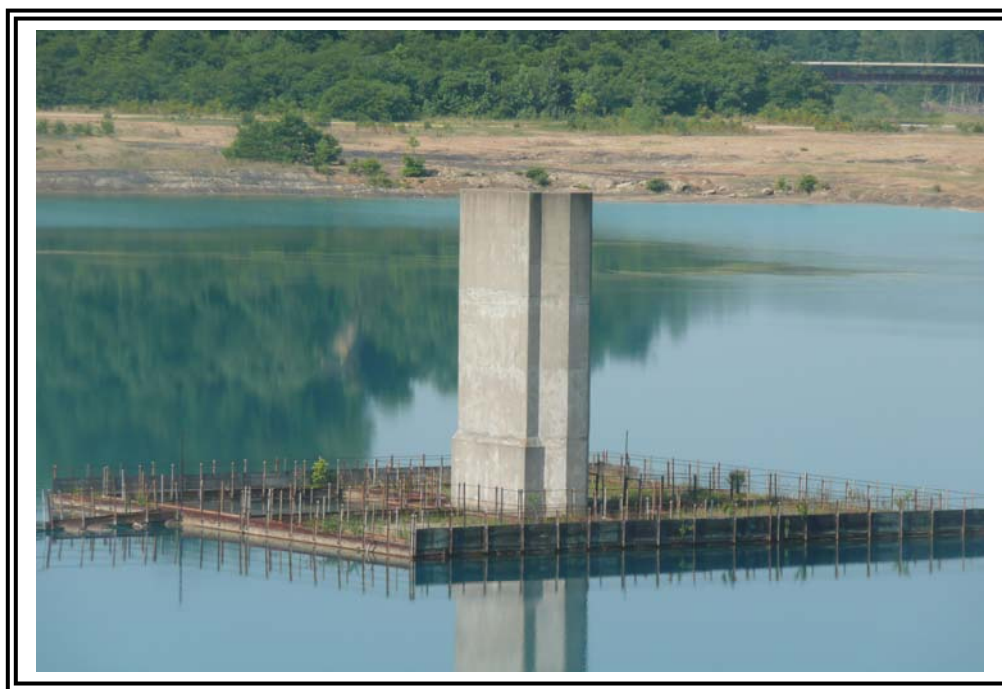
The Intake Tower in Stingy Run Dam was inaccessible at the time of our visit. The floating access bridge to the tower is severely deteriorated and AEP blocked it off in 2008. Photos 65 and 66 show the tower and access bridge.

The intake tower was inaccessible due to recent (spring 2009) closing of floating access bridge due to safety concerns.

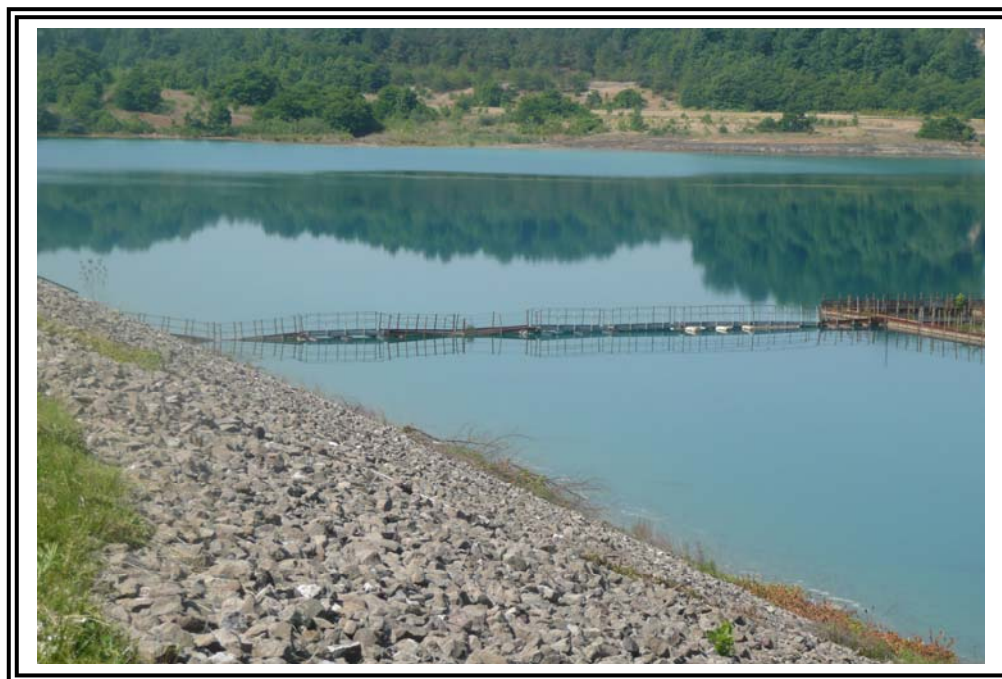
66

Floating Bridge to Intake Tower. Note the deteriorated condition of this structure resulted in AEP closing it in the spring of 2009.
