# Assessment of Dam Safety

## Coal Combustion Surface Impoundments (Task 3)

### Final Report

American Electric Power  
General James Gavin  
Power Plant  
Cheshire, Ohio

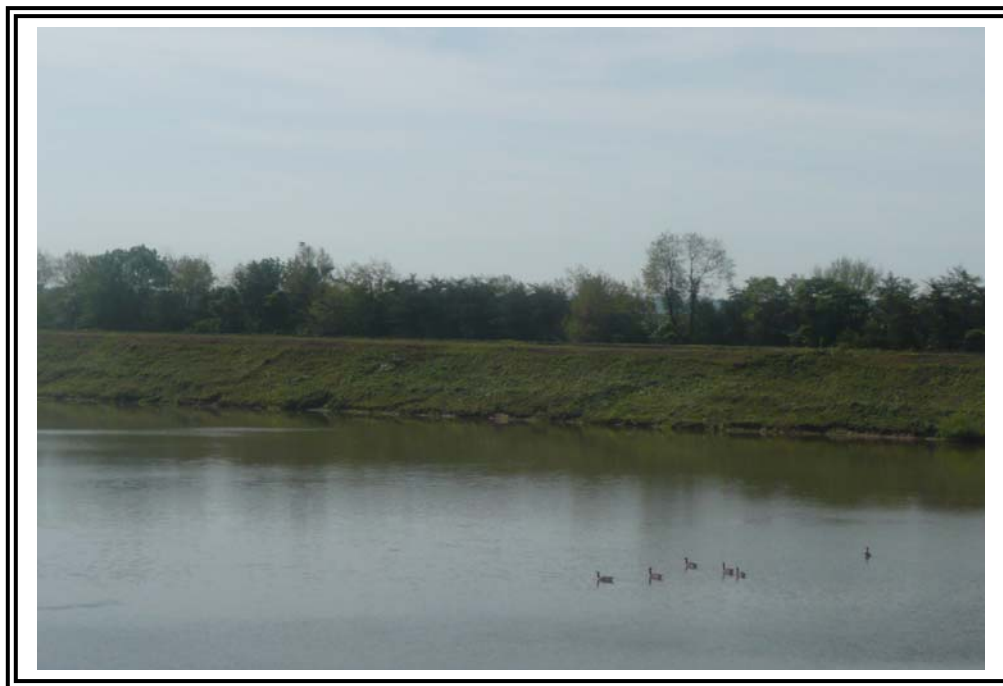
11

Upstream slope of the south dike, looking south. Note surficial sloughing.

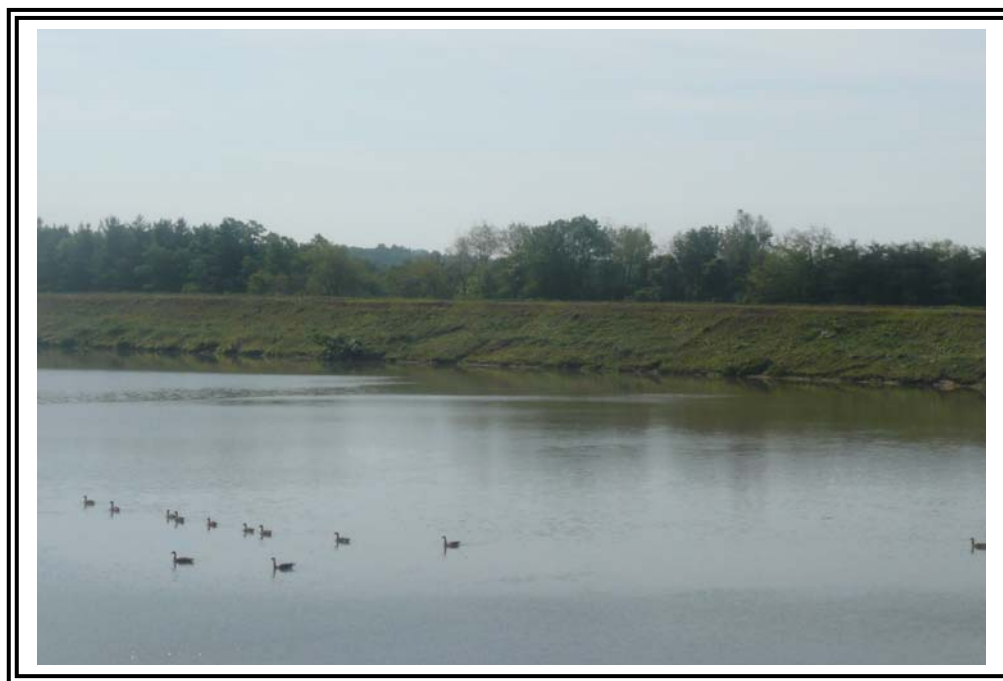
12

Upstream slope of the south dike, looking south. Note surficial sloughing.

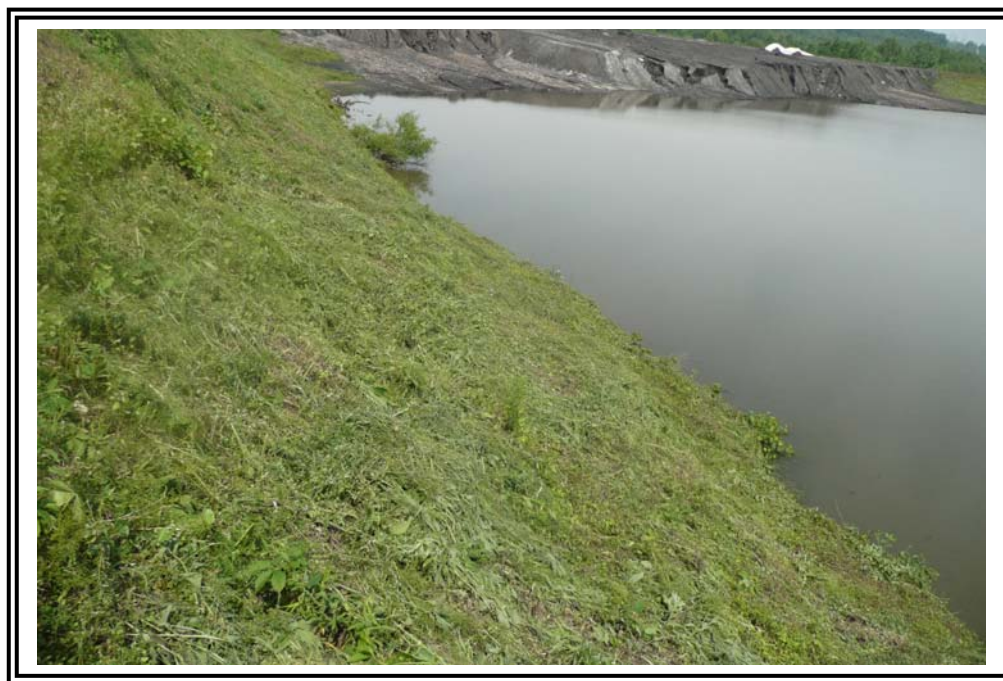
14

Close up of surficial slough on the upstream slope of the south dike, looking west.

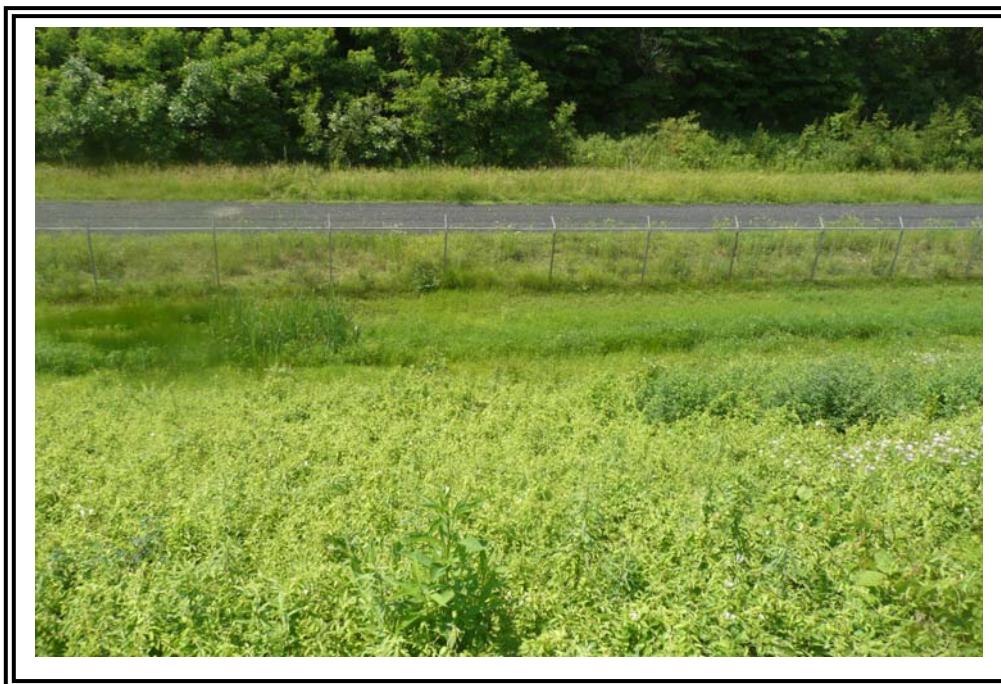
17

At about the mid point along the length of the south dike downstream slope, there is a wet area that has been noted in previous reports to be seepage. AEP personnel indicated that in February 2009 the storm water drainage from the field to the south of the Bottom Ash Pond was re-graded so rather than draining towards the Bottom Ash Pond, the runoff would run away from the Bottom Ash Pond. AEP indicated this appears to be largely improving the condition at the toe of the south dike. Piezometer readings indicate the groundwater table is about 18 feet below the toe of the south dike further suggesting that the observed water was perched on surface soil layers. No flow was observed in ponded water at the toe of the south dike.

Downstream slope of the south dike about mid-slope. Note cattails growing at the toe of the slope. This area has been reportedly a wet area, but AEP believes it is related to surface drainage and in the fall 2008 reset culverts crossing the adjacent access road to pitch away from the wet area and the conditions appears to be improving. Recent spring rains have resulted in standing water in this area.

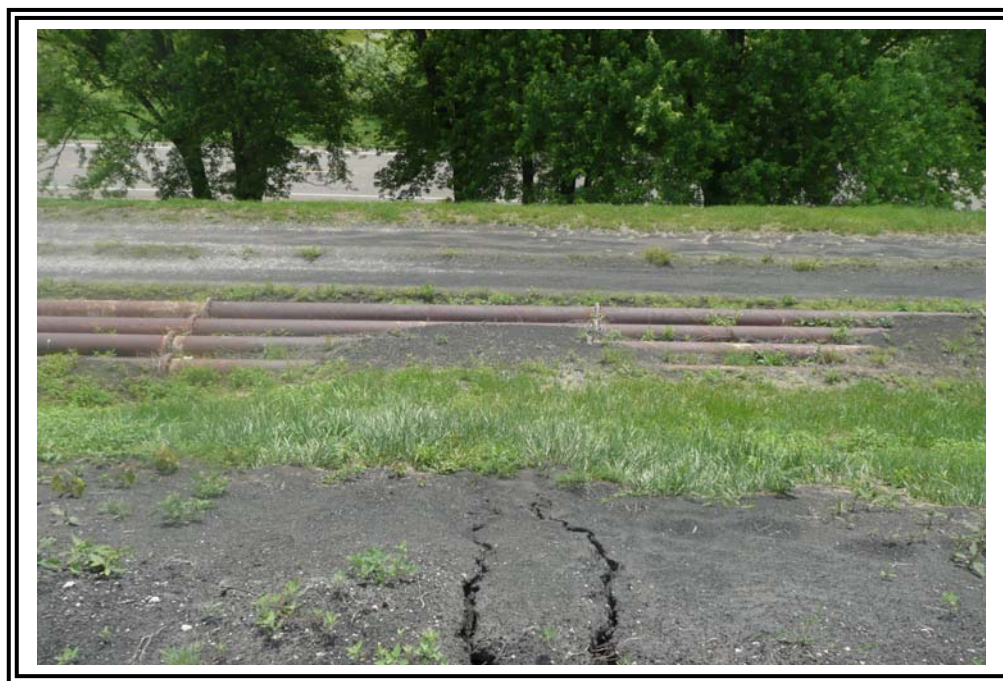
There were many areas of erosion gullies along the transition from the crest to the downstream slope. The deepest of these was 18 inches deep. There was evidence that the development of these is common and that AEP routinely repairs them as part of ongoing maintenance of the dikes. Photos 22 and 23 show a typical representation of these areas on the east dike.

Surface erosion features (typical) along graded ash at east dike upstream slope/crest transition.

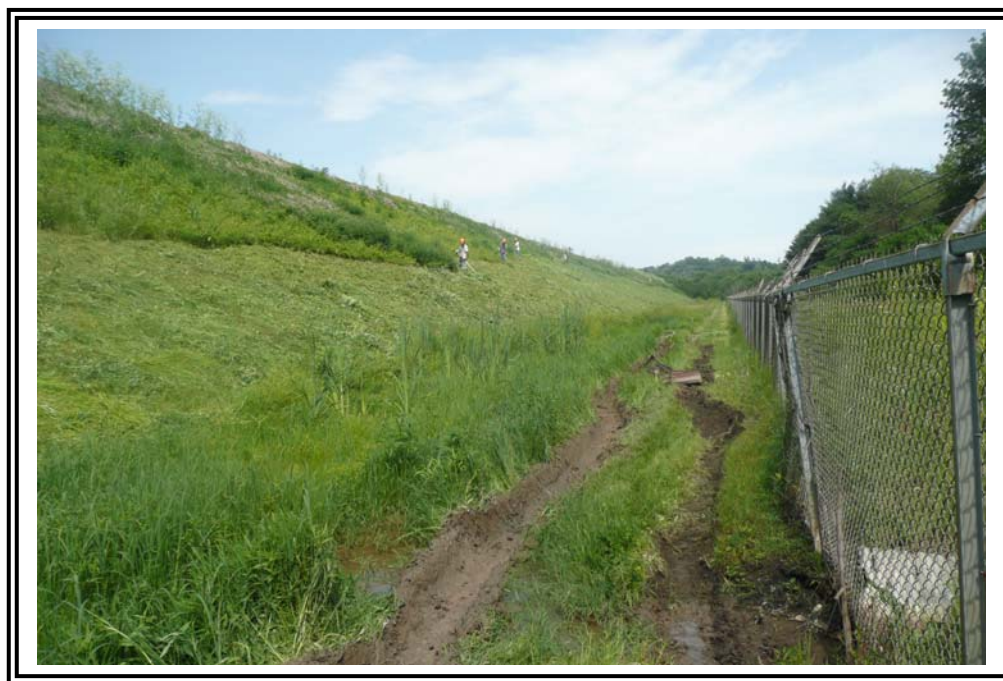
30

Downstream slope of south dike, looking east. Tractor ruts are in wet area at the toe where drainage backs up. This has been previously reported as a seepage area. Recent regrading to improve surface runoff appears to have dried this area and piezometer readings indicate the water table is below the toe of the dike.

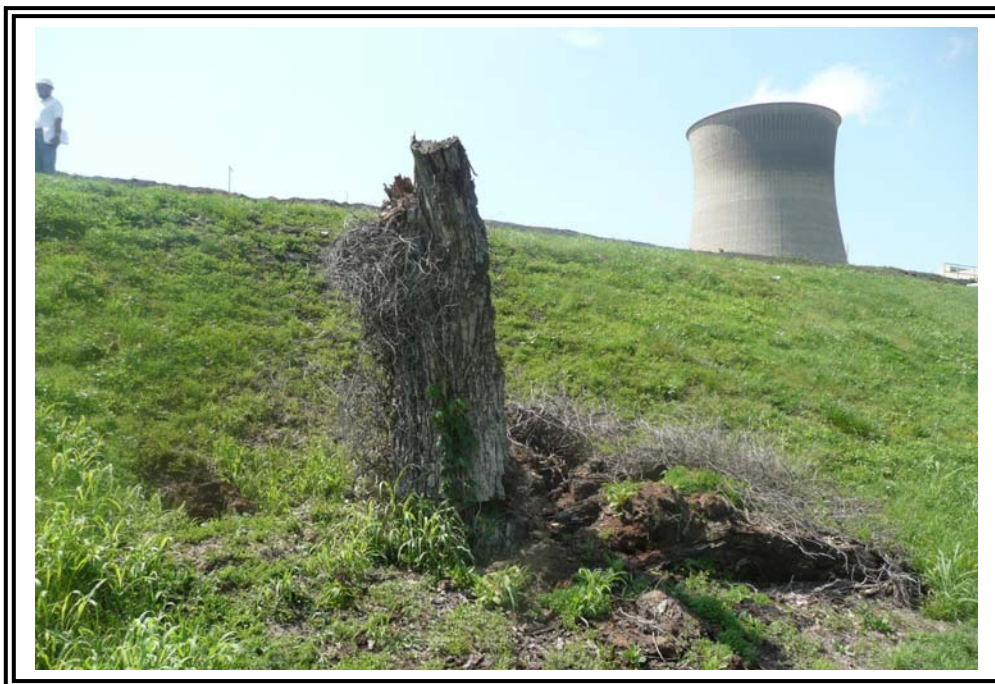
33

There are a few tree stumps along the toe of the east dike as shown in Photo 33. AEP personnel did not know when these trees were cut or why the bench with the access road was apparently constructed around them. These stumps should be monitored for decay and the stumps and associated root balls removed as a maintenance task in the next 2 to 5 years under the direction of a professional engineer.

Several tree stumps noted on the downstream slope of the east dike (others except this one were cut flush to ground surface). This is in the benched out area of the east dike.

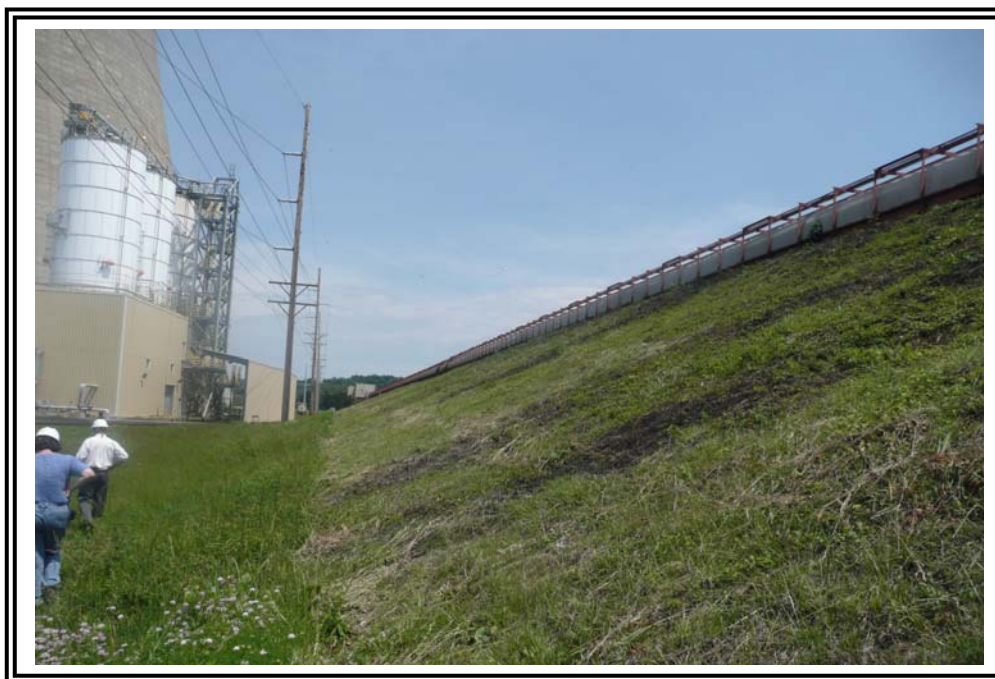
34

Downstream slope of north dike, looking east. Note dark areas in the grass on the slope are coal residue runoff from flushing the coal conveyor to remove dust buildup.

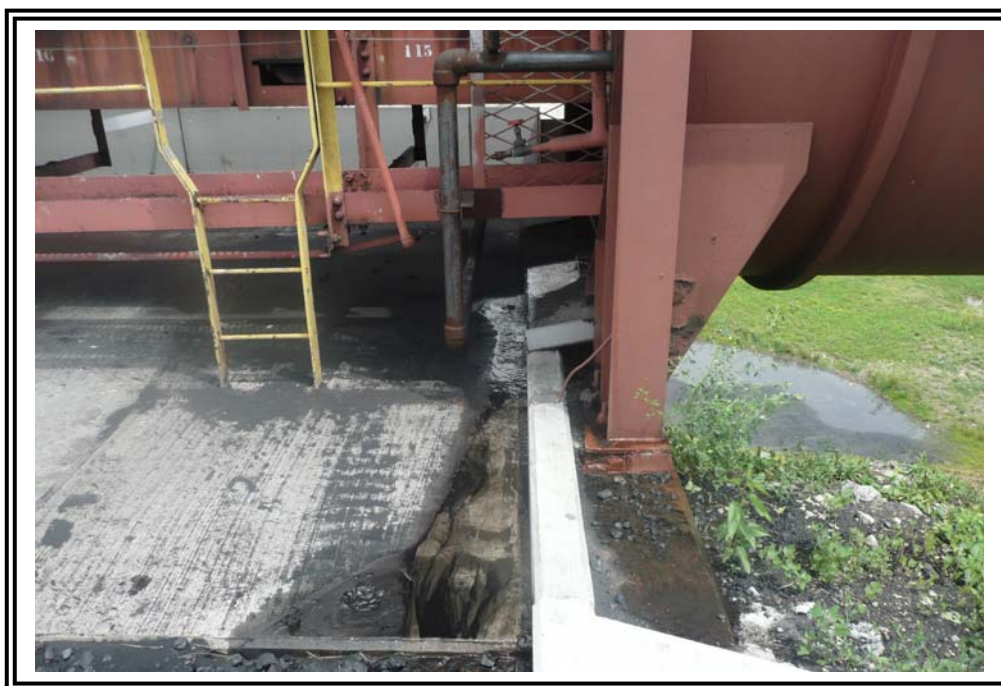
44

In 2008 a concrete pad and knee wall was placed under the coal conveyor at this location to minimize the impact of routine cleaning of the coal conveyor on the dike. The runoff now flows across the crest and drains to the pond.

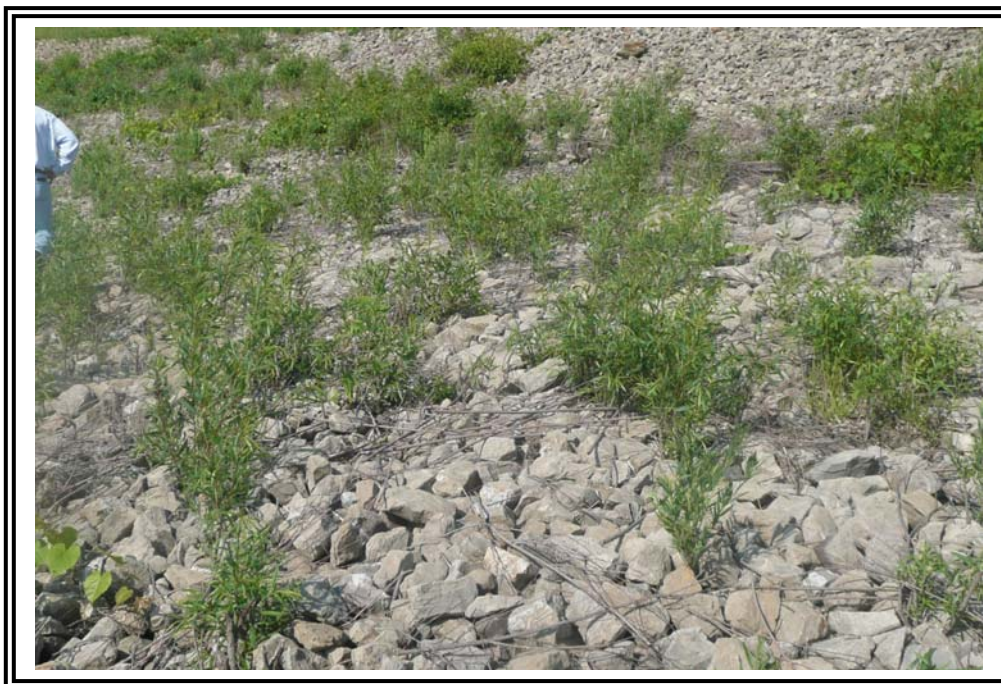
53

Vegetative growth within toe drain rip rap.

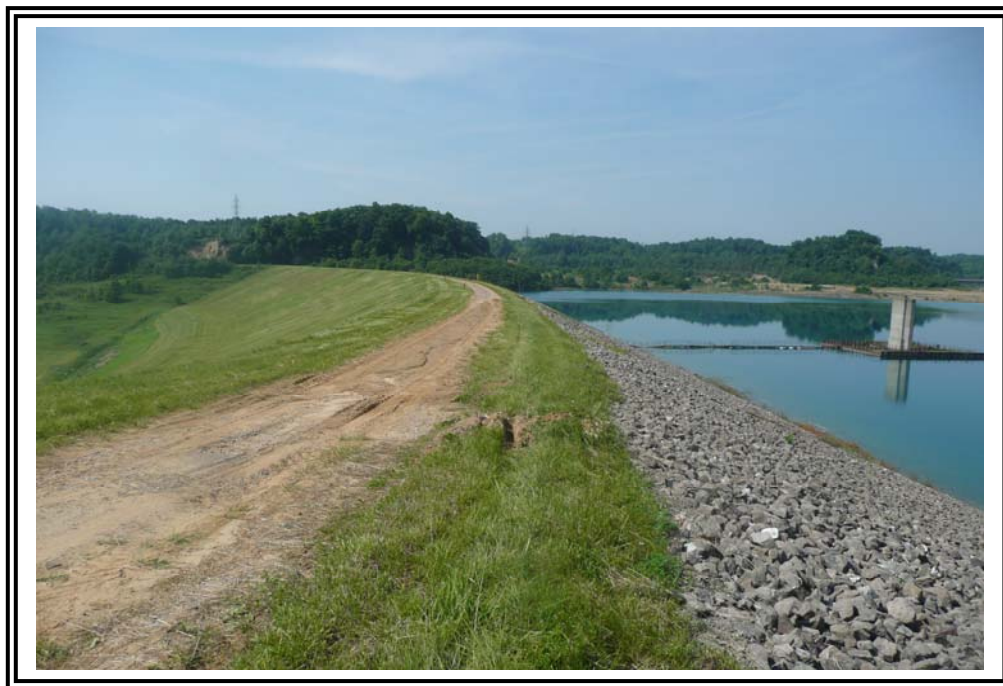
61

Dam crest from left (south) abutment. Note area of tire ruts appears to be from wet area resulting from runoff from the abutment.

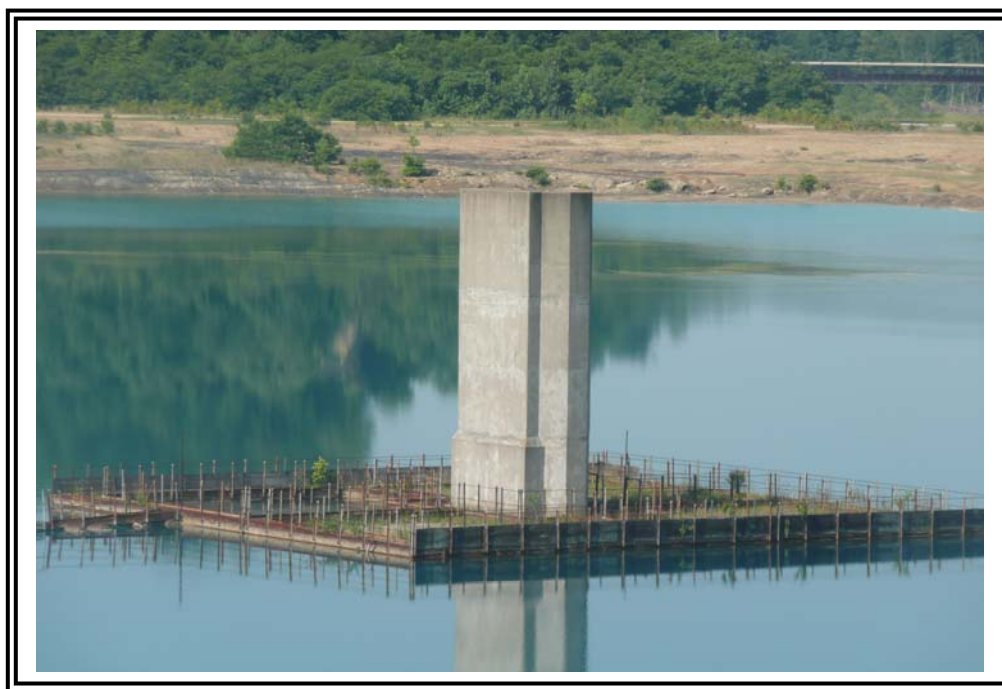
The intake tower in Stingy Run Dam was inaccessible at the time of our visit. The floating access bridge to the tower is severely deteriorated and AEP blocked it off in 2008. Photos 65 and 66 show the tower and access bridge.

The intake tower was inaccessible due to recent (spring 2009) closing of floating access bridge due to safety concerns.
