**CCW IMPOUNDMENTS
INSPECTION REPORT**

**MITCHELL POWER PLANT
MARSHALL COUNTY,
WEST VIRGINIA**

**PROJECT NO. 09-4157
OCTOBER 2009**

**TRANSMITTAL
ASSESSMENT OF DAM SAFETY OF
COAL COMBUSTION SURFACE IMPOUNDMENTS
DRAFT INSPECTION REPORT
SITE 24 (MITCHELL)**

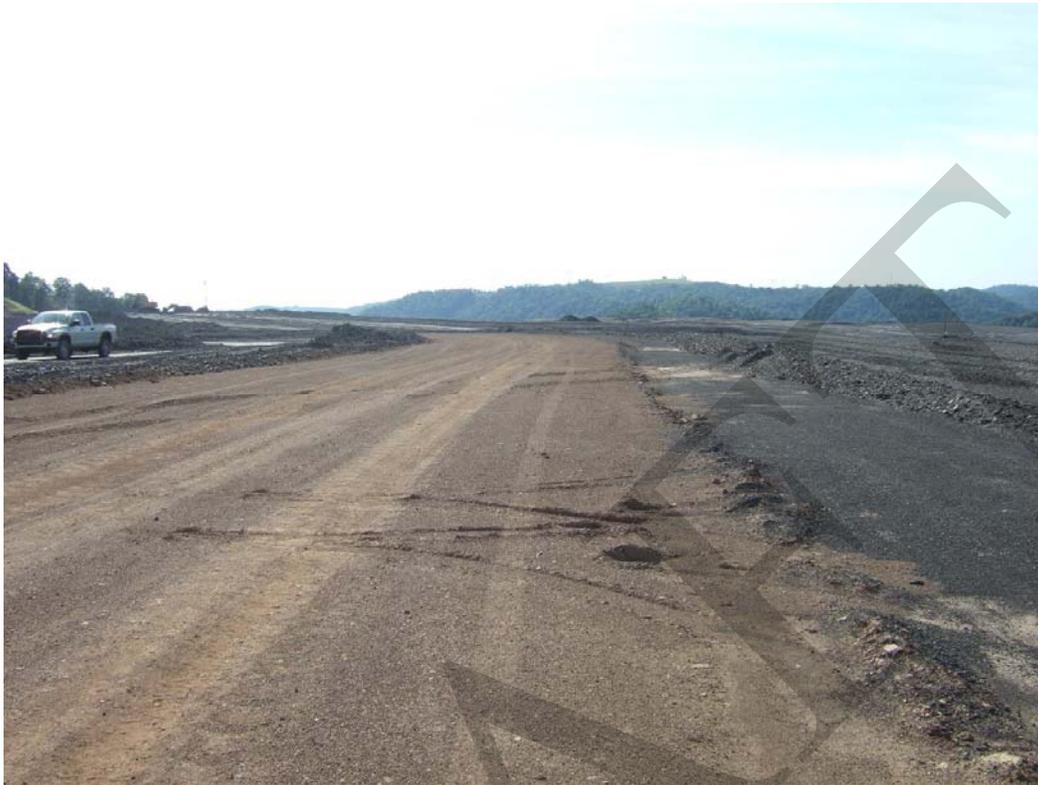
PHOTO 5: CLAY CORE ALONG CREST OF CONNER RUN DAM

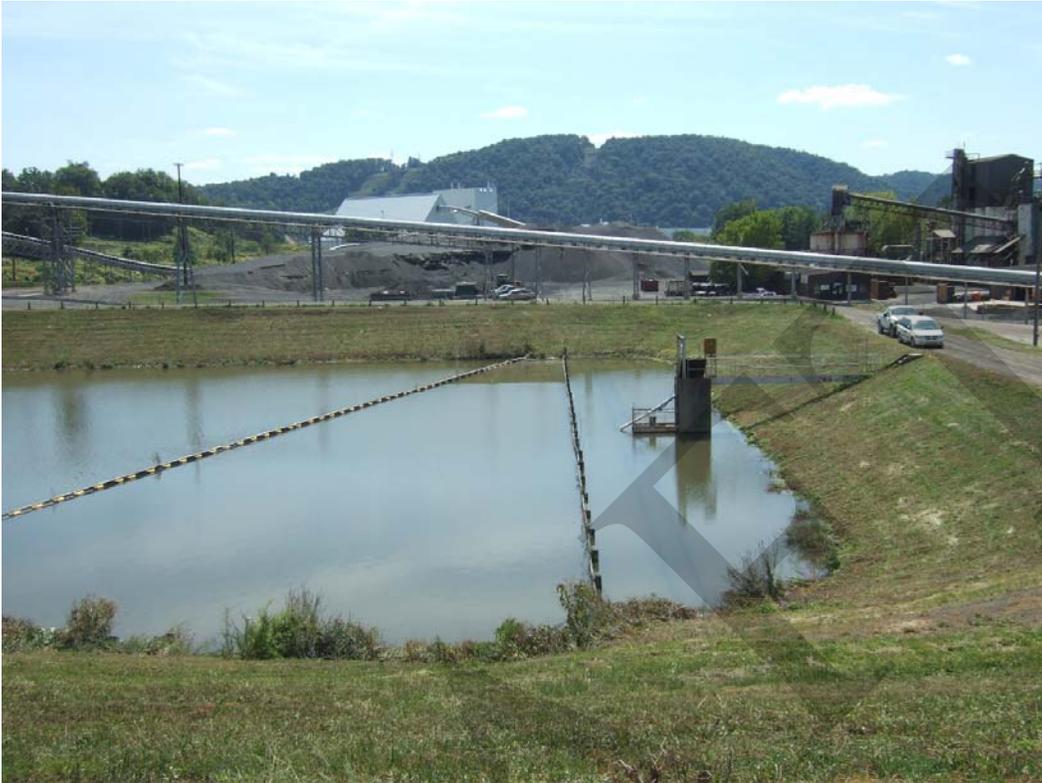
PHOTO 37: NORTH WEST CORNER OF CLEAR WATER POND
