Mountaineer Bottom Ash Complex Report

**Lockheed Martin
Contractor for the USEPA**

October 2009

Mountaineer Bottom Ash Complex Assessment Report

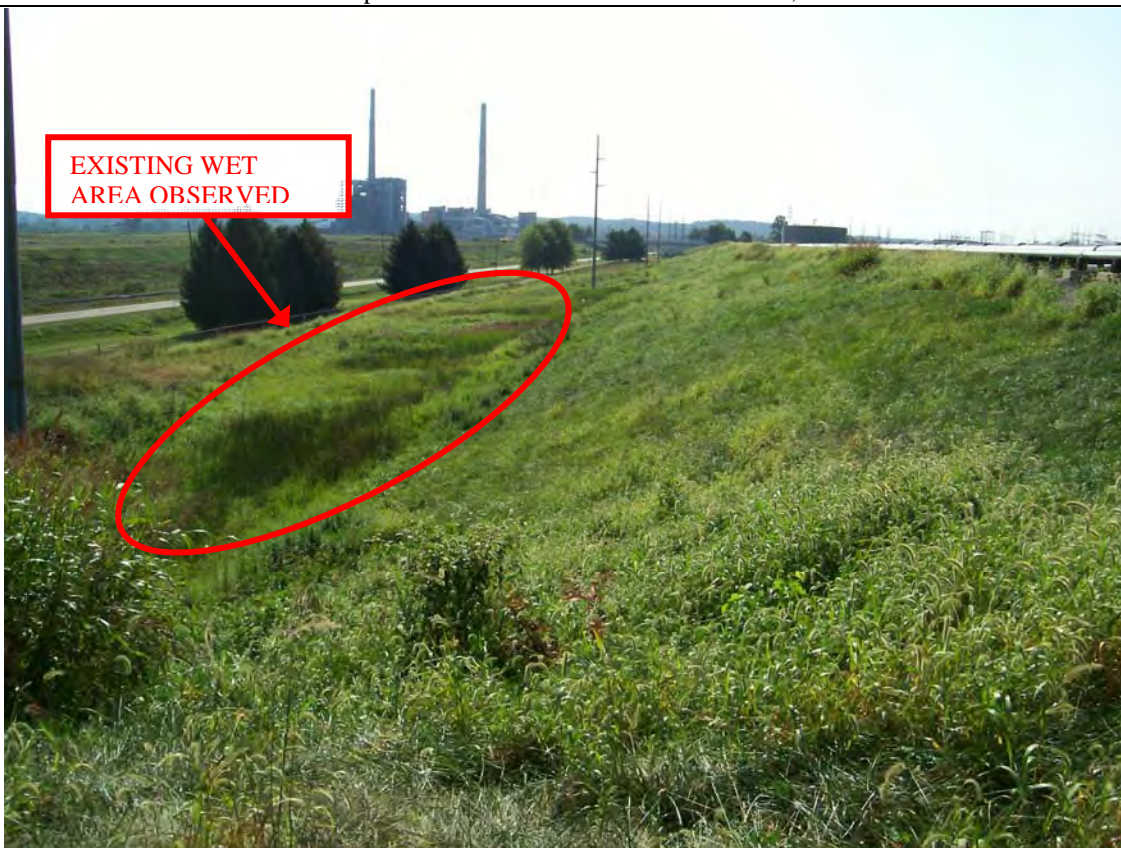
Photo Number: 1

- A large wet area was observed at the toe of the north portion of the east embankment (Appendix B – Photo 1).
- A small wet area was observed at the toe of the central portion of the north embankment (Appendix B – Photo 2).

The wet area observed at the toe of slope near the north end of the east dike was cause for a recent investigation of the dike's stability. The March 2009 report by H.C. Nutting indicates that the dike meets minimum slope stability criteria under the current conditions. Review of historic records indicates that the observed conditions have persisted since the impoundment was constructed. H.C. Nutting's recommendation that means be developed for positive drainage of the wet area is appropriate.

Description: View along downstream side of east embankment. Note poorly drained area at toe as described in report.

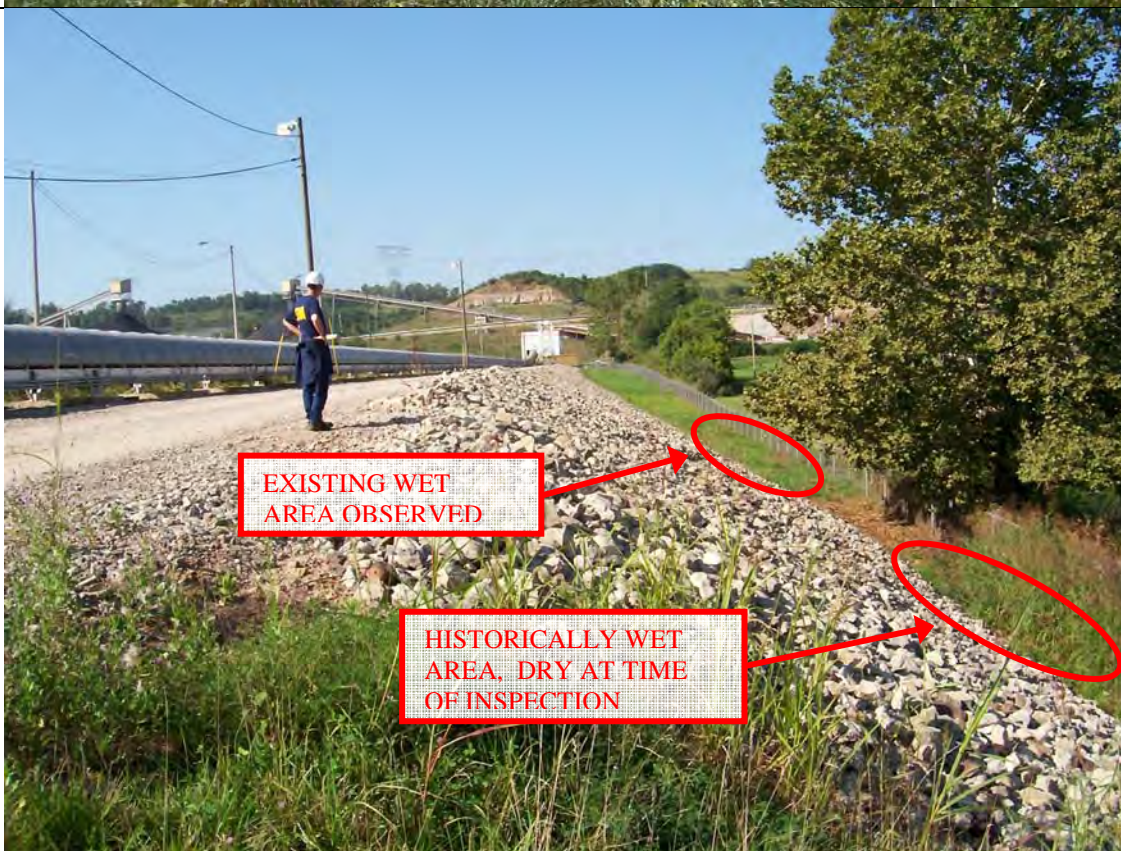
Photo Number: 2

Description: View along downstream side of north embankment. Note historically wet area and existing wet area at toe.

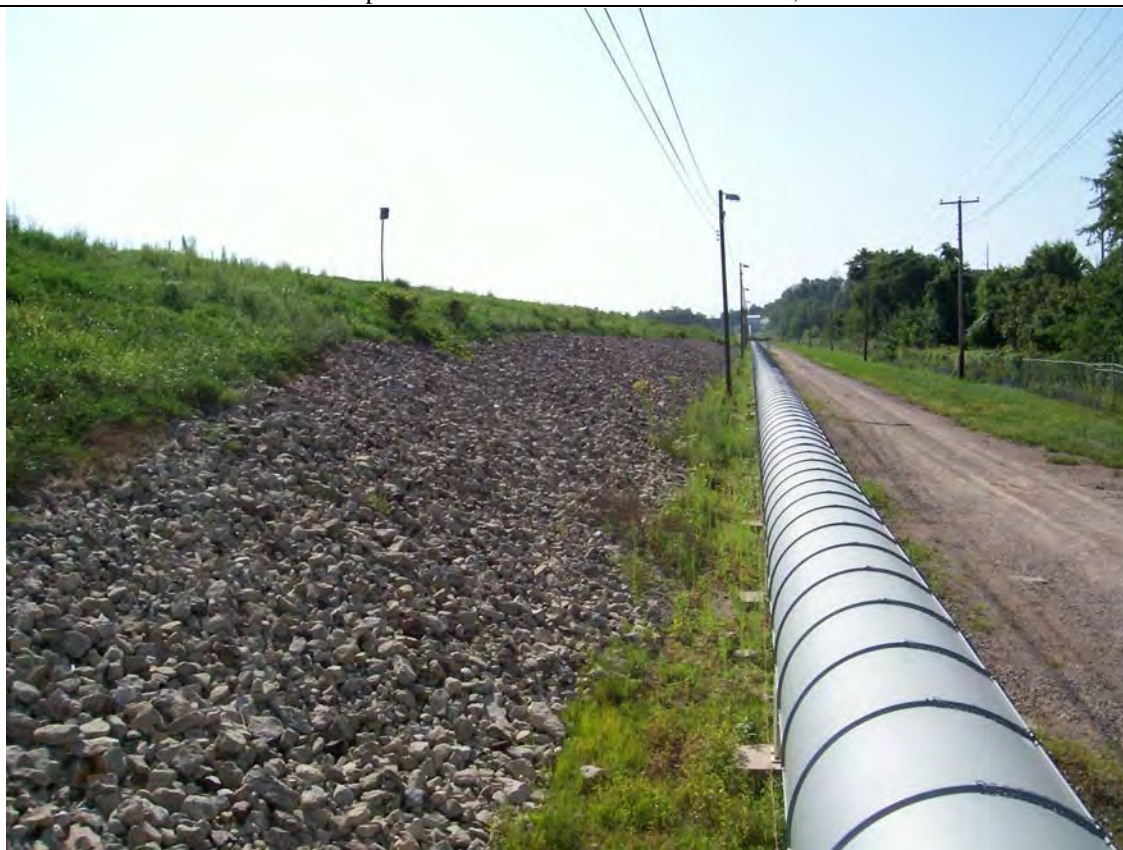
Photo Number:
3

Description:
View along
downstream
side of west
embankment.
Area of
embankment
covered by rip
rap was cut
away to make
way for covered
conveyor show
at right.

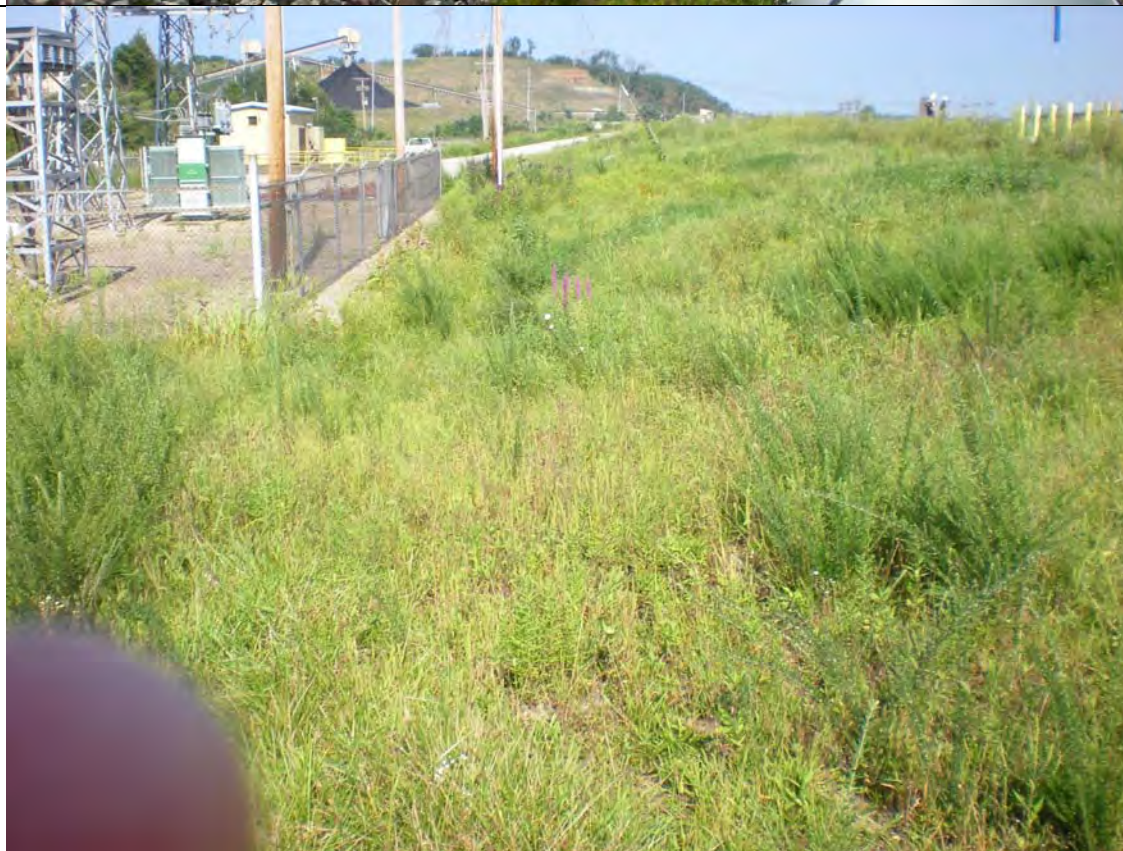
Photo Number:
4

Description:
View along
downstream
side of west
embankment.

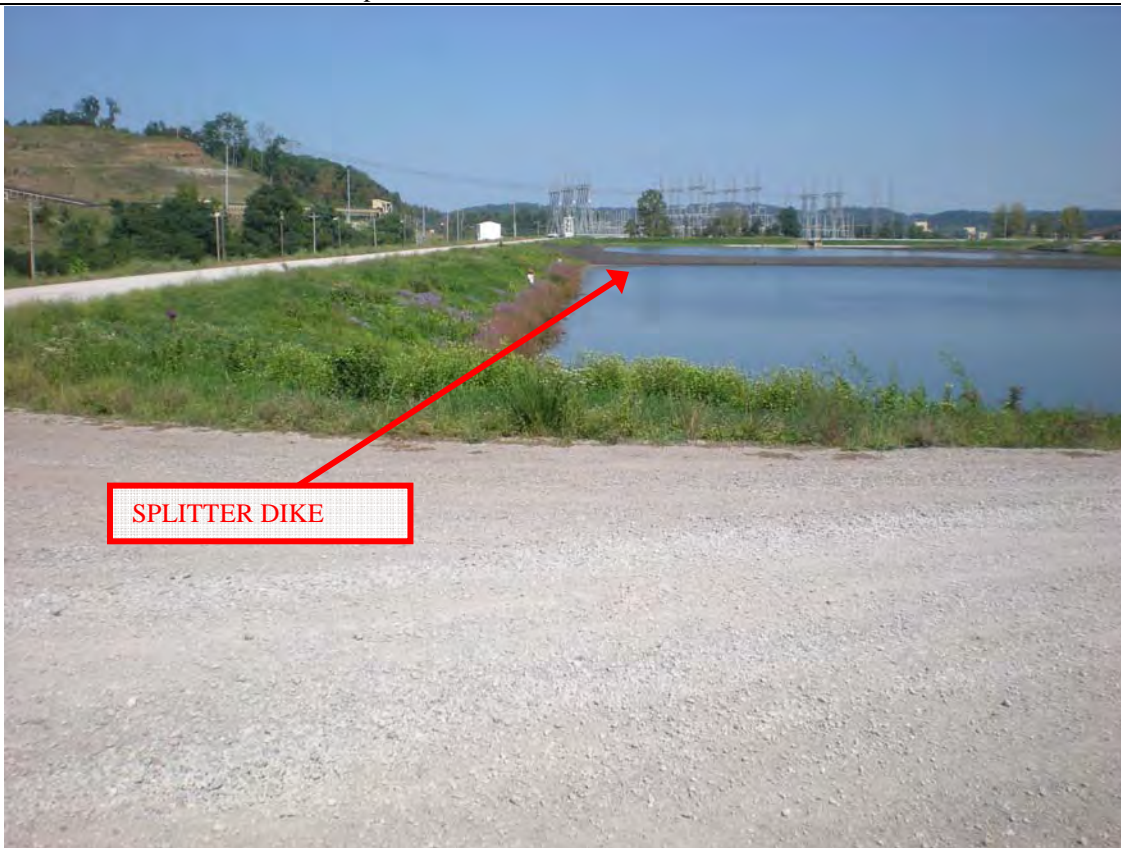
Photo Number:
5

Description:
View along upstream side of west embankment across West Bottom Ash Pond. Note "splitter" dike in pond to prevent short circuiting of flow and contain ash to north end of pond.

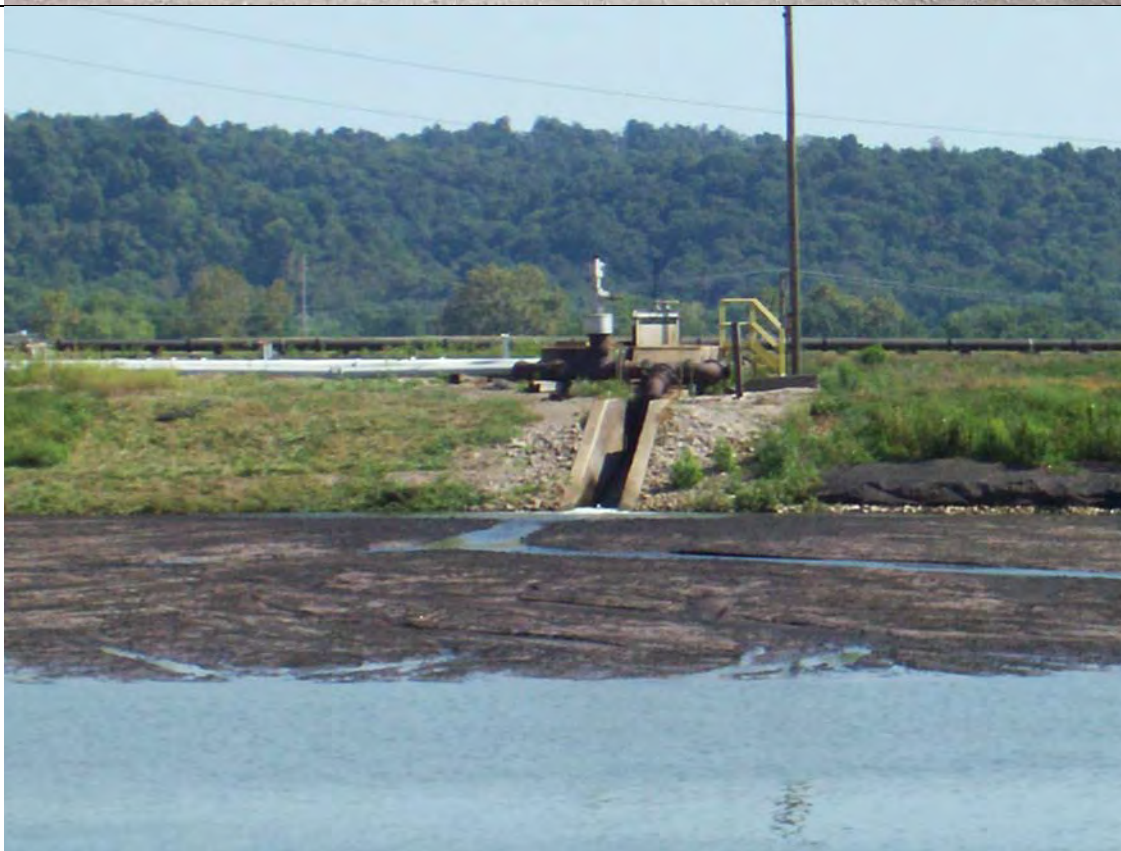
Photo Number:
6

Description:
Inlet to West Bottom Ash Pond. Bottom Ash slurry enters the pond at this point.

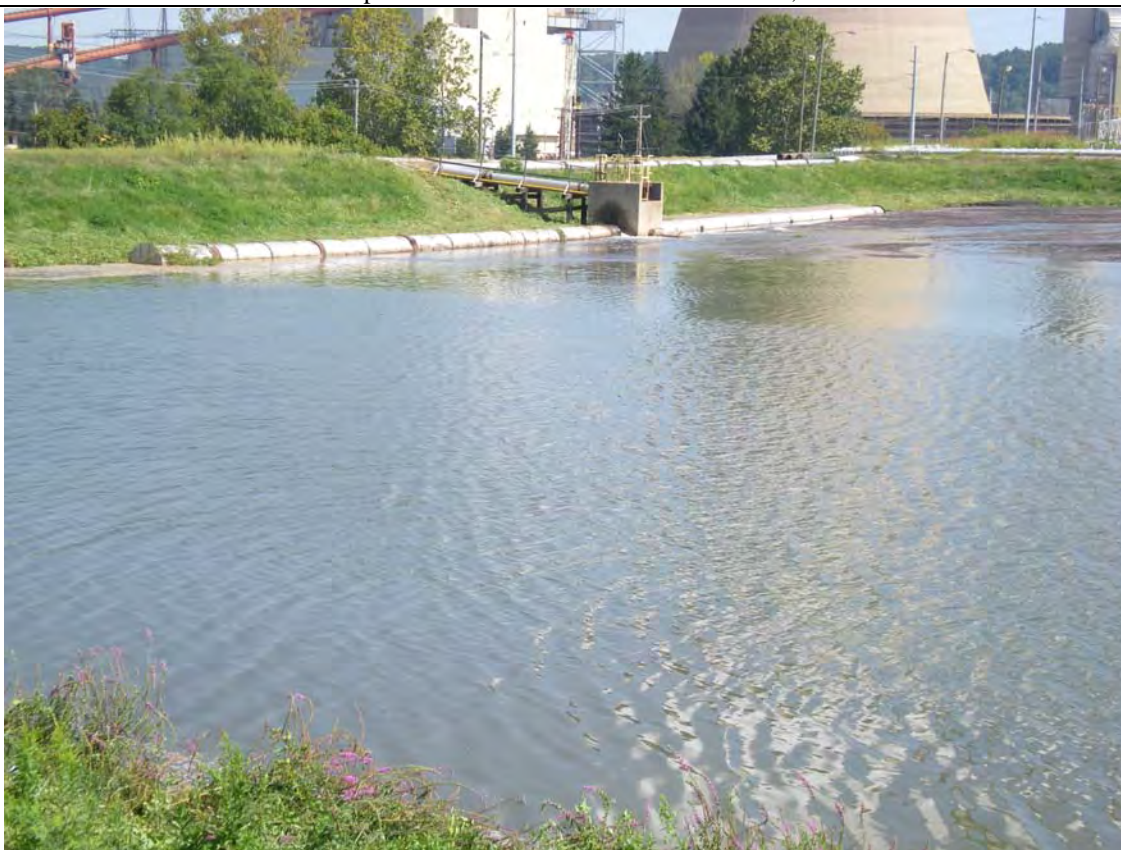
Photo Number:
7

Description:
Turbine room
sump discharge
structure into
West Bottom
Ash Pond

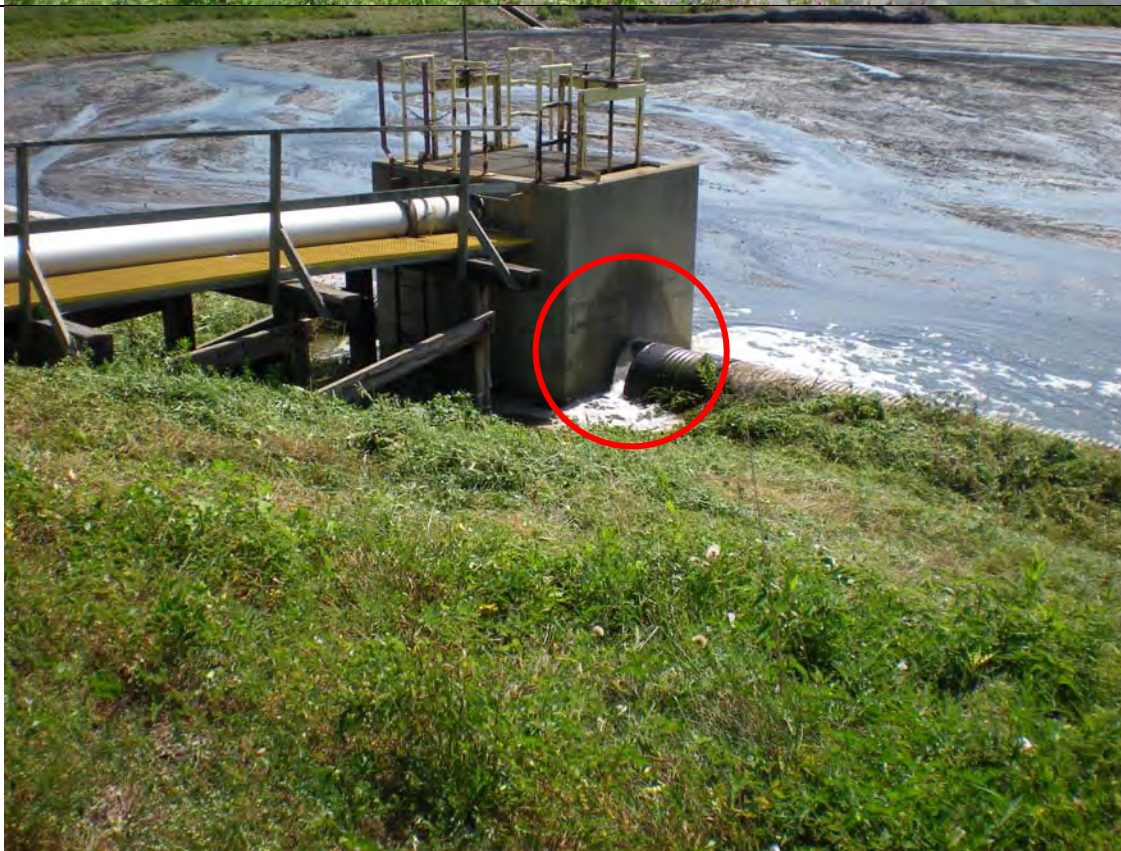
Photo Number:
8

- The Turbine Room Sump Discharge chamber in the West Bottom Ash Pond was observed to have separated from the west manifold pipe. The discharging water was roughly surging out of the separation and beginning to erode the soil behind the chamber, connecting with the erosion described above (Appendix B – Photo 8).

Description:
Close up of
Turbine Room
Sump discharge
junction box.
Note pipe
separated from
junction box.

Erosion of the dike embankment crest and slope at the Turbine Room Sump Discharge into the West Bottom Ash Pond should be repaired, including measures to prevent runoff from accumulating on the crest and being channeled to this location. The connection of the Turbine Room Sump discharge header to the junction chamber should also be restored to prevent pond slope and bottom erosion around the junction chamber.

For repair of the erosion and Turbine Room Sump Discharge chamber in the West Bottom Ash Pond, the West Bottom Ash Pond could be allowed to finish its annual service cycle. The repair should be completed prior to reinstating the West Bottom Ash Pond into service for its next annual cycle. Should the condition of this area be observed to significantly worsen prior to the end of the annual service cycle, the area should be repaired immediately.

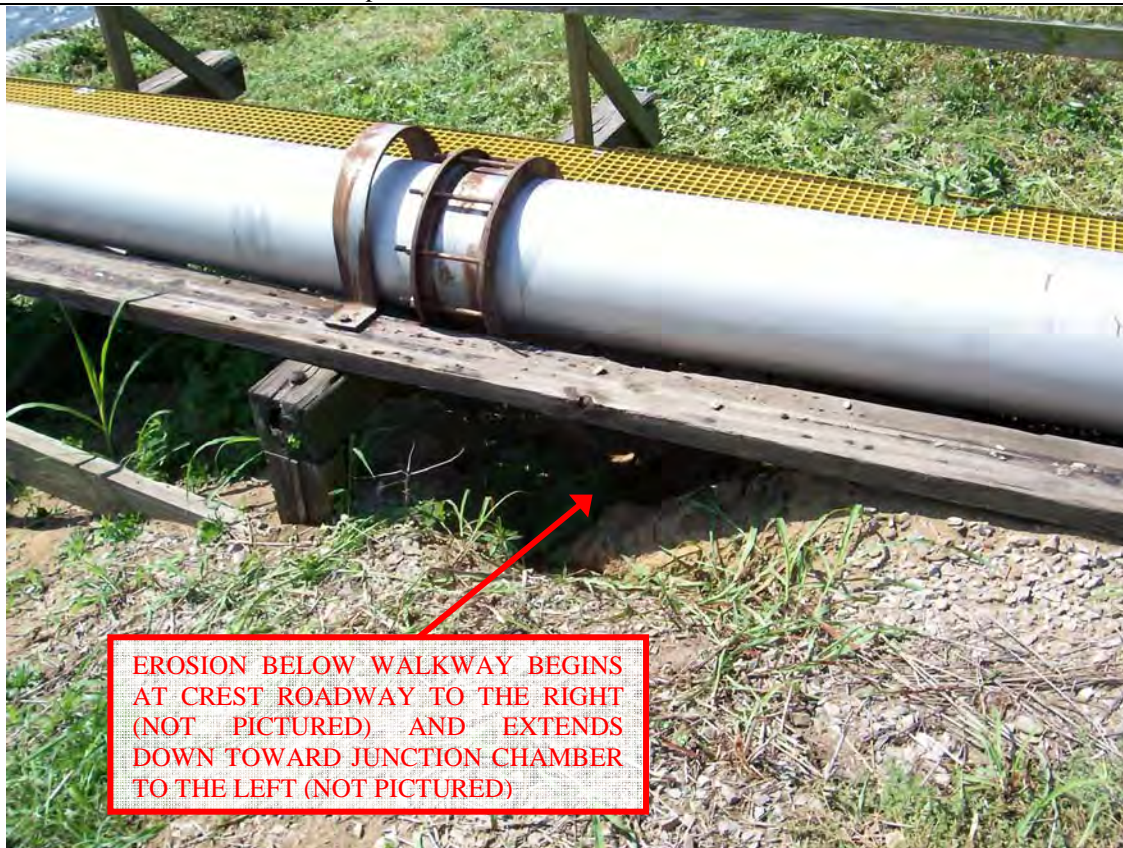
Photo Number:
9

- An isolated eroded area was observed on the in-board slope of the north dike embankment near the crest roadway and below the walkway to the Turbine Room Sump Discharge into the West Bottom Ash Pond. The eroded area extended the full length of the slope, deepening to a gully more than one foot deep near the bottom of the slope (Appendix B – Photo 9).

19.	One area of erosion was noted along the upstream crest of the north embankment. This area is located at the center of the west bottom ash pond where piping from the turbine room sump discharges. Erosion was observed 12" – 18" deep starting near the crest running down the inside embankment slope below a wooden walkway leading to the discharge point. The concrete junction box at the discharge has also separated from the west discharge pipe allowing water to forcefully surge from the separation. This flow is eroding the slope behind the concrete junction up toward the erosion which is working down the slope.
21	Minor natural wet areas observed near northeast corner of bottom ash complex, area is poorly drained and is currently being monitored using piezometers to confirm/dispute that the water is a result of seepage.

Description:
Erosion at crest of upstream side of north embankment below walkway to turbine room sump discharge

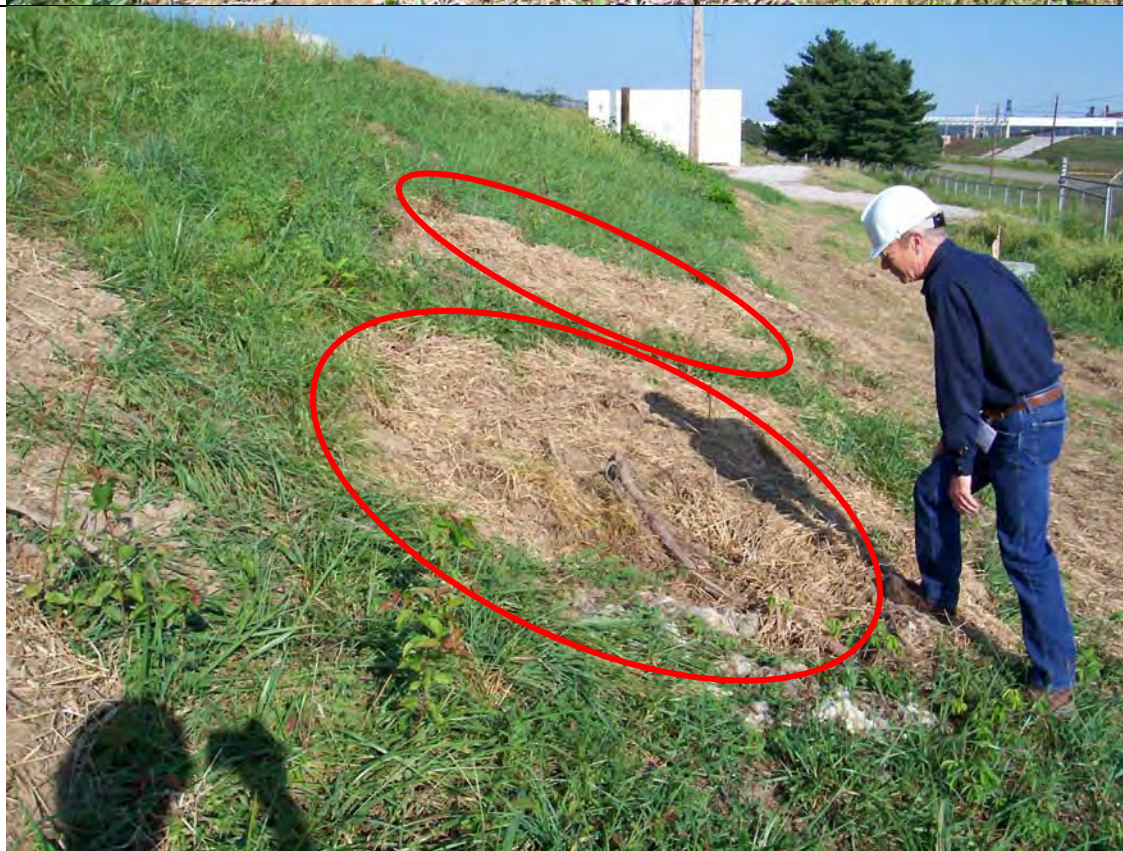
Photo Number:
10

- Isolated sloughing of surface soil was observed along the east embankment where trees and shrubs were recently removed. The sloughing was observed occurring in locations where vegetative cover had not yet reestablished (Appendix B – Photo 10).

12.	Pond outlets are fitting with baffle systems or inverted pipe elbows to keep outlet weirs and piping clear of floating debris.
18.	Trees were recently removed from the downstream toe along a stretch of the east embankment. Minor sloughing of surface soil was observed in these areas where grassy vegetation has not yet taken root. Minor irregularities appear randomly on the embankment slopes that appear to be the result of vegetative growth, animal burrows and maintenance activities

Description:
Area on east embankment where trees were recently removed. Note sloughing of surface soil observed at numerous dead areas where vegetation not re-established.

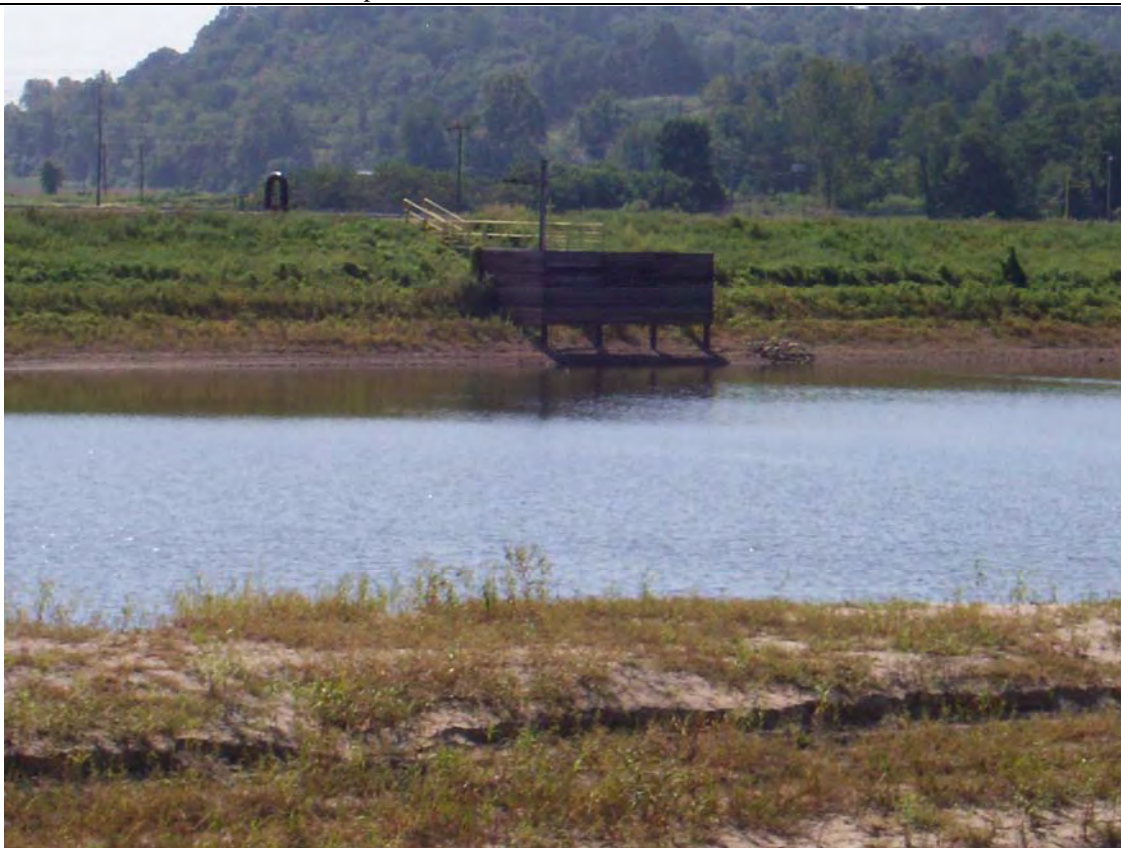
Photo Number:
11

Description:
Exterior view of
outlet skimming
structure in East
Bottom Ash
Pond.

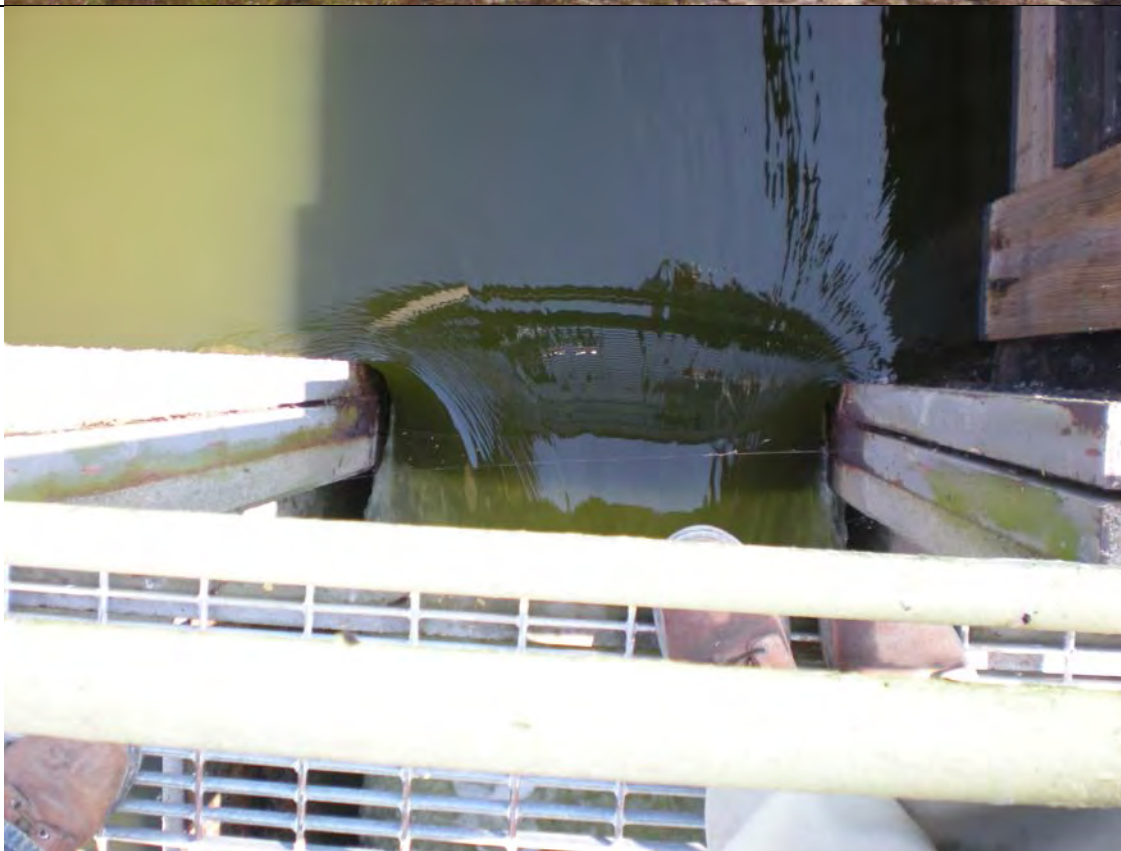
Photo Number:
12

Description:
View of water
flowing into
weir at
discharge from
West Bottom
Ash Pond.

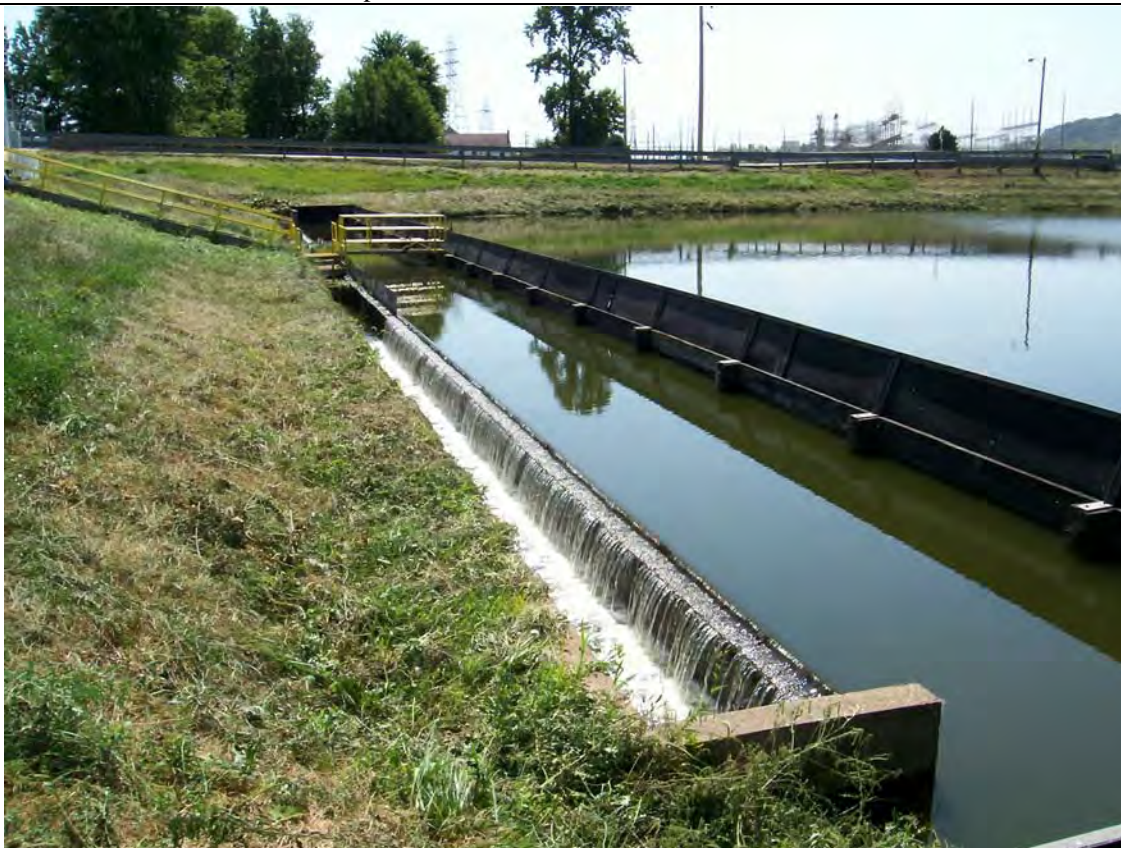
Photo Number:
13

Description:
View of outlet
weir from
Clearwater
Pond with
surface skimmer
structure.

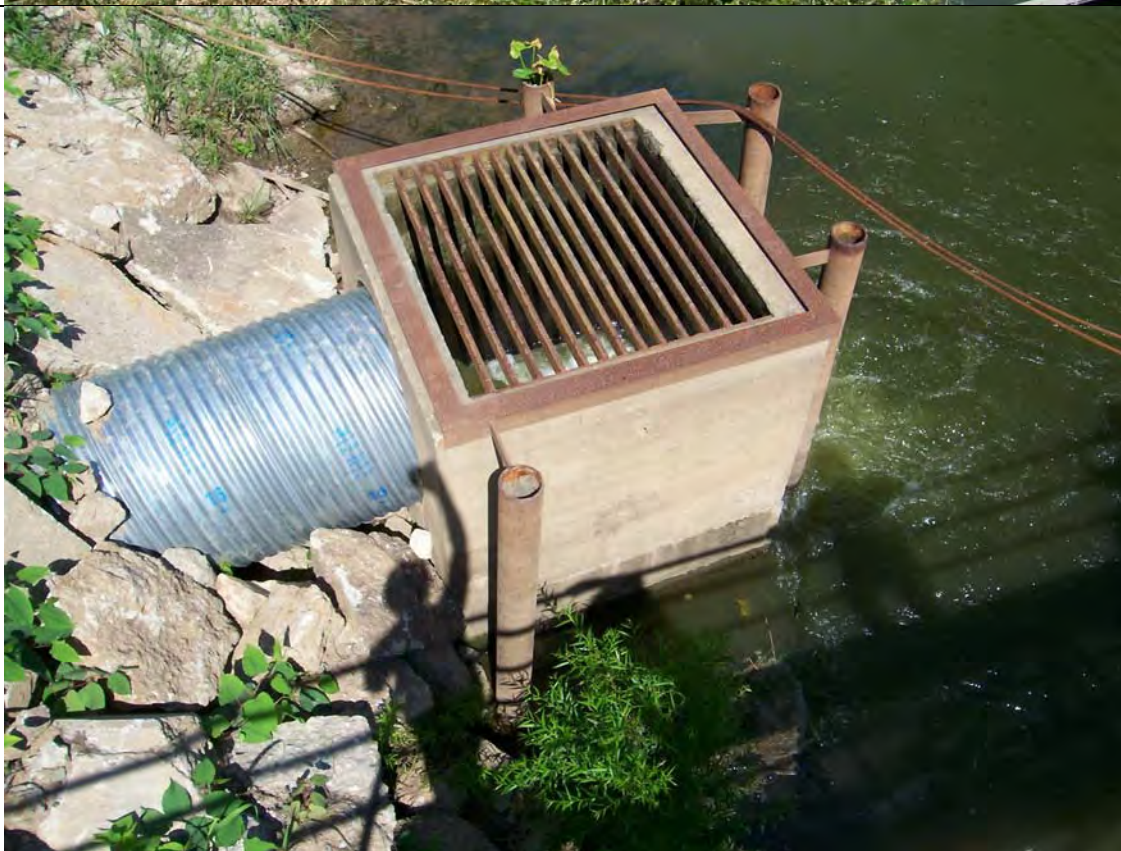
Photo Number:
14

Description:
Discharge
chamber at
Ohio River
