Assessment of Dam Safety

Coal Combustion Surface Impoundments (Task 3)

American Electric Power

Muskingum River
Power Plant

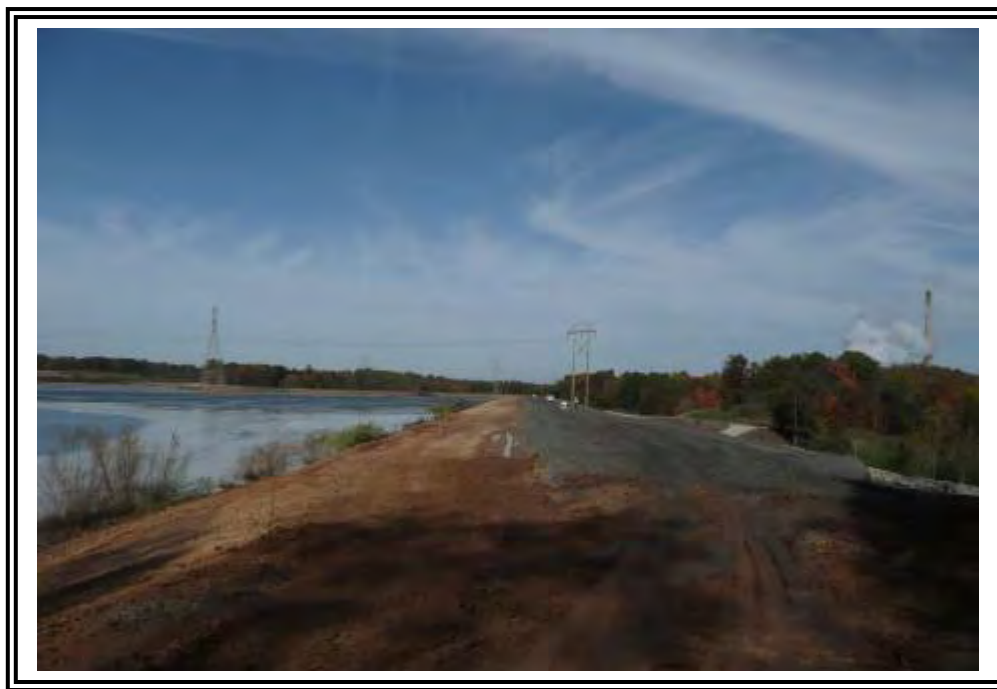
1

Crest area of Mill Stone Creek Dam, No-Name Creek Dam and part of Wing Dam, looking northwest.
Note upstream clay zone and fly ash crest area – active construction.

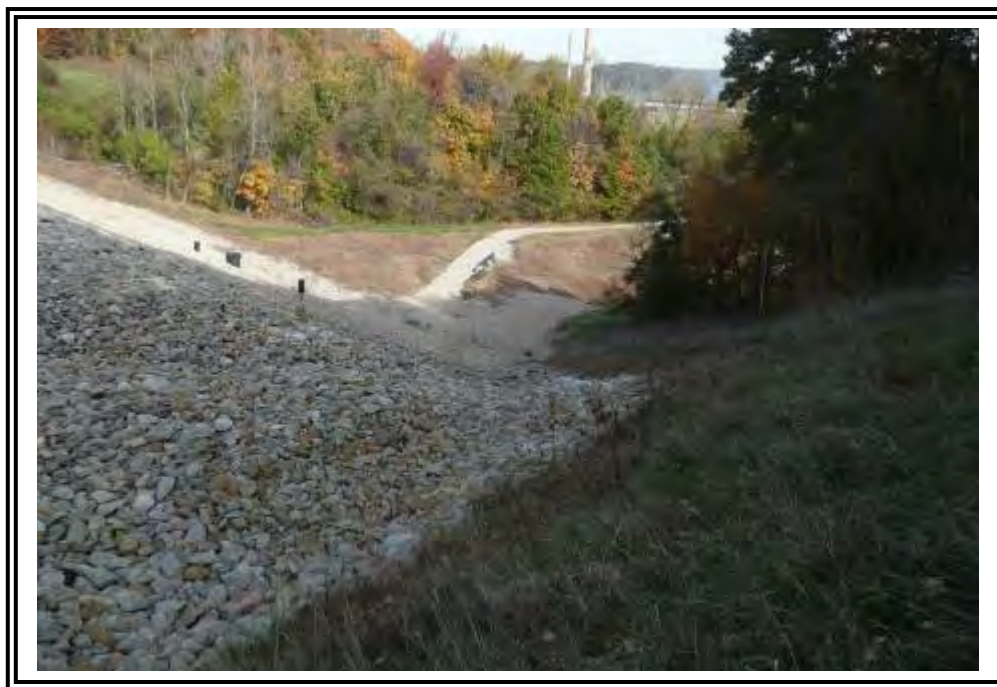
3

Looking downstream at Mill Stone Creek Dam right (southeast) abutment groin contact.

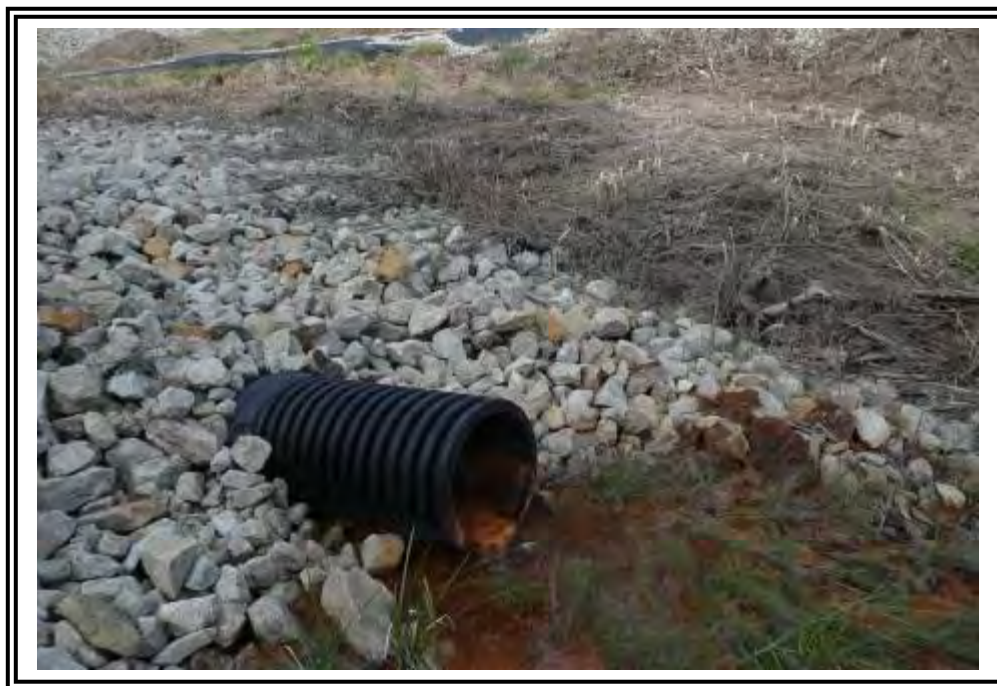
5

Active blanket drain outlet at Mill Stone Creek Dam. Note iron precipitate.

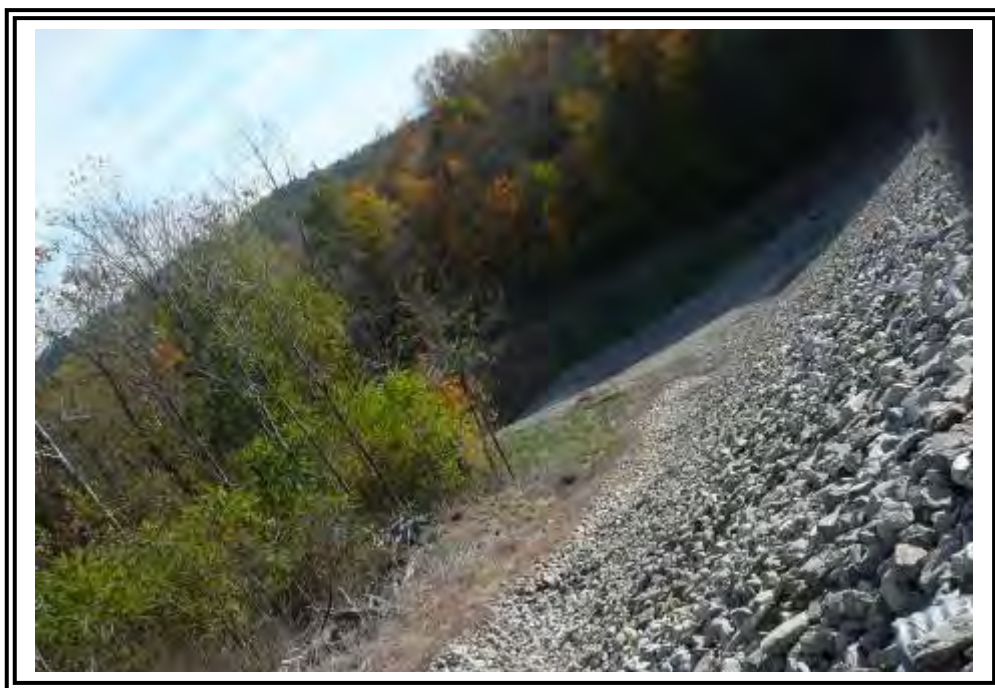
8

The downstream embankment slope of the Mill Stone Creek Dam is armored with rip rap (Photo 4). The rip rap is well maintained and in general free from vegetation, with only isolated, dying woody plants being visible. Rip rap is also used to line the drainage ditches along the southeast and northwest abutments at the natural hillside contact (Photo Nos. 3 and 8). Rock check dams were observed in these drainage ditches.

Downstream slope of Mill Stone Creek Dam left (northwest) abutment groin contact.

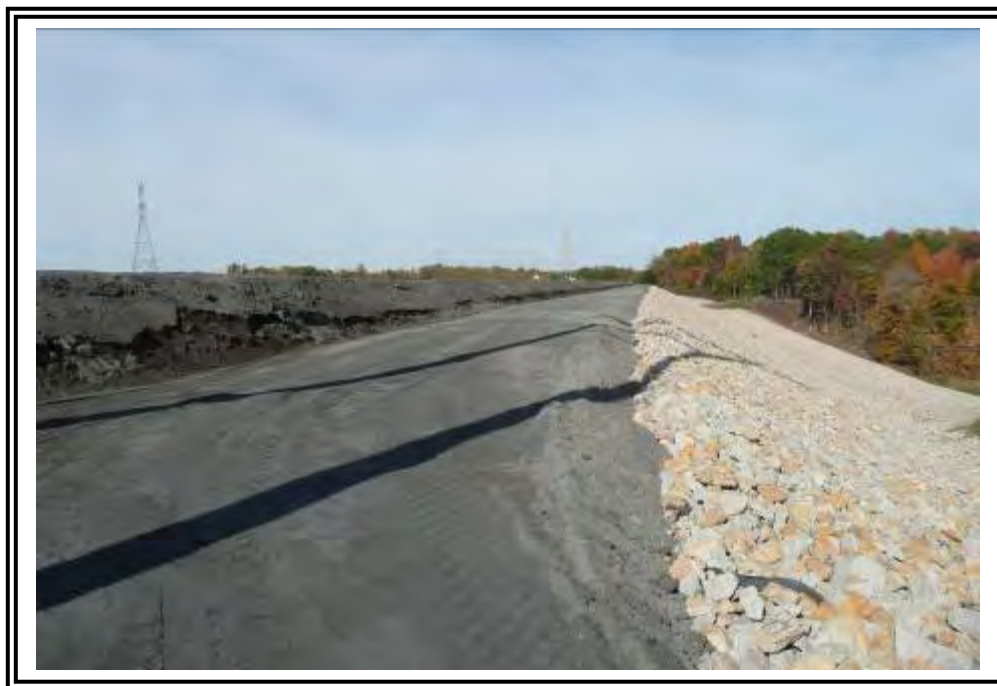
9

The No-Name Creek Dam is approximately 930 feet in length with its centerline aligned in a northwest to southeast orientation. It has a similar construction to the Mill Stone Creek Dam (Photo 11). The crest area of the dam consists of exposed compacted ash and appears to be stable and free from any abrupt lateral translation, vertical deformation or cracking (Photo 29). An exposed compacted ash construction bench, a continuation of the construction bench observed on the Mill Stone Creek Dam was observed near the crest of the dam at its present elevation (Photo 9).

Fly ash bench near the crest of the No-Name Creek Dam.

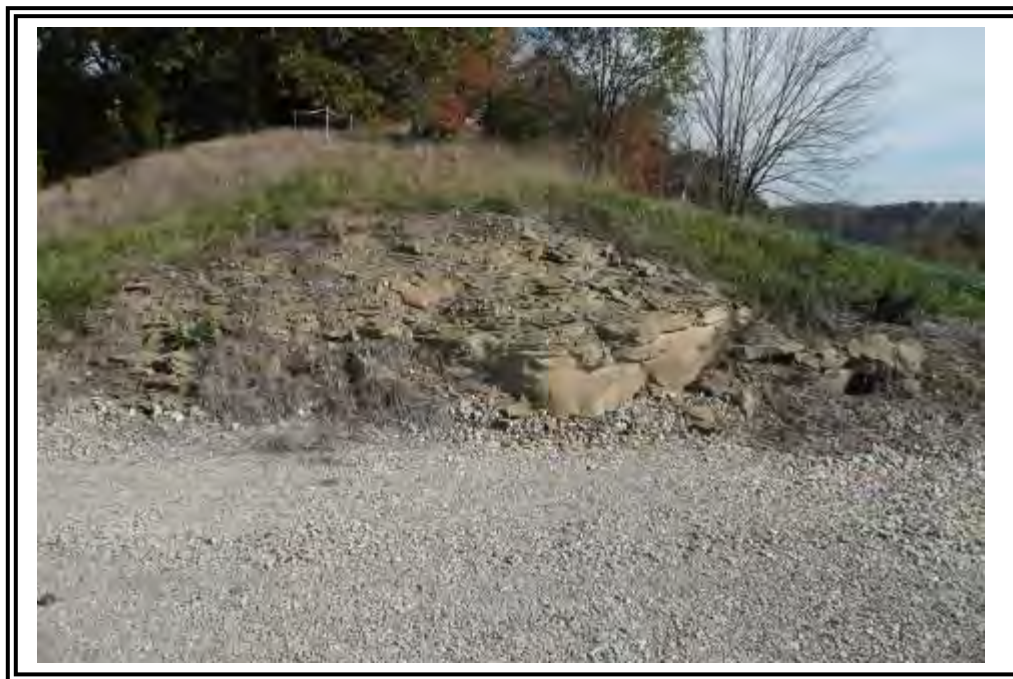
10

Rock outcrop (sandstone and siltstone) in hillside between No-Name Creek Dam and Mill Stone Creek Dam.

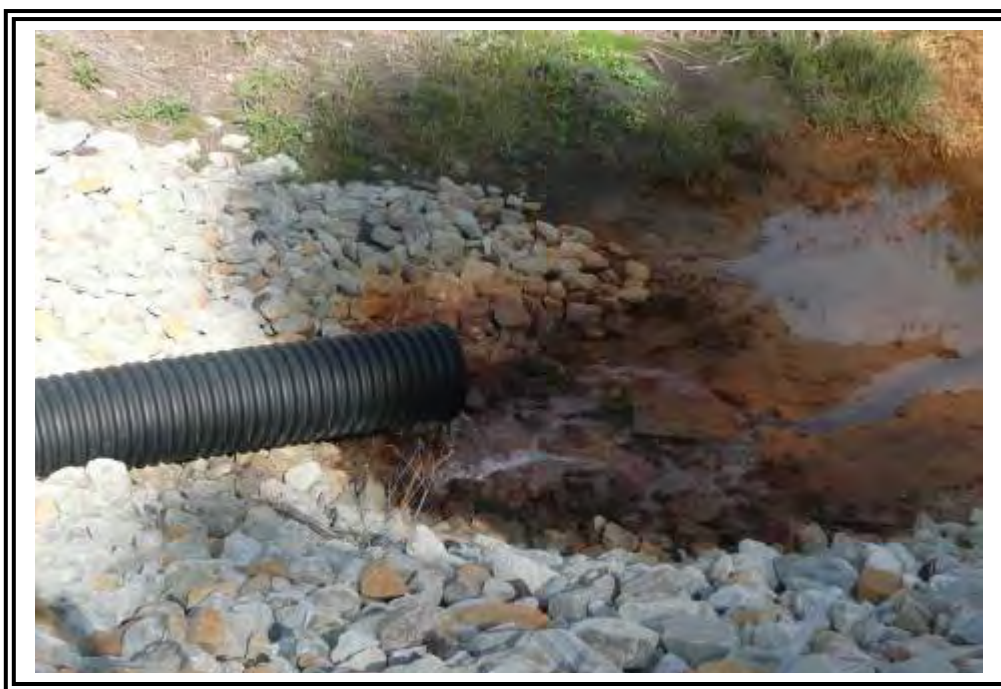
13

Active blanket drain outlet at No-Name Creek Dam. No Iron precipitate.

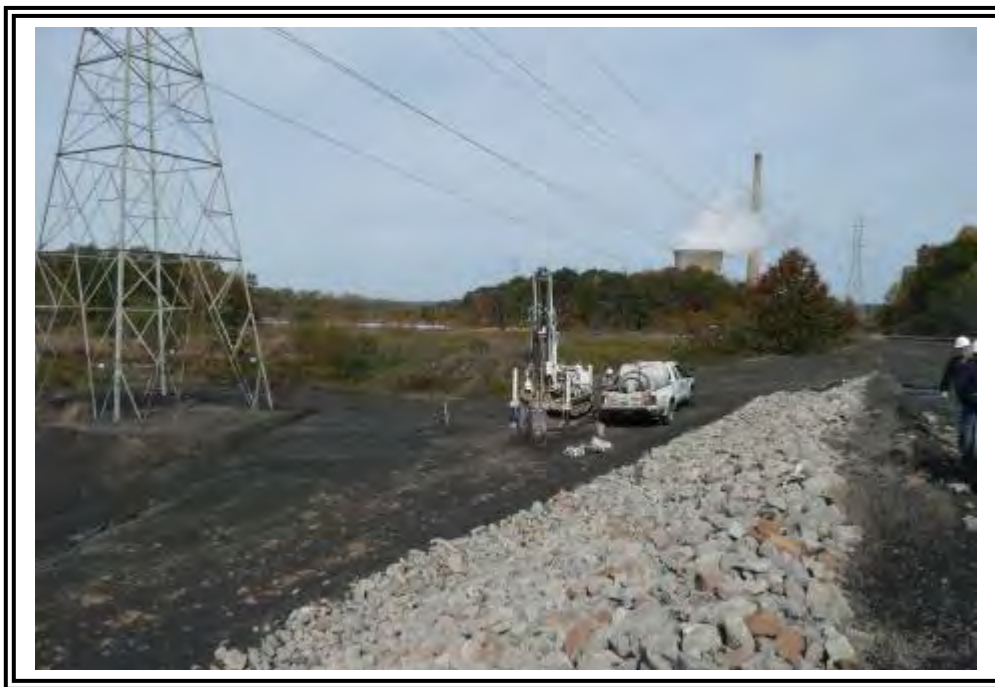
20

Downstream slope of the Wing Dam, looking north. The embankment makes a curve to an east-west alignment at this location. Crews were drilling for a new transmission tower foundation at the time of the site visit.

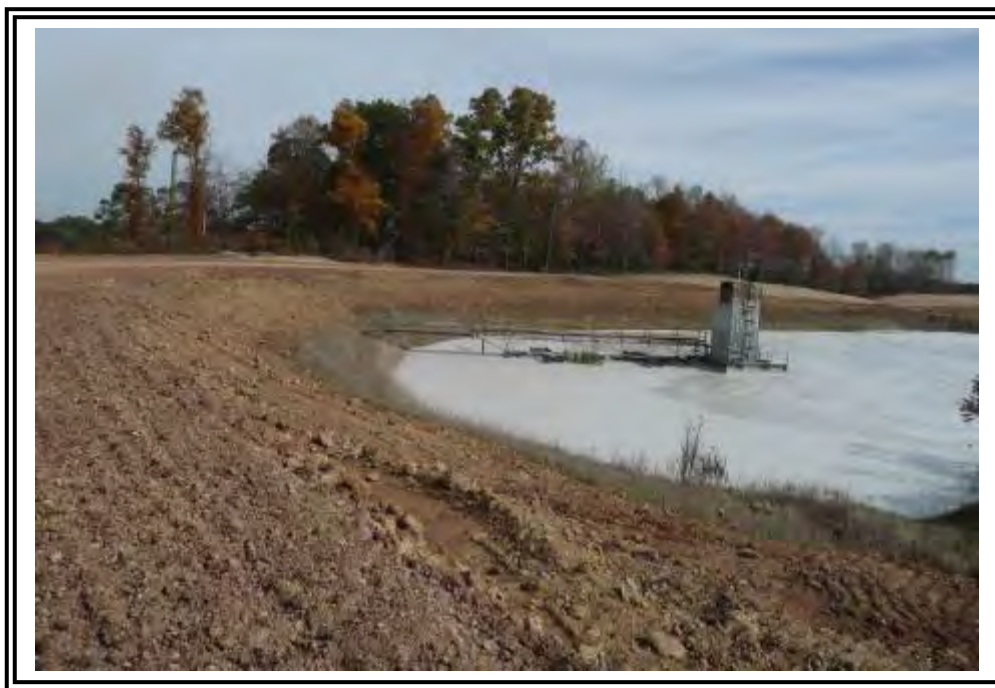
24

Upstream slope of the Spillway Dam, looking northeast. Spillway riser structure is visible in the right of the photo.

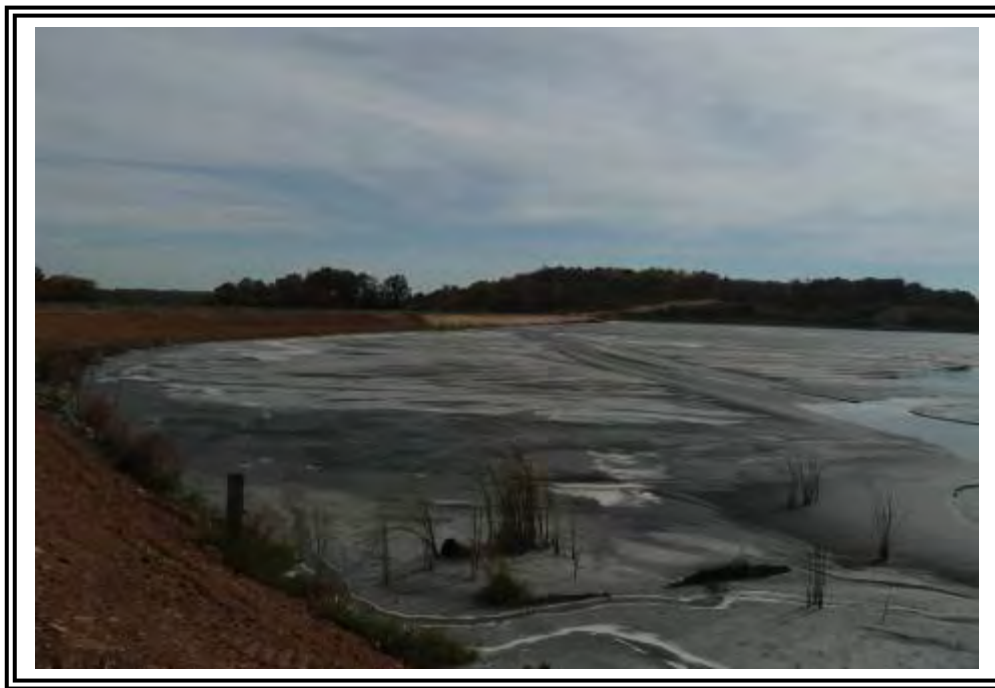
28

Upstream slope of the Wing Dam and ash deposit, looking east towards upstream slopes of the No-Name Creek Dam and the Mill Stone Creek Dam.

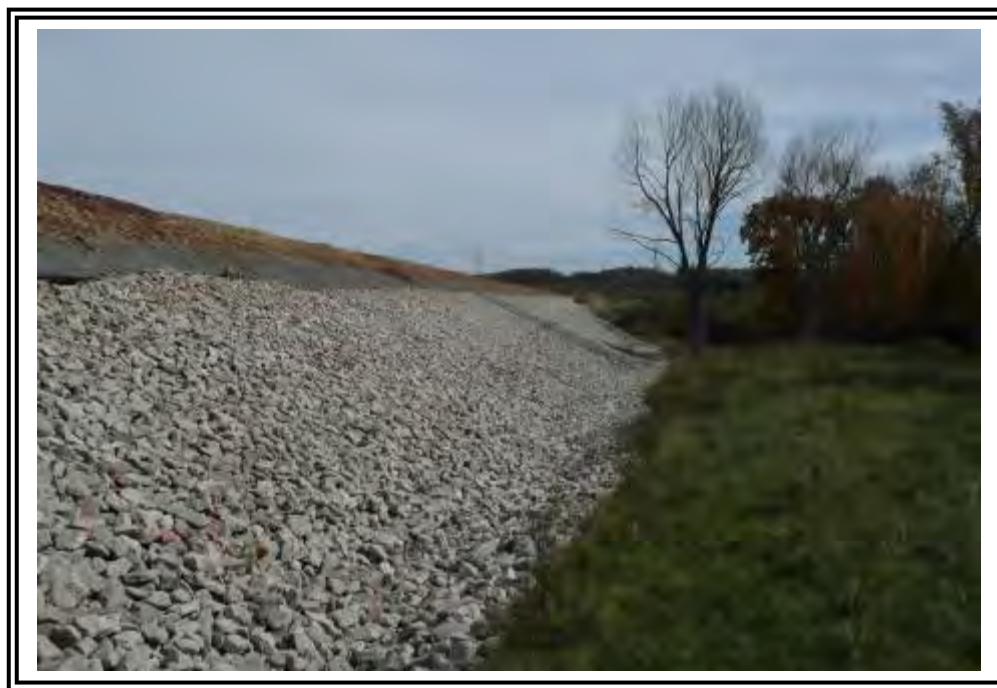
30

Downstream slope toe area of the Freeboard Dam, looking east.

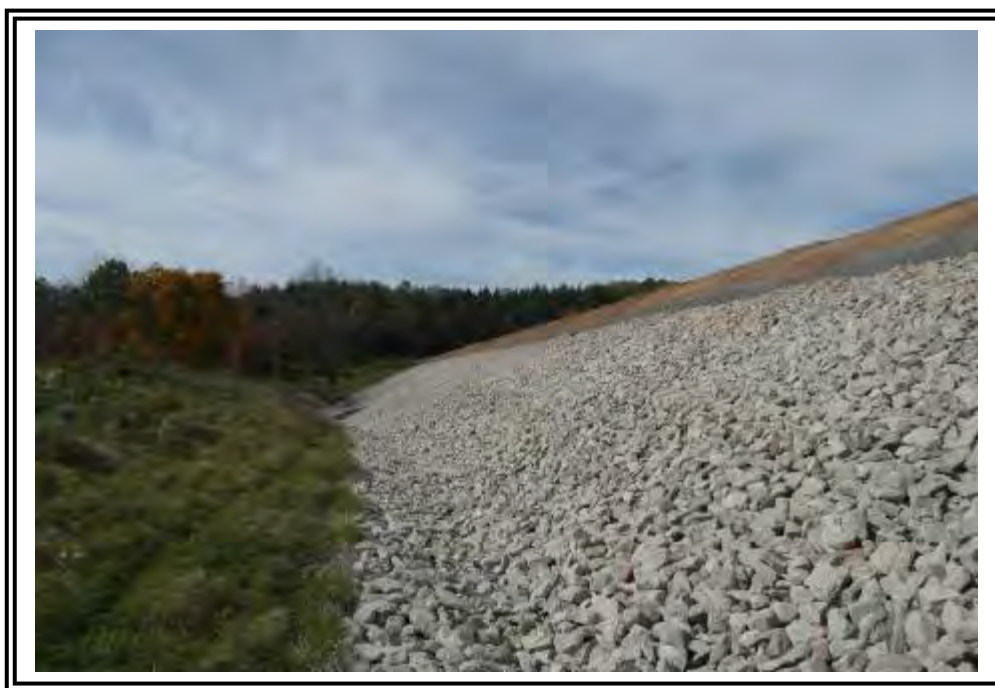
32

Downstream slope of the Freeboard Dam, looking west.

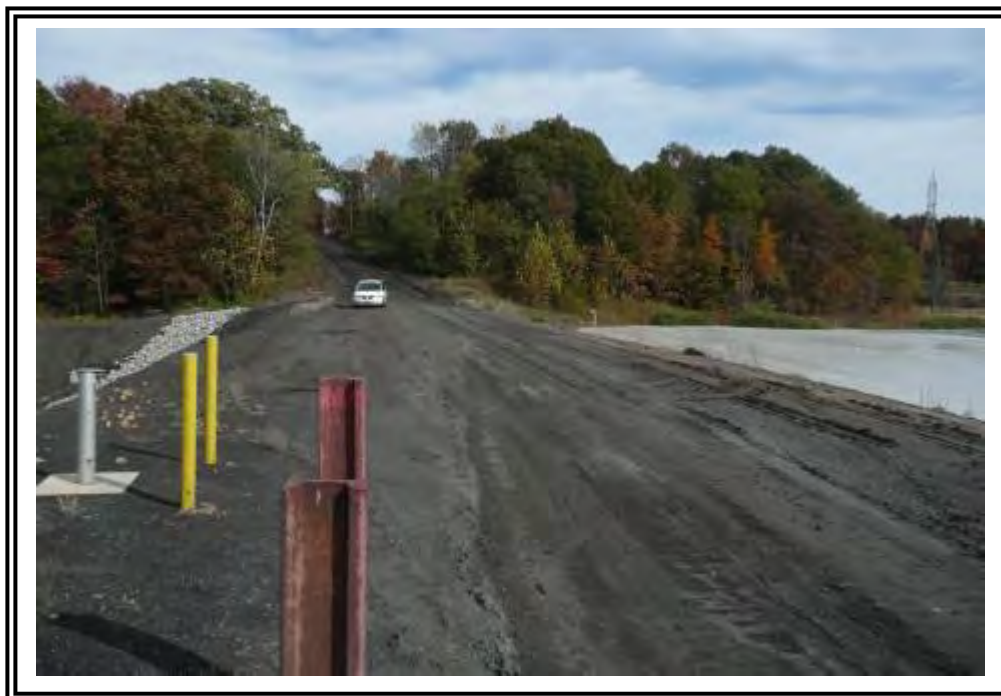
36

Crest of the Middle Fly Ash Dam, looking east. Note groundwater monitoring well.

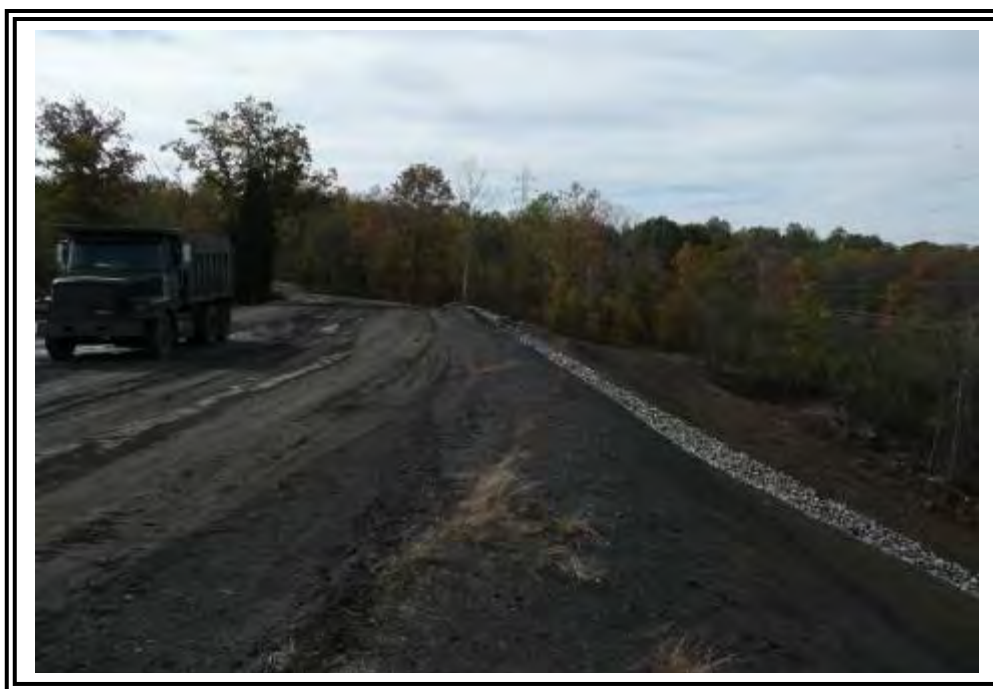
37

Crest of the Middle Fly Ash Dam, looking west.

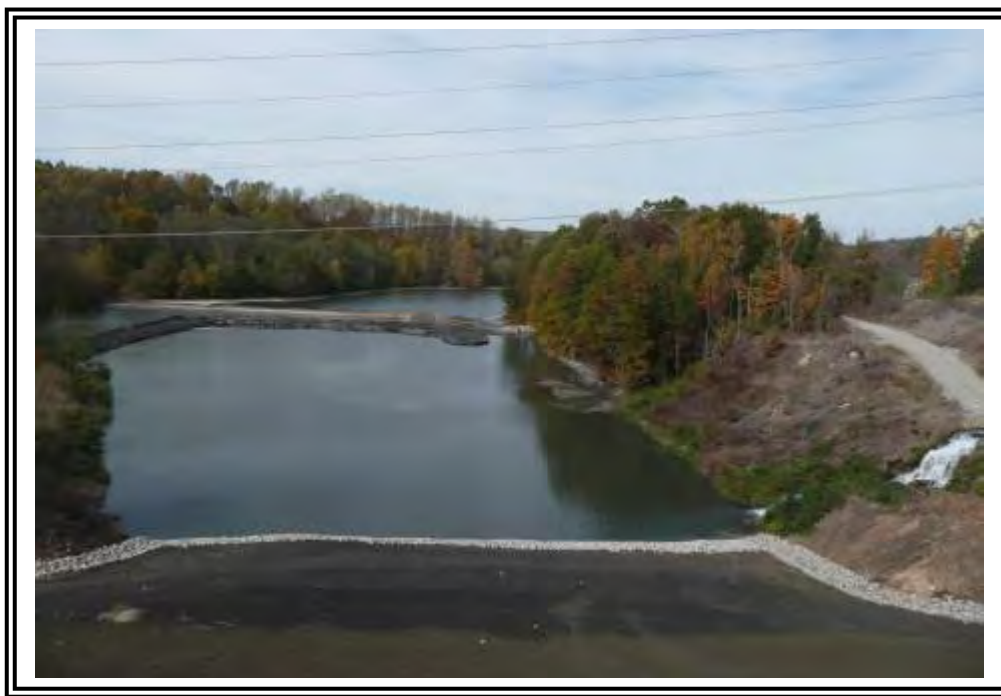
38

Looking downstream from the Middle Fly Ash Dam. Note ash slope construction and rip-rap toe protection.

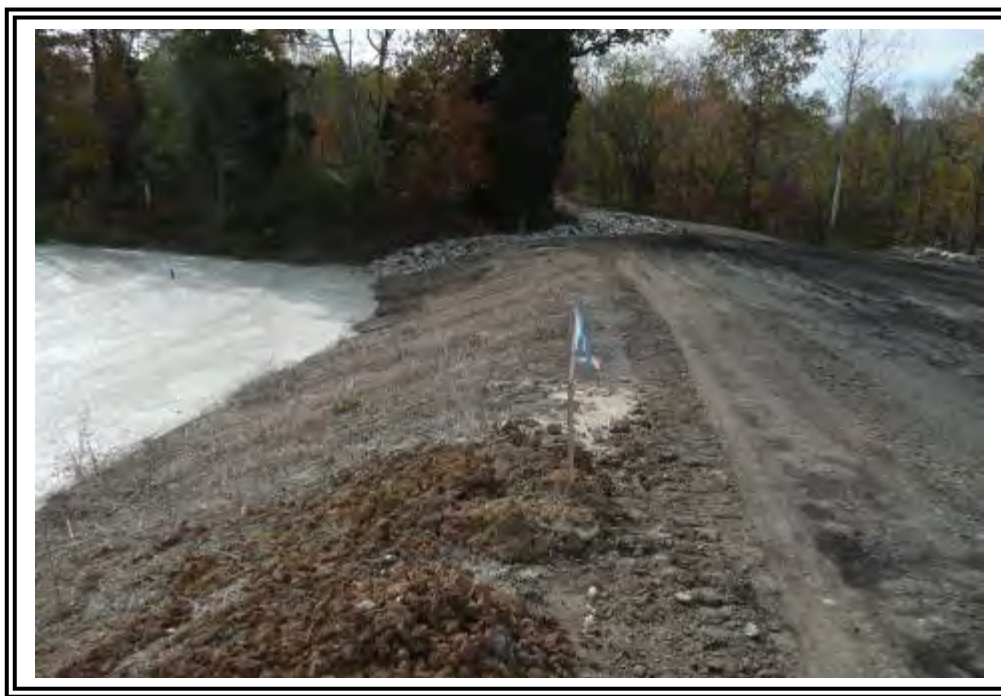
40

Upstream slope of the Middle Fly Ash Dam at left (west) abutment rock groin contact, looking west.

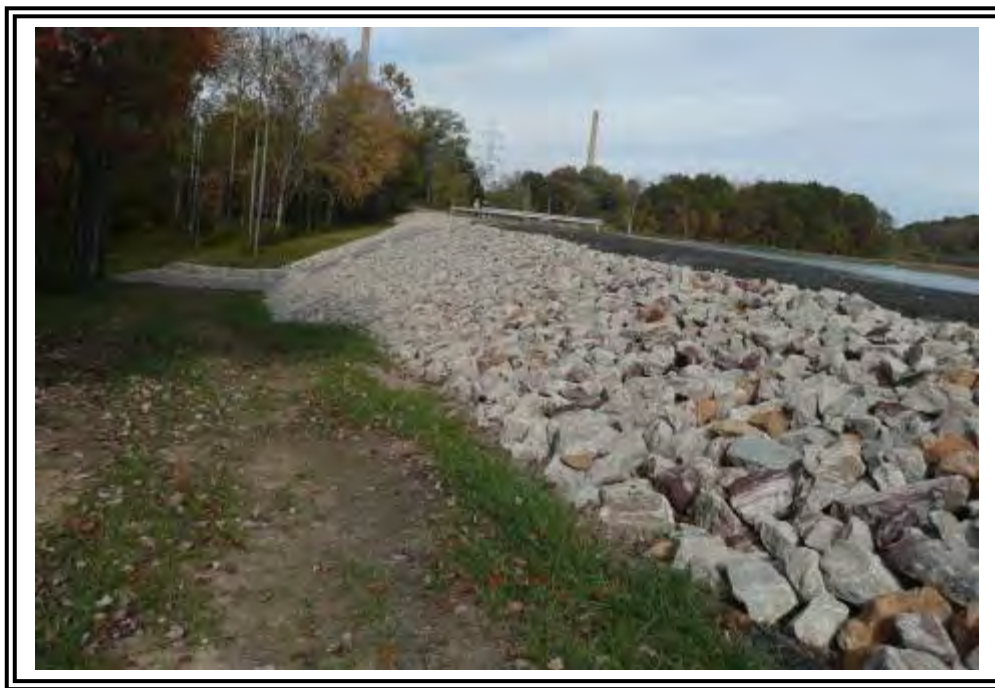
41

Downstream slope of emergency spillway embankment for the Middle Fly Ash Dam, looking northeast.

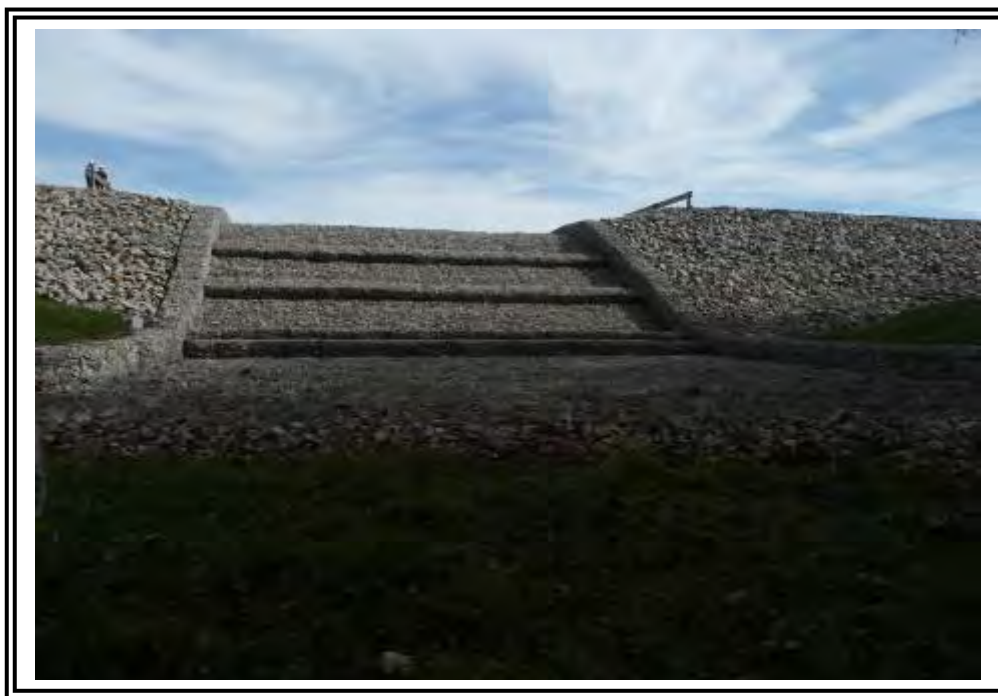
42

Middle Fly Ash Dam, emergency spillway section, looking upstream.

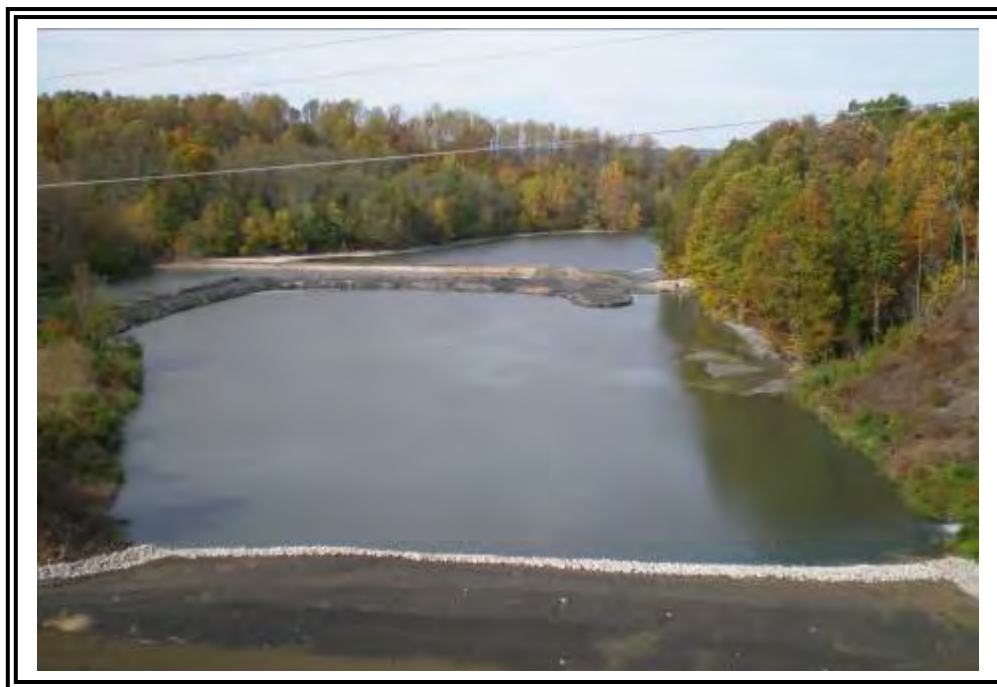
48

Looking north-northwest from crest of the Middle Fly Ash Dam across the Lower Fly Ash Reservoir.

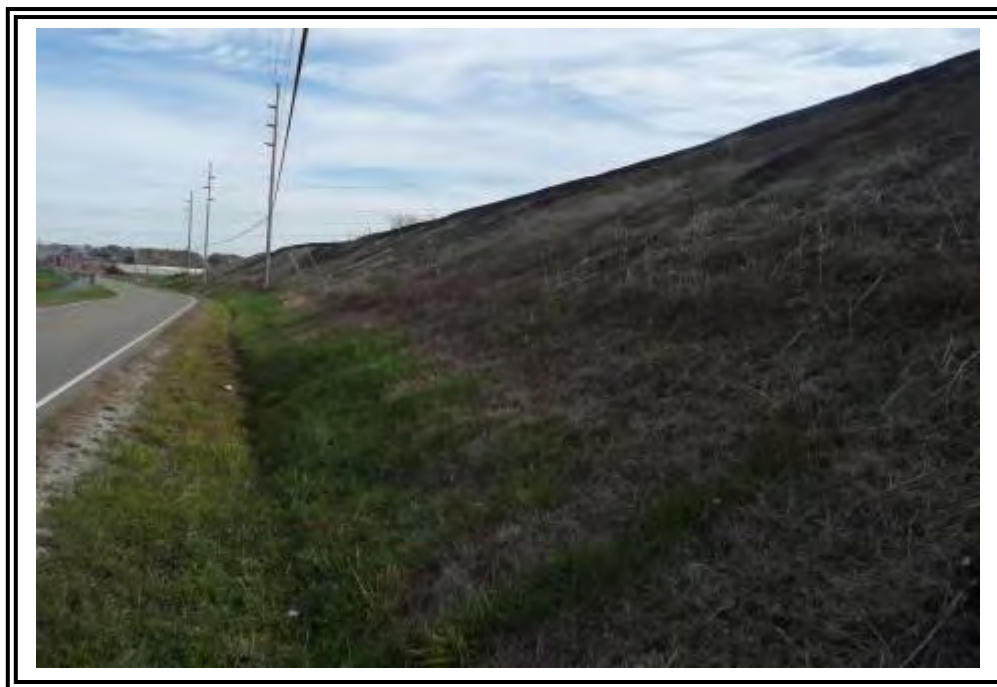
51

Lower Fly Ash Dam along downstream slope from the roadway bench elevation, looking southeast.

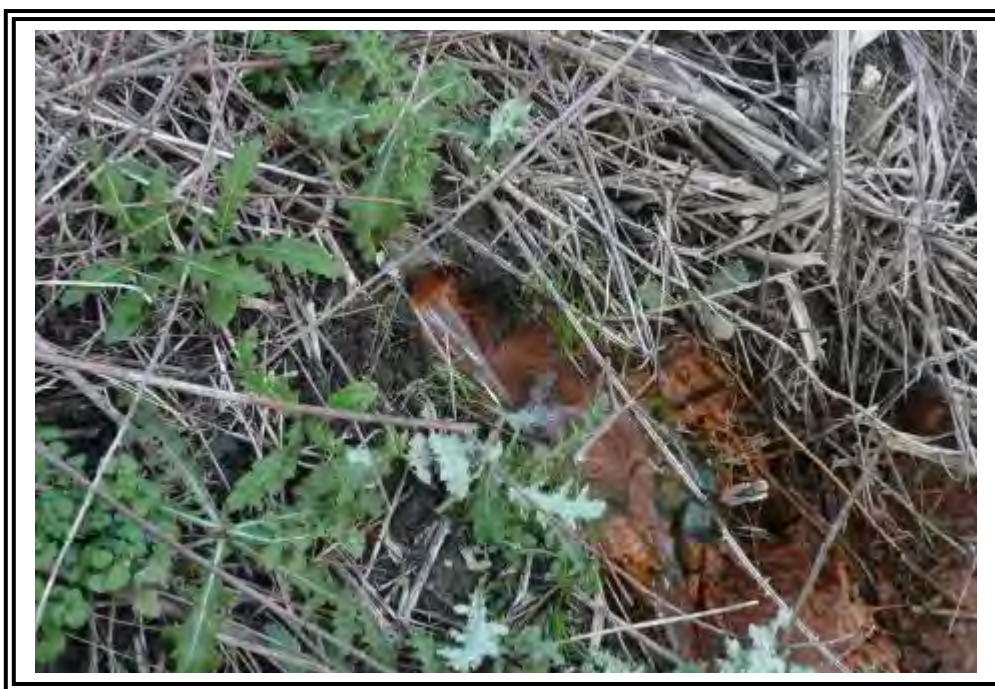
59

Lower Fly Ash Dam, active underdrain/toe drain outlet. Note iron precipitate.

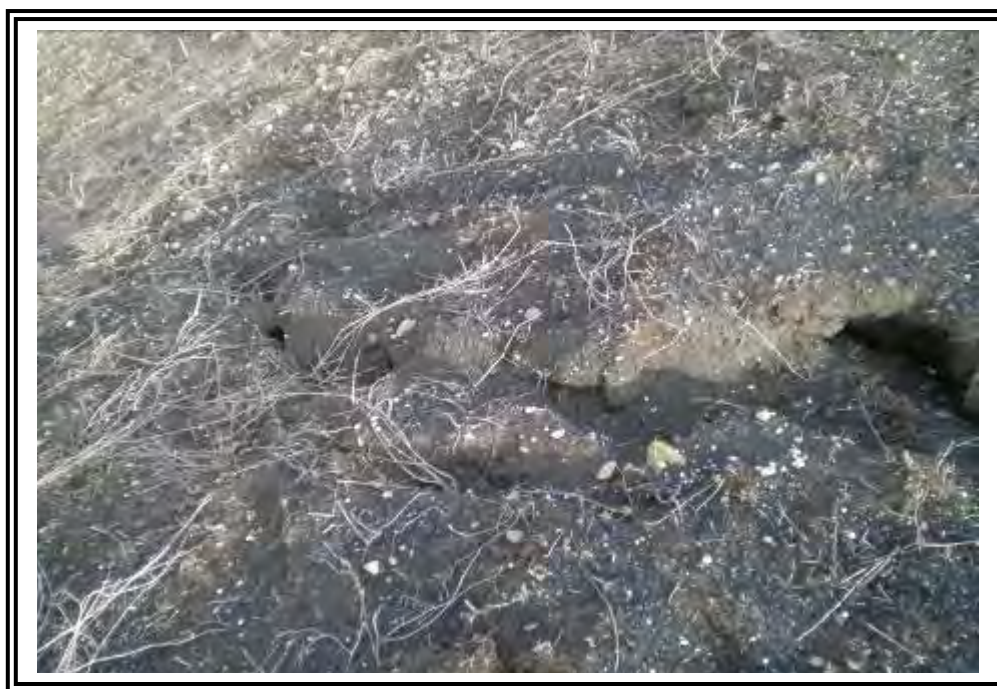
63

Erosion rills in bottom ash and soil surface on downstream slope of the Lower Fly Ash Dam.

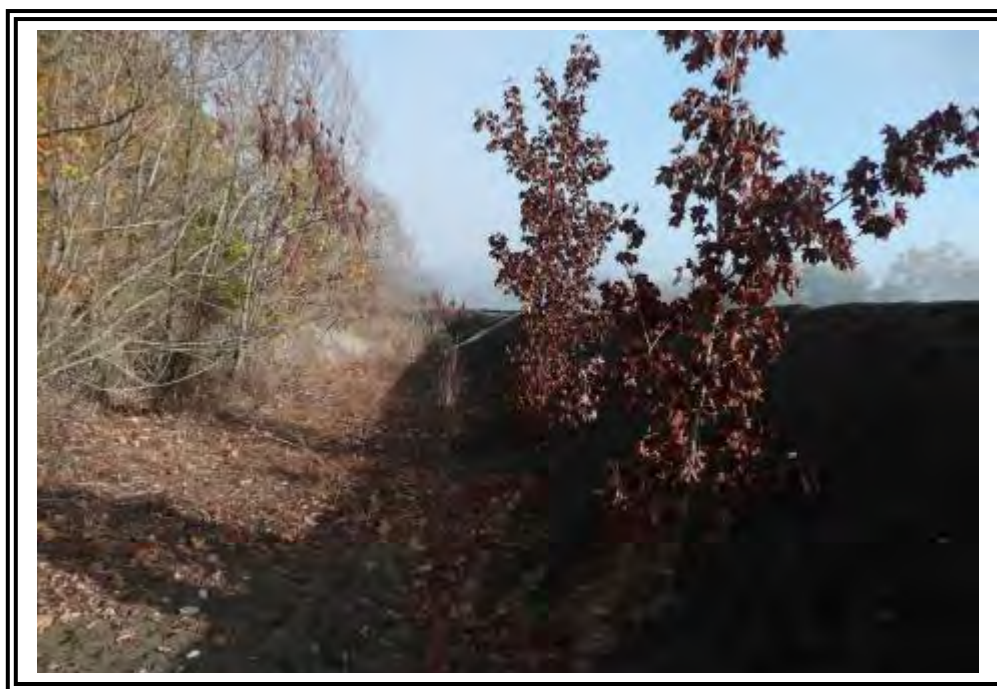
65

Units 1-4 Bottom Ash Pond west dike exterior slope, looking north. Note dying woody vegetation.

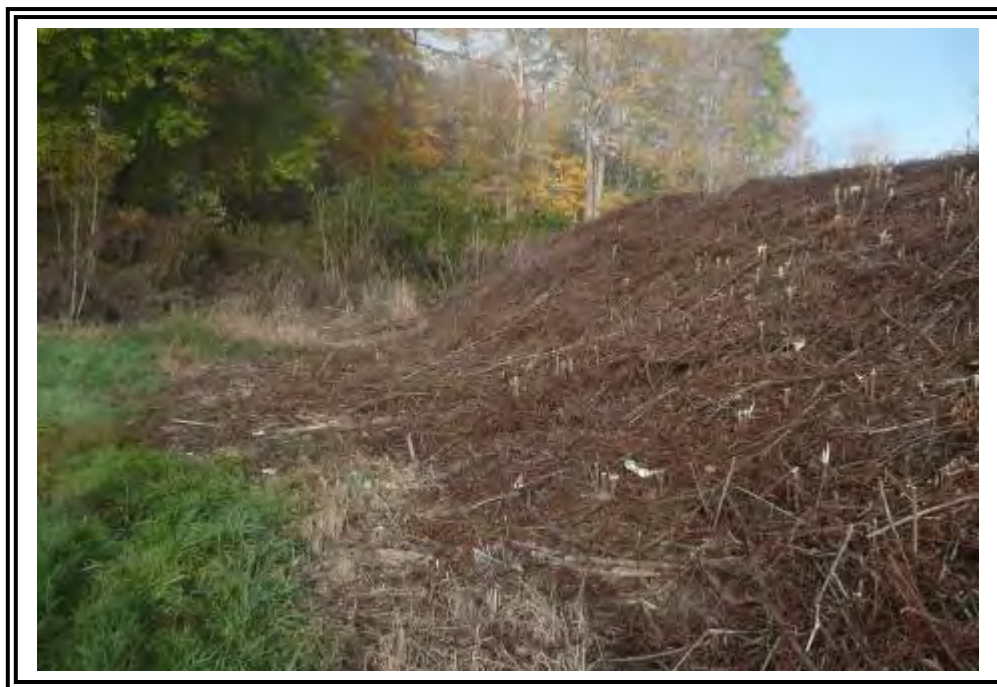
67

Units 1-4 Bottom Ash Pond south dike exterior slope, looking west.
Note recently cut heavy vegetation and woody brush.

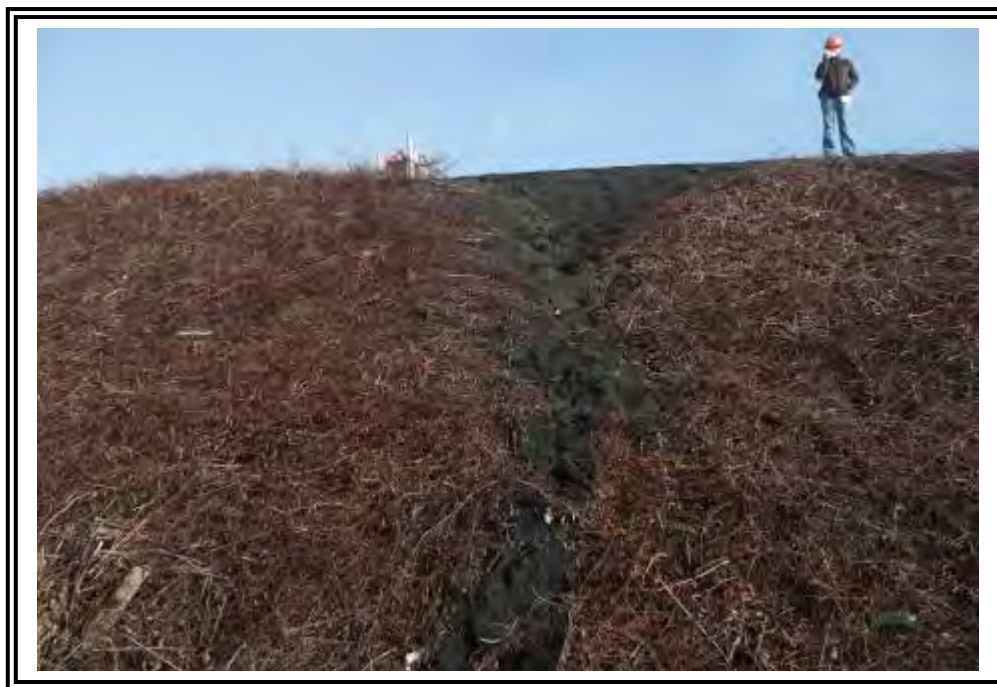
69

Erosion rill on the Units 1-4 Bottom Ash Pond south dike exterior slope.

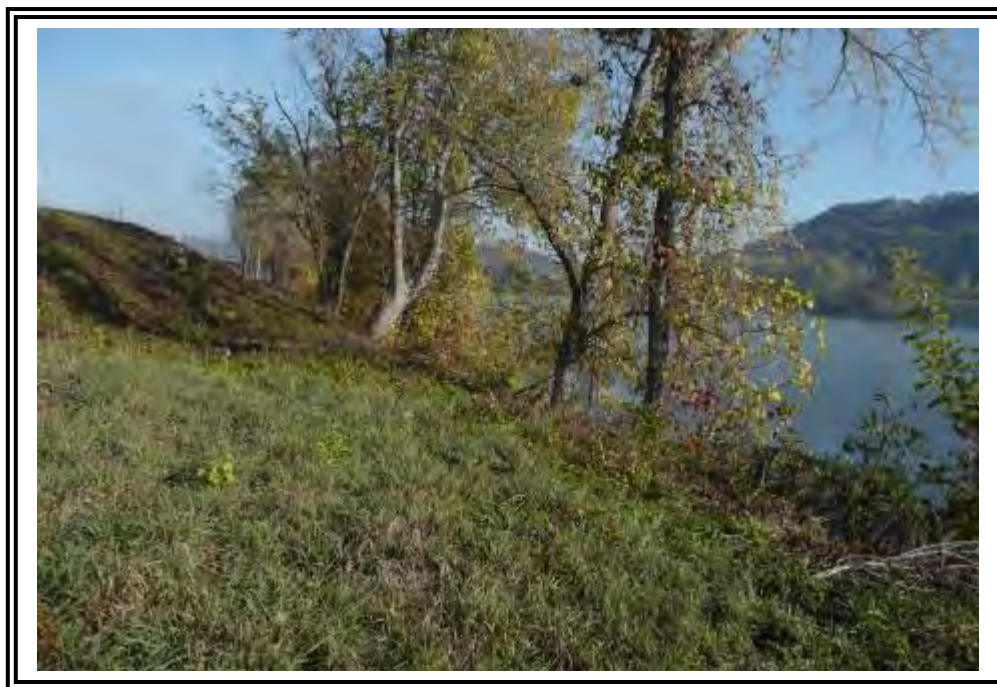
71

Units 1-4 Bottom Ash Pond east dike exterior slope along the Muskingum River, looking north (or upstream with respect to the river flow). Note relatively large trees at the river bank leaning towards the river.

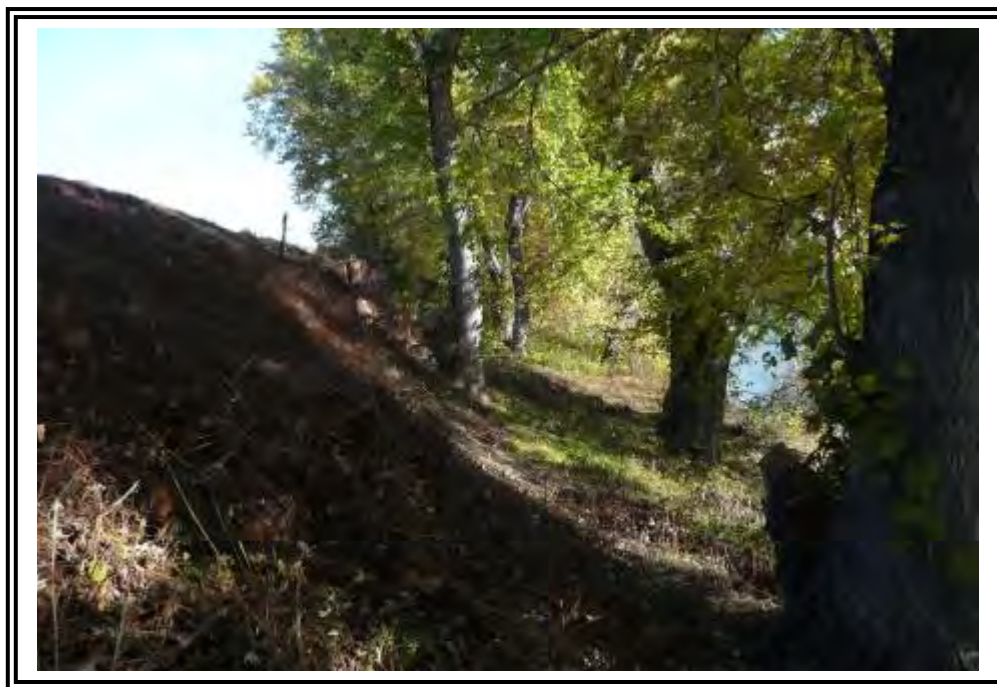
75

Units 1-4 Bottom Ash Pond east dike toe, looking north. Note large trees at the toe and between the dike and river bank.

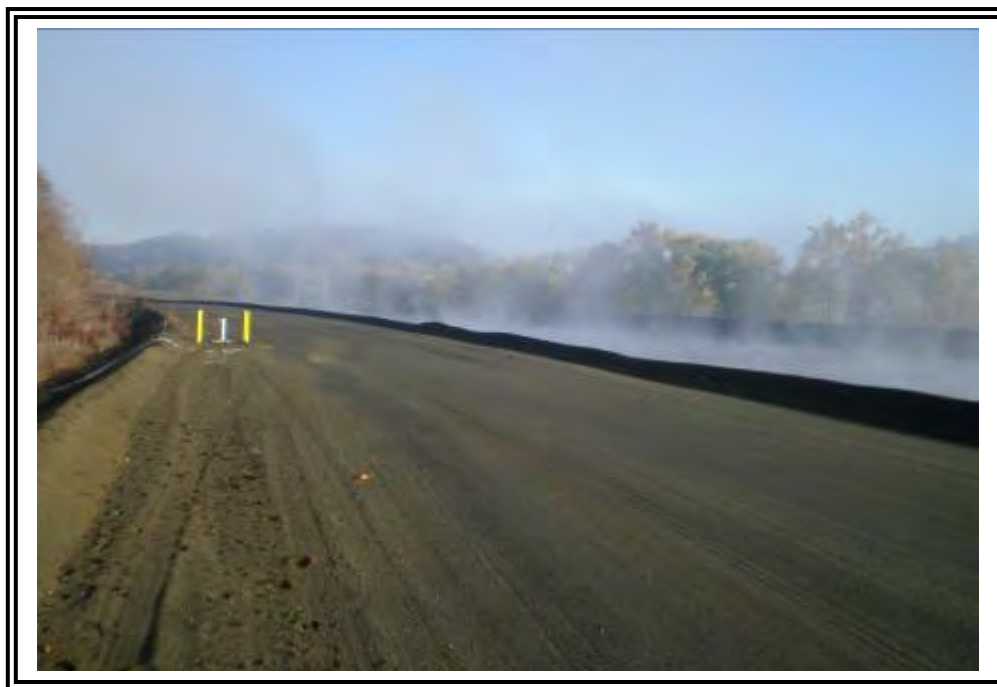
77

Units 1-4 Bottom Ash Pond west dike crest, looking north.

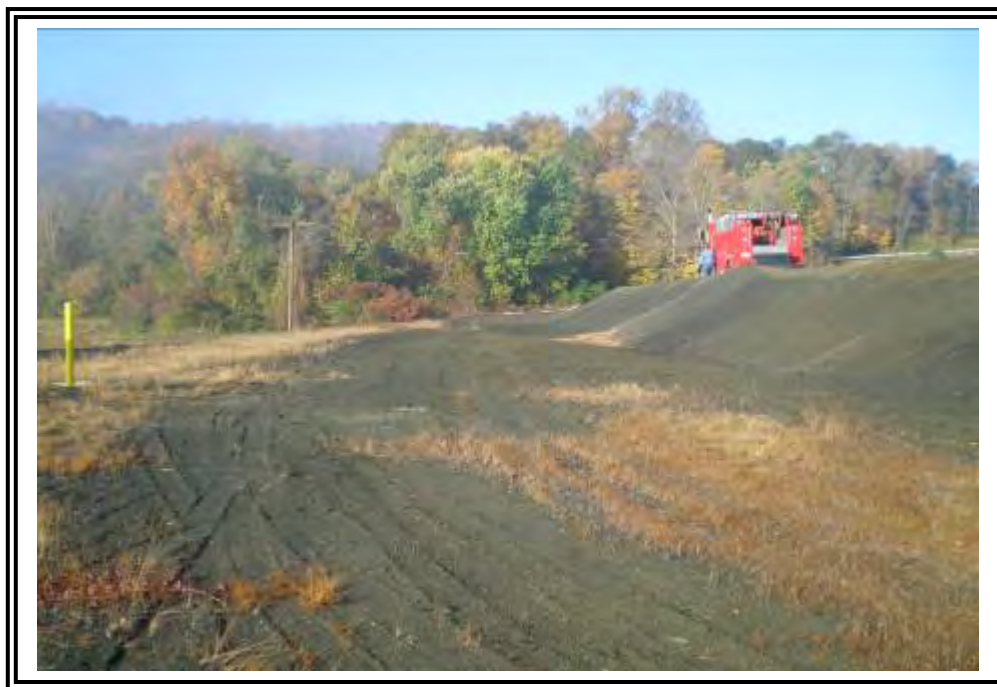
79

Units 1-4 Bottom Ash Pond south dike upper exterior slope and bench area, looking west.
Note bench width in this area is on the order of 30 to 40 feet.

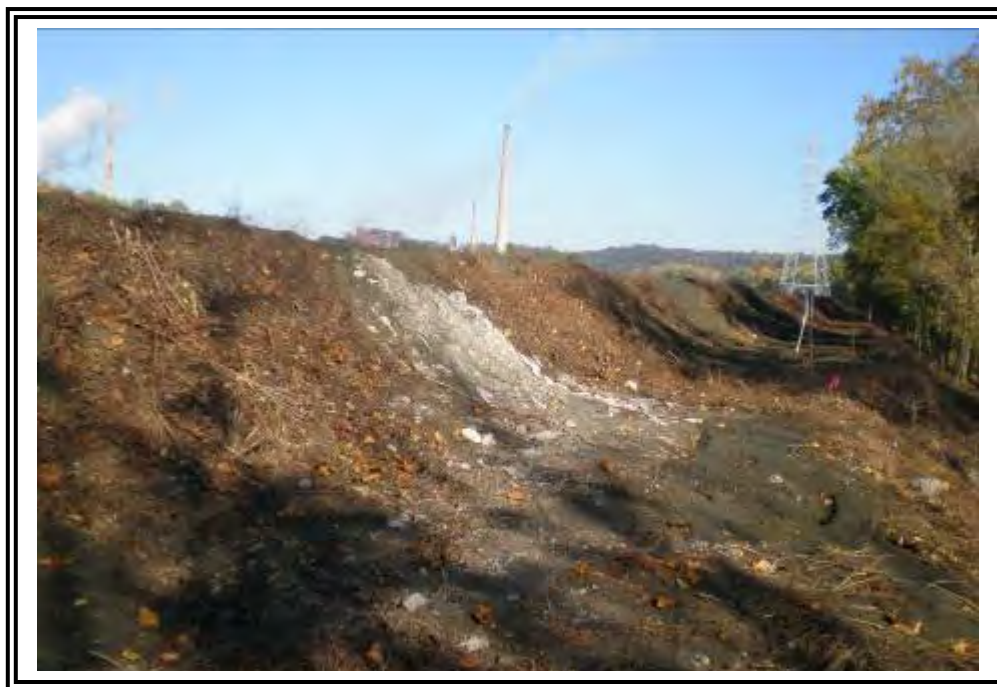
83

Units 1-4 Bottom Ash Pond upper east dike slope and bench area toward the central portion of the dike, looking north. Bench has narrowed to 8 to 8 feet wide.
