# Assessment of Dam Safety Coal Combustion Surface Impoundments (Task 3) Final Report

American Electric Power  
Muskingum River  
Power Plant  
Waterford, Ohio

March 23, 2010

Have been assessed on October 20, 2009 and October 21, 2009

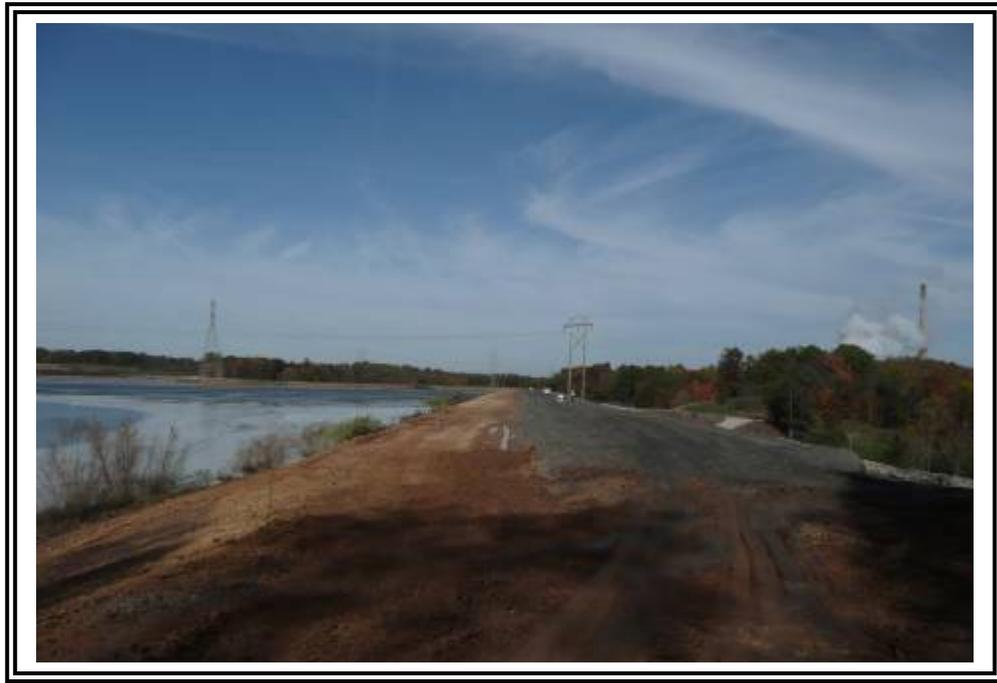
1

Crest area of Mill Stone Creek Dam, No-Name Creek Dam and part of Wing Dam, looking northwest.  
Note upstream clay zone and fly ash crest area – active construction.

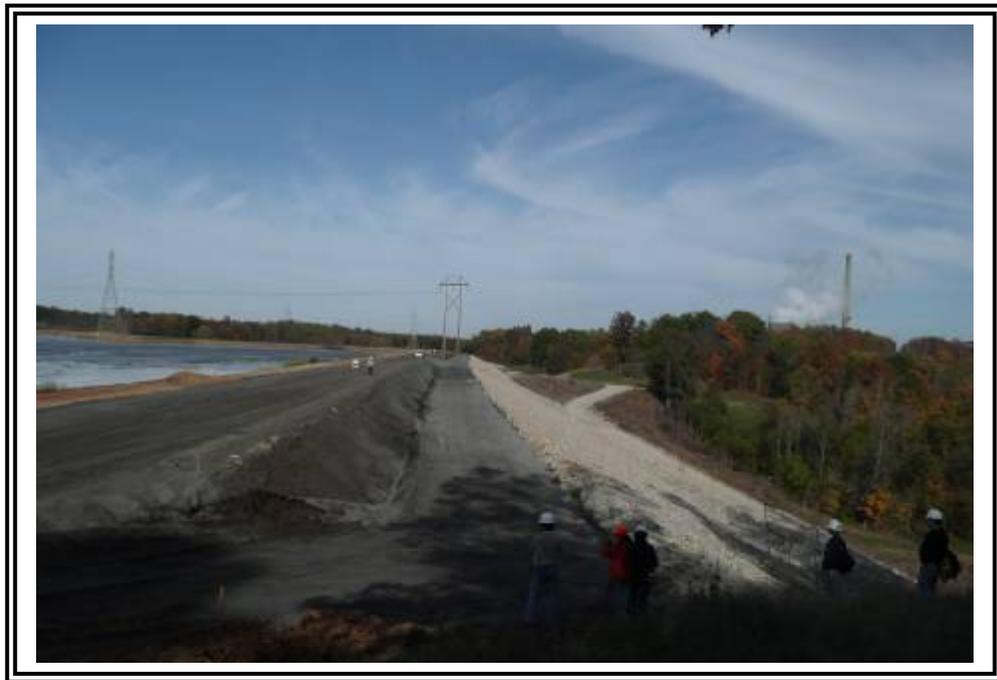
2

Crest and downstream fly ash construction bench of the Mill Stone Creek Dam, looking northwest.

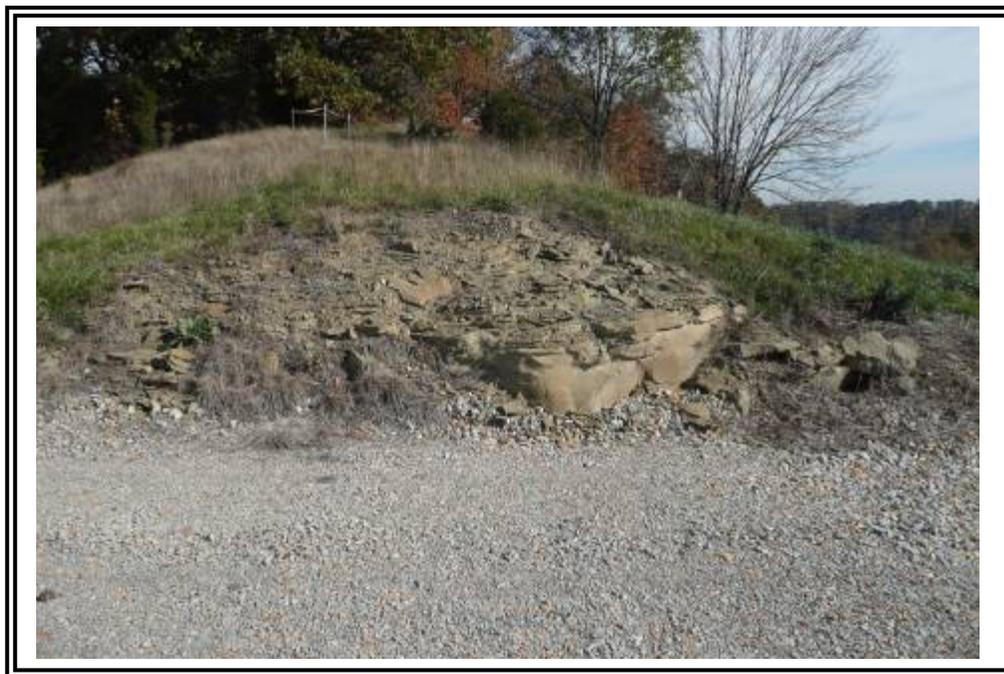
10

Rock outcrop (sandstone and siltstone) in hillside between No-Name Creek Dam and Mill Stone Creek Dam.

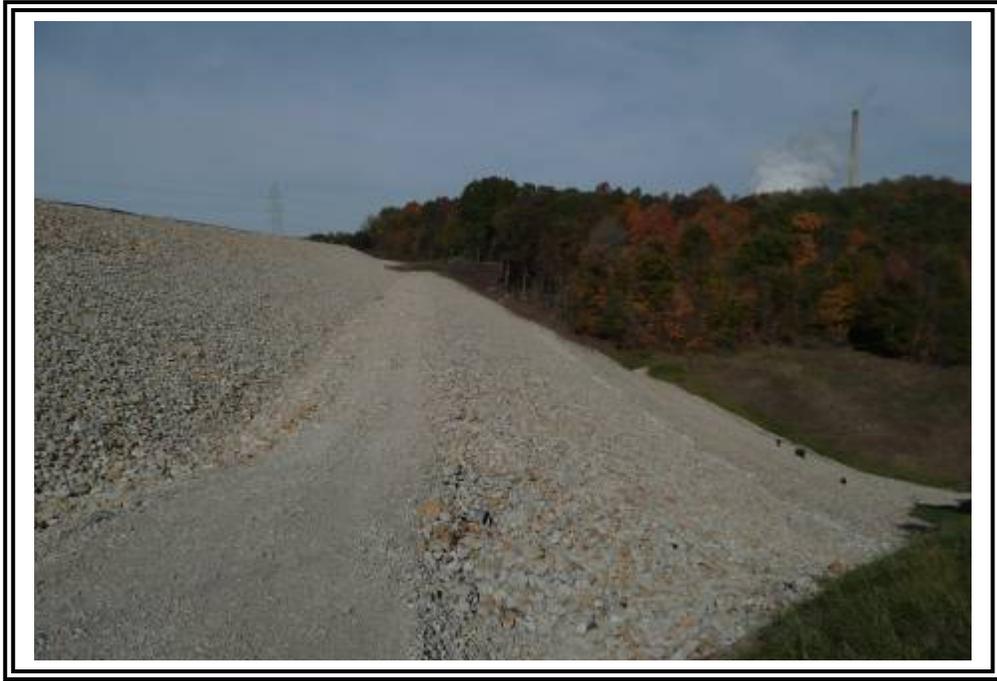
11

The No-Name Creek Dam is approximately 930 feet in length with its centerline aligned in a northwest to southeast orientation. It has a similar construction to the Mill Stone Creek Dam (Photo 11). The crest area of the dam consists of exposed compacted ash and appears to be stable and free from any abrupt lateral translation, vertical deformation or cracking (Photo 29). An exposed compacted ash construction bench, a continuation of the construction bench observed on the Mill Stone Creek Dam was observed near the crest of the dam at its present elevation (Photo 9).

No-Name Creek Dam, looking northwest along the downstream slope at bench area.

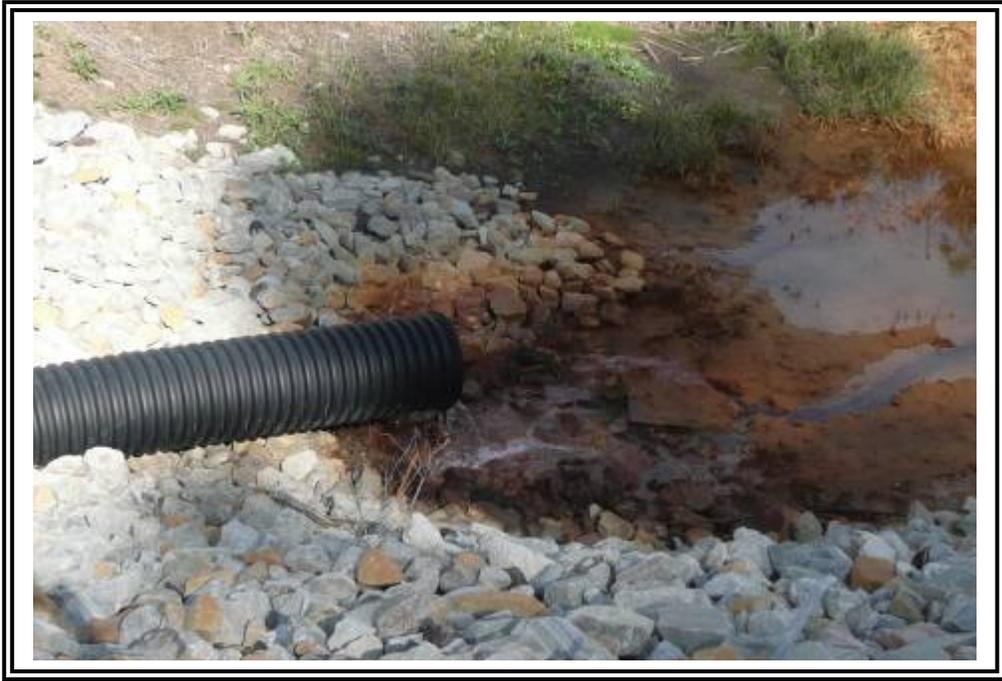
13

the dam are visible. The blanket drain discharges via an 18-inch corrugated HPDE pipe at the toe of the embankment (Photo 13), which conveys the seepage into an open channel leading to a seepage collection pond (Photo 14). The seepage observed at this pipe was clear at the time of our site visit. Iron precipitate staining from the seepage was evident. Seepage in the pond is collected from the No-Name Creek and the Wing Dams and pumped back into the Upper Fly Ash Reservoir. According to AEP personnel, this collection pond was installed to meet environmental discharge requirements.

Active blanket drain outlet at No-Name Creek Dam. No iron precipitate.

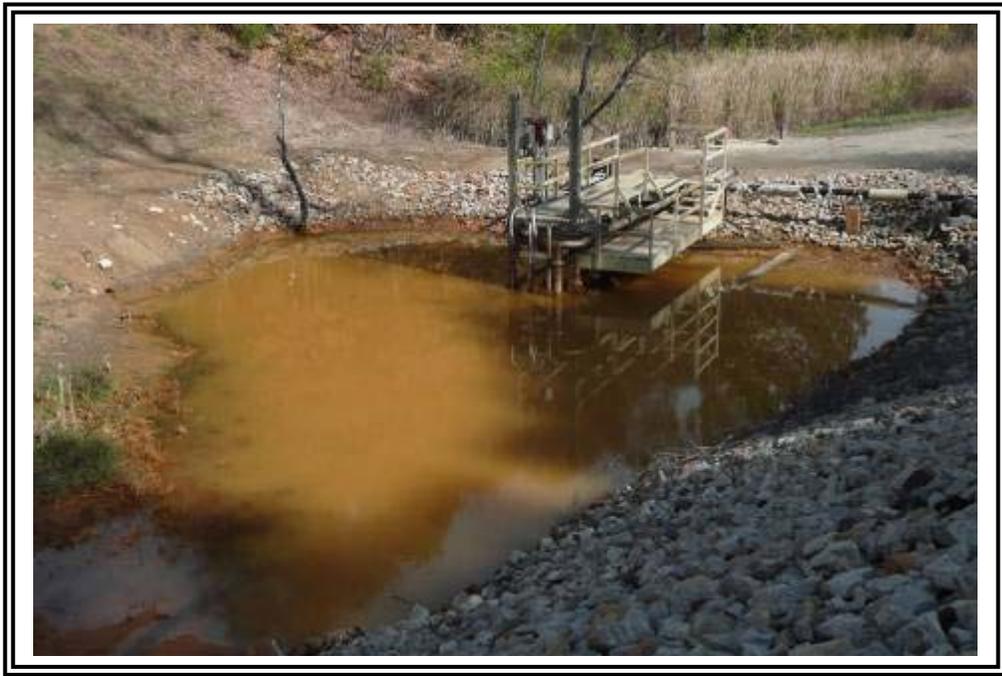
14

Seepage collection, treatment, and recirculation basin at No-Name Creek Dam.

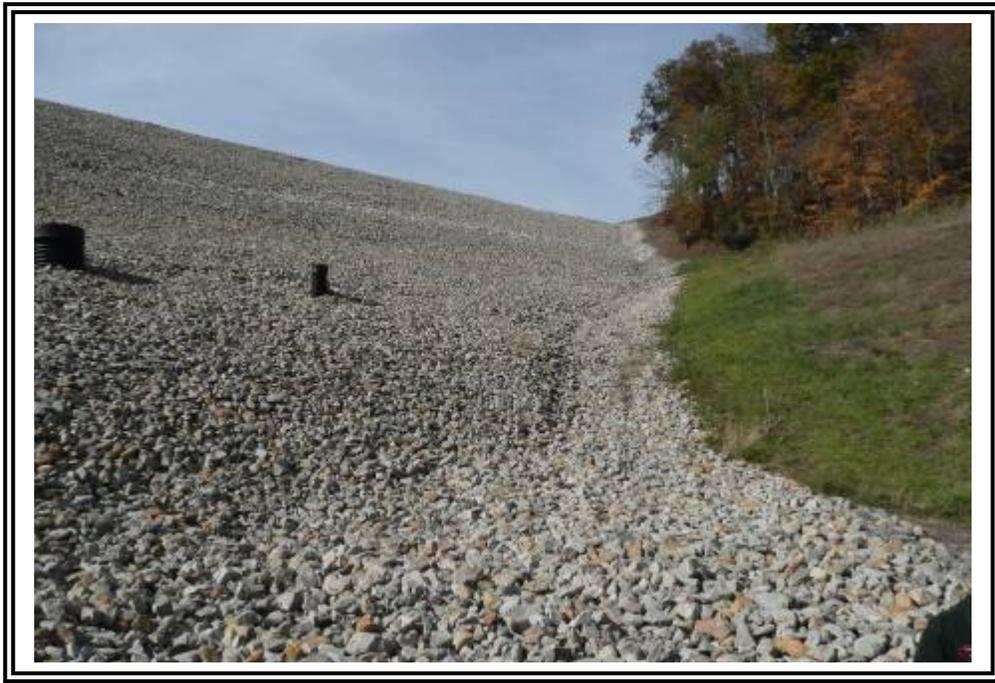
15

Downstream slope and left (northwest) abutment groin contact of the No-Name Creek Dam.  
Note blanket drain system inspection, access and cleanout ports.

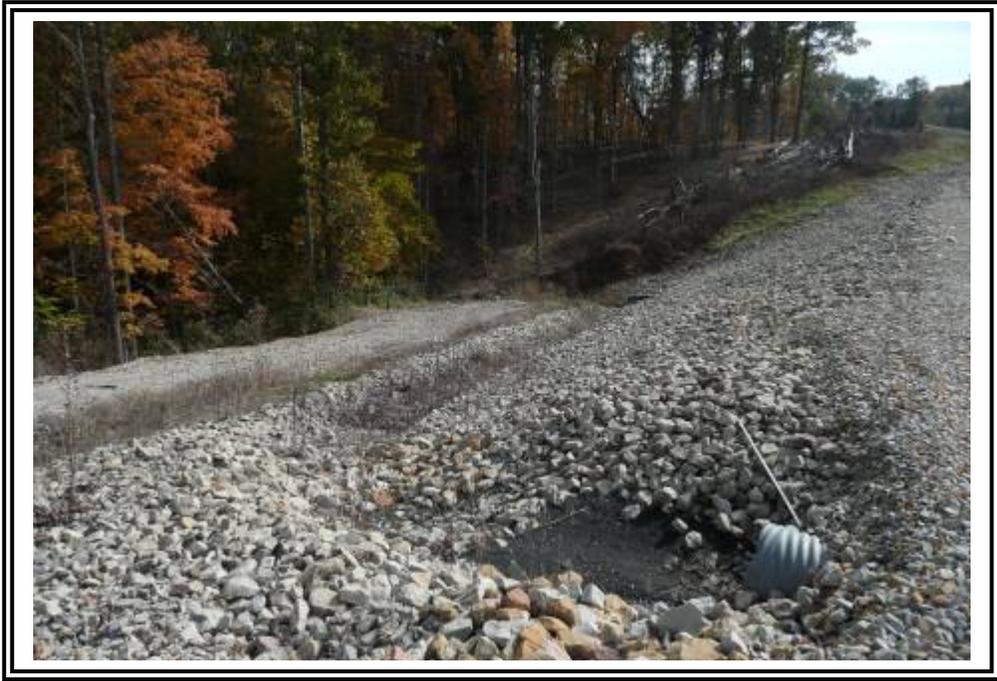
19

Mid-slope drainage groins and swale at toe of the Wing Dam downstream slope.

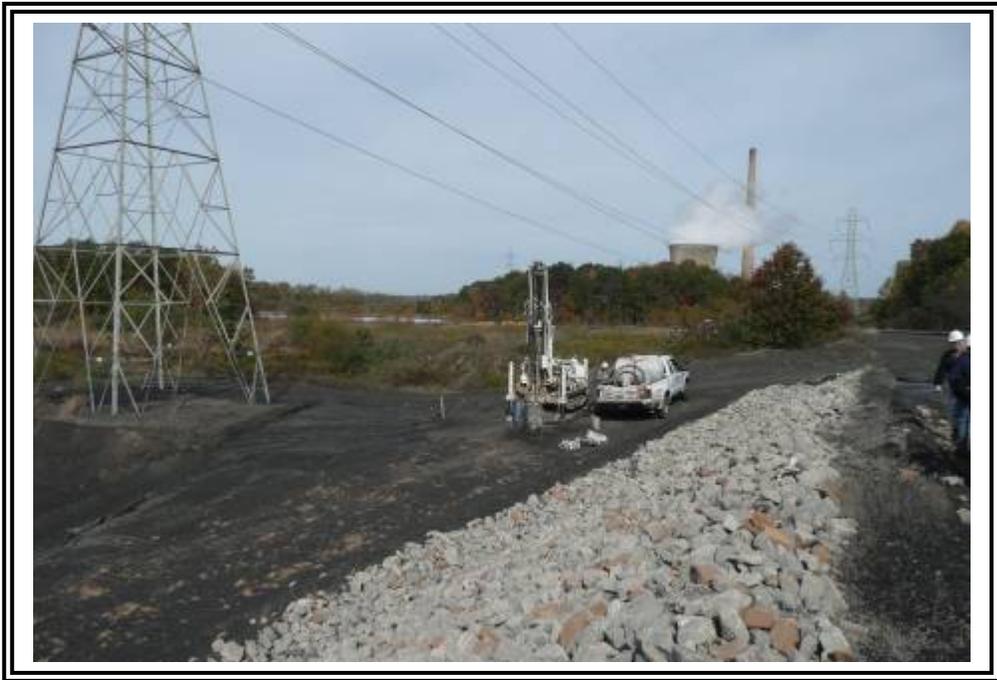
20

Downstream slope of the Wing Dam, looking north. The embankment makes a curve to an east-west alignment at this location. Crews were drilling for a new transmission tower foundation at the time of the site visit.

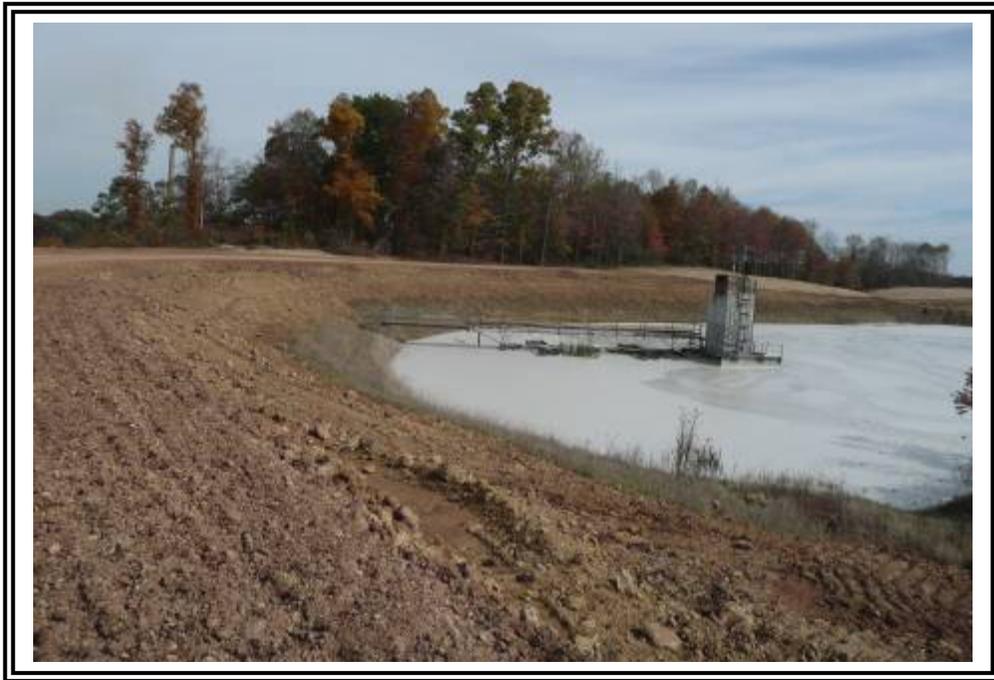
24

Upstream slope of the Spillway Dam, looking northeast. Spillway riser structure is visible in the right of the photo.

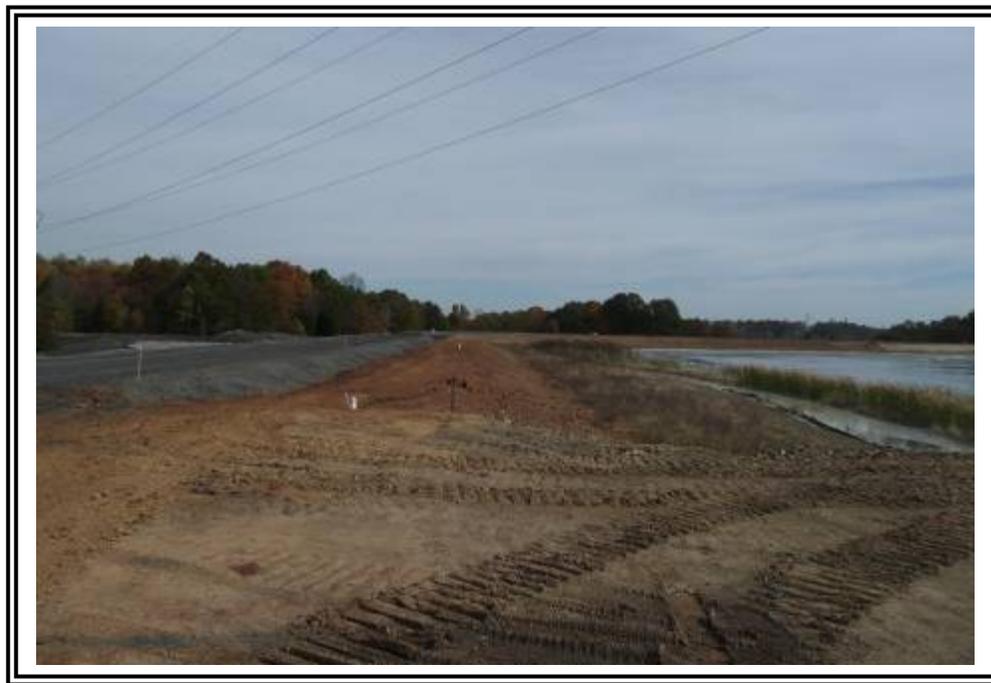
26

Crest and upstream slope of the Wing Dam, looking east.

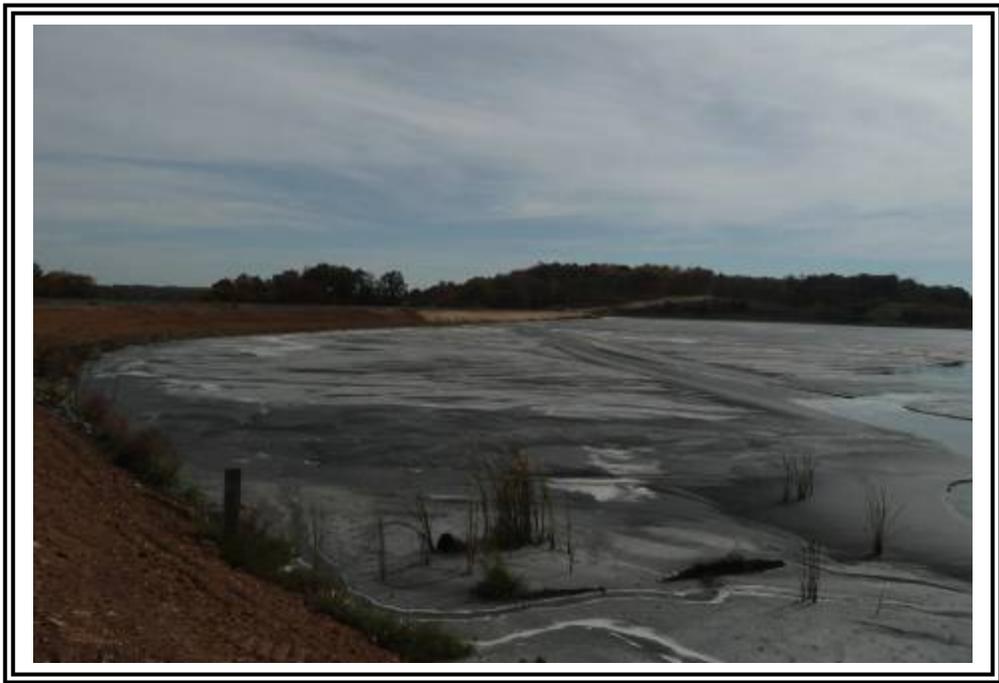
28

Upstream slope of the Wing Dam and ash deposit, looking east towards upstream slopes of the No-Name Creek Dam and the Mill Stone Creek Dam.

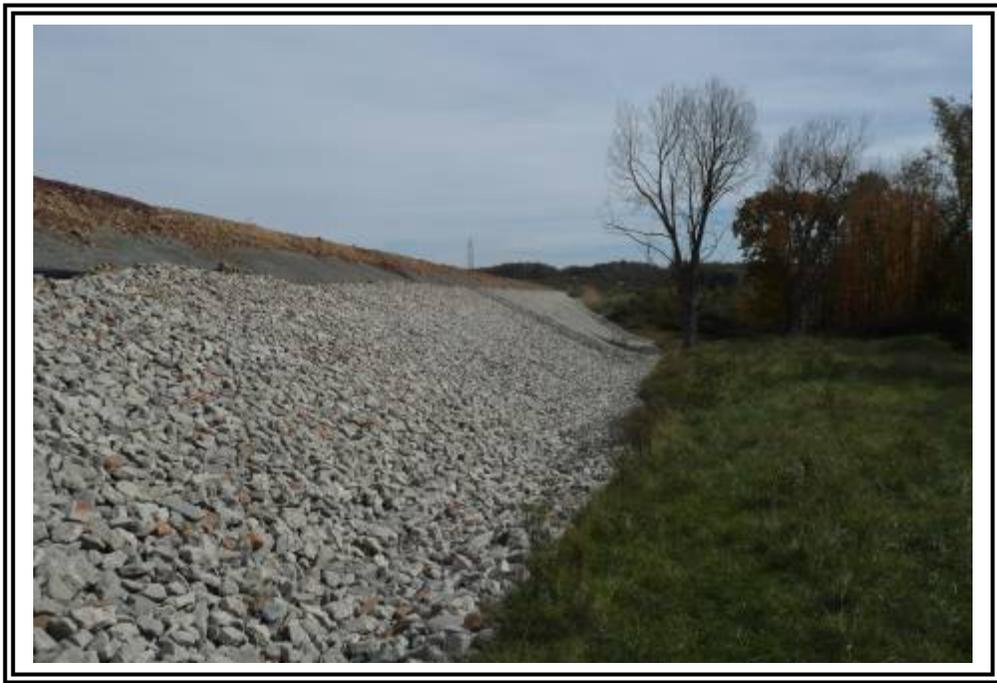
30

Downstream slope toe area of the Freeboard Dam, looking east.

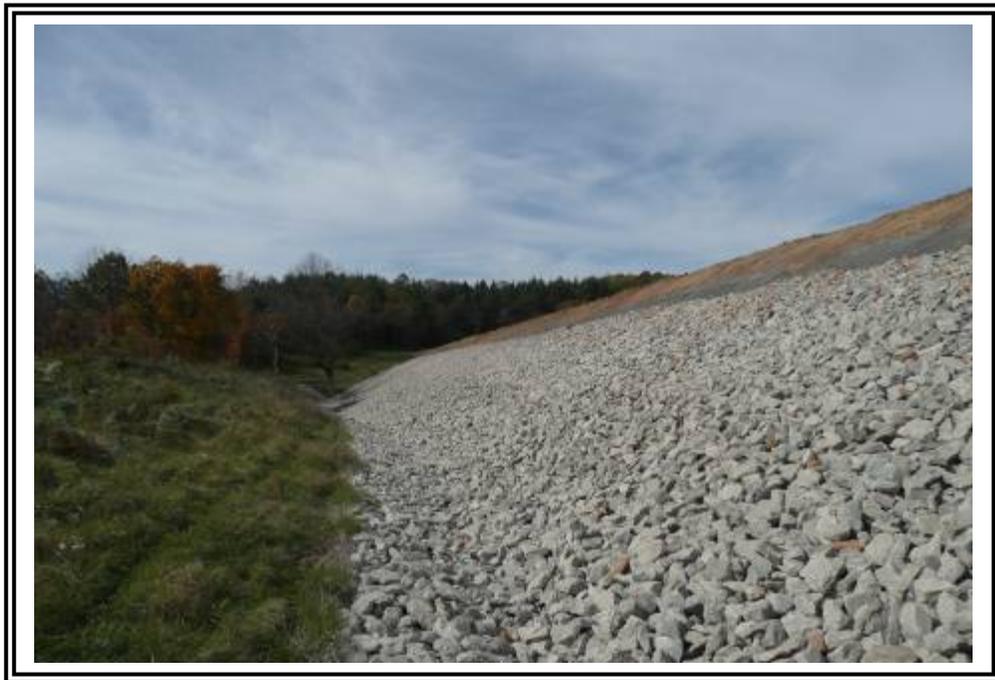
32

Downstream slope of the Freeboard Dam, looking west.

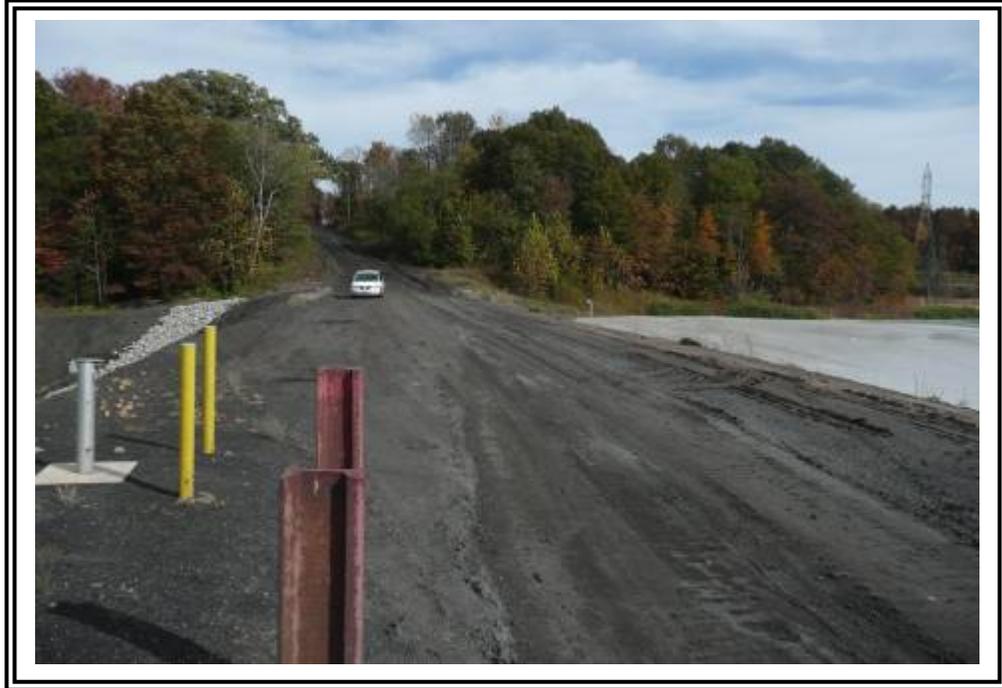
36

Crest of the Middle Fly Ash Dam, looking east. Note groundwater monitoring well.

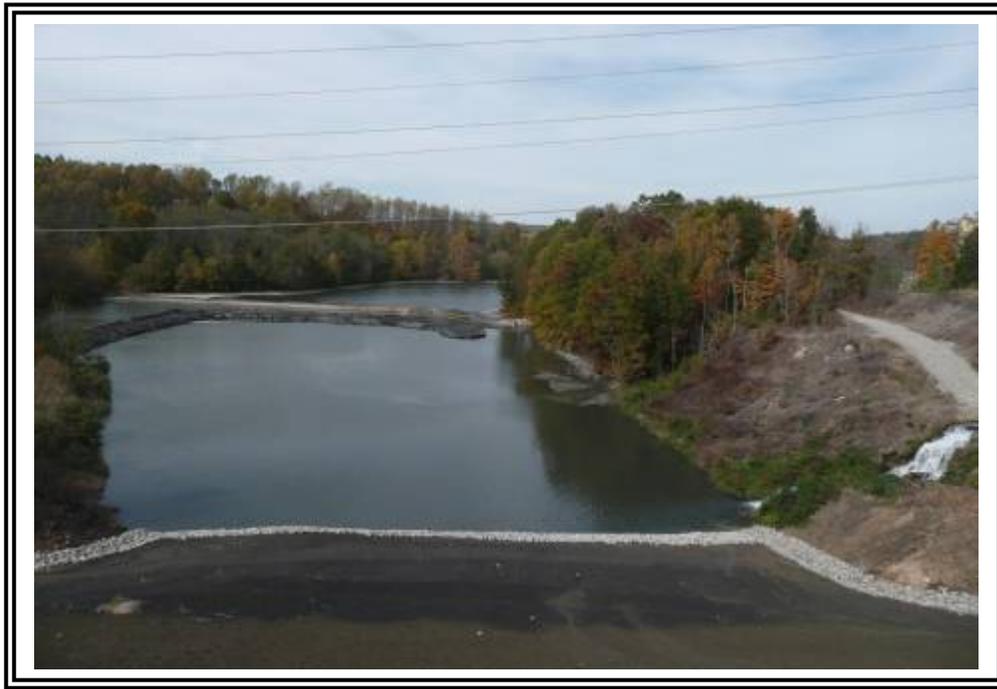
38

Looking downstream from the Middle Fly Ash Dam. Note ash slope construction and rip-rap toe protection.

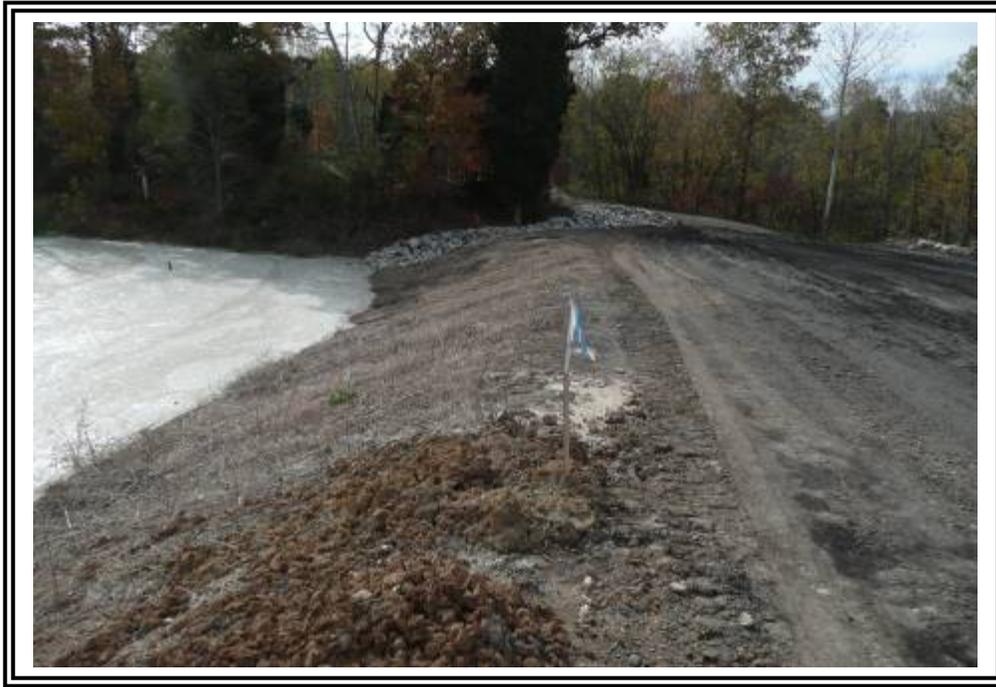
40

Upstream slope of the Middle Fly Ash Dam at left (west) abutment rock groin contact, looking west.

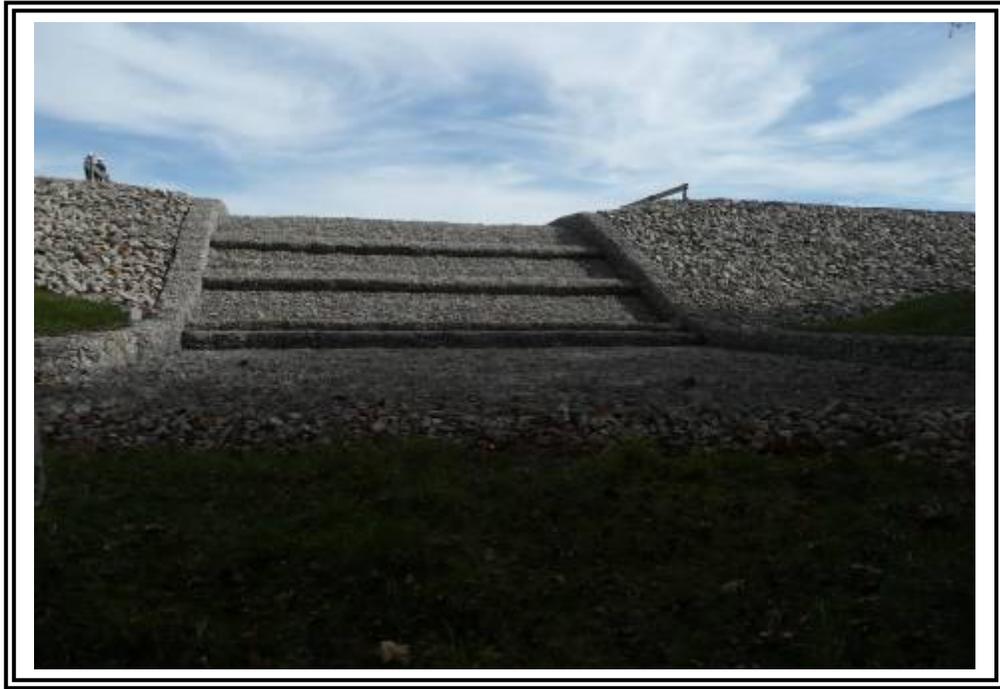
42

Middle Fly Ash Dam, emergency spillway section, looking upstream.

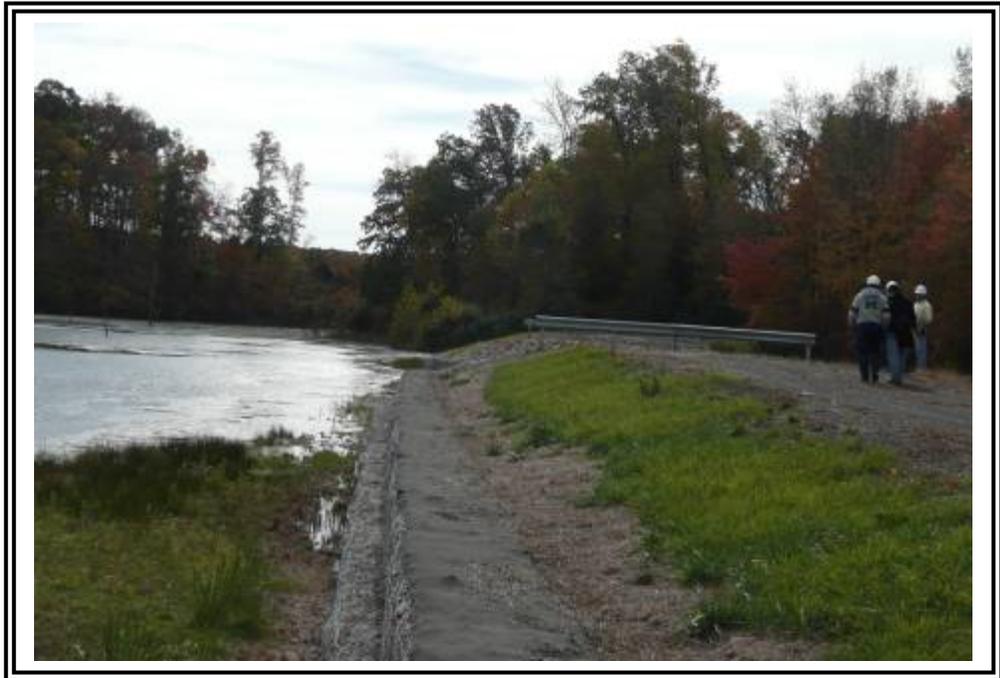
43

Looking southwest along upstream slope of the gabion emergency spillway.

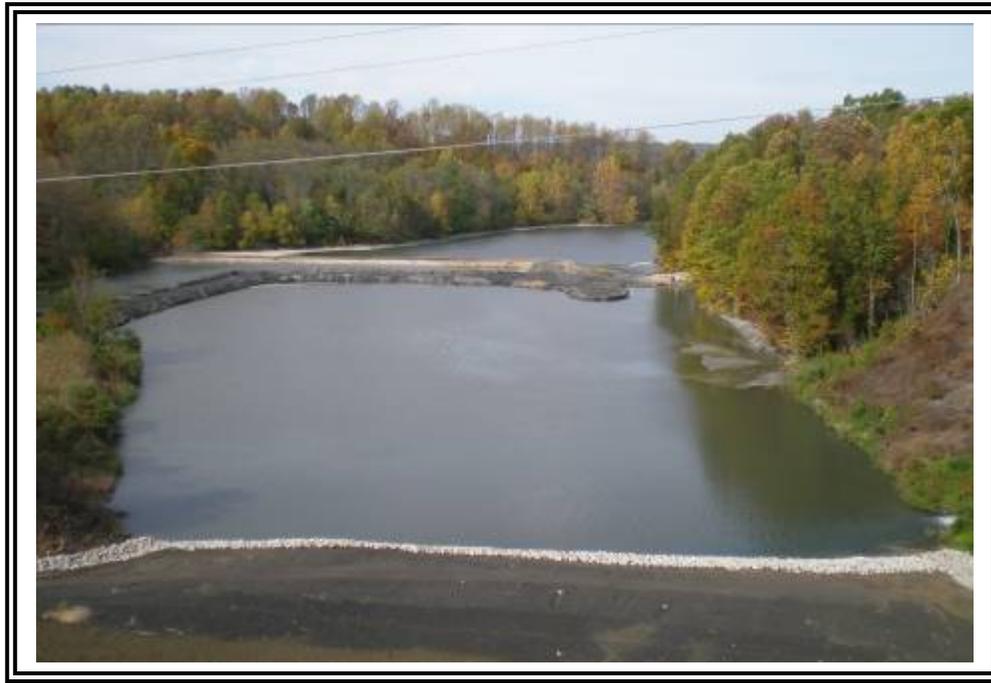
48

Looking north-northwest from crest of the Middle Fly Ash Dam across the Lower Fly Ash Reservoir.

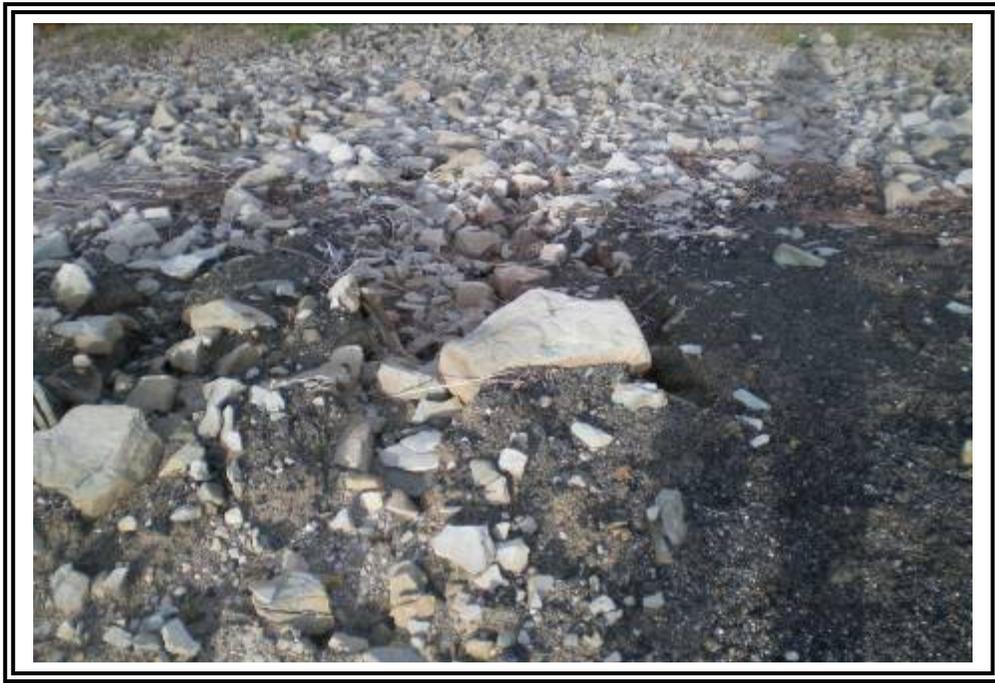
61

Migration of bottom ash material used to grade the crest onto the slope protection at the Lower Fly Ash Dam.

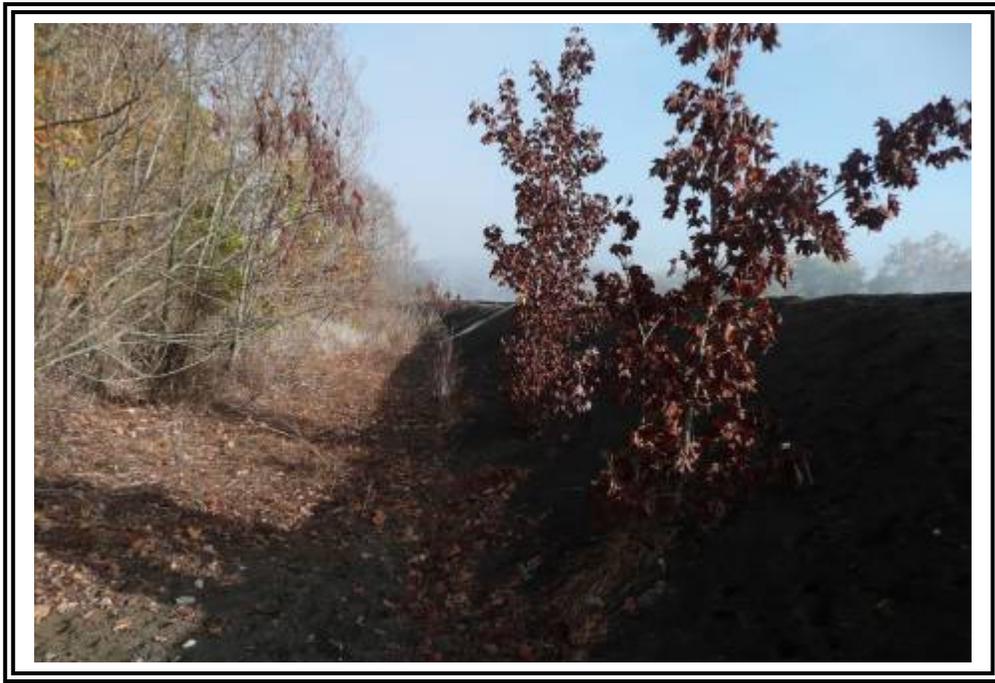
65

Units 1-4 Bottom Ash Pond west dike exterior slope, looking north. Note dying woody vegetation.

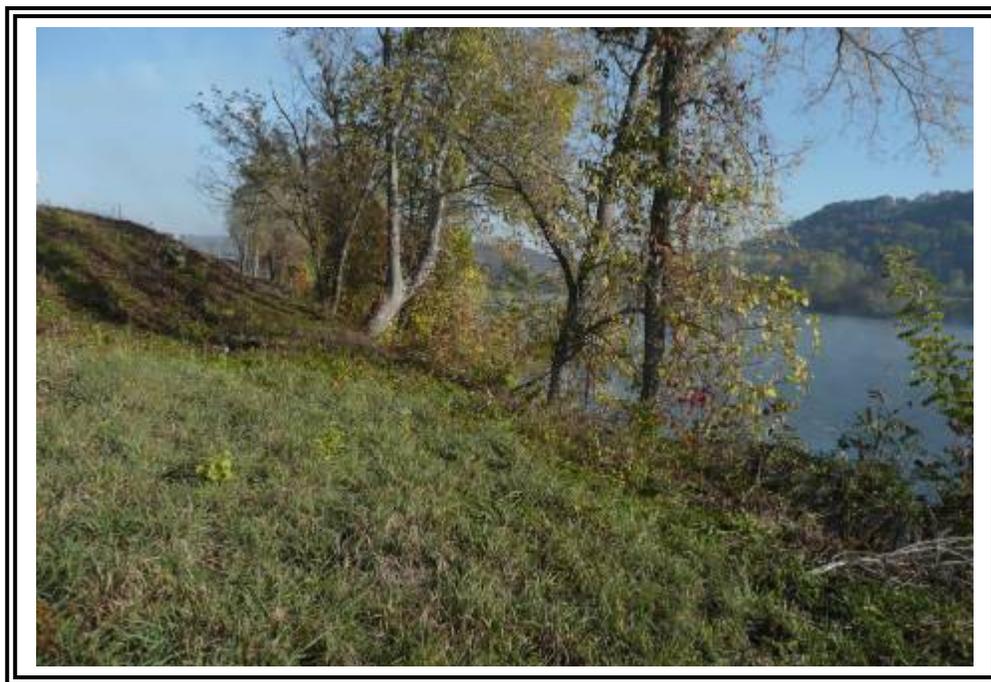
71

Units 1-4 Bottom Ash Pond east dike exterior slope along the Muskingum River, looking north (or upstream with respect to the river flow). Note relatively large trees at the river bank leaning towards the river.

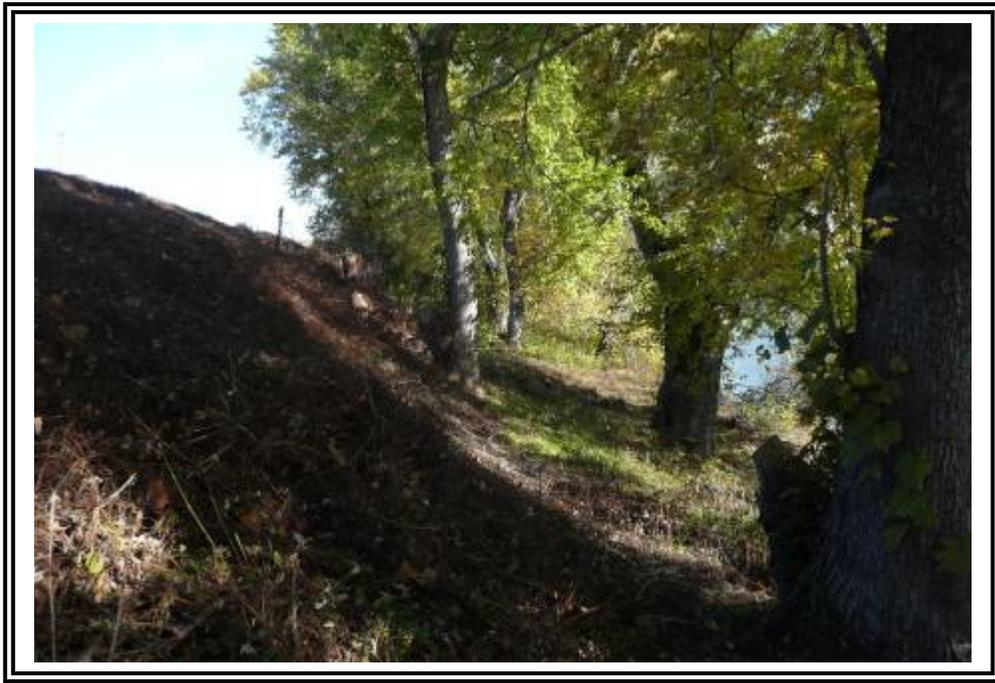
75

Units 1-4 Bottom Ash Pond east dike toe, looking north. Note large trees at the toe and between the dike and river bank.

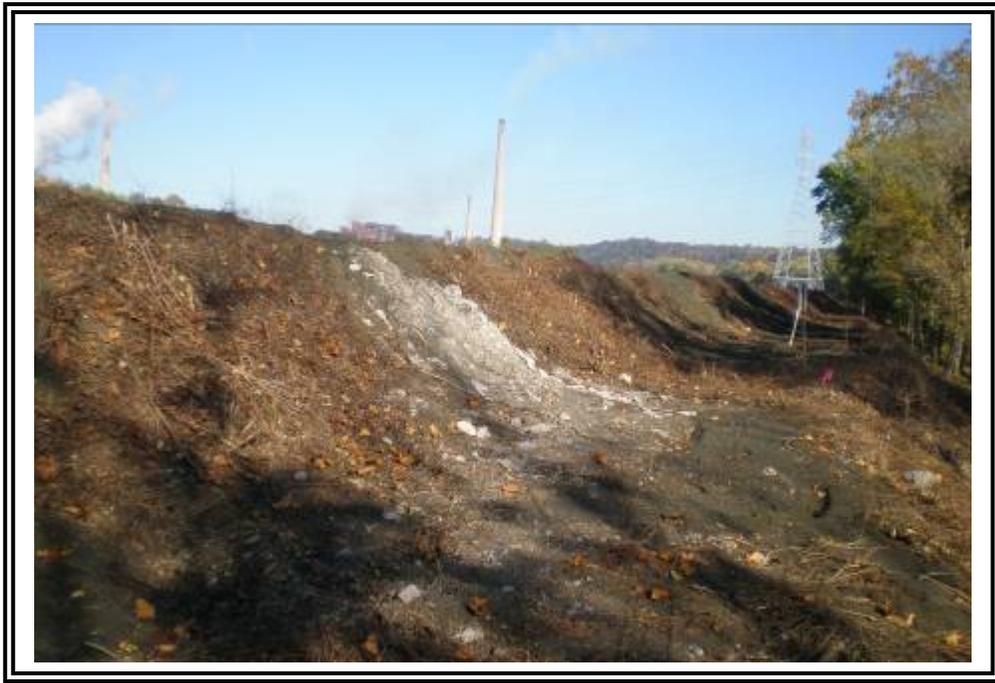
83

Units 1-4 Bottom Ash Pond upper east dike slope and bench area toward the central portion of the dike, looking north. Bench has narrowed to 8 feet wide.
