**FINAL REPORT  
ROUND 10 DAM ASSESSMENT  
AMERICAN ELECTRIC POWER  
PICWAY GENERATING STATION  
ASH POND**

**August 17, 2012**

Re: Round 10 Dam Assessment - Final Report  
EPA Contract No. EP10W001313  
American Electric Power – Picway Generating Station  
Ash Pond  
Lockbourne, Ohio

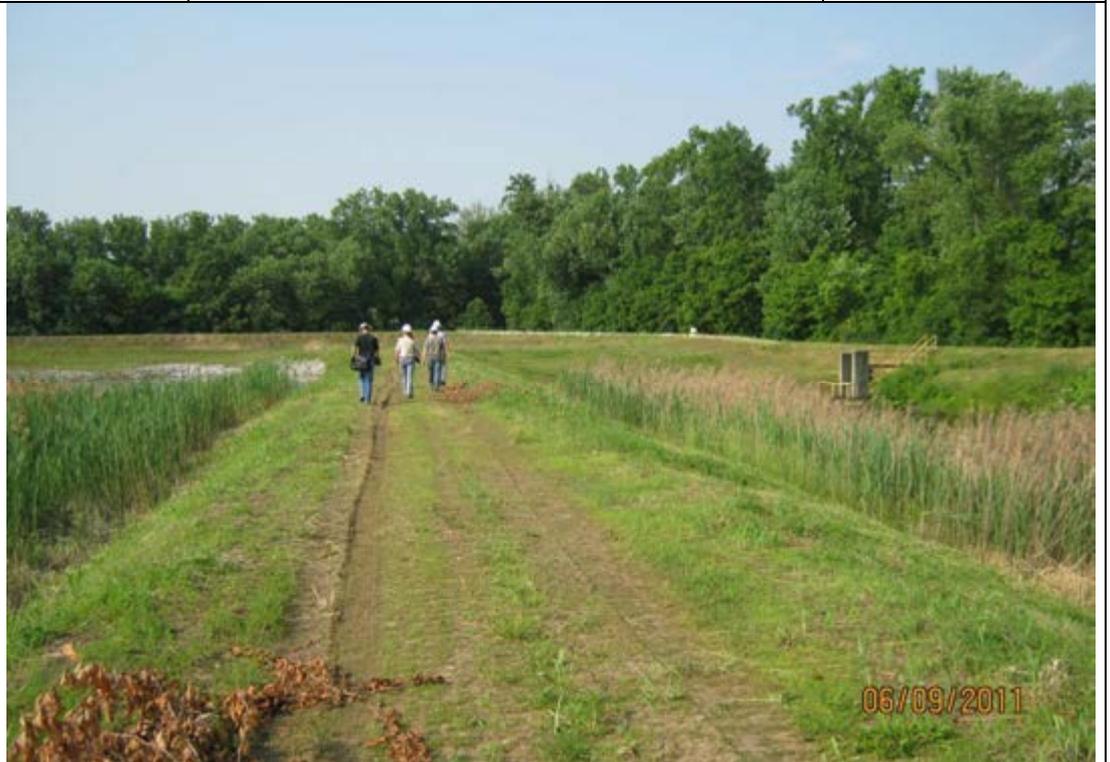
View of berm dividing Cell S2 (left) from clearwater pond (right). Note concrete discharge structure in clearwater pond.

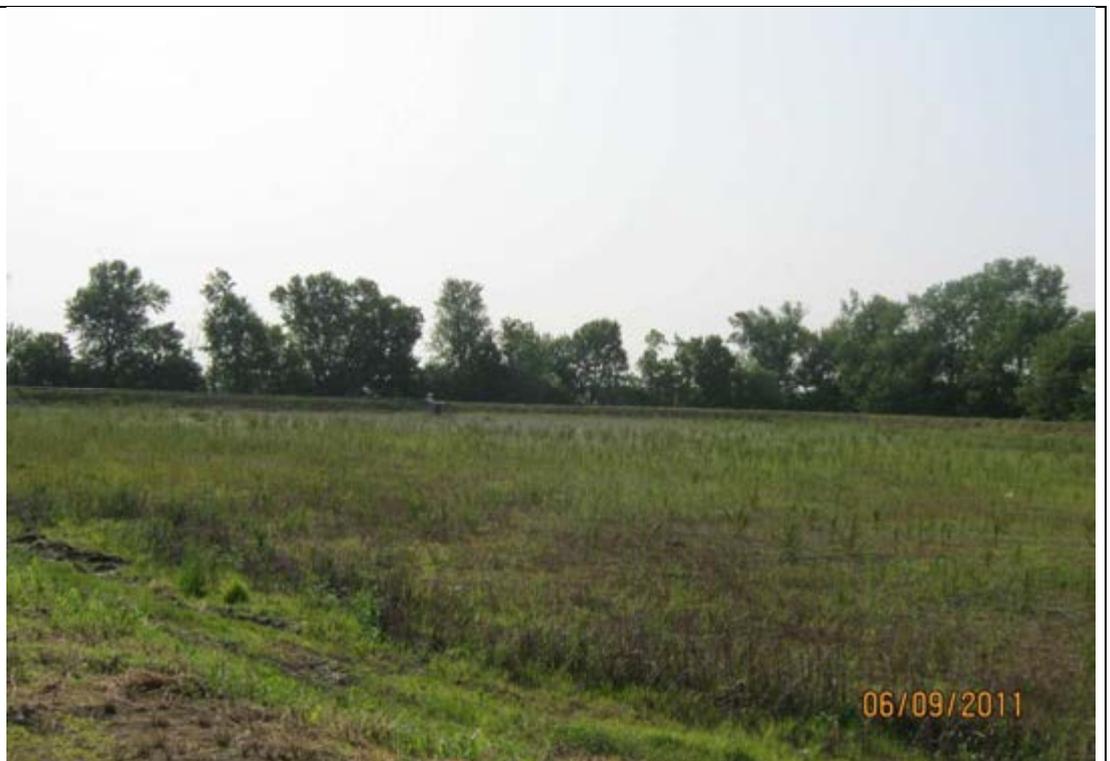
View of Cell S1 in south pond.

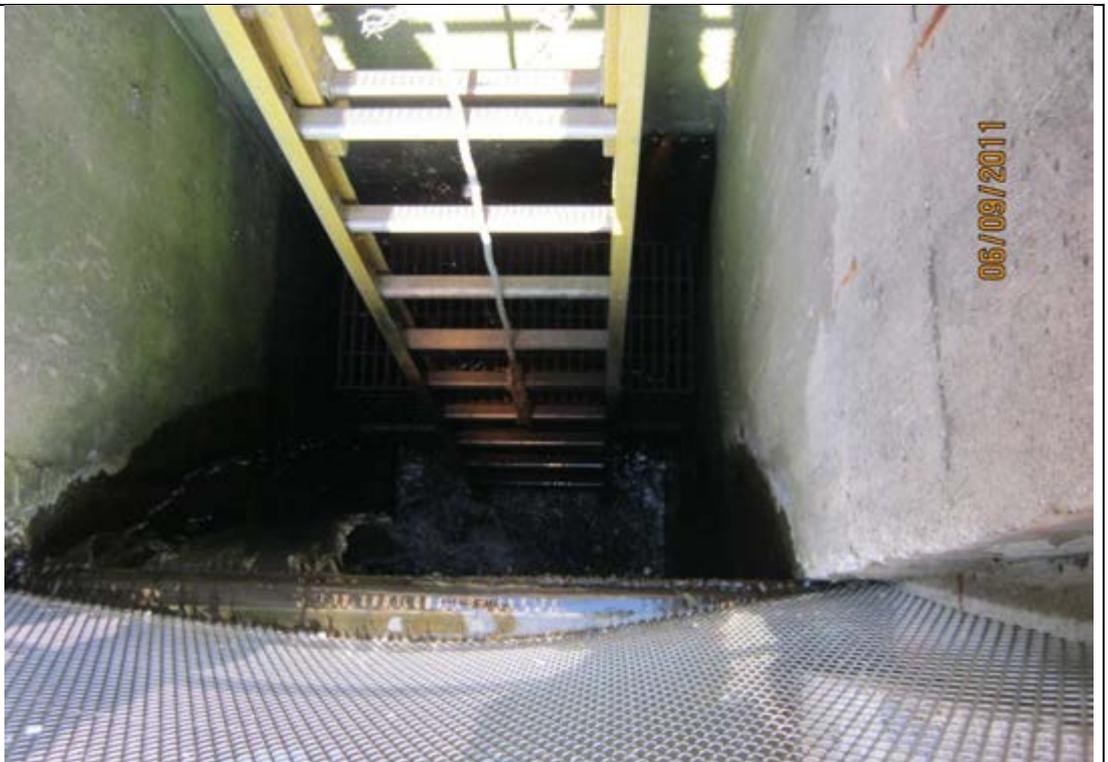
View of interior of concrete discharge structure in clearwater pond.

1. Minor concrete repair work on the concrete discharge structure in the clearwater pond;
2. Re-seed and/or over seed bare areas of the embankments and crest to establish healthy grass cover;
3. Clear the area of established vegetation near the lower portion and toe of the outer embankment slopes near the outfall structure; and,
4. Regrade areas near the toe of exterior slopes to facilitate proper drainage away from the embankments.

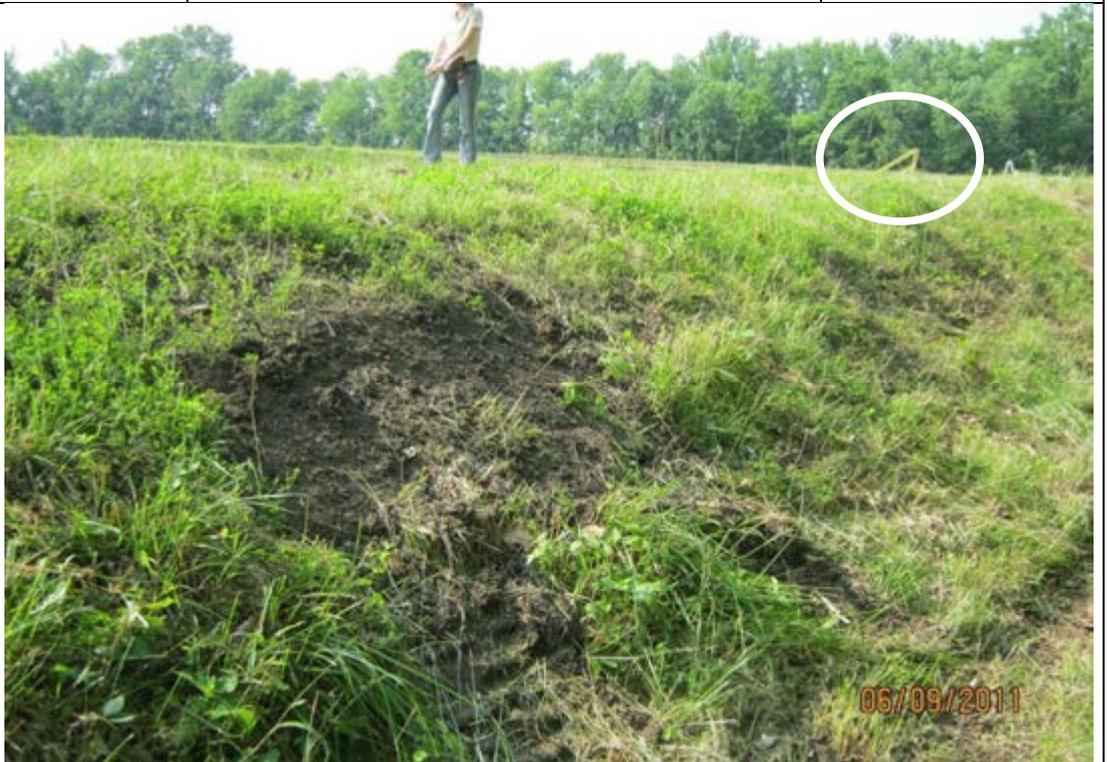
Area of outer west embankment observed to be bare of vegetation. Note hand rail of concrete discharge structure in background for reference point (circled).

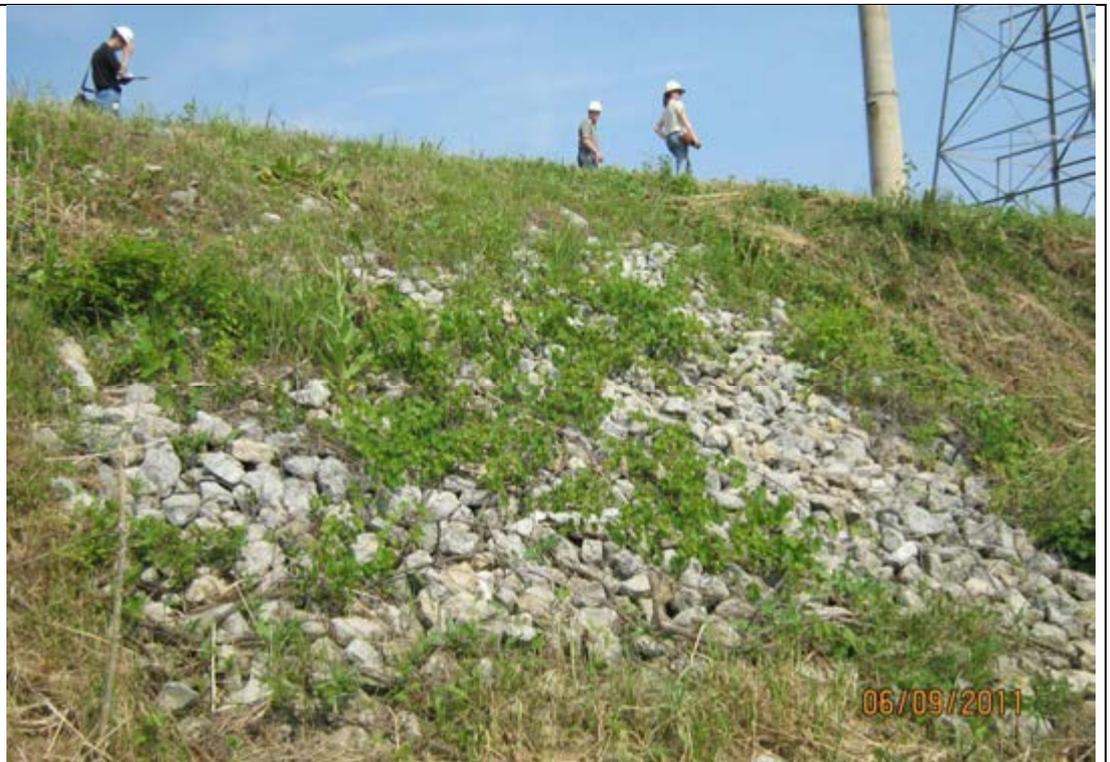
View of rip rap placed on the outer east embankment to address isolated area of erosion.

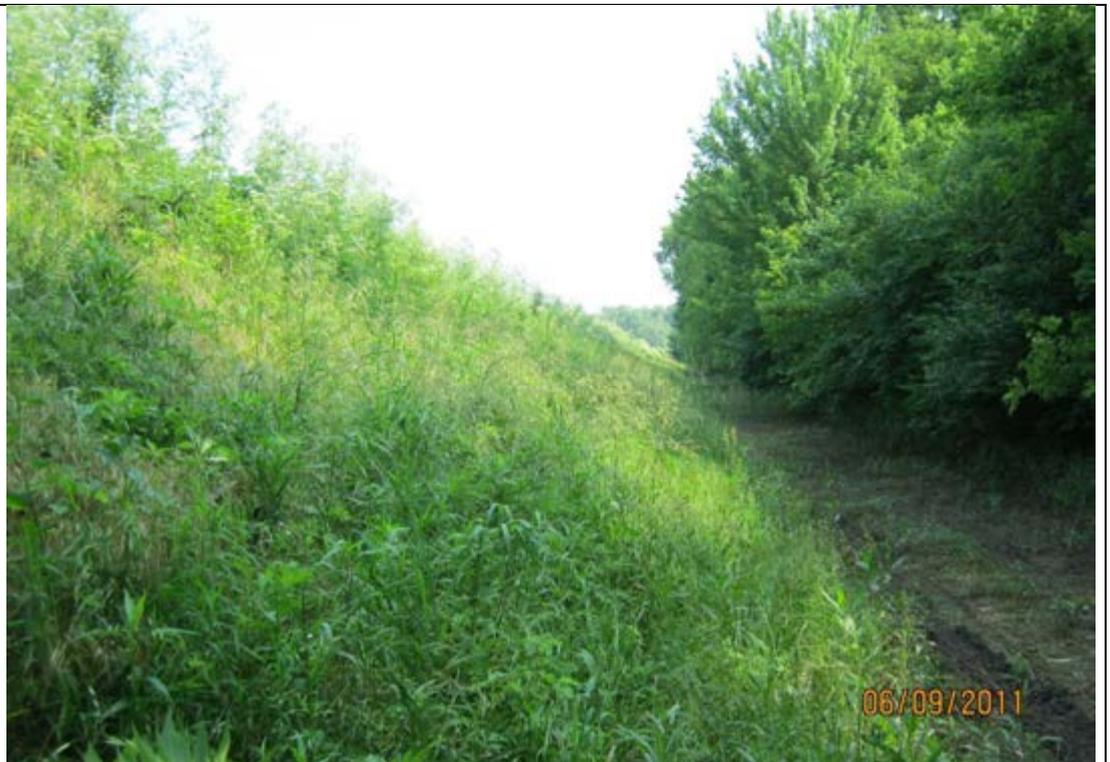
View of outer east embankment of the north pond. Note un-mowed vegetation.

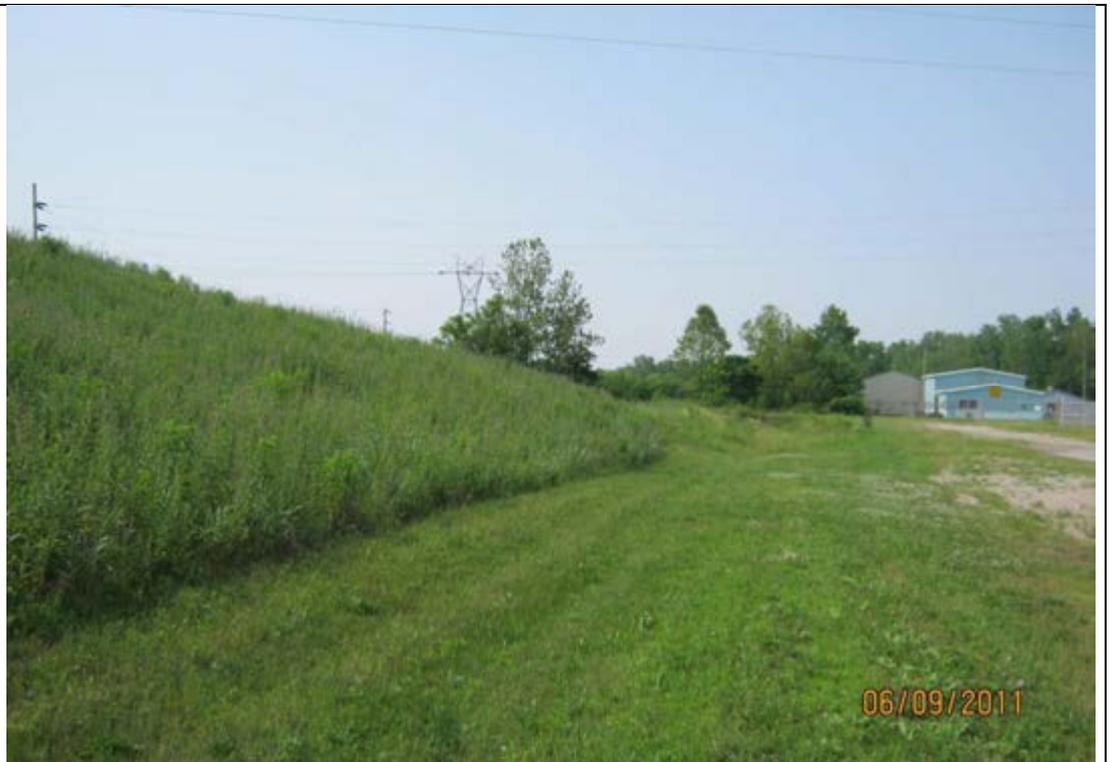
View of crest of west embankment of the north pond. Note capped portion of north pond to left.
