# ASSESSMENT OF DAM SAFETY OF COAL COMBUSTION SURFACE IMPOUNDMENTS

**FirstEnergy Corp  
Albright Power Station  
Albright, West Virginia**

Prepared for  
*U.S. Environmental  
Protection Agency  
Washington, D.C.*

October 2012

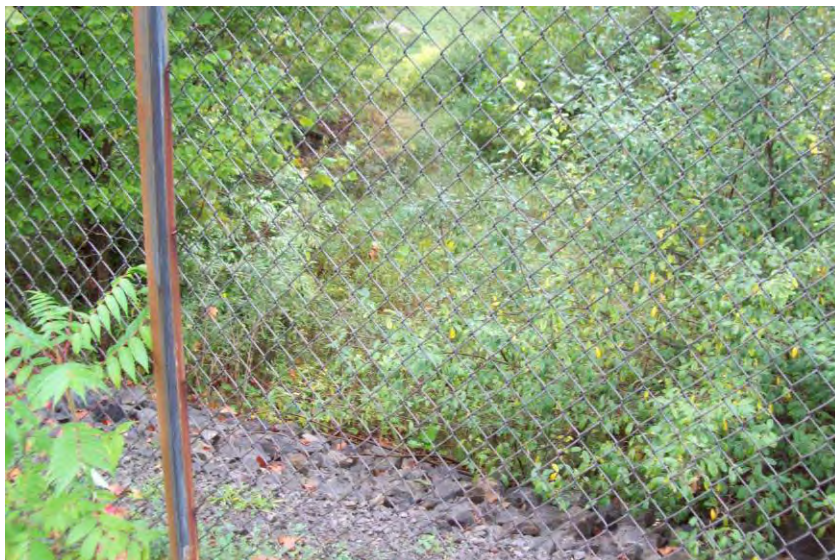
Photo 15: North embankment exterior slope, looking northwest. Note typical riprap and vegetation

Trees and dense vegetation along the exterior slopes of the North and South Lagoon, adjacent to the Cheat River, should be removed and embankments slopes be restored to the original contours by placing select structural fill and compacting, as recommended by a qualified professional engineer. After slope restoration, it is recommended to stabilize the exposed surface of the embankment with sod, hydro seeding, or riprap consisting of a heterogeneous mixture of irregular-shaped rocks placed over the compacted fill and a geotextile fabric. Regular maintenance activities should be performed at least twice a year or as conditions warrant from the spring to fall to control and limit growth of vegetation on the embankments.

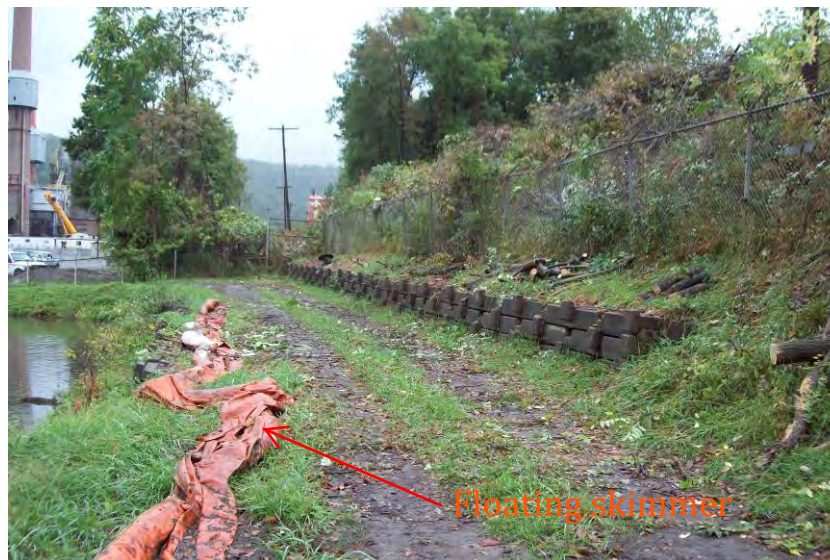
Information regarding major repairs or rehabilitation to the embankments of the lagoons was not provided. Evidence of repair/rehabilitation included the concrete crib retaining walls near the southwest corner of the North Lagoon that may have been installed as part of remedial measures, but no information on the purpose or date of construction was provided. No evidence of prior releases or failures was observed on the embankments during CDM Smith's visual assessment. There was no documentation provided that indicates otherwise.

Photo 20: West embankment, looking southeast. Note concrete crib retaining walls.

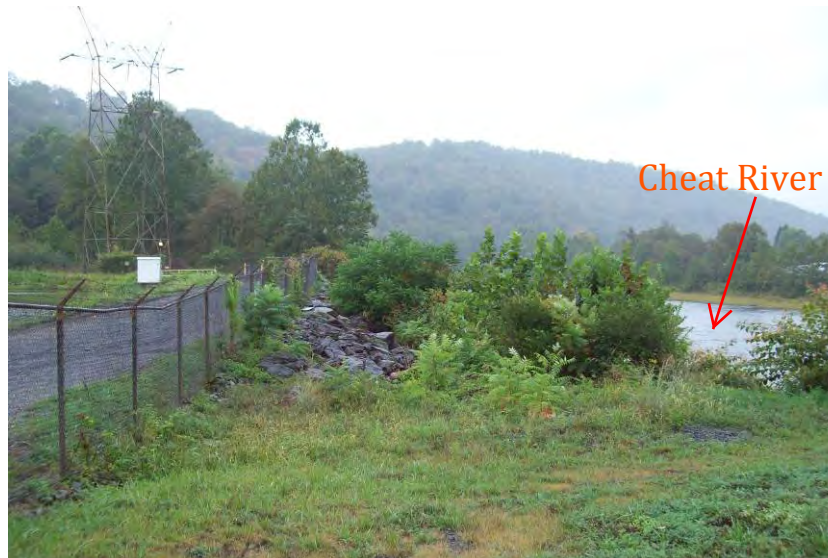
Photo 26: East embankment exterior slope, looking northwest. Note typical vegetation and riprap.

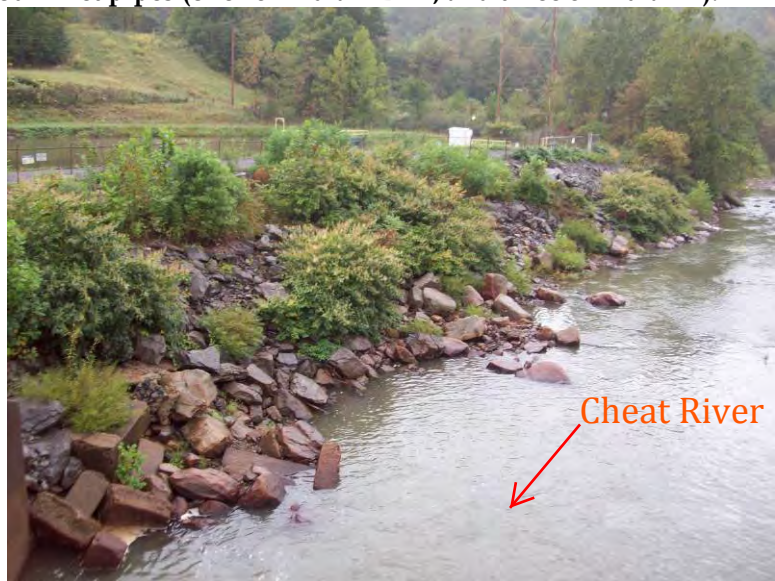
Photo 27: East embankment exterior slope, looking west. Note typical vegetation and riprap.

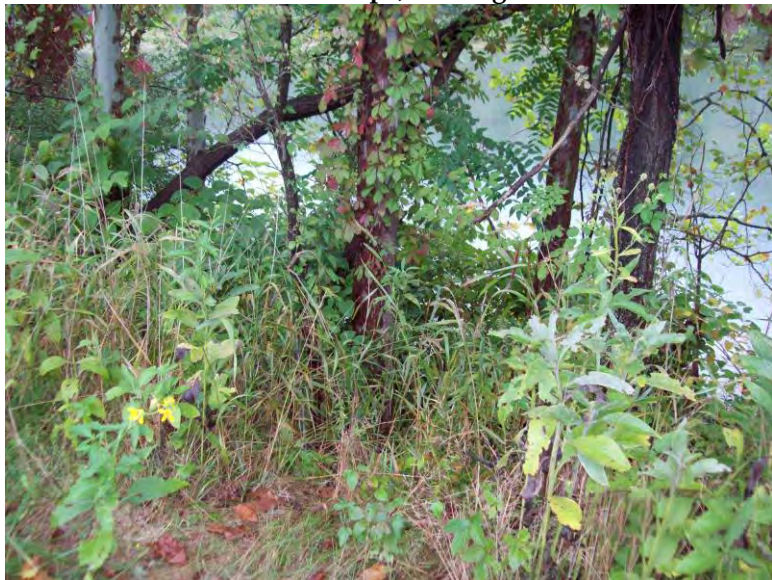
Photo 62: East embankment exterior slope looking northeast. Note typical vegetation and Cheat River in background.
