Report of Geotechnical  
Assessment of Coal Combustion Surface  
Impoundments  
Minnesota Power  
Boswell Energy Center, Cohasset, MN

AMEC Project No. 3-2106-0174.0300

June 2010

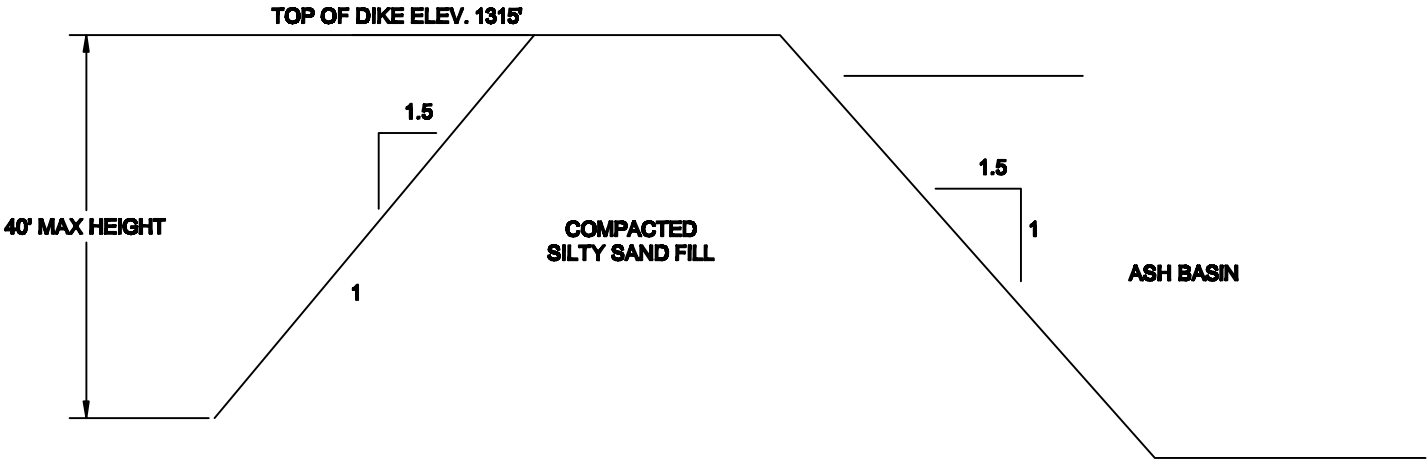
TYPICAL SECTION DIVIDING DIKE (WESTERN DIKE)

NOTE: SECTION IIIB OF EBASCO'S AUGUST 1981 REPORT STATED " DURING INITIAL FILLING OF THE BOTTOM ASH POND, SOME INSTABILITY OF THE DIVIDING DIKE WAS NOTED AND A DOWNSTREAM BERM WAS CONSTRUCTED TO INCREASE THE EFFECTIVE SLOPE, THEREBY INCREASING THE STABILITY OF THE EMBANKMENT. RIP-RAP WAS USED TO INCREASE STABILITY OF THE UPSTREAM SLOPE ". NO OTHER DETAILS OR DRAWINGS WERE PROVIDED REGARDING THIS MODIFICATION

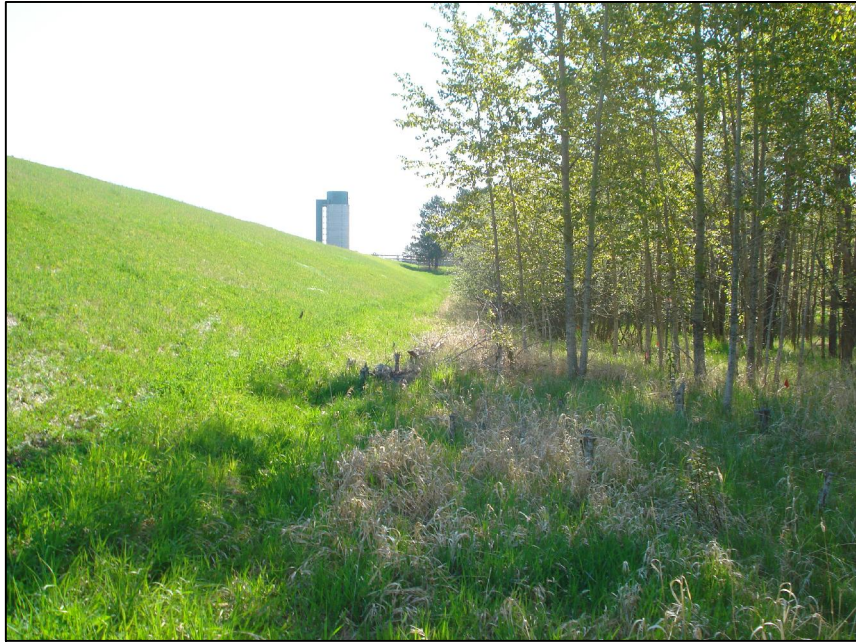
**1-7**

**WETLAND AREA ALONG SOUTHERN DOWNSTREAM TOE**

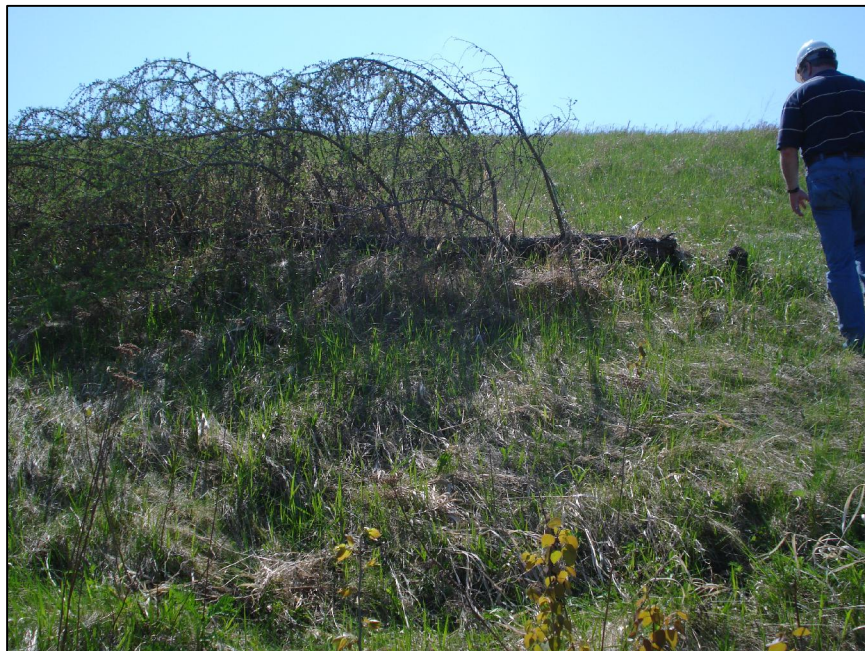
**1-14**

**TREE WITHIN SOUTHERN EMBANKMENT DOWNSTREAM SLOPE**

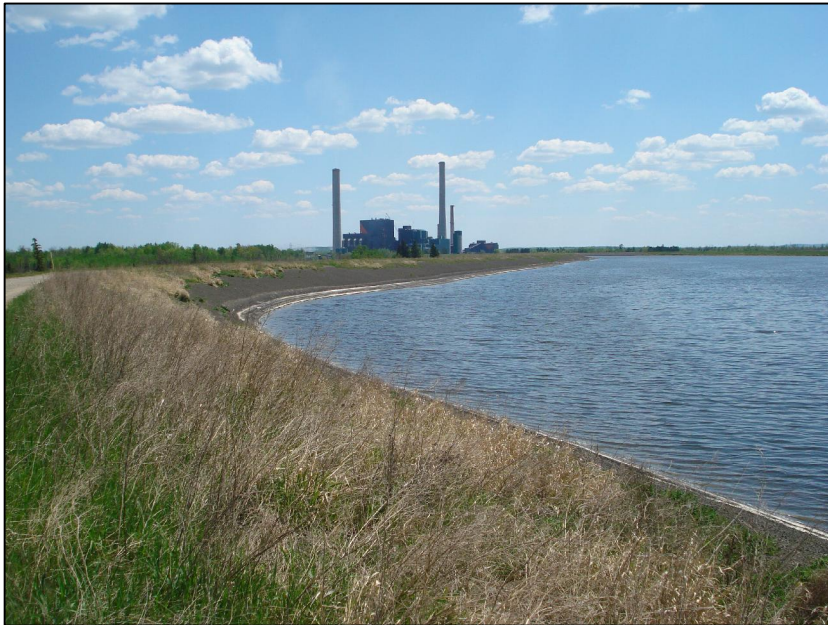
**1-34**

Erosion repair efforts were noted along the interior of the perimeter dikes (photos 1-34, 1-35, and 1-36). According to interoffice Minnesota Power emails, dike repairs were completed in May 2008 and June 2009. The affected areas include Pond 3, southeastern perimeter dike, Pond 4 northern, northeastern and eastern perimeter dike, and southwestern interior dike. The Bottom Ash Pond was in need of repair along the southern perimeter dike, and northeastern interior dike. Repair areas varied in size from 30 feet to 2100 feet in length, 4 feet to 45 feet in width, and 1 foot to 4 feet in depth. At the time of the inspection, wave action erosion was evident on the inside face of certain segments of the dikes.

**VIEW FROM NORTHERN DIKE LOOKING TOWARDS BOSWELL ENERGY CENTER  
ILLUSTRATES REPAIRED DIKE ALONG POND 4**

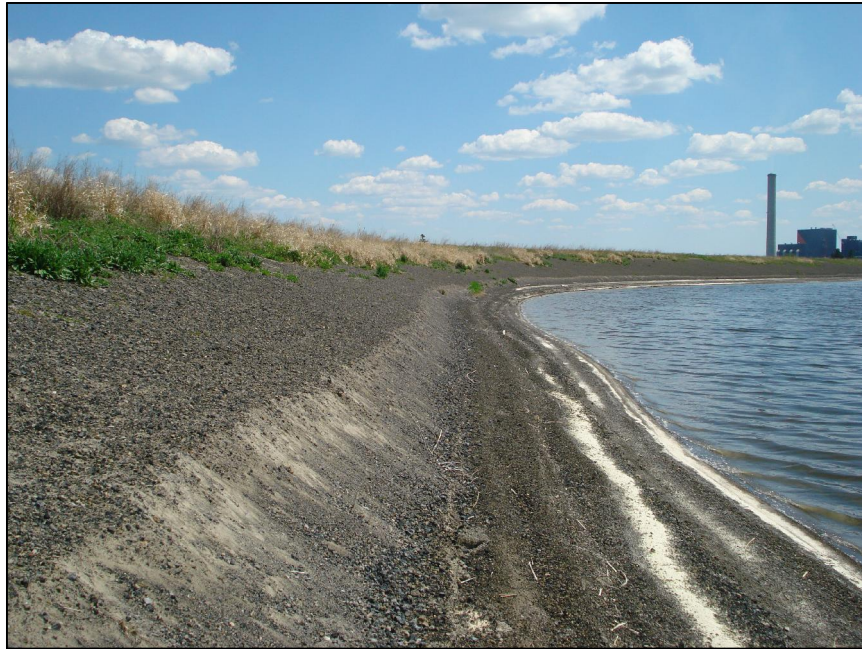
**1-35**

**VIEW FROM NORTHERN UPSTREAM DIKE ALONG POND 4 LOOKING EAST - ILLUSTRATES  
PREVIOUS DIKE EROSION REPAIRS AND WAVE ACTION**

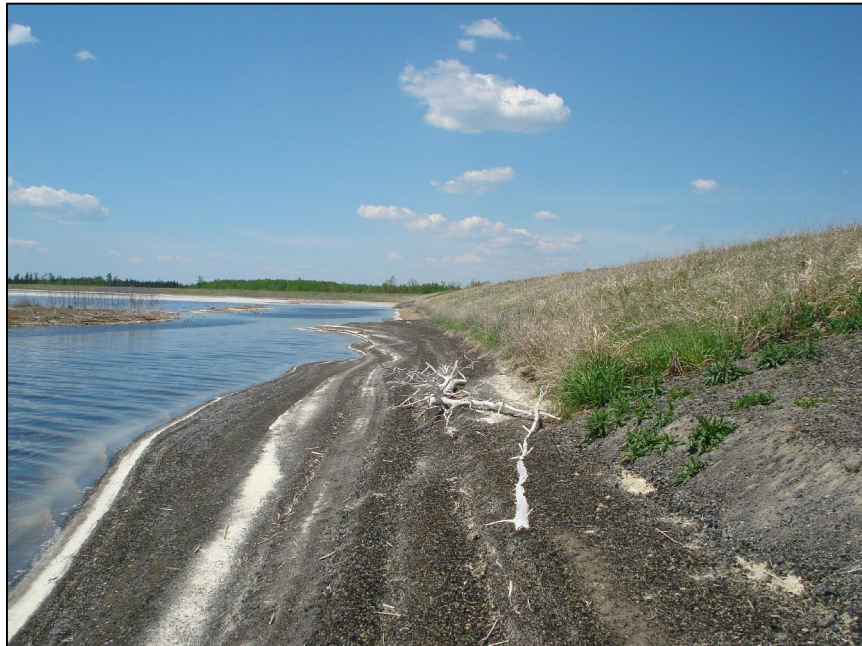
**1-36**

**VIEW FROM NORTHERN UPSTREAM DIKE ALONG POND 4 LOOKING WEST - ILLUSTRATES  
PREVIOUS DIKE EROSION REPAIRS AND WAVE ACTION**

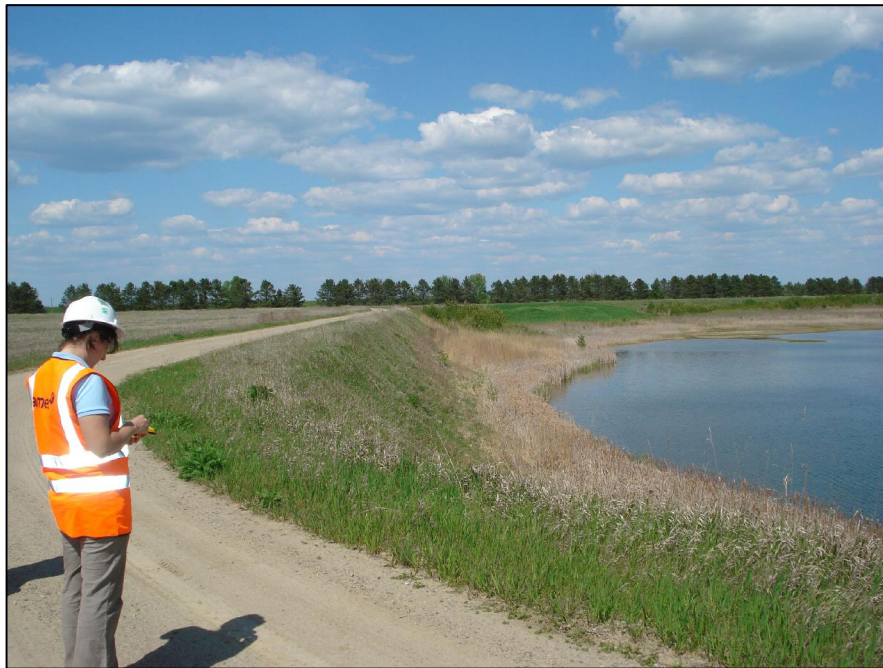
**3-14**

The Inactive Bottom Ash Pond has a 26.7-foot high, diked embankment. The pool had approximately 22 feet of freeboard at the time of the site visit (photo 3-14). Water within the structure was assumed to be runoff from recent rain events. The northeast and northwest portion of the ash in the pond is covered with grass (photos 3-1, 3-2, 3-3, 3-4, and 3-6). Steep interior dikes were noted along the northeast dike (photo 3-14). The dikes appeared to be maintained and mowed.

**VIEW FROM WESTERN DIKE LOOKING NORTHEAST (NOTE STEEP SLOPES)**
