**DRAFT REPORT  
ROUND 7 DAM ASSESSMENT  
ALLETE, INC. - LASKIN ENERGY CENTER  
CELLS A-D AND CELL E IMPOUNDMENTS**

**November 18, 2010**

Re: Round 7 Dam Assessment - Draft Report  
EPA Contract No. EP10W001313  
Allete Inc. Laskin Energy Center  
Cells A-D Impoundment and Cell E Impoundment  
Hoyts Lake, Minnesota

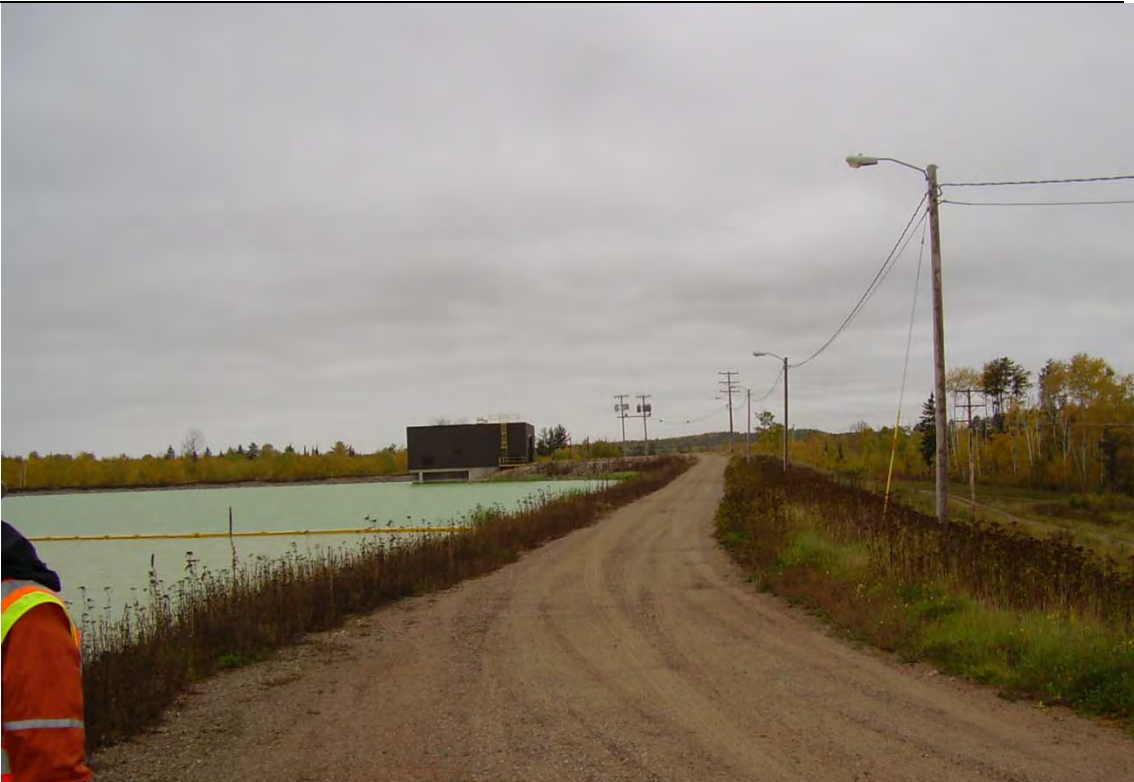
The top of the Cell E Impoundment had a gravel cover, with some grasses. The top of impoundment had occasional minor pot holes along the entire length from vehicular traffic. The alignment of the top of impoundment appeared generally level, with no depressions or irregularities observed. Based on information provided by Barr, the top of impoundment elevation ranged from elevation 1479 feet to elevation 1483 feet MSL. No significant settlement was observed at the time of our inspection. There was approximately 3 feet of free board at the time of our inspection.

| <b>Description:</b><br>Example of potholes in top of embankment in Cell E. | | | |

1. Increased mowing of the grasses on the embankments to facilitate daily inspections and reduce the risk of burrowing animals;
2. Repair the potholes present in the gravel crest access road. Grade the road to provide better drainage and reduce future potholing;
3. Clear deep rooted vegetation from embankments and top of impoundments;
4. Document impoundment inspections conducted by facility personnel each shift; and,
5. Extend monitoring, maintenance and emergency action plans to include the Cells A-D Impoundment.

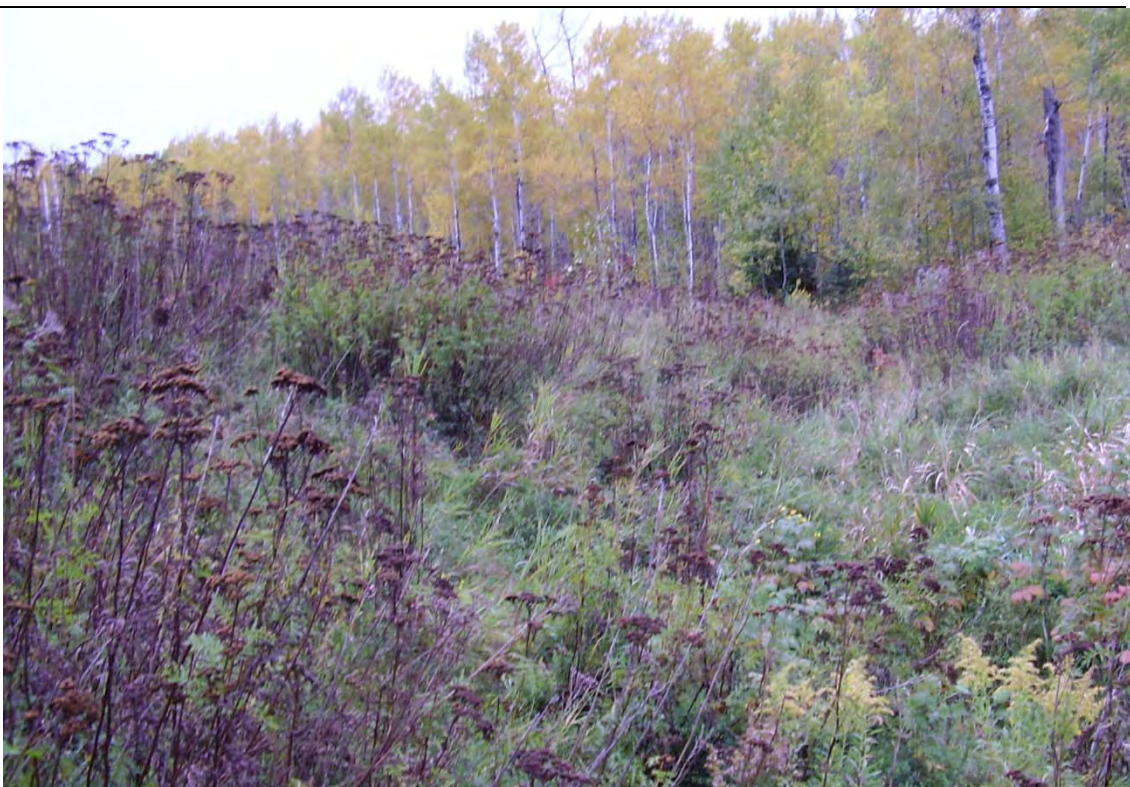
**Description:**  
Downstream slope and toe of  
Cell E. Trees growing on  
the slope are shown on right  
of photo.

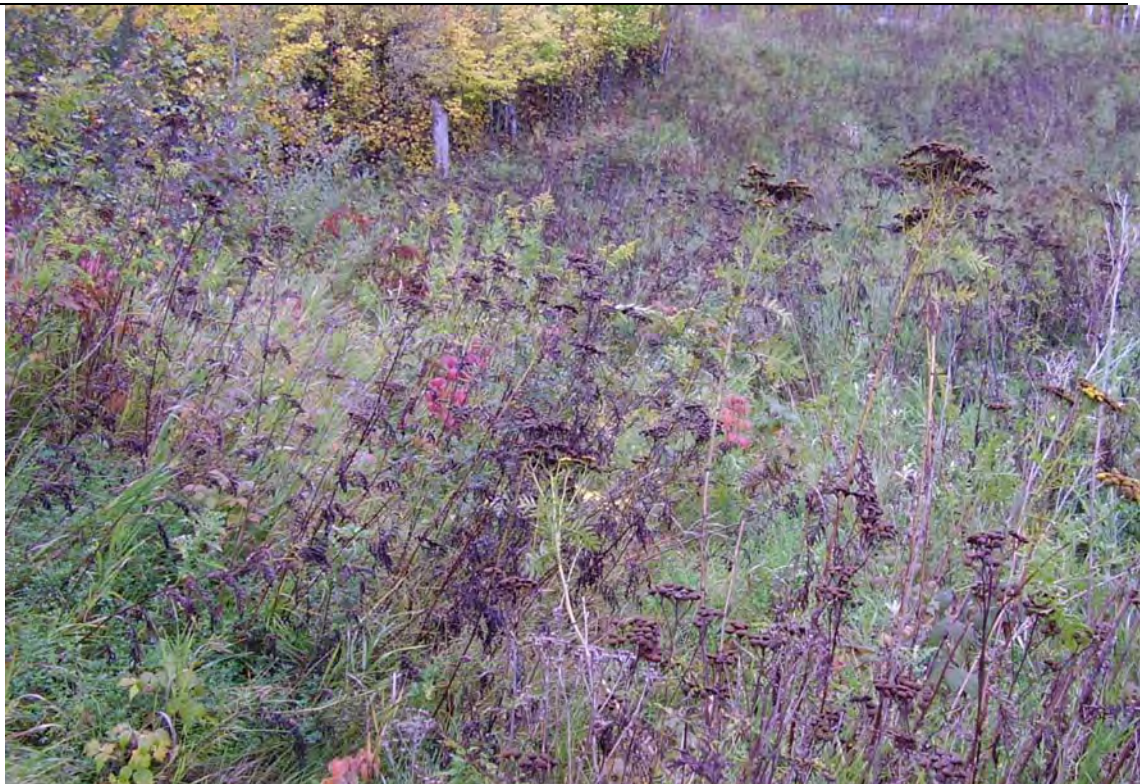
**Photo No.**  
**34**

The downstream slope of the impoundment was generally in good condition. The surface cover of the slope was grassed but had not been recently mowed. A minor erosion rill was observed along the toe of the eastern embankment as shown in Photo No. 34 and Photo No. 35. The rill was noted in the 2009 and 2010 inspections completed by Barr as being vegetated and apparently stable. Two 2-inch diameter trees/shrubs were observed on the toe at the northwest corner of the impoundment as shown in Photo No. 27. No unusual movement or sloughing was observed in the slope. A gravel access road was present along the toe of the downstream slope on the northern portion of the impoundment. The access road was in good condition, with minor rutting on the surface. No seepage or sloughing was observed on the downstream slope.

**Description:**  
Erosion feature on toe of east  
slope that has been  
overgrown with grass.

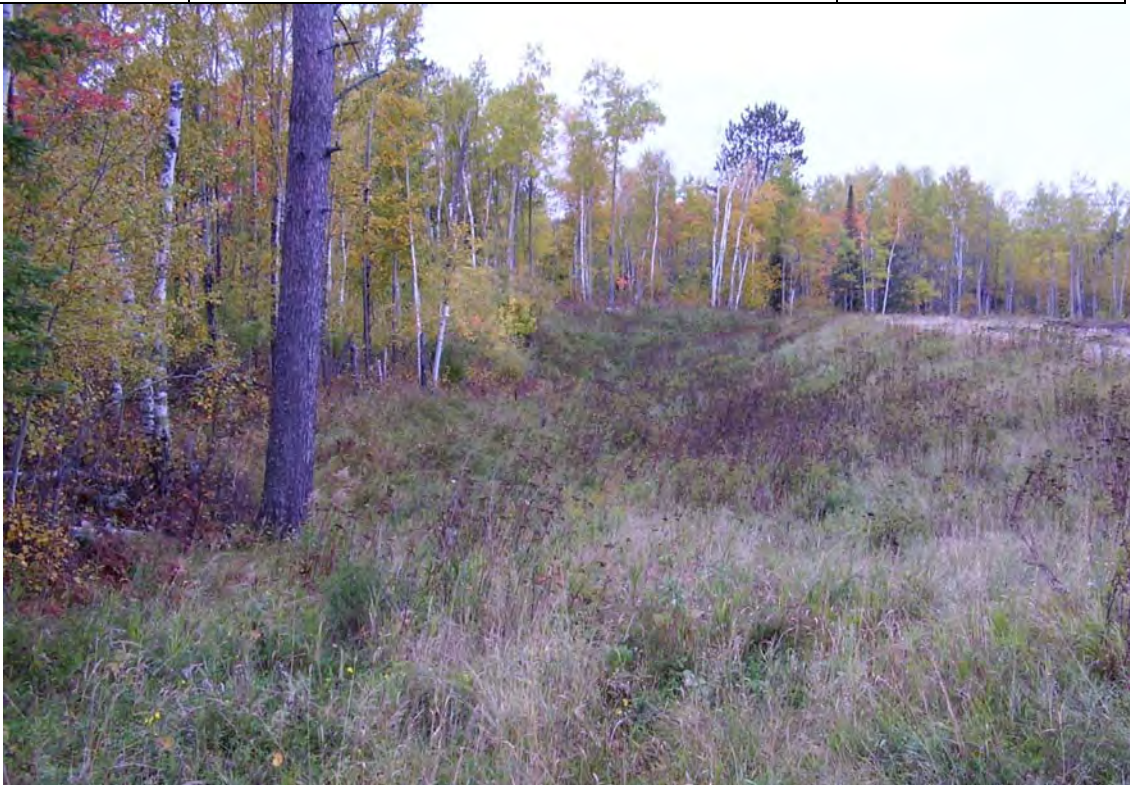
Erosion feature on toe of east  
slope that has been  
overgrown with grass.
