minnesota power / 30 west superior street / duluth, minnesota 55802-2093 / 800-228-4966 / www.mnpower.com

Re. Minnesota Power Laskin Energy Center CCR Site Assessment Follow-Up

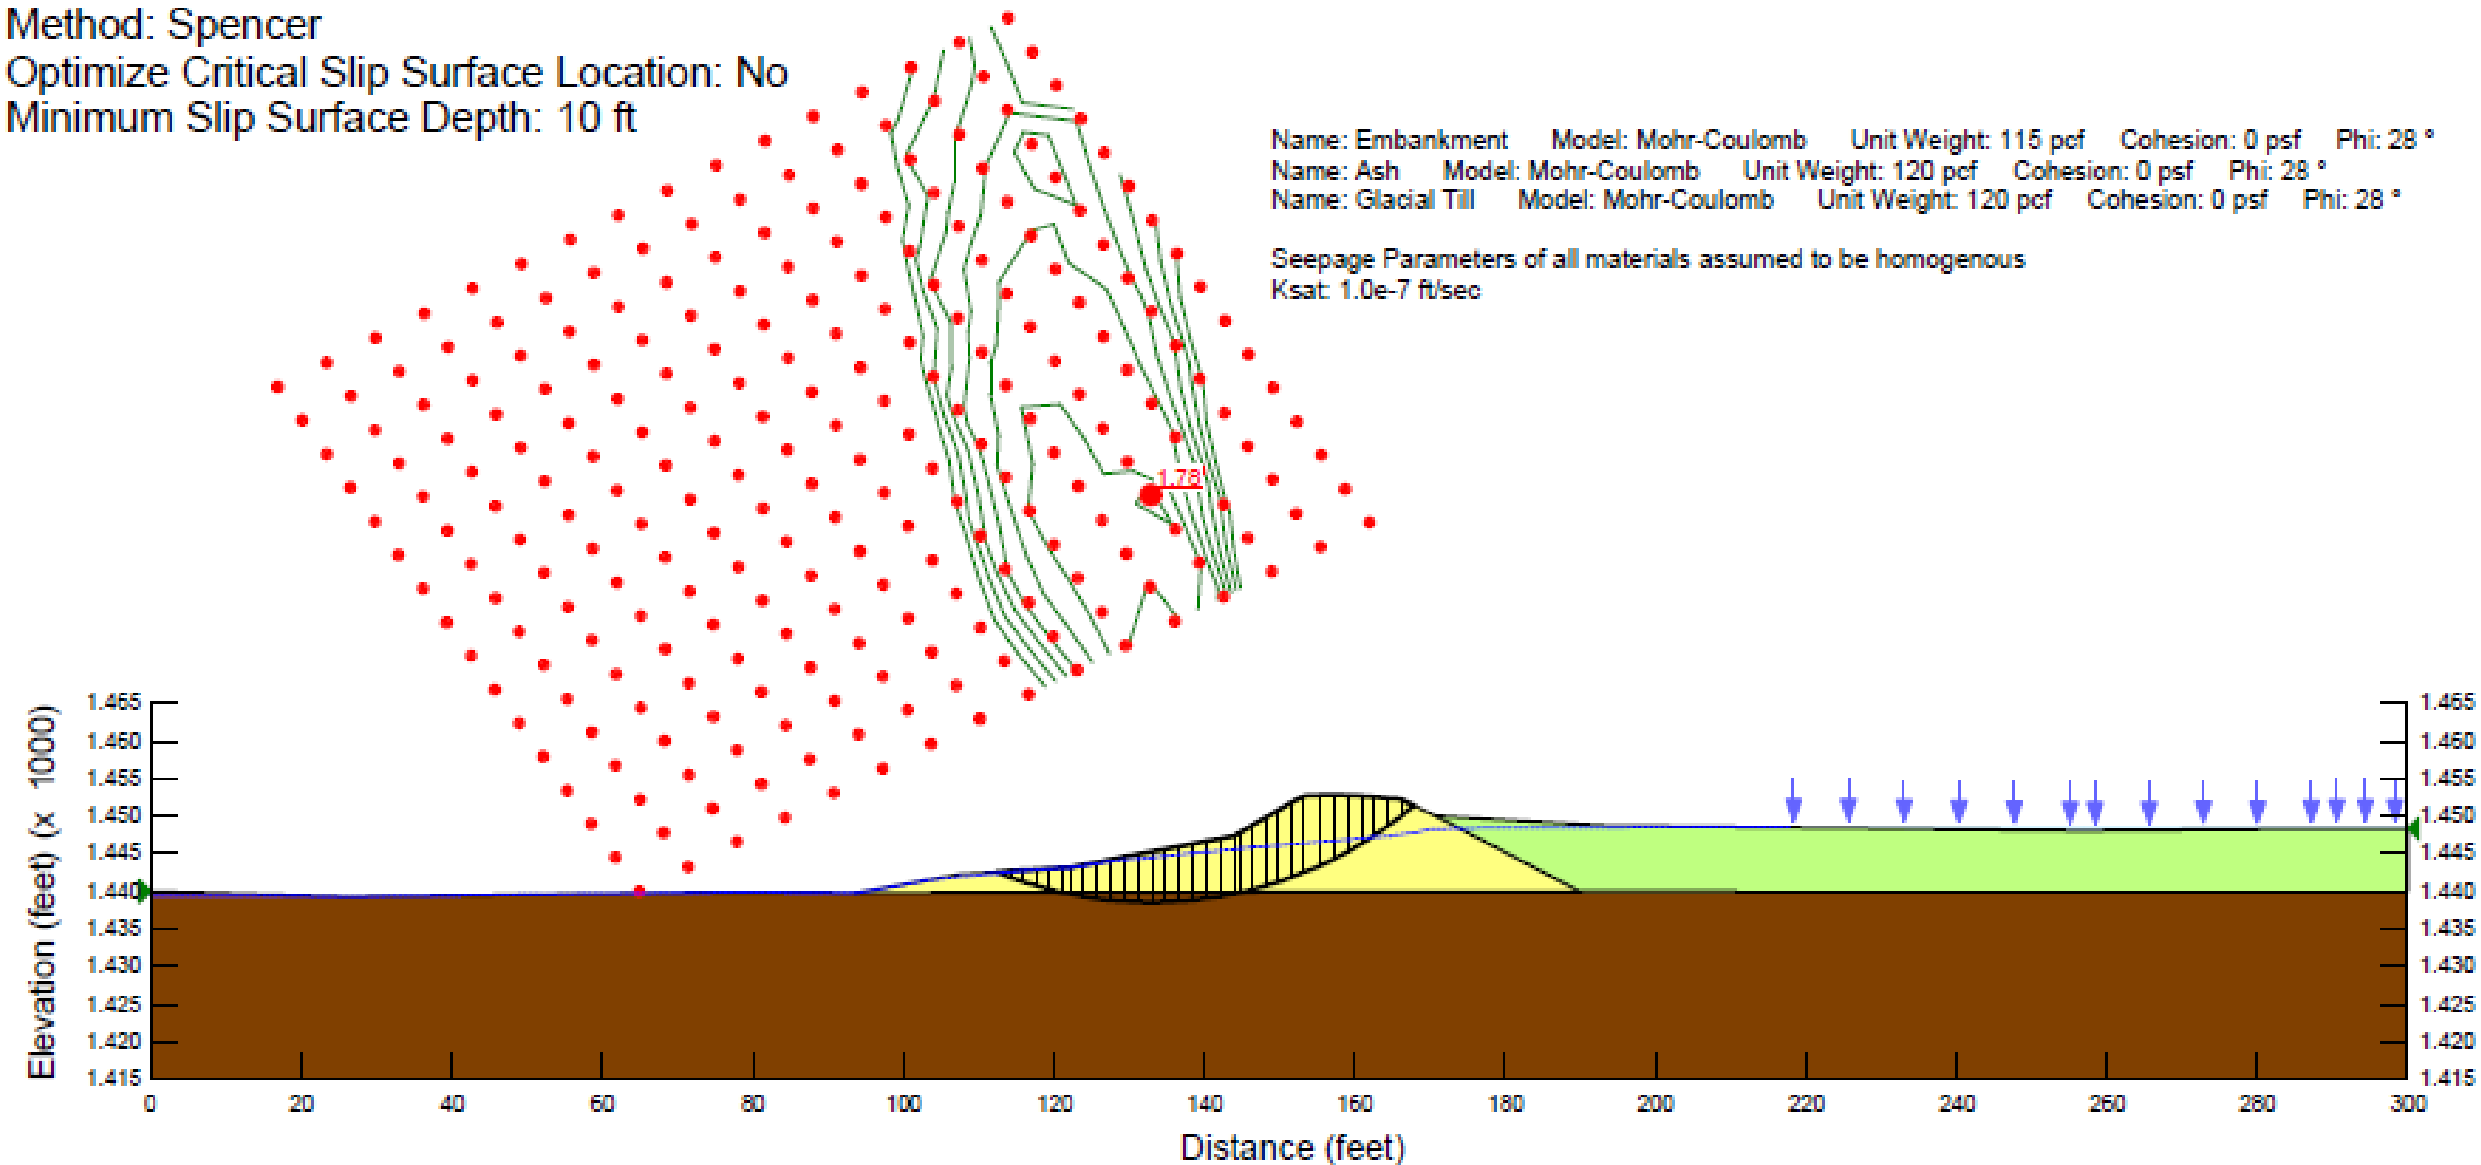
Laskin Energy Center  
Minnesota Power  
EPA Critical Slope Stability Analysis - Section 1  
Steady State Seepage Model - Pond Elev. 1448.5 feet

Critical FOS: 1.85  
Method: Spencer  
Optimize Critical Slip Surface Location: No  
Minimum Slip Surface Depth: 10 ft

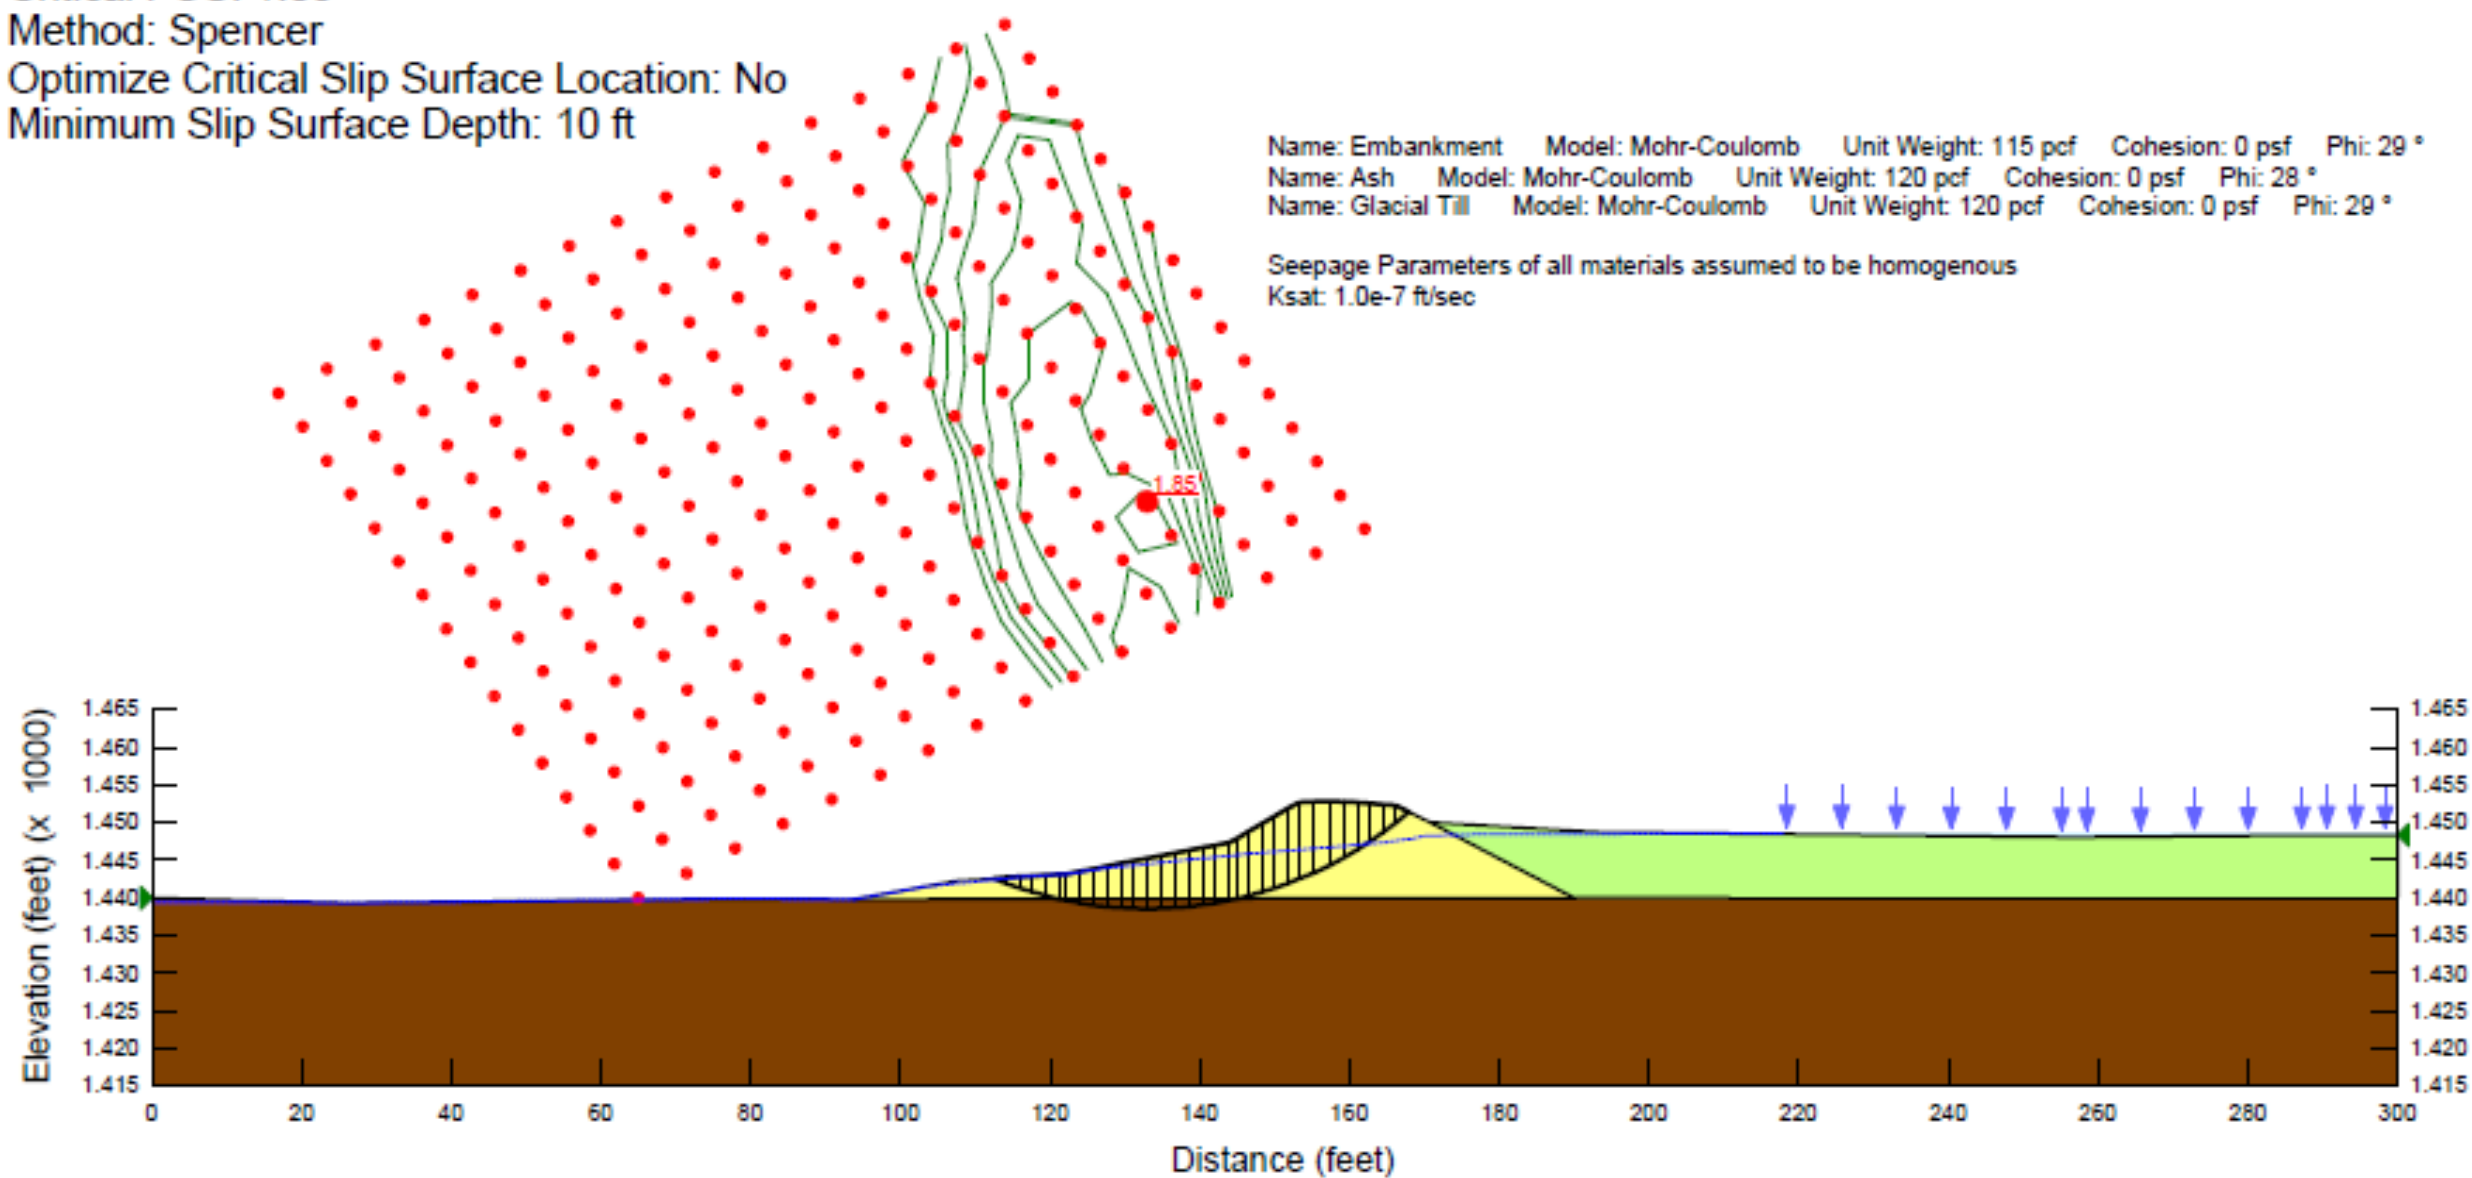
Laskin Energy Center  
Minnesota Power  
EPA Critical Slope Stability Analysis - Section 1  
Steady State Seepage Model - Pond Elev. 1448.5 feet

Critical FOS: 1.93  
Method: Spencer  
Optimize Critical Slip Surface Location: No  
Minimum Slip Surface Depth: 10 ft

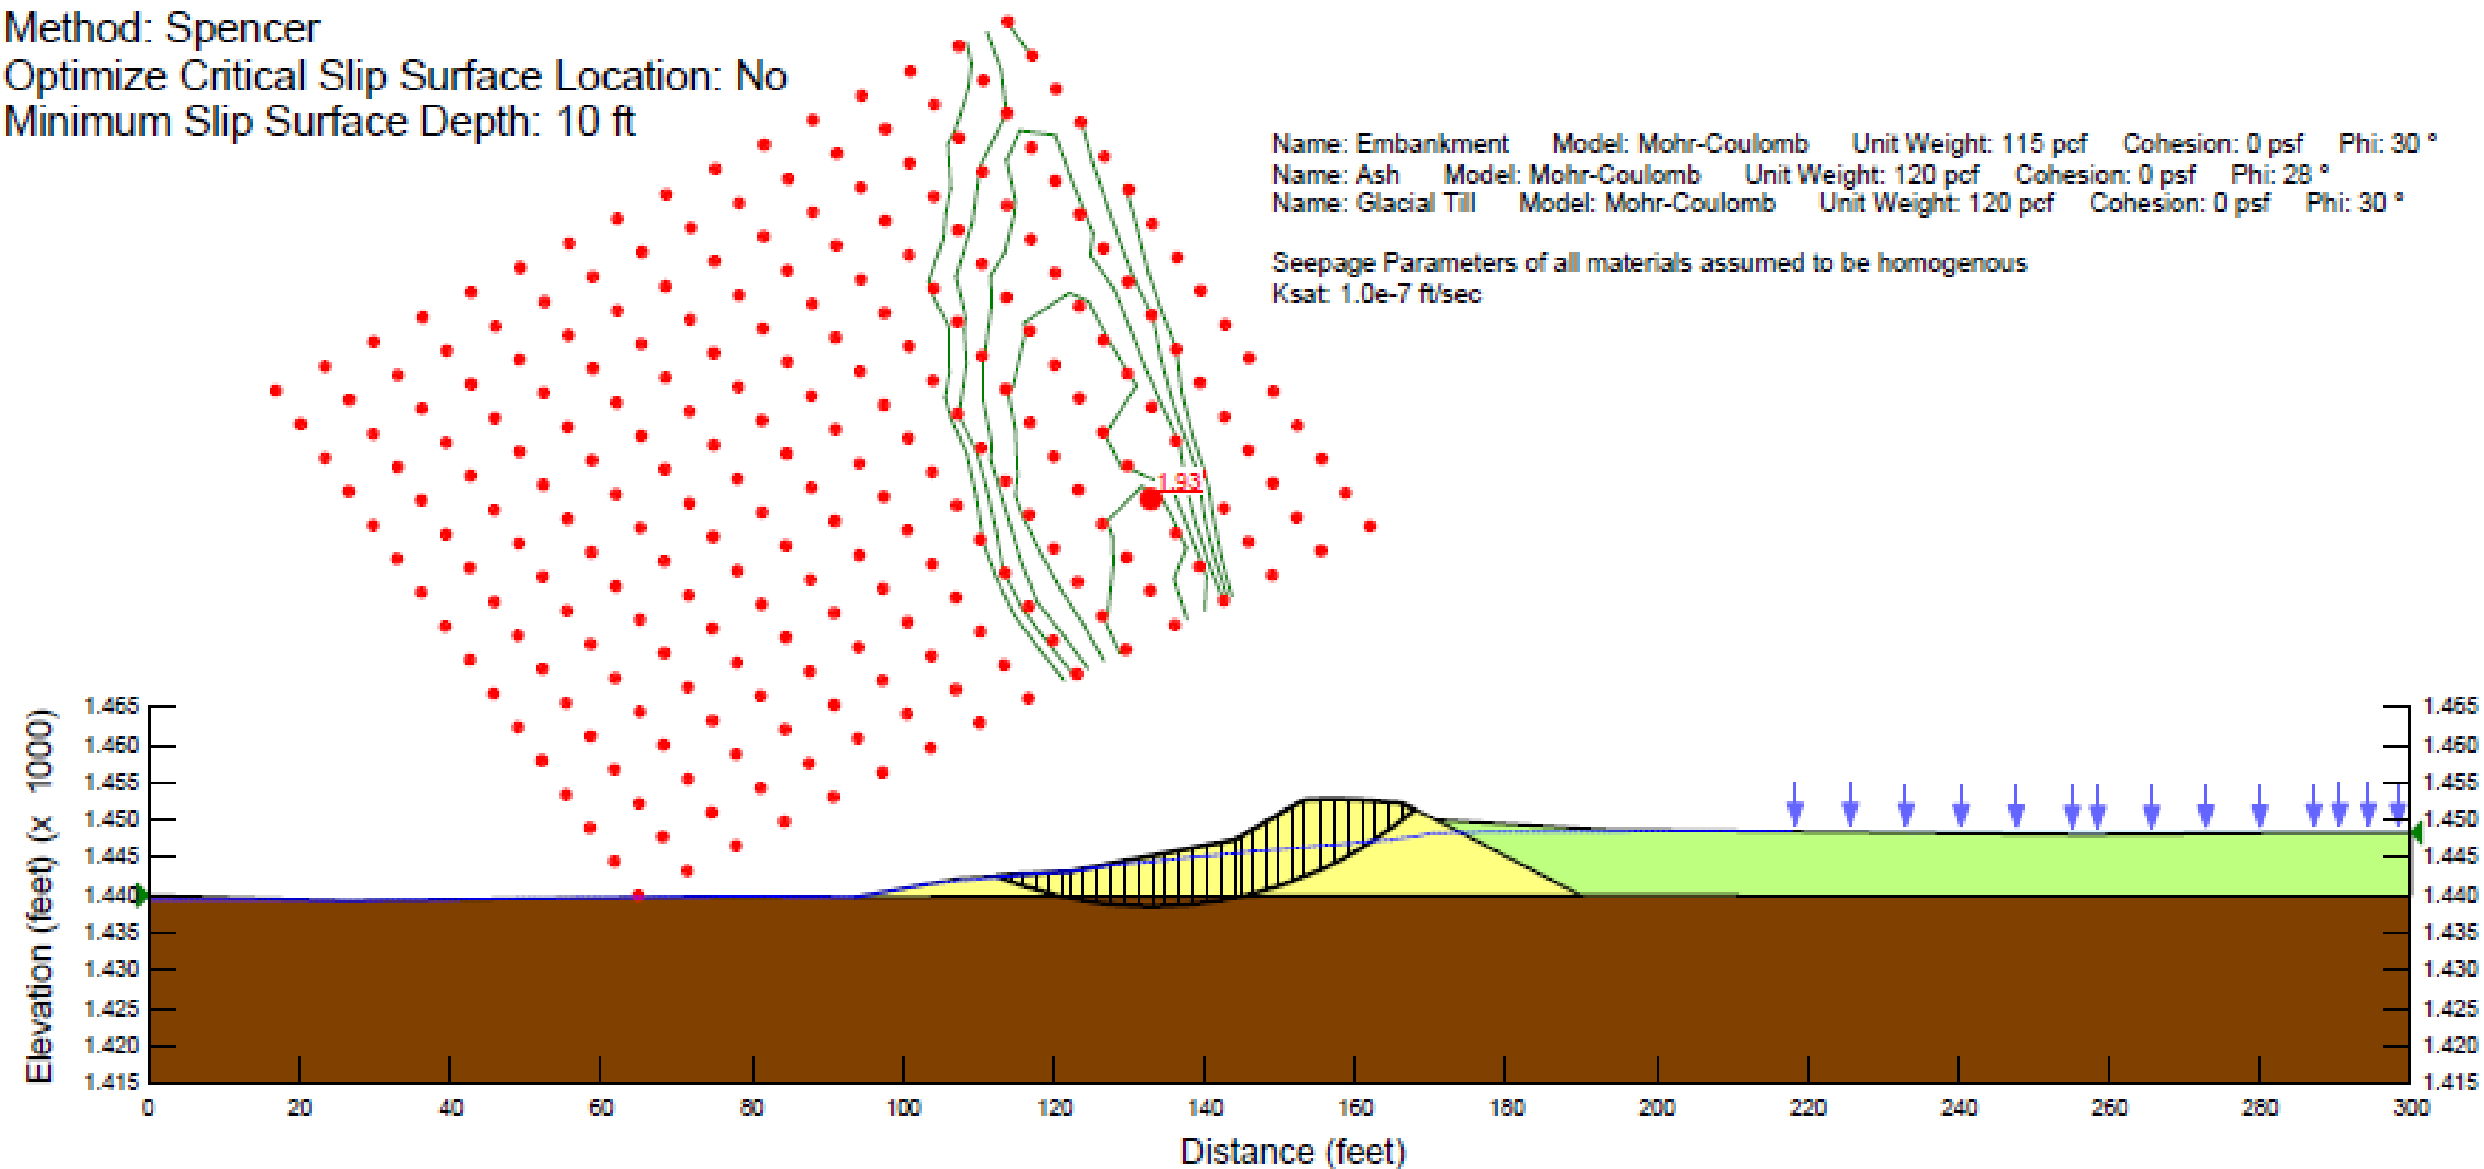
Laskin Energy Center  
Minnesota Power  
EPA Critical Slope Stability Analysis - Section 1  
Steady State Seepage Model - Pond Elev. 1452.0 feet

Critical FOS: 1.42  
Method: Spencer  
Optimize Critical Slip Surface Location: No  
Minimum Slip Surface Depth: 10 ft

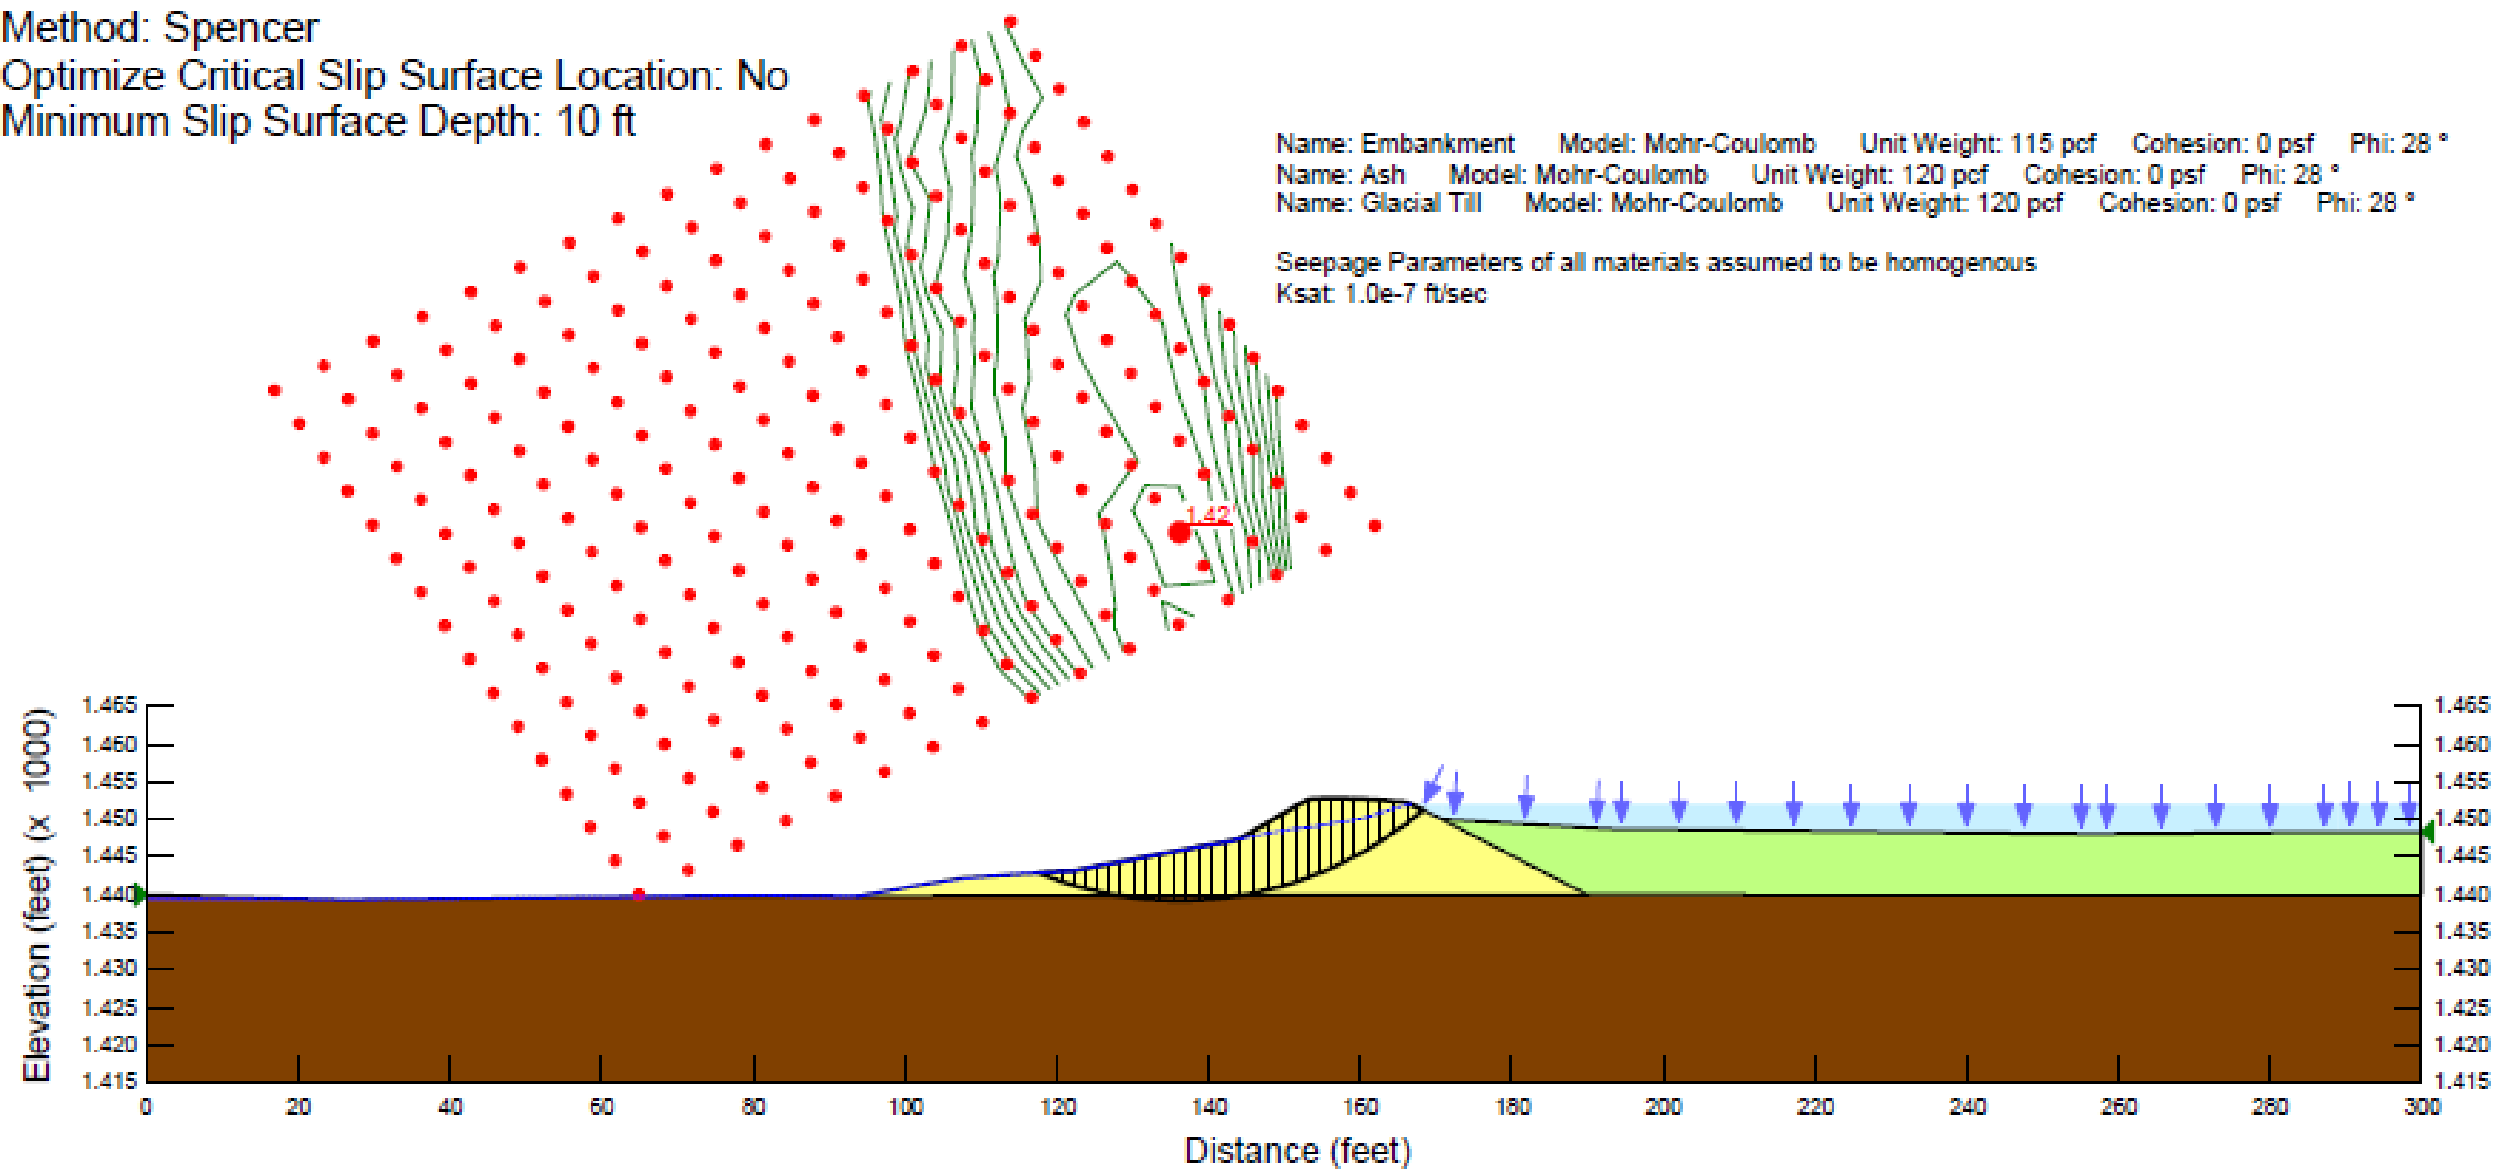
Laskin Energy Center  
Minnesota Power  
EPA Critical Slope Stability Analysis - Section 1  
Steady State Seepage Model - Pond Elev. 1452.0 feet

Critical FOS: 1.48  
Method: Spencer  
Optimize Critical Slip Surface Location: No  
Minimum Slip Surface Depth: 10 ft

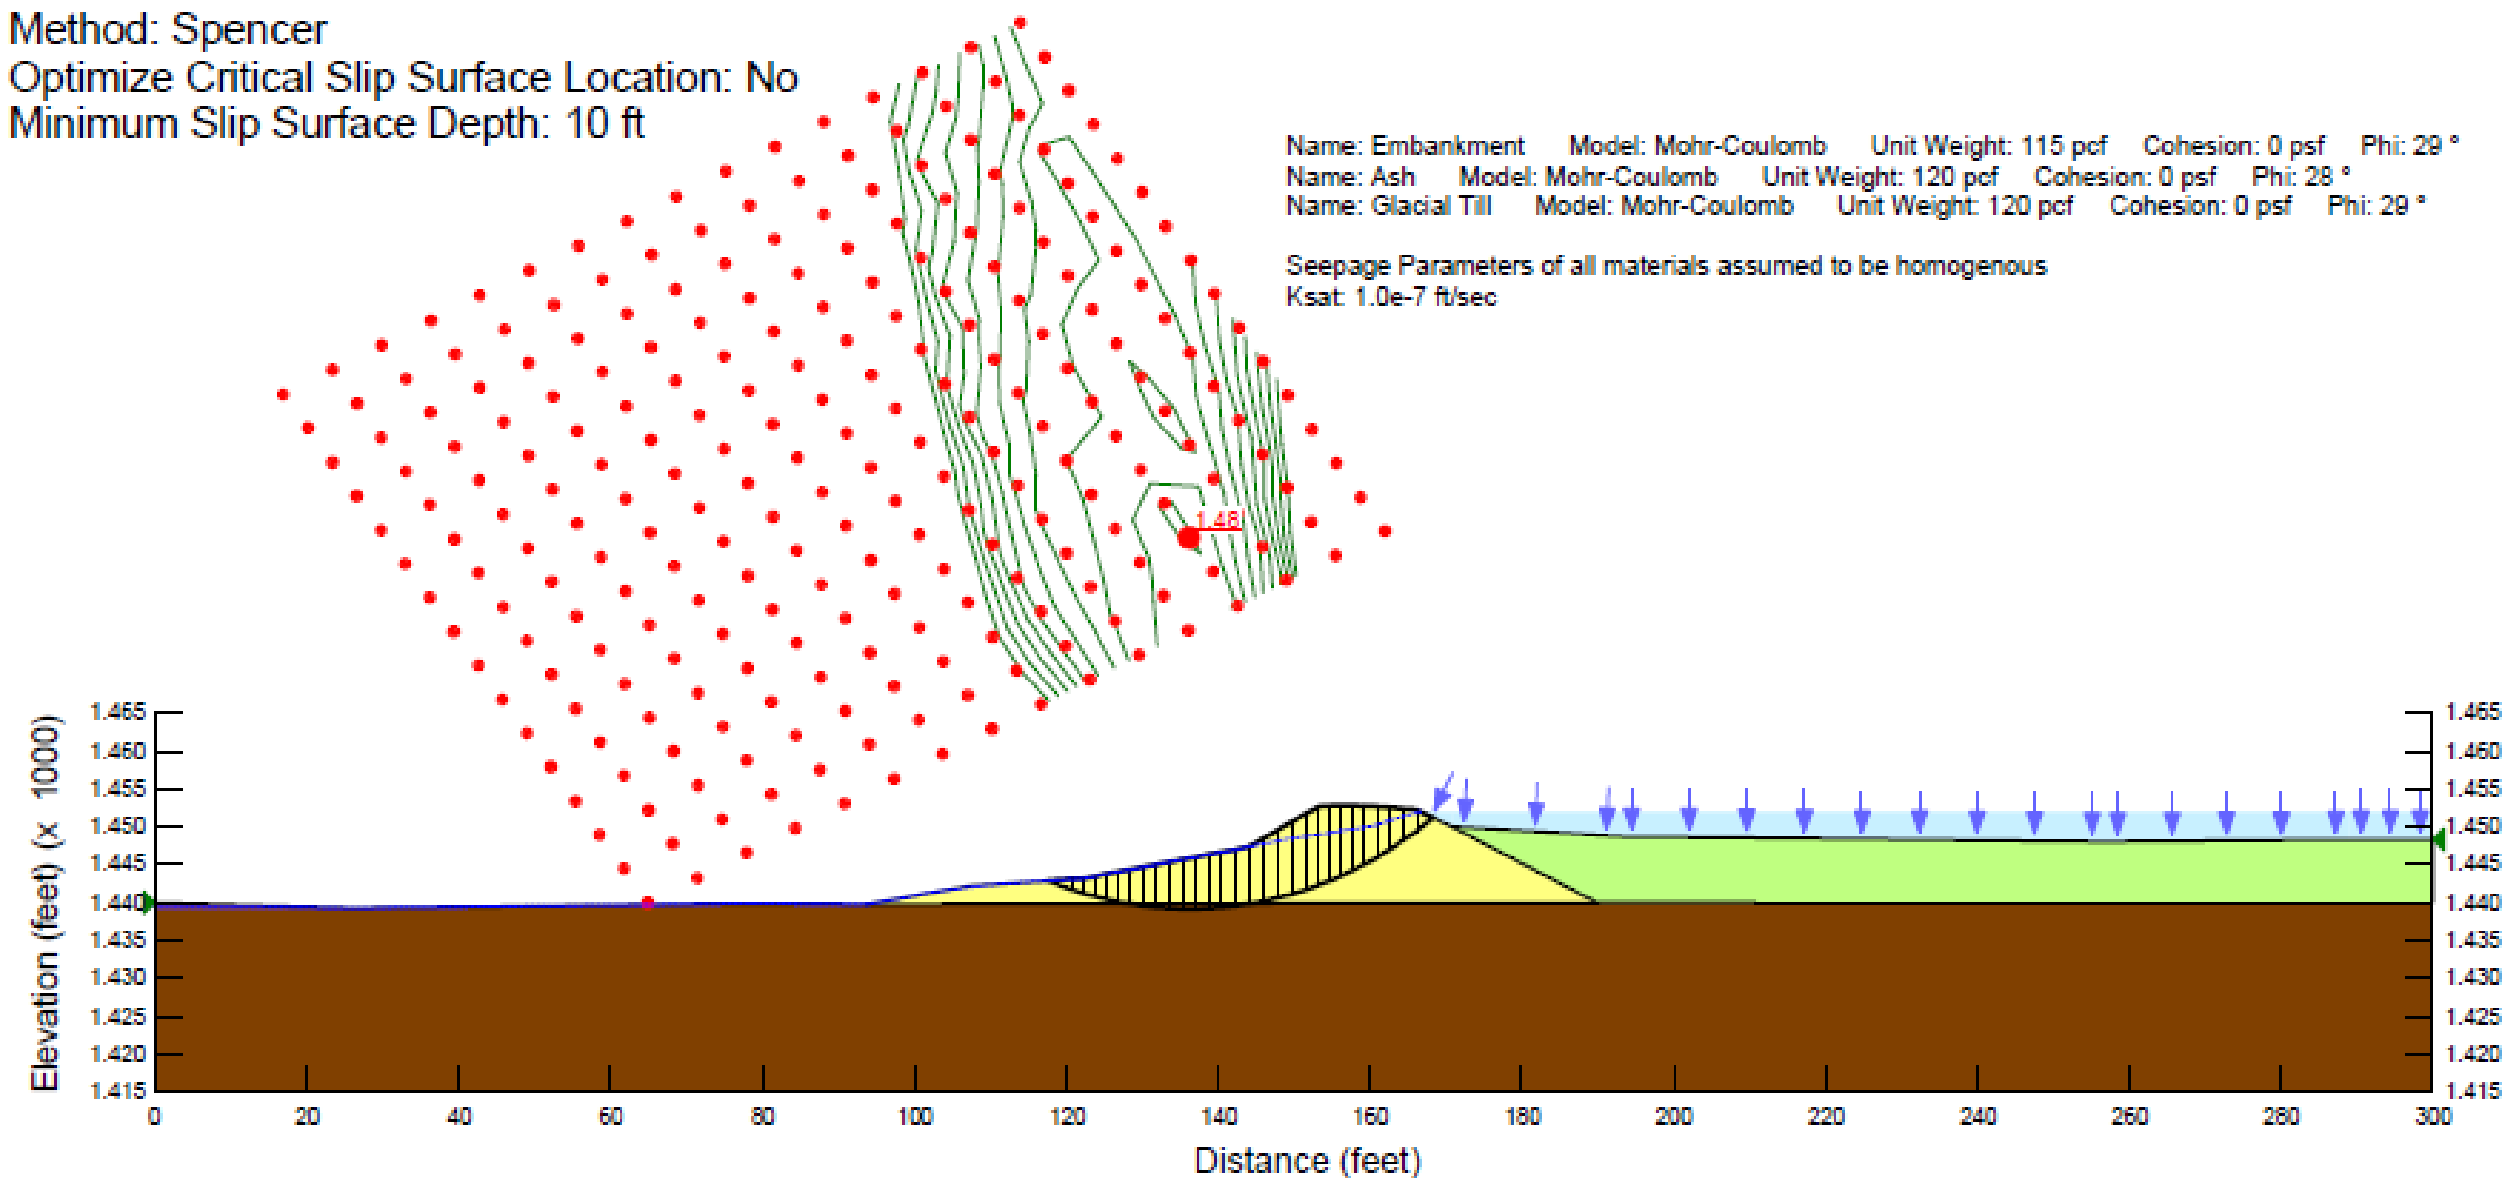
Laskin Energy Center  
Minnesota Power  
EPA Critical Slope Stability Analysis - Section 1  
Steady State Seepage Model - Pond Elev. 1452.0 feet

Critical FOS: 1.54  
Method: Spencer  
Optimize Critical Slip Surface Location: No  
Minimum Slip Surface Depth: 10 ft

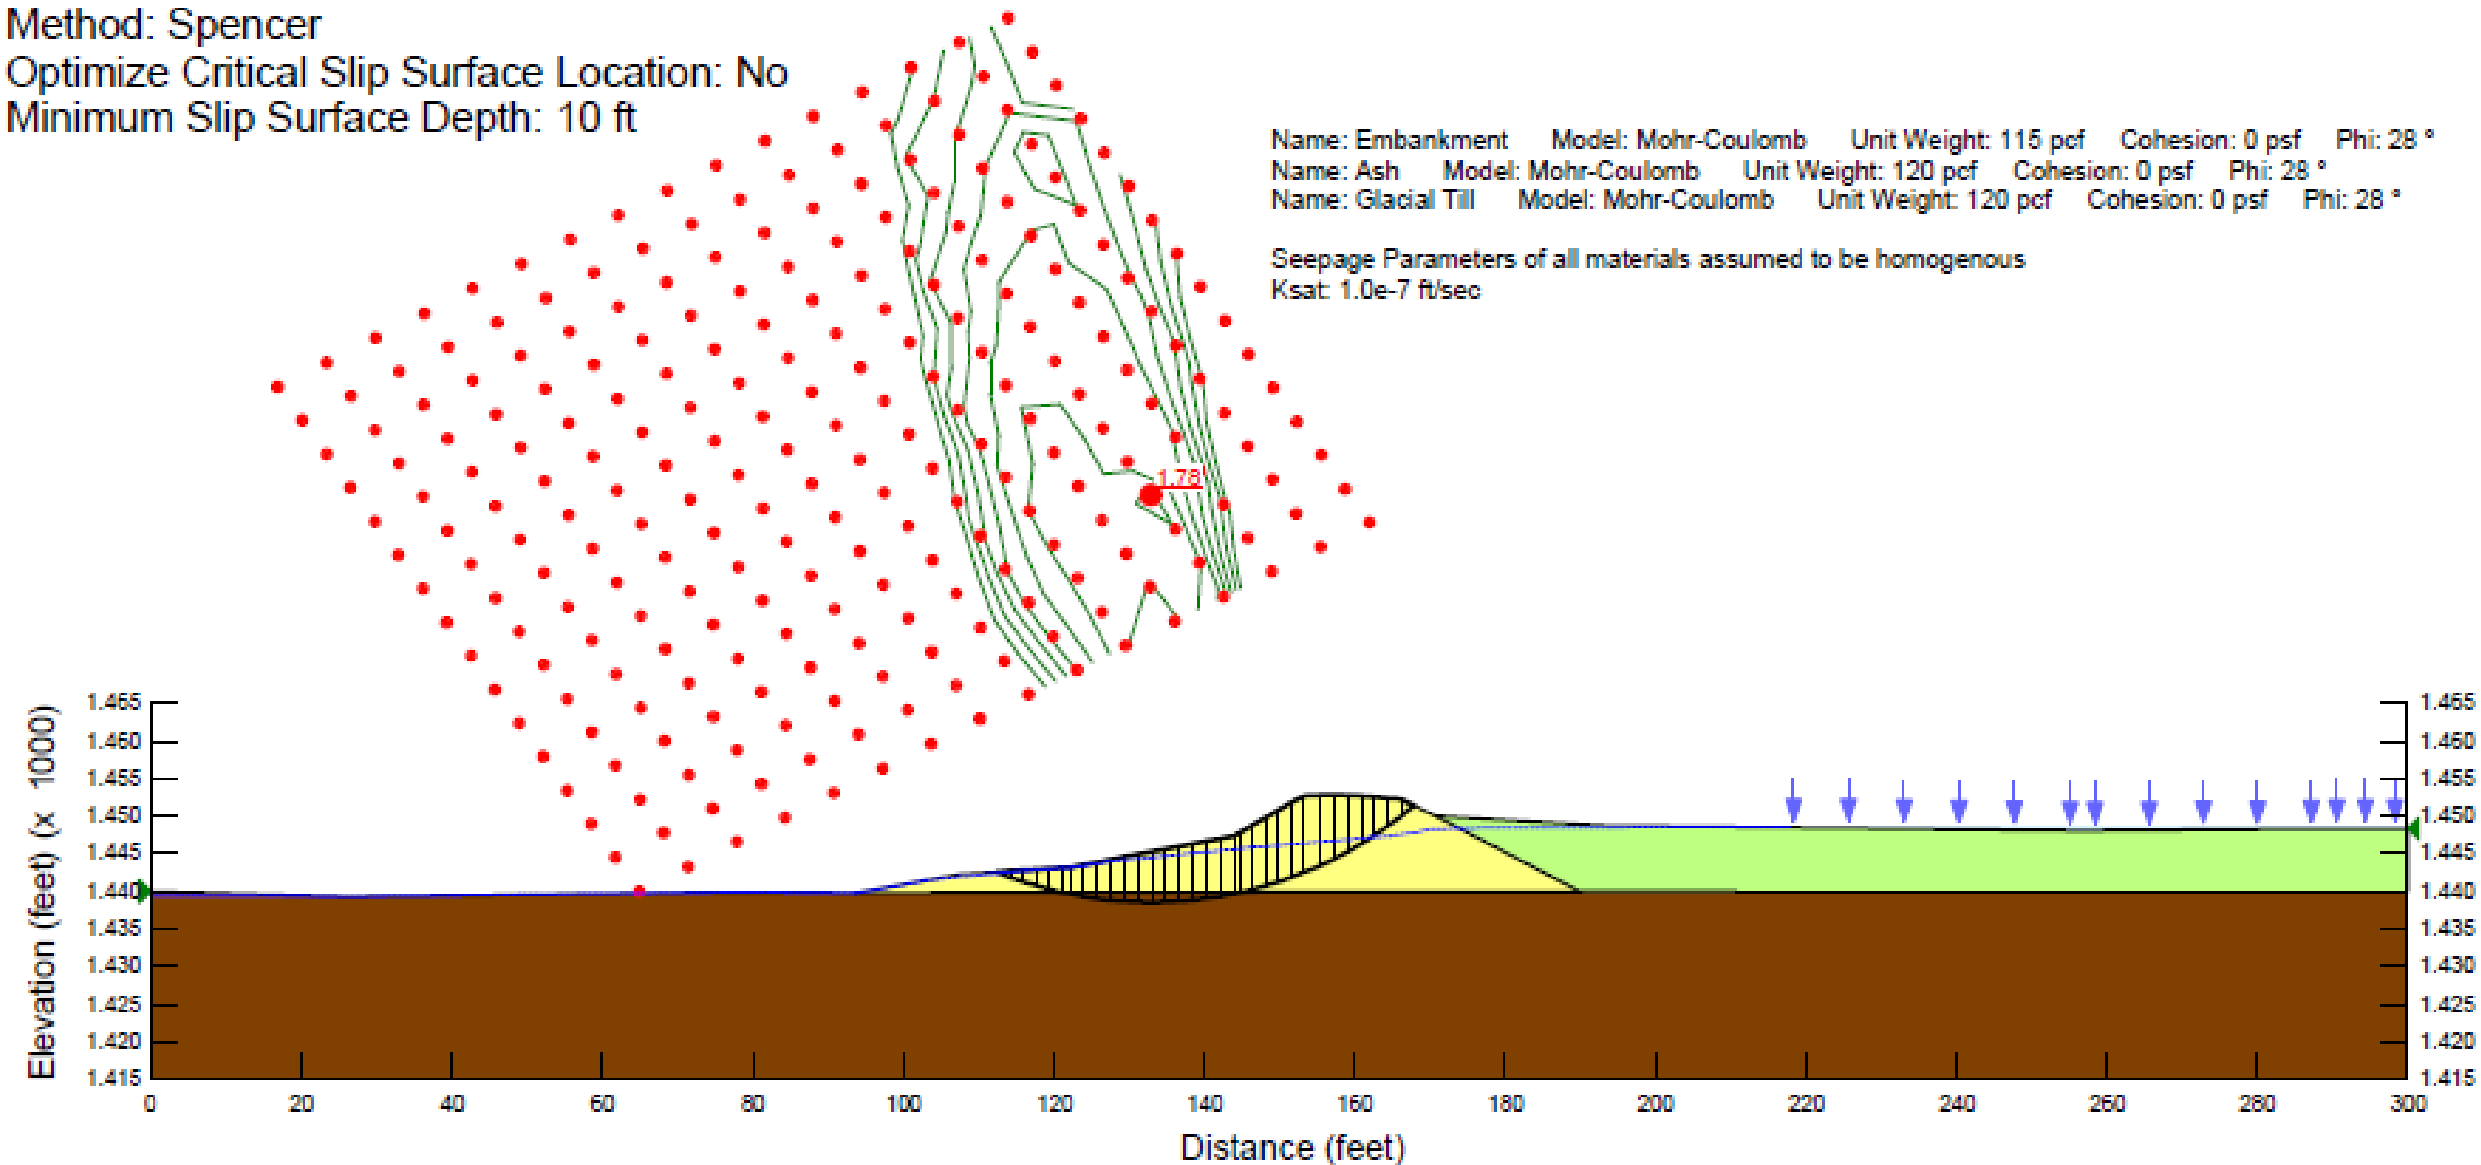
Laskin Energy Center  
Minnesota Power  
EPA Critical Slope Stability Analysis - Section 1  
Steady State Seepage Model - Pond Elev. 1448.5 feet

Critical FOS: 1.85  
Method: Spencer  
Optimize Critical Slip Surface Location: No  
Minimum Slip Surface Depth: 10 ft
