**Coal Combustion Waste Impoundment
Round 7 - Dam Assessment Report**

Burlington Generating Station

*Ash Impoundment Dikes
Interstate Power and Light
Burlington, Iowa*

June 2011

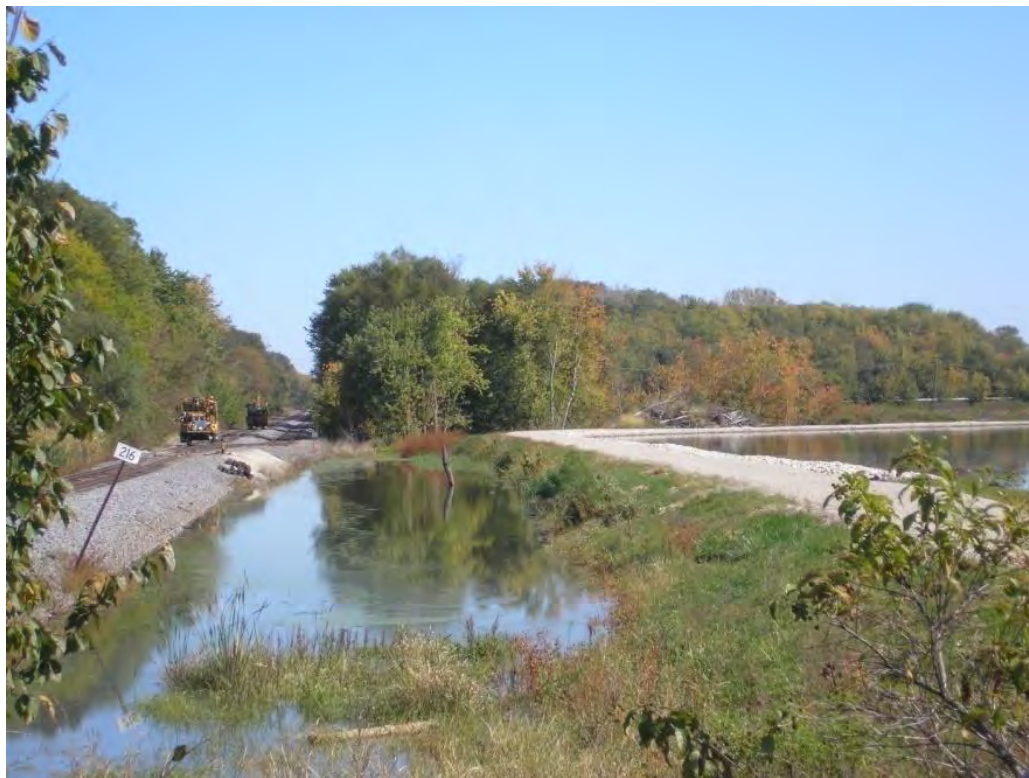
There is a main railroad line along the west side, and cross gradient to, the Ash Pond 1 and Ash Pond 2 impoundments. Based on the heights of the dikes along the western boundaries of those impoundments and the presences of a substantial drainage ditch between the dikes and the railroad, it is not expected that a failure of a western dike would have a significant impact on the adjoining railroad. Figure 2.5- 1 show the railroad tracks relative to the west boundary of Ash Pond 1. The Ash Pond 1 dike has a height of approximately 5 feet.

Figure 2.5-1: Railroad Right-of-Way Along West Boundary of Ash Pond 1.

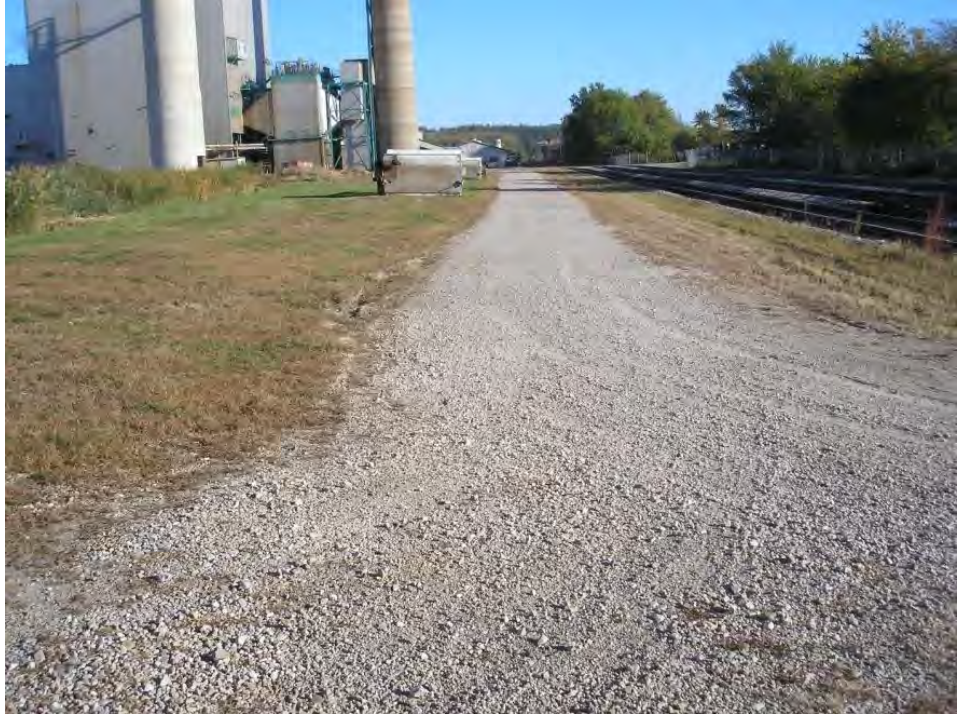
Figure 5.2.1-1: Ash Seal Pond East Dike Crest

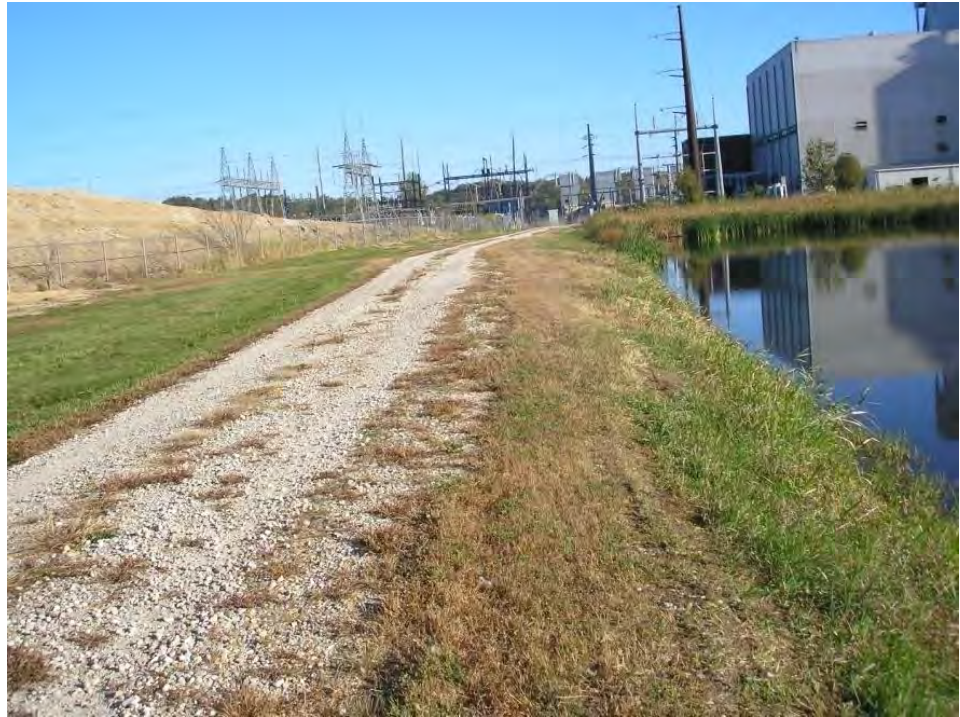
The Ash Seal Pond west dike is also the west edge of the plant fill pad. The crest is covered with grass and gravel surface roadway for vehicle access. The crest had no signs of significant depressions, tension cracks or other indications of settlement or shear failure. Photograph 5.2.1-3 shows the Ash Seal Pond west dike crest.

Figure 5.2.1-3: Ash Seal Pond West Dike Crest and Inside Slope

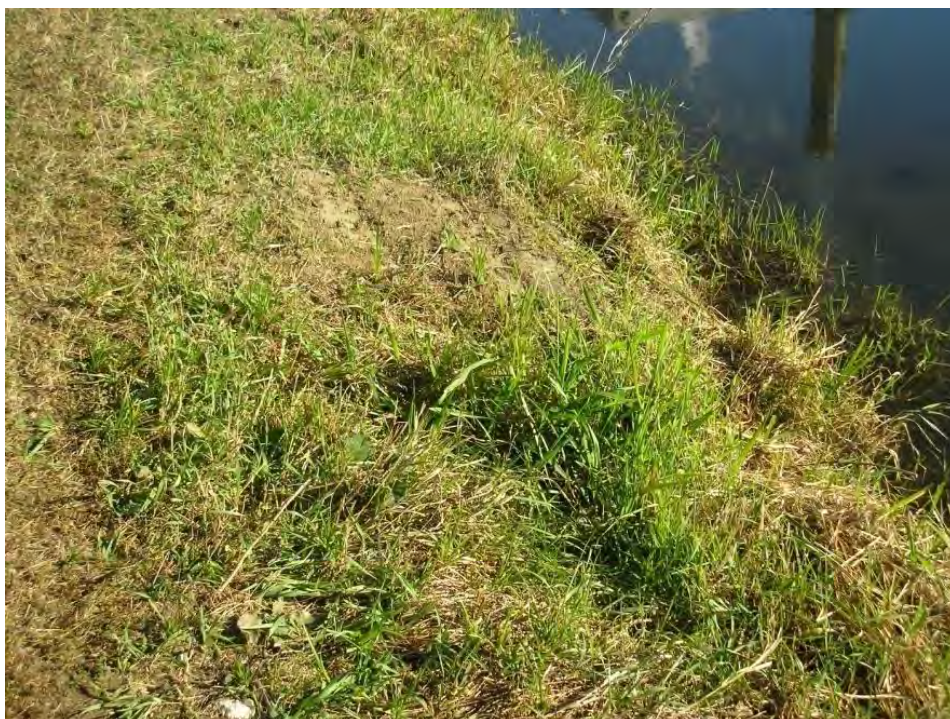
The inside slopes of the Ash Seal Pond dikes are vegetated with various species of grass and weeds. There were no observed scarps, sloughs, bulging, cracks, depressions or other indications of slope instability. Figure 5.2.2-1 shows typical vegetation conditions of the inside slopes of Ash Seal Pond embankments

Figure 5.2.2-1: Ash Seal Pond Typical Inside Slope Vegetation Cover

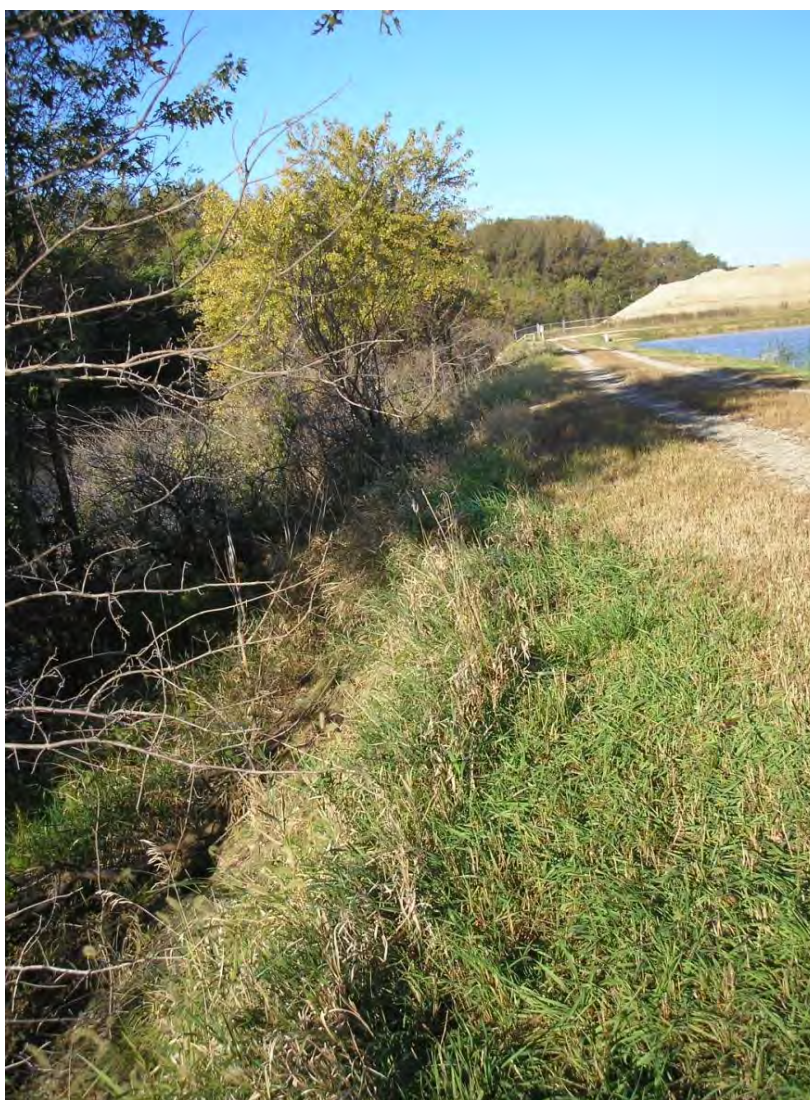
The outside slope of the Ash Seal Pond south dike is vegetated with grass and weeds near the crest and small to medium trees beginning a short distance below the crest. There were no observed scarps, sloughs, bulging, cracks, depressions or other indications of slope instability. Figure 5.2.3-1 shows the outside slope of the Ash Seal Pond south dike.

Figure 5.2.3-1: Ash Seal Pond South Dike Outside Slope

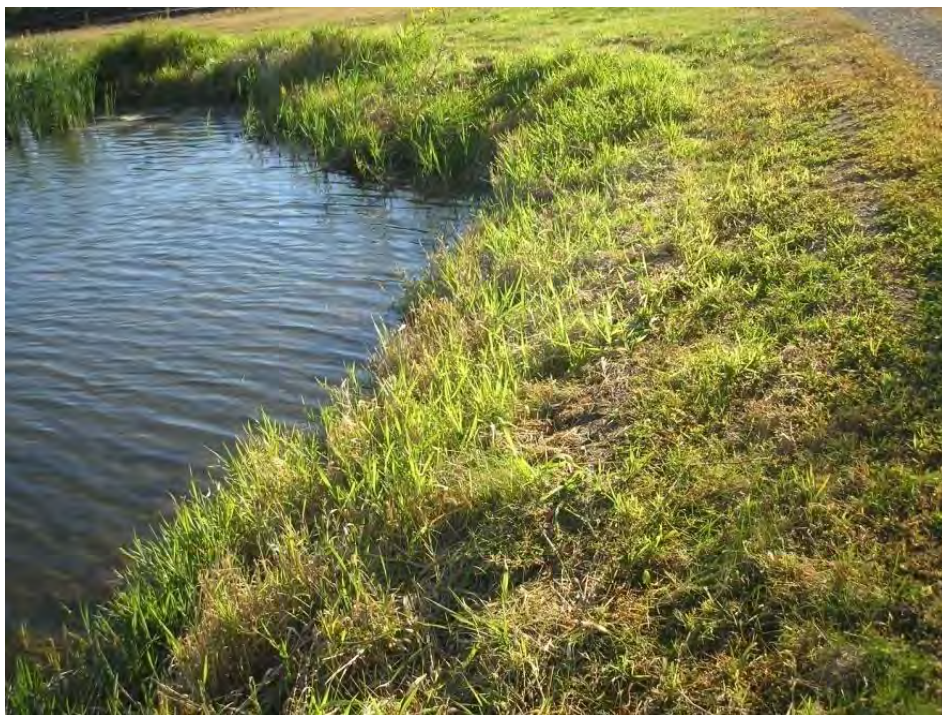
The Ash Seal Pond is a diked impoundment formed by fill on four sides; therefore there are no abutments. Neither erosion nor uncontrolled seepage was observed along the groins. Groin slopes were protected with the same vegetative cover as the adjoining slopes. Figure 5.2.4-1 shows typical conditions observed at inside groins.

Figure 5.2.4-1: Ash Seal Pond inside Groin at Southeast Corner

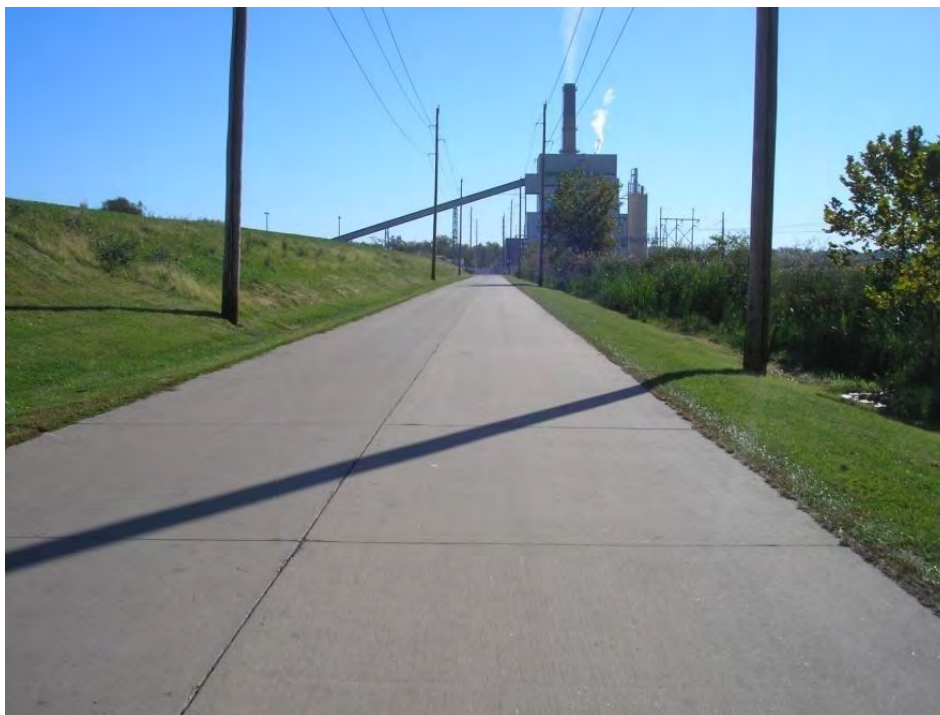
The north boundary of the Bottom Ash Pond is the fill embankment constructed as part of the structural site preparation work. The embankment was originally constructed as the traffic access road to the plant. The crest is paved with rigid concrete pavement. The crest had no signs of significant depressions, tension cracks or other indications of settlement or shear failure. Photograph 5.3.1-1 shows the Bottom Ash north dike crest.

Figure 5.3.1-1: Bottom Ash Pond North Dike Crest

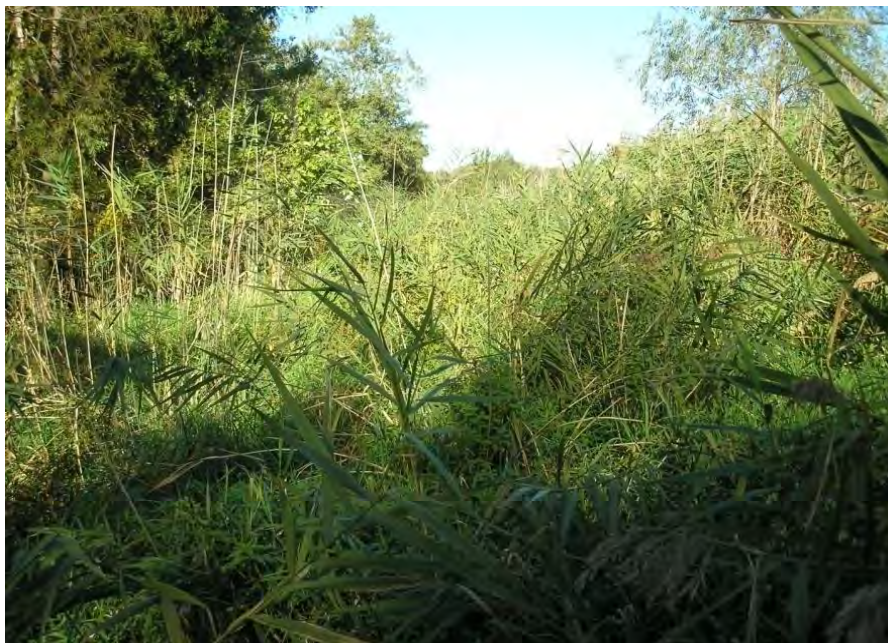
The crest of the Bottom Ash Pond south dike is heavily vegetated with weeds and swamp vegetation, much of which is over 6-ft. high making observations of surface conditions problematic. Figure 5.3.1-2 shows the conditions observed over much of the crest of the Bottom Ash Pond south dike.

Figure 5.3.1-2: Bottom Ash Pond South Dike Crest.

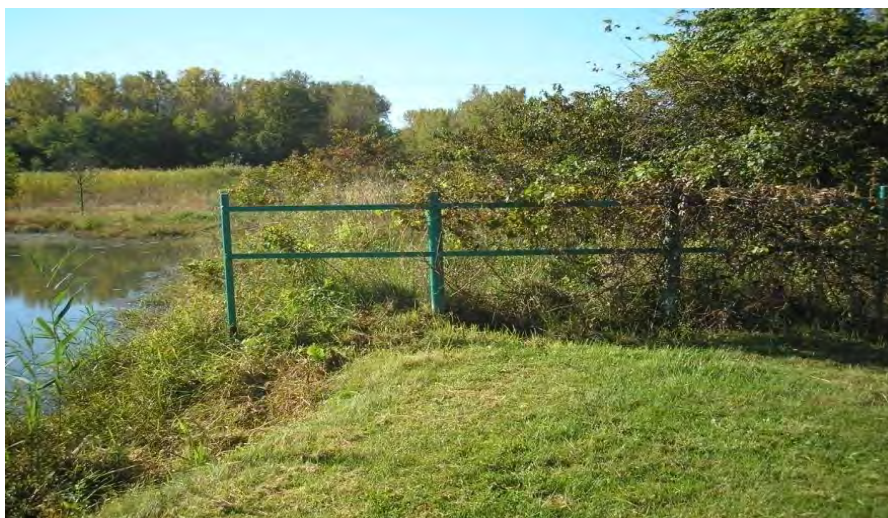
Similar vegetative conditions were observed at the Bottom Ash Pond west dike, except at the northern end of the dike. Figure 5.3.1-3 shows conditions at the northern end of the Bottom Ash Pond west dike. There were no observed scarps, sloughs, bulging, cracks, depressions or other indications of slope instability where observations were possible.

Figure 5.3.1-3: Bottom Ash Pond North End of West Dike

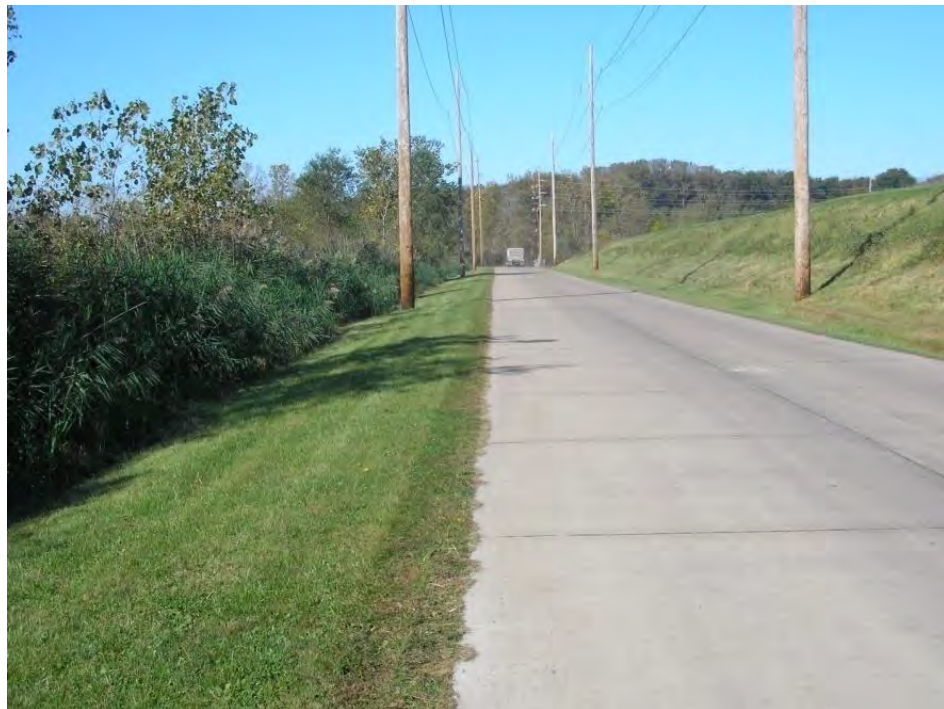
The upstream slope of the Bottom Ash Pond north dike is vegetated with grass, except near the normal pool elevation. Near the normal pool elevation vegetation consisted of small trees and bushes. Figure 5.3.2-1 shows conditions along the upstream slope of the Bottom Ash Pond north dike.

Figure 5.3.2-1: Bottom Ash Pond North Dike Upstream Slope

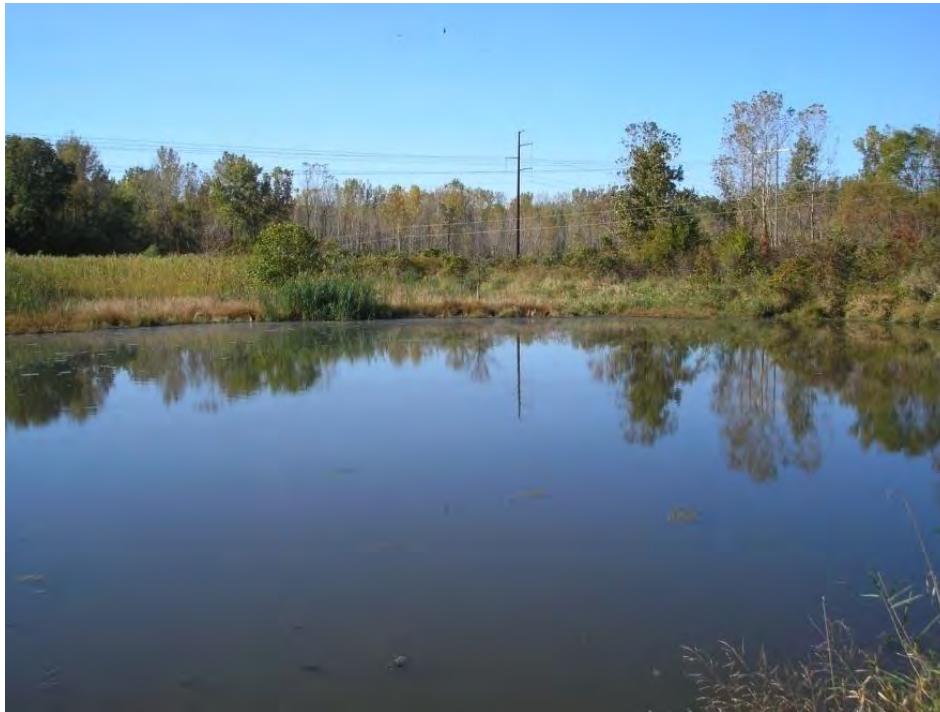
The upstream slopes of the Bottom Ash Pond south and west dikes were generally vegetated with marsh grasses, bamboo and small trees. Photograph 5.3.2-2 shows conditions typical of the upstream slope of the west dike.

Figure 5.3.2-2: Bottom Ash Pond Upstream Slopes South and West Dikes

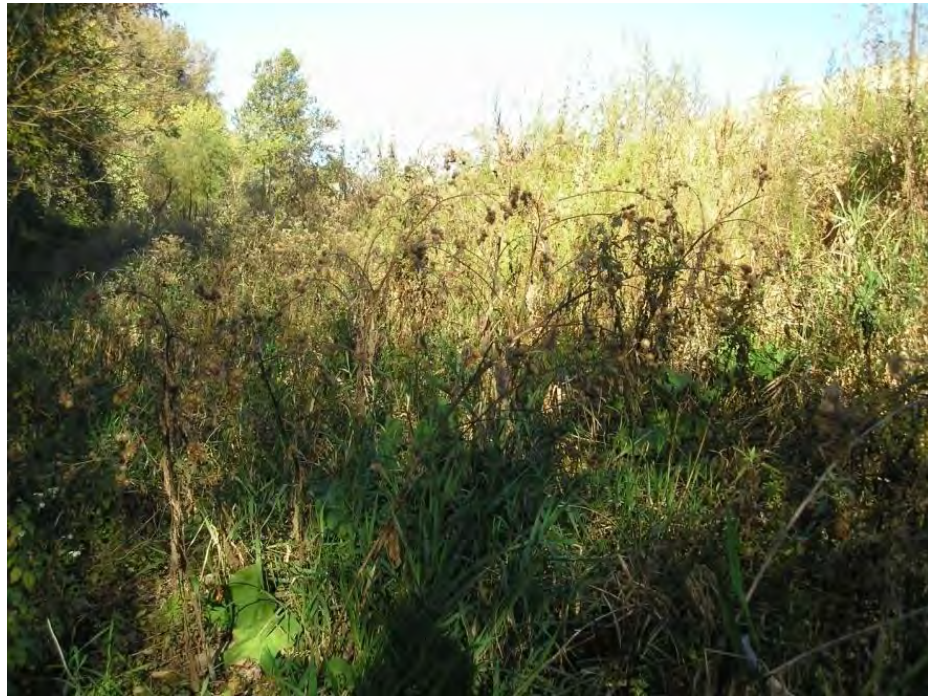
The downstream slope of the Bottom Ash Pond south dike was vegetated with tall grass and weeds, and small bushes. Figure 5.3.3-1 shows typical conditions of the downstream slope of the Bottom Ash south dike.

Figure 5.3.3-1: Bottom Ash Pond Downstream Slope South Dike

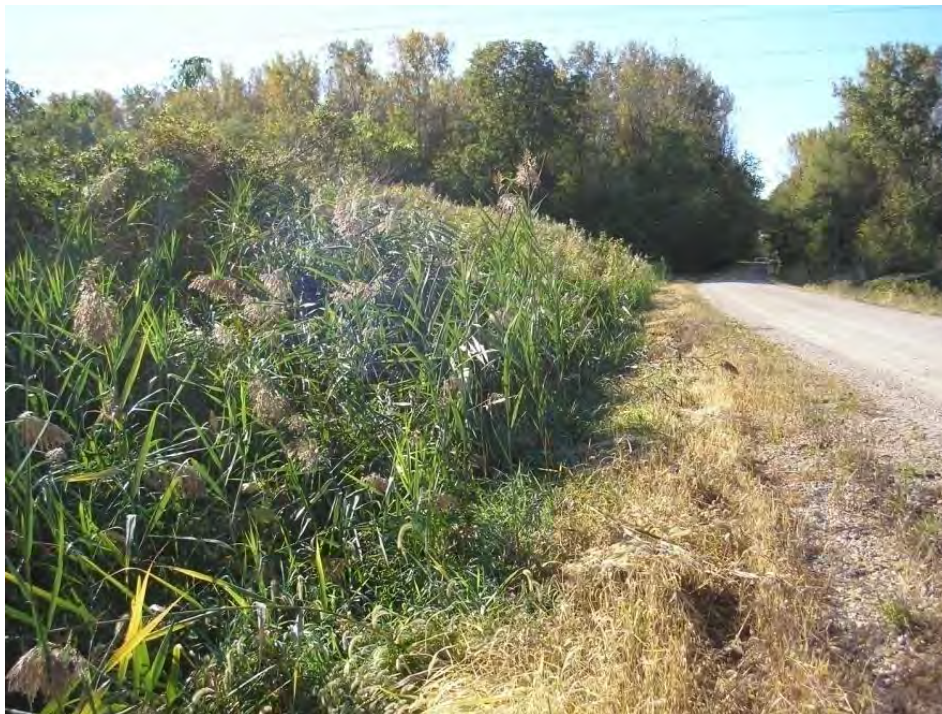
The downstream slope of the Bottom Ash Pond west slope is vegetated with tall plants and small trees. Figure 5.3.3-3 shows conditions along the Bottom Ash Pond west dike downstream embankment. No areas of seepage were observed along the toe of the downstream slope.

Figure 5.3.3-3: Bottom Ash Pond West Dike Downstream Slope

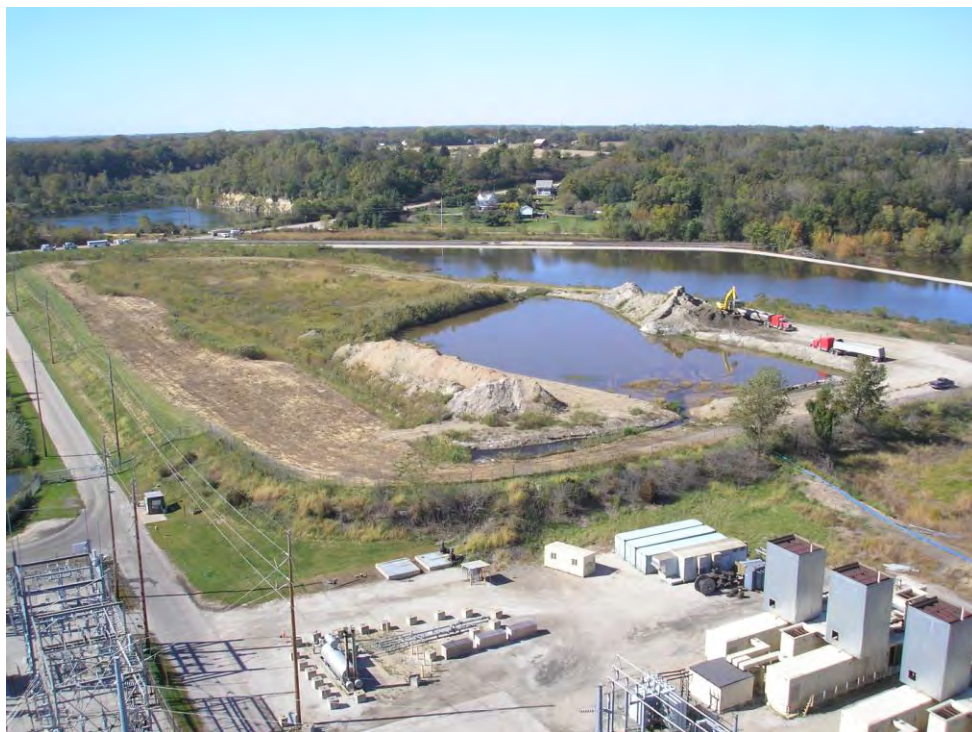
The crest of the Economizer Ash Pond had no signs of significant depressions, tension cracks or other indications of settlements or shear failure. The crest is gravel covered to provide access for service vehicles. Figure 5.4.1-1 shows typical crest conditions. Note that subsequent to this picture, IPL has agreed to minimize the stockpiling of ash and storage of heavy equipment on the north embankment.

Figure 5.4.1-1: Overhead View of Economizer Ash Pond Crest with Dredging Equipment.

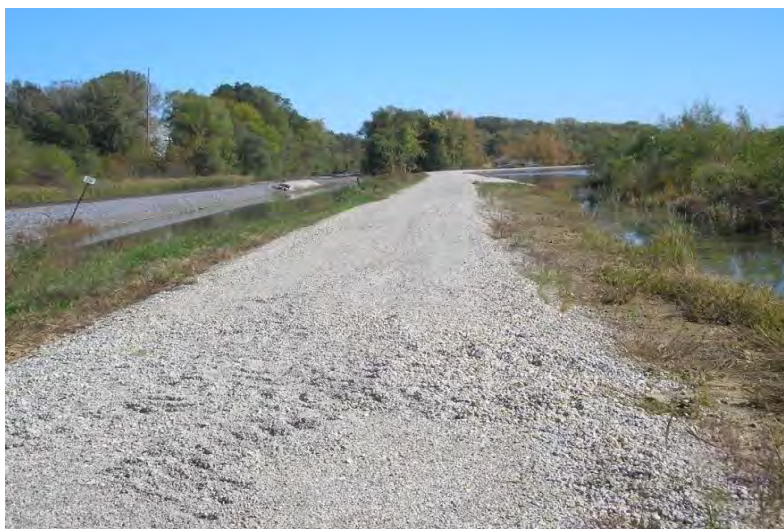
The crest Ash Pond 1 dike had no significant depressions, tension cracks or other indications of settlements or shear failure. The crest of the Ash Pond 1 dike is gravel paved for service vehicle access. Figure 5.5.1-1 shows typical crest conditions.

Figure 5.5.1-1: Ash Pond 1 Crest at Southwest End

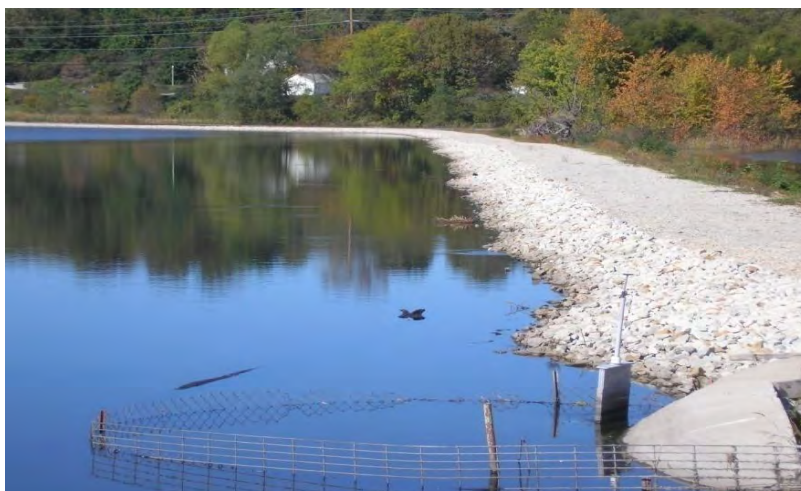
The upstream slope of Ash Pond 1 dike was protected by crushed stone riprap. There were no observed scarps, sloughs, bulging, cracks, depressions or other indications of slope instability. Figure 5.5.2-1 shows a representative section of the upstream slope of the embankment.

Figure 5.5.2-1: Ash Pond 1 Embankment Upstream Slope

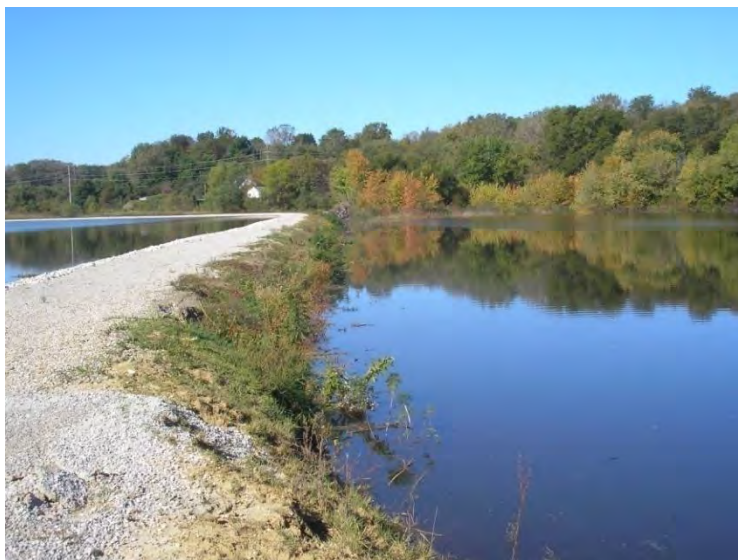
At the east and center portion of Ash Pond 1 the downstream slope is the southern boundary of Ash Pond 2. Above the Ash Pond 2 water level the downstream slope of the embankment is vegetated with small weeds. Figure 5.5.3-1 shows the conditions of the eastern and central portion of Ash Pond 1 dike downstream slope. Ash Pond 2 is on the right side of the photograph.

Figure 5.5.3-1: Ash Pond 1 Dike Central Section Downstream Slope

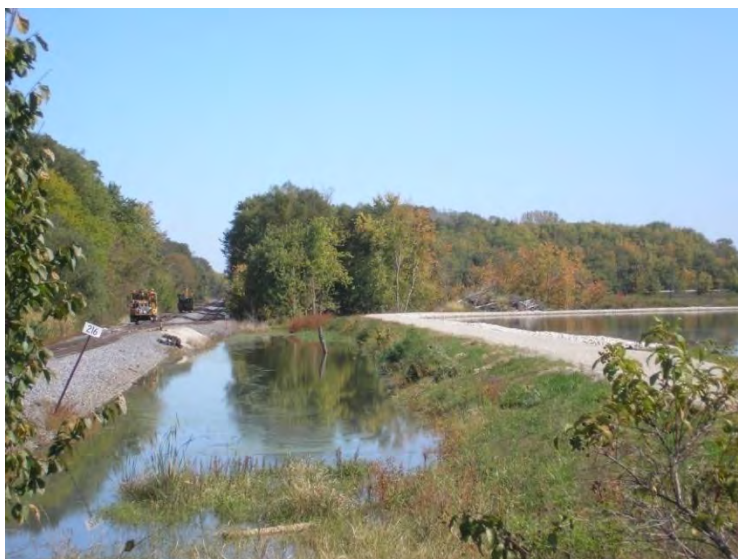
The western portion of the Ash Pond 1 dike is bordered by a railroad drainage ditch. Figure 5.5.3-2 shows the conditions along the western portion of the dike downstream slope.

Figure 5.5.3-2: Ash Pond 1 West Section Downstream Slope

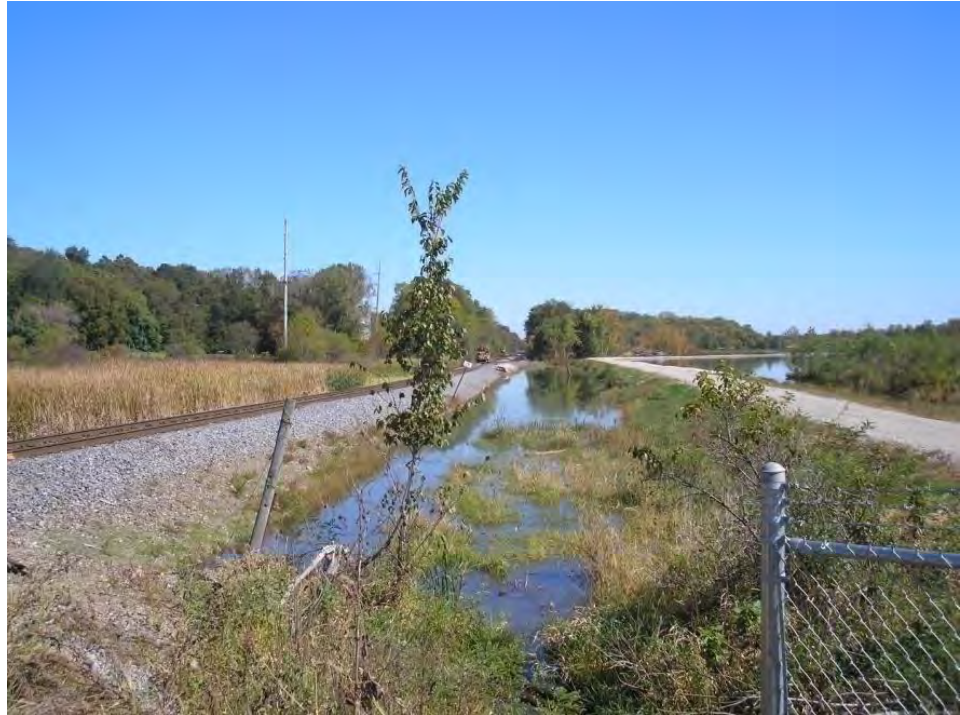
No erosion we observed at the abutments or groins. No seepage was observed above the water elevation at the abutments. Potential seepage below the water level could not be observed. Figure 5.5.4-1 shows conditions at the western abutment.

Figure 5.5.4-1: Ash Pond 1 West Abutment

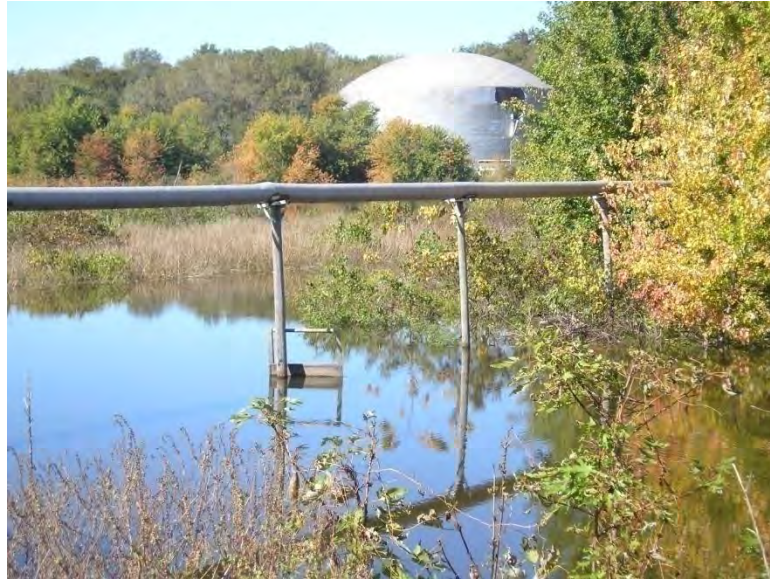
The Ash Pond 2 dike was overtopped by flood waters from the Mississippi river. Flood flow into a drainage way on the discharge side of Ash Pond 2 was back-flowing over the 3-ft. high Ash Pond 2 dike at the time of the site visit. Figure 5.6.1-1 shows the location of the ash pond dike. The elevated pipeline is supported by foundation along the Ash Pond 2 dike crest.

Figure 5.6.1-1: Ash Pond 2 Dike Crest Location beneath Pipe Support Columns.

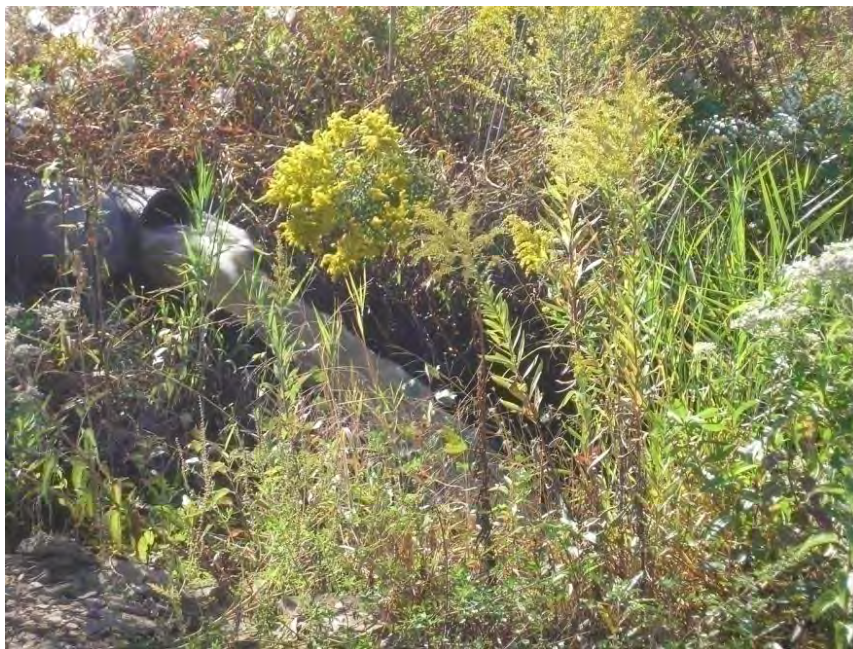
The Economizer Ash Pond spillway pipes also discharge into the interior drainage ditch at the southwest corner of Ash Pond 1. Figure 5.7.2-2 shows the Economizer Ash Pond spillway discharge pipes.

Figure 5.7.2-2: Economizer Ash Pond Spillway Outlet Conduits

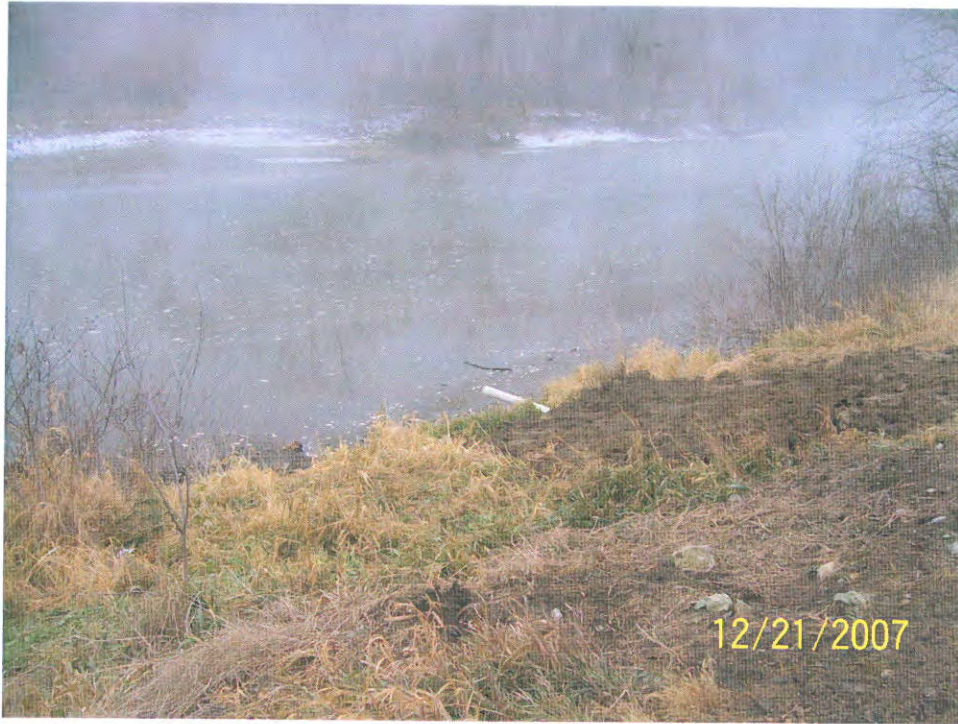
Photograph of drain tile outfall pipe. Old drain tile was determined to be the source of the seep. It was properly plumbed out to daylight so it can be observed in the future.

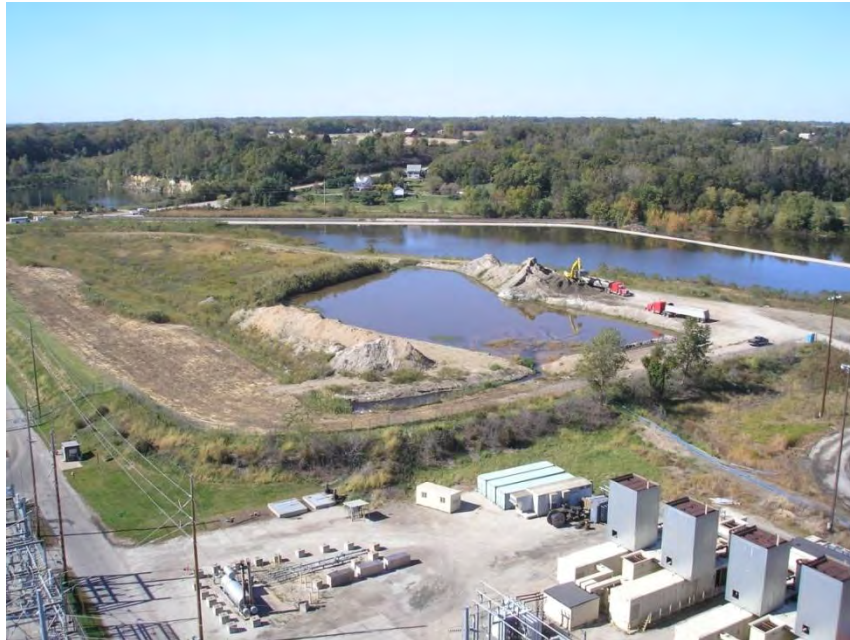
Figure 10.4.1-1” Economizer Ash Pond with Stockpile and Construction Equipment October 7, 2010 (Photo by Dewberry)
