**DRAFT REPORT
ROUND 7 DAM ASSESSMENT - WISCONSIN POWER & LIGHT
COLUMBIA GENERATING STATION
PRIMARY ASH, SECONDARY ASH, POLISHING & LANDFILL
STORMWATER PONDS
PARDEEVILLE, WISCONSIN**

January 17, 2011

Re: Round 7 Dam Assessment - Draft Report
EPA Contract No. EP10W001313
Wisconsin Power & Light – Columbia Generating Station
Primary Ash, Secondary Ash, Polishing & Landfill Storm Water Ponds
Pardeeville, Wisconsin

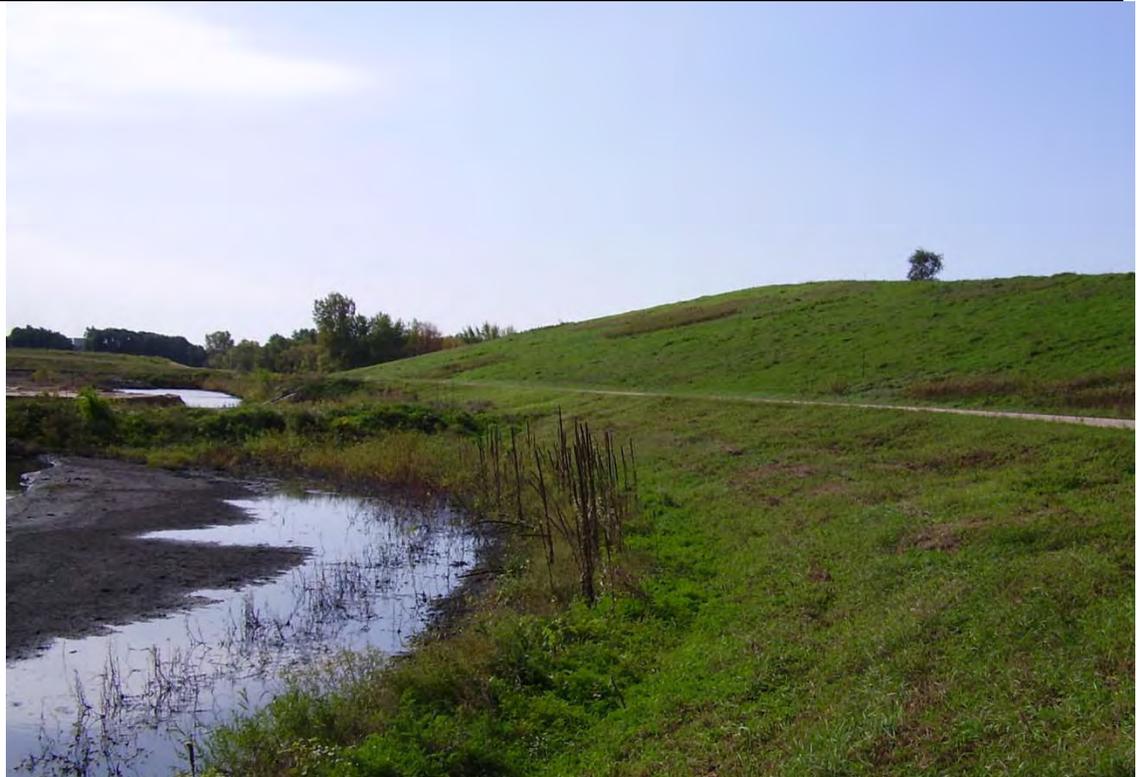
Description:
Upstream slope of Primary Ash Pond Impoundment (PAP).

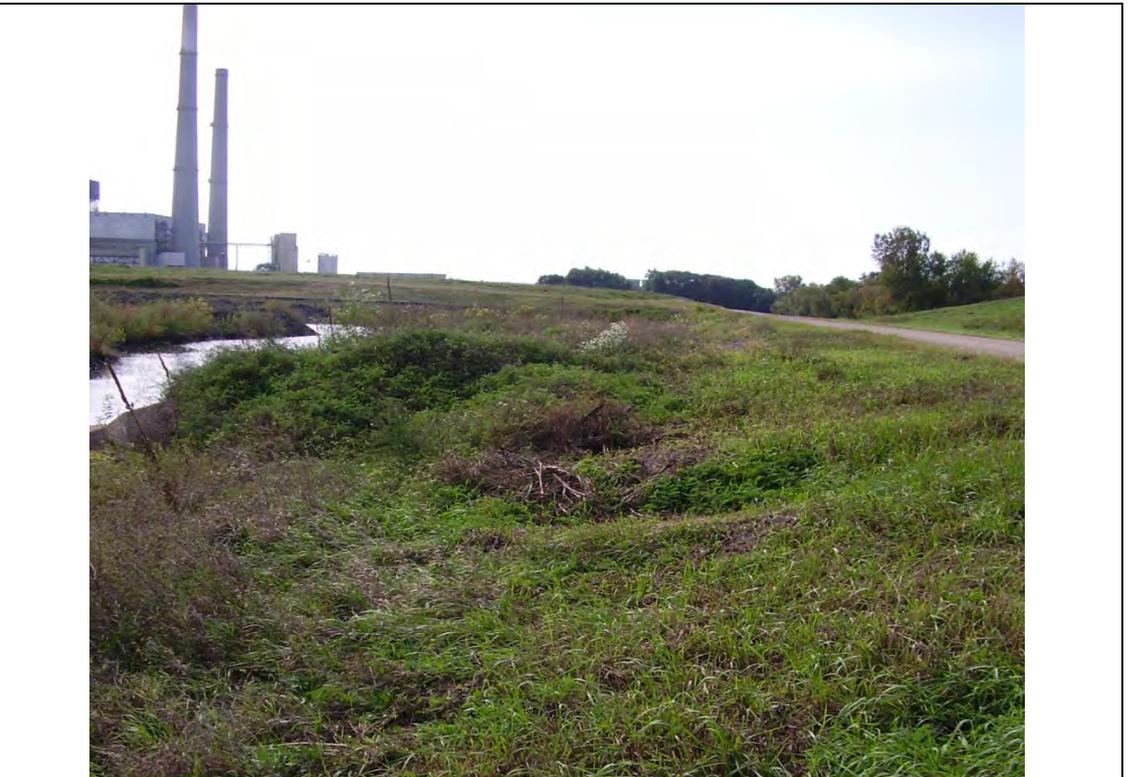
Photo No. 2	Date: 9/28/10
-----------------------	-------------------------

Description:
Upstream slope of PAP.

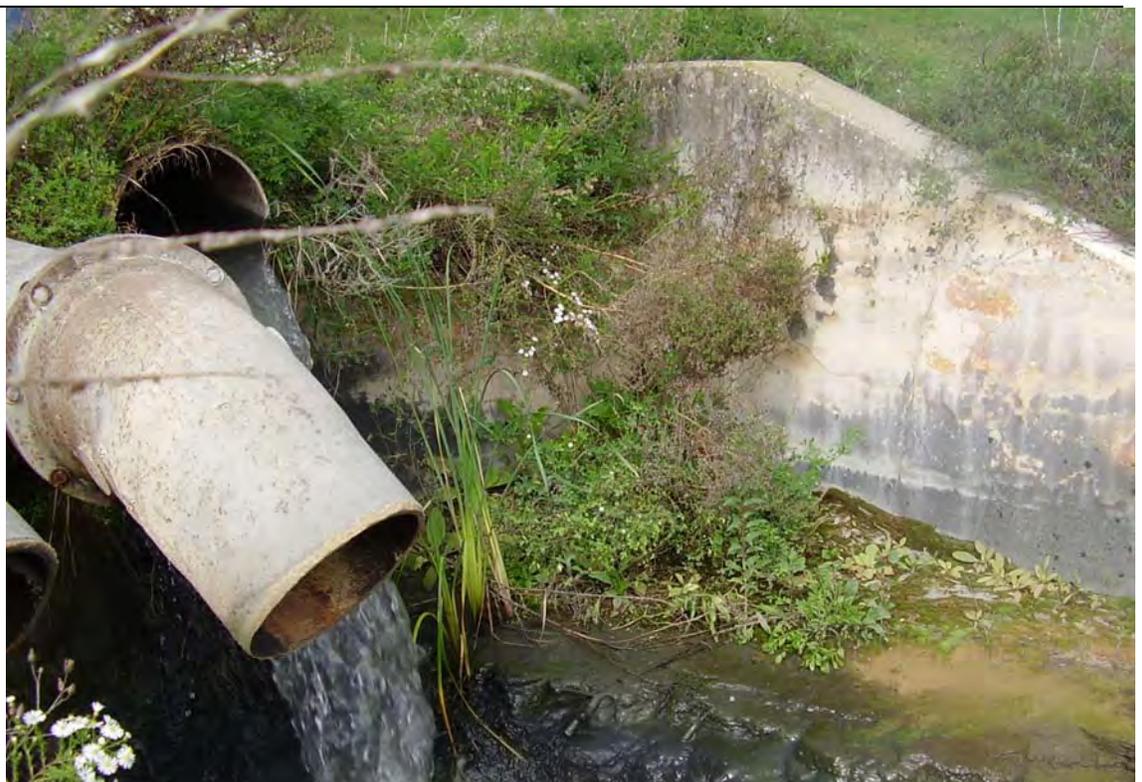
Photo No. 4	Date: 9/28/10
Direction Photo Taken: Northwest

Description:
Discharge Pipeline (behind
12" Diameter pipeline):
(1) 18" Diameter in PAP

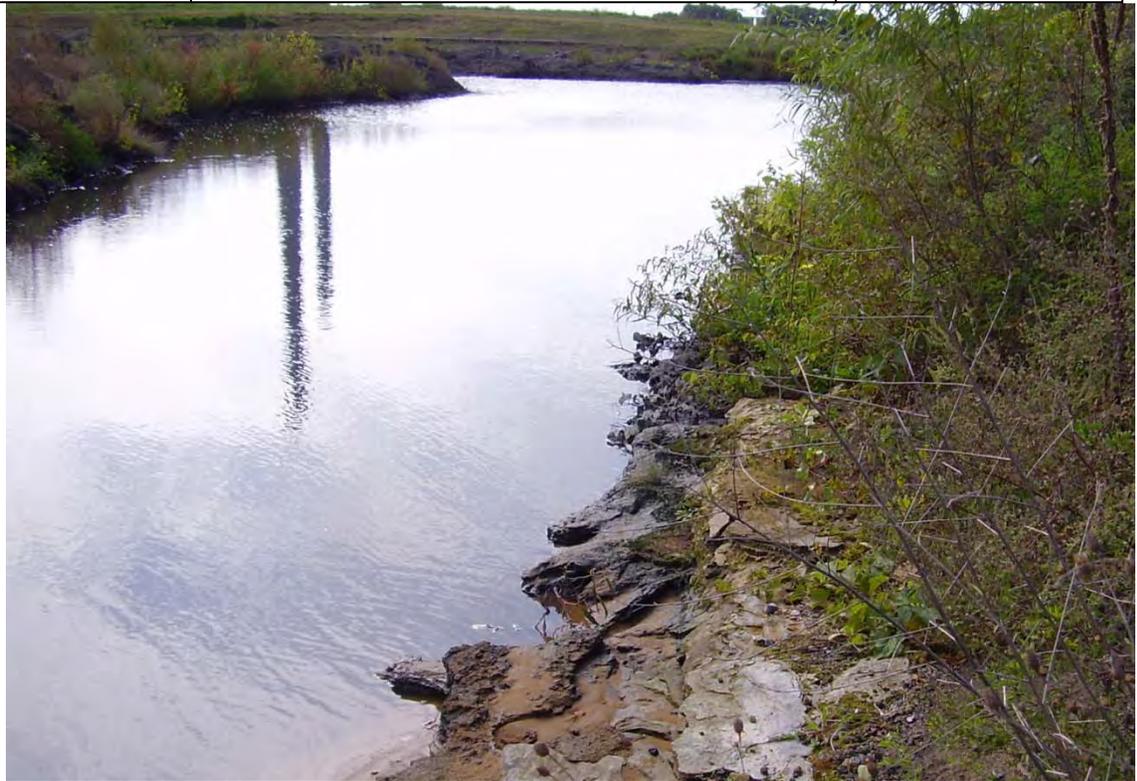
Description:
Upstream slope of PAP.

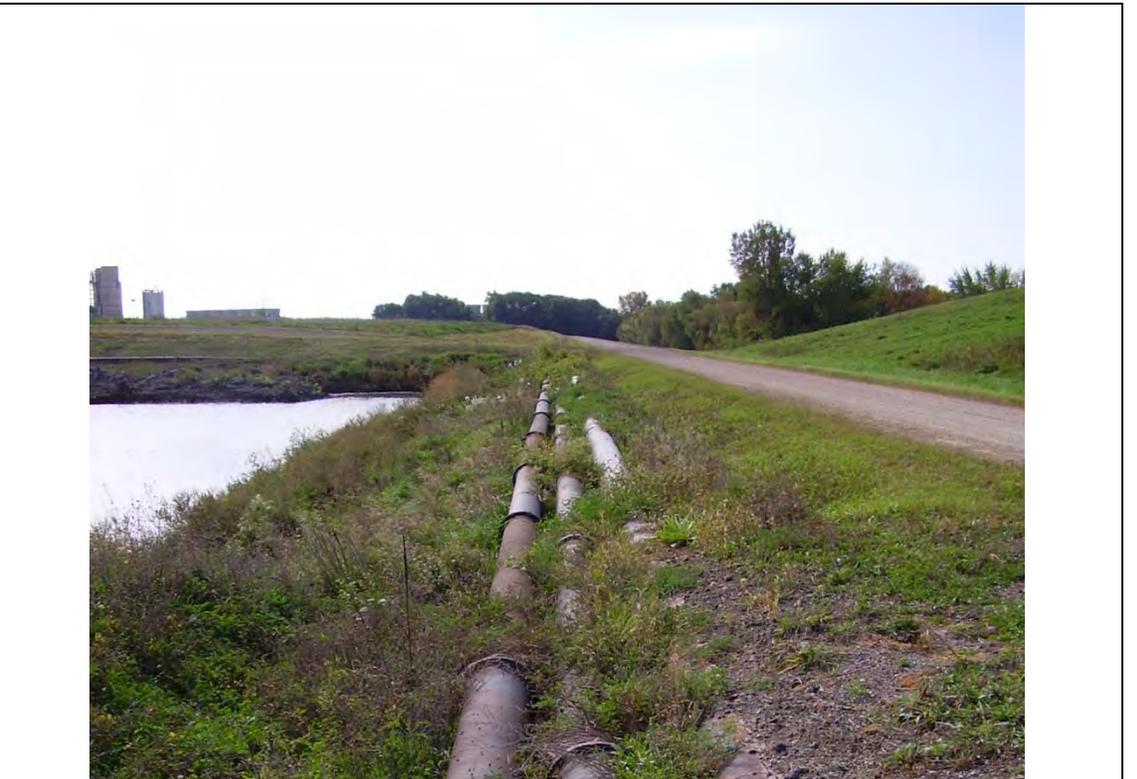
Photo No.
6

Description:
Upstream slope, top of
embankment of PAP, and
discharge pipelines.

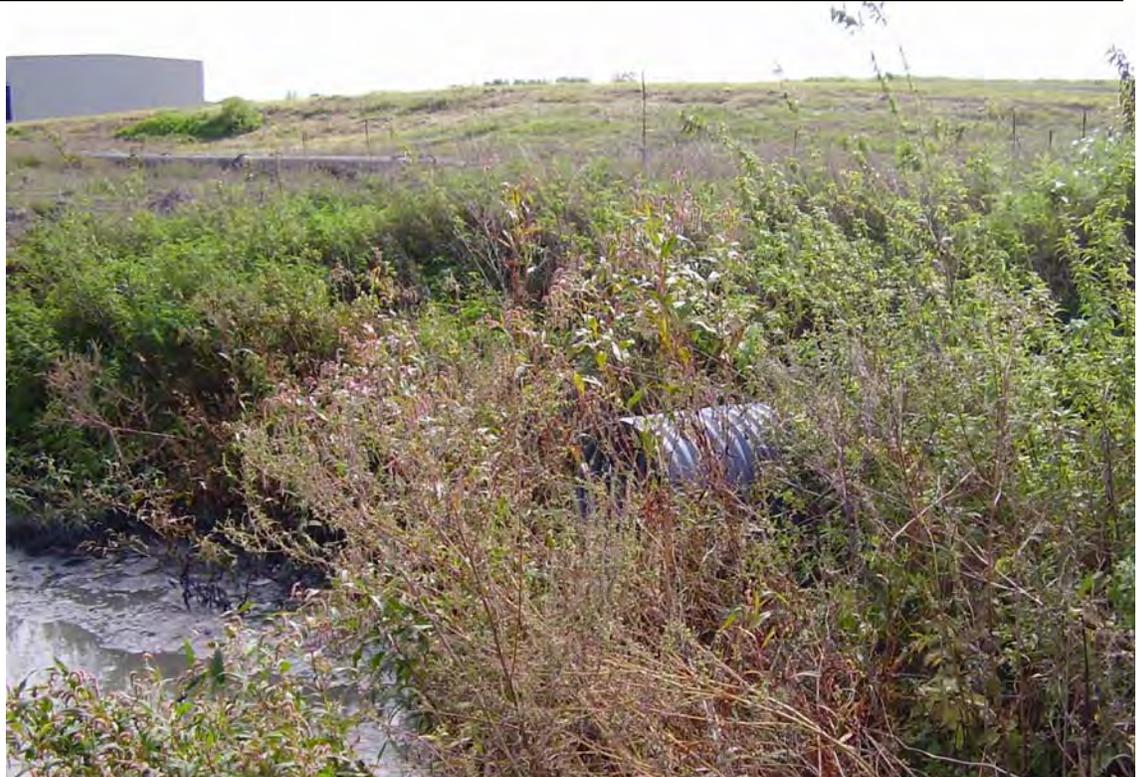
Photo No. 7	Date: 9/28/10
Direction Photo Taken: Southeast

Description:
Upstream slope of PAP and water treatment sump discharge pipeline:
(1) 24" Diameter.

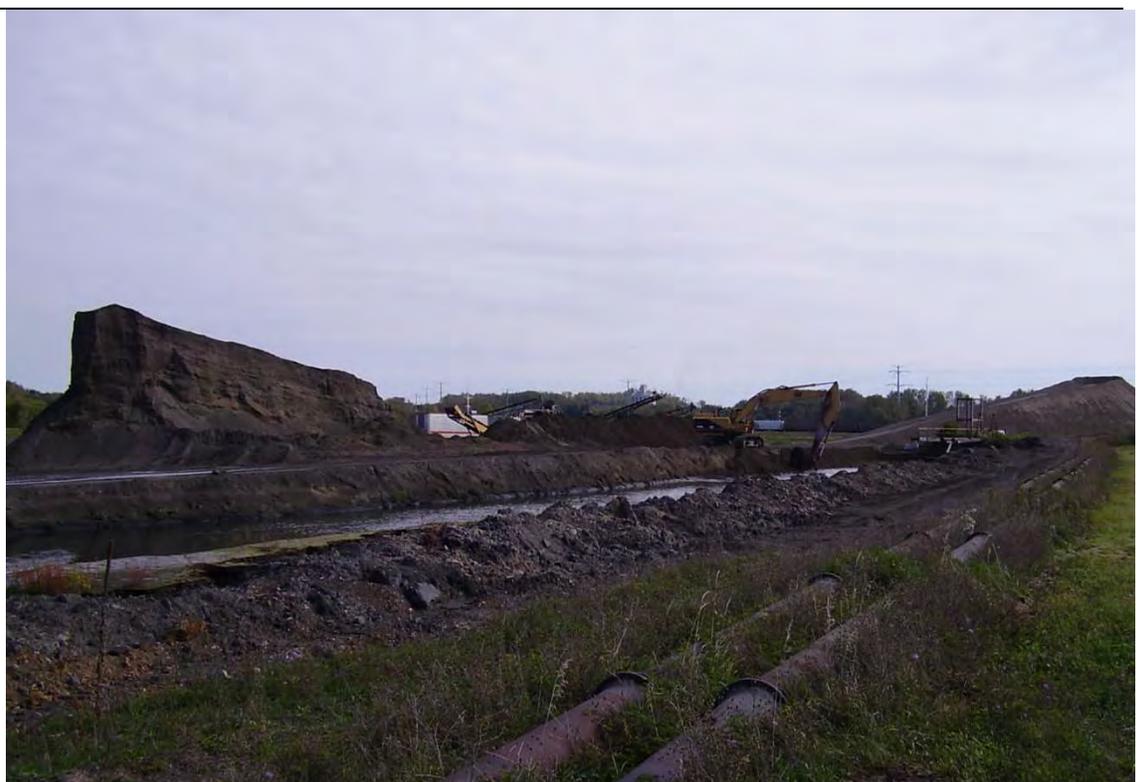
Photo No. 8	Date: 9/28/10
Direction Photo Taken: East

Description:
Upstream slope of PAP, ash recovery operations, and discharge pipelines.

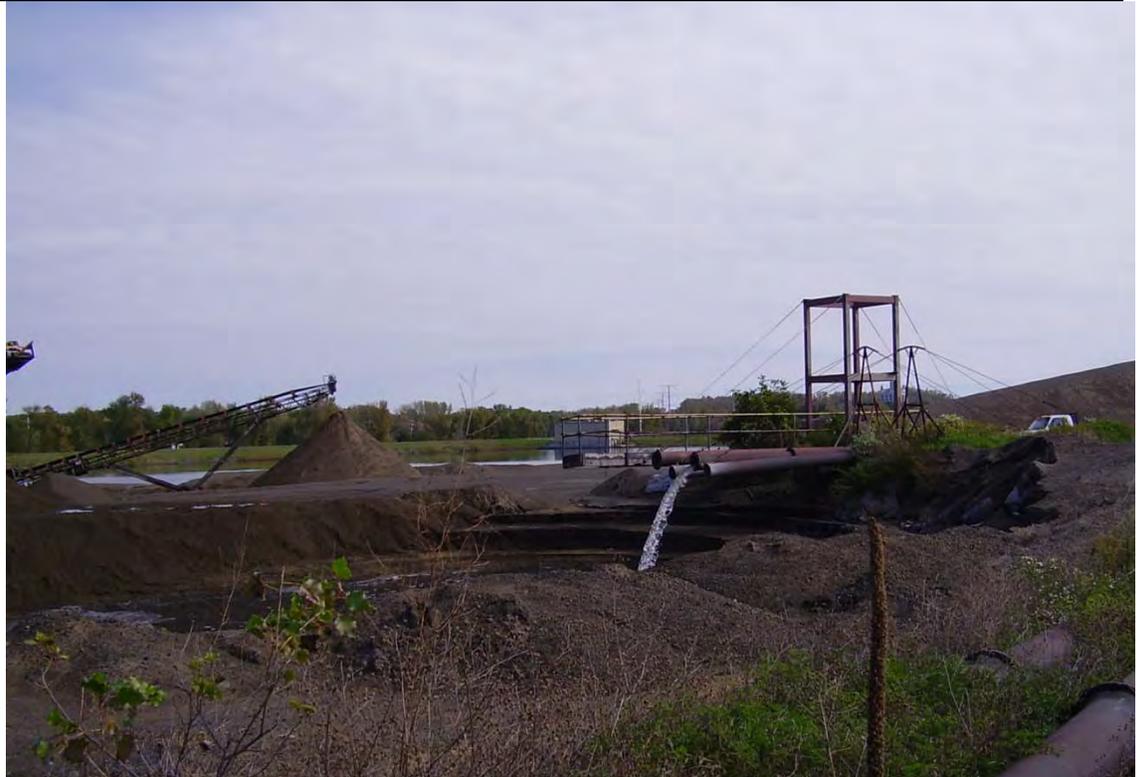
Photo No. 9	Date: 9/28/10
Direction Photo Taken: Northeast

Description:
Discharge Pipelines in southeast portion of PAP:
(2) 12" Diameter,
(2) 8" Diameter.

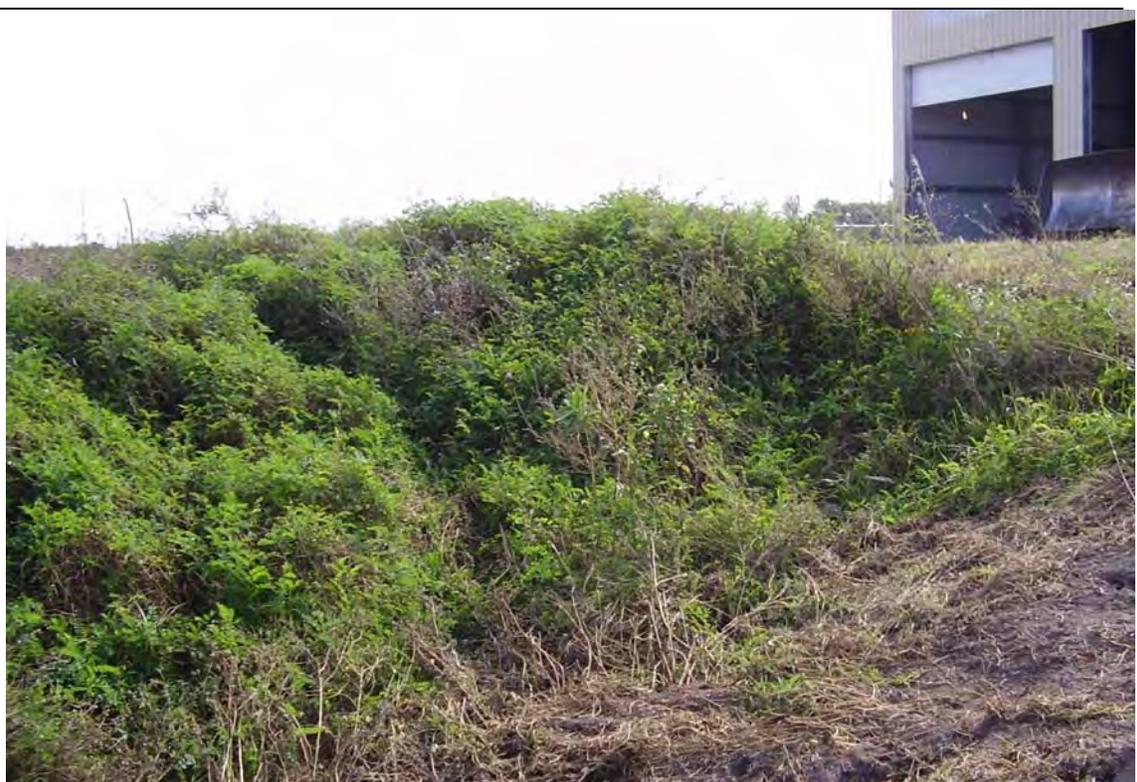
Photo No. 10	Date: 9/28/10
Direction Photo Taken: Southeast

Description:
Upstream slope of PAP.

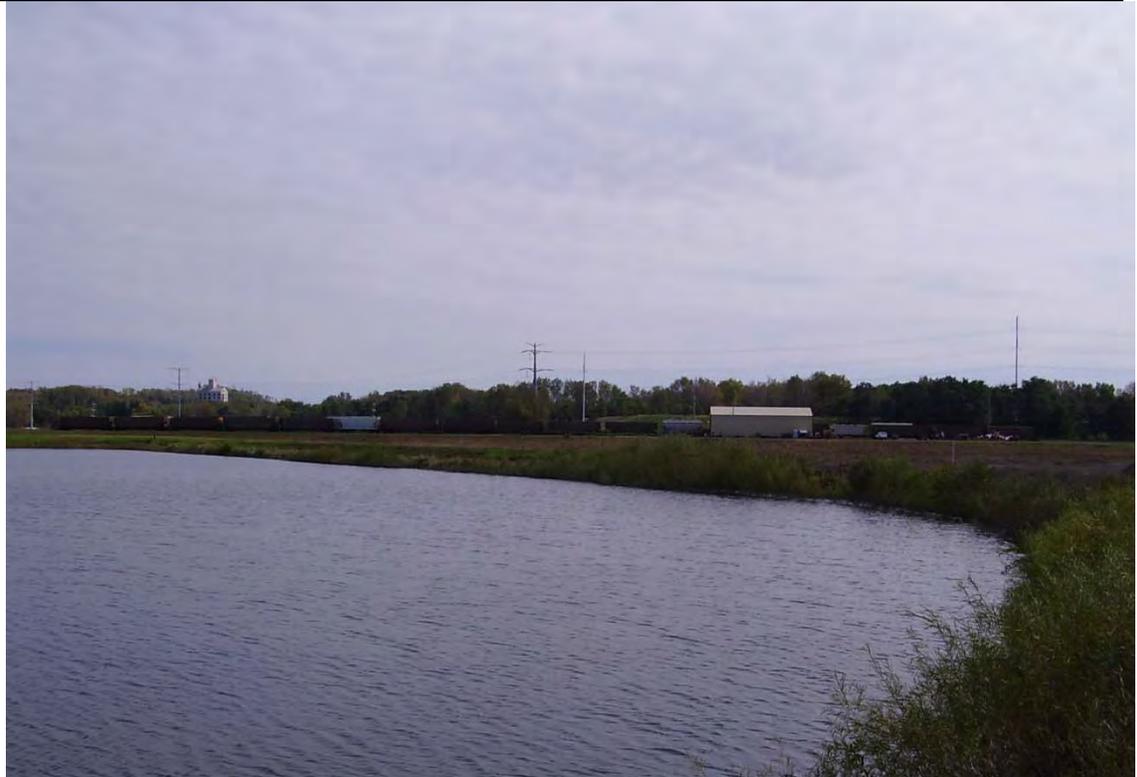
Photo No. 13	Date: 9/28/10
Direction Photo Taken: Northeast

Description:
Upstream slope of PAP and downstream slope of Secondary Ash Pond Impoundment (SAP).

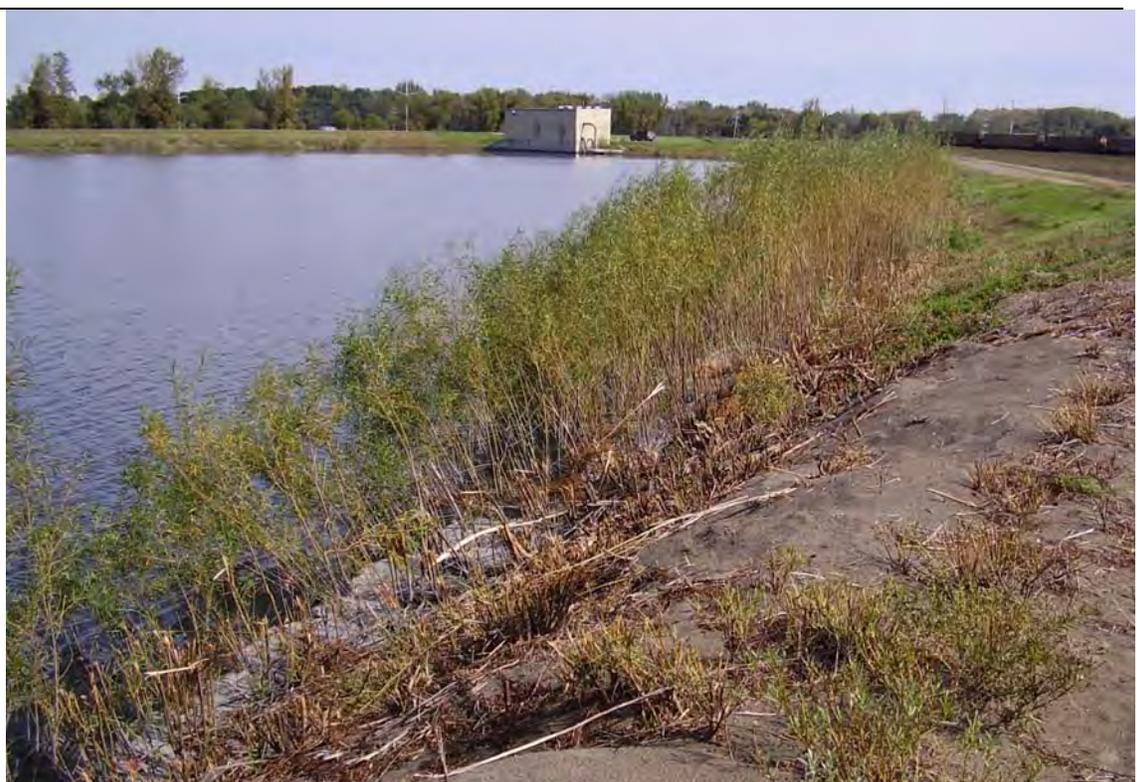
Photo No. 14	Date: 9/28/10
Direction Photo Taken: Northeast

Description:
Upstream slope of PAP, downstream slope of SAP and PAP pump house.

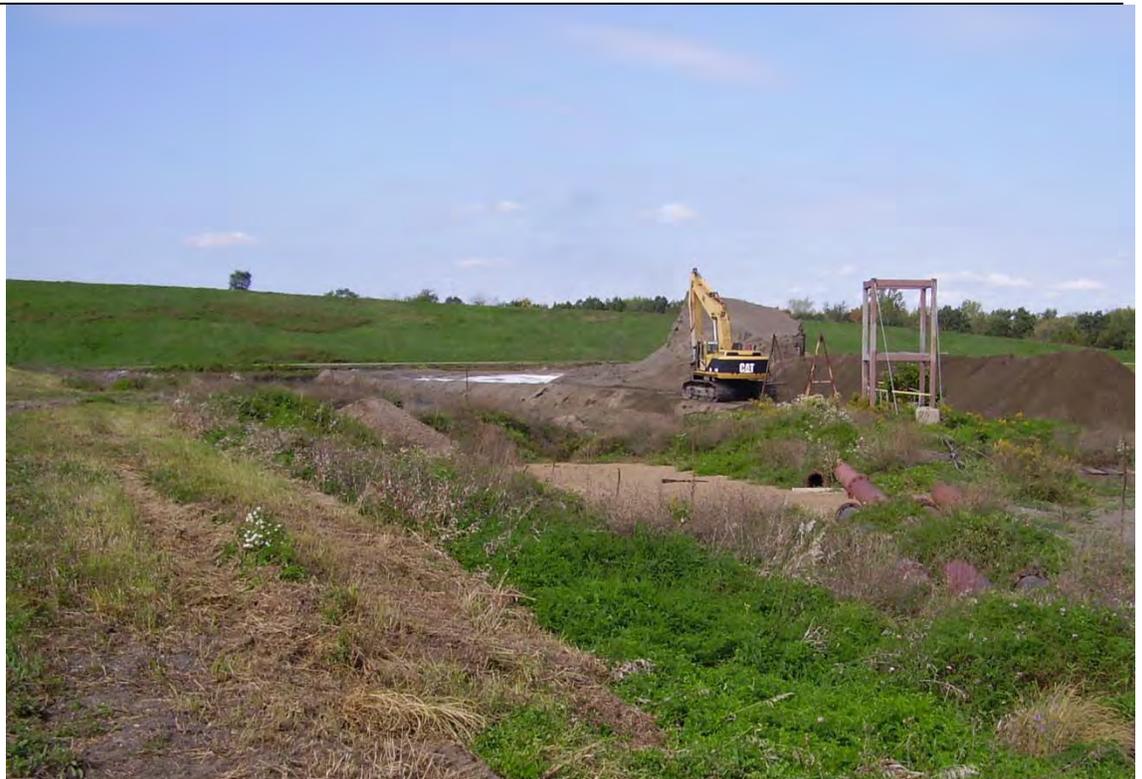
Photo No.
22

Description:
Crest of PAP.

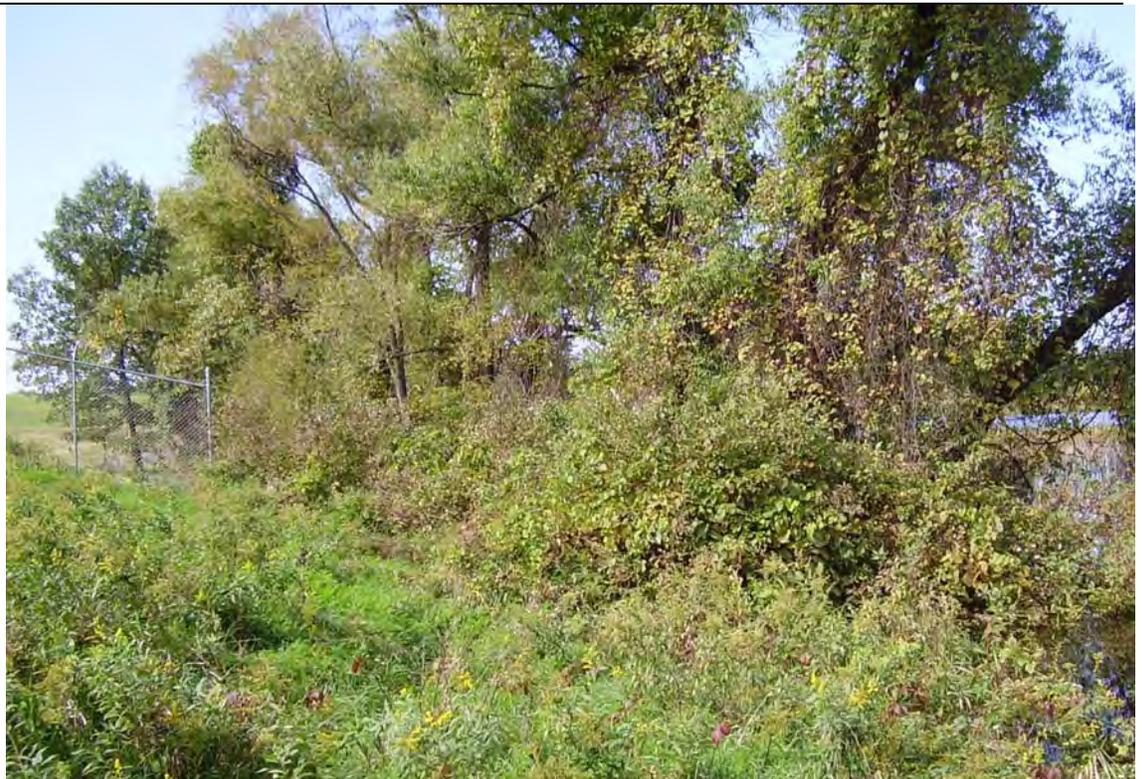
Photo No.
94

Description:
SAP downstream slope.
